HISTORIC AND DESIGN REVIEW COMMISSION

March 06, 2024

HDRC CASE NO: 2024-076
ADDRESS: 825 BURLESON ST
LEGAL DESCRIPTION: NCB 1301 BLK 2 LOT 20
ZONING: R-5, H
CITY COUNCIL DIST.: 2
DISTRICT: Dignowity Hill Historic District
APPLICANT: Vanessa Shelton/MORGAN KEITH & SHELTON VANESSA
OWNER: Vanessa Shelton/MORGAN KEITH & SHELTON VANESSA
TYPE OF WORK: Column replacement, column removal (pilaster)
APPLICATION RECEIVED: February 16, 2024
60-DAY REVIEW: April 16, 2024
CASE MANAGER: Jessica Anderson

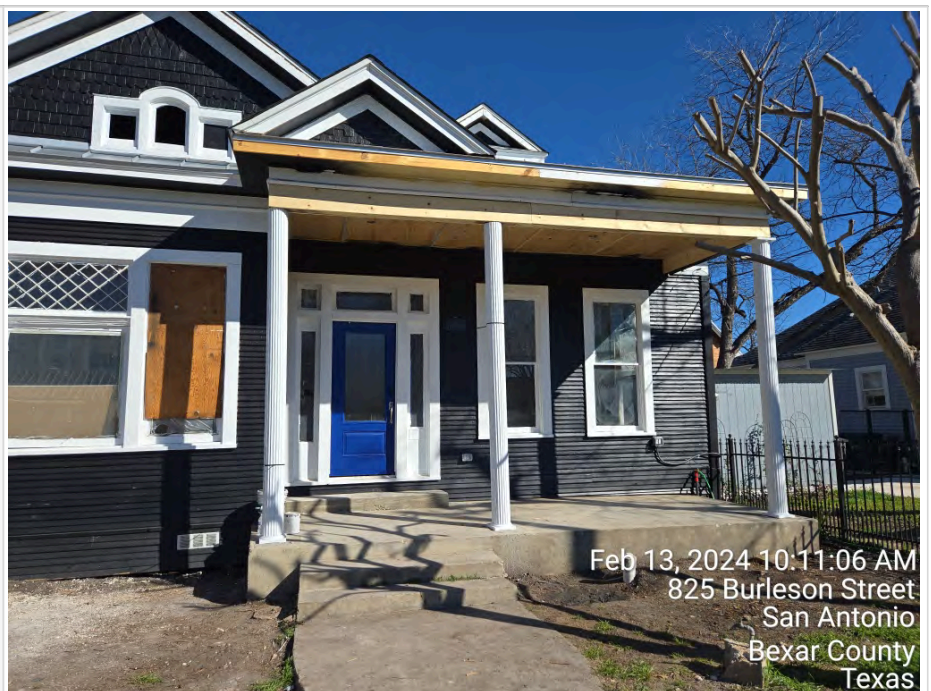
02/13/2024 10:54 AM
--	---------------------

Date	02/13/2024
Time	10:48 AM (-6 GMT)
Context	drive-by
Present Staff	Jessica Anderson
Present Individuals	None
Types of Work Observed	Exterior Maintenance and Alterations
Amount of Work Completed	Completed
Description of work	Installation of nonconforming front-porch columns.
Description of interaction	No one on site. Staff took timestamped photo from right of way.

Violation Type	No Certificate of Appropriateness (Code 35-451a)
OHP Action	No Action Taken/Photos Only
Will post-work application fee apply?	To be determined

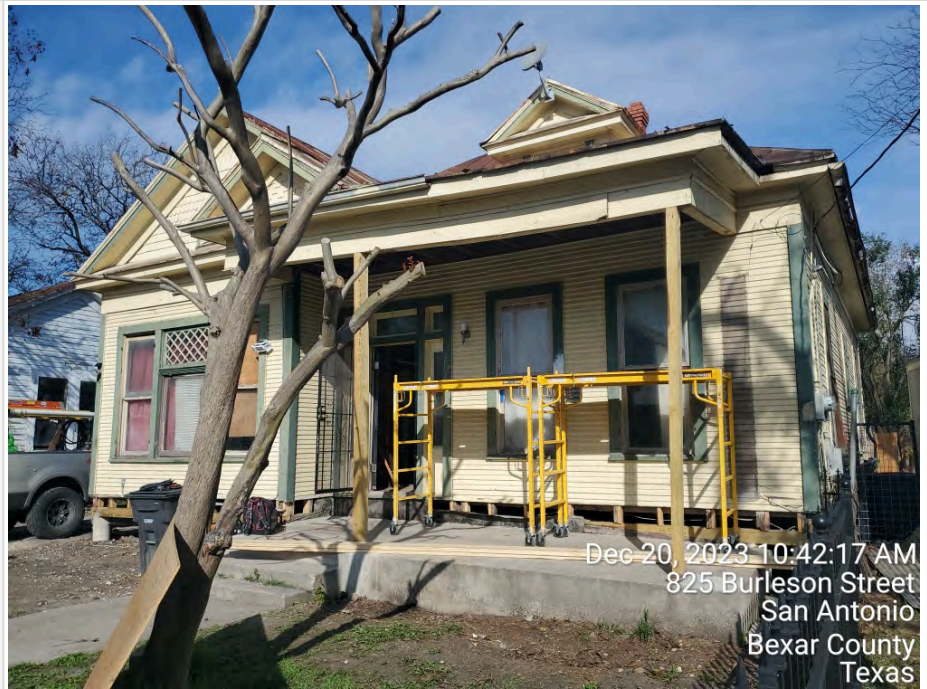
12/20/2023 10:46 AM

Date	12/20/2023
Time	10:42 AM (-6 GMT)
Context	drive-by
Present Staff	Jessica Anderson
Present Individuals	Homeowner, Contractor(s)
Contractor/Realtor Companies	Lopez Custom Work
Types of Work Observed	Exterior Maintenance and Alterations
Amount of Work Completed	50%
Description of work	Front porch column removal
Description of interaction	Spoke with property owner, who says the columns fell in the course of foundation work. She stated she was told she only needed a COA if she intended to replace the columns. She stated she intends to continue work despite staff issuing a Stop Work Order. Also said she will submit application for COA today.

Violation Type	No Certificate of Appropriateness (Code 35-451a)
OHP Action	Spoke with property owner
Will post-work application fee apply?	To be determined

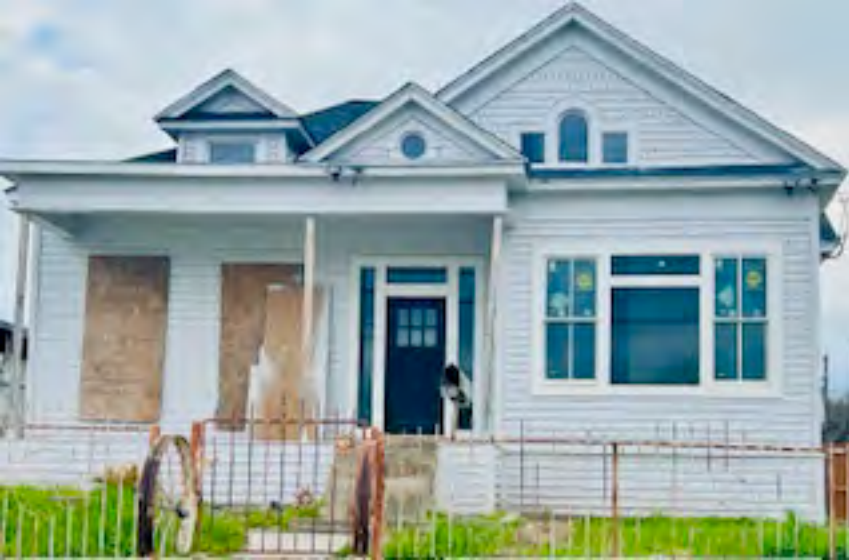
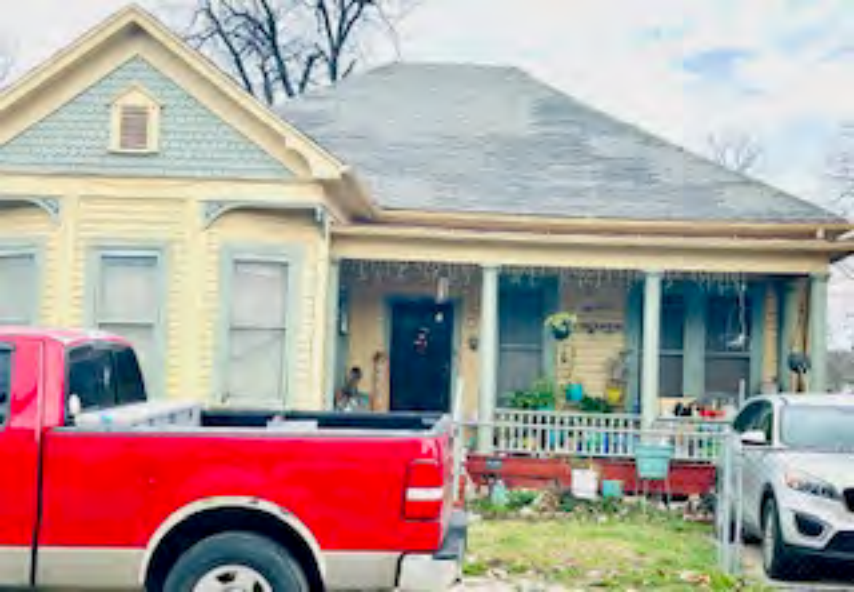
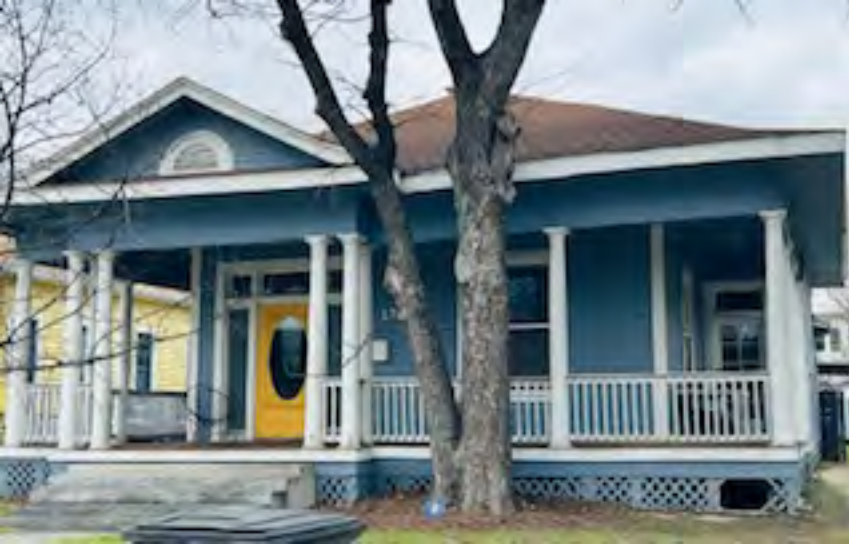
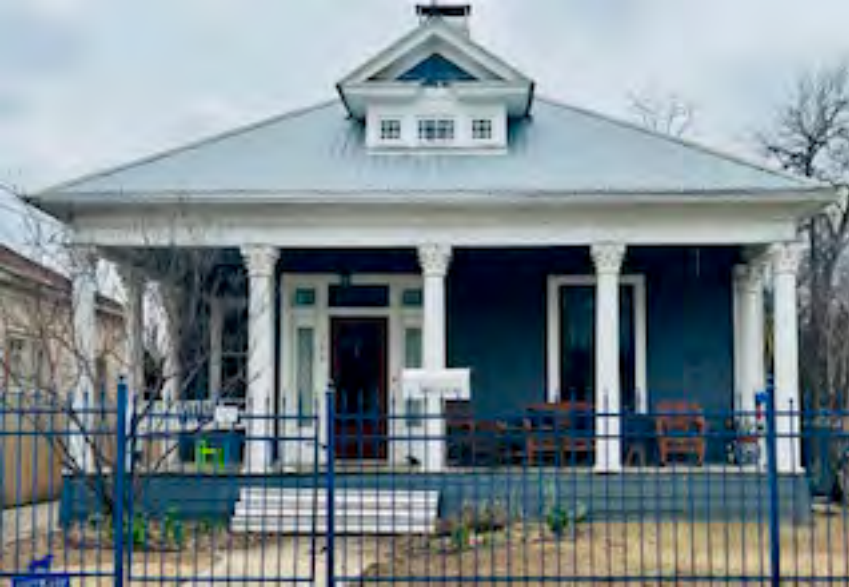
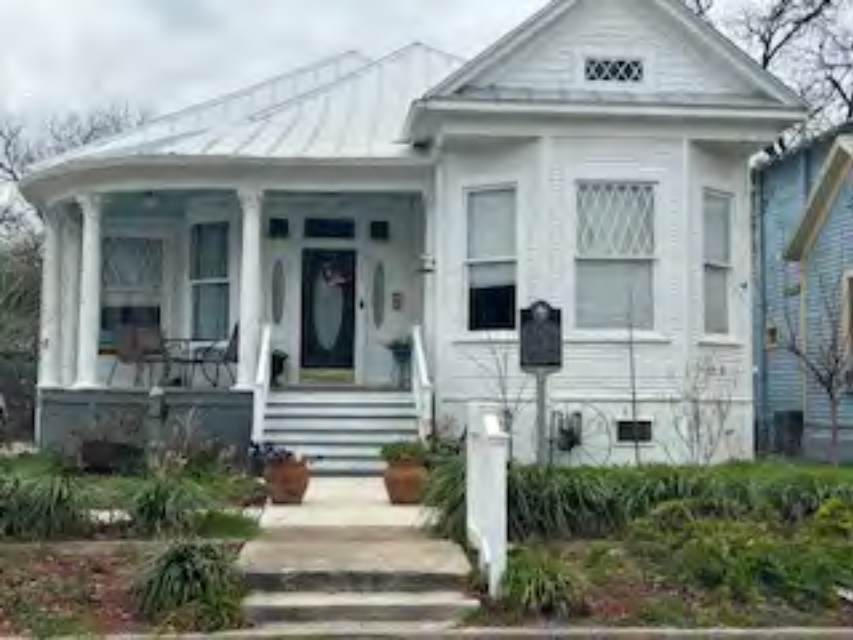
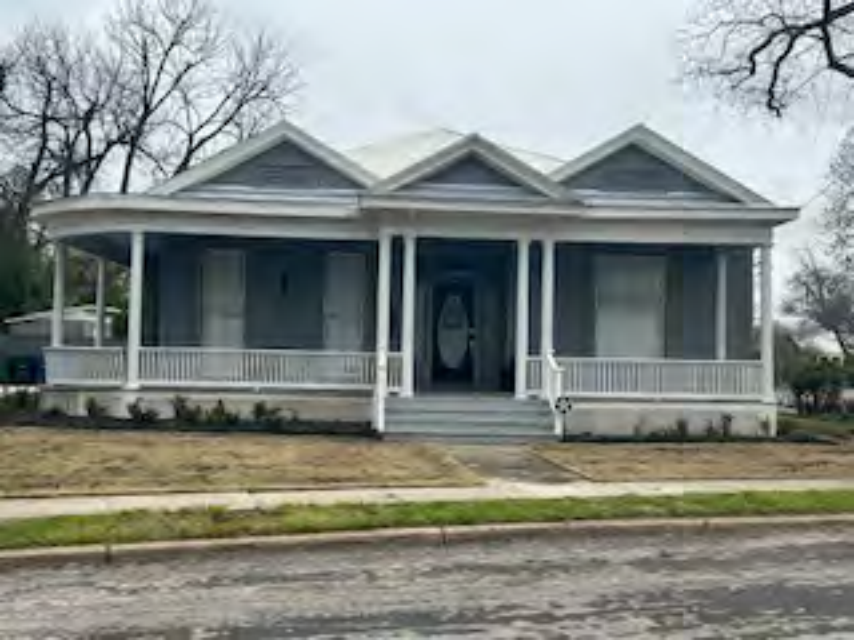
Column conditions on other houses
submitted by applicants
