HISTORIC PRESERVATION

**504 N Hackberry St
Dignowity Hill Historic District**

BOA-24-10300035

April 15, 2024

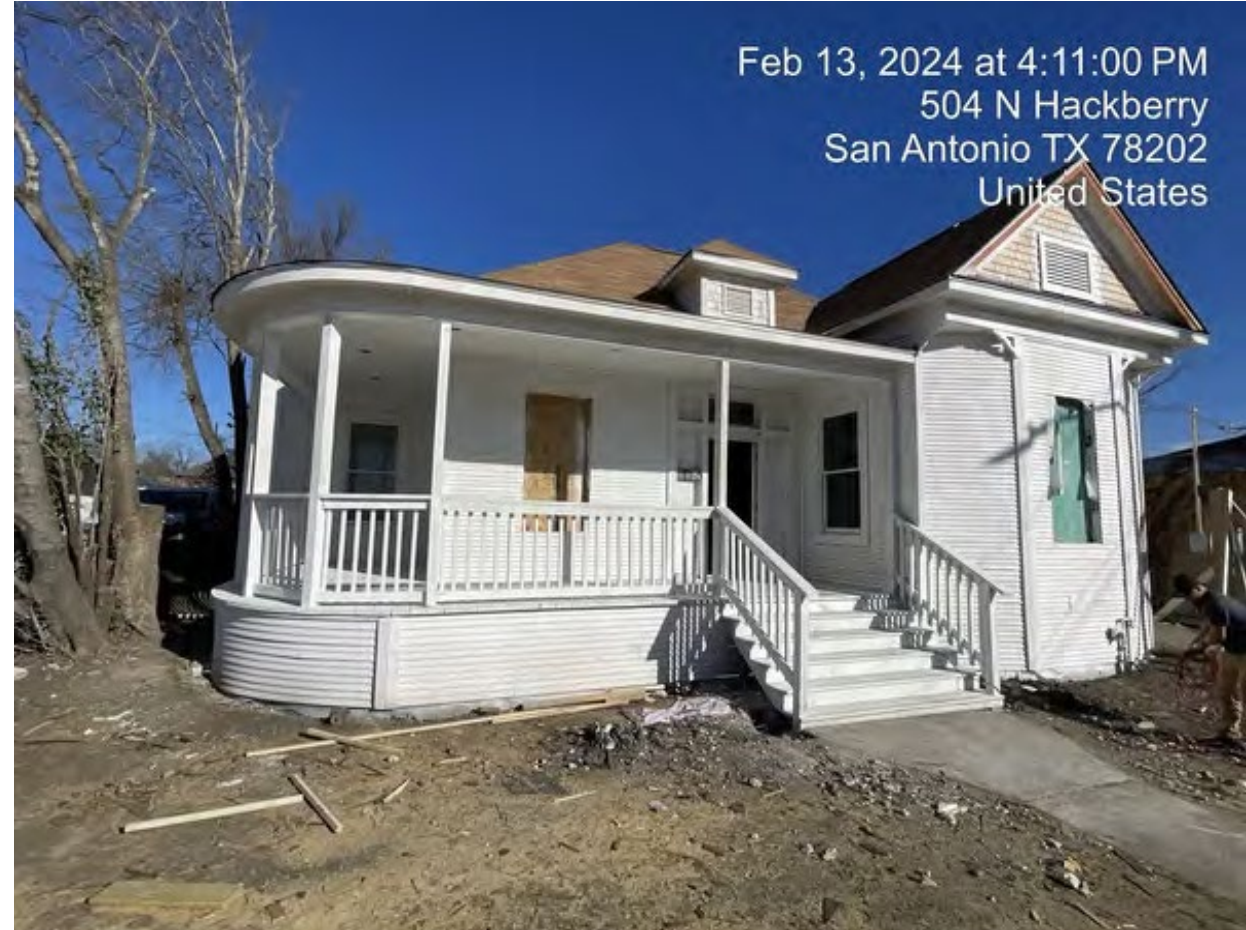
After

- c. SITE VISIT – On February 13, 2024, staff conducted a site visit to take current photos of the structures condition. The photos taken show the modifications made as described in finding b.
