## HISTORIC AND DESIGN REVIEW COMMISSION

March 20, 2024

**HDRC CASE NO:** 2024-106  
**ADDRESS:** 2619 MCCULLOUGH AVE  
**LEGAL DESCRIPTION:** NCB 1704 BLK 12 LOT N1-2 OF 12 & 13  
**ZONING:** O-1, H  
**CITY COUNCIL DIST.:** 1  
**DISTRICT:** Monte Vista Historic District  
**APPLICANT:** Bertha Zuniga/Zuniga Law, PLLC  
**OWNER:** Bertha Zuniga/Zuniga Law, PLLC  
**TYPE OF WORK:** Fenestration modifications and infill of eight wood windows  
**APPLICATION RECEIVED:** March 07, 2024  
**60-DAY REVIEW:** May 6, 2024  
**CASE MANAGER:** Claudia Espinosa

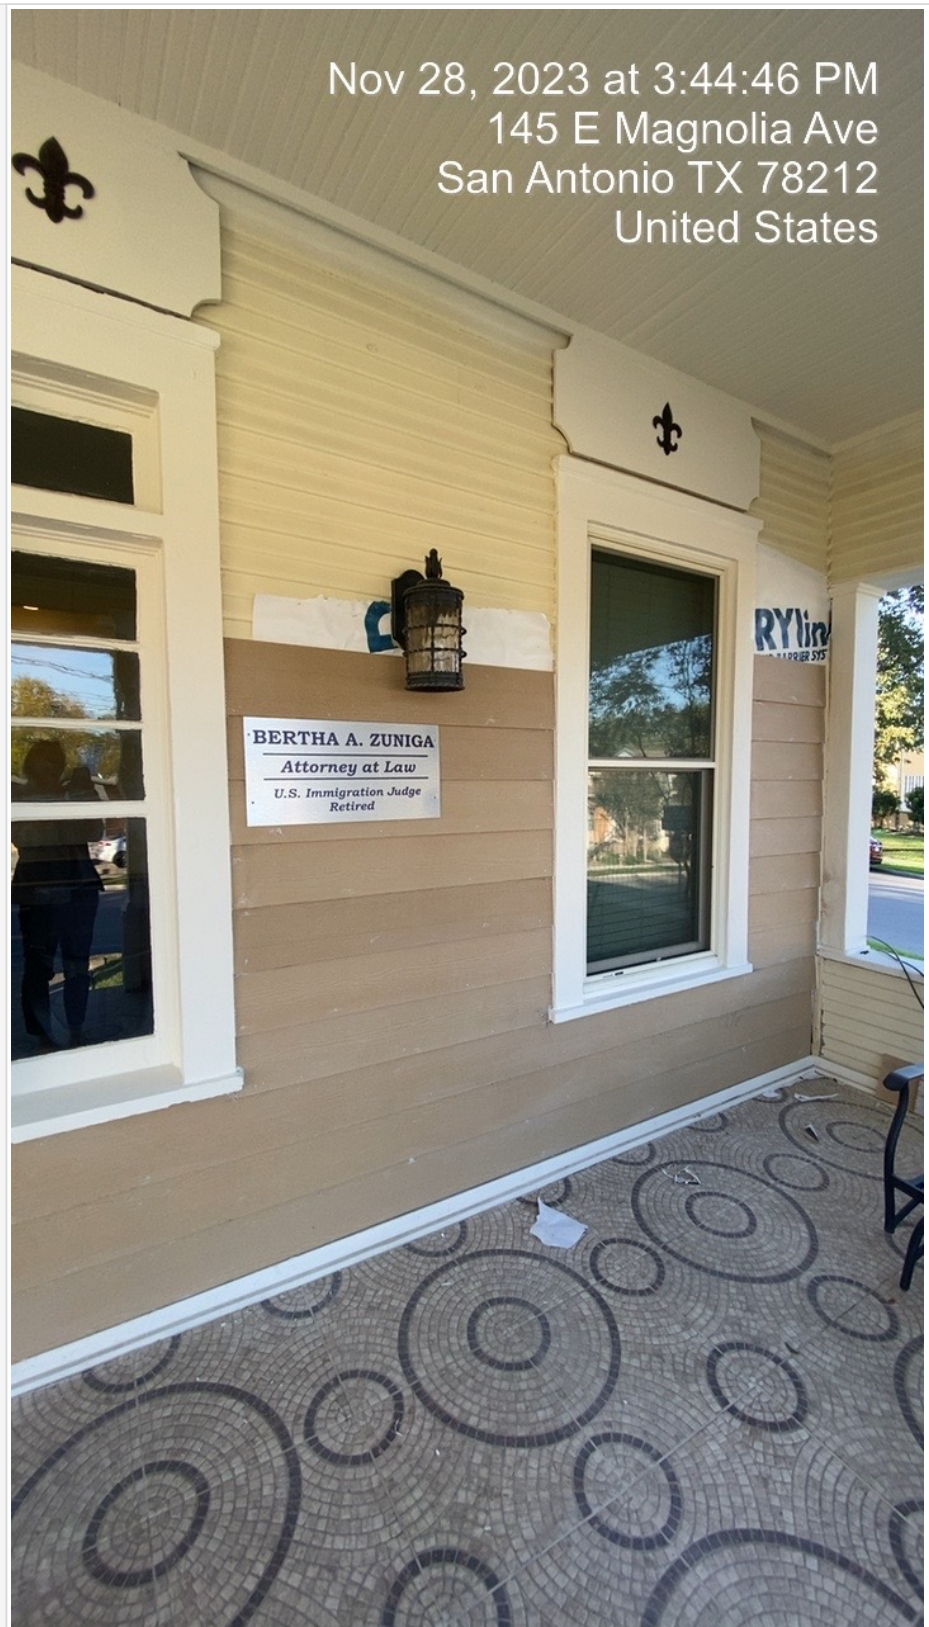
Date	11/28/2023
Time	03:46 PM (-6 GMT)
Context	citizen report
Present Staff	Rachel Rettaliata
Present Individuals	Other
Types of Work Observed	Exterior Maintenance and Alterations
Amount of Work Completed	Initiated
Description of work	Installation of siding on top of existing siding.
Description of interaction	Left Stop Work Order with receptionist.

Violation Type	No Certificate of Appropriateness (Code 35-451a)
OHP Action	Spoke with neighbor/family/tenant, Posted additional "Stop Work Notice"
Will post-work application fee apply?	No

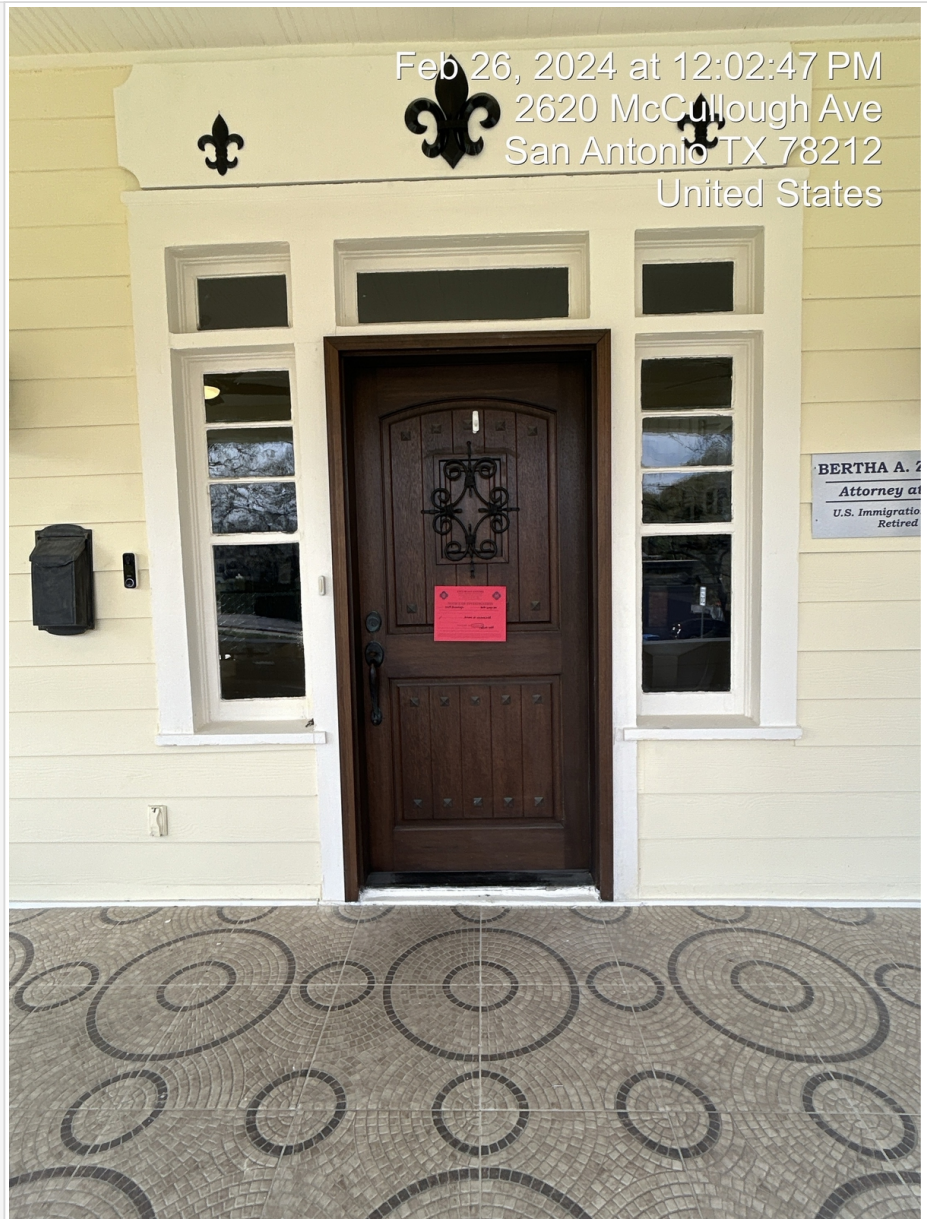
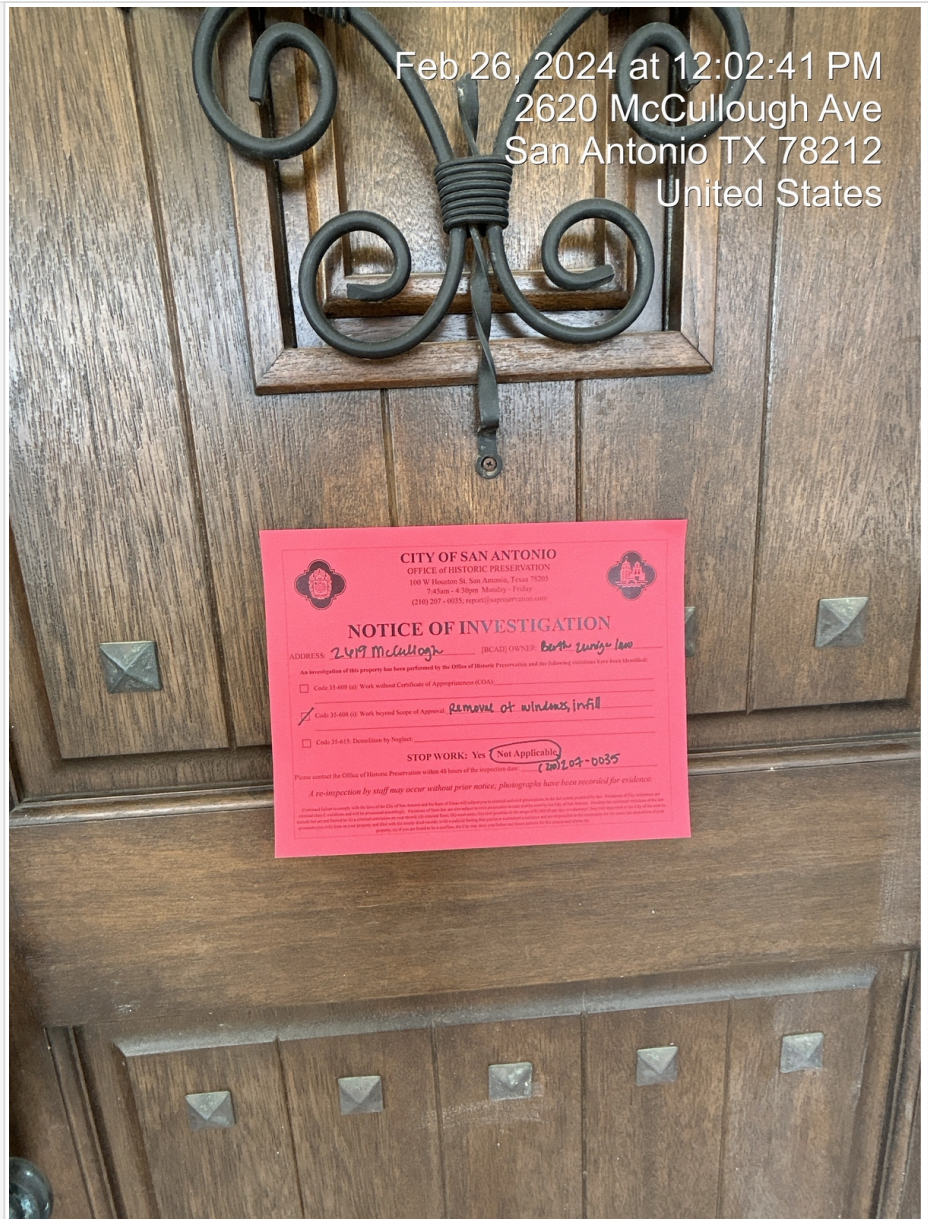
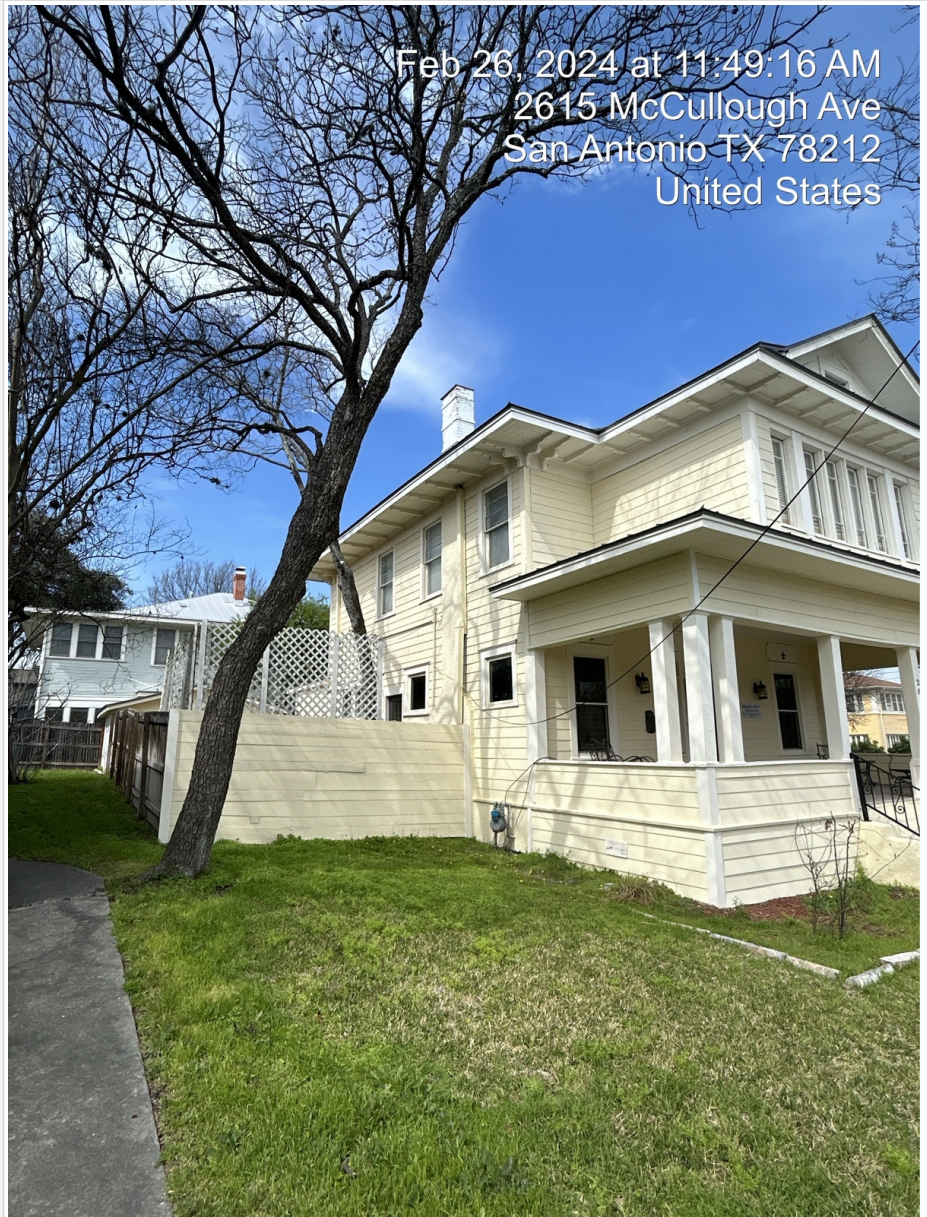
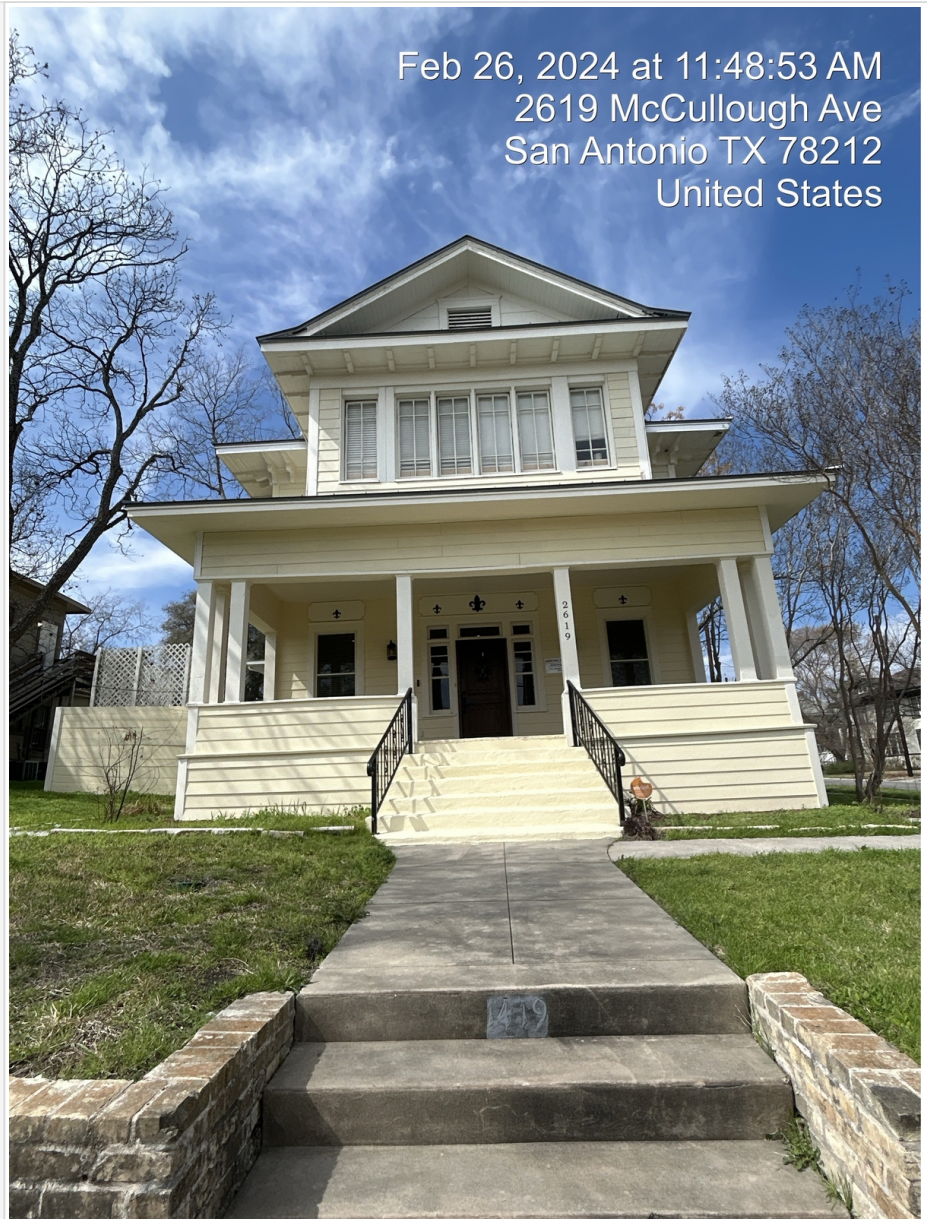
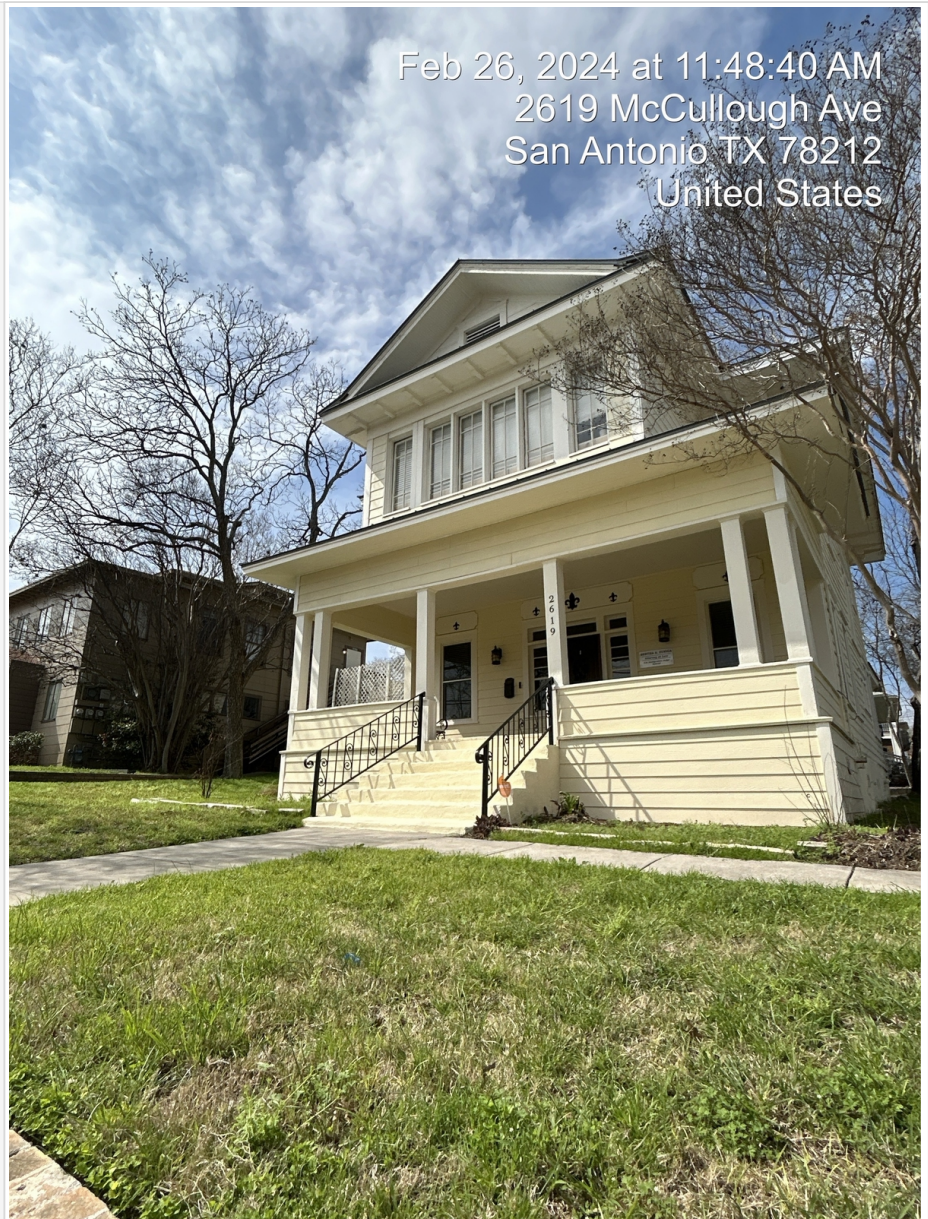
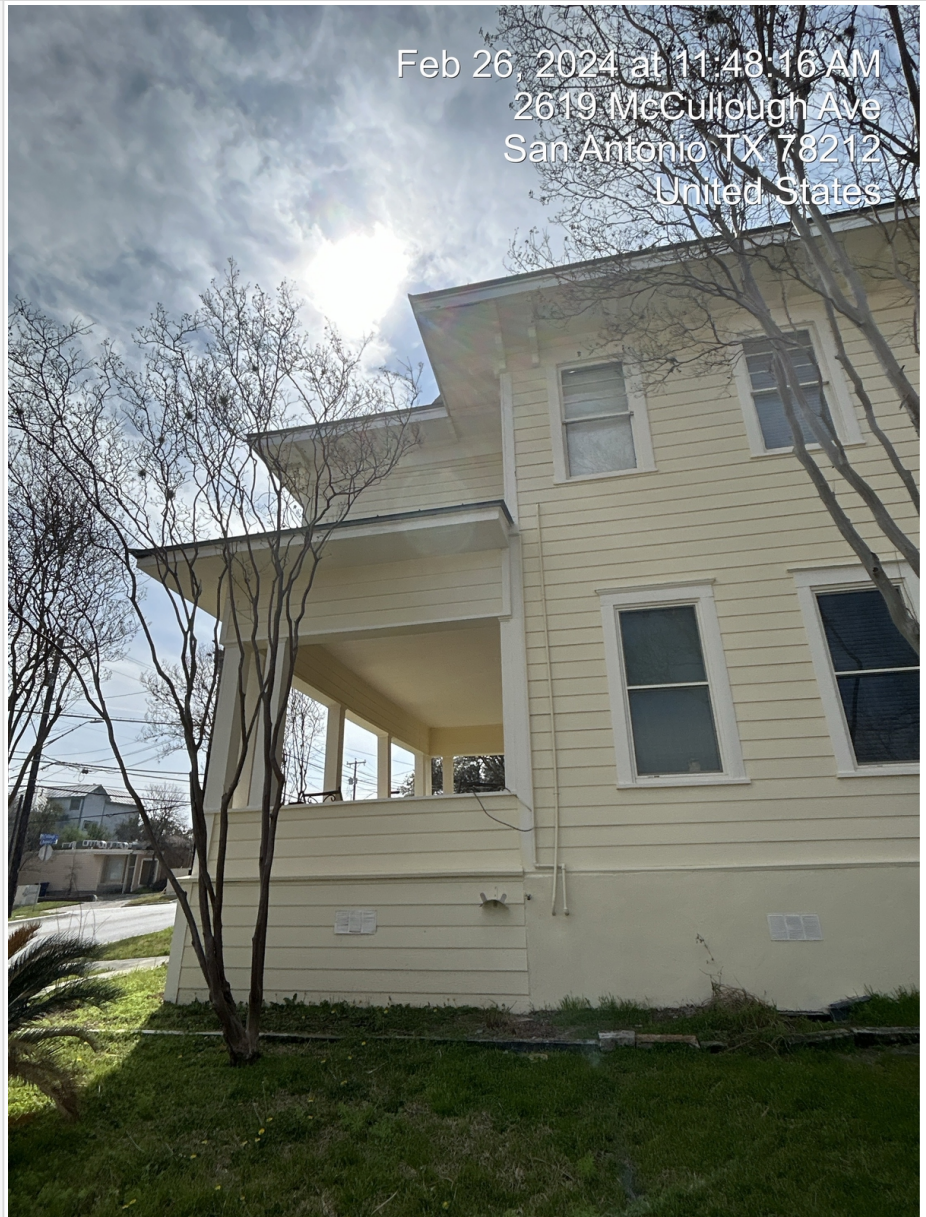
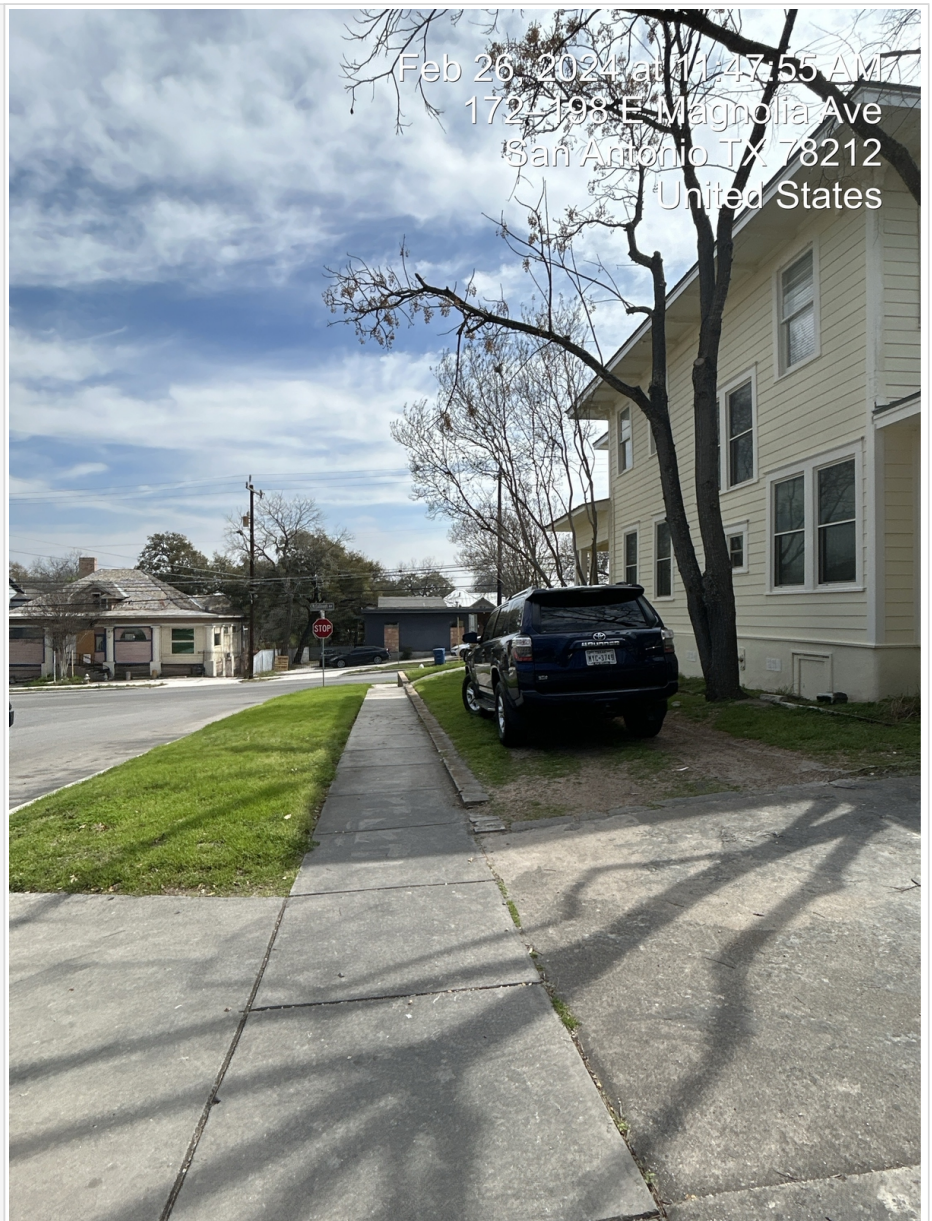
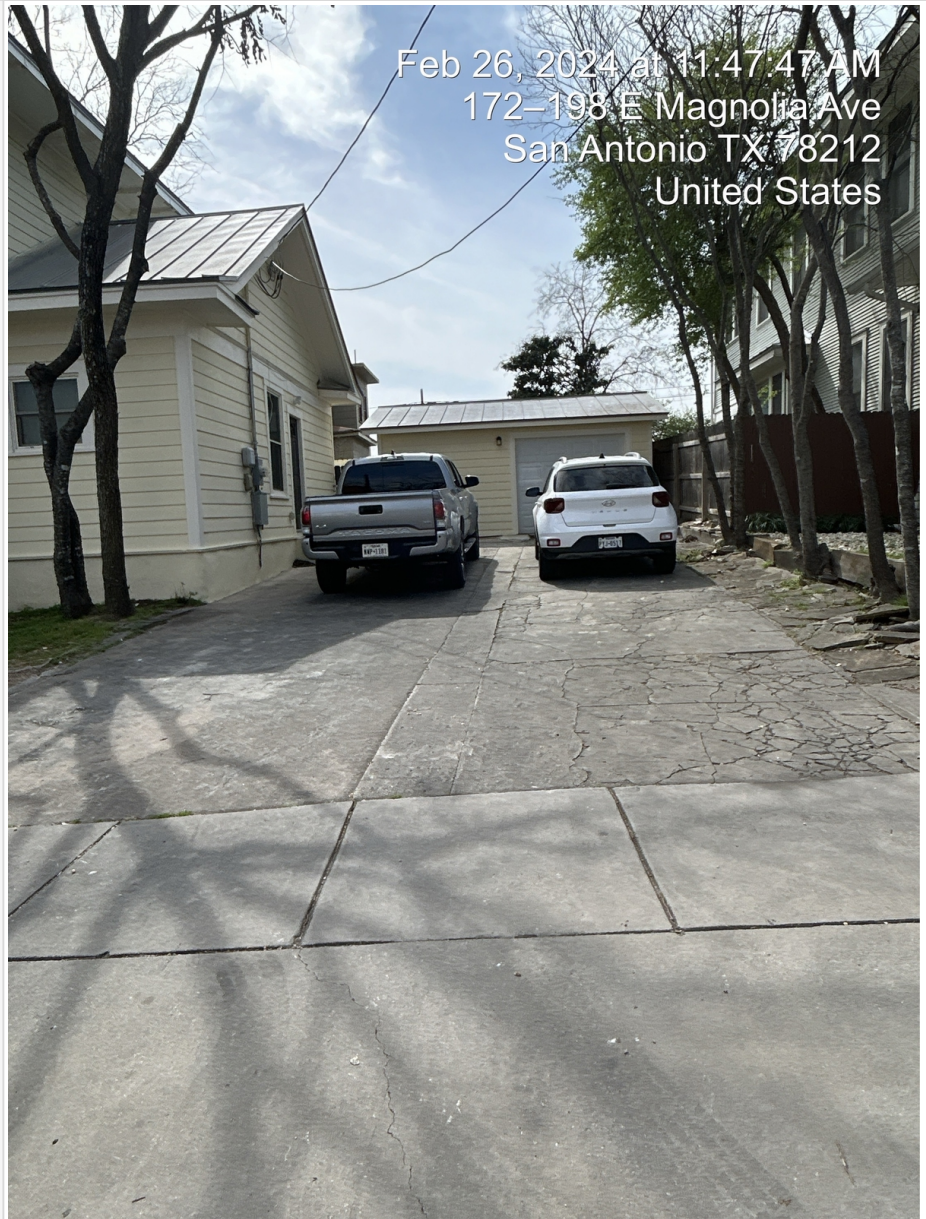
Date	02/26/2024
Time	12:00 PM (-6 GMT)
Context	citizen report, drive-by
Present Staff	Claudia Espinosa
Present Individuals	Homeowner
Types of Work Observed	Exterior Maintenance and Alterations
Amount of Work Completed	Completed
Description of work	Wood window removal and infill
Description of interaction	Staff spoke with the property owner regarding the reported scope of work. The property owner stated she made the decision to remove windows on the north and south facade on the second floor sunroom and infill the openings without approval. Staff discussed the COA process and the CTAB process. The property owner stated she would apply for a COA regarding the infill. As of today, 3/4/2024, no application is on file.

Violation Type	Beyond scope of Certificate of Appropriateness (Code 35-451h)
OHP Action	Spoke with property owner
Will post-work application fee apply?	To be determined
