**HISTORIC AND DESIGN REVIEW
COMPLIANCE AND TECHNICAL ADVISORY BOARD
February 23, 2024**

HDRC CASE NO: 2024-045
ADDRESS: 504 N HACKBERRY ST
LEGAL DESCRIPTION: NCB 570 BLK 6 LOT N 56.05 FT OF 13-14
ZONING: C-2, H
CITY COUNCIL DIST.: 2
DISTRICT: Dignowity Hill Historic District
APPLICANT: Richard Gonzalez | Chapawu Properties LLC
OWNER: Richard Gonzalez | Chapawu Properties LLC
TYPE OF WORK: Front fence installation; front porch steps, porch decking, and wood window replacement; chimney removal; and fenestration modifications
APPLICATION RECEIVED: January 15, 2024
60-DAY REVIEW: March 5, 2024
CASE MANAGER: Bryan Morales

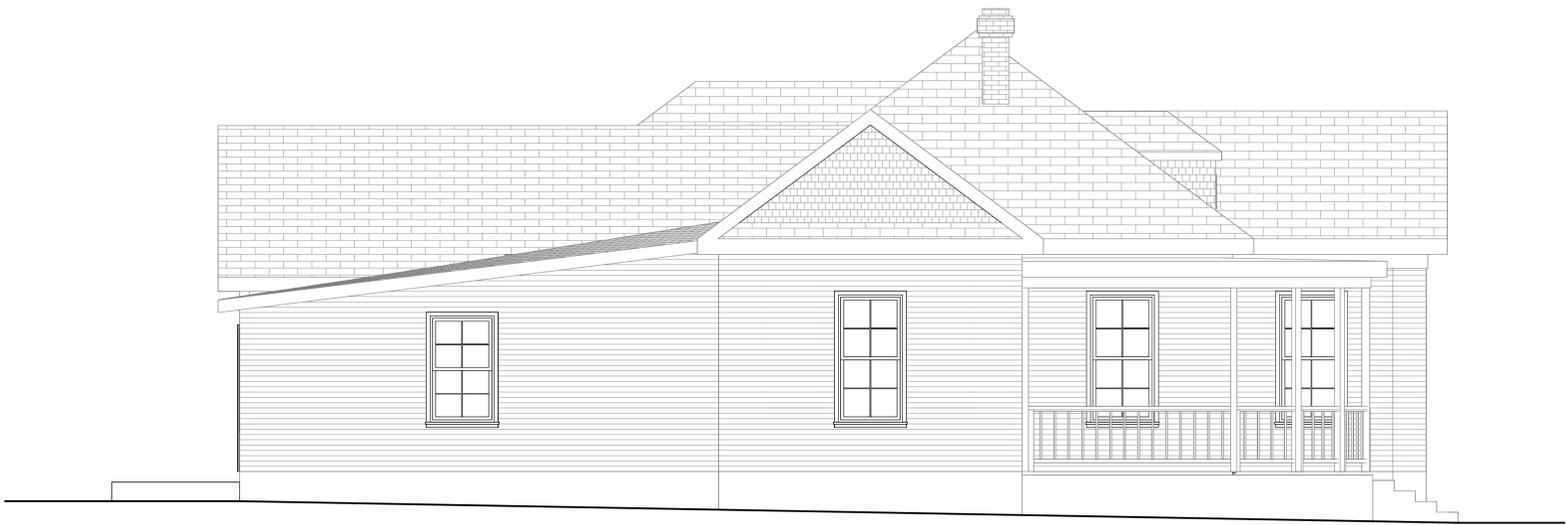
1 NORTH
SCALE: 1/4" = 1'-0"

states to install new windows to match the historic or existing windows in terms of size, type, configuration, material, form, appearance, and detail when original windows are deteriorated beyond repair. Staff finds the proposed fenestration modifications to the north façade does not conform to guidelines.

Staff does not recommend approval of items 4 through 6 based on findings a and i through p. Staff recommends the applicant restore the previous conditions which includes the chimney reconstruction and wood windows, with trim, in the same historic fenestration pattern (sizes and locations of openings).
