**HISTORIC AND DESIGN REVIEW  
COMPLIANCE AND TECHNICAL ADVISORY BOARD**

**March 22, 2024**

**HDRC CASE NO:** 2024-108  
**ADDRESS:** 215 MUNCEY  
**LEGAL DESCRIPTION:** NCB 1660 BLK H LOT N 50 FT OF 15 & 16 ARB A15  
**ZONING:** R-6, H  
**CITY COUNCIL DIST.:** 2  
**DISTRICT:** Dignowity Hill Historic District  
**APPLICANT:** CUNNINGHAM TAYLYN & PAULINA  
**OWNER:** CUNNINGHAM TAYLYN & PAULINA  
**TYPE OF WORK:** Window replacement, fenestration modifications, door replacement, painting and exterior modifications  
**APPLICATION RECEIVED:** March 07, 2024  
**60-DAY REVIEW:** May 06, 2024  
**CASE MANAGER:** Edward Hall

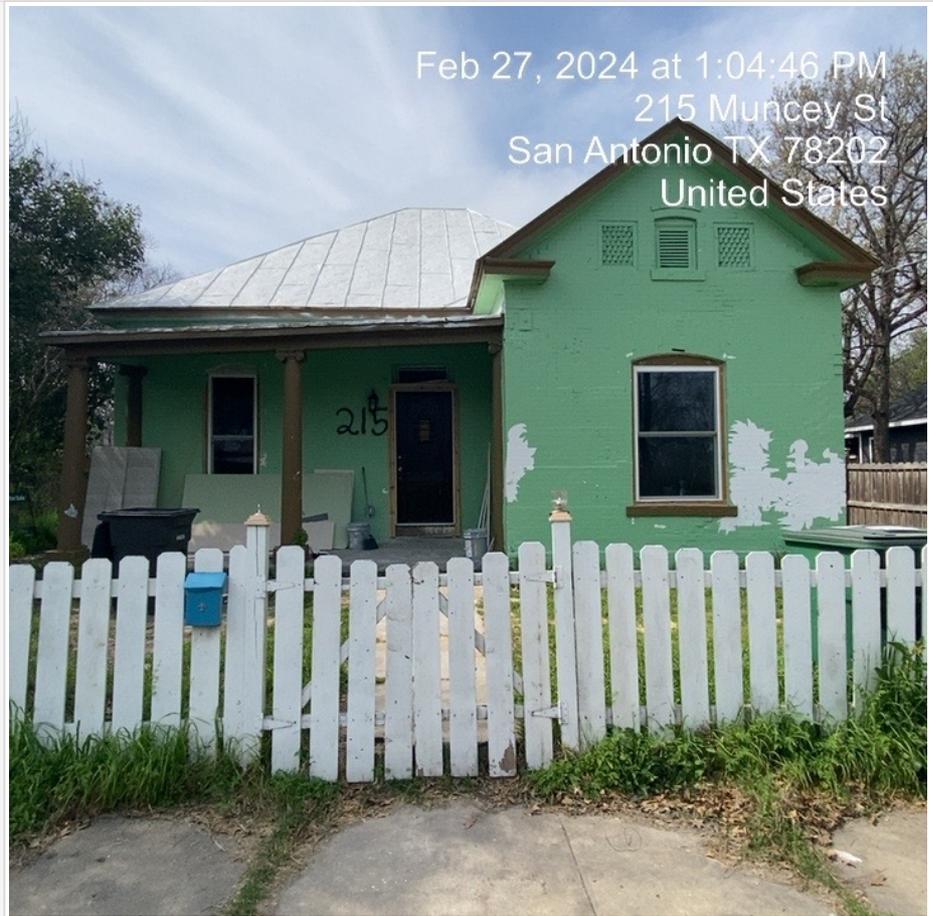
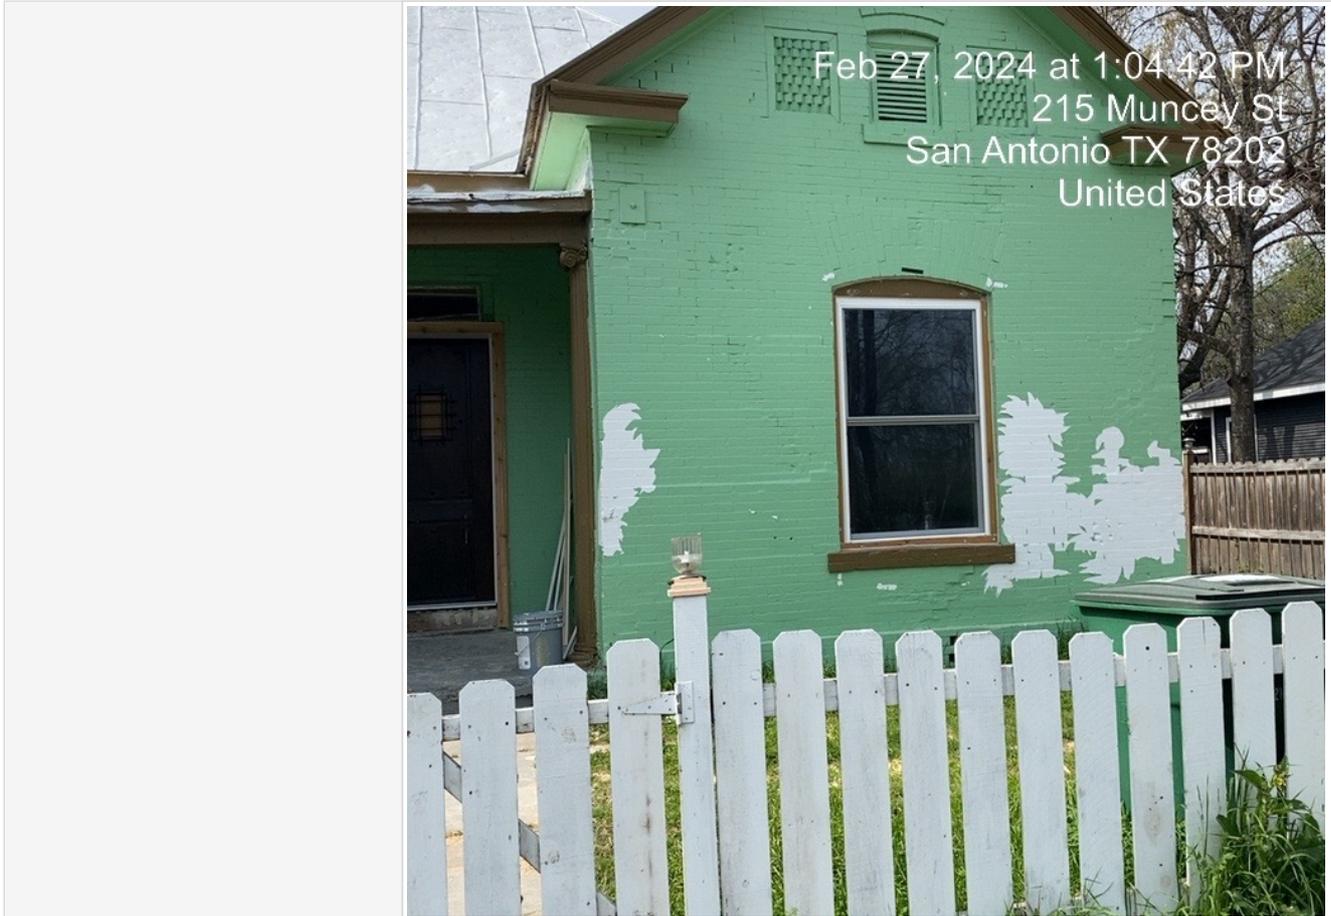
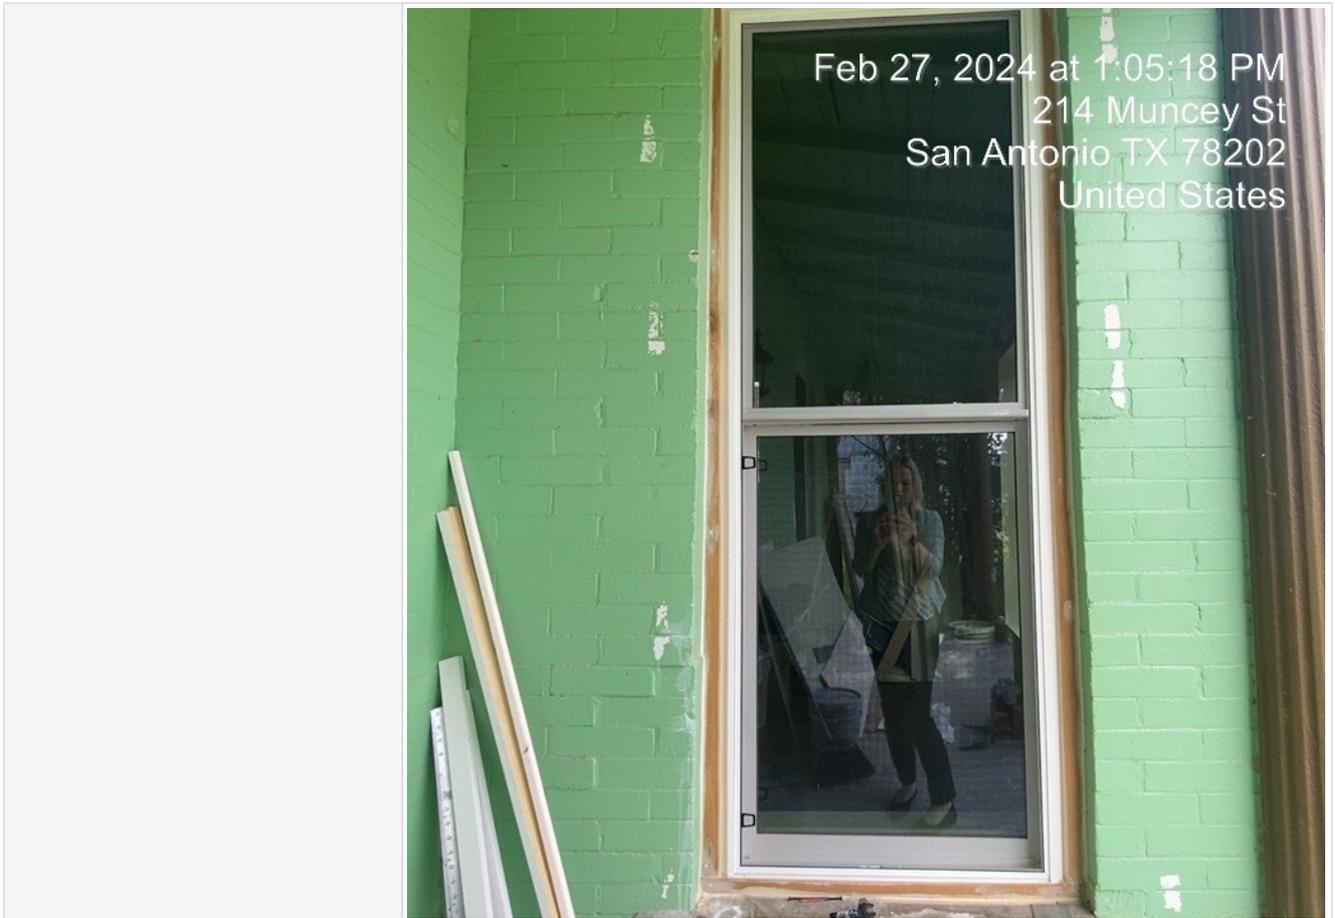
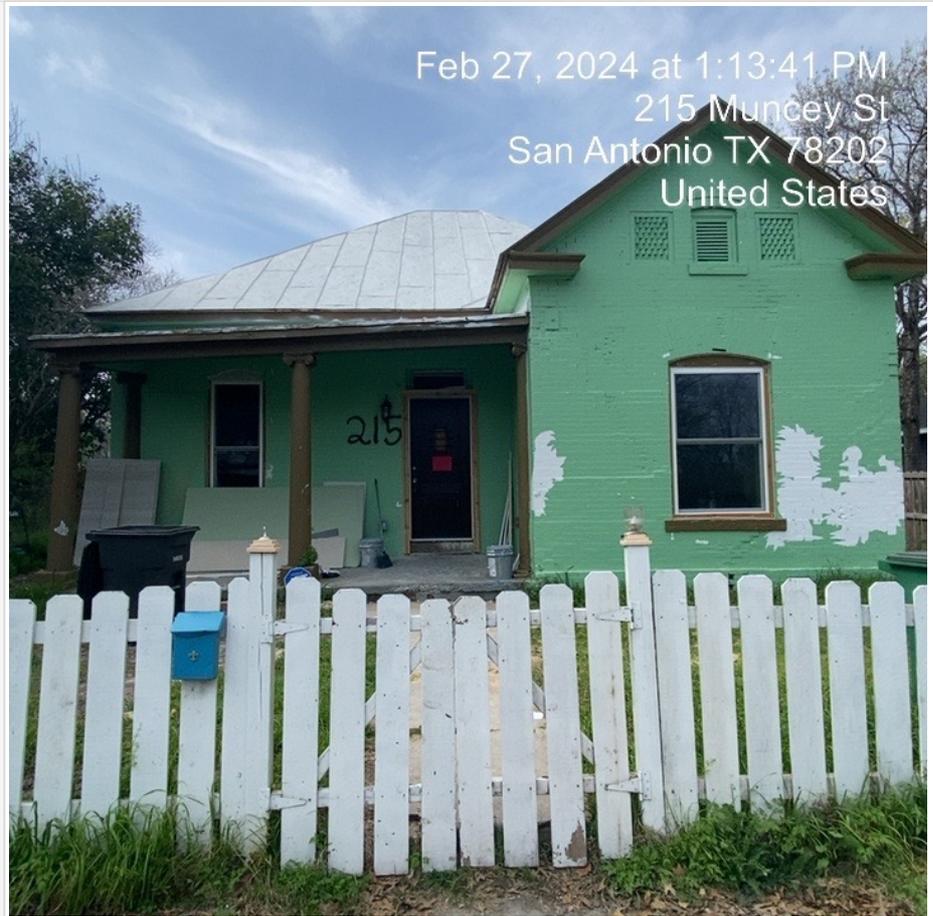
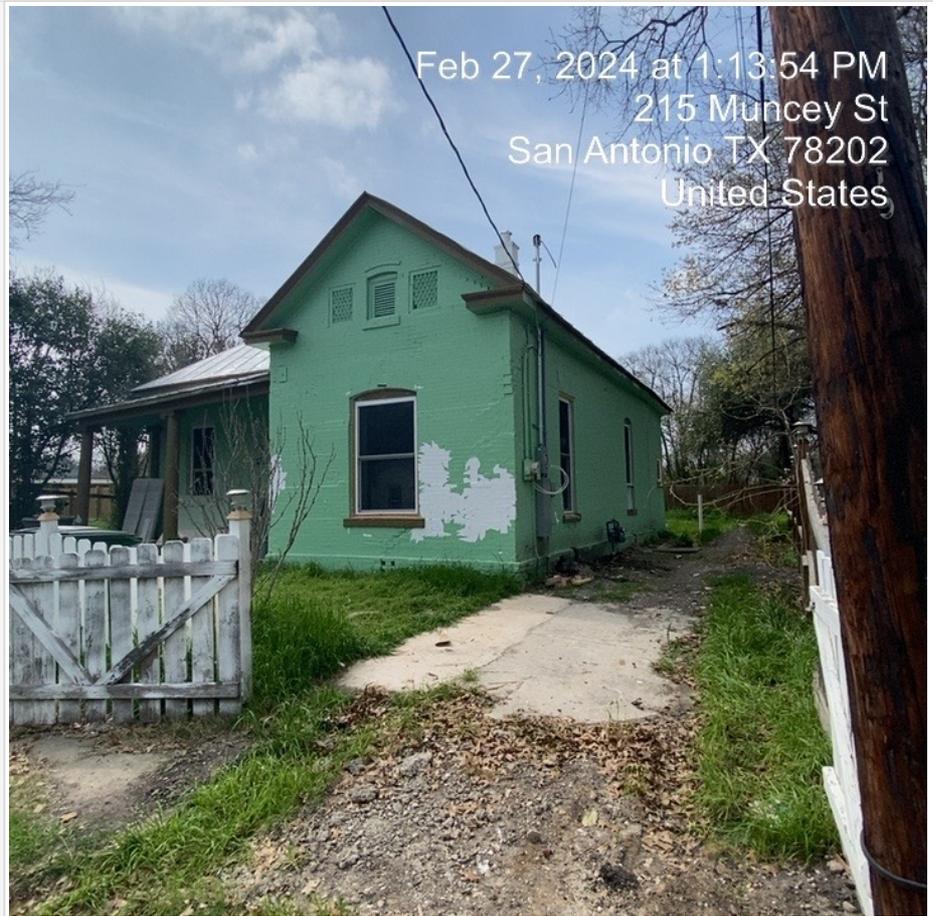
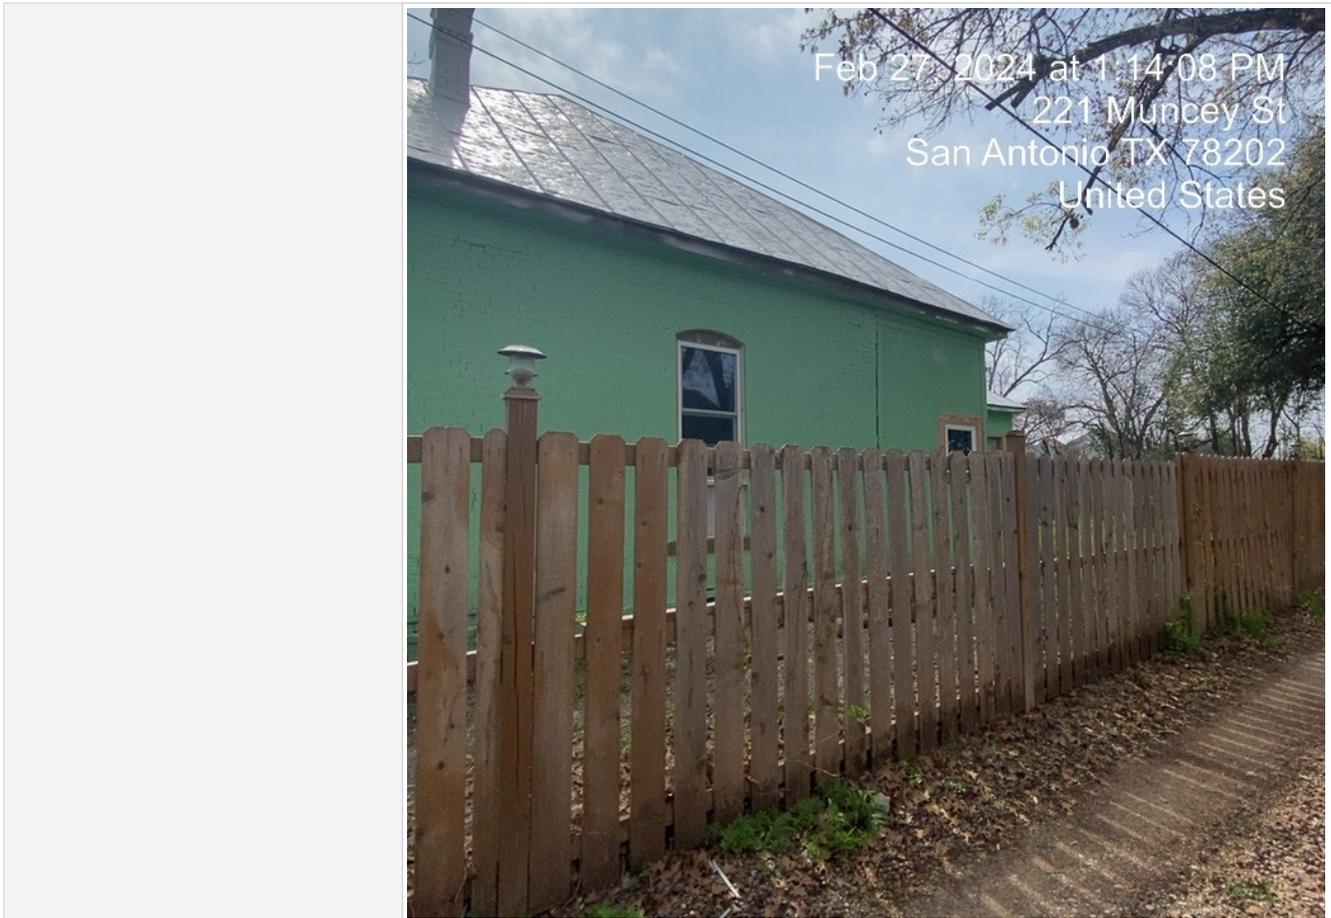
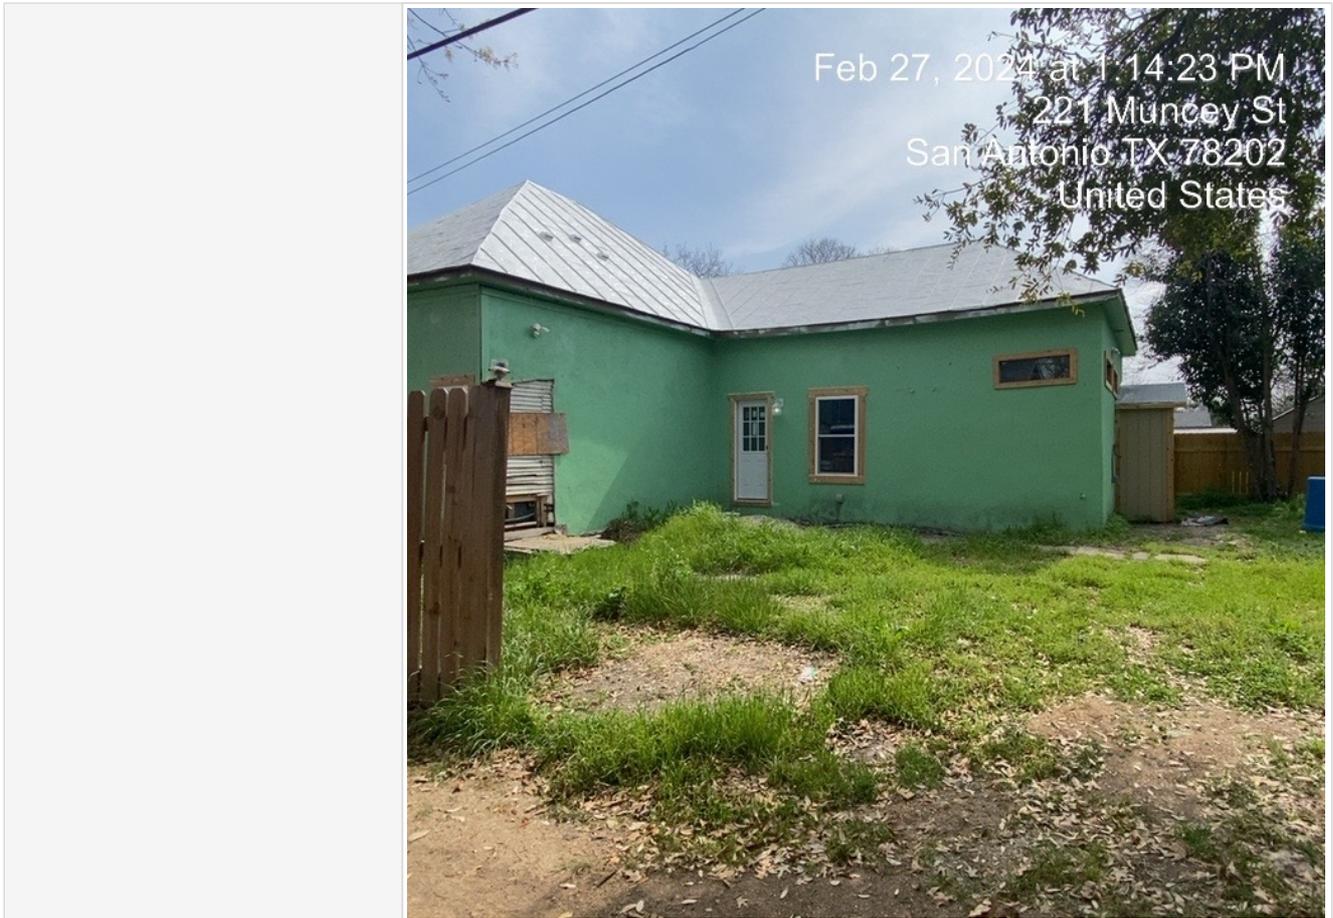
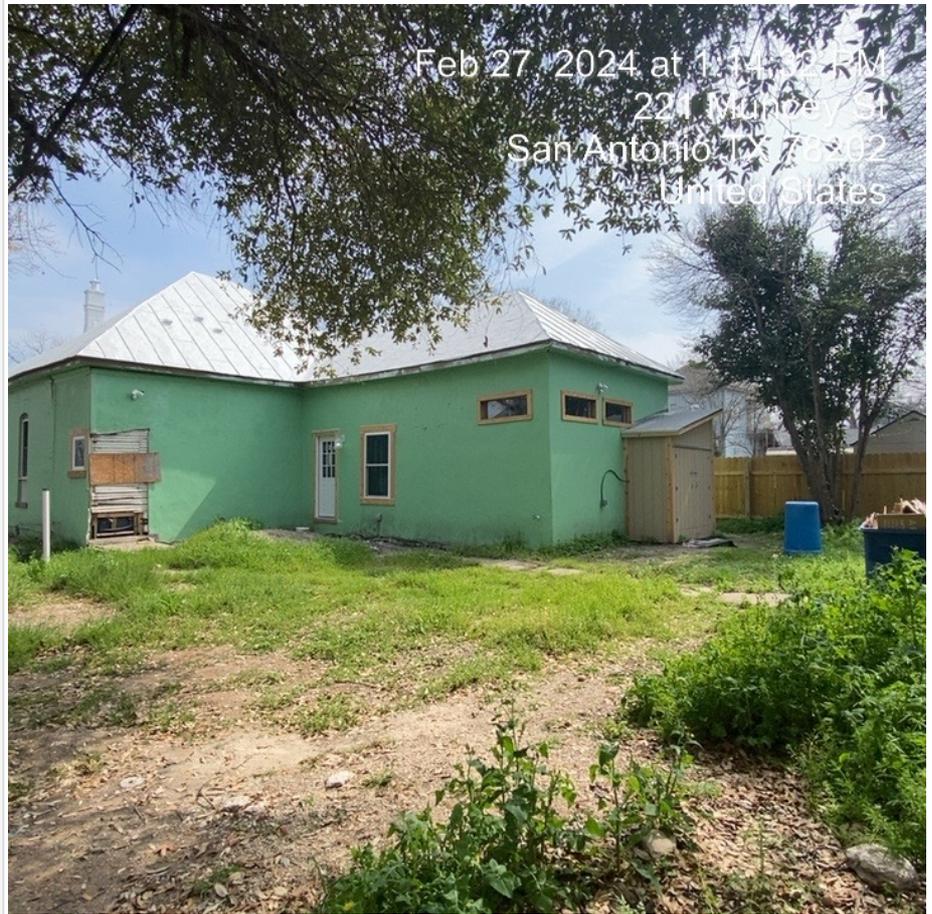
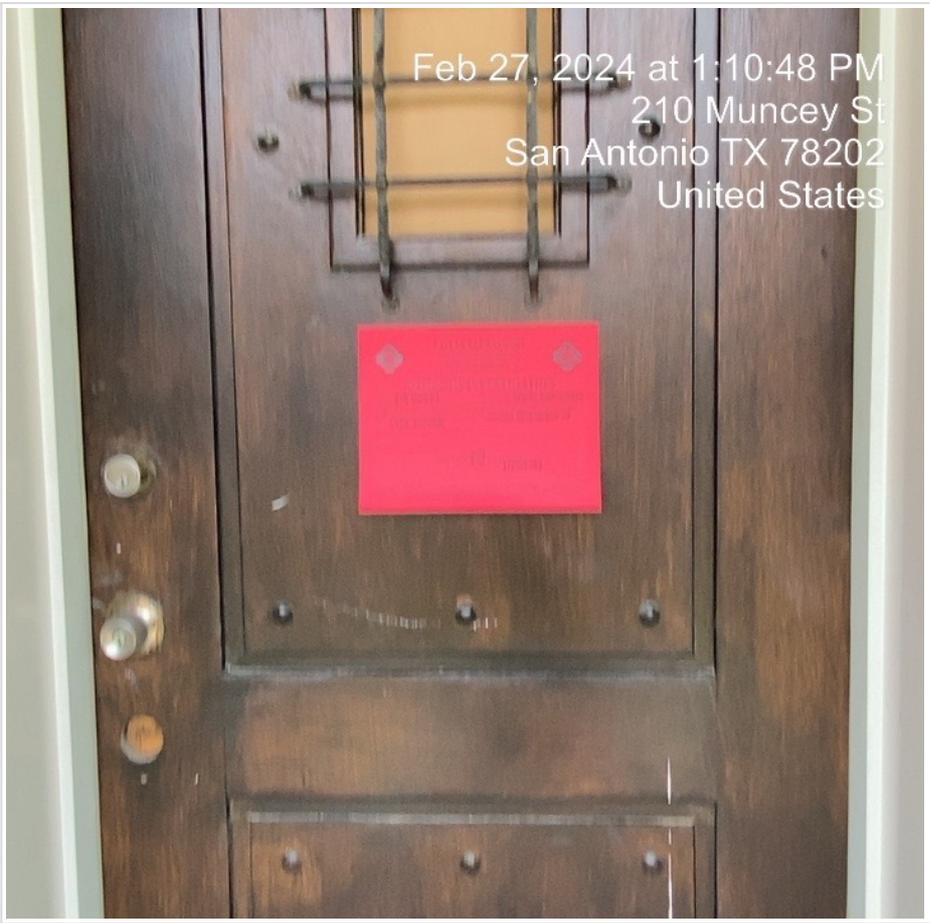
Date	02/27/2024
Time	01:20 PM (-6 GMT)
Context	citizen report
Present Staff	Rachel Rettaliata
Present Individuals	Homeowner
Types of Work Observed	Exterior Maintenance and Alterations
Amount of Work Completed	Completed
Description of work	Replacement of previously existing wood windows with vinyl windows. Previously existing wood windows do not appear to be on site.
Description of interaction	Spoke with homeowner who was not cooperative. Homeowner stated that they would not be answering questions.

Code 35-608 (a): Work without Certificate of Appropriateness (COA): WINDOW REPLACEMENT VINYL WINDOWS
