# HISTORIC AND DESIGN REVIEW COMPLIANCE AND TECHNICAL ADVISORY BOARD

February 23, 2024

**HDRC CASE NO:** 2024-032  
**ADDRESS:** 103 FIR  
**LEGAL DESCRIPTION:** NCB 2966 BLK 1 LOT 9  
**ZONING:** RM-4, H  
**CITY COUNCIL DIST.:** 1  
**DISTRICT:** King William Historic District  
**APPLICANT:** Otoniel Trevino/STATT PROPERTIES INC  
**OWNER:** Otoniel Trevino/STATT PROPERTIES INC  
**TYPE OF WORK:** Conversion of an original window opening to a door opening  
**APPLICATION RECEIVED:** January 07, 2024  
**60-DAY REVIEW:** March 07, 2024  
**CASE MANAGER:** Edward Hall

# 103 FIR

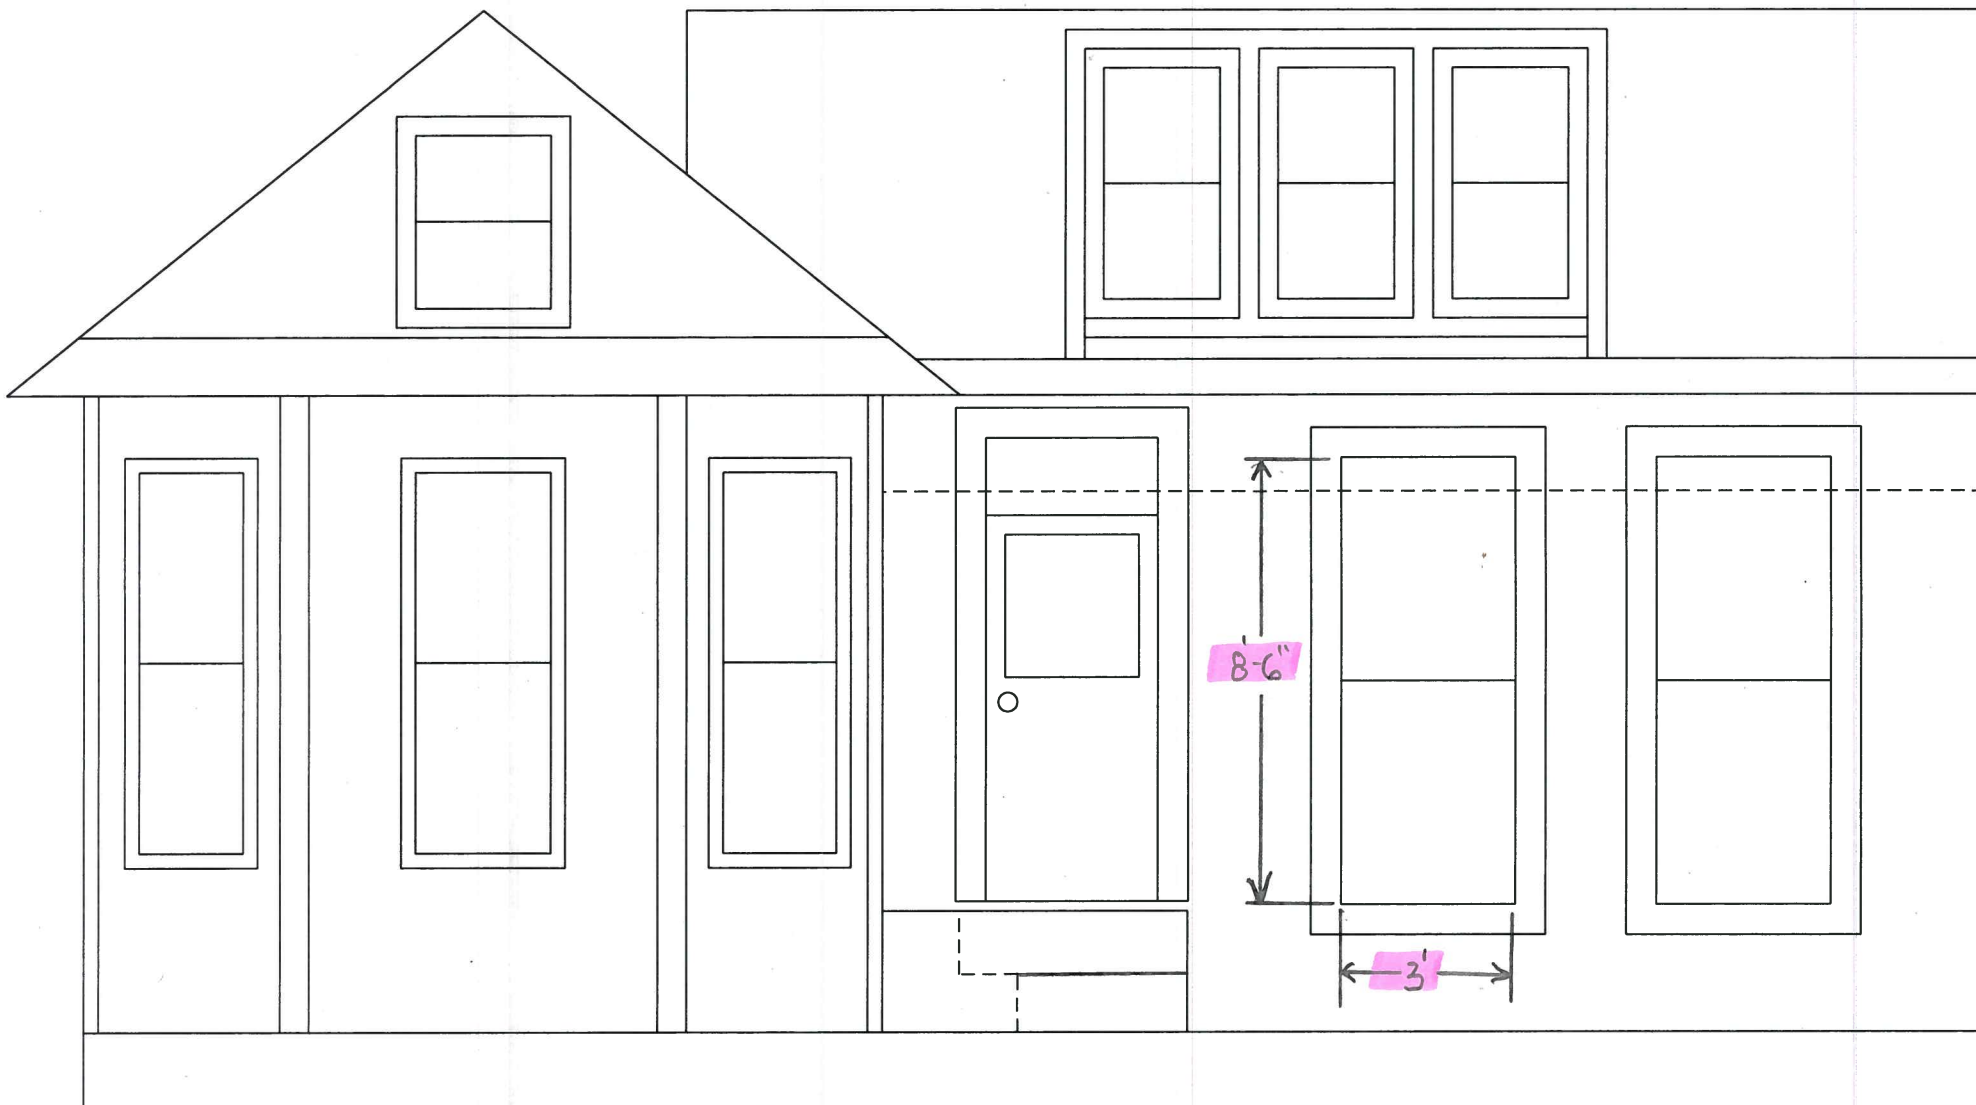
103 Fir St  
Before Front Door Install

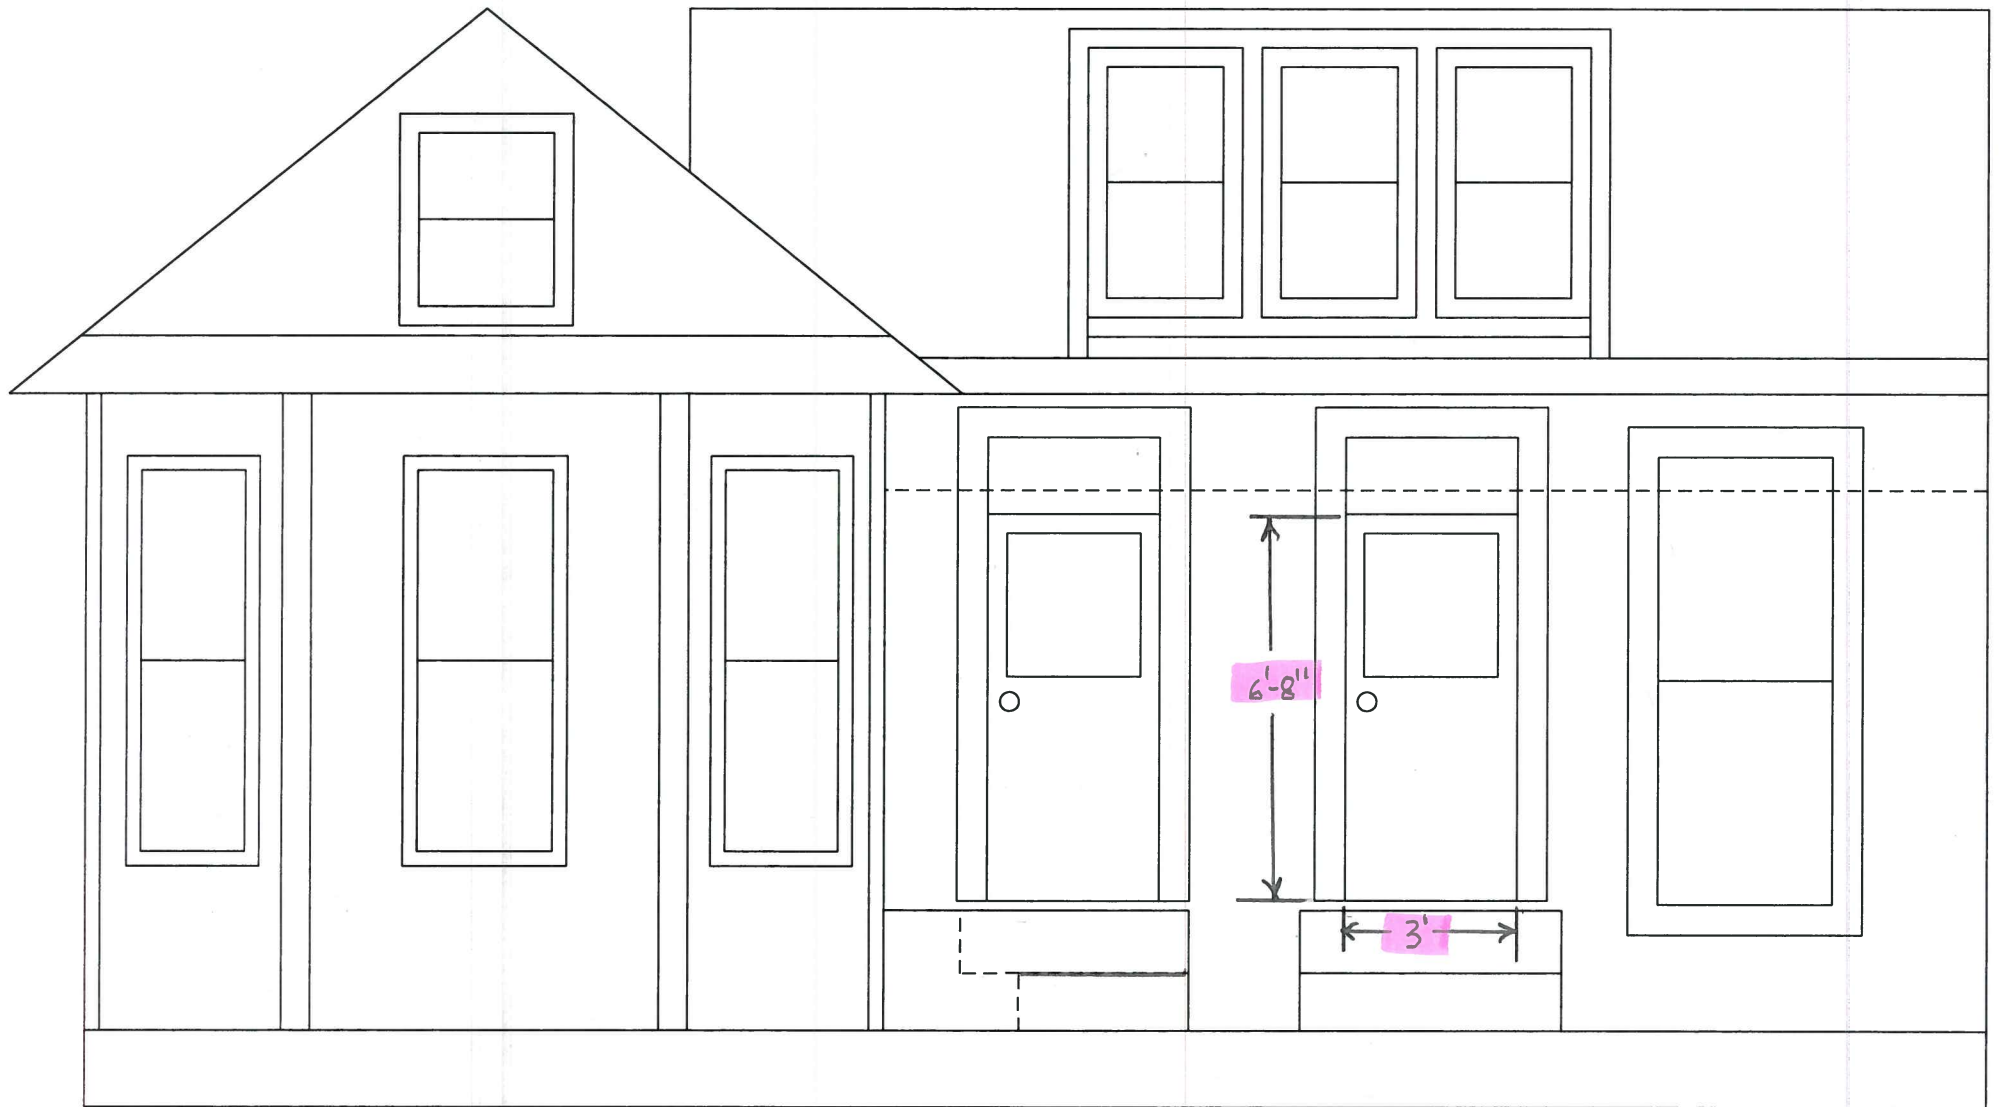
- d. INSTALLED DOOR – The Guidelines for Exterior Maintenance and Alterations 6.B.i. notes that replacement doors and new doors in historic structures should match the size, material, and profile of the historic element. Staff finds that the installed door, a fiberglass door with an oval lite with faux divisions is not consistent with the Guidelines.

103 Fir St  
After Front Door Install

Staff does not recommend approval based on findings c and d. Staff recommends that the original window be reinstalled and that the opening should return to its original size and profile.

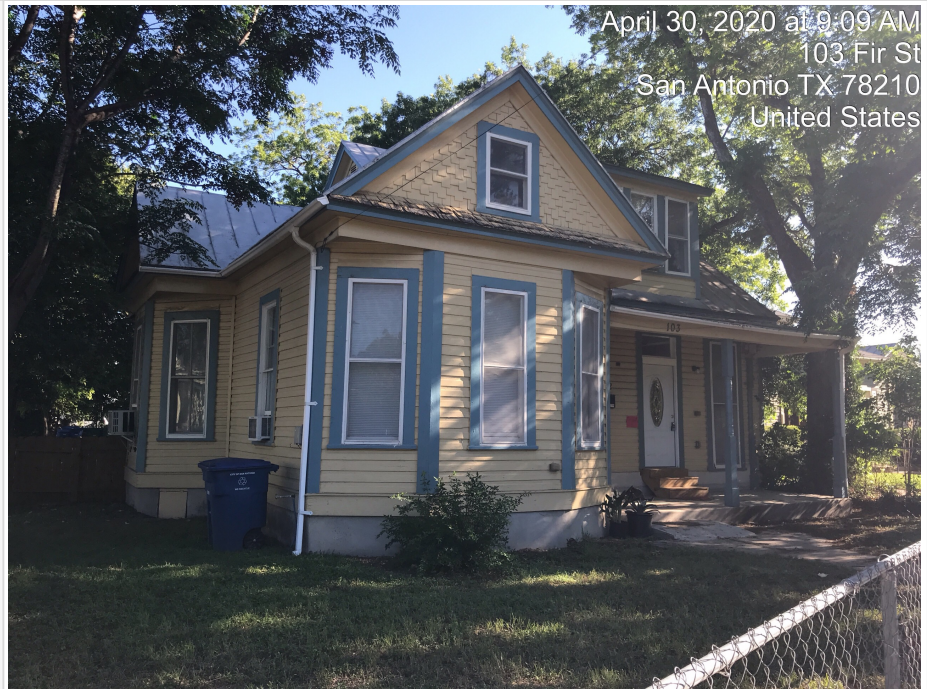
April 30, 2020 at 9:09 AM  
103 Fir St  
San Antonio TX 78210  
United States

Date	04/30/2020
Time	09:10 AM (-5 GMT)
Context	citizen report
Present Staff	Huy Pham, Edward Hall
Present Individuals	Family/Tenant
Types of Work Observed	Exterior Maintenance and Alterations
Amount of Work Completed	Completed
Description of work	Removal of front two-over-two wood window and installation of new steel door.
Description of interaction	Notified tenant in unit 3 that staff is posting a SWO and to forward the notification to property owner.
