HISTORIC AND DESIGN REVIEW COMMISSION

January 17, 2024

HDRC CASE NO: 2023-330
ADDRESS: 919 MASON ST
LEGAL DESCRIPTION: NCB 1267 BLK 3 LOT S 105 FT OF 6
ZONING: R-6, H
CITY COUNCIL DIST.: 2
DISTRICT: Government Hill Historic District
APPLICANT: Juan M Guajardo | By Grace Floors and Construction LLC
OWNER: Rose Galindo
TYPE OF WORK: Wholesale wood window replacement
APPLICATION RECEIVED: August 8, 2023
60-DAY REVIEW: October 7, 2023 (Applicant postponed to January 17th)
CASE MANAGER: Bryan Morales

The applicant is requesting a Certificate of Appropriateness for approval to replace all wood windows at the property.

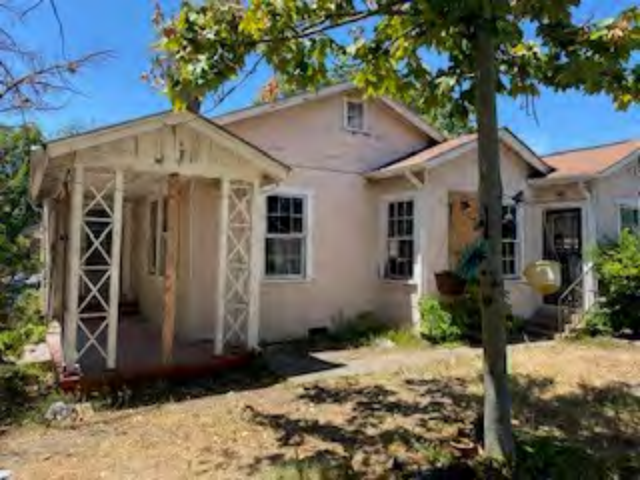
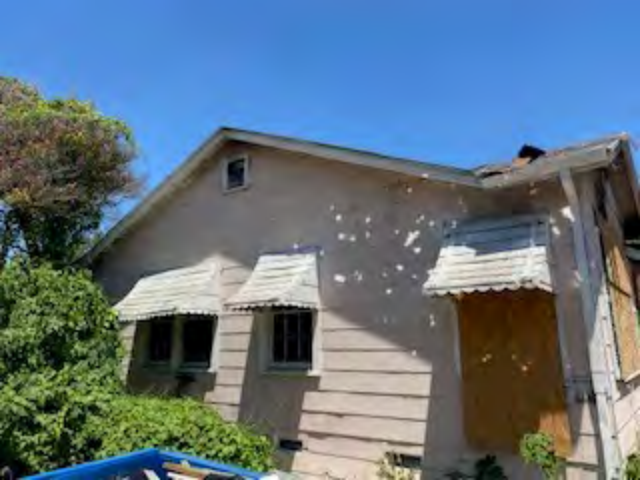
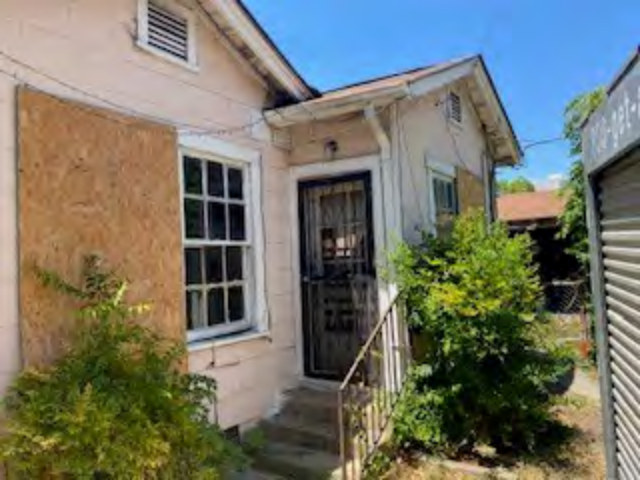
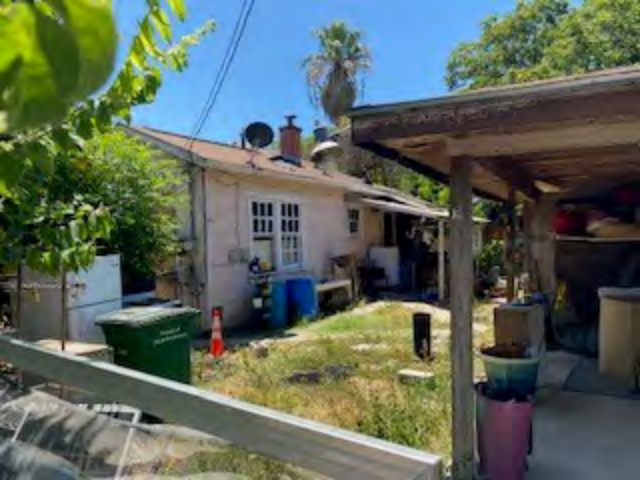
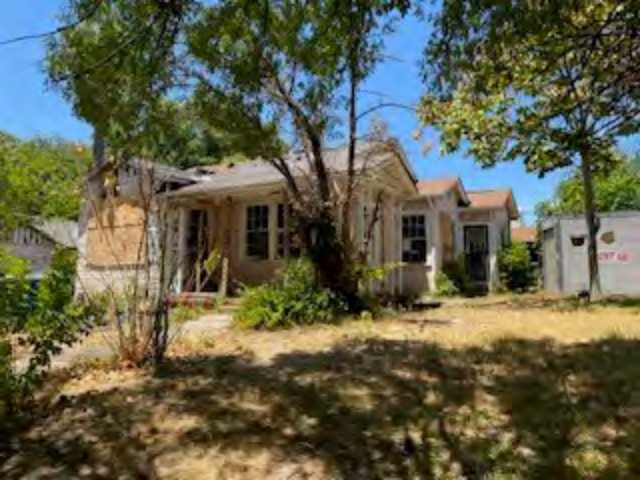
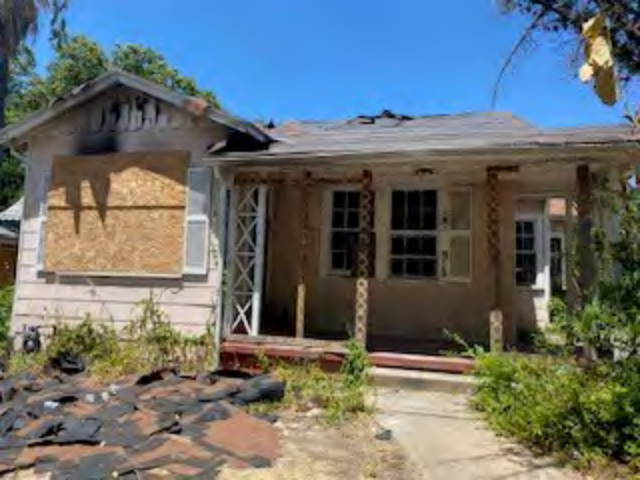
December 14, 2023

- b. SITE VISIT – On December 8, 2023, staff conducted a site visit to assess the window conditions at 919 Mason St. Staff was able to observe the exterior of windows 1-8 and 14-19.

- c. WINDOW REPLACEMENT: EXISTING CONDITION – Staff has observed evidence of paint stripping and flaking, deteriorated glazing, and some areas where the bottom rail has begun separating at the joint. However, with the exception of windows 17-19, almost all of the original wood is intact in all cases with very limited evidence of irreversible rot or damage. The joints of the top sashes are in excellent condition with no evidence of slipping or separation. Staff finds windows 1-16 are in repairable condition, with most requiring minimal repair and intervention like re-glazing and painting, along with refitting into the trim and frames.

Staff does not recommend approval of the request, based on findings a through f. Staff recommends the applicant work with staff concerning the repair of windows 1-16 and replacement of windows 17-19 in-kind for administrative approval.
