HISTORIC AND DESIGN REVIEW COMMISSION

February 07, 2024

HDRC CASE NO: 2024-003
ADDRESS: 1024 BURNET ST
LEGAL DESCRIPTION: NCB 1660 BLK H LOT E 16.2 FT OF N 120 FT OF 6 & W 39 FT OF N 120 FT OF 7
ZONING: R-6, H
CITY COUNCIL DIST.: 2
DISTRICT: Dignowity Hill Historic District
APPLICANT: Jose Alex Barrera | Elite Remodeling and Flooring LLC
OWNER: Tammy De Long | ITB Enterprises Inc.
TYPE OF WORK: Wholesale window replacement and fenestration modifications
APPLICATION RECEIVED: January 3, 2024
60-DAY REVIEW: March 3, 2024
CASE MANAGER: Bryan Morales

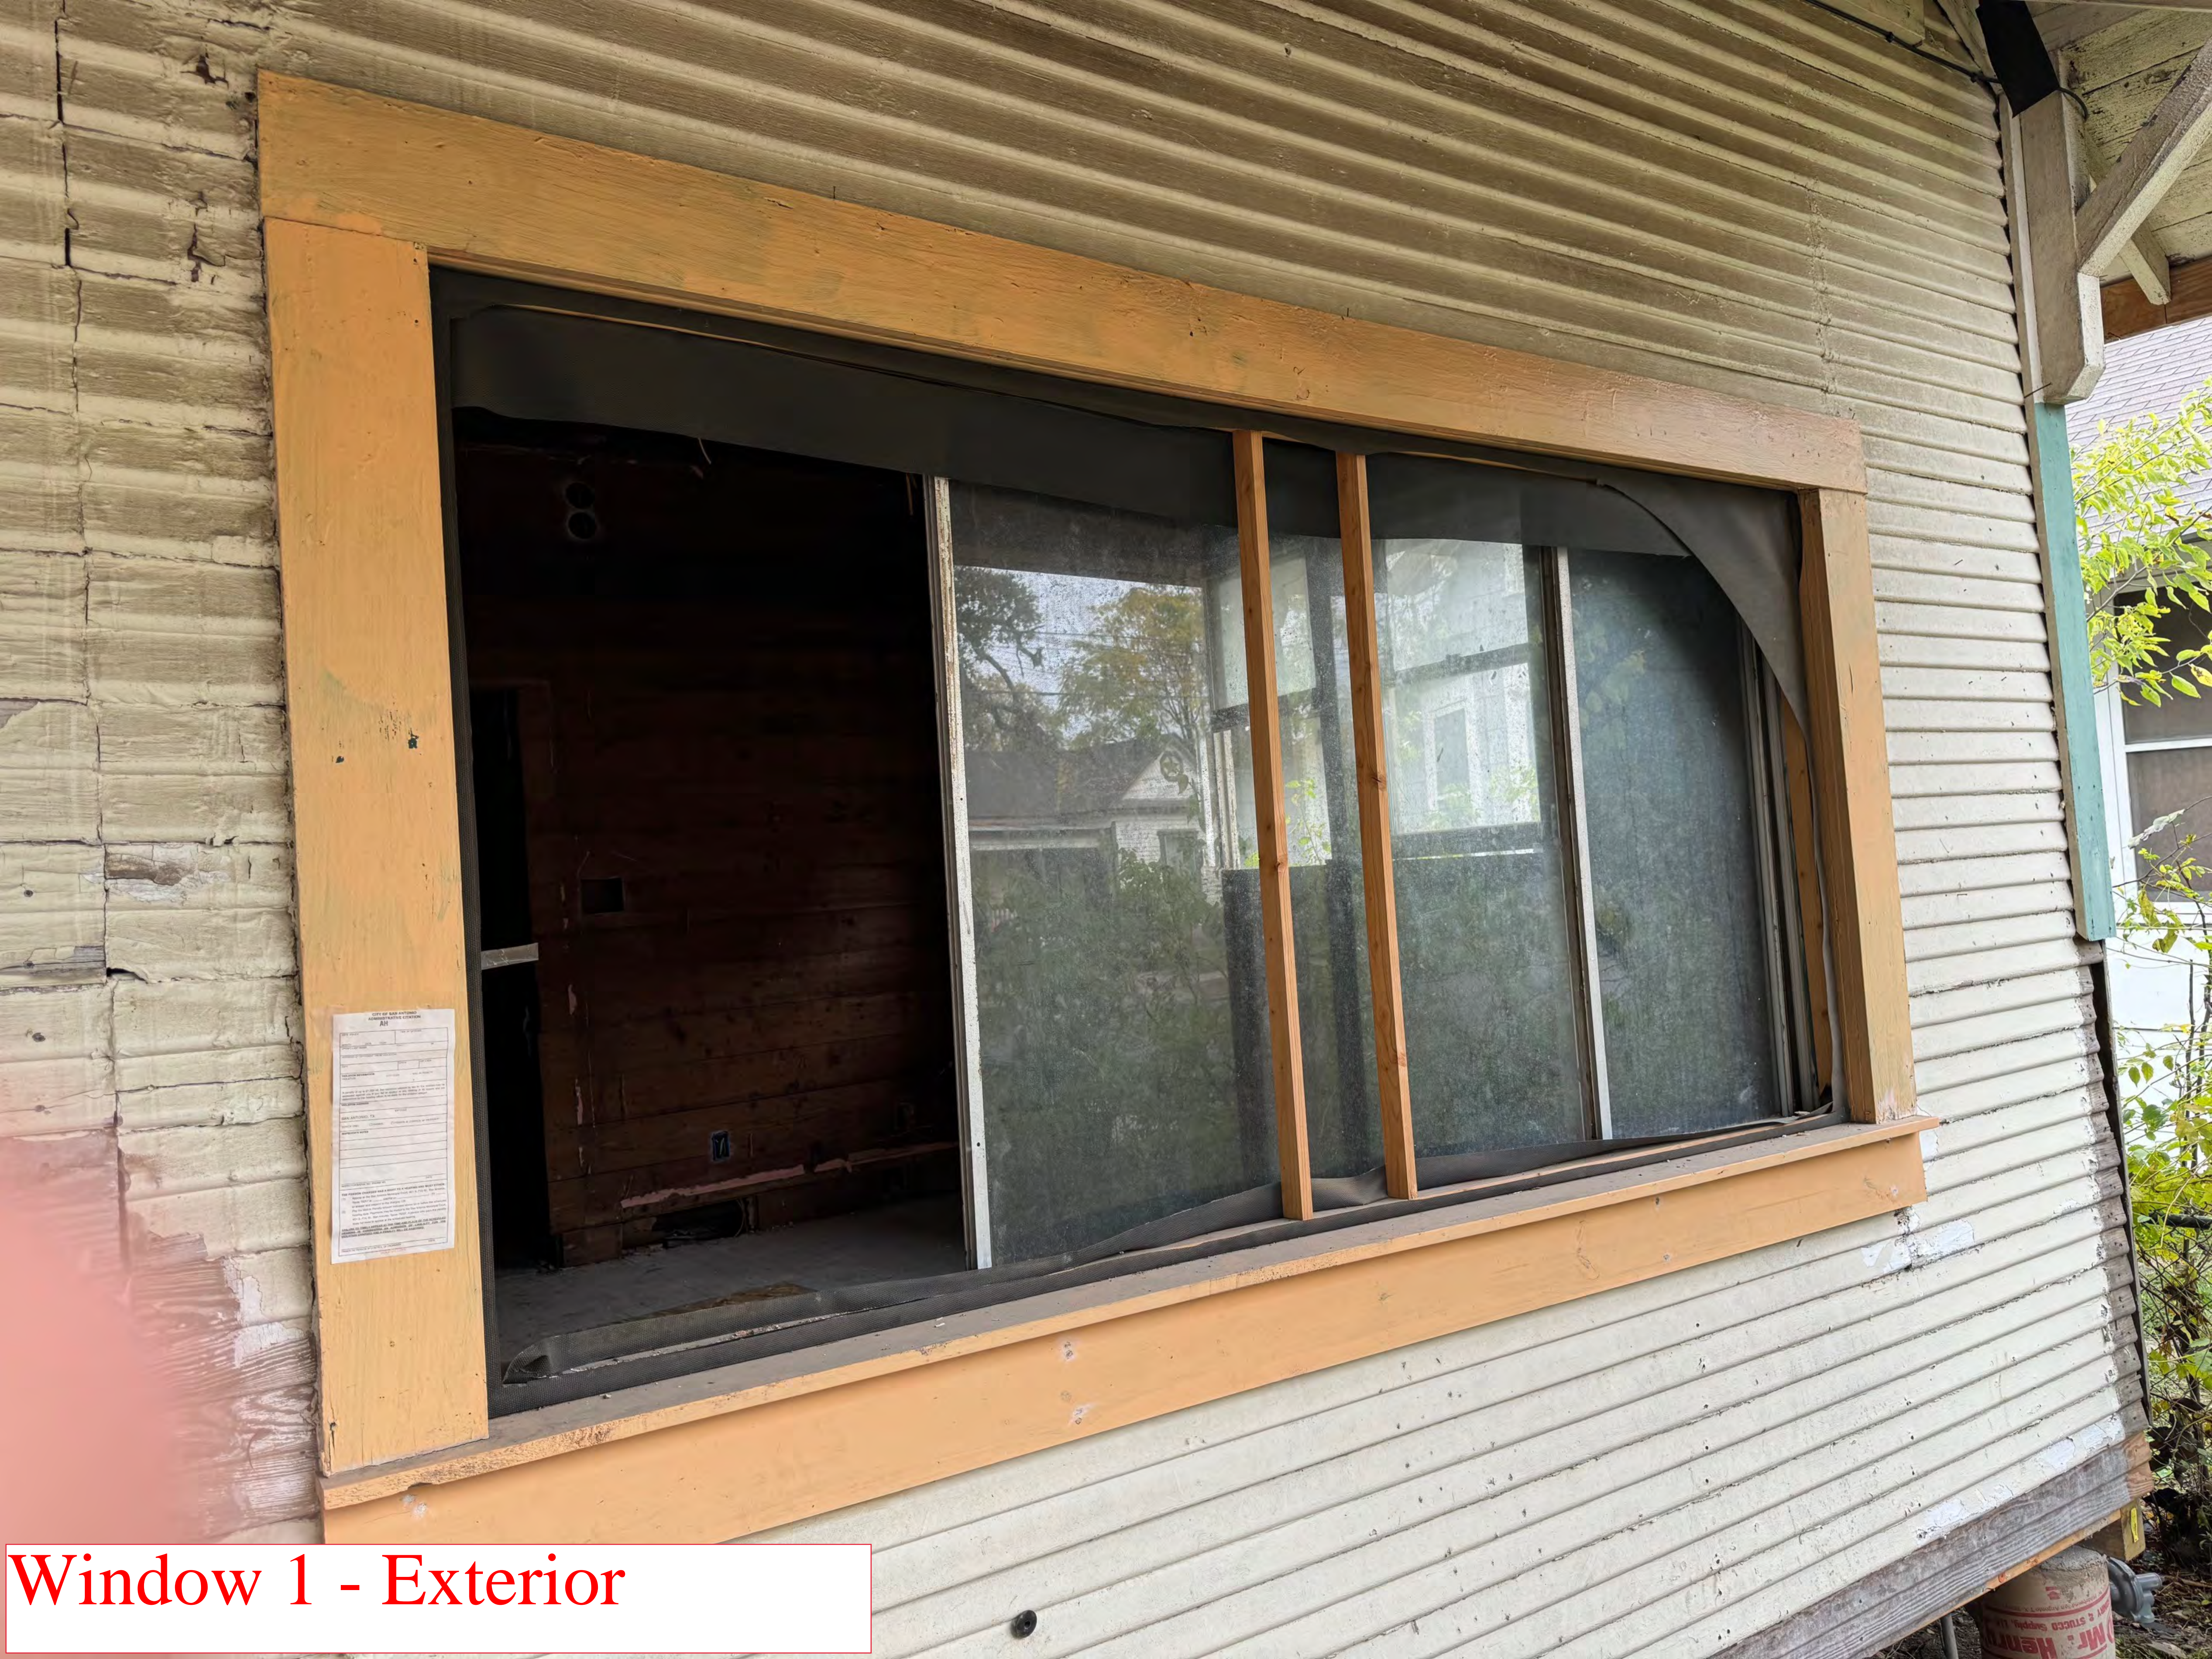
Window 1 - Exterior

- d. **WINDOW REPLACEMENT: EXISTING CONDITION** – Staff has observed evidence of paint stripping and flaking, deteriorated glazing, and some areas where the bottom rail has begun separating at the joint. However, almost all of the original wood is intact in all cases with very limited evidence of irreversible rot or damage. The joints of the top sashes are in excellent condition with no evidence of slipping or separation. Staff finds the wood windows onsite are in repairable condition, with most requiring minimal repair and intervention like re-glazing and painting, along with refitting into the trim and frames.

- i. That the applicant repair the existing wood windows in-kind.
- ii. That any aluminum windows replaced feature an inset of two (2) inches within facades and should feature profiles that are found historically within the immediate vicinity. Meeting rails must be no taller than 1.25” and stiles no wider than 2.25”. White manufacturer’s color is not allowed, and color selection must be presented to staff. There should be a minimum of two inches in depth between the front face of the window trim and the front face of the top window sash. This must be accomplished by recessing the window sufficiently within the opening or with the installation of additional window trim to add thickness. Window trim must feature traditional dimensions and architecturally appropriate sill detail. Window track components must be painted to match the window trim or concealed by a wood window screen set within the opening.

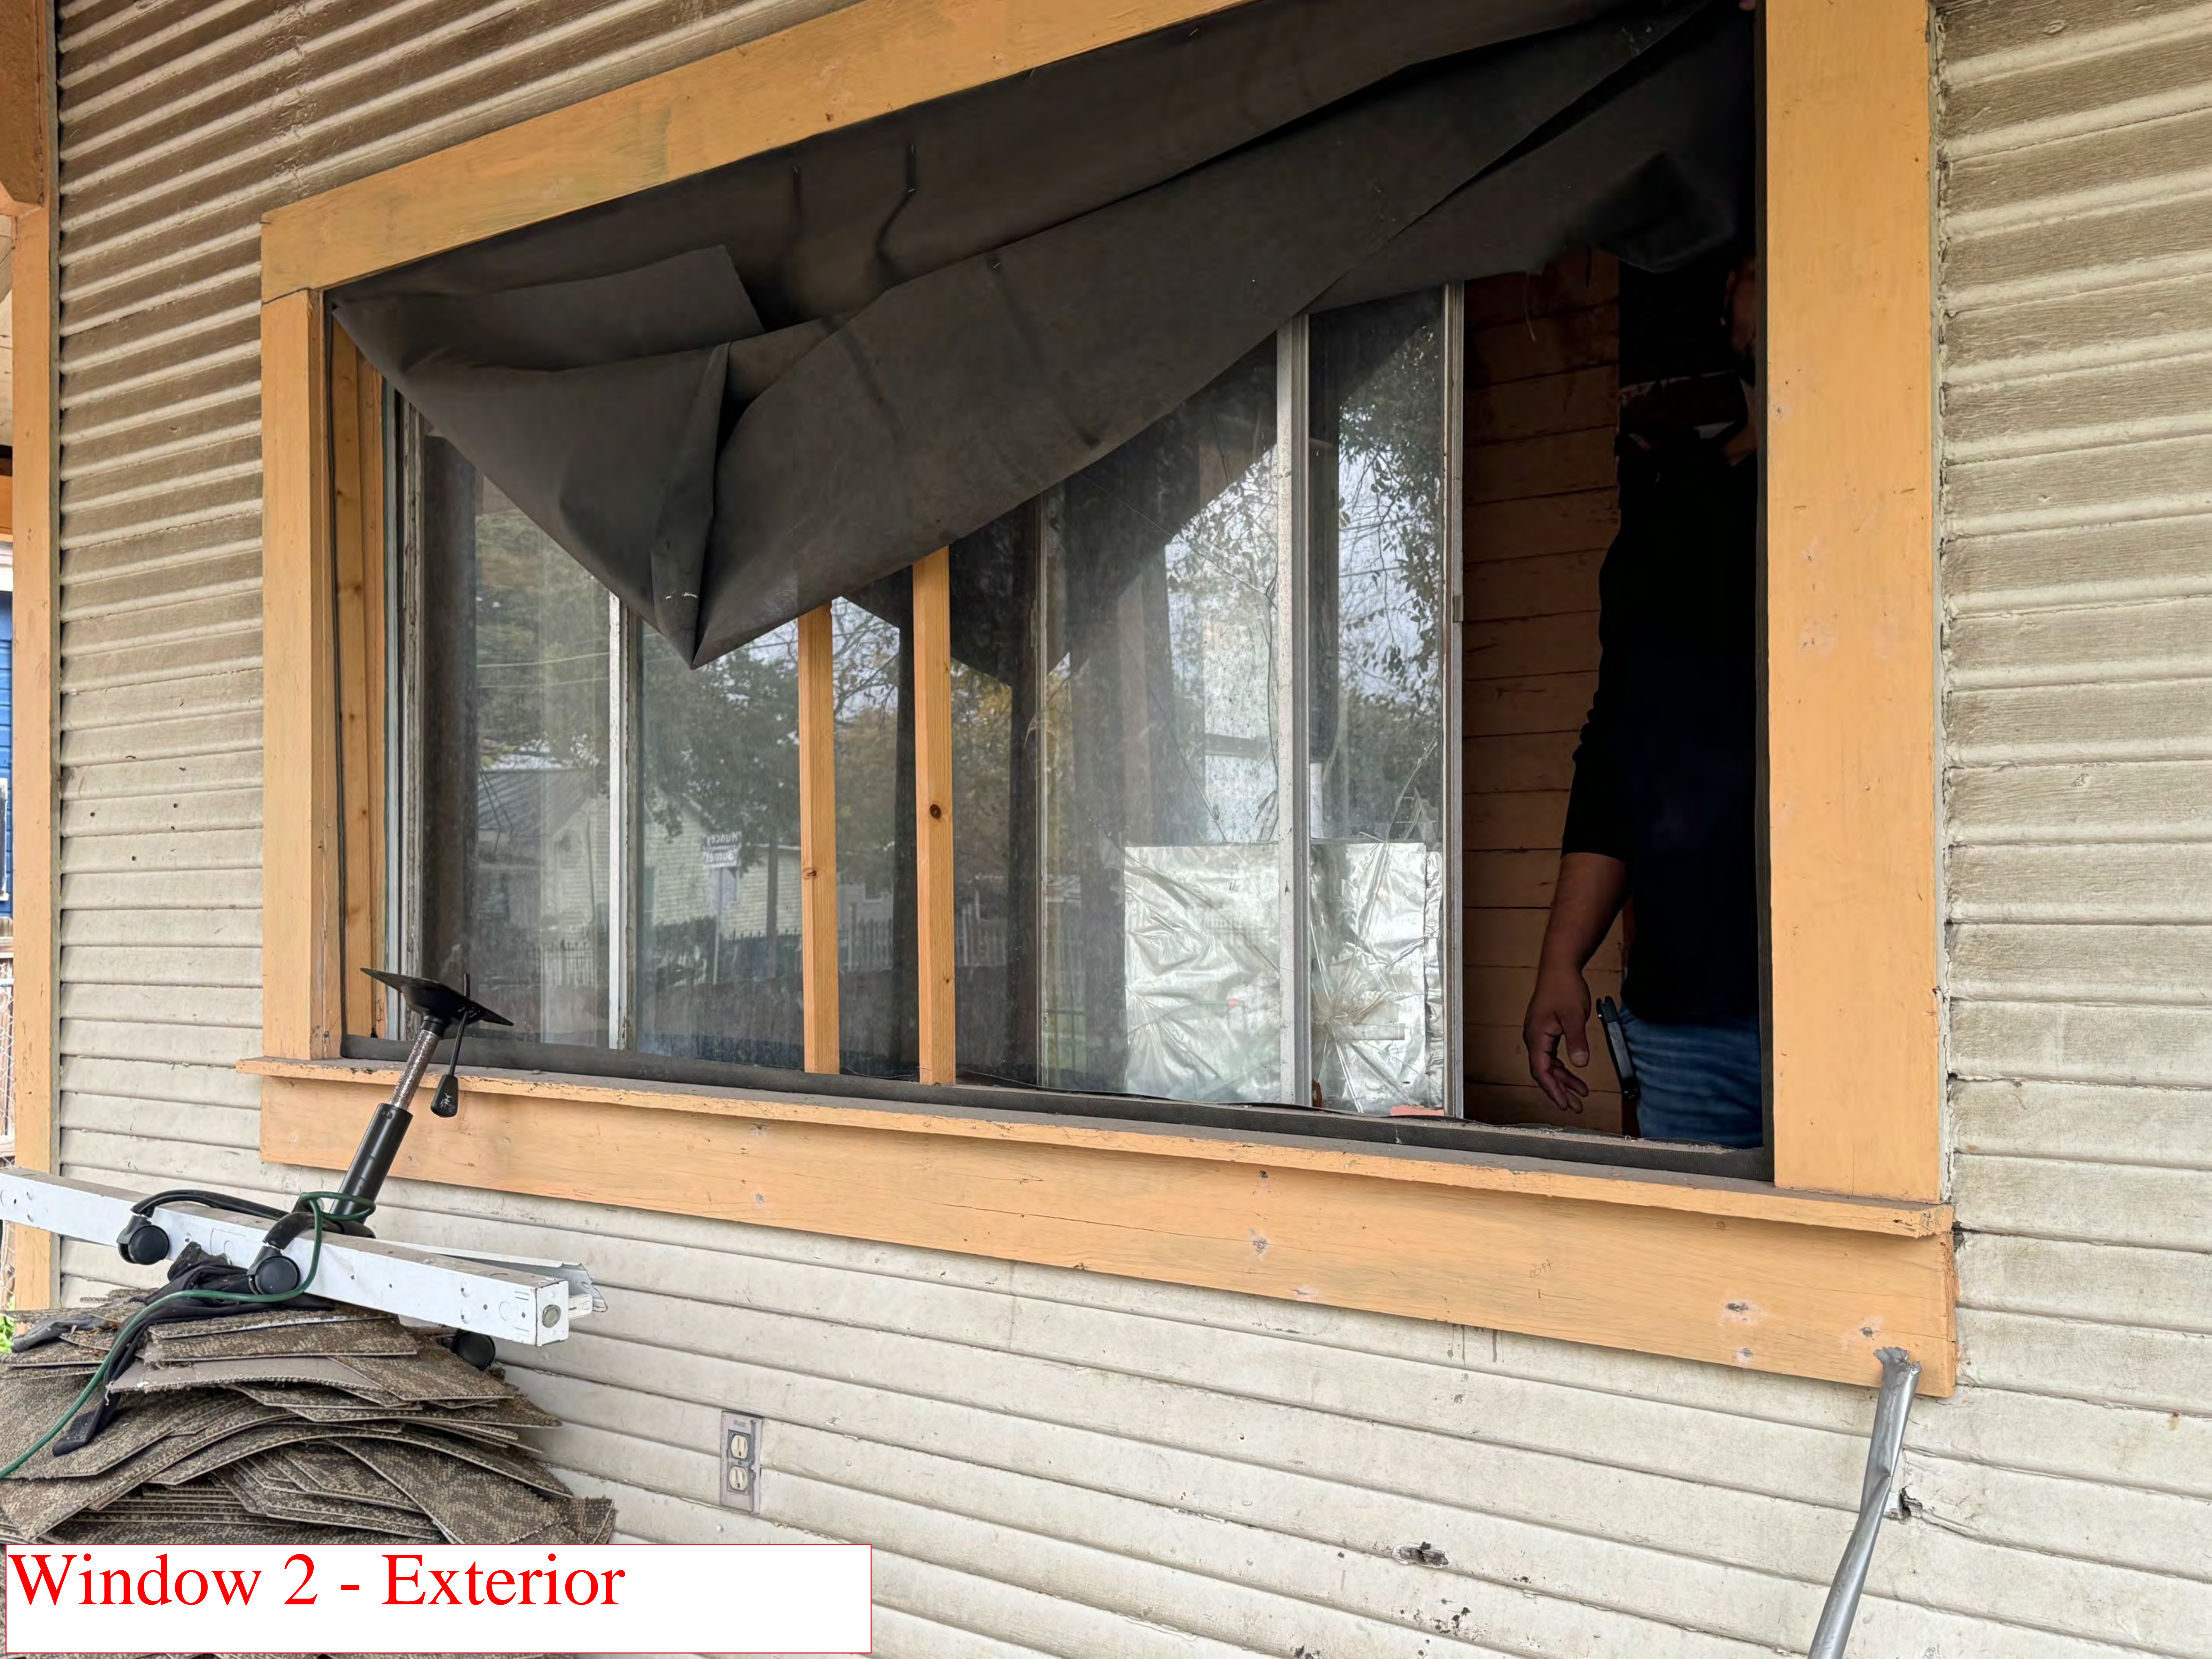
Window 2 - Exterior

- g. **WINDOW REPLACEMENT** – The applicant has proposed to replace all existing windows with new windows of unspecified material. According to the Historic Design Guidelines, wood windows should be repaired in place and restored whenever possible, unless there is substantial evidence that the windows are deteriorated beyond repair. If a window assembly is deemed irreparable, the window should be replaced in-kind in terms of materiality, configuration, inset, proportion, style, and detailing. As noted in finding d, staff finds the wood windows on the property are in repairable condition. Staff does not find replacement of the wood windows on the property consistent with the guidelines, but that windows 1, 2, 4-7, 15, and 16 are eligible for replacement or installation.

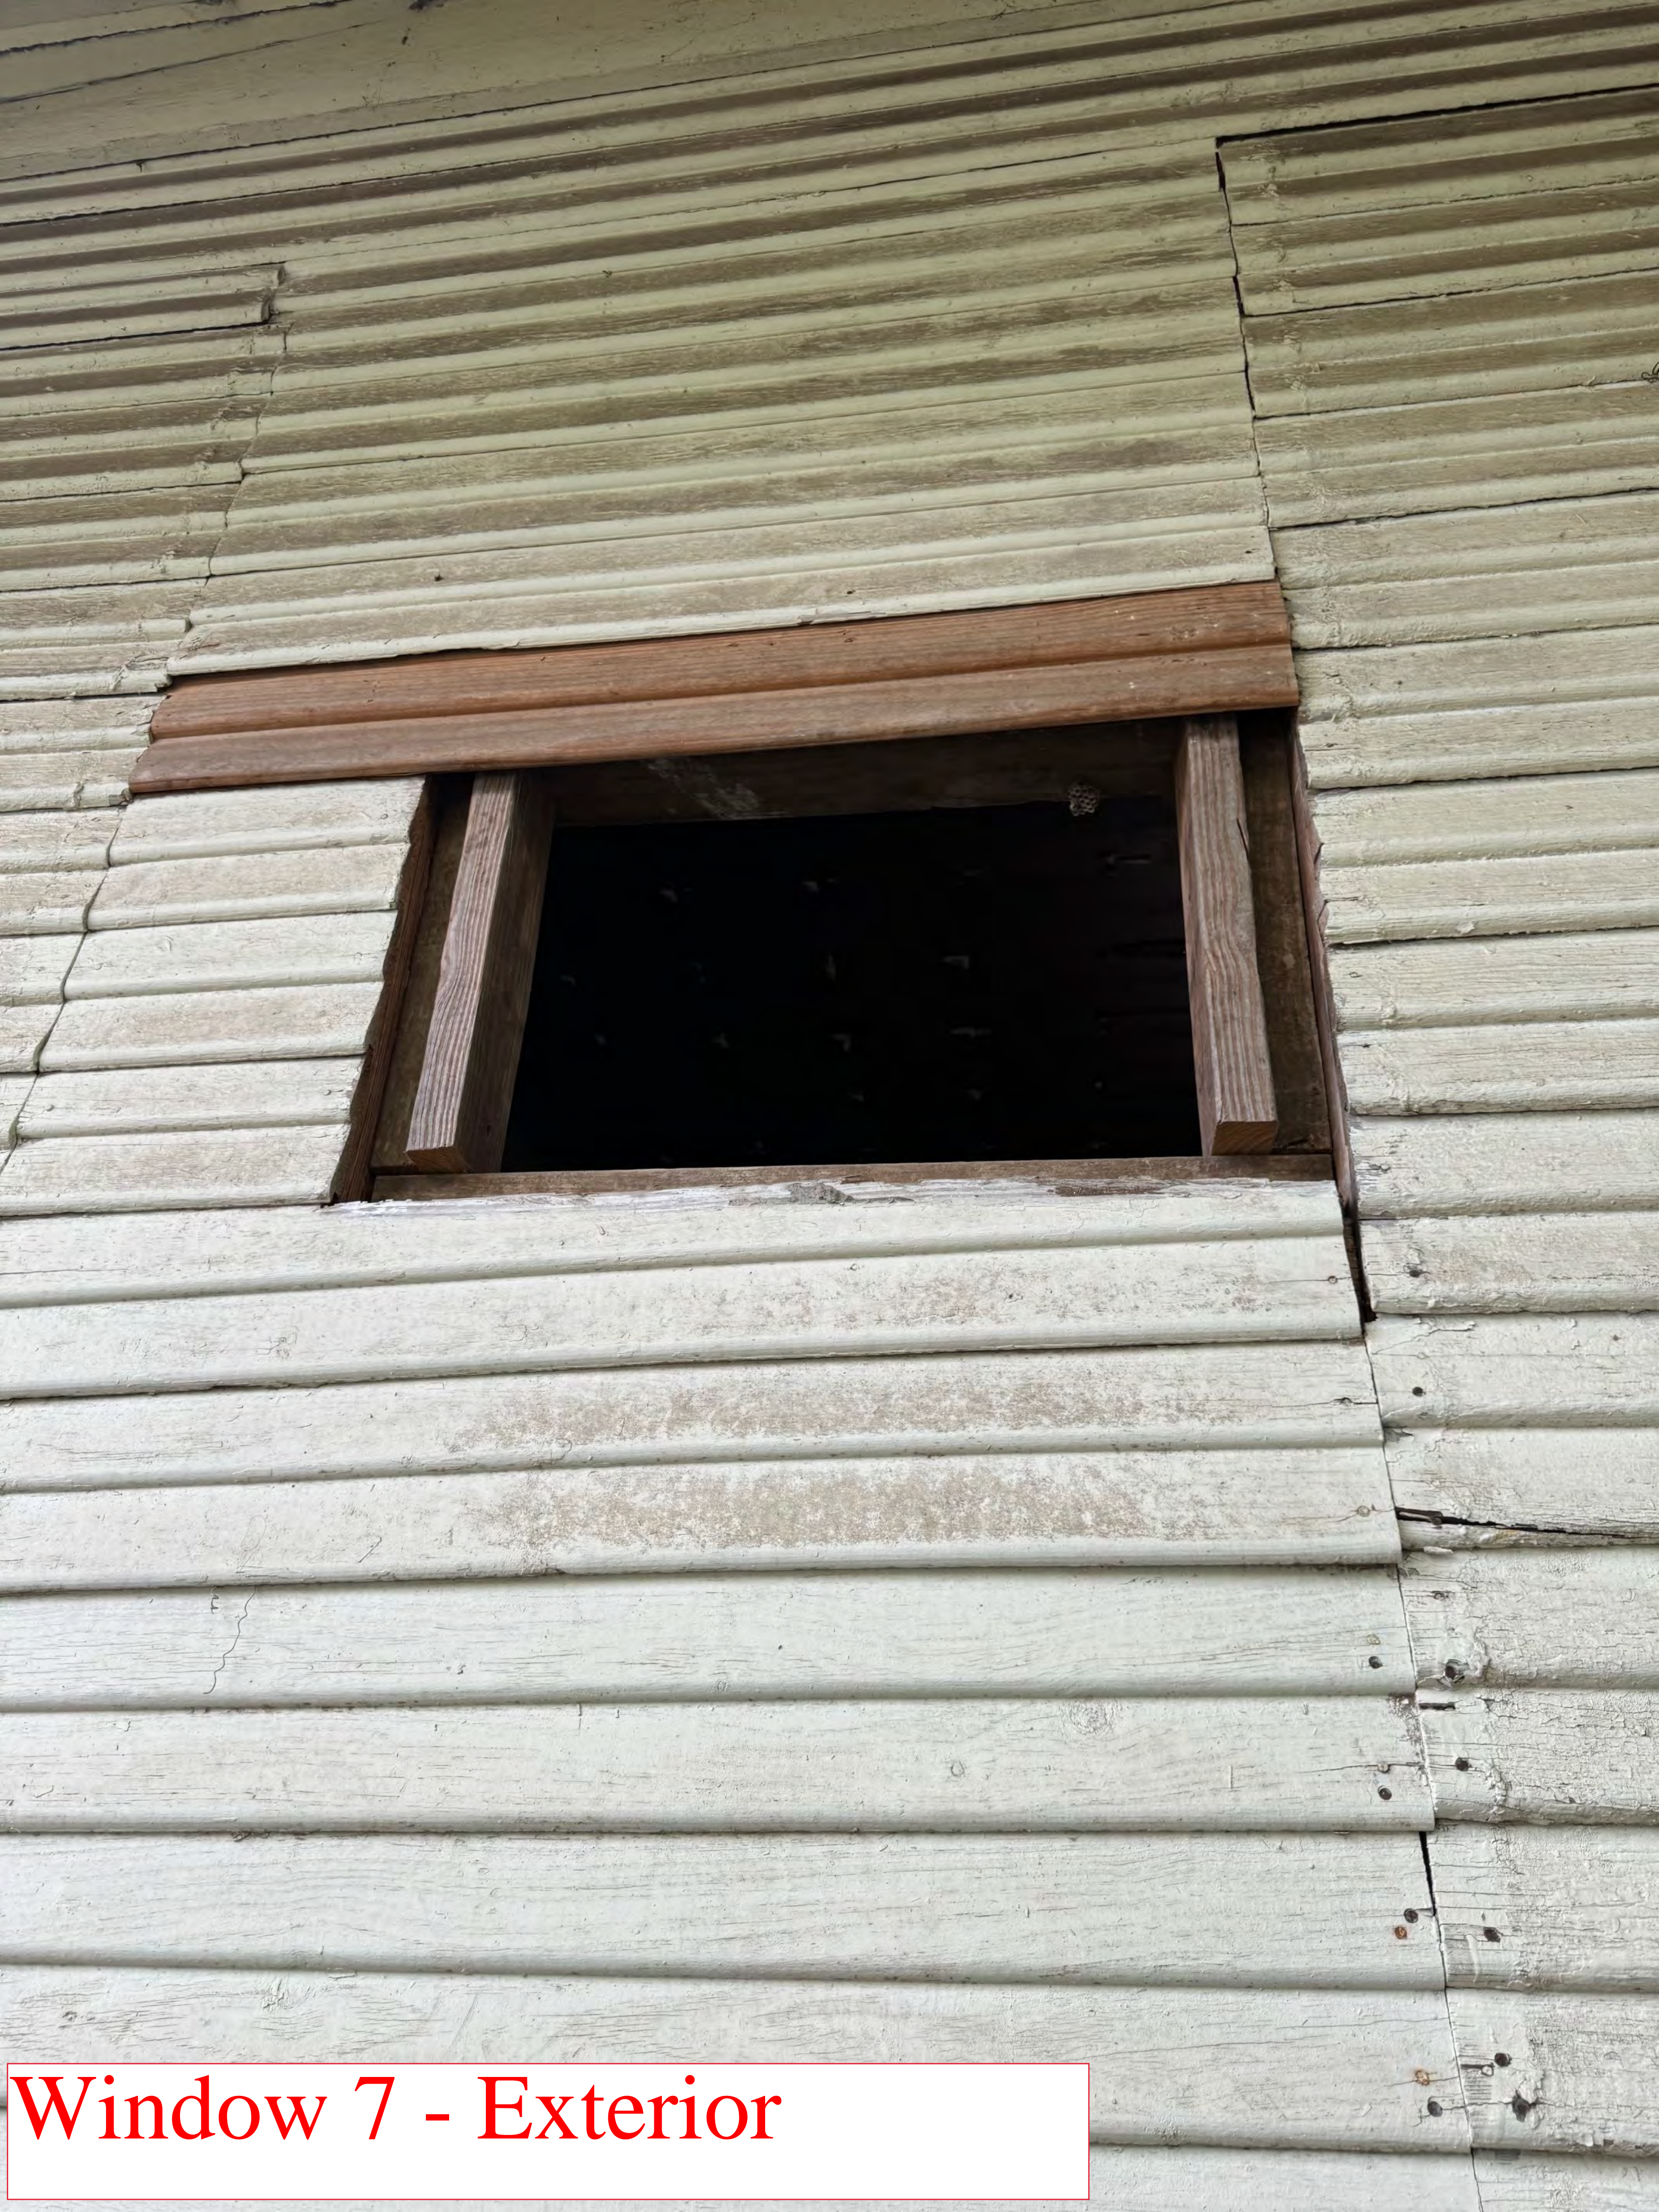
Window 7 - Exterior

- c. **SITE VISIT** – On January 23, 2024, staff conducted a site visit to assess the window conditions at 1024 Burnet St. Staff was able to observe all windows except windows 7-10. Windows 1, 2, 4, 5, 6, 15, and 16 are aluminum windows, windows 3 and 8-14 are wood, and window 7 does not have a window installed.

- iii. That the applicant submit additional evidence to demonstrate the appropriate locations and sizes for new windows. This can include any intact wall framing or areas where siding has been patched. New windows sizes
