**HISTORIC AND DESIGN REVIEW COMMISSION
COMPLIANCE AND TECHNICAL ADVISORY BOARD**

HDRC CASE NO: 2024-043
ADDRESS: 418 FURR DR
LEGAL DESCRIPTION: NCB 6696 BLK 5 LOT 32
ZONING: R-6, H
CITY COUNCIL DIST.: 7
DISTRICT: Monticello Park Historic District
APPLICANT: John and Chelsey Hunter/HUNTER JOHN T & CHELSEY ANN
OWNER: John and Chelsey Hunter/HUNTER JOHN T & CHELSEY ANN
TYPE OF WORK: Replace seven wood windows with aluminum-clad windows
APPLICATION RECEIVED: January 19, 2024
60-DAY REVIEW: March 19, 2024
CASE MANAGER: Claudia Espinosa

REQUEST:

The applicant is requesting a Certificate of Appropriateness for approval to remove seven existing wood windows and replace them with five double-hung aluminum-clad wood windows and two fixed windows.

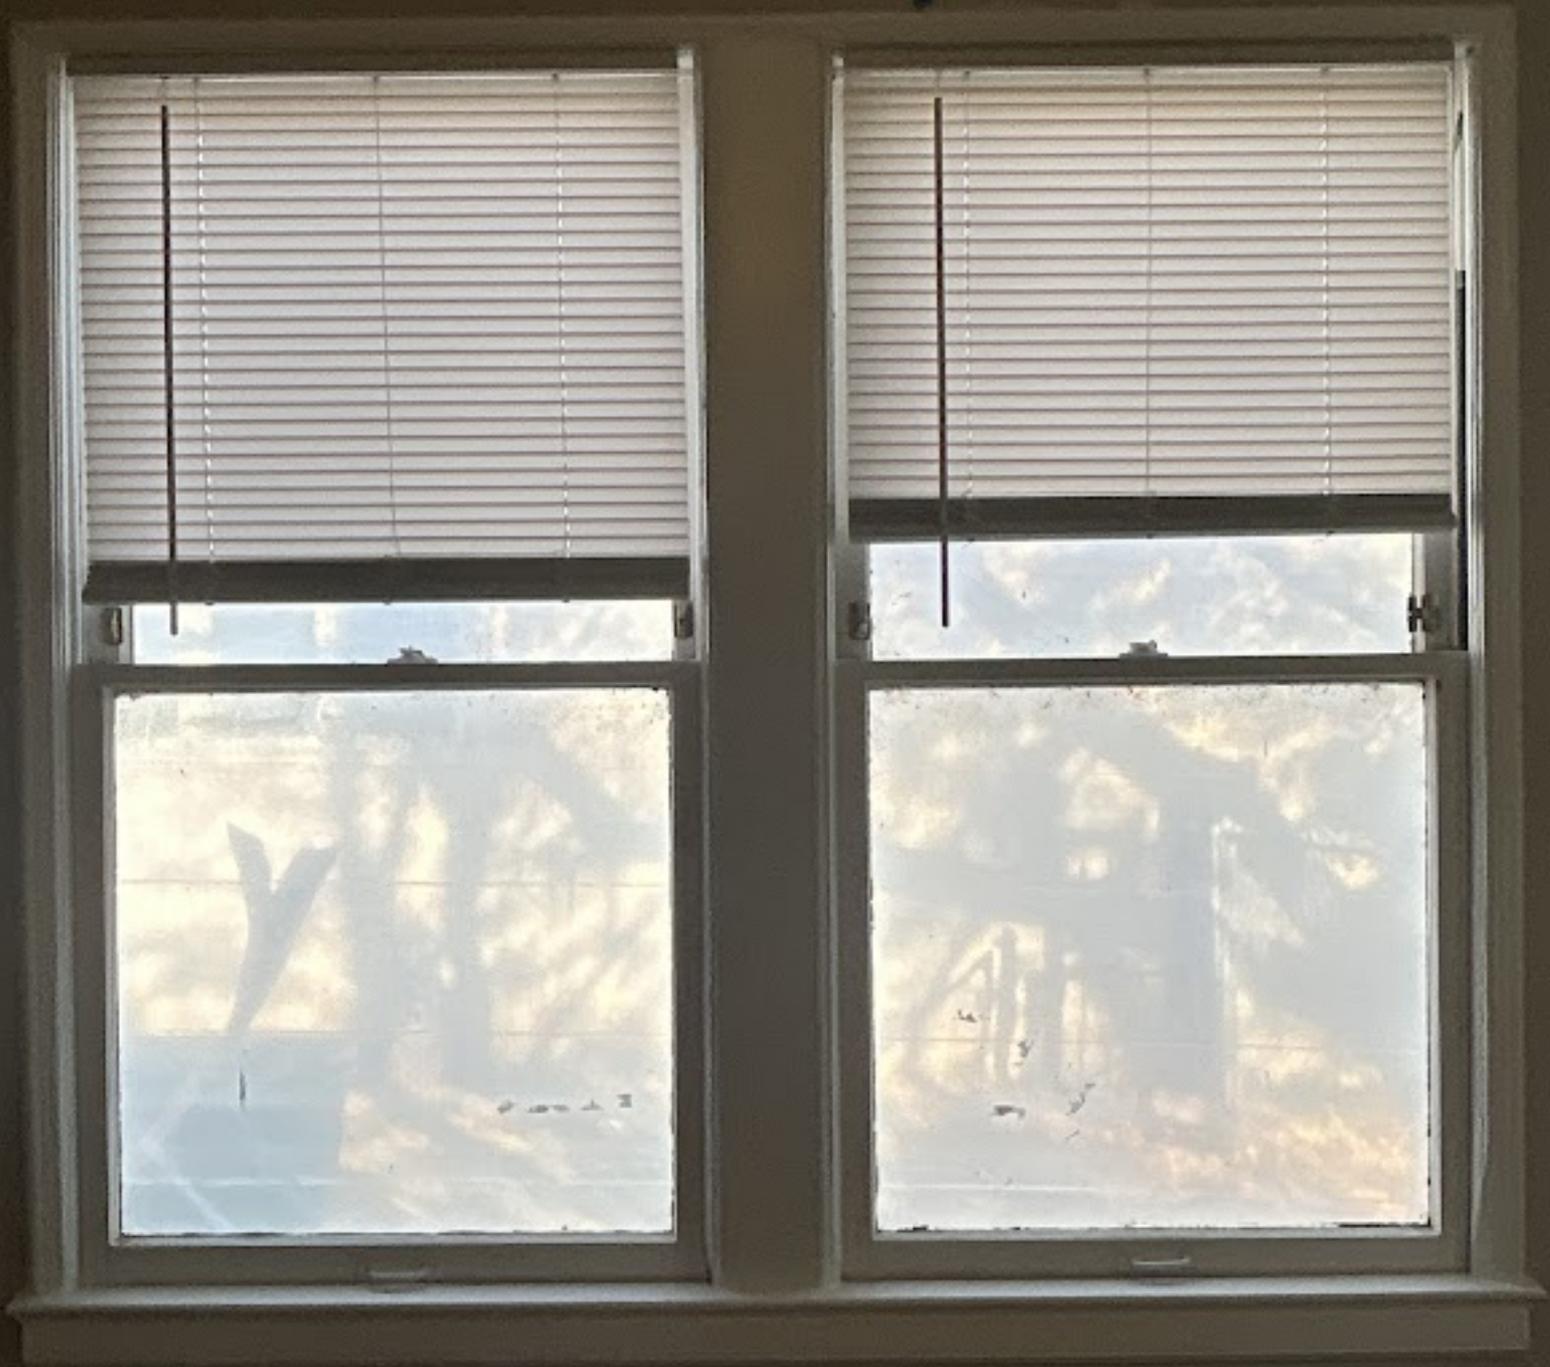
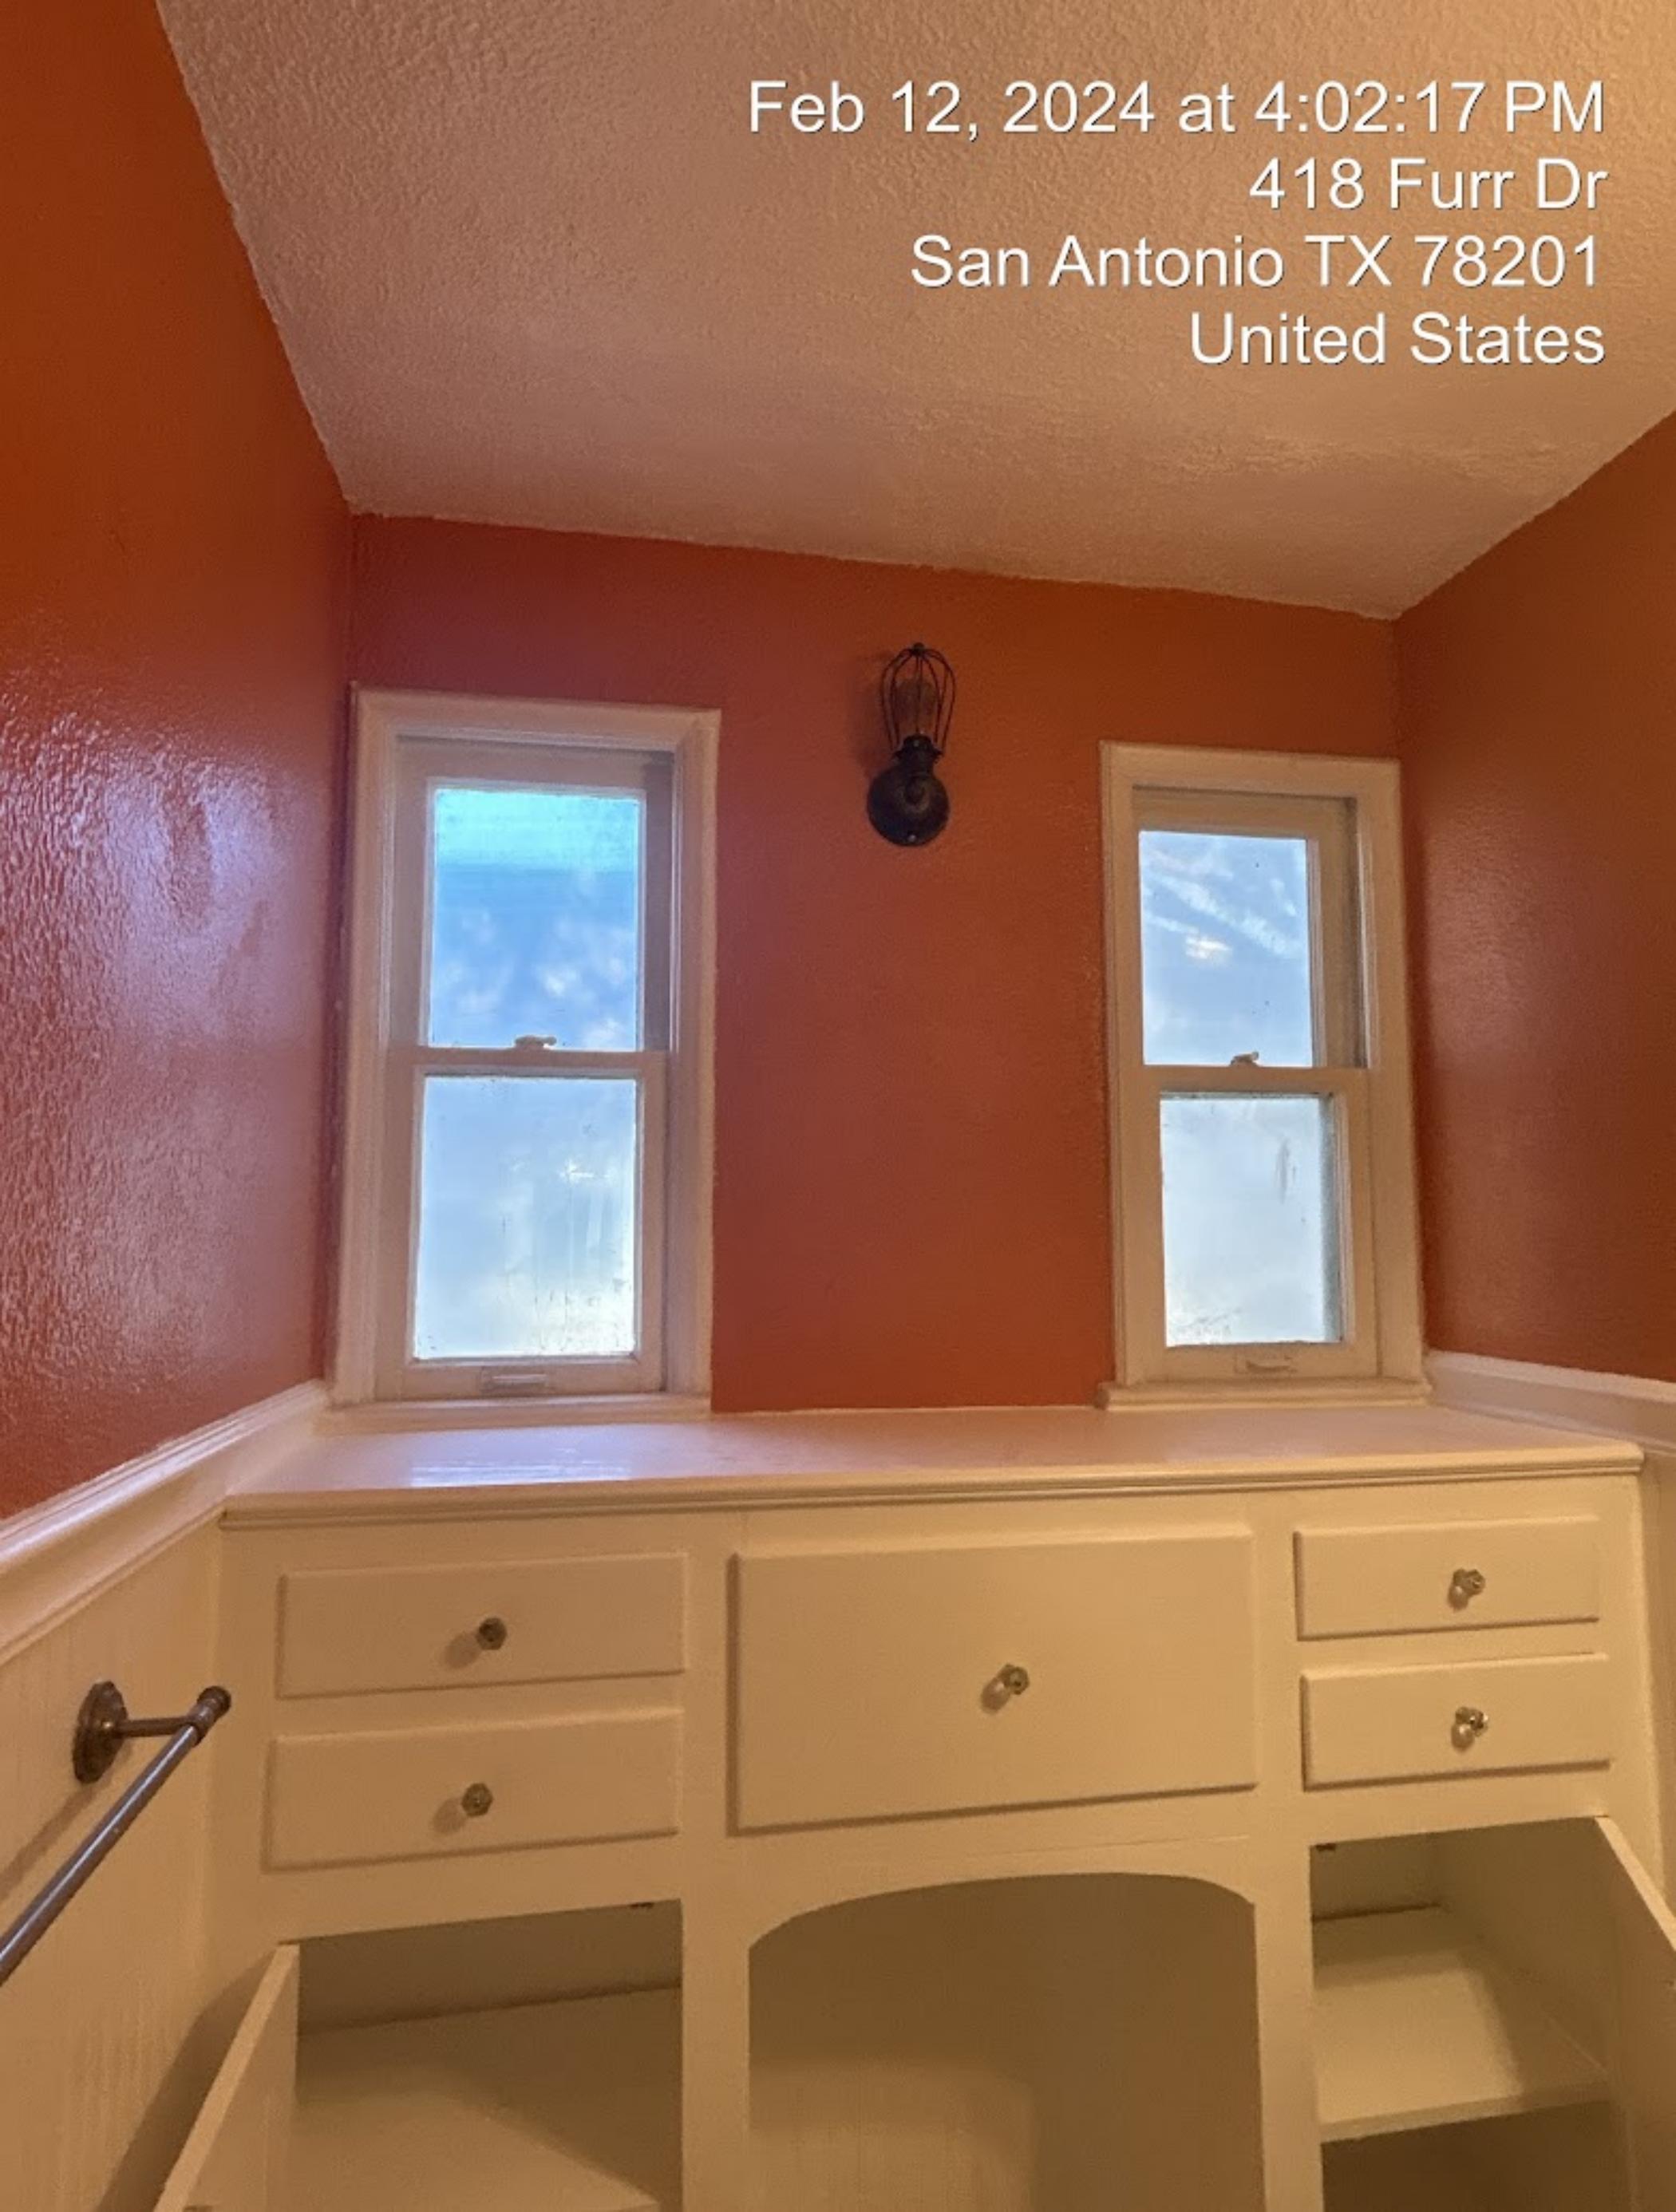
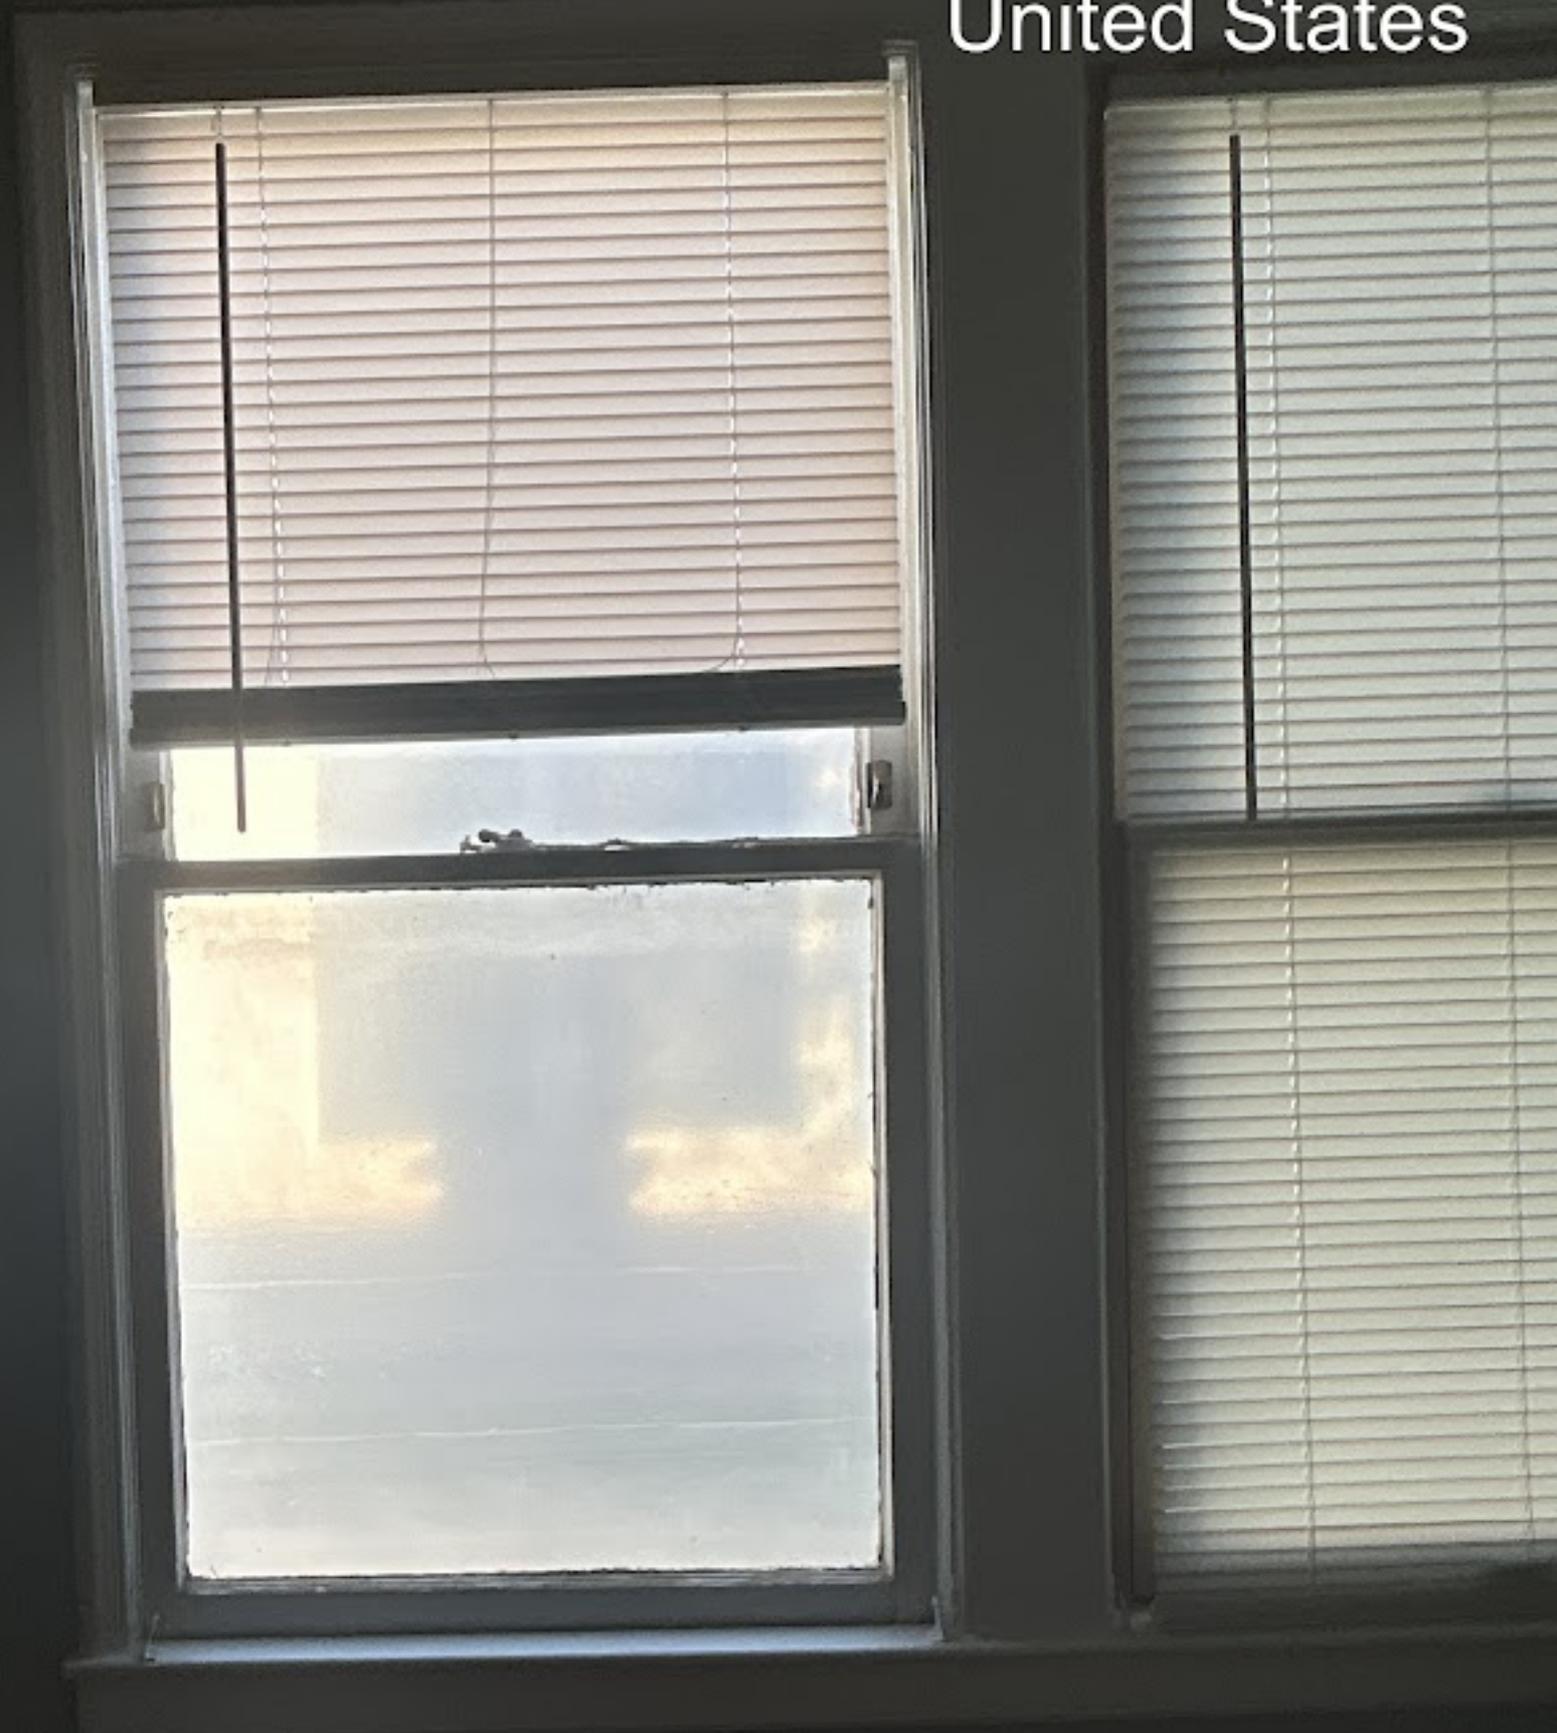
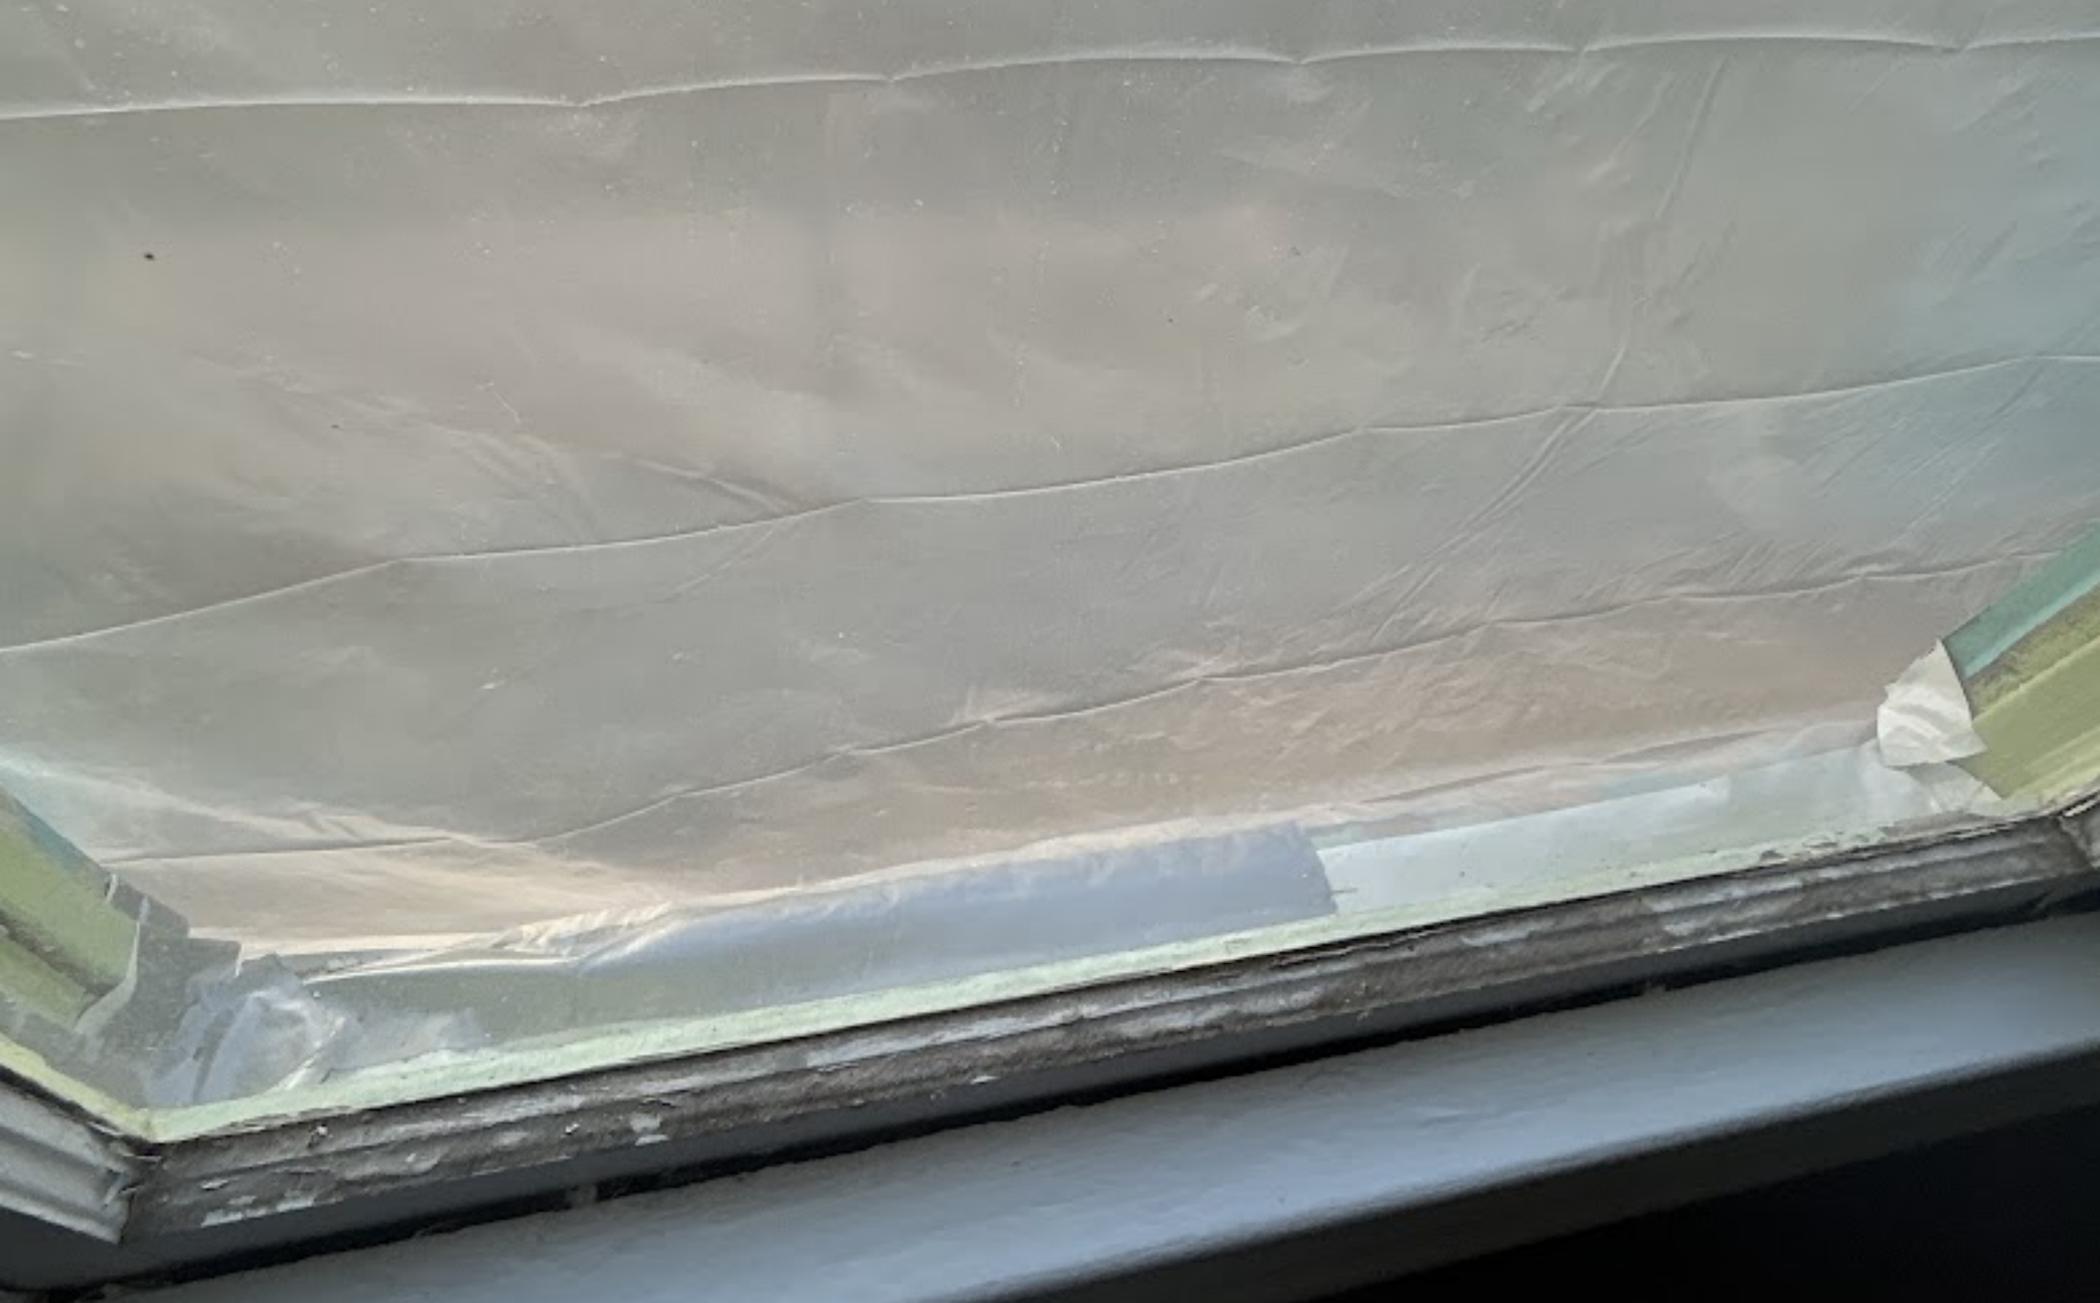
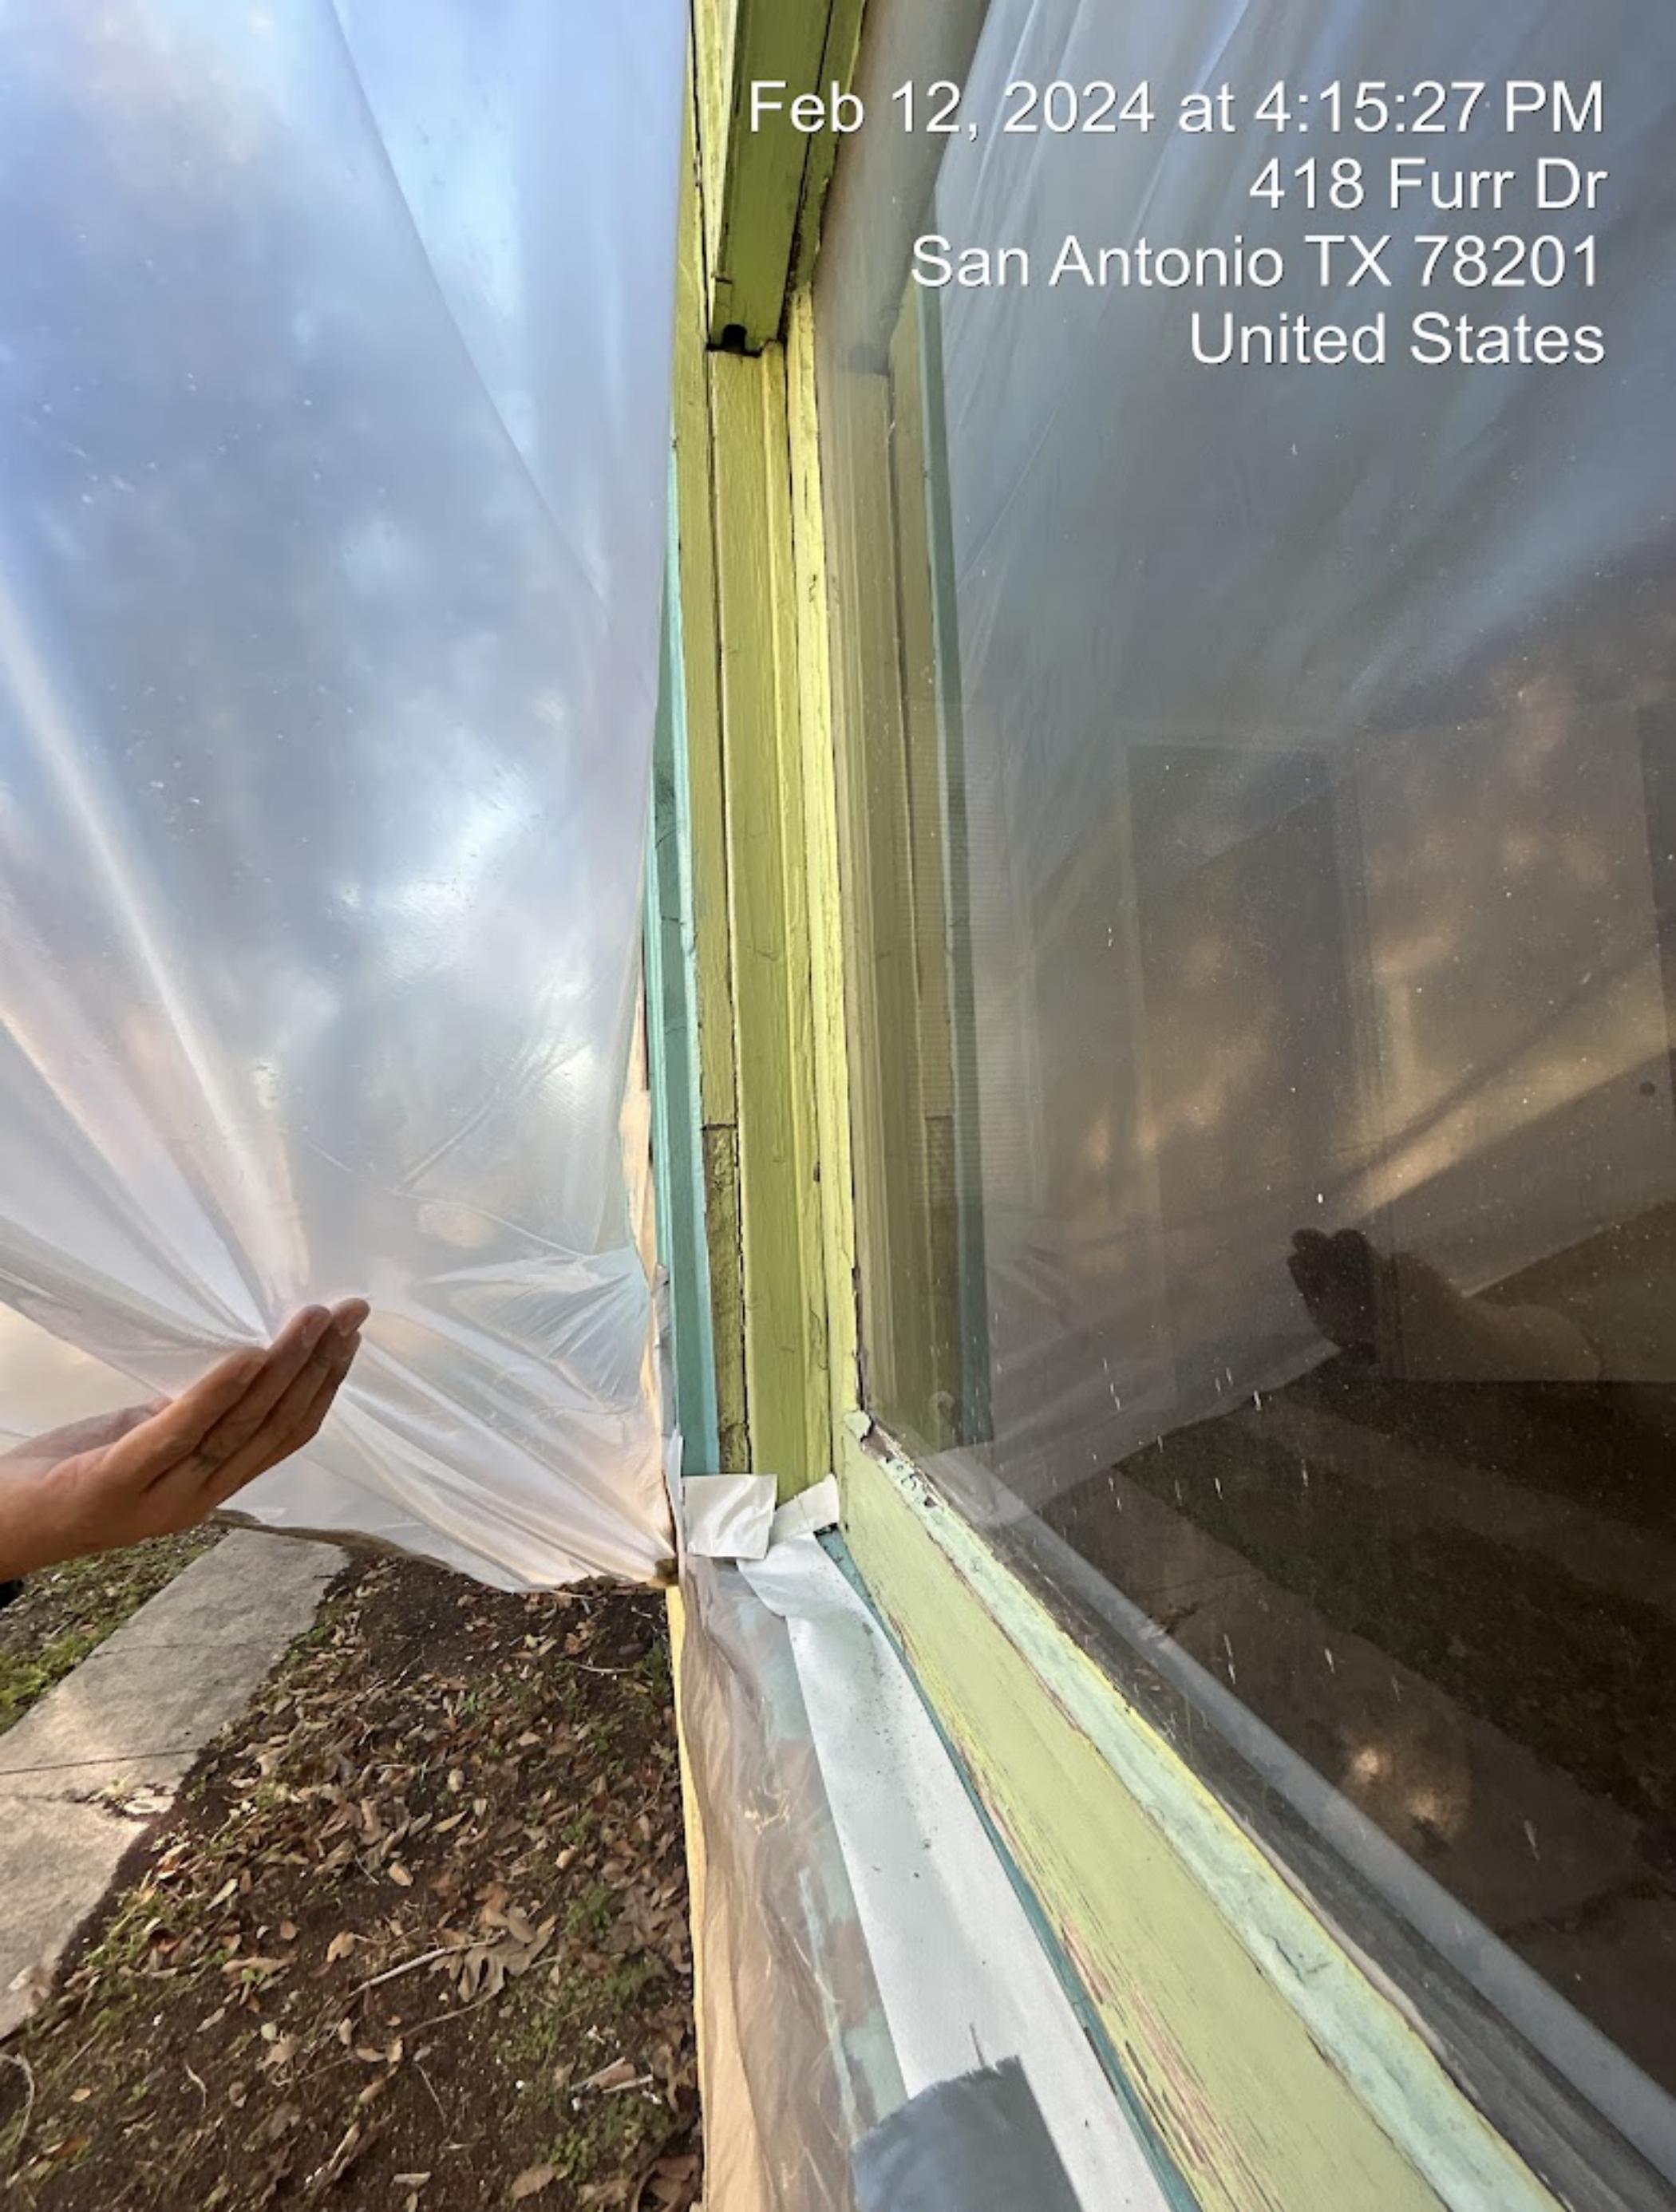
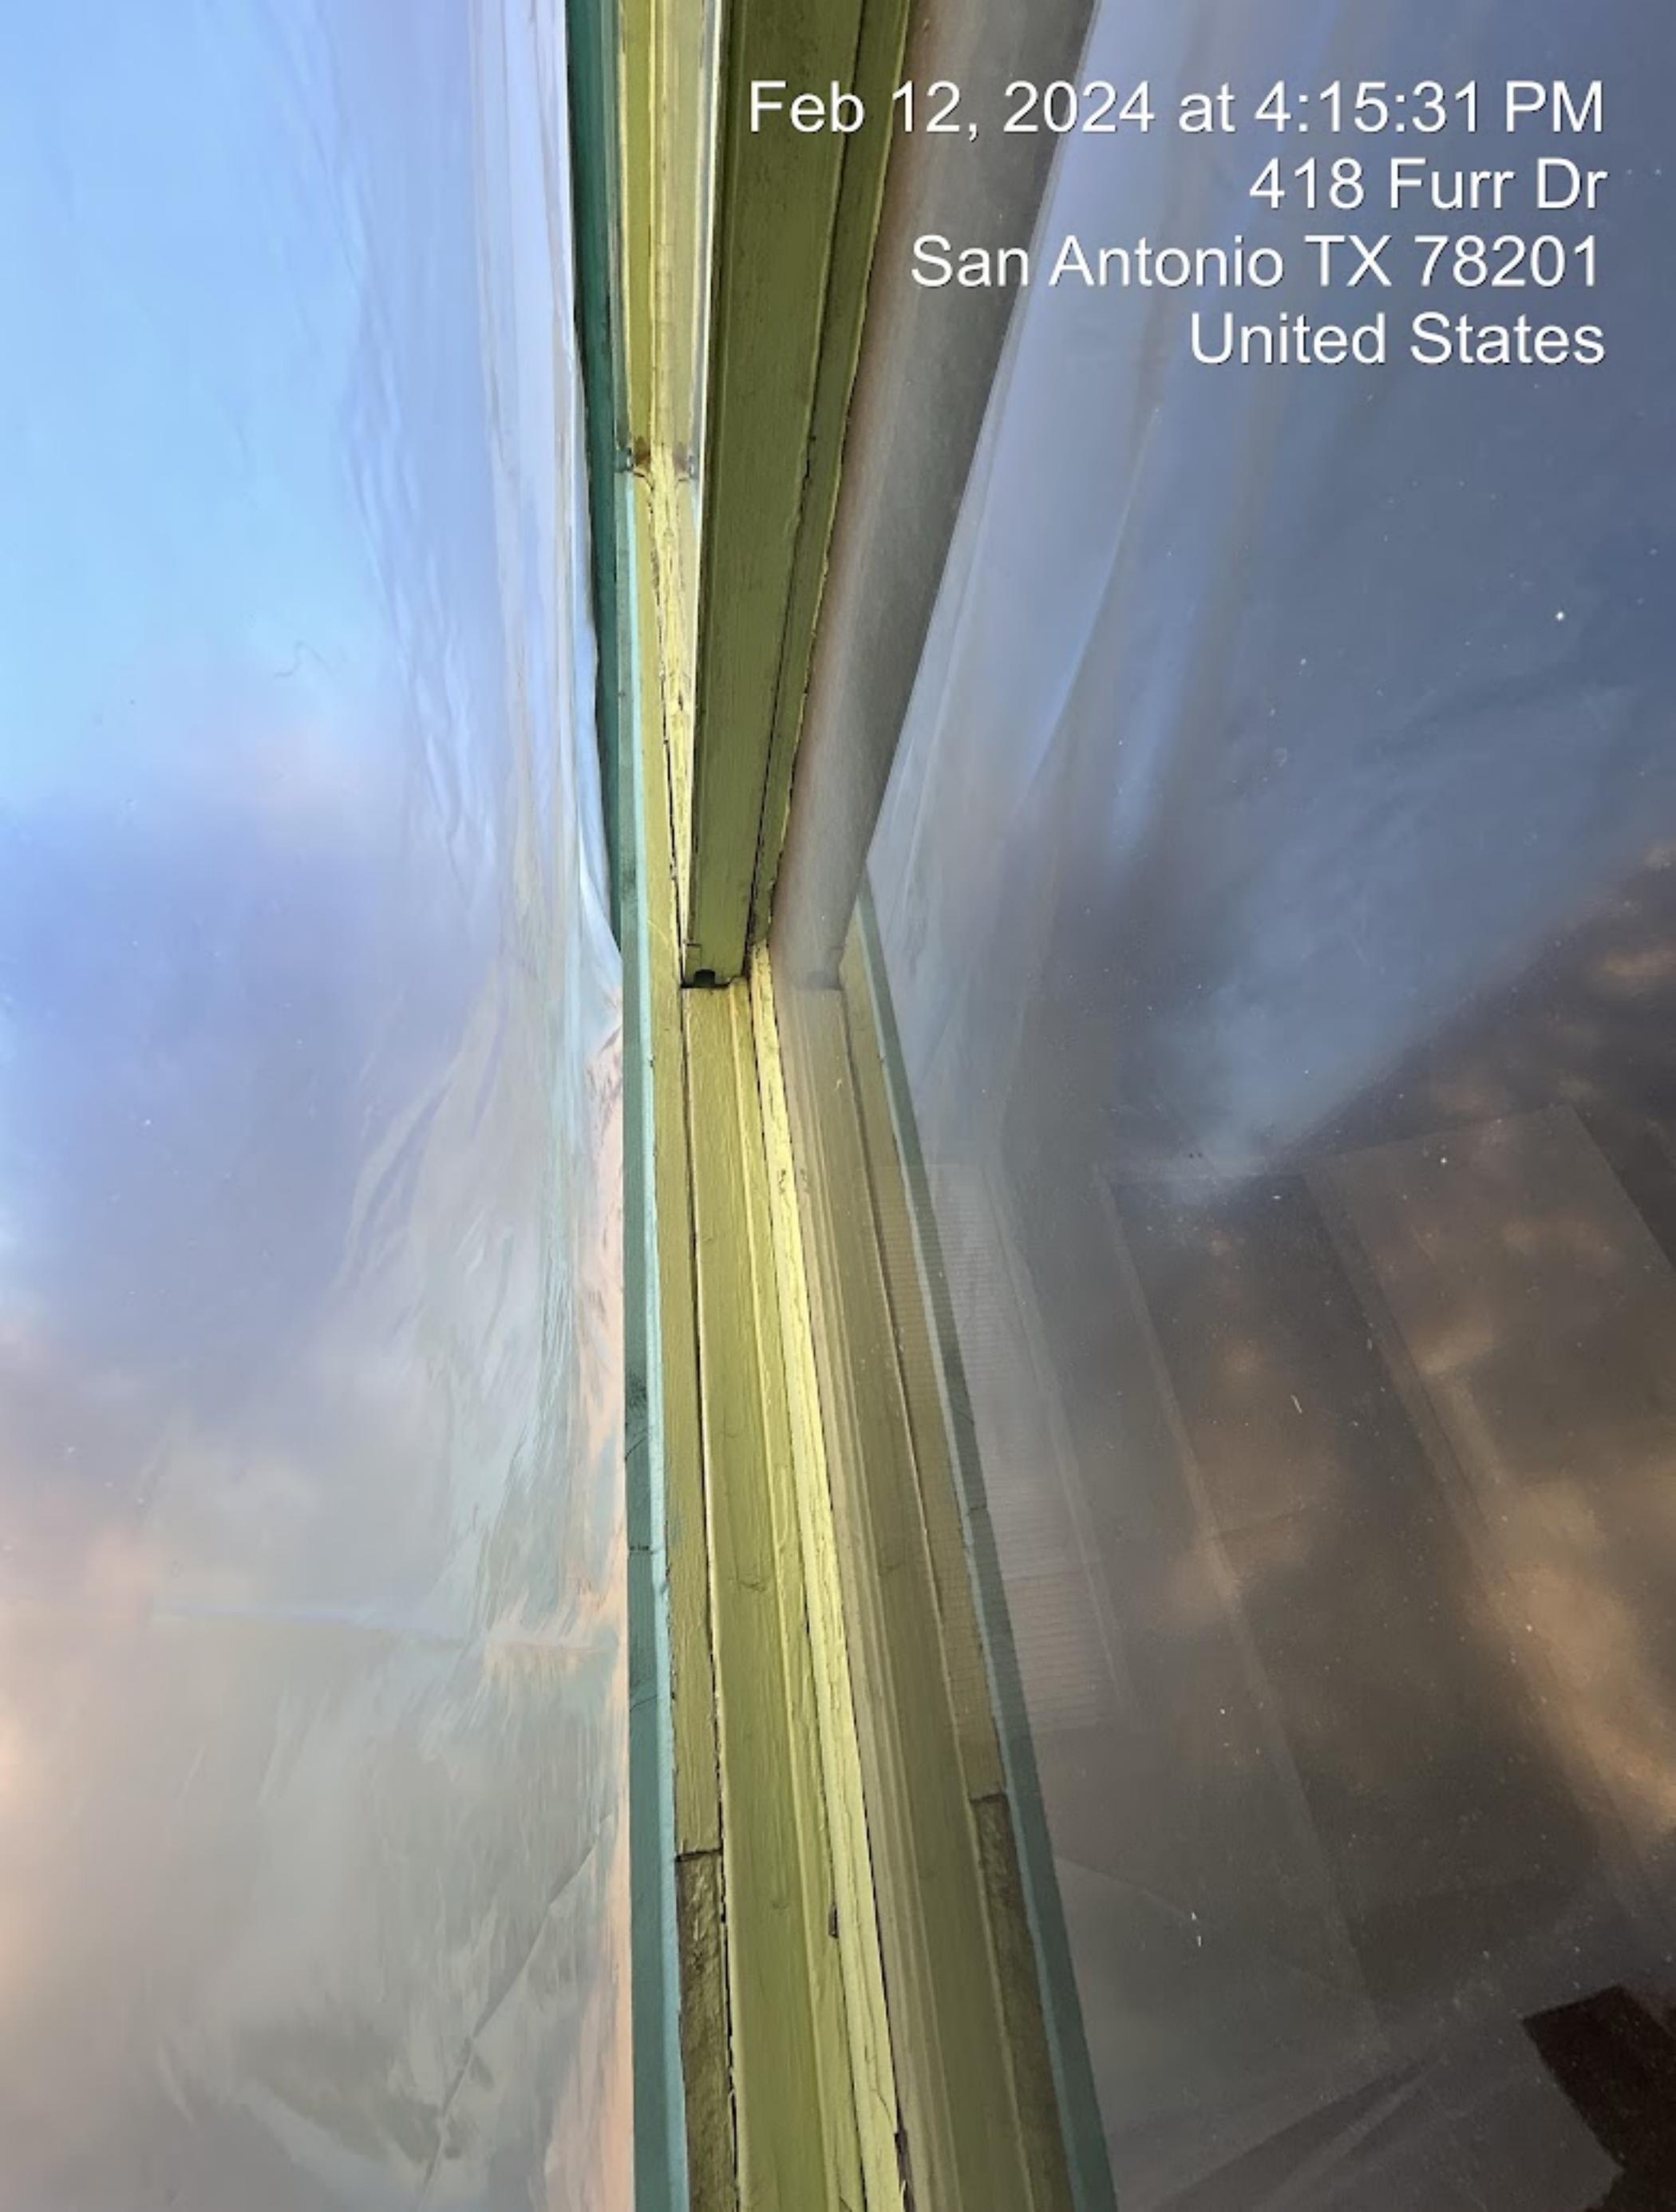
- b. SITE VISIT – On February 12, 2024, Staff was able to meet with the contractor to conduct a window inspection. During the inspection, staff noticed the deterioration of the existing window trim and sill on the exterior of the house. The lower window sashes had noticeable wear and tear, but staff recommends exploring reglazing and repair of the bottom sashes prior to wholesale replacement.

Staff does not recommend approval of the replacement of the existing wood windows with aluminum-clad windows, based on findings b through e. Staff recommends that the windows be repaired with in-kind materials.
