HISTORIC AND DESIGN REVIEW COMMISSION

January 17, 2024

HDRC CASE NO: 2023-505
ADDRESS: 2619 MCCULLOUGH AVE
LEGAL DESCRIPTION: NCB 1704 BLK 12 LOT N1-2 OF 12 & 13
ZONING: O-1, H
CITY COUNCIL DIST.: 1
DISTRICT: Monte Vista Historic District
APPLICANT: Bertha Zuniga/Zuniga Law, PLLC
OWNER: Bertha Zuniga/Zuniga Law, PLLC
TYPE OF WORK: Siding installation
APPLICATION RECEIVED: December 05, 2023
60-DAY REVIEW: February 3, 2024
CASE MANAGER: Claudia Espinosa

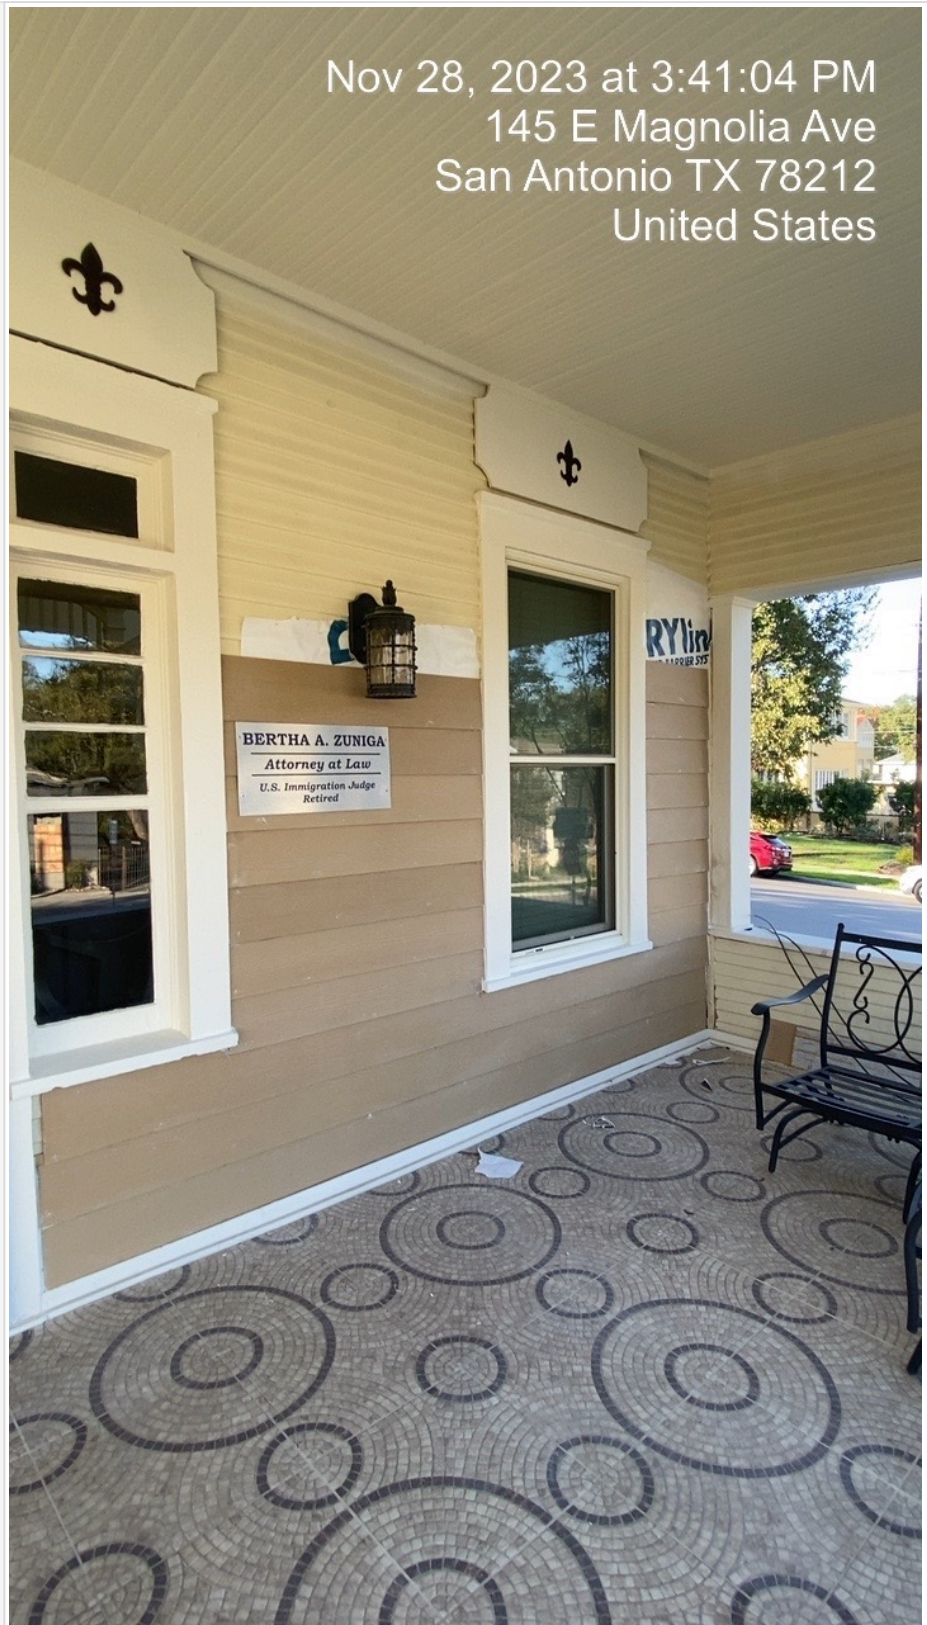
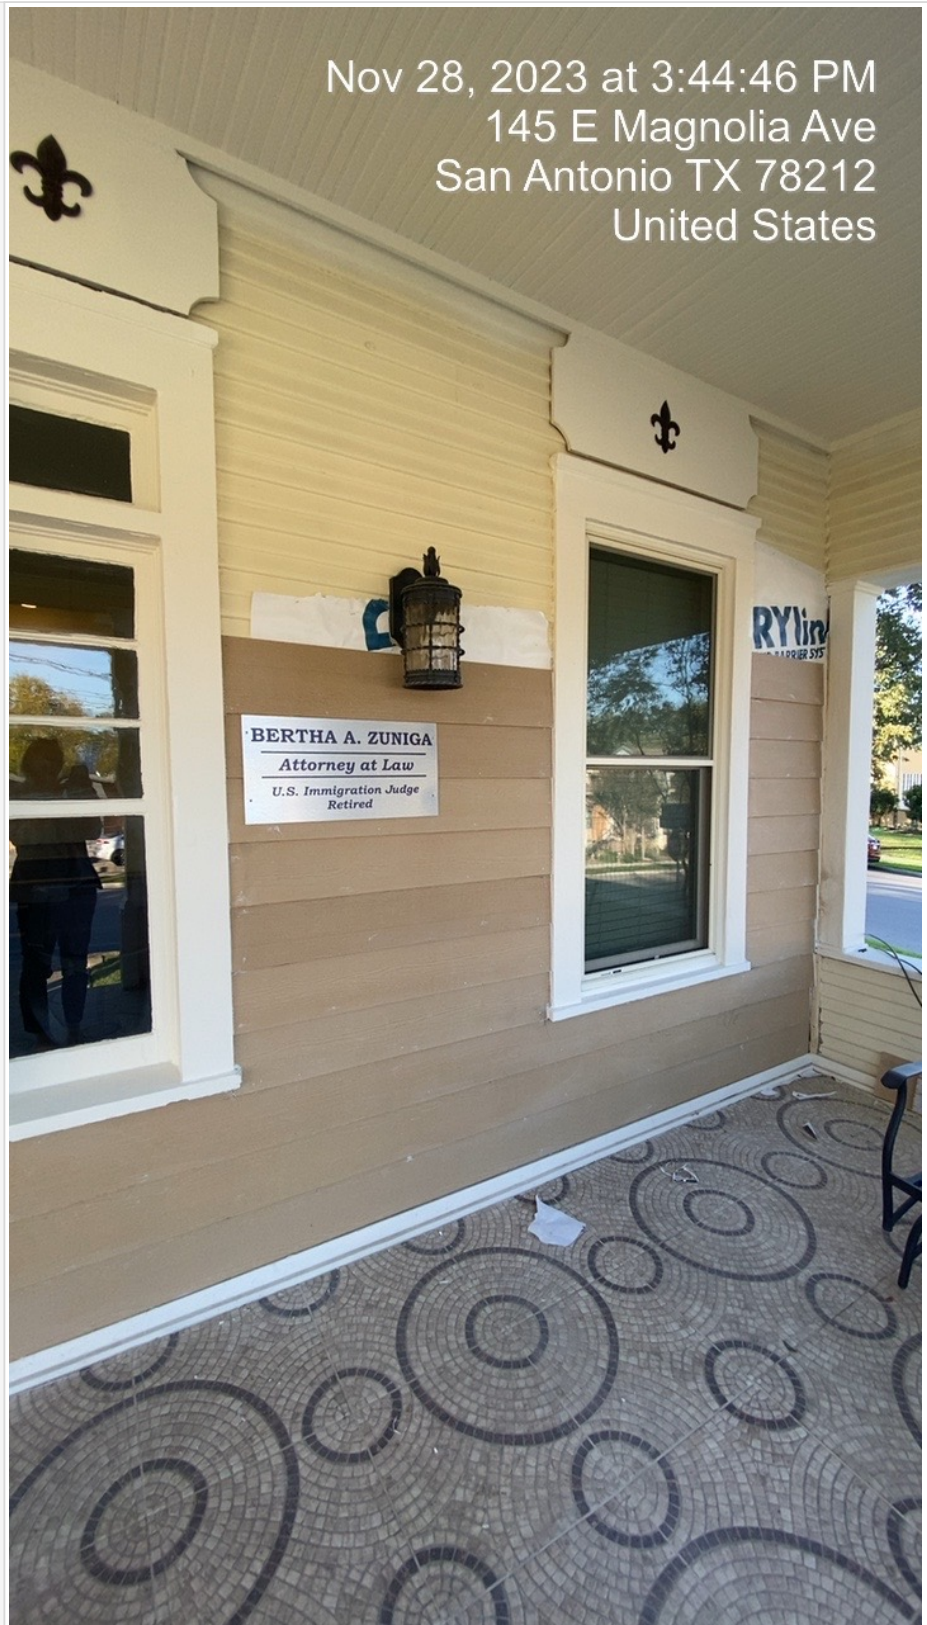
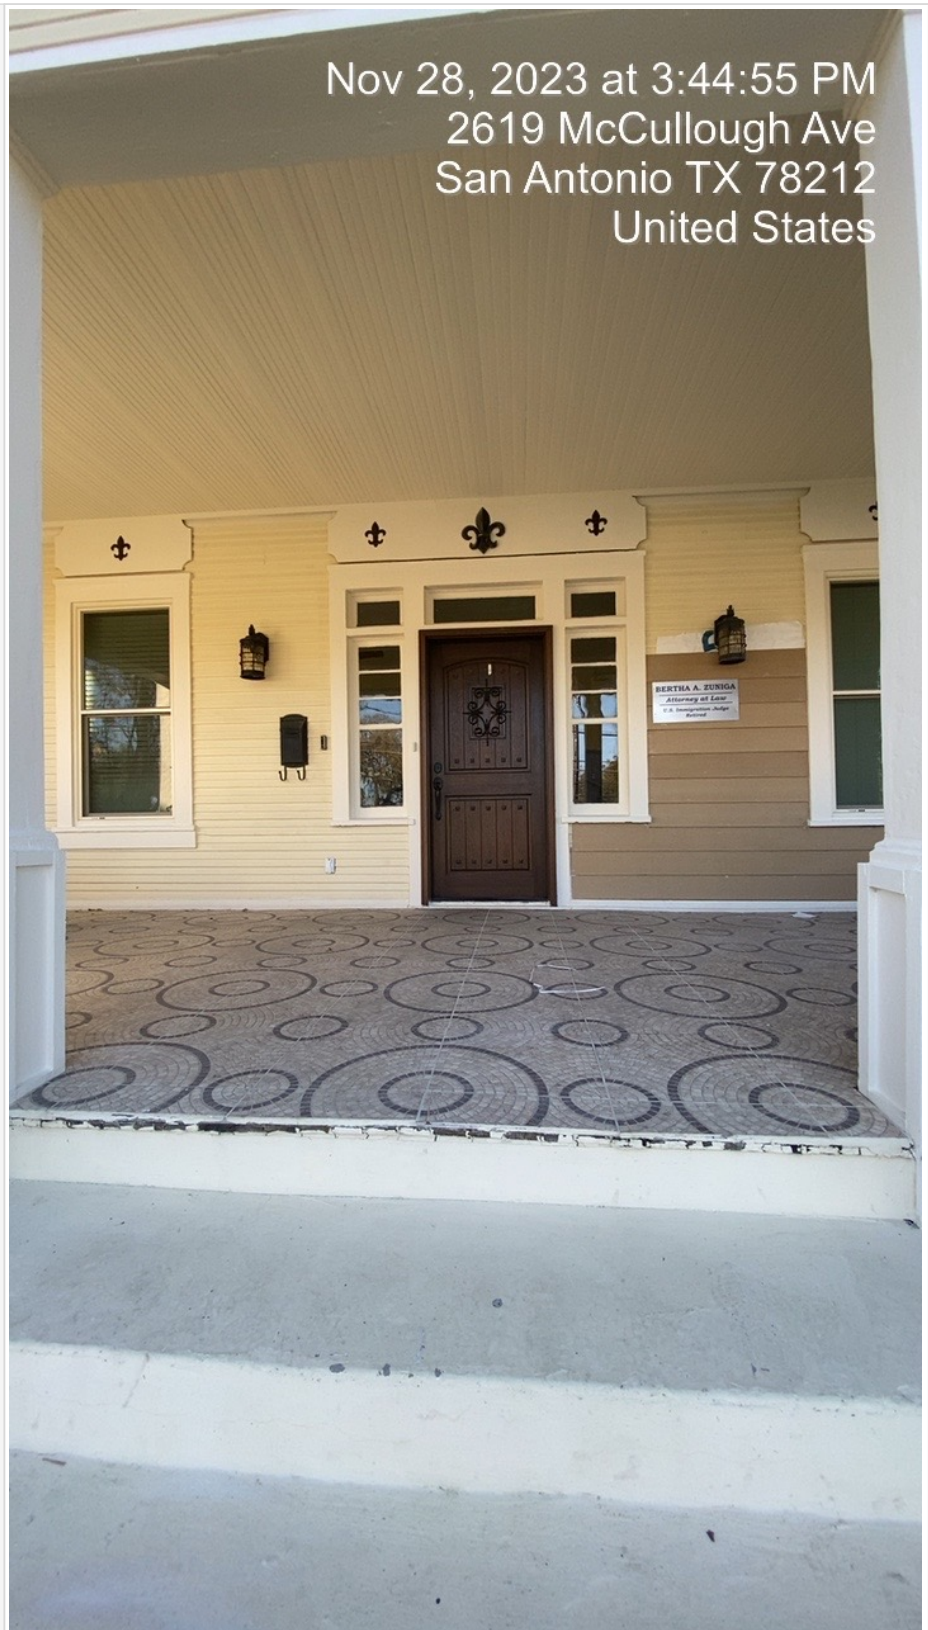
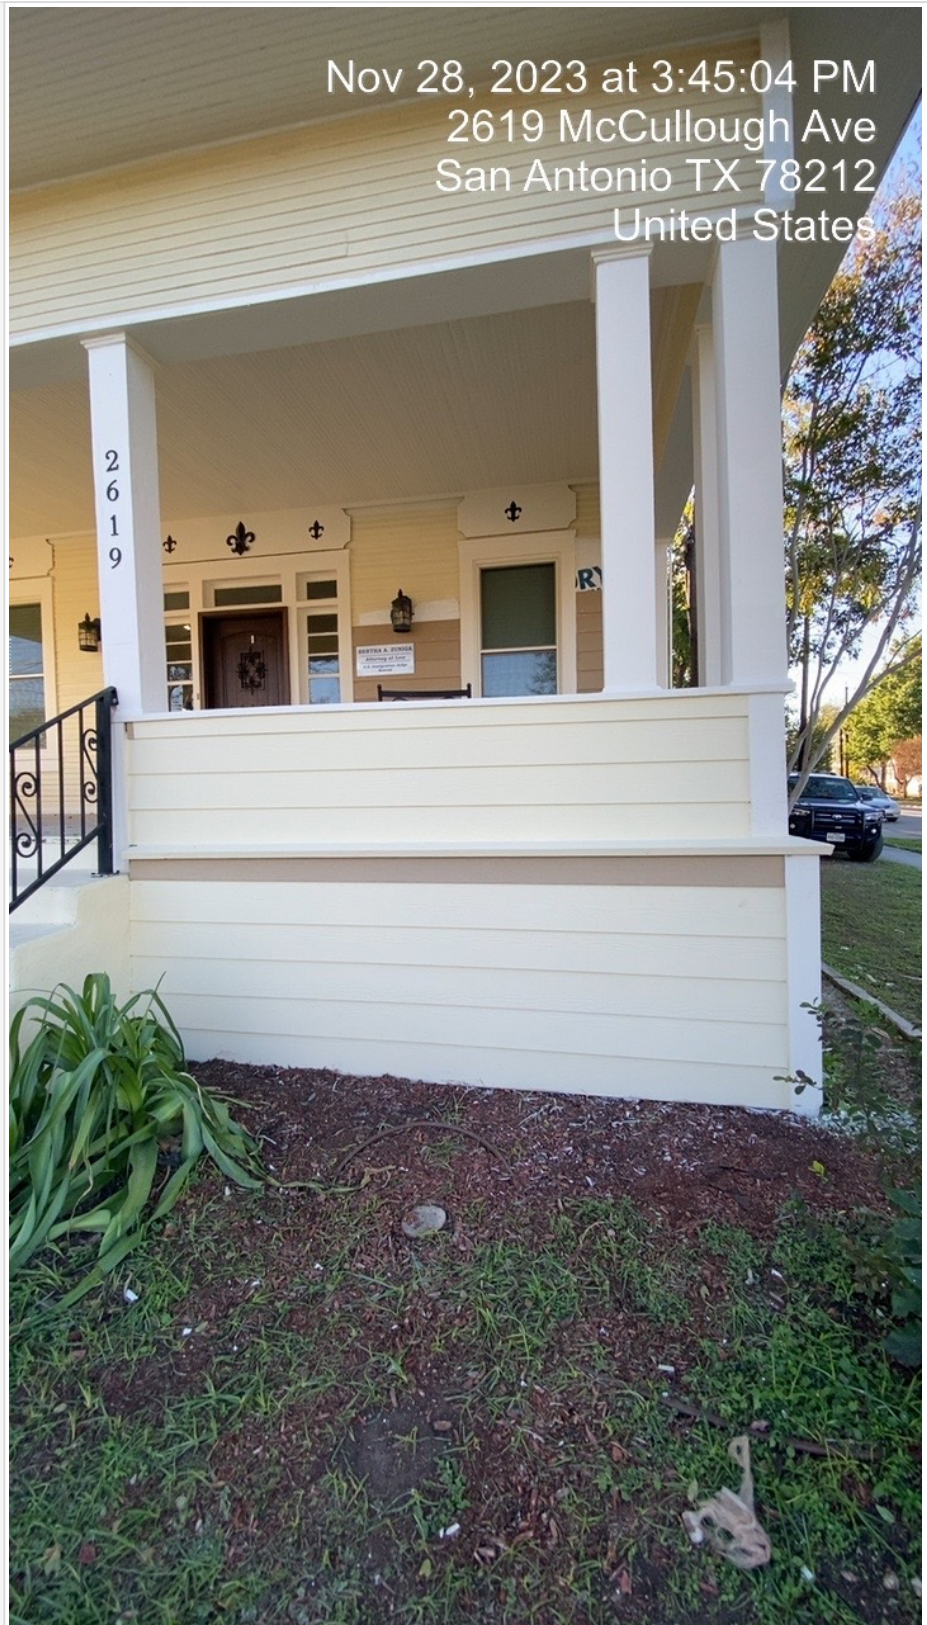
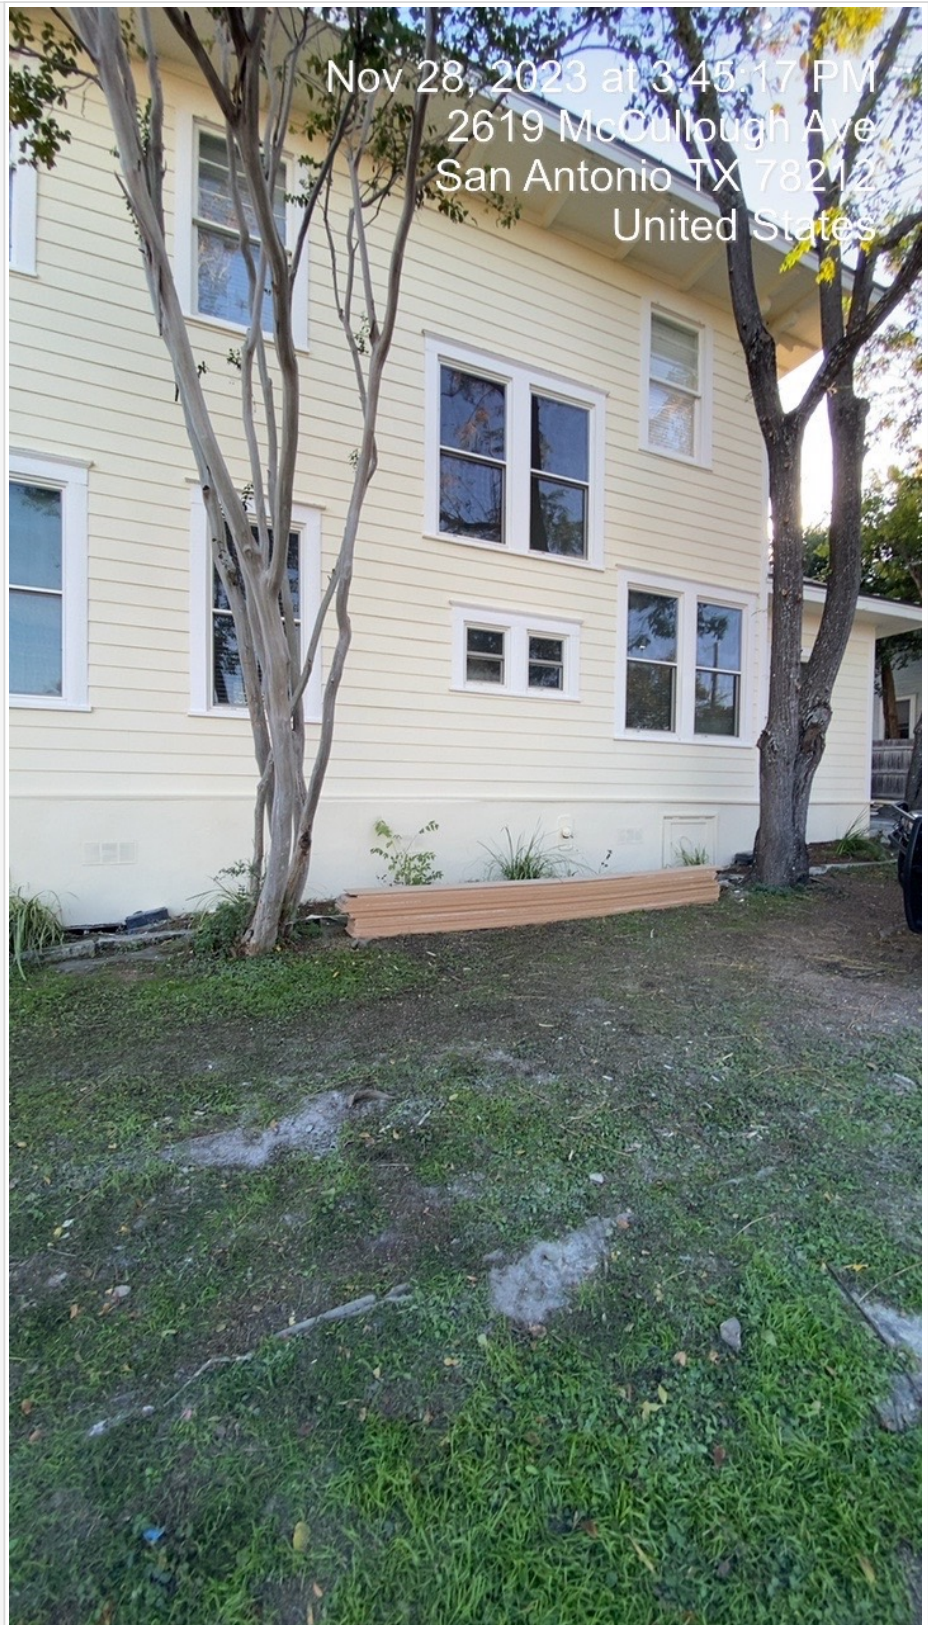
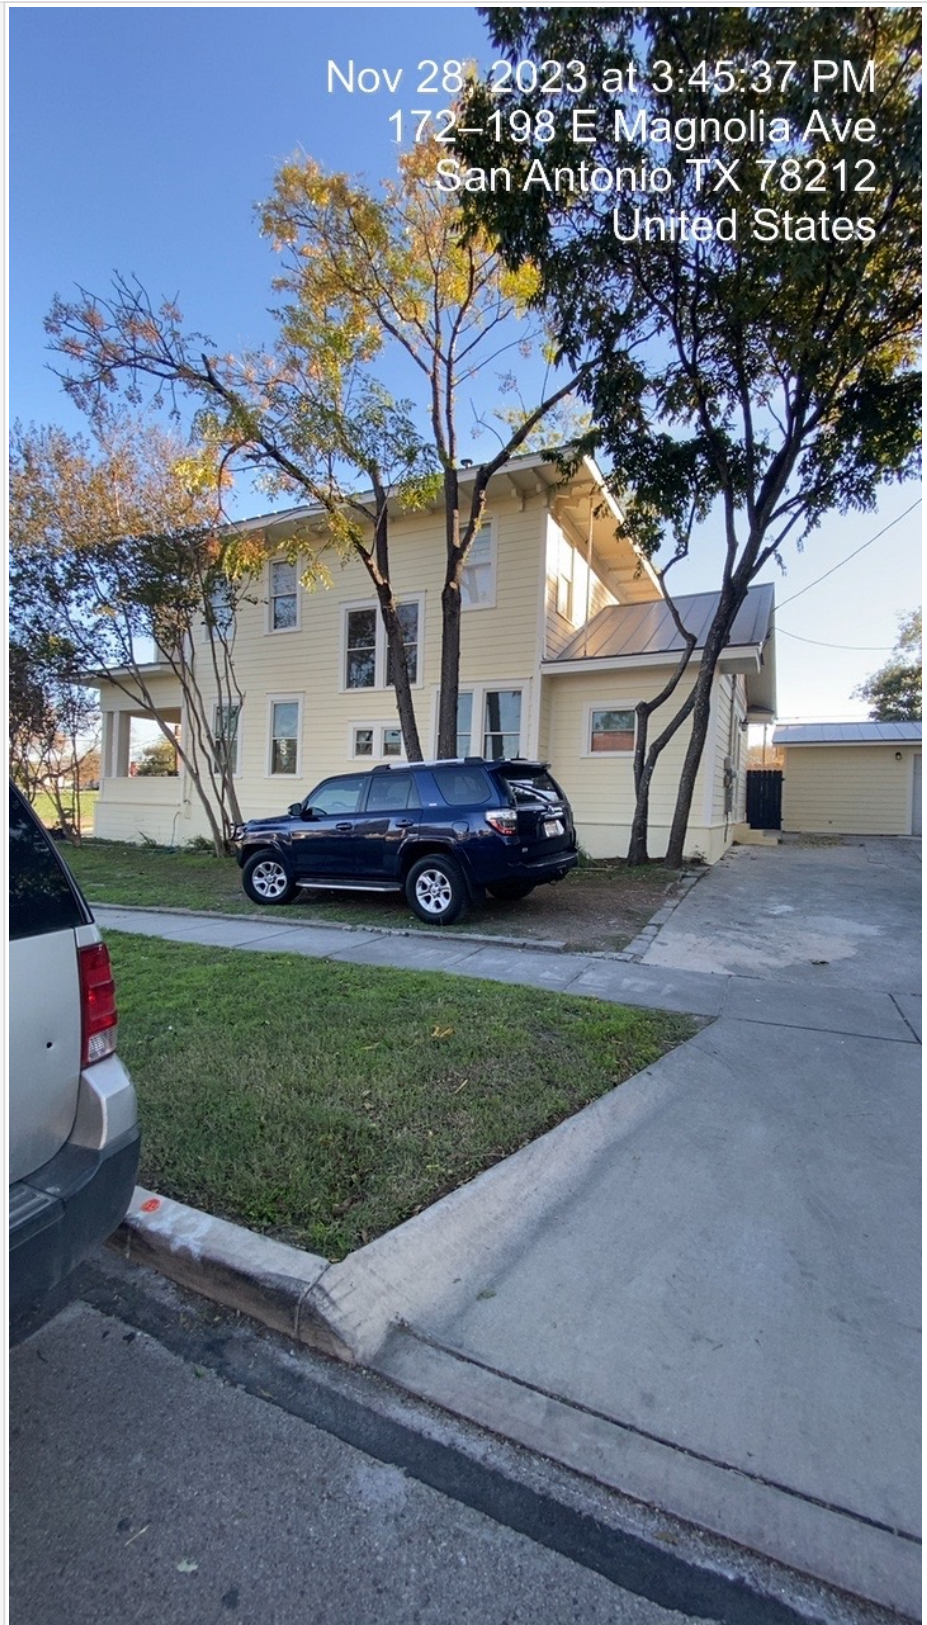
Photographs

b. CASE HISTORY – On November 28, 2023, an anonymous report was submitted to 311 for building repairs. Staff contacted the property owner on November 28, 2023, to discuss the report and issued a Stop Work Order via email. Staff conducted a site visit to assess the violation the same day and noticed a large amount of work had been completed. Staff issued an additional Stop Work Order on site. The property owner states, 95% of the work was completed and agreed to stop work until obtaining a Certificate of Appropriateness.

| Description of work | Installation of siding on top of existing siding. |

Staff does not recommend approval of the installation of Hardie lap siding on top of the existing wood siding on the primary structure and the garage based on finding c Staff recommends that the applicant repairs the existing wood siding and that any elements that are deteriorated beyond repair are replaced with fully wood siding matching the existing dimension, profile, reveal, and finish.
