HISTORIC AND DESIGN REVIEW COMMISSION

April 06, 2022

HDRC CASE NO: 2022-133
ADDRESS: 1118 NOLAN ST
LEGAL DESCRIPTION: NCB 1668 BLK L LOT E, 46 FT OF 6
ZONING: R-5, H
CITY COUNCIL DIST.: 2
DISTRICT: Dignowity Hill Historic District
APPLICANT: Tim Riley
OWNER: ASSI SARA
TYPE OF WORK: Replacement of wood windows with vinyl windows
APPLICATION RECEIVED: March 24, 2022
60-DAY REVIEW: Not applicable due to City Council Emergency Orders
CASE MANAGER: Claudia Espinosa
REQUEST:

The applicant is requesting a Certificate of Appropriateness for approval to install nine (9) Andersen 400 Series Woodwright windows. Same size, shape, location and appearance as the existing windows.

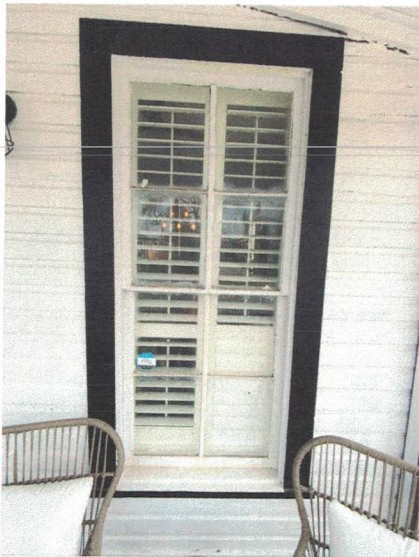
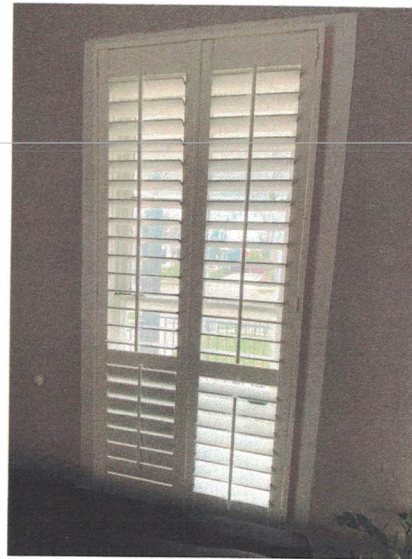
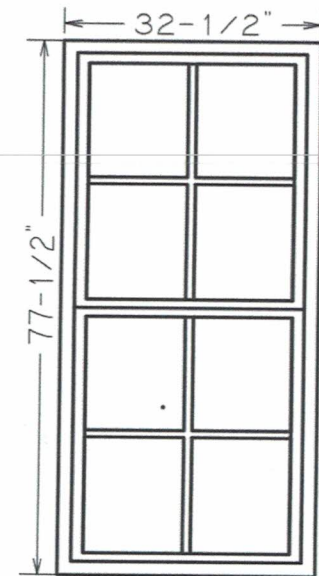
1st Floor Living Room #1

Simonton 6500, Double Hung, White Int. Finish, White Ext. Finish, Width 33, Height 77.5, Width + Height 110.5, Sculptured - Grids Between Glass Grid, COLONIAL Pattern, White Int. Grid Color, White Ext. Grid Color, ALL Grid Position, 1 Bar(s) Horizontal, 1 Bar(s) Vertical, ALL Grid Position, 1 Bar(s) Horizontal, 1 Bar(s) Vertical, Glass - 6500 - SoundSecurity - Southern, New Exterior Casing / Replace Rotted Wood F&I, New Exterior Fiber Cement Casing F&I

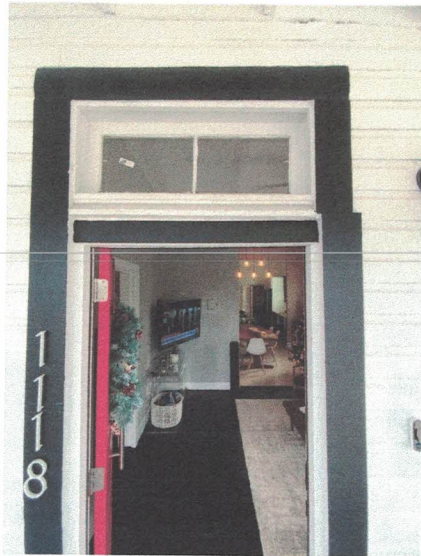
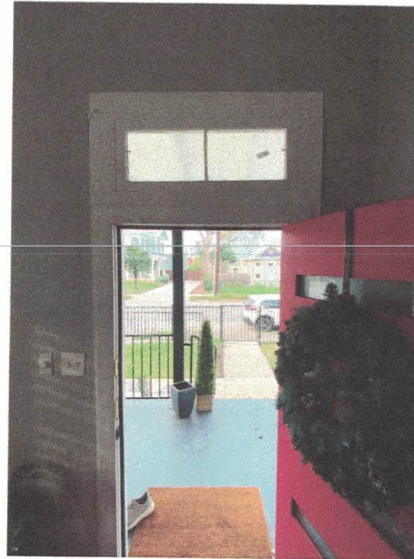
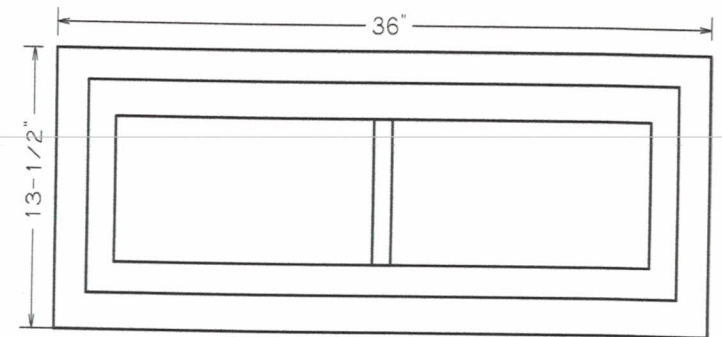
1st Floor Entry #2

Simonton 6500, Picture Window, White Int. Finish, White Ext. Finish, Width 36, Height 14, Width + Height 50, Sculptured - Grids Between Glass Grid, COLONIAL Pattern, White Int. Grid Color, White Ext. Grid Color, ALL Grid Position, 1 Bar(s) Vertical, Glass - Standard Tempered Glass Full, New Exterior Casing / Replace Rotted Wood F&I, Metal Out / Vinyl Flange Window Removal, New Exterior Fiber Cement Casing F&I

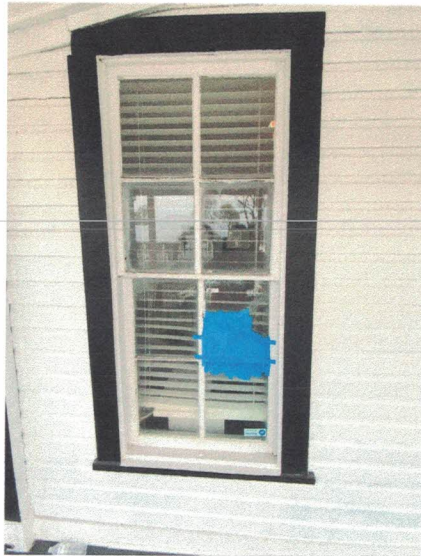
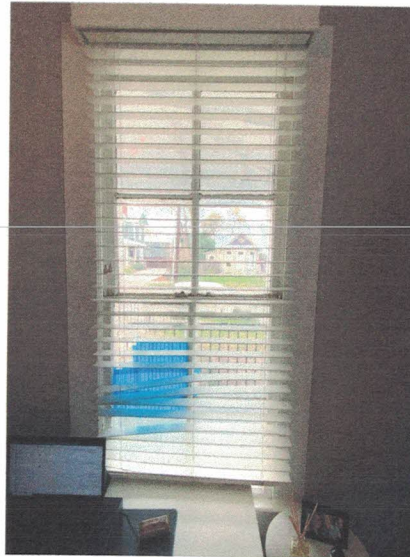
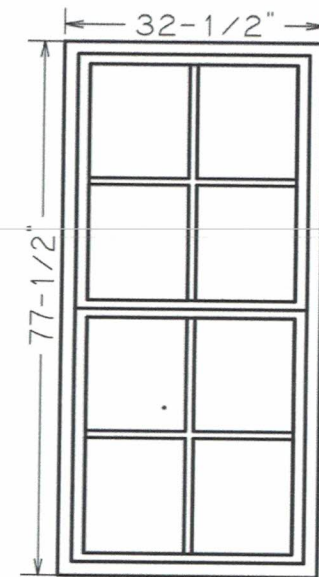
1st Office #3

Simonton 6500, Double Hung, White Int. Finish, White Ext. Finish, Width 33, Height 77.5, Width + Height 110.5, Sculptured - Grids Between Glass Grid, COLONIAL Pattern, White Int. Grid Color, White Ext. Grid Color, ALL Grid Position, 1 Bar(s) Horizontal, 1 Bar(s) Vertical, ALL Grid Position, 1 Bar(s) Horizontal, 1 Bar(s) Vertical, Glass - 6500 - SoundSecurity - Southern, New Exterior Casing / Replace Rotted Wood F&I, New Exterior Fiber Cement Casing F&I

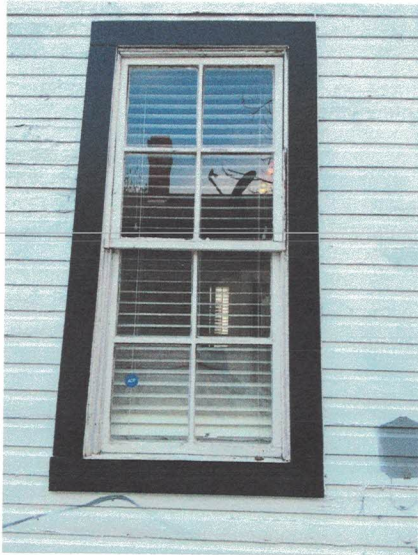
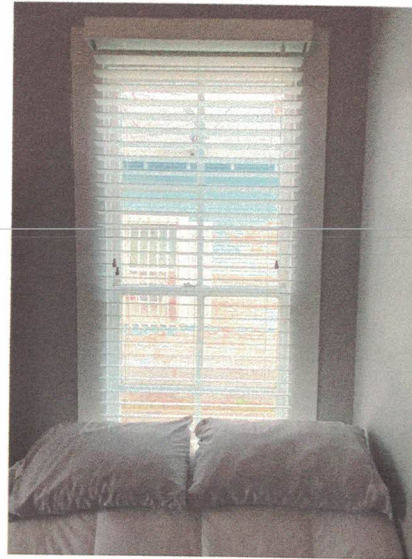
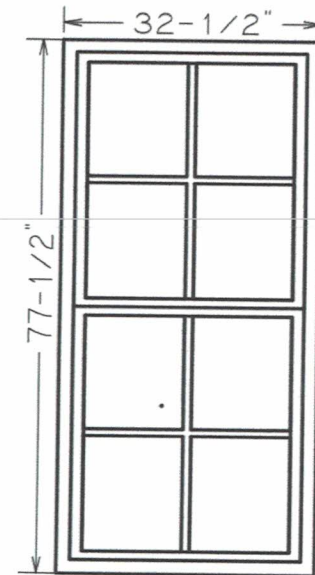
1st Office #4

Simonton 6500, Double Hung, White Int. Finish, White Ext. Finish, Width 33, Height 77.5, Width + Height 110.5, Sculptured - Grids Between Glass Grid, COLONIAL Pattern, White Int. Grid Color, White Ext. Grid Color, ALL Grid Position, 1 Bar(s) Horizontal, 1 Bar(s) Vertical, ALL Grid Position, 1 Bar(s) Horizontal, 1 Bar(s) Vertical, Glass - 6500 - SoundSecurity - Southern, New Exterior Casing / Replace Rotted Wood F&I, New Exterior Fiber Cement Casing F&I

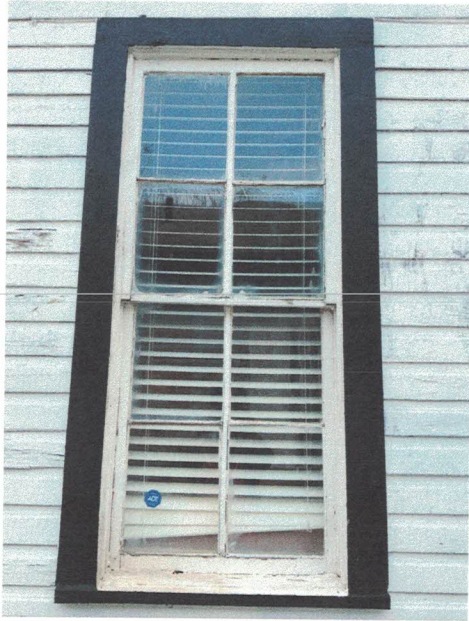
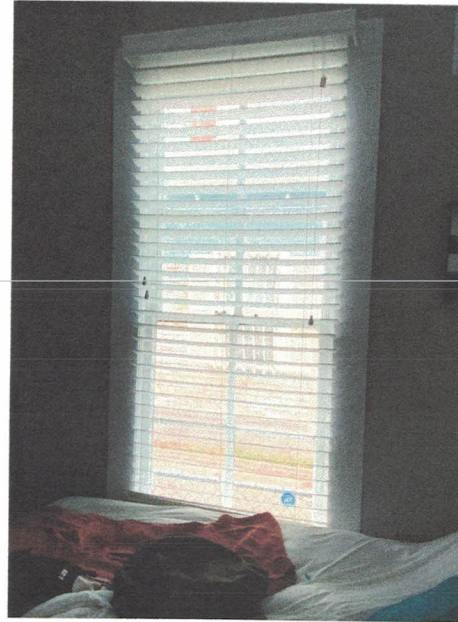
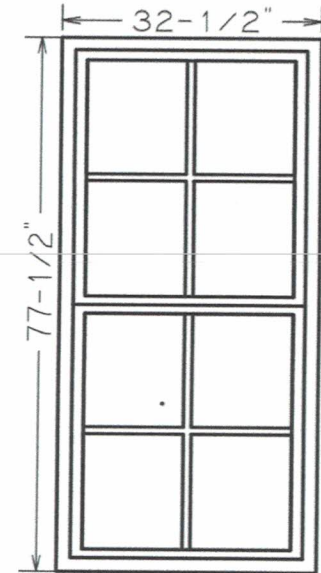
1st Bedroom #1 #5

Simonton 6500, Double Hung, White Int. Finish, White Ext. Finish, Width 33, Height 77.5, Width + Height 110.5, Sculptured - Grids Between Glass Grid, COLONIAL Pattern, White Int. Grid Color, White Ext. Grid Color, ALL Grid Position, 1 Bar(s) Horizontal, 1 Bar(s) Vertical, ALL Grid Position, 1 Bar(s) Horizontal, 1 Bar(s) Vertical, Glass - 6500 - SoundSecurity - Southern, New Exterior Casing / Replace Rotted Wood F&I, New Exterior Fiber Cement Casing F&I

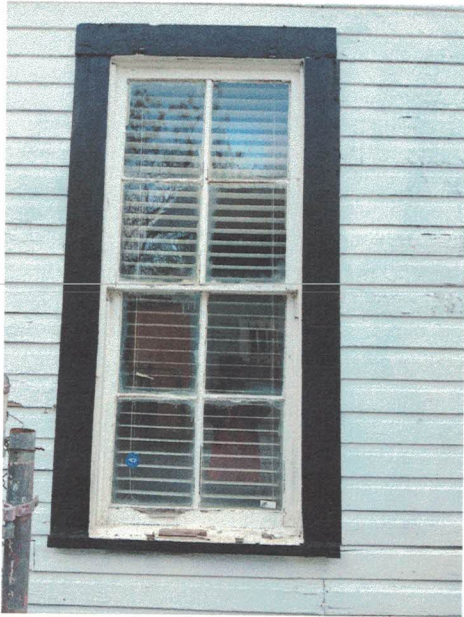
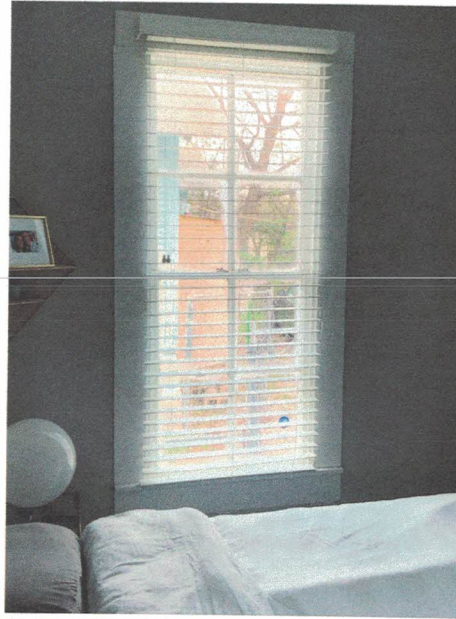
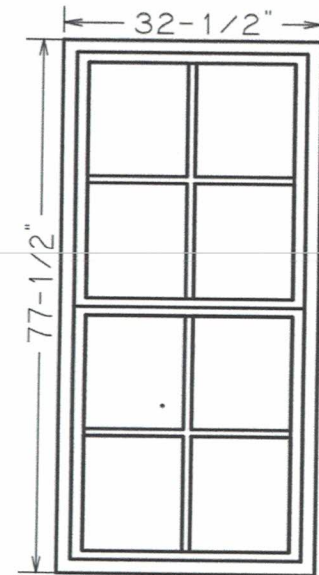
1st Floor Bedroom Room #6

Simonton 6500, Double Hung, White Int. Finish, White Ext. Finish, Width 33, Height 77.5, Width + Height 110.5, Sculptured - Grids Between Glass Grid, COLONIAL Pattern, White Int. Grid Color, White Ext. Grid Color, ALL Grid Position, 1 Bar(s) Horizontal, 1 Bar(s) Vertical, ALL Grid Position, 1 Bar(s) Horizontal, 1 Bar(s) Vertical, Glass - 6500 - SoundSecurity - Southern, New Exterior Casing / Replace Rotted Wood F&I, New Exterior Fiber Cement Casing F&I

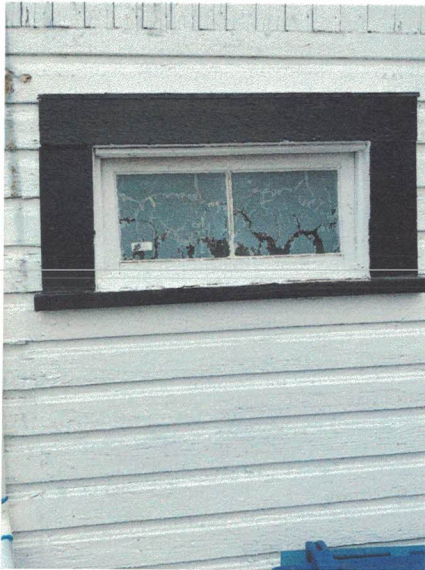
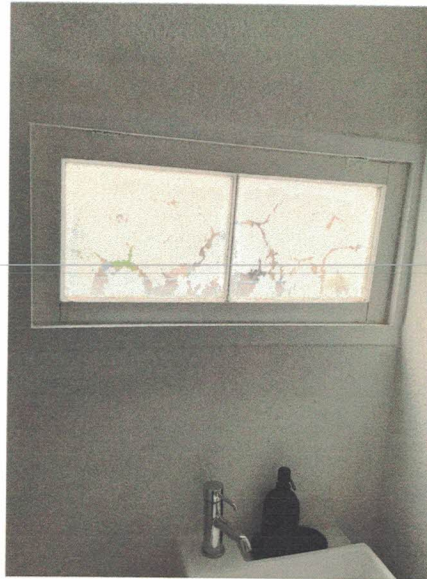
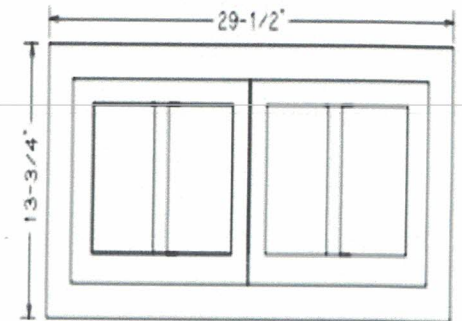
1st Floor Bathroom #7

Simonton 6500, Picture Window, White Int. Finish, White Ext. Finish, Width 30, Height 15, Width + Height 45, Sculptured - Grids Between Glass Grid, COLONIAL Pattern, White Int. Grid Color, White Ext. Grid Color, ALL Grid Position, 1 Bar(s) Vertical, Glass - Standard, New Exterior Fiber Cement Casing F&I

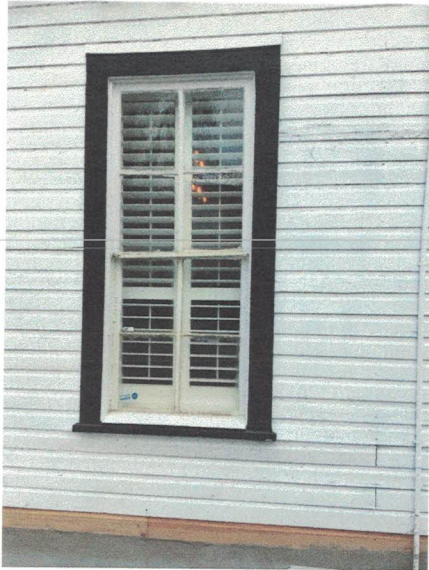
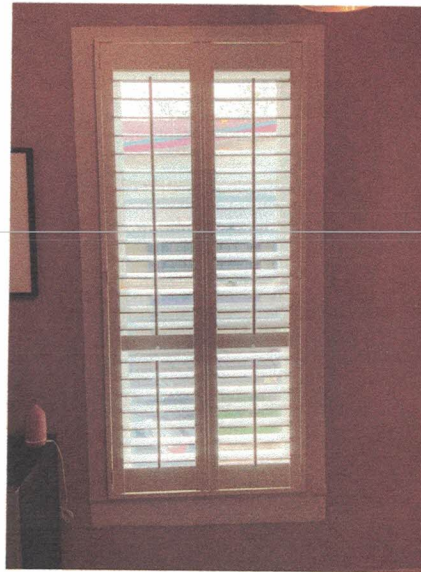
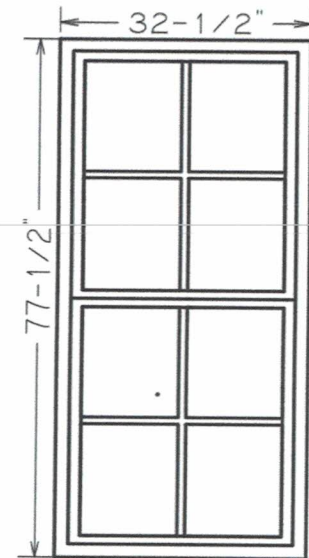
1st Floor Dinning Room #8

Simonton 6500, Double Hung, White Int. Finish, White Ext. Finish, Width 33, Height 77.5, Width + Height 110.5, Sculptured - Grids Between Glass Grid, COLONIAL Pattern, White Int. Grid Color, White Ext. Grid Color, ALL Grid Position, 1 Bar(s) Horizontal, 1 Bar(s) Vertical, ALL Grid Position, 1 Bar(s) Horizontal, 1 Bar(s) Vertical, Glass - 6500 - SoundSecurity - Southern, New Exterior Fiber Cement Casing F&I, New Exterior Casing / Replace Rotted Wood F&I

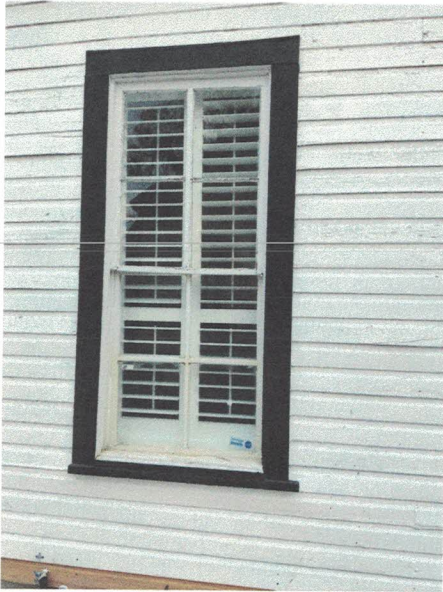
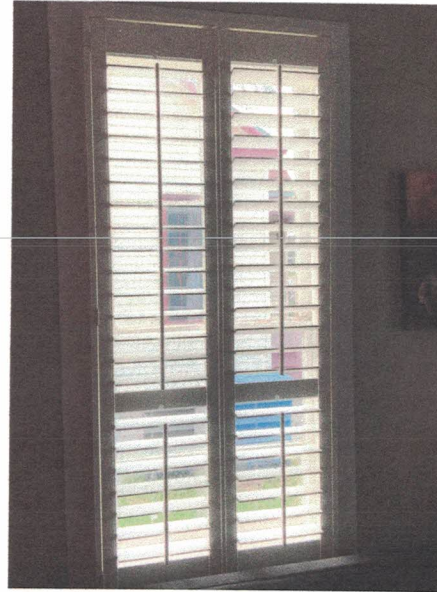
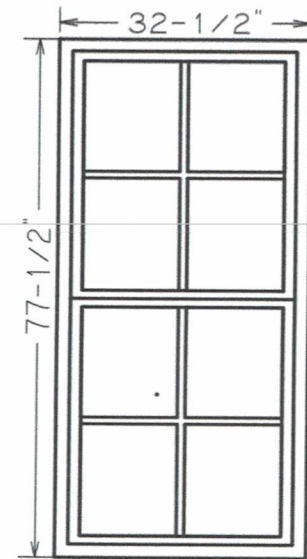
1st Floor Living Room #9

Simonton 6500, Double Hung, White Int. Finish, White Ext. Finish, Width 33, Height 77.5, Width + Height 110.5, Sculptured - Grids Between Glass Grid, COLONIAL Pattern, White Int. Grid Color, White Ext. Grid Color, ALL Grid Position, 1 Bar(s) Horizontal, 1 Bar(s) Vertical, ALL Grid Position, 1 Bar(s) Horizontal, 1 Bar(s) Vertical, Glass - 6500 - SoundSecurity - Southern, New Exterior Fiber Cement Casing F&I, New Exterior Casing / Replace Rotted Wood F&I
