HISTORIC AND DESIGN REVIEW COMMISSION

May 18, 2022

HDRC CASE NO: 2022-267
ADDRESS: 1502 BUENA VISTA ST
LEGAL DESCRIPTION: NCB 2340 BLK 7 LOT N 101.25 FT OF 1
ZONING: C-2, HL
CITY COUNCIL DIST.: 5
LANDMARK: Individual Landmark
APPLICANT: Alberto Mejia
OWNER: Alberto Mejia
TYPE OF WORK: Historic Tax Verification
APPLICATION RECEIVED: May 04, 2022
60-DAY REVIEW: Not applicable due to City Council Emergency Orders
CASE MANAGER: Rachel Rettaliata

The applicant is requesting Historic Tax Verification for the property at 1502 Buena Vista.

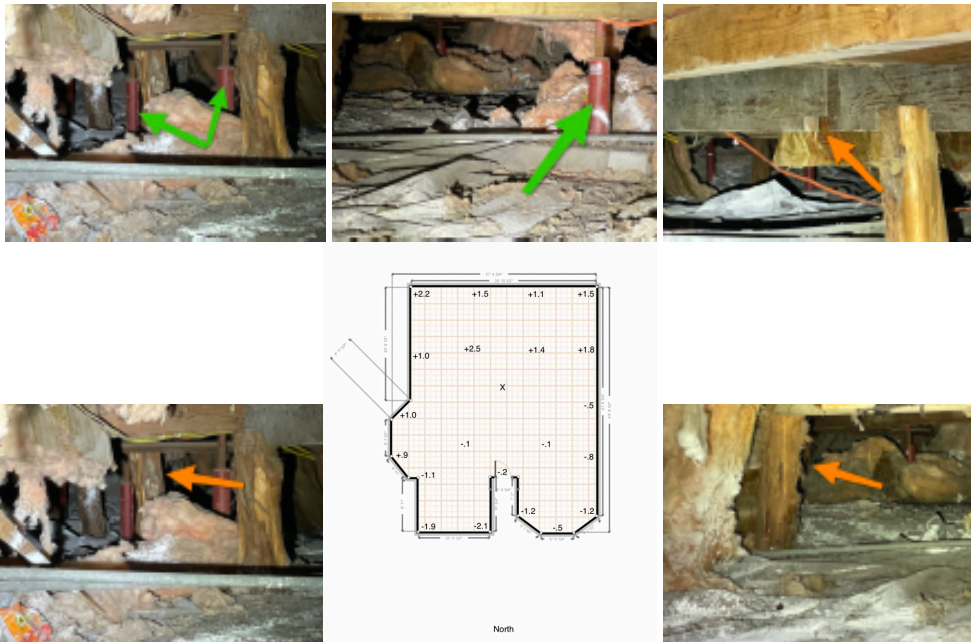
Repair Foundation

Currently collecting bids. The home still has cedar piers that need immediate replacement. There are unsupported spliced in the beams and some subfloor areas need attention. See photos below

Work needed: The home had cedar piers that need immediate replacement. There are unsupported spliced in the beams and some subfloor areas need attention.

Work completed: All cedar piers replaced, entire foundation of home completely stabilized and skirting replaced with 10 years warranty. Work completed by CJ House leveling on 12/10/2021- **Total:**

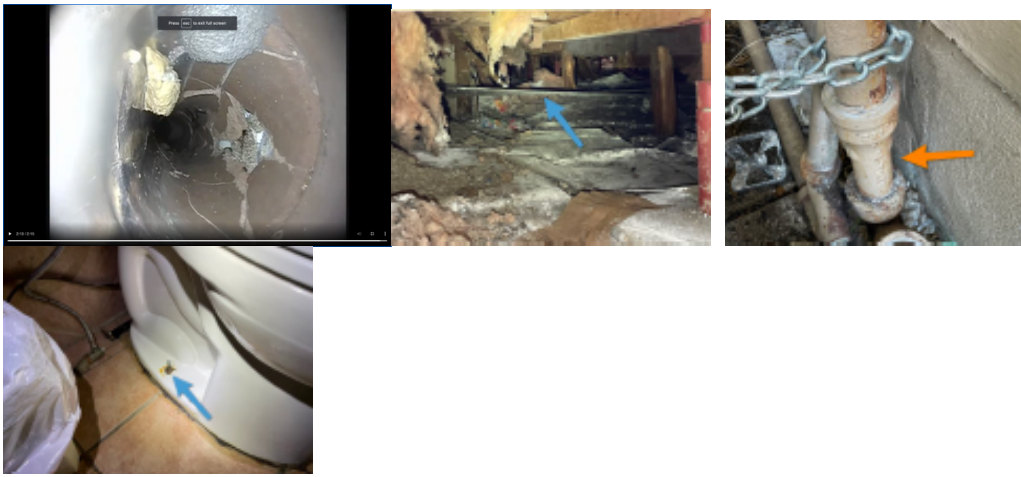
Plumbing Repair

Following foundation repair, plumbing issues need to be addressed. Previous renters did not report any plumbing issues. Supply lines are galvanized steel and need insulation. Waste lined are cast iron and may need evaluation. Inspection with sewer camera shows broken clay pipes and or PVC pipes with soil seepage and obstructions between city sewer connection and where pipes meet the north/street facing portion of the home. Inspection also shows moderate water damage to subfloor beneath bathroom toilet, may be an eroded wax seal or more intensive replacement of pipes. See photos below

Work completed: Supply lines and waste lines replaced with PEX/PVC, 30 ft of clay sewer pipes completely replaced with new PVC pipe,. Plumbing work completed by Jesse the Plumber on 12/15/2021- Total

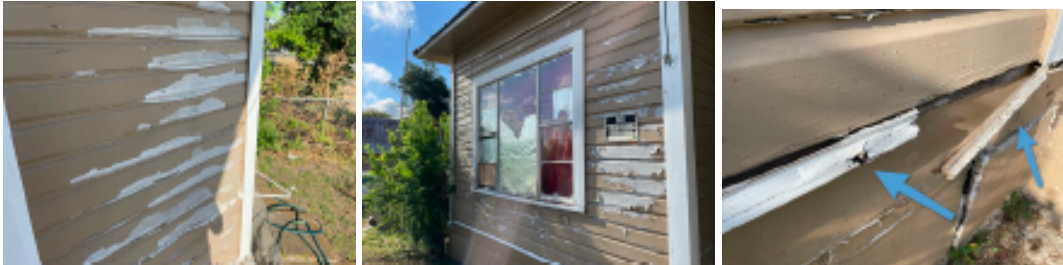
Exterior paint

Following/during plumbing work completion the exterior of the home will be repainted as paint is peeling and chipping on all sides of the home, with some damage to soffits and trim. There are currently no plans to modify the original siding as it appears in decent shape. There are also no plans to modify any of the original distinguishing features and/or ornamentation of the homes folk Victorian character.

Work completed: Entire exterior of the home scrapped, recaulked and repainted in blue with white trim – retaining and significantly enhancing the original distinguishing features and/or ornamentation of the homes folk Victorian character. Work completed by Brother's painting on January 10th 2022.

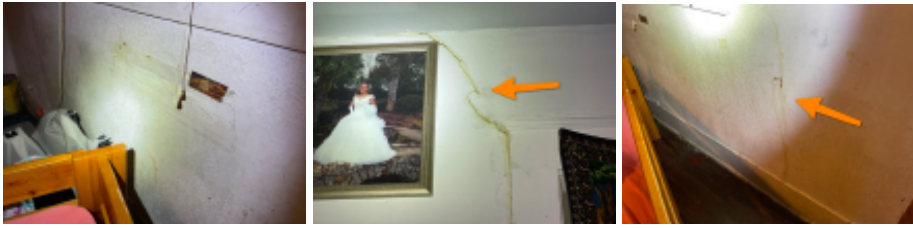
Interior paint

Walls are stained and or damaged throughout the house, all interior walls will likely be repainted in a uniform way, likely flat/subtle grays and whites. See photos

Work completed: Most walls and ceilings required demolition and removal, all walls and ceilings repaired, prepped and painted throughout entire home. Sweat Equity : _____ **Total** _____ Custom Texas Living (contractor) installed crown molding and new wall trim throughout home: **Total** : _____ All Work completed on 4/15/2022

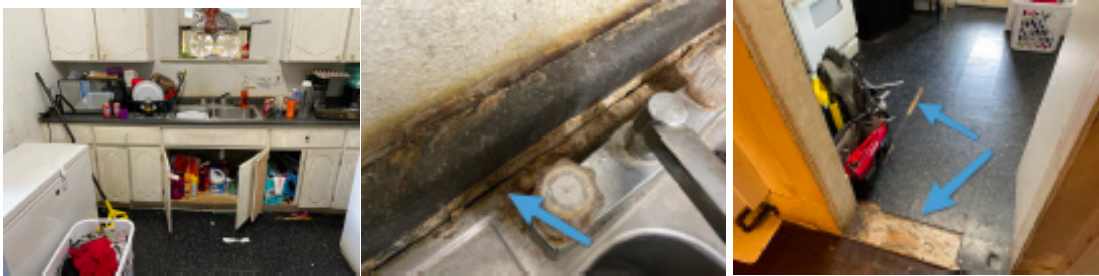
Kitchen & mudroom remodel

Kitchen is in need of a complete remodel. Work will include installation of new sink, cabinetry and stove. Mudroom will need new washer/dryer unit and new drywall.

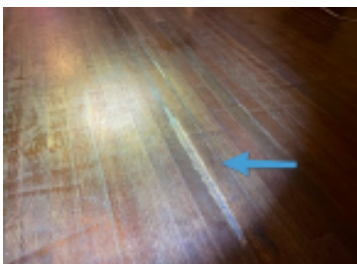
Wood floor repair and refinish

If possible, original wood flooring will be repaired and refinished throughout all rooms in the home.

Work completed: original wood flooring repaired, refinished throughout all rooms in the home. Work completed by Custom Texas Living work completed on 3/25/2022, **Total** :

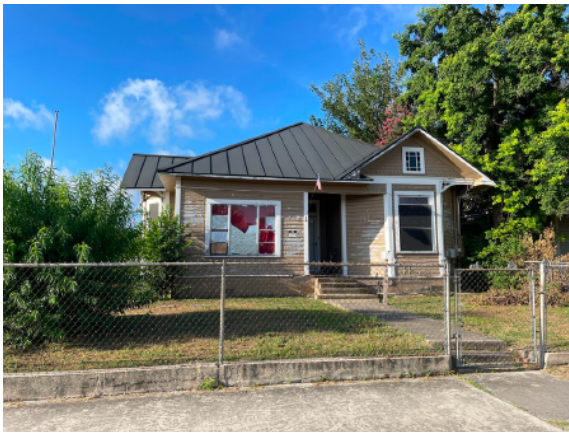
Security Fence

The rolling gate facing east toward Las Moras St. may need some repair. The remaining perimeter is currently a chain link iron fence, this will likely be replaced with a wood picket fence more fitting to the folk Victorian architecture/character of the home.
