HISTORIC AND DESIGN REVIEW COMMISSION June 01, 2022

HDRC CASE NO: 2022-303

ADDRESS: 226 E HUISACHE AVE **LEGAL DESCRIPTION:** NCB 3086 BLK 2 LOT 7

TYPE OF WORK: Window replacement

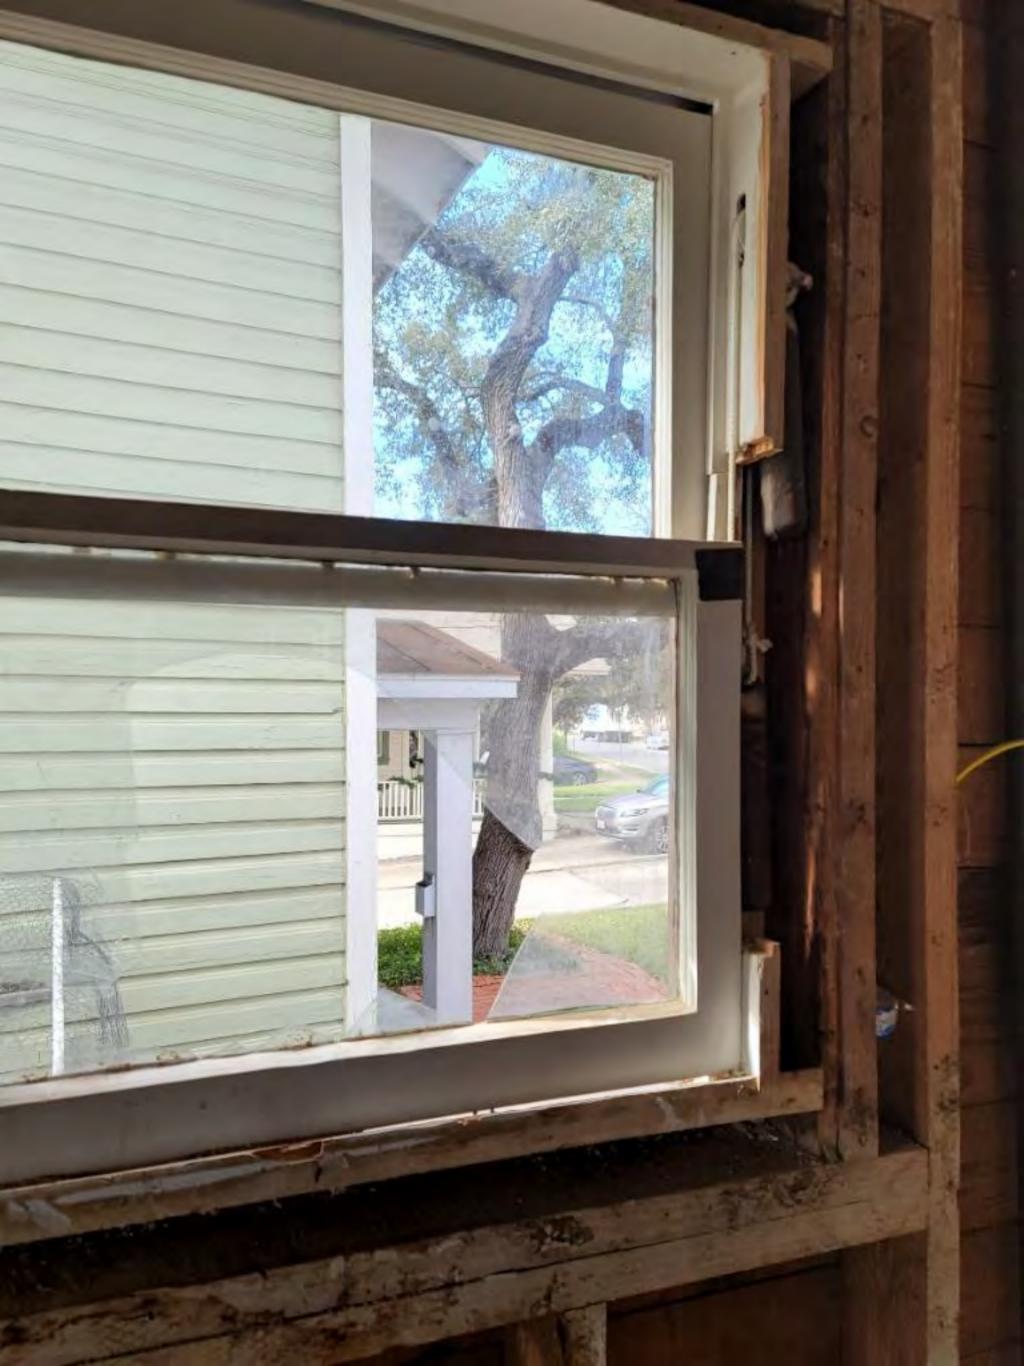
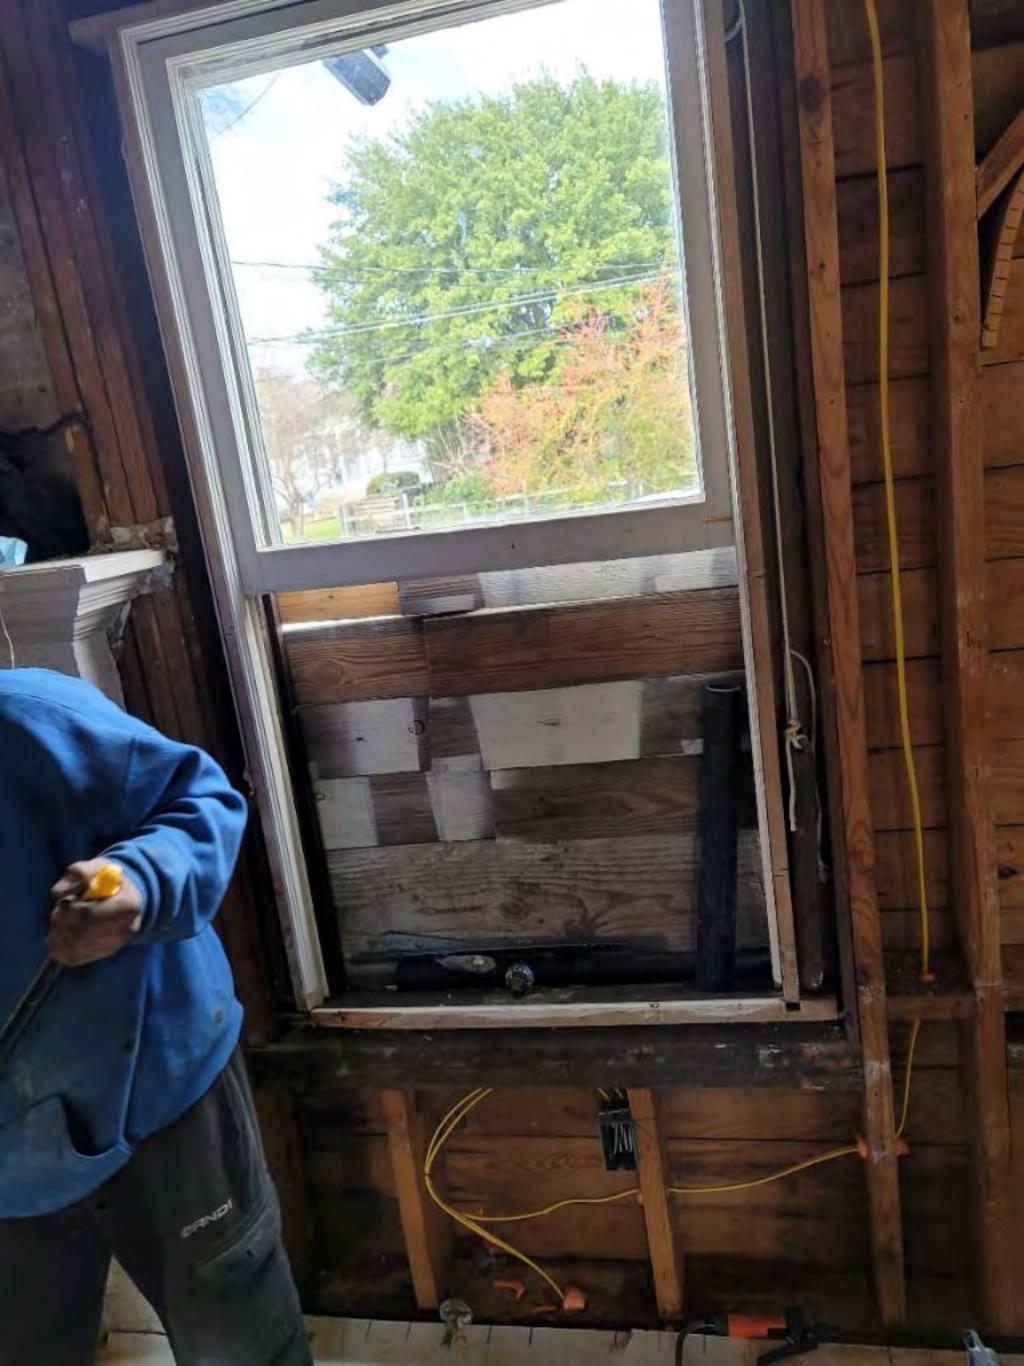
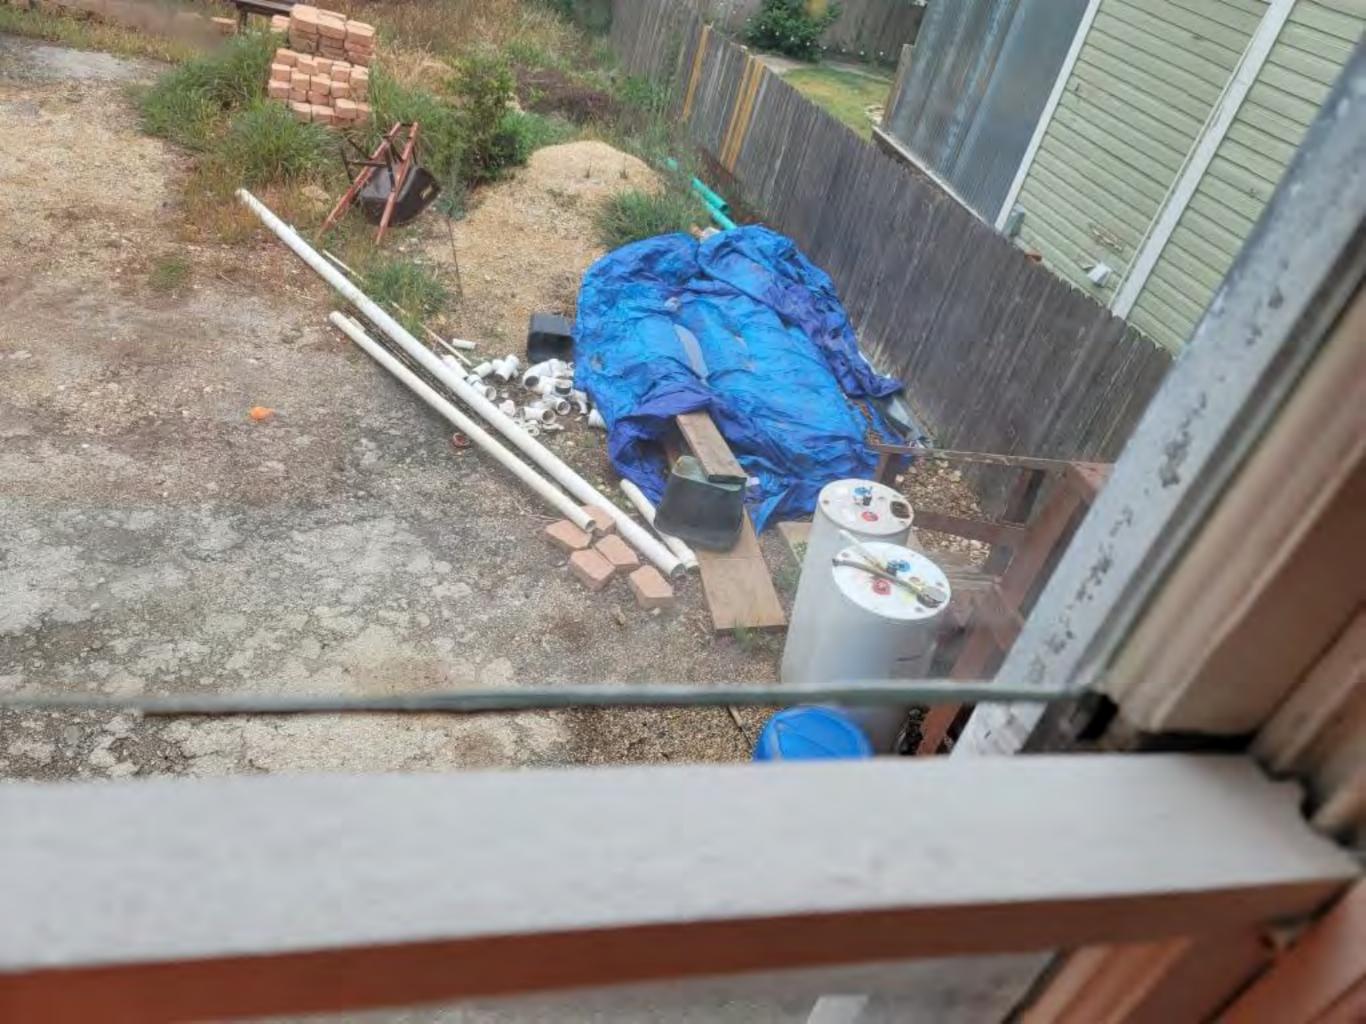
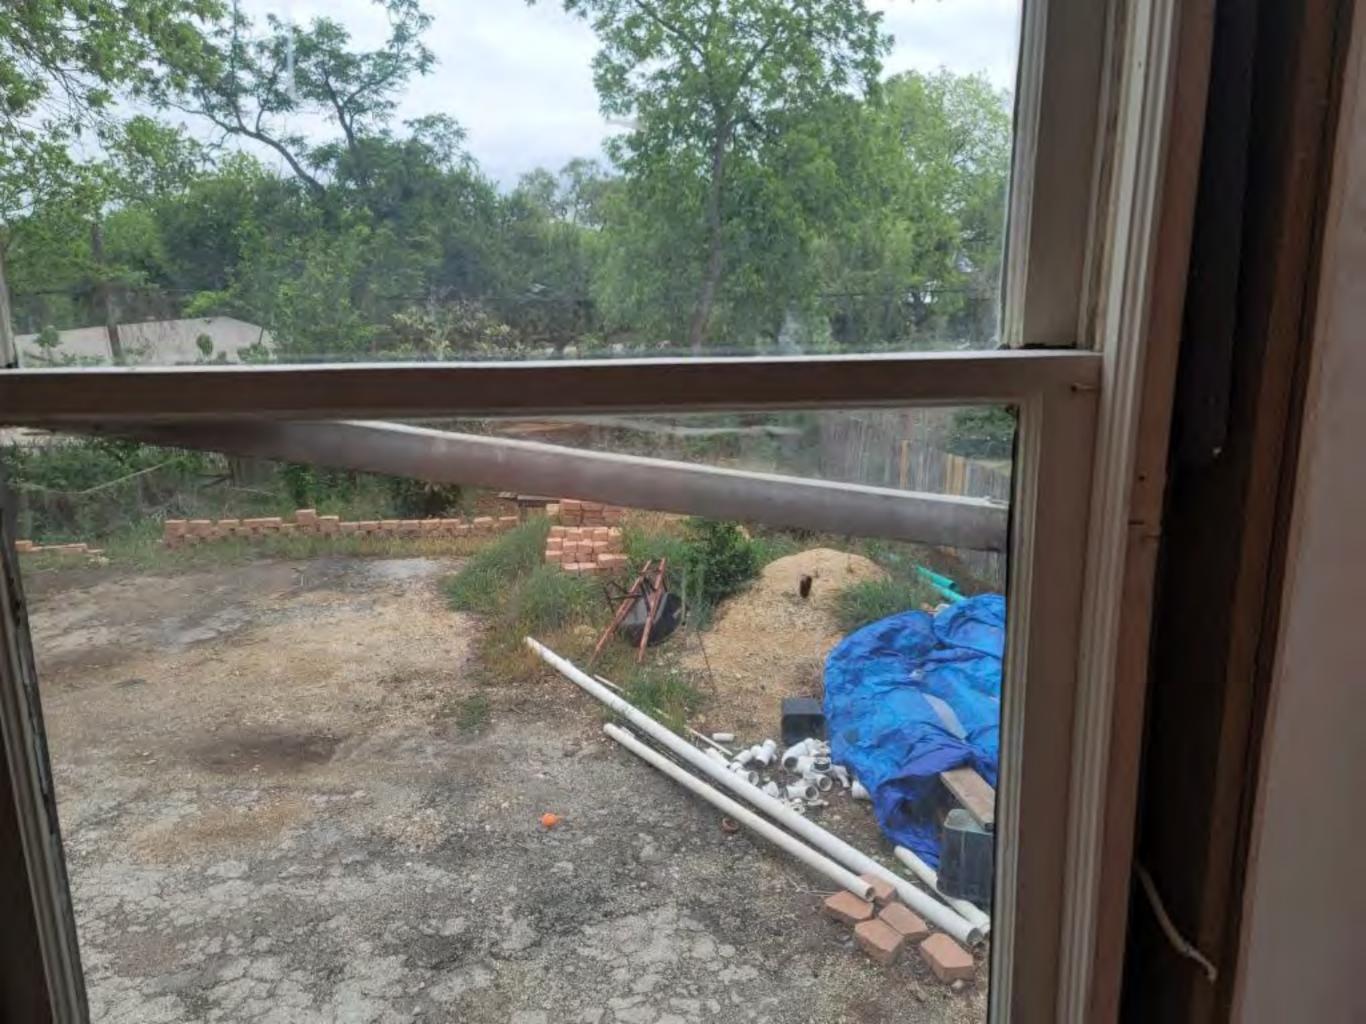
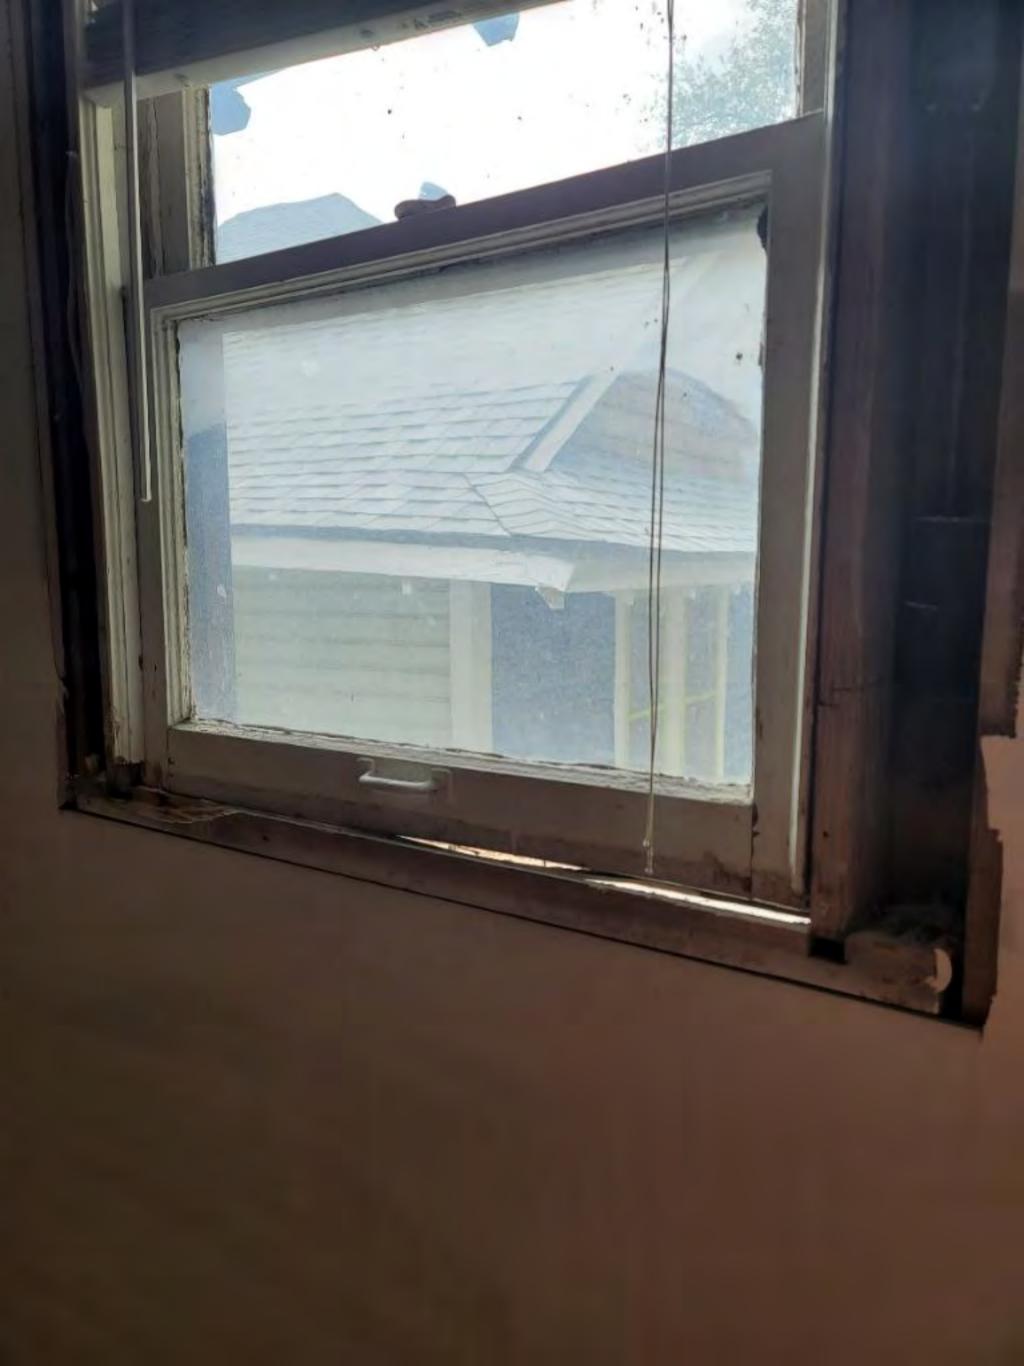
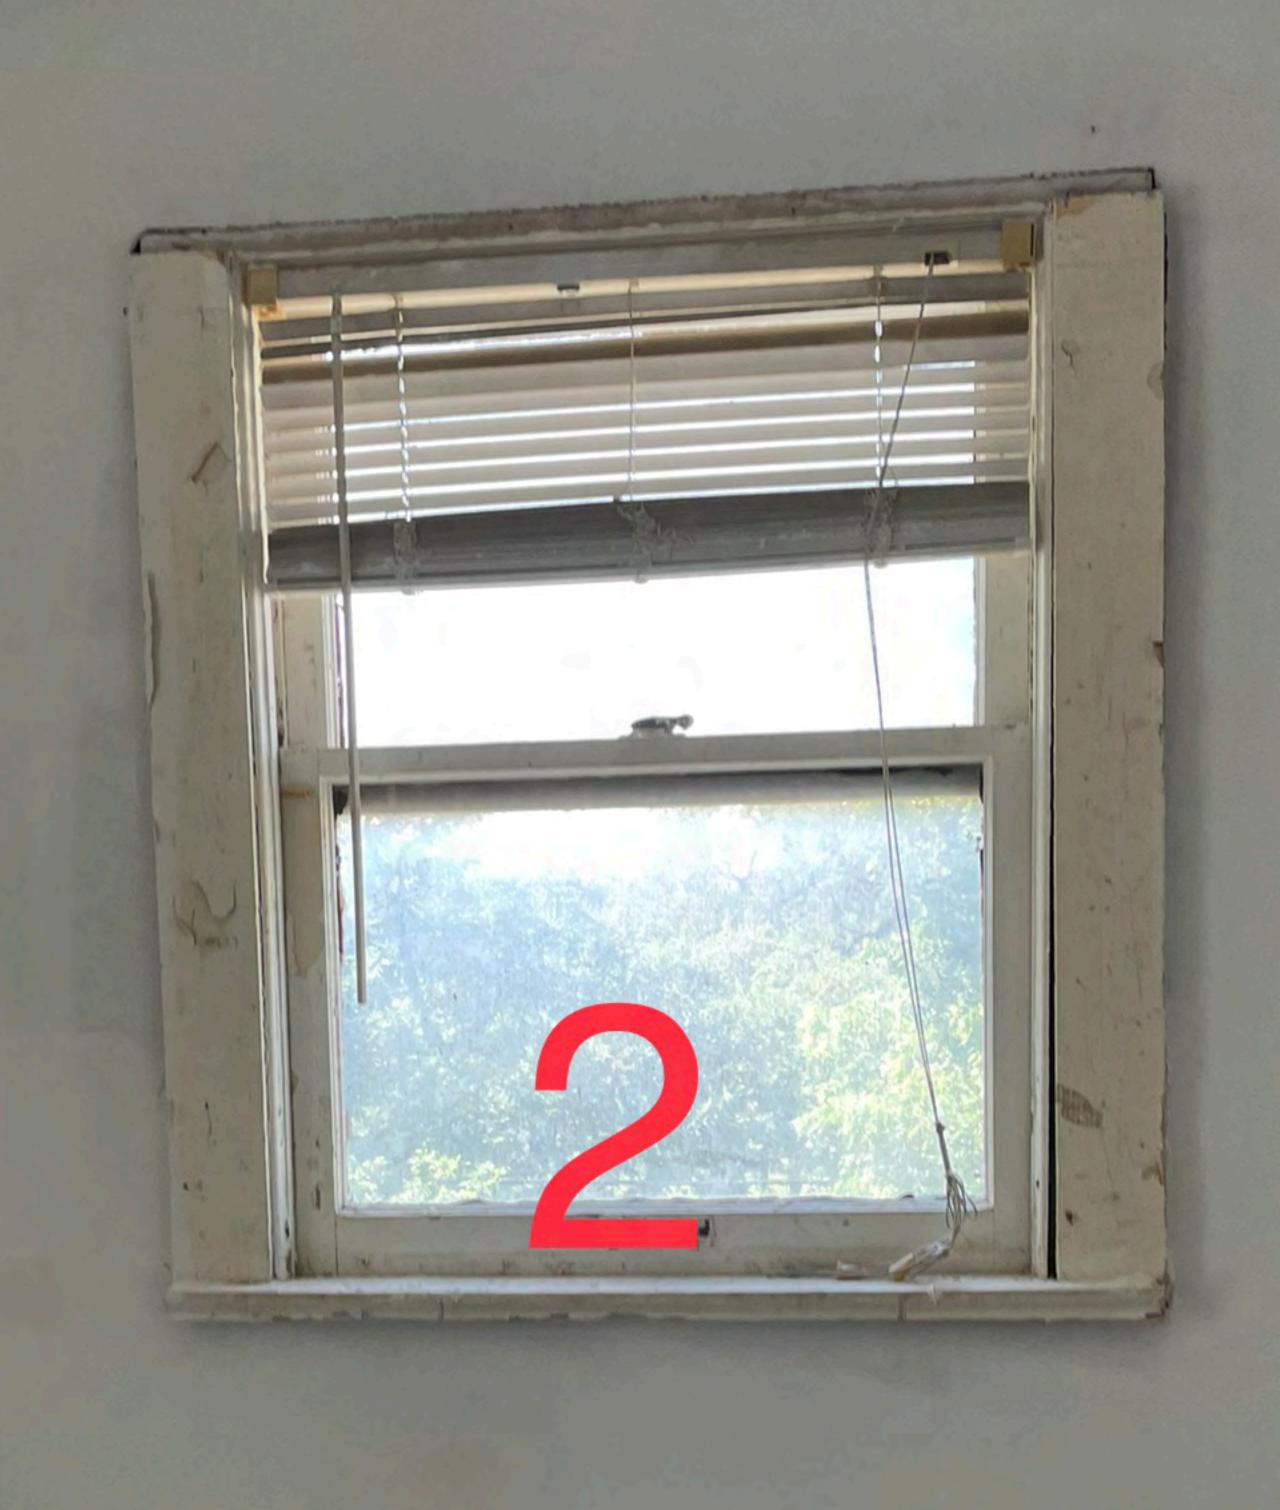
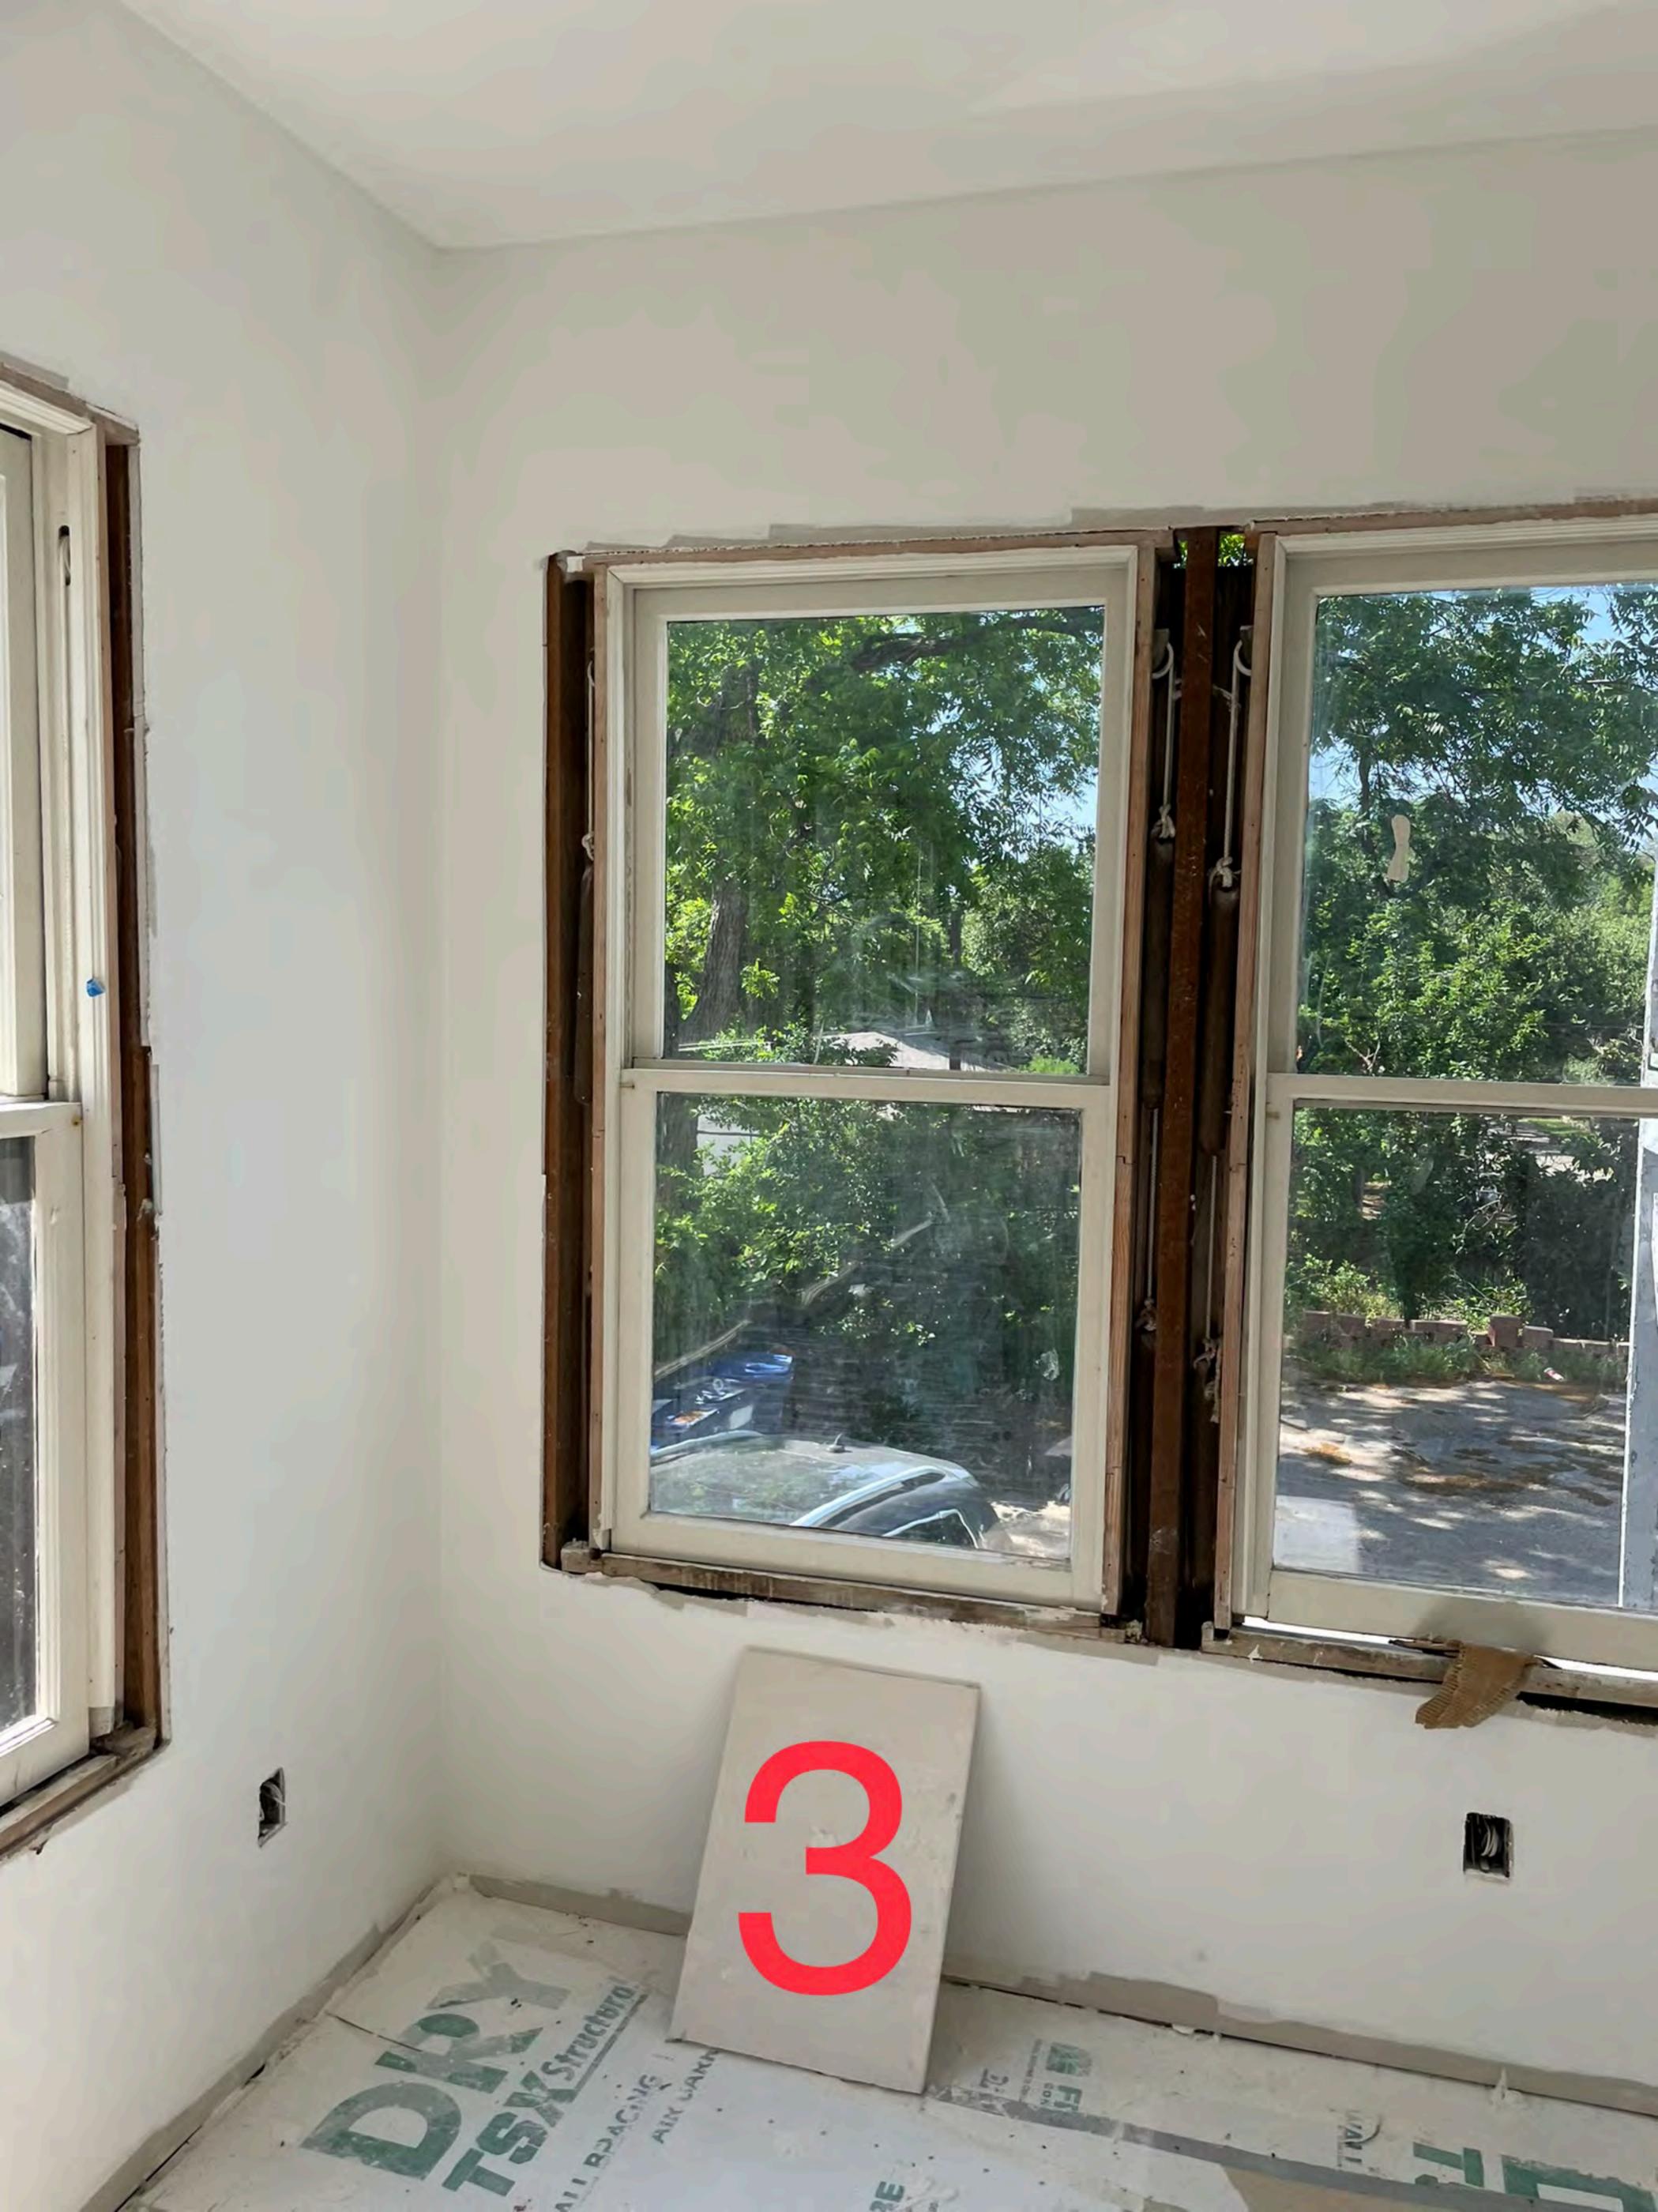
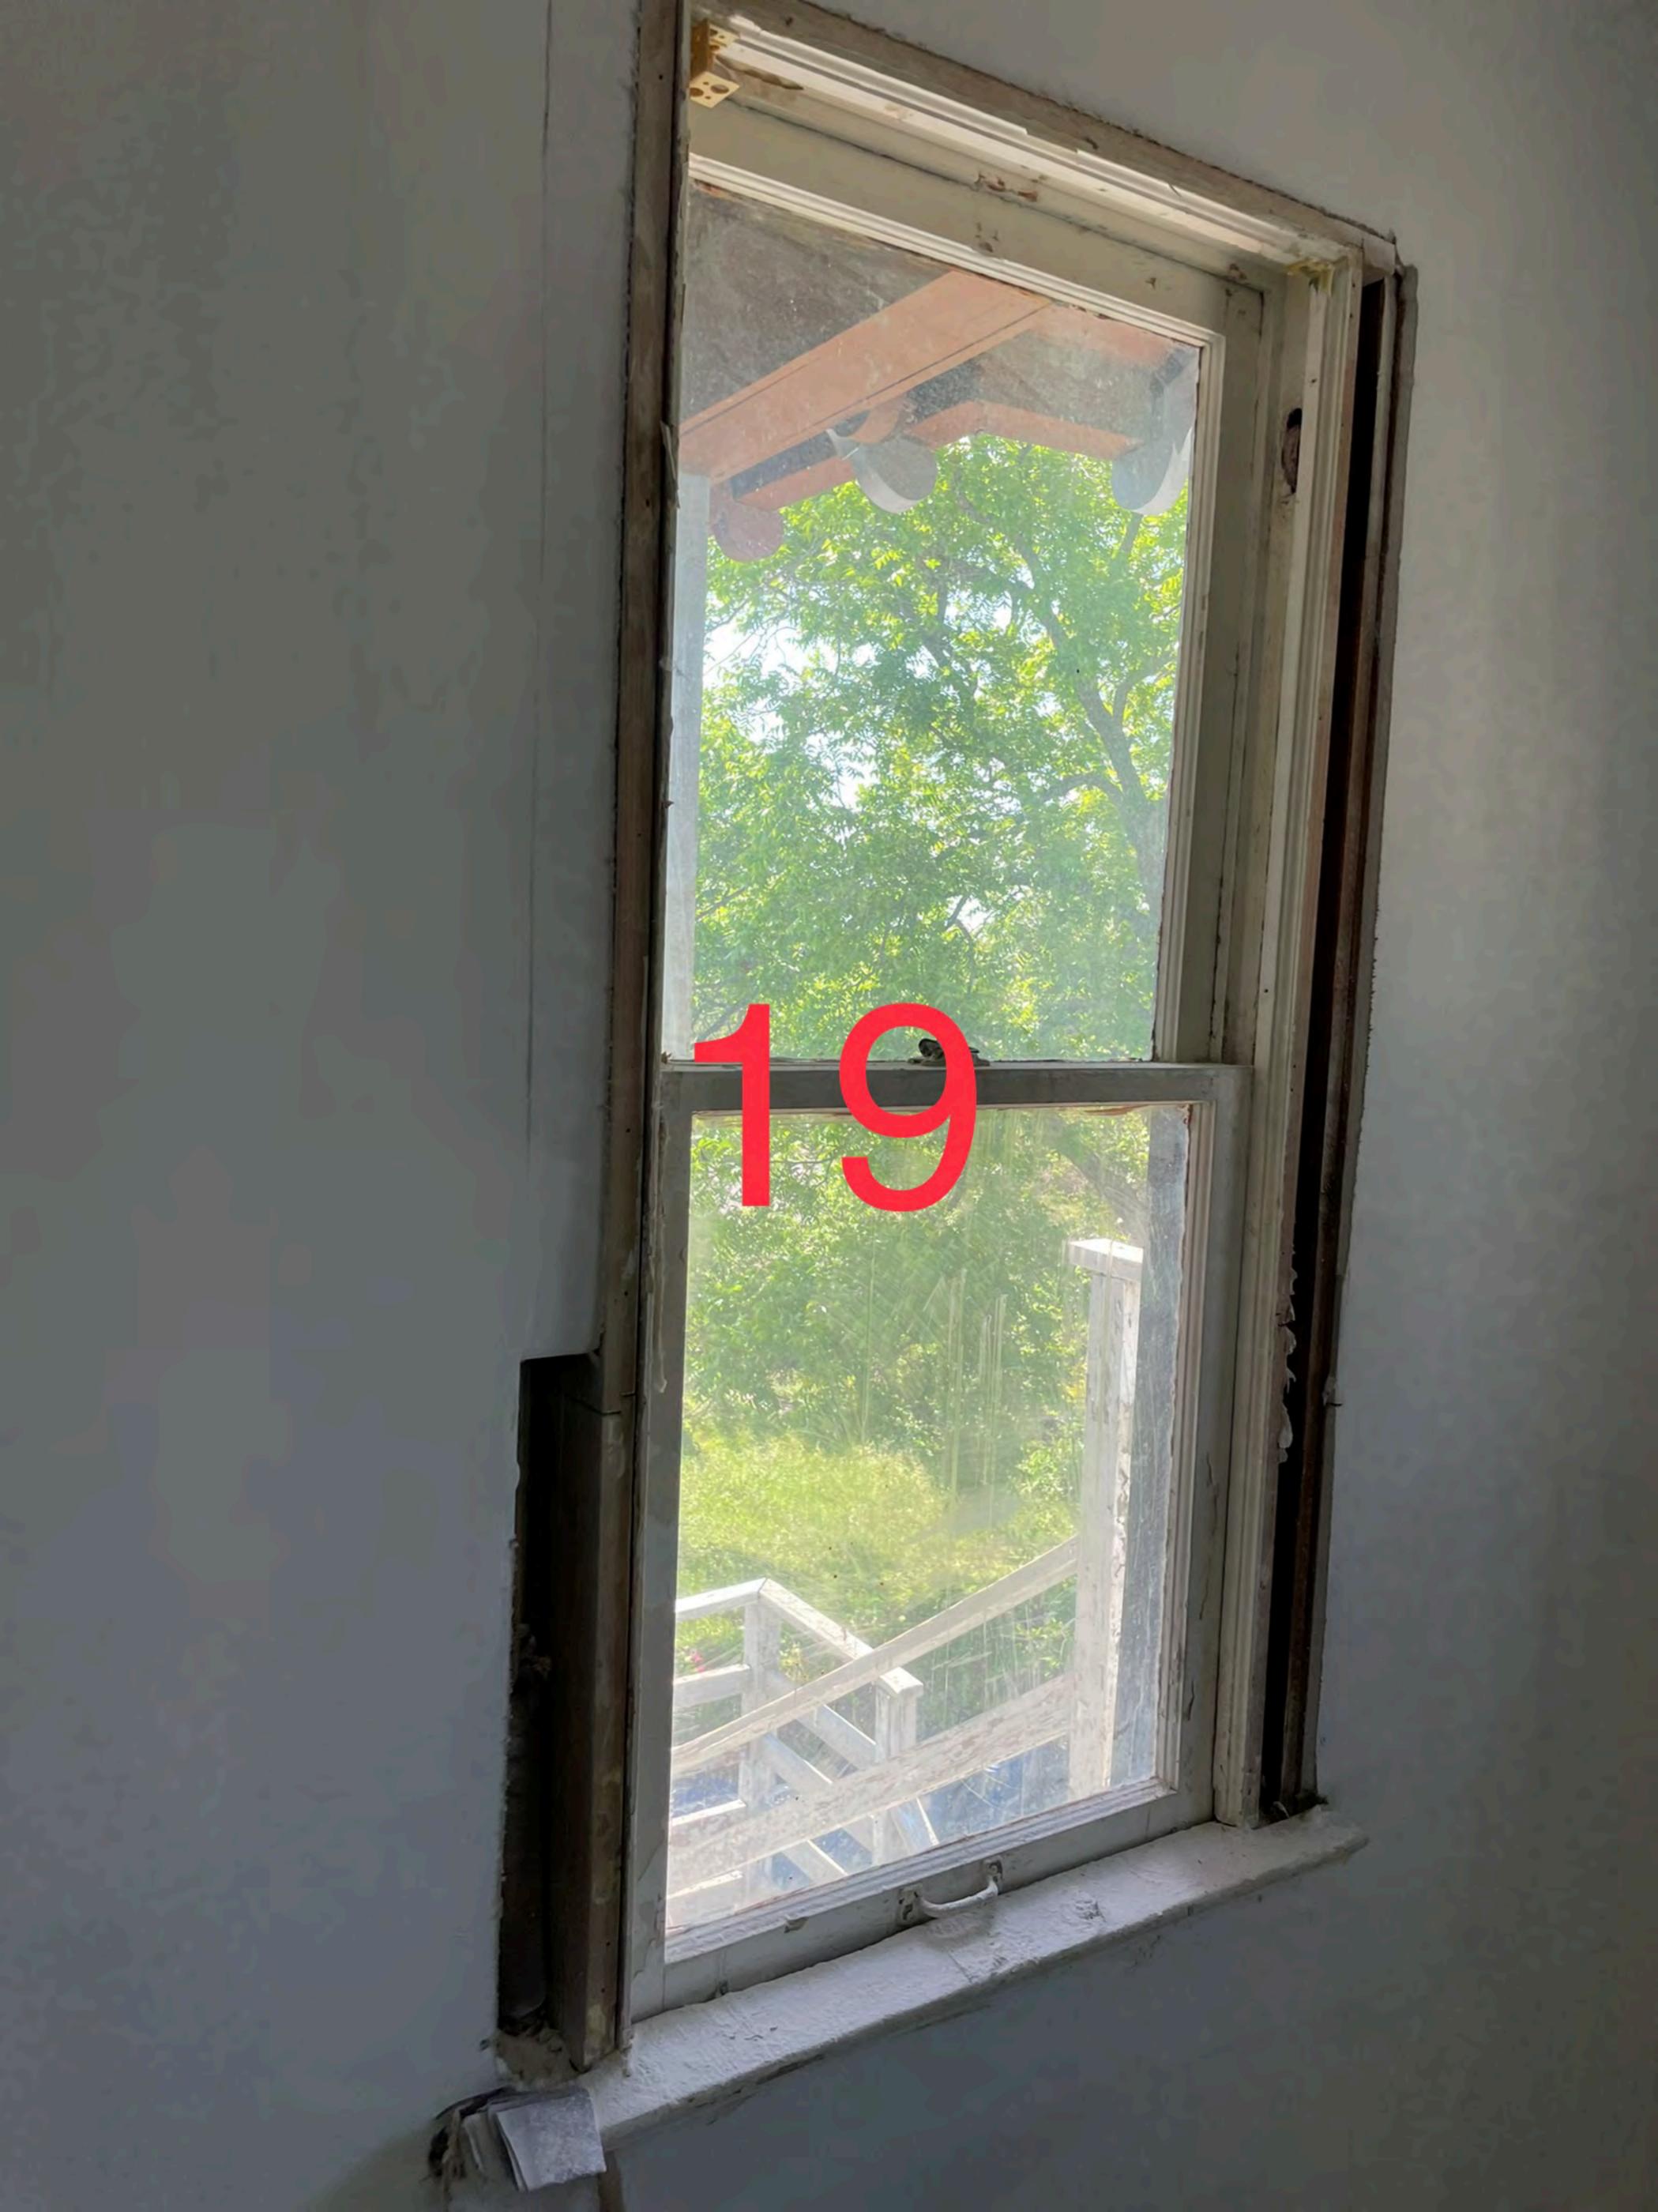
The current condition of the windows is such that many are unrepairable. I've had multiple contractors visit the site and have commented as such. I need to replace them with comparable Marvin windows that are approved for historic window replacement.
