HISTORIC AND DESIGN REVIEW COMMISSION

August 03, 2022

HDRC CASE NO: 2022-303
ADDRESS: 226 E HUISACHE AVE
LEGAL DESCRIPTION: NCB 3086 BLK 2 LOT 7
ZONING: R-4 CD, H
CITY COUNCIL DIST.: 1
DISTRICT: Monte Vista Historic District
APPLICANT: Nadav Givoni/GR-226 HUISACHE LLC
OWNER: Nadav Givoni/GR-226 HUISACHE LLC
TYPE OF WORK: Window replacement
APPLICATION RECEIVED: May 01, 2022
60-DAY REVIEW: Not applicable due to City Council Emergency Orders
CASE MANAGER: Hannah Leighner
REQUEST:

The applicant is requesting a Certificate of Appropriateness for approval to replace nineteen (19) existing wood windows with new wood windows.

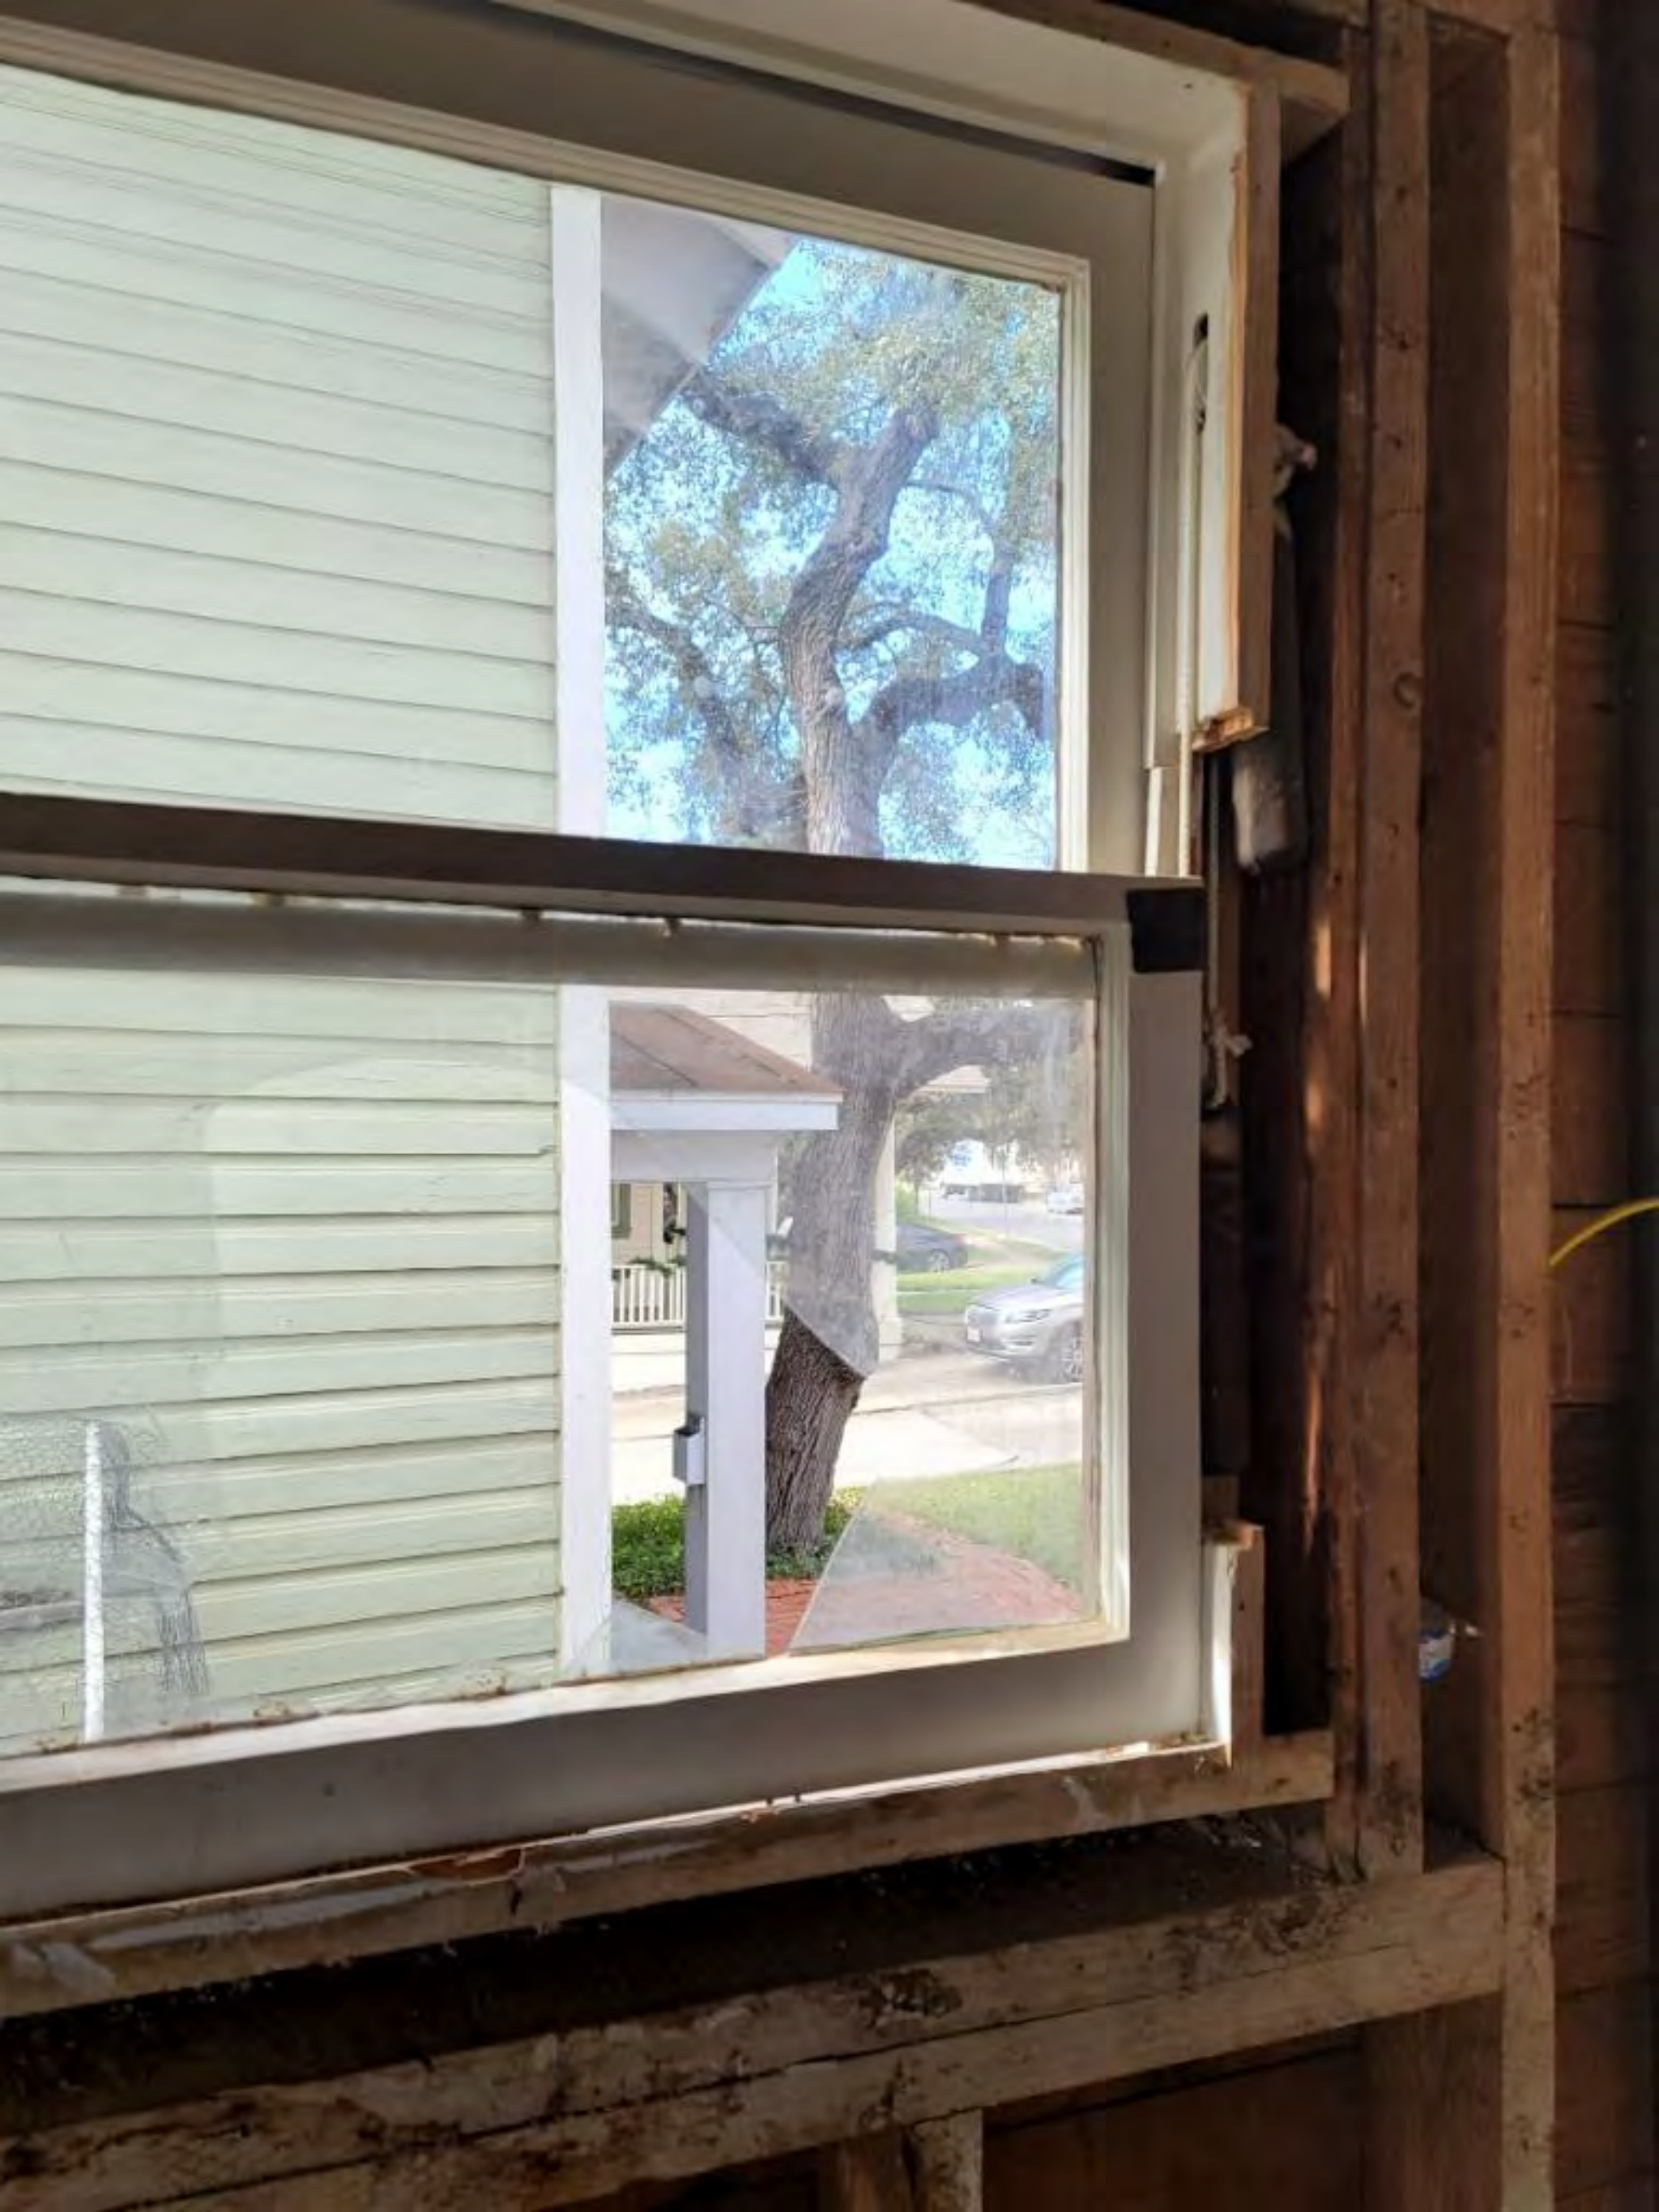
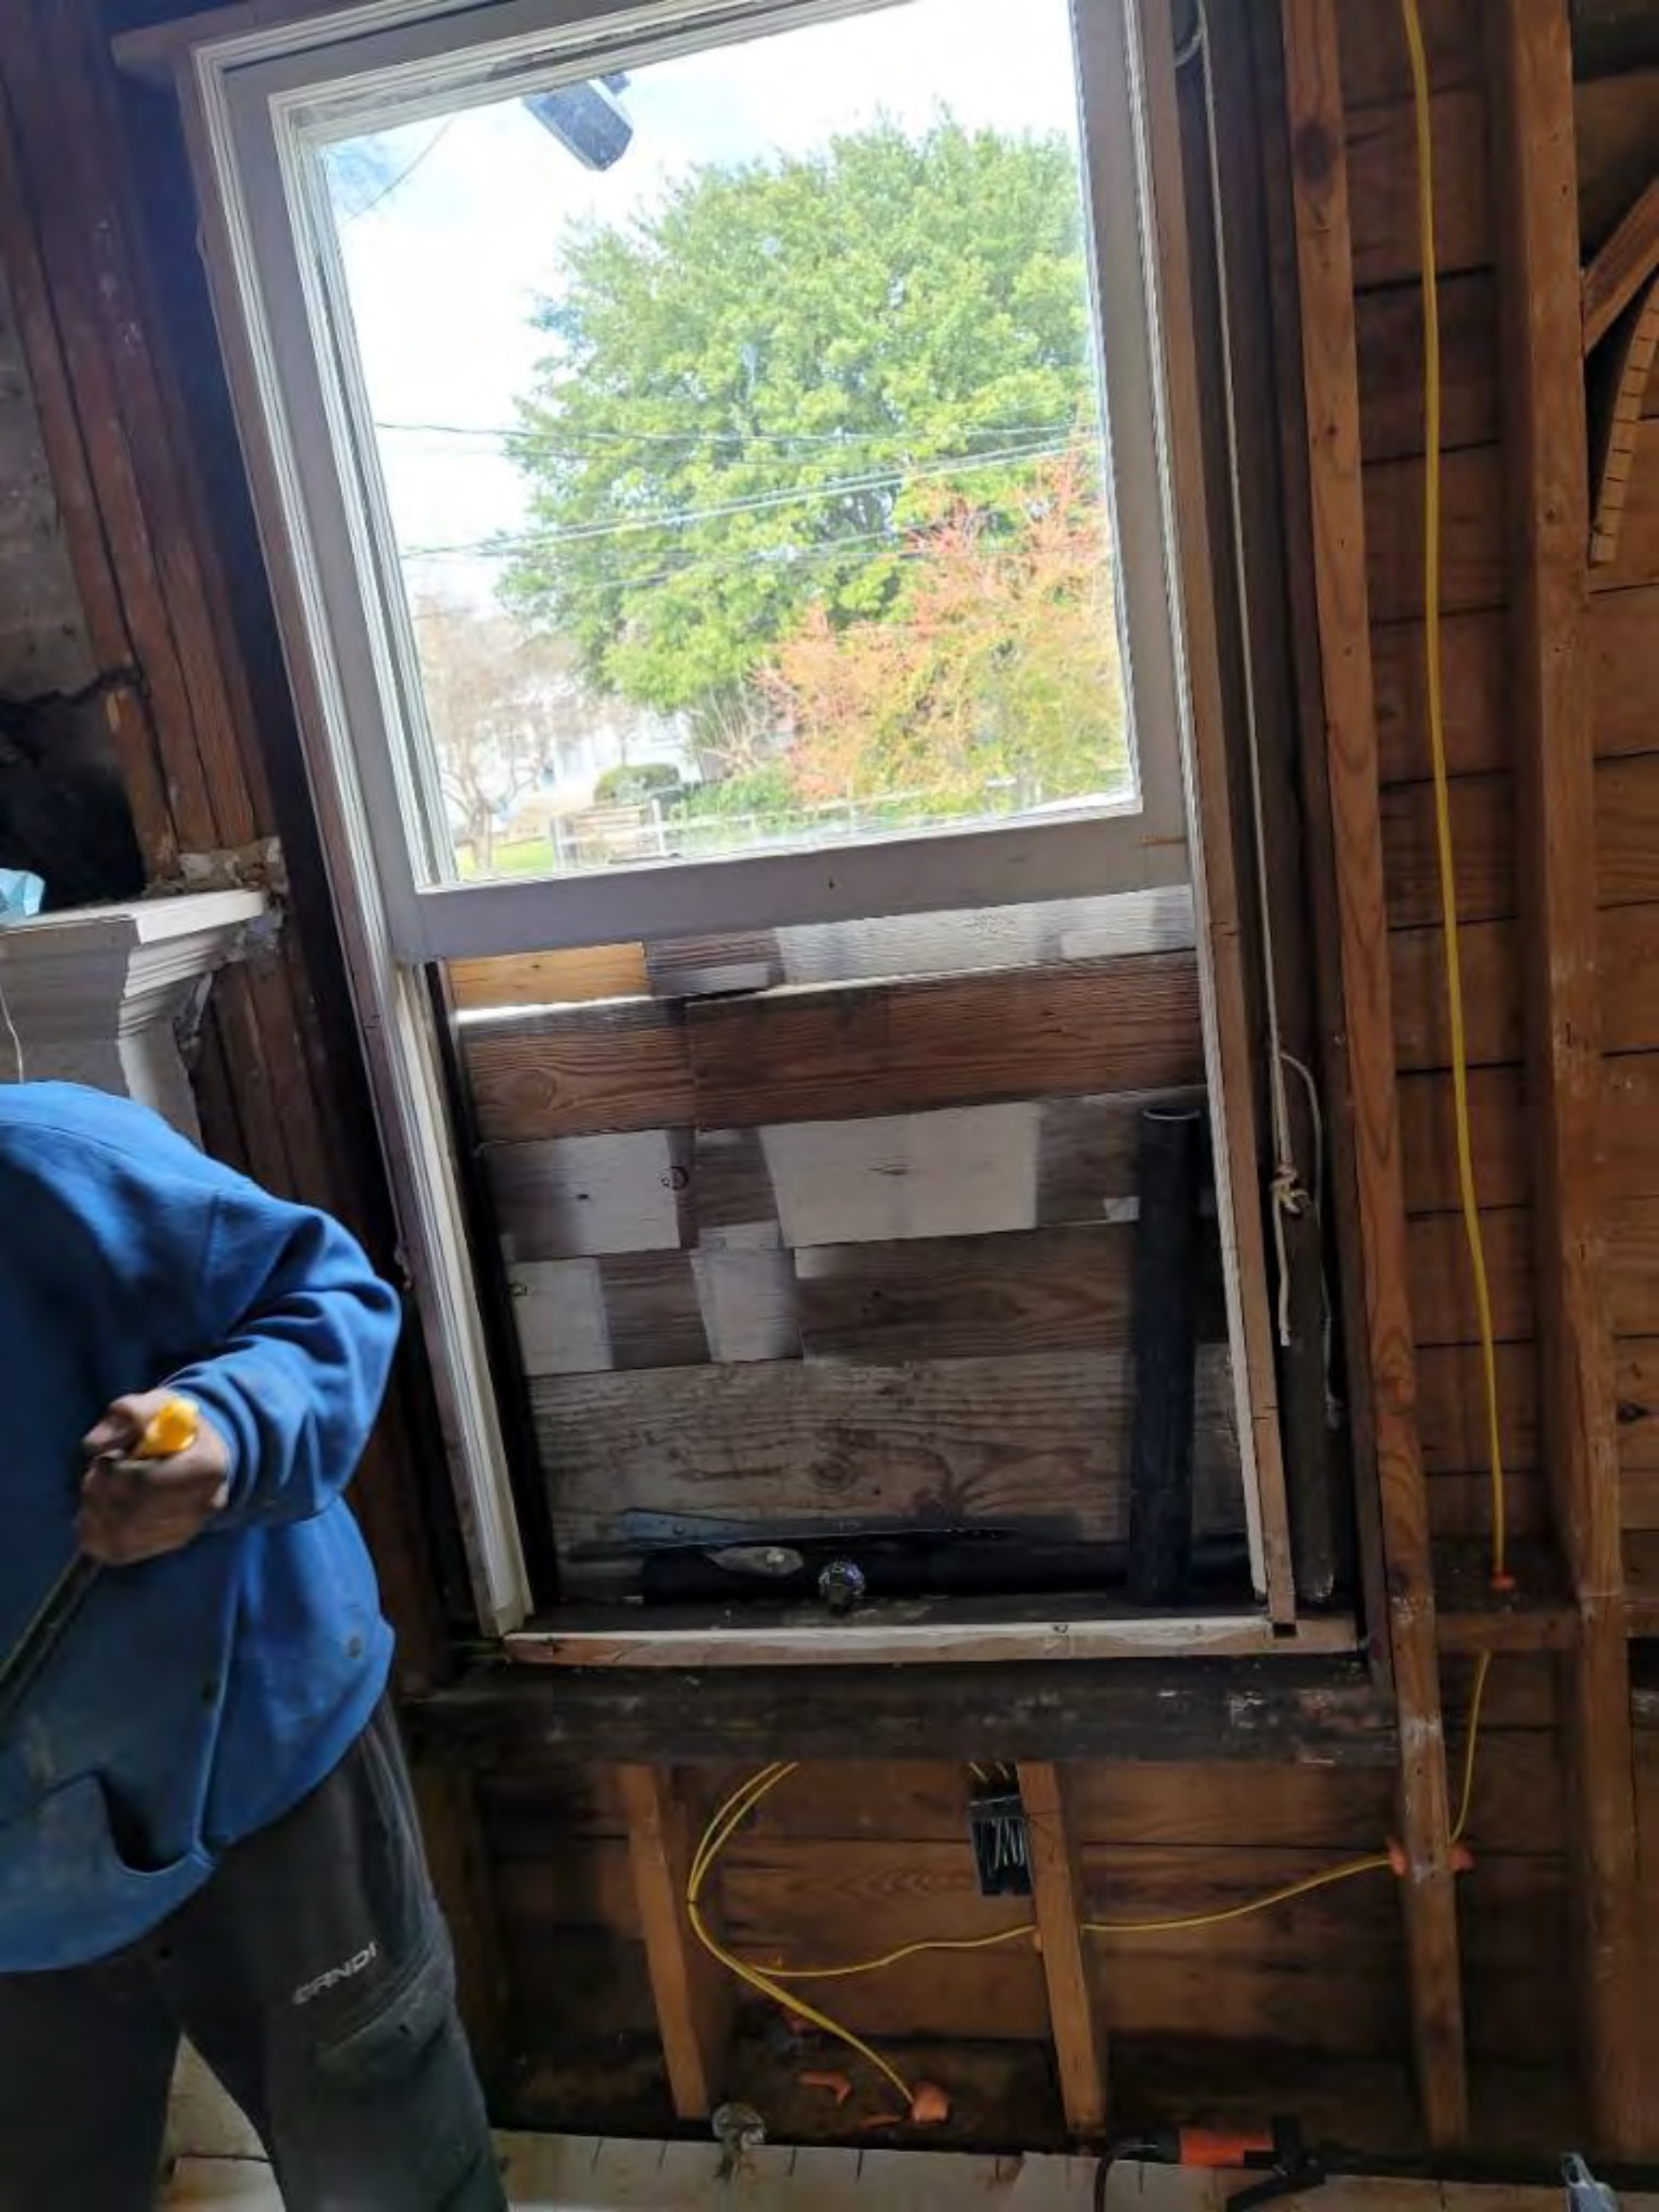
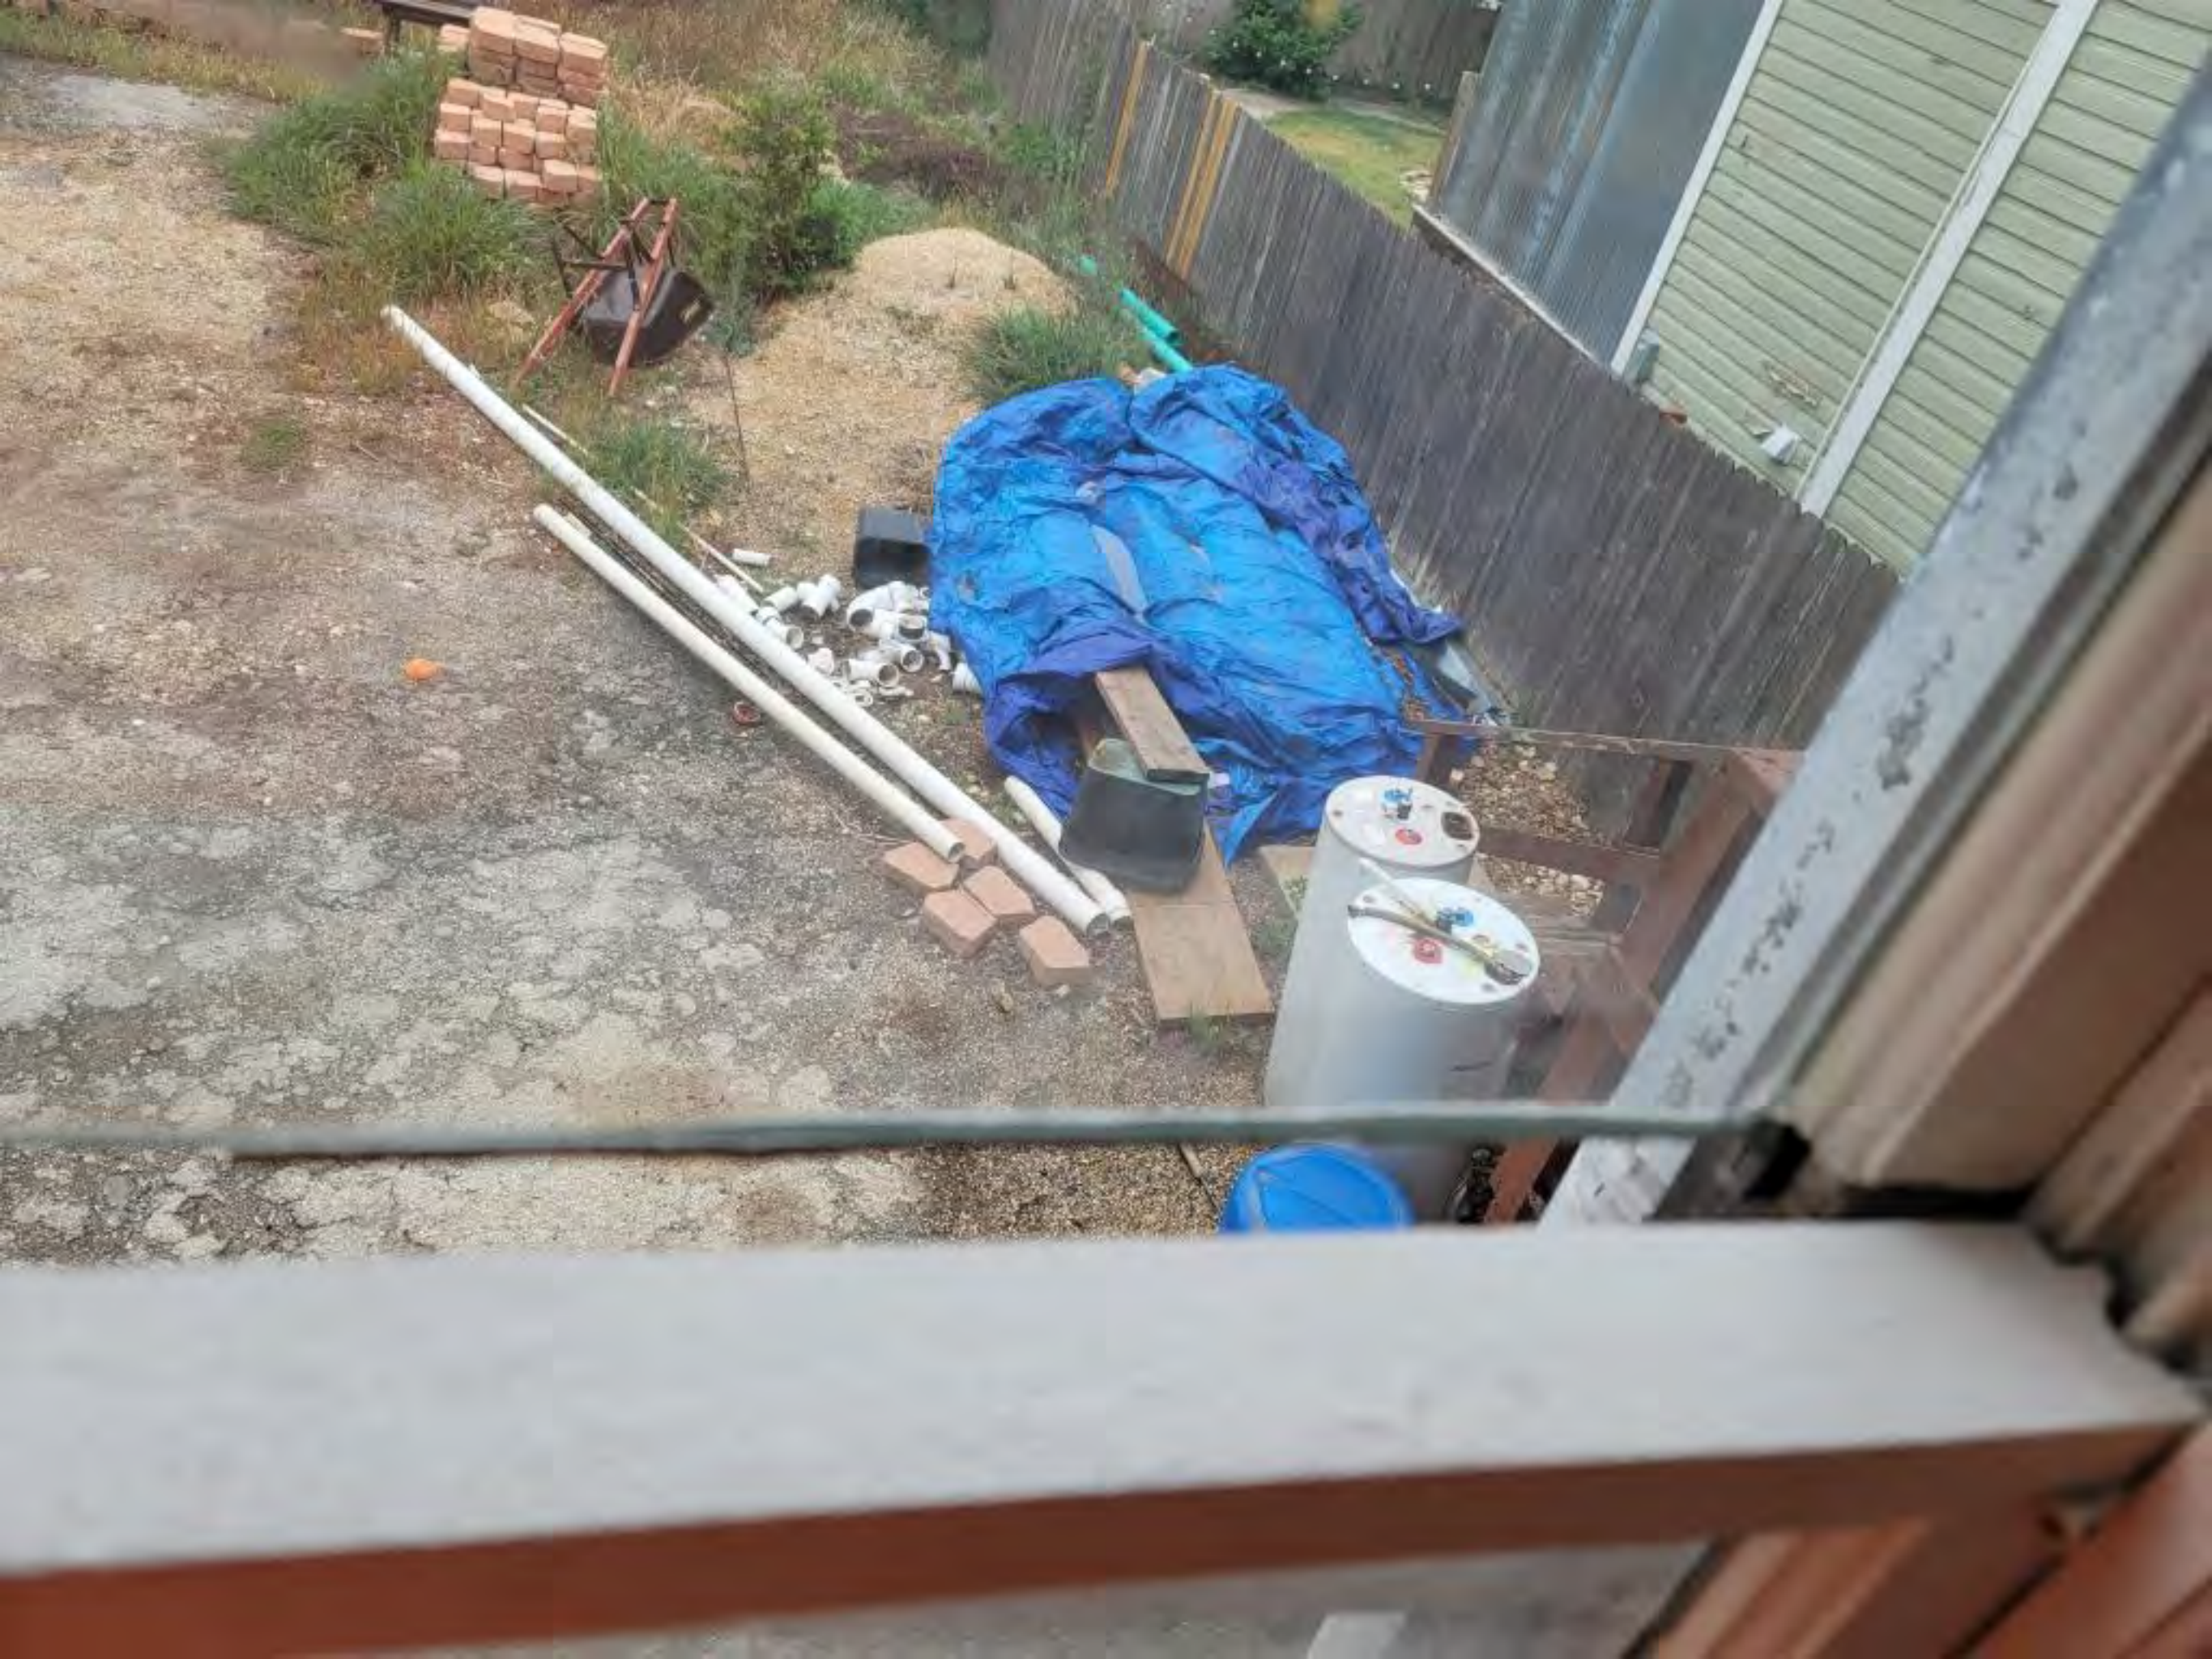
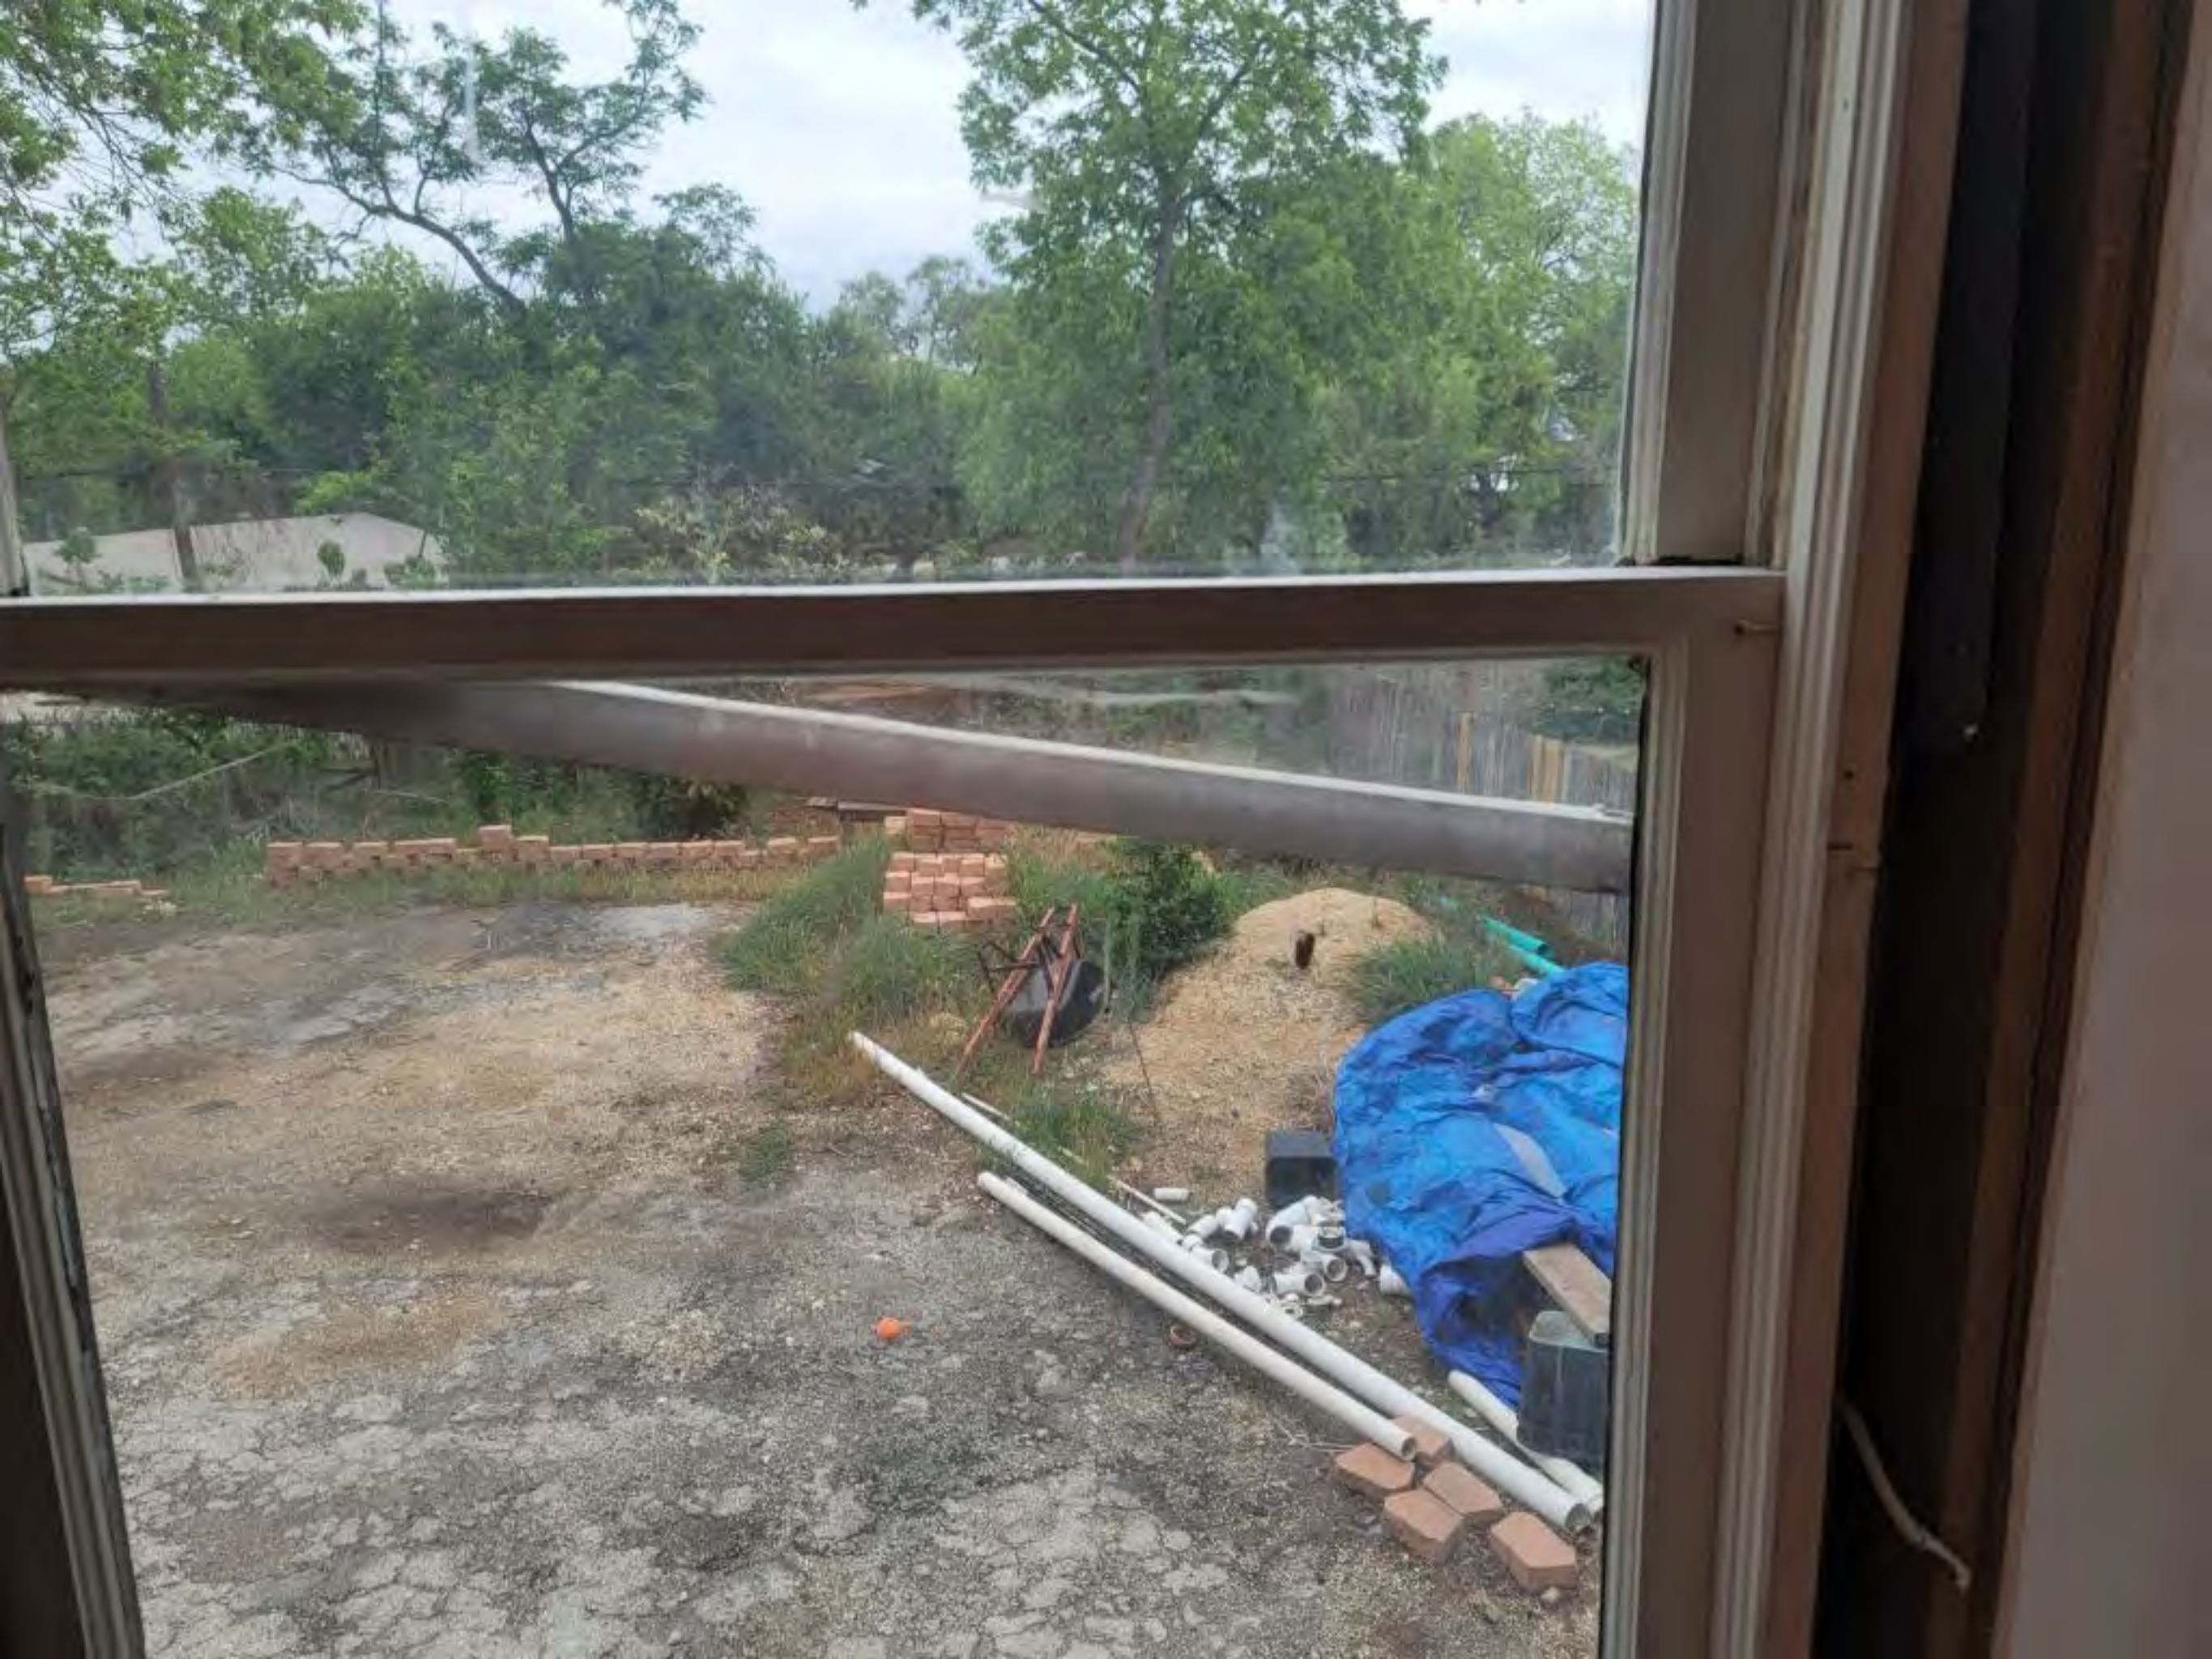
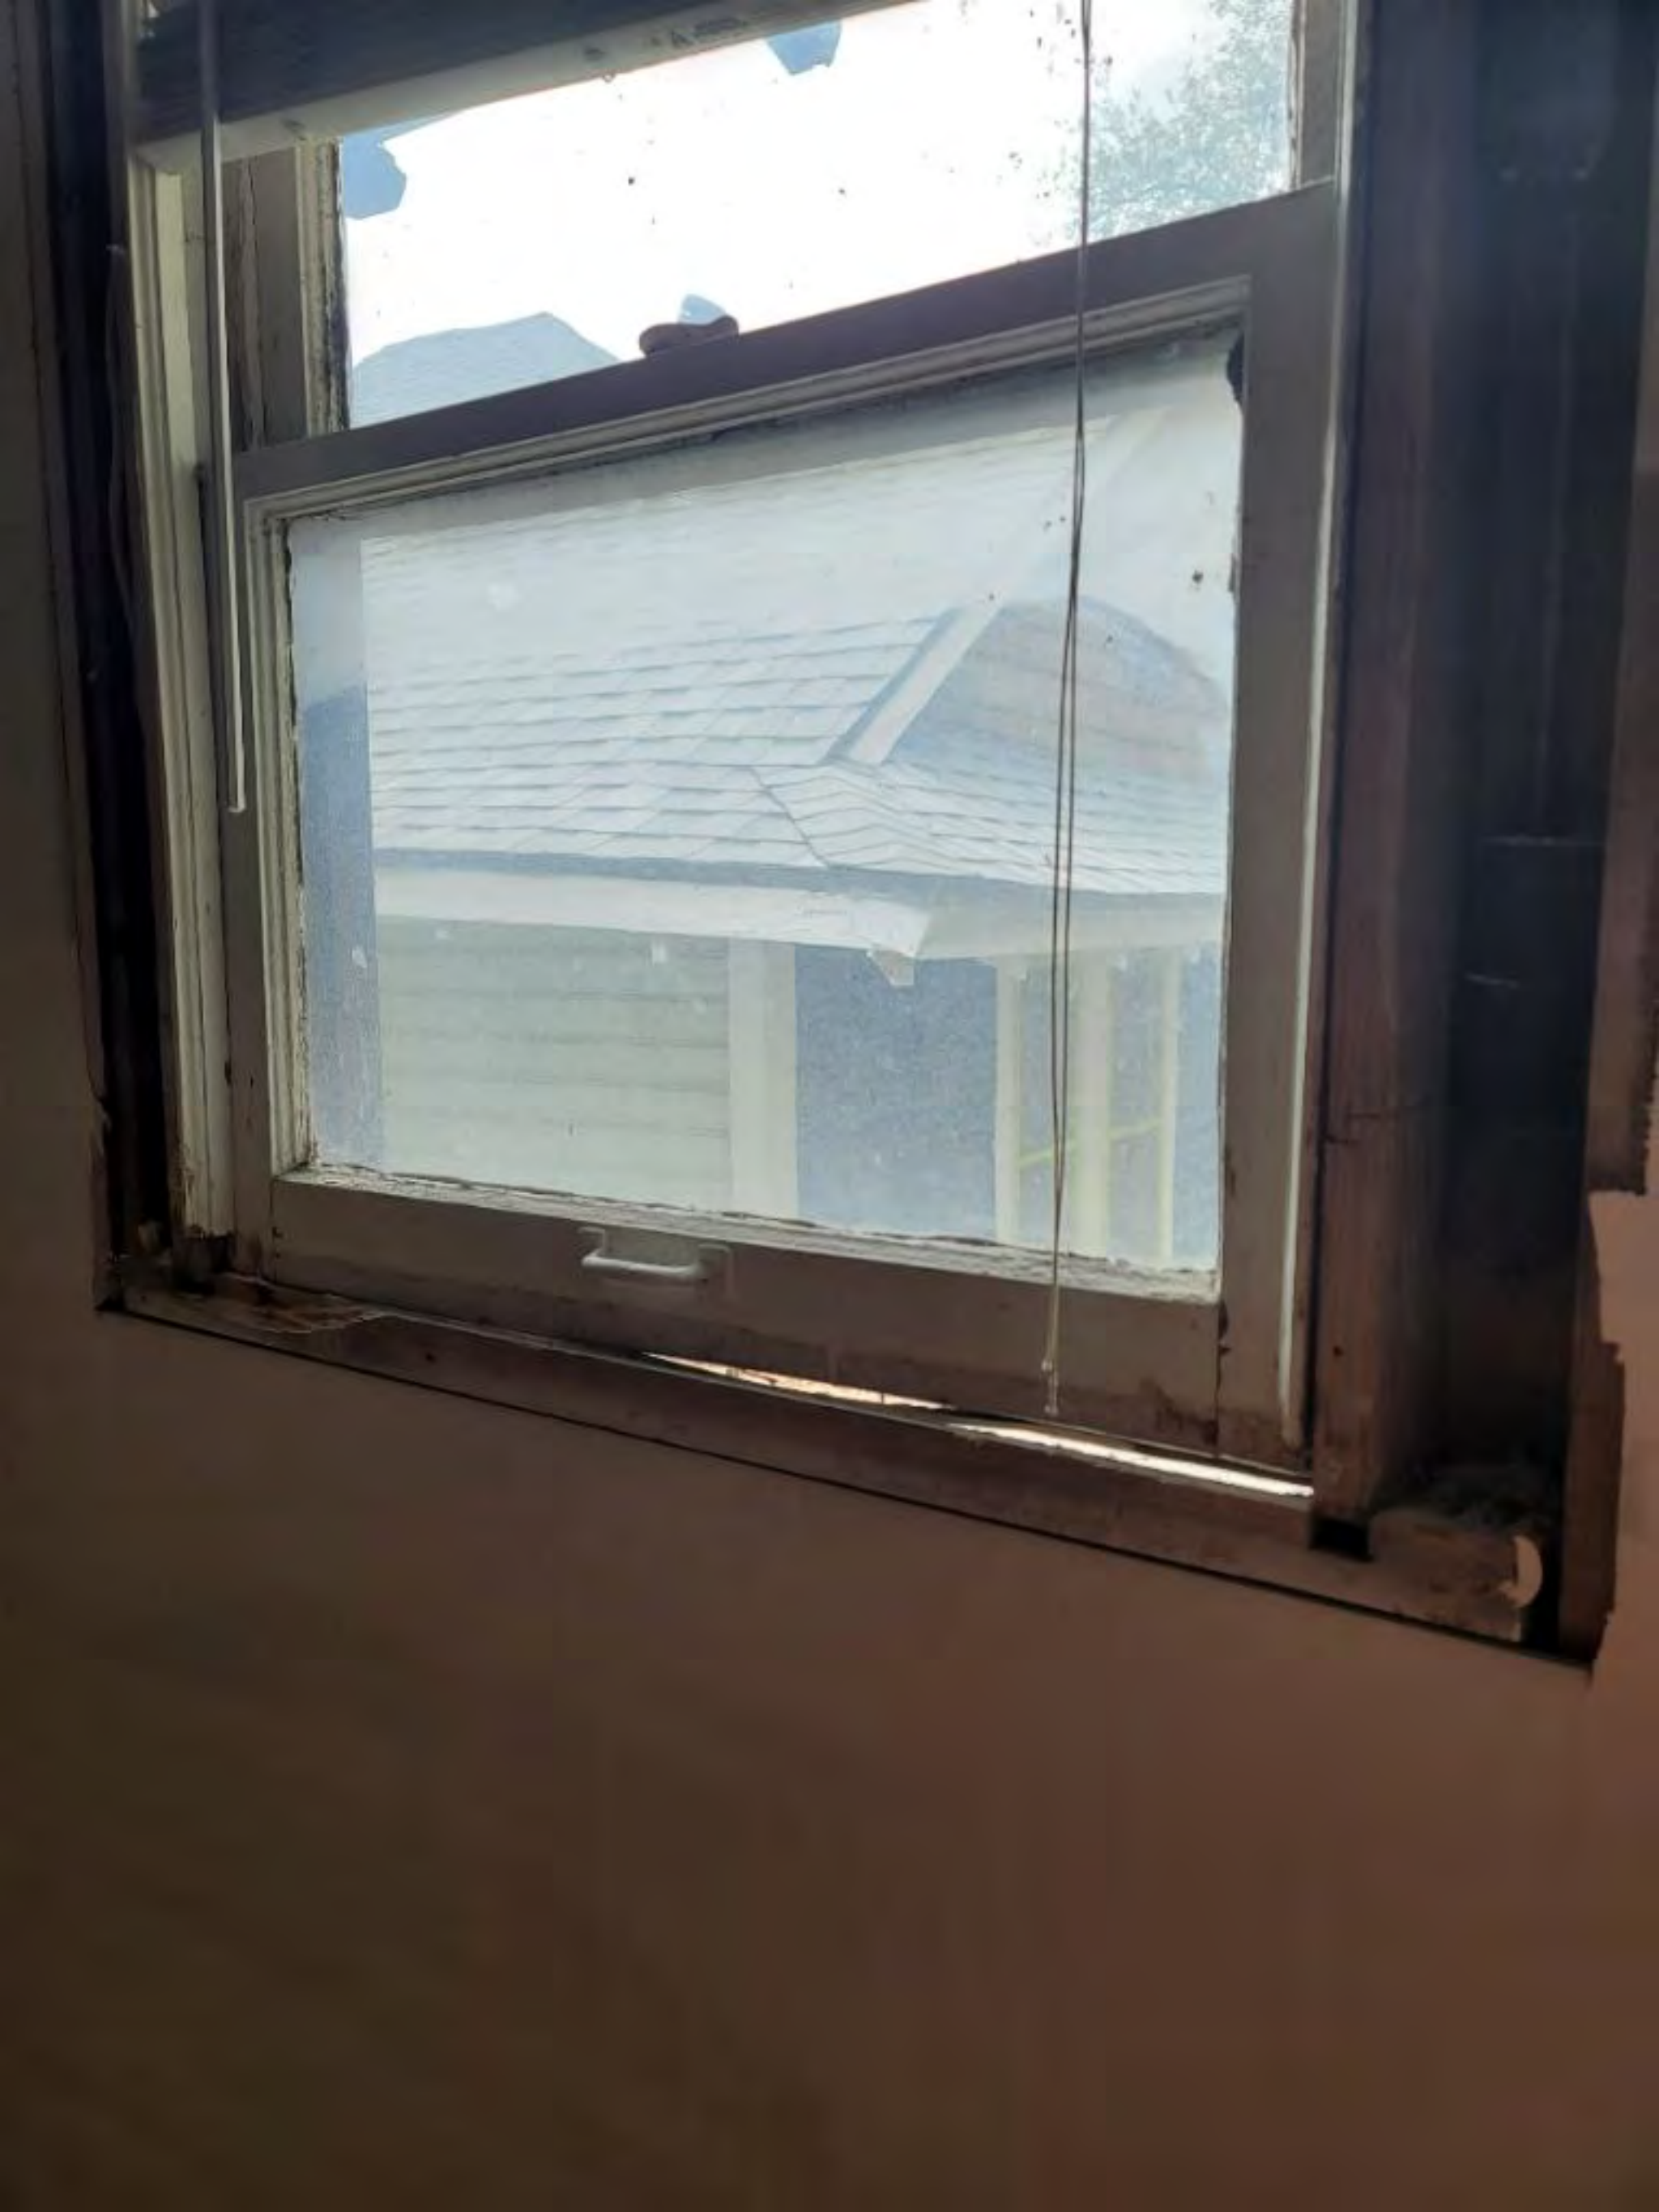
- d. WINDOW REPLACEMENT: EXISTING CONDITION – From the photos submitted to date, the wood windows proposed for replacement appear to be of historic-age, fully wood one-over-one windows. The windows do not show signs of significant wood rot, wood damage, or severe deterioration. Staff finds that the wood windows are in repairable condition based on the documentation provided, with most requiring minimal repair and intervention such as the reworking of the sashes and re-glazing, along with refitting into the trim and frames. Staff has scheduled a site visit with the applicant for Monday, May 30 and may be able to report additional information at the hearing.

The current condition of the windows is such that many are unrepairable. I've had multiple contractors visit the site and have commented as such. I need to replace them with comparable Marvin windows that are approved for historic window replacement.

Staff does not recommend approval based on findings b – e. Staff recommends that the applicant restore the deteriorated wood windows and preserve all original window openings.
