HISTORIC AND DESIGN REVIEW COMMISSION

August 17, 2022

HDRC CASE NO: 2022-399
ADDRESS: 363 NORTH DR
LEGAL DESCRIPTION: NCB 7026 BLK 5 LOT 16, E11 FT OF 18
ZONING: R-6, H
CITY COUNCIL DIST.: 7
DISTRICT: Monticello Park Historic District
APPLICANT: Thomas Gandy/GANDY THOMAS R
OWNER: Thomas Gandy/GANDY THOMAS R
TYPE OF WORK: Exterior modifications, fenestration modifications
APPLICATION RECEIVED: July 24, 2022
60-DAY REVIEW: Not applicable due to City Council Emergency Orders
CASE MANAGER: Edward Hall

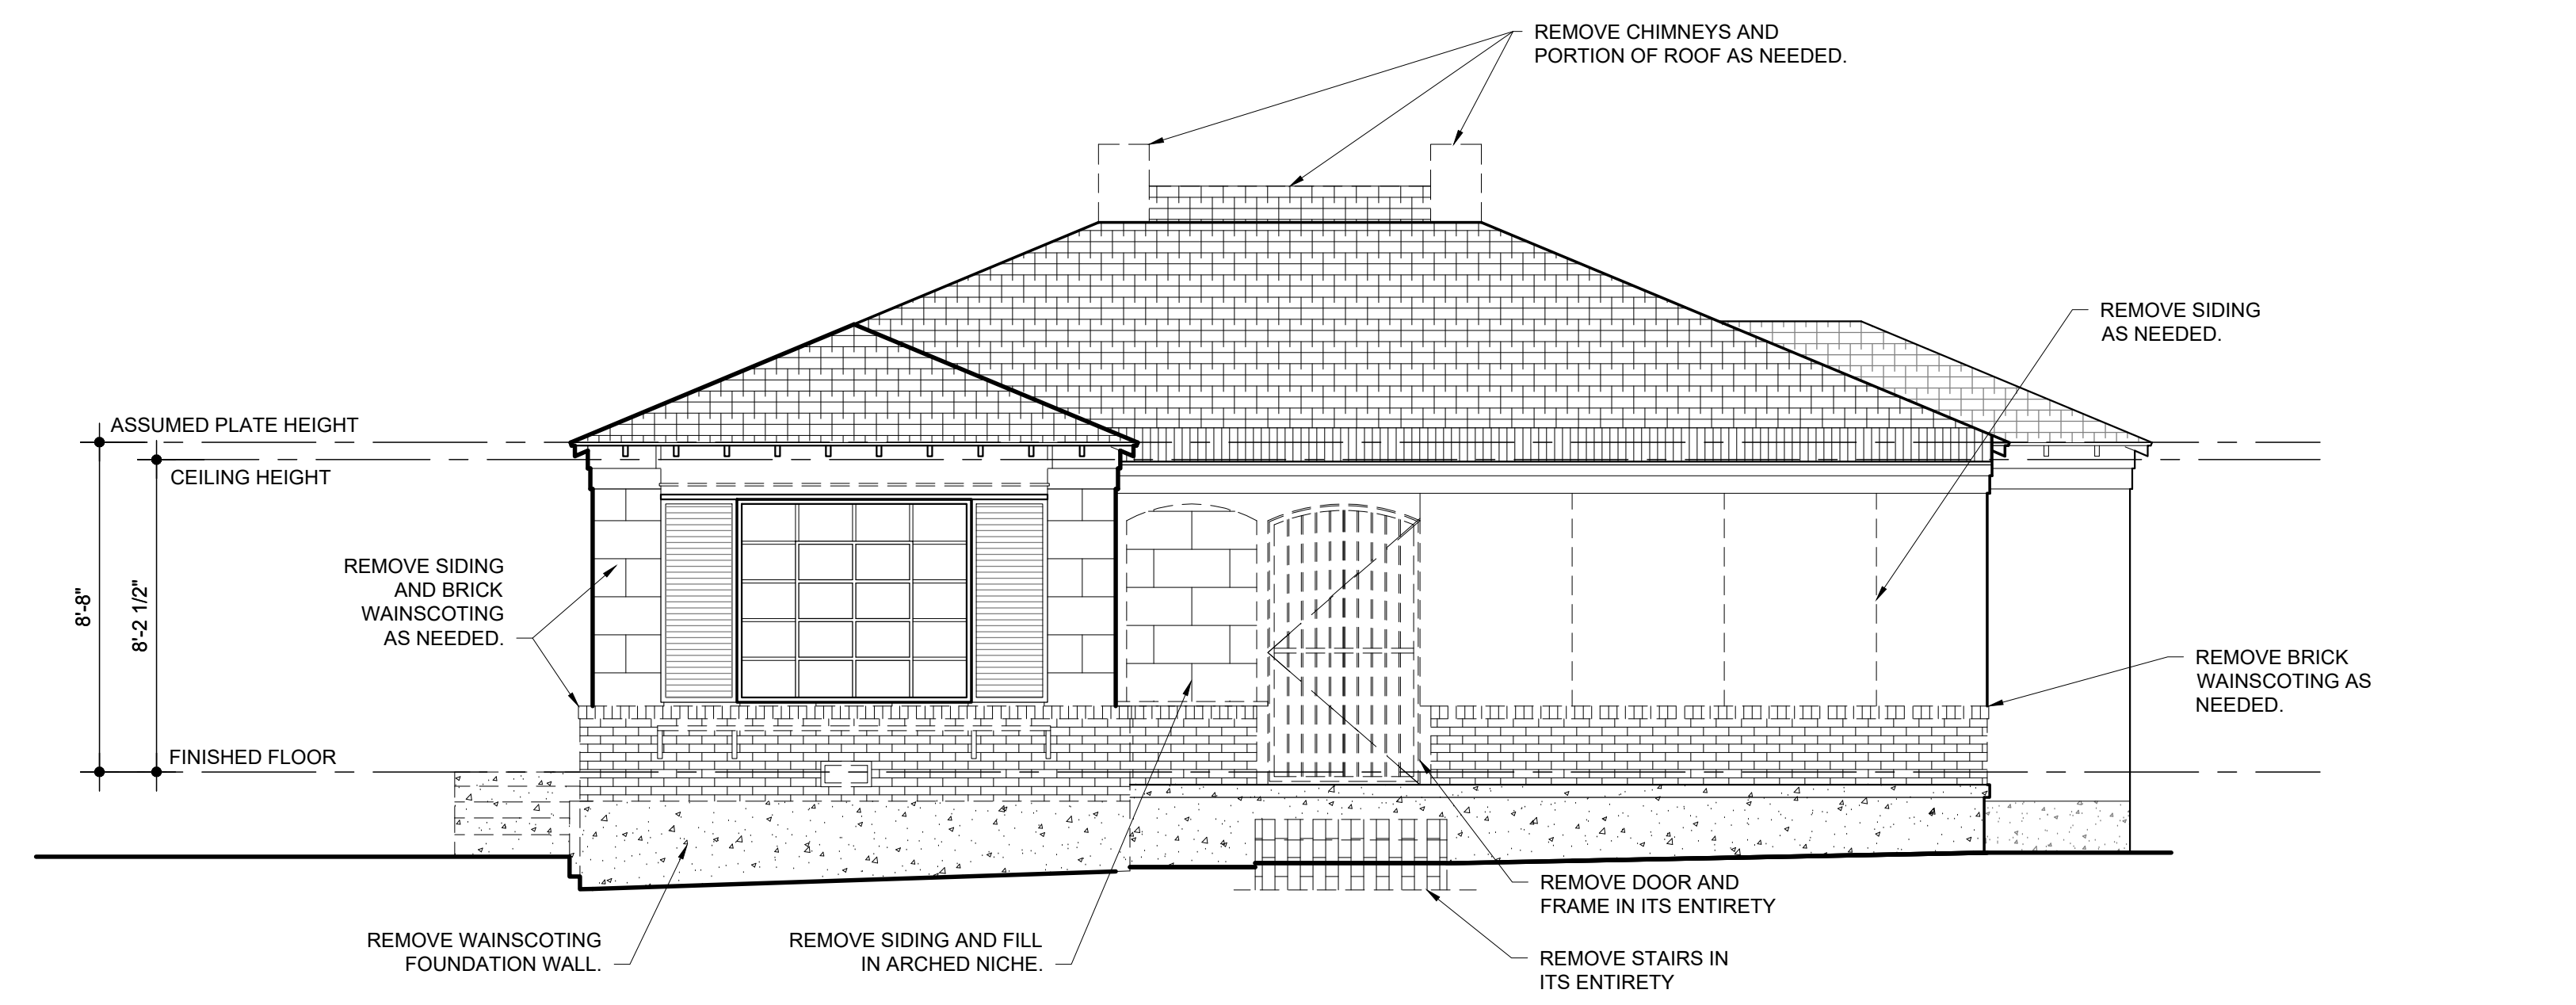
2 FRONT ELEVATION
AD-10 1/4"=1'-0"

- d. EXTERIOR MODIFICATIONS (Front Façade) – The applicant has proposed to perform modifications to the front façade to include the installation of two, one over one windows on the front façade. This wall plane is not original and is the front of a previously enclosed front porch. The Guidelines for Exterior Maintenance and Alterations 7.A and B. note that front porches should not be enclosed. When porches are enclosed, the Guidelines note that they should function and visible read as a porch. Per photos, the front porch has been enclosed with screening elements since 2007, at least. Staff finds that either windows should be added across the entirety of the enclosed porch to read as an open element with visible porch columns, or that the structure should be returned to its previous condition.

2. Staff does not recommend approval of item #2, modifications to the front façade, as noted in finding d. Staff recommends that either windows be added across the entirety of the enclosed porch to read as an open element with visible porch columns or that the structure be returned to its previous condition.

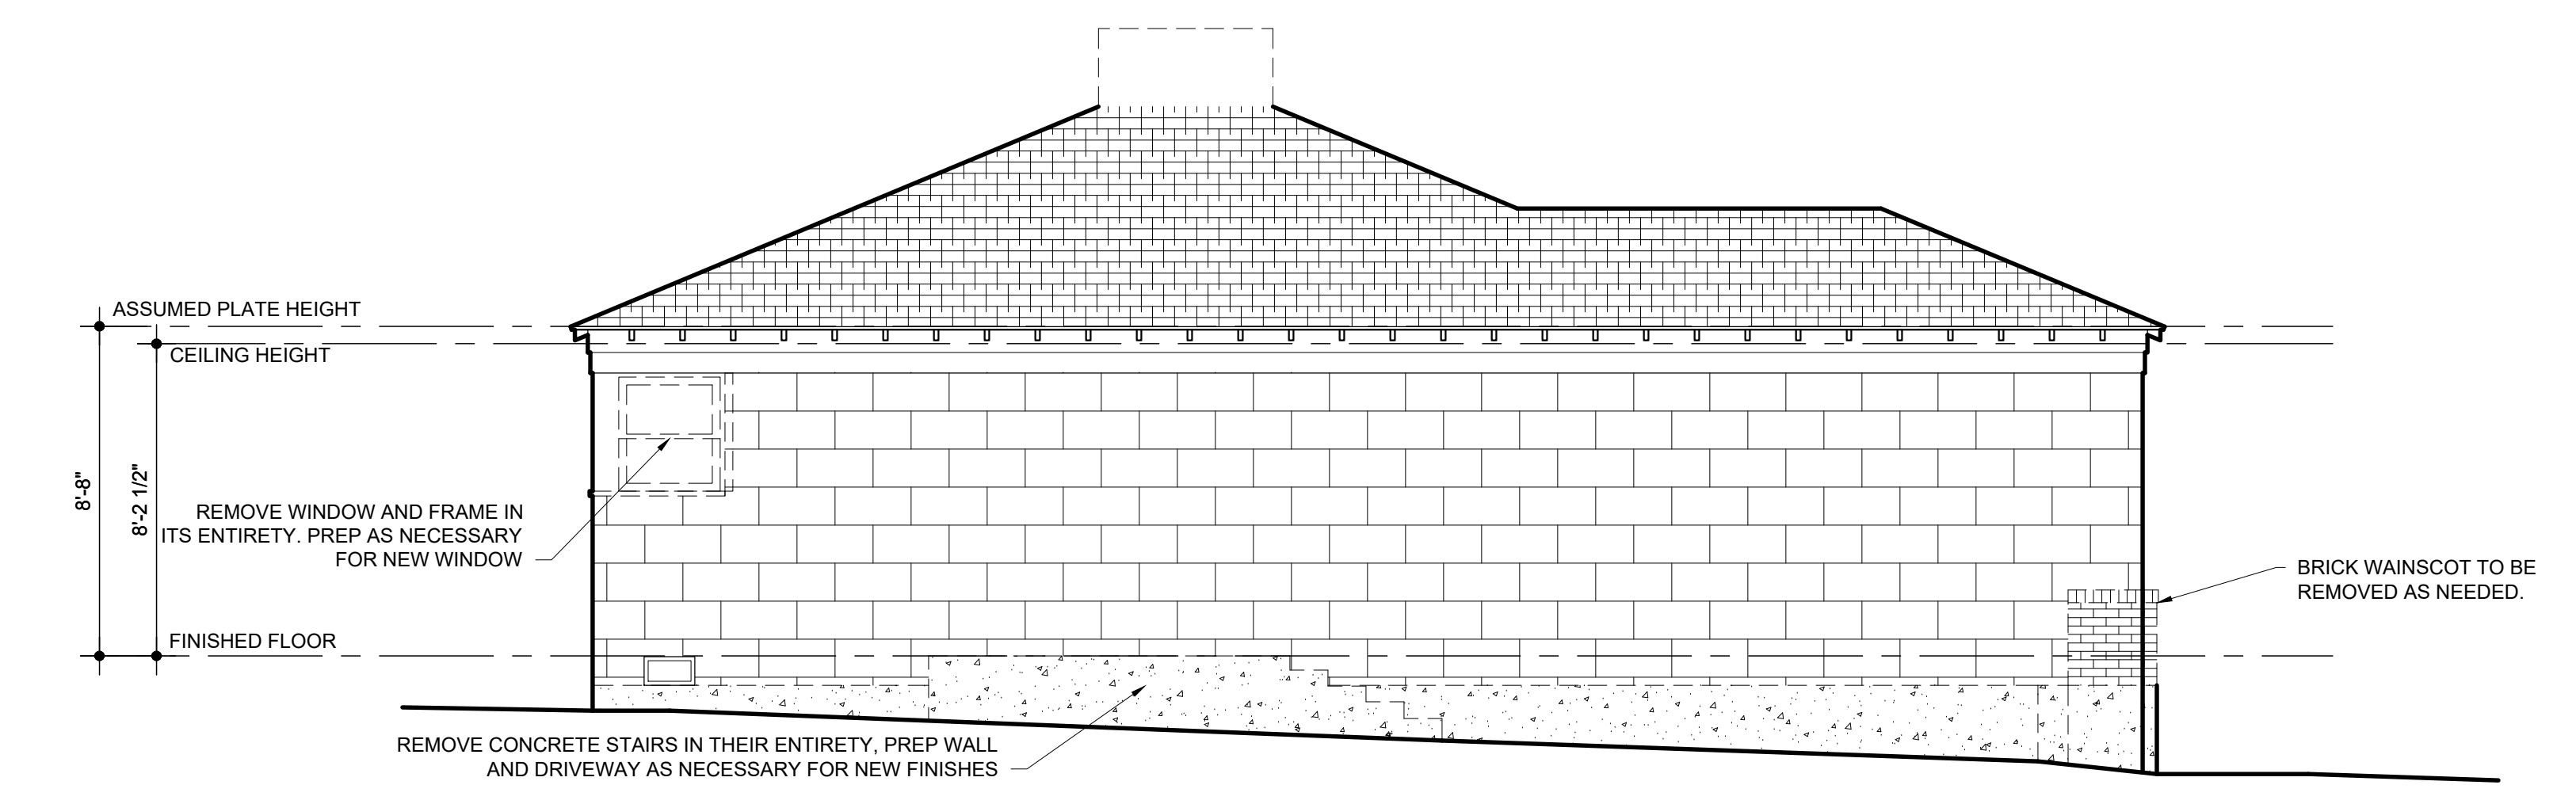
3 LEFT ELEVATION
AD-10 1/4"=1'-0"

- e. EXTERIOR MODIFICATIONS (Side Façade) – The applicant has proposed to perform modifications to the side (west) façade to include the removal of an existing door opening, and the removal of an existing concrete stoop and steps. Per the Guidelines for Exterior Maintenance and Alterations 6.A.i., exiting window and door openings are to be preserved. The proposal to remove the existing, side door is inconsistent with the Guidelines. Staff finds this door opening should be preserved in its original location. Additionally, staff finds that the side stoop and porch steps are an original element and should be preserved.

3. Staff does not recommend approval of item #3, modifications to the side (west) façade to include the removal of an existing door opening, and the removal of an existing concrete stoop and steps, as noted in finding e. Staff recommends that the door opening, concrete stoop and stairs be preserved.

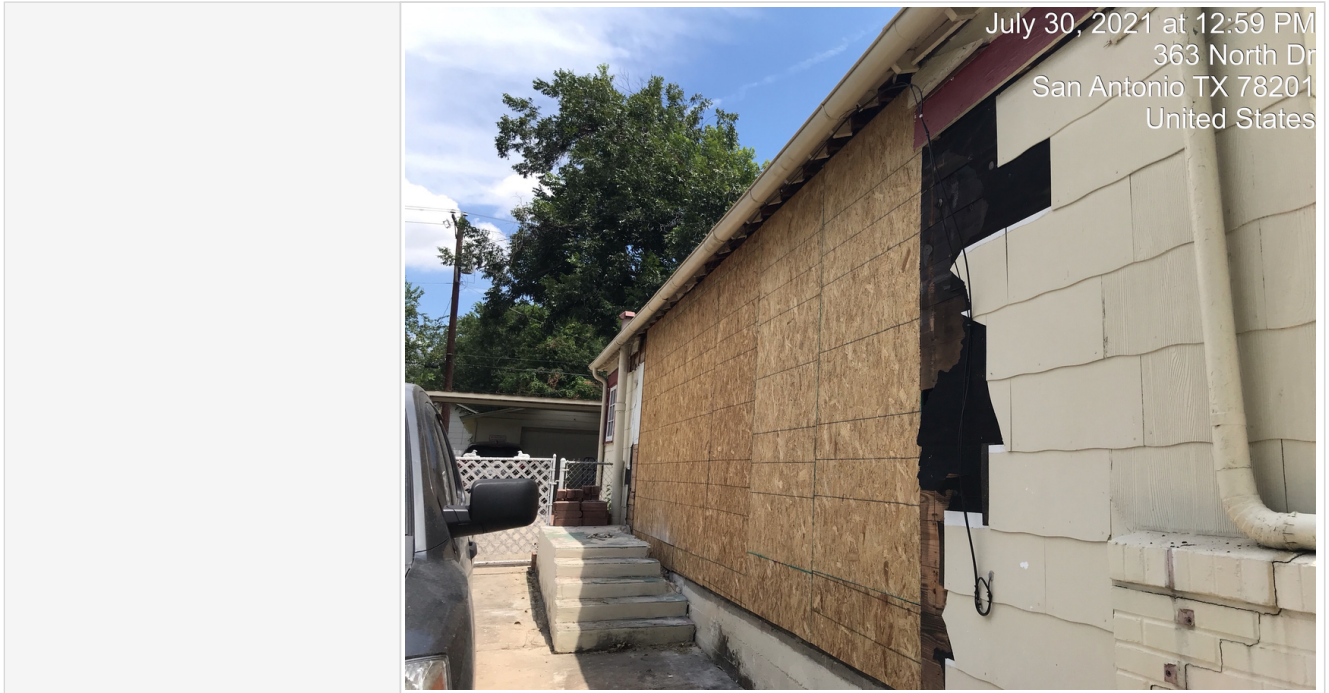
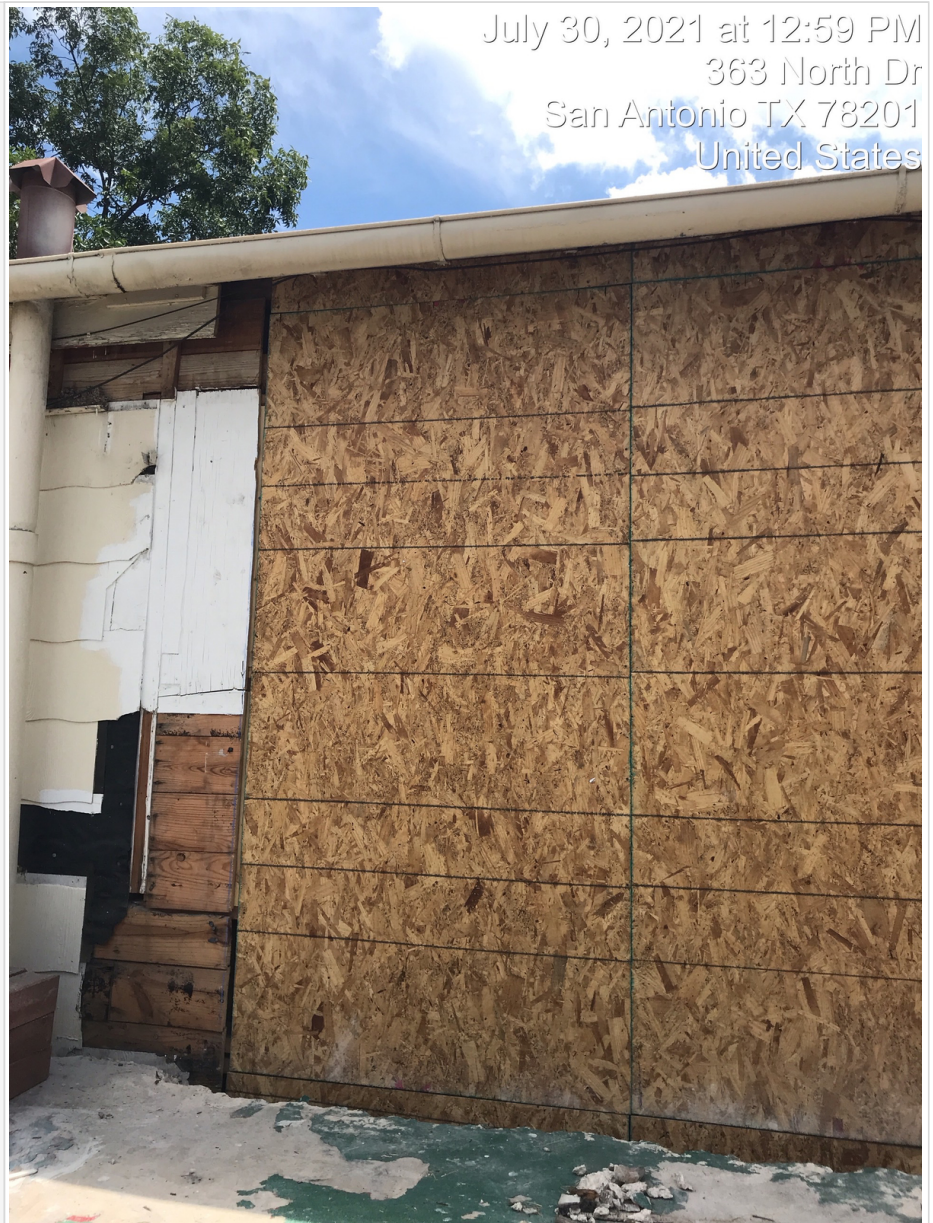
Date	07/30/2021
Time	02:01 PM (-5 GMT)
Context	citizen report
Present Staff	Edward Hall
Present Individuals	Homeowner
Types of Work Observed	Exterior Maintenance and Alterations
Amount of Work Completed	50%
Description of work	Removal of side facade materials and one side door. Installation of new sheathing on side facade.
Description of interaction	OHP staff issued a Stop Work Order and spoke with the property owner. OHP advised that no further work was to occur with the exception of placing building wrap on exposed framing and building materials to prevent water damage and water infiltration into the historic structure.

EXTERIOR MODIFICATIONS ON SIDE FRONTS (REMOVAL OF FRONT MATERIALS)
