# HISTORIC AND DESIGN REVIEW COMMISSION

September 07, 2022

**HDRC CASE NO:** 2022-456  
**ADDRESS:** 902 E GRAYSON ST  
**LEGAL DESCRIPTION:** NCB 992 BLK 1 LOT 15  
**ZONING:** R-6, H  
**CITY COUNCIL DIST.:** 2  
**DISTRICT:** Government Hill Historic District  
**APPLICANT:** ERIN OSHAUGHNESSY/OSHAUGHNESSY ERIN E  
**OWNER:** ERIN OSHAUGHNESSY/OSHAUGHNESSY ERIN E  
**TYPE OF WORK:** Construction of a carport, driveway modification  
**APPLICATION RECEIVED:** August 19, 2022  
**60-DAY REVIEW:**  
**CASE MANAGER:** Jessica Anderson

The applicant requests a Certificate of Appropriateness for approval to extend the driveway and install a carport.

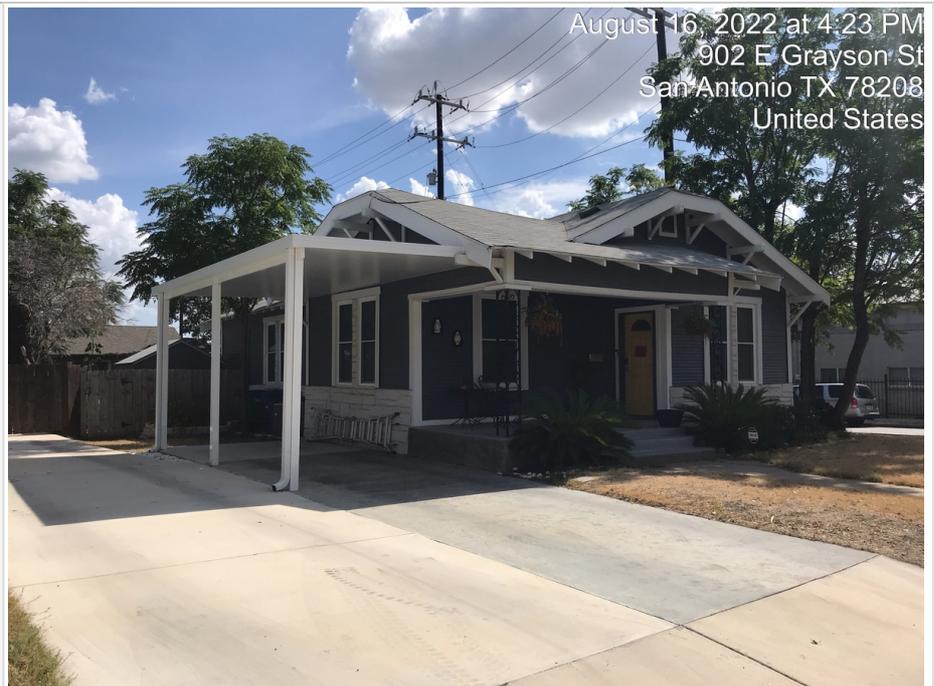
<p>August 16, 2022 at 4:23 PM 902 E Grayson St San Antonio TX 78208 United States</p>

Date	08/16/2022
Time	04:15 PM (-5 GMT)
Context	citizen report
Present Staff	Edward Hall
Present Individuals	None
Types of Work Observed	New Construction
Amount of Work Completed	Completed
Description of work	Construction of an attached carport.

Violation Type	No Certificate of Appropriateness (Code 35-451a)
OHP Action	Posted "Notice of Investigation"
Will post-work application fee apply?	To be determined
