HISTORIC AND DESIGN REVIEW COMMISSION

HDRC CASE NO: 2022-396
ADDRESS: 206 LAVACA ST
LEGAL DESCRIPTION: NCB 713 BLK 10 LOT 10
ZONING: RM-4, H
CITY COUNCIL DIST.: 1
DISTRICT: Lavaca Historic District
APPLICANT: Sam Xu/Lake Flato Architects
OWNER: URBAN CREATIVE LLC HILL
TYPE OF WORK: Front façade modification
APPLICATION RECEIVED: December 09, 2022
60-DAY REVIEW: Not applicable due to City Council Emergency Orders
CASE MANAGER: Rachel Rettaliata

206 Lavaca Street

Petrographic Examination of a Stucco Sample
WJE No. 2022.6200.0

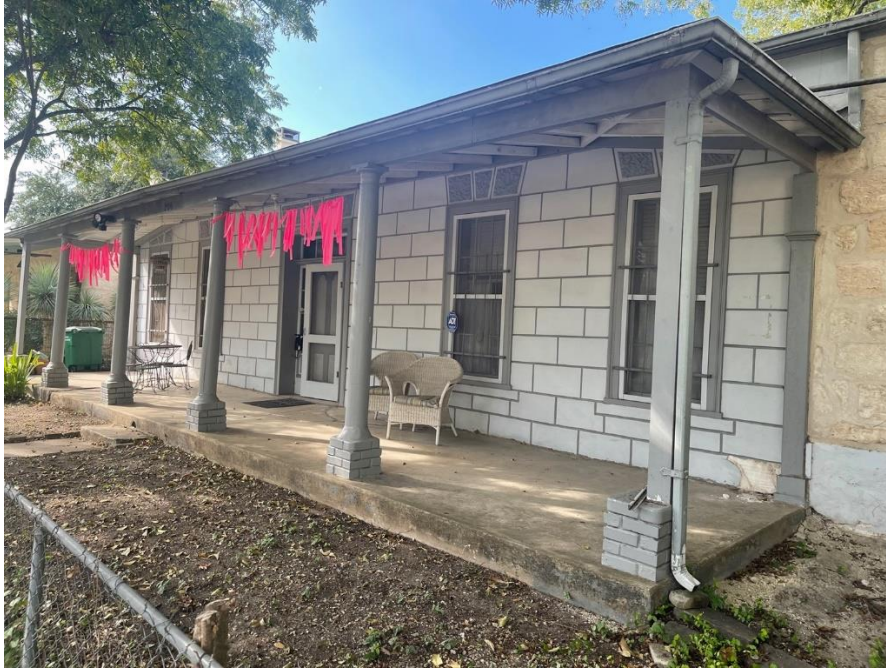
While there is no standard test method for determining the age of a stucco, there are features providing circumstantial evidence for its relative age. Historical stucco made in the 19th century or early 20th century tend to have larger and poorly graded aggregate particles. The paste may contain no portland cement or large residual portland cement particles exceeding 150 μm . In addition, animal hairs were often used as fiber reinforcement. The stucco represented by the sample contained no such features. The aggregate was relatively fine and well graded. The stucco was uniform and contained abundant residual white portland cement particles that were intermediate to small in particle size. Therefore, it is WJE's opinion that the stucco represented by the sample was not the original and was likely placed after 1950 and should not be considered historical for restoration purpose.

Figure 1. The front view of the residence at 206 Lavaca Street showing the stucco wall (courtesy of Rubiola Construction).

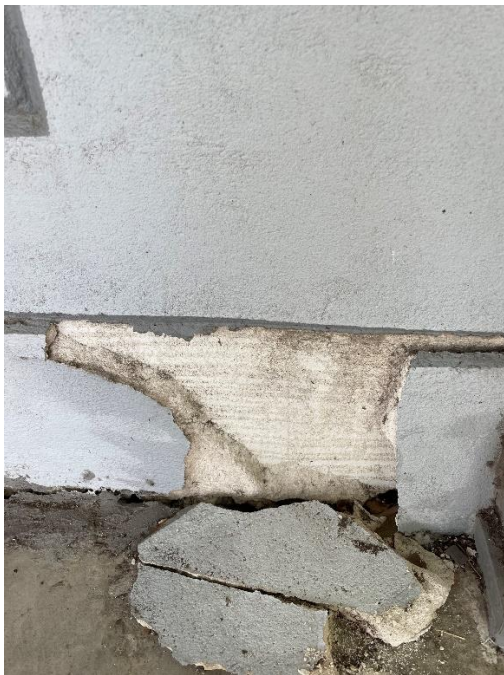
Figure 2. Sampling of the stucco (courtesy of Rubiola Construction).

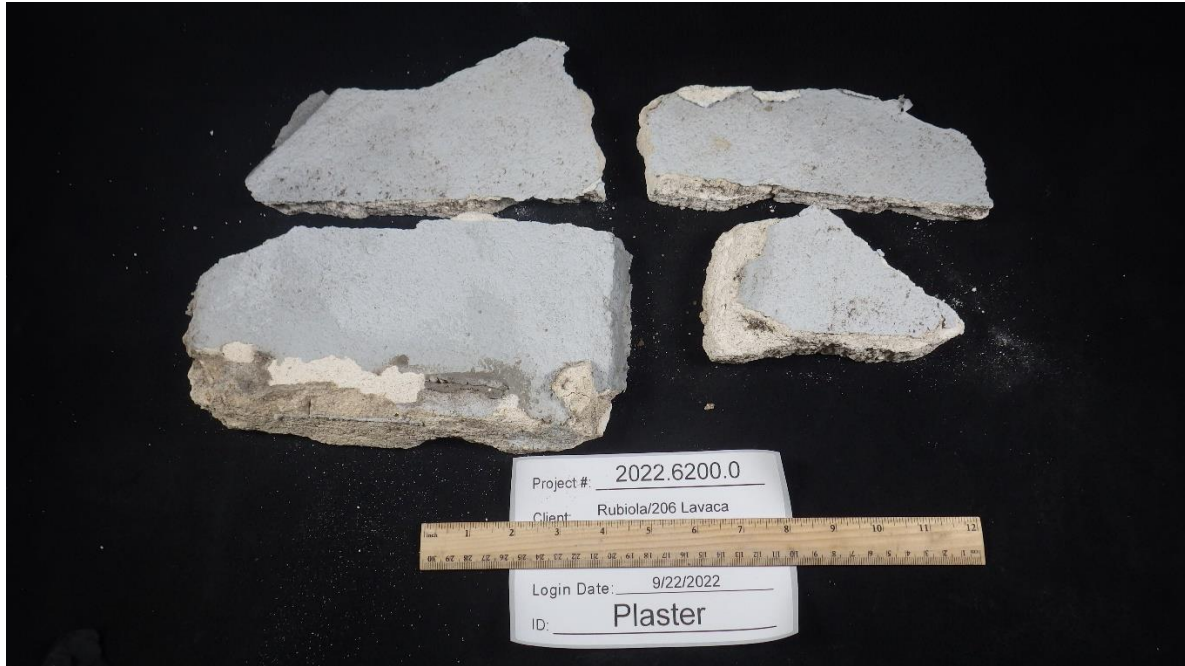
Three pieces of stucco reportedly removed from the exterior front wall of the residence were received (Figure 2 to Figure 4). The largest piece of the stucco measured approximately 12 inches long, 4 inches wide, and 1 inch thick.

Figure 3. As received samples.

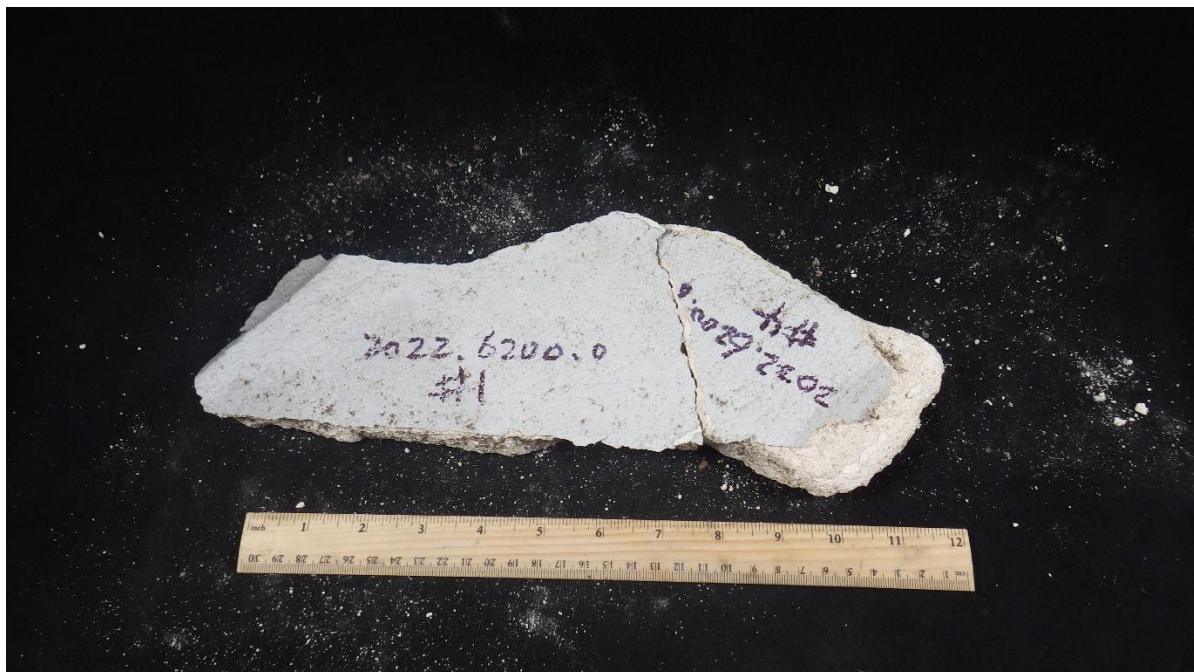
Visual examination indicated that all pieces represented the same stucco sample. Therefore, only one sample (identified as No. 4 in Figure 4) was selected for the petrographic examination. Due to the softness, no cutting or polishing was attempted. The selected sample was impregnated with a blue-dyed epoxy first and then cut. One piece was used to fabricate a thin section. A thin section is about 25 μm in thickness and transparent and allows for detailed evaluation of the stucco, including mineral identification for aggregate, identification of residual cement and other components in the paste, and general characteristics of the stucco. The blue epoxy serves to highlight voids and cracks. The other piece was polished. Powder mounts of the paste and areas of interest were also prepared. The powder mounts and thin section were examined using a petrographic (polarized light) microscope at magnifications up to 630X. Freshly fractured surfaces and the polished surface were examined using a computer-controlled stereomicroscope at magnifications up to 160X.

Figure 4. The broken pieces of one of the samples reassembled together.

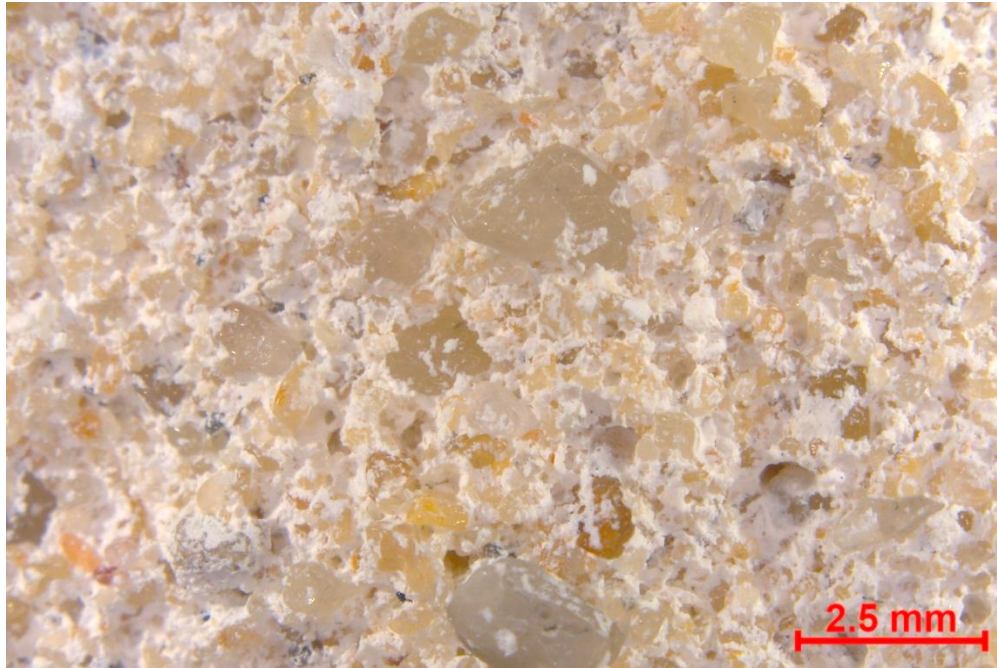
The stucco was white, with a nearest matching Munsell Color Index of N9 (Figure 5). The stucco was moderately soft and relatively porous and contained natural sand aggregate uniformly distributed in a portland cement and hydrated lime paste that was non-air-entrained. No animal hairs or other natural or synthetic fibers were detected. No metal lath reinforcement was detected. A summary of the properties of the mortar, including the results of the point count, is given in Table 1.

Figure 5. A fracture surface of the stucco showing the uniform paste color and aggregate distribution.

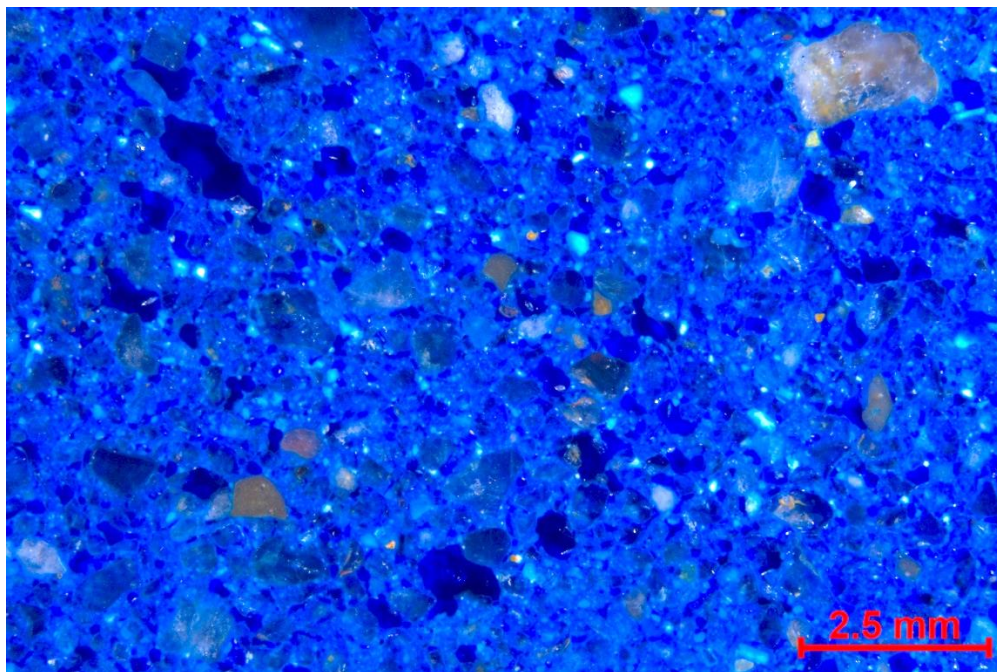
The aggregate was natural sand and accounted for 53.2 percent of the total stucco volume based on the point count (Table 1). The aggregate was composed primarily of quartz (95.0 percent) with a minor amount of chert (4.1 percent) and trace amounts of limestone (0.5 percent) and feldspar (0.5 percent). The sand was subangular to subrounded, mostly clear to buff to brown, hard, dense, and had a nominal top size of 1/16 inch. The aggregate was well-graded and uniformly distributed (Figure 5 to Figure 7).

Figure 6. A polished and blue epoxy impregnated section showing the uniform distribution of aggregate particles.

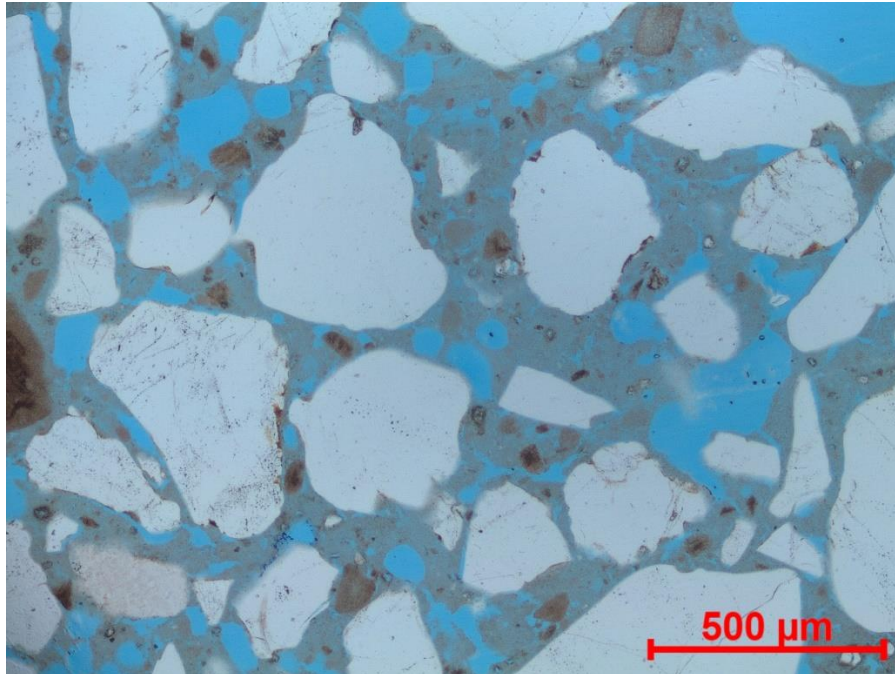
Figure 7. A thin section image of the stucco showing the abundant air voids (filled with blue epoxy) and uniform aggregate distribution.

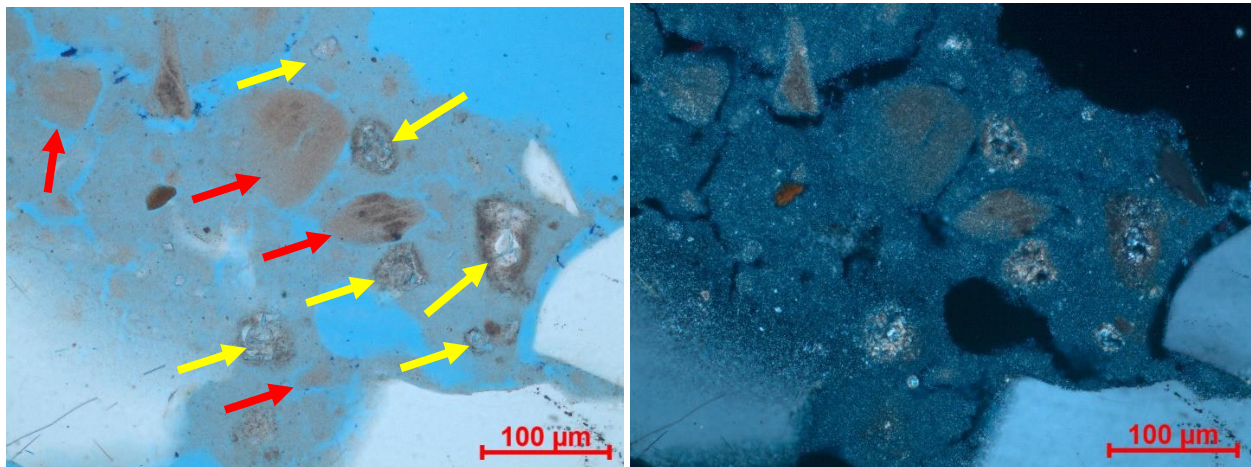
The paste was off white and completely carbonated. The paste was uniform, soft, porous, and had a finely granular texture. The Mohs' Hardness Index of the paste was approximately 2.0 or slightly less than 2.0. The paste accounted for 31.7 percent of the stucco volume and was composed of abundant residual portland cement particles and an abundant amount of lumps of hydrated lime (Figure 8). No fly ash or other supplementary cementitious materials were detected. The residual cement particles were primarily pseudomorphs of alite (mostly consumed during hydration but left voids in the forms of original alite and filled with carbonated calcium hydroxide). No significant belite and/or ferrite phases in ordinary portland cement were detected, suggesting that the cement used was likely white portland cement. The pseudomorphs of alite were typically 70 µm or smaller. No large (greater than 100 µm) residual cement particles were detected.

The lumps of lime were hydrated lime that was not uniformly mixed in the paste; the lumps were carbonated and turned into calcite but still retained the shape of lime lumps. The lime lumps were typically smaller than 100 µm.

Figure 8. Photomicrographs of the same field of view of the thin section of the stucco taken under plane polarized light (left) and crossed polars (right) of a petrographic microscope showing a fully carbonated paste with abundant lumps of hydrated lime (red arrows) and residual cement particles (yellow arrows).

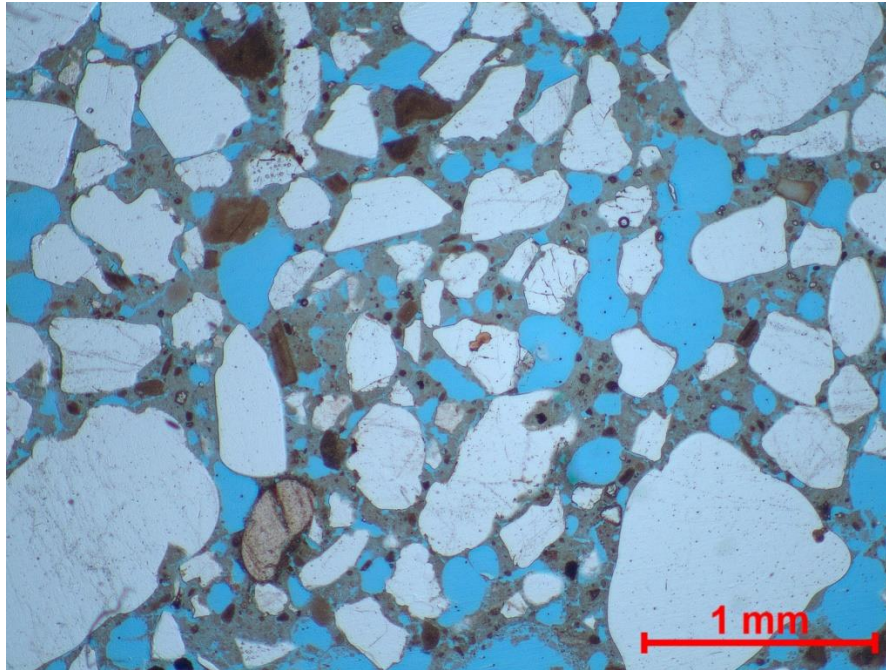
The stucco was non-air-entrained but contained relatively abundant entrapped voids and water voids, measuring at 15.1 percent via the point count method (Table 1). Most voids were irregular, relatively large, uniformly distributed, and essentially free of secondary deposits (Figure 9).

Figure 9. A thin section image of the stucco showing the entrapped air voids (filled with blue epoxy).
