#### HISTORIC AND DESIGN REVIEW COMMISSION

**January 18, 2023**

**HDRC CASE NO:** 2022-527

**ADDRESS:** 108 SCHREINER PLACE

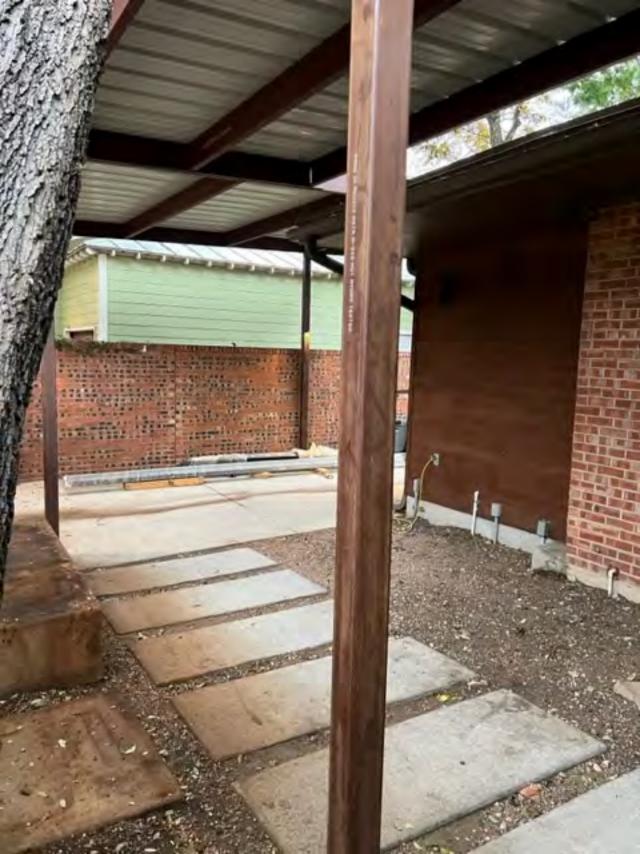
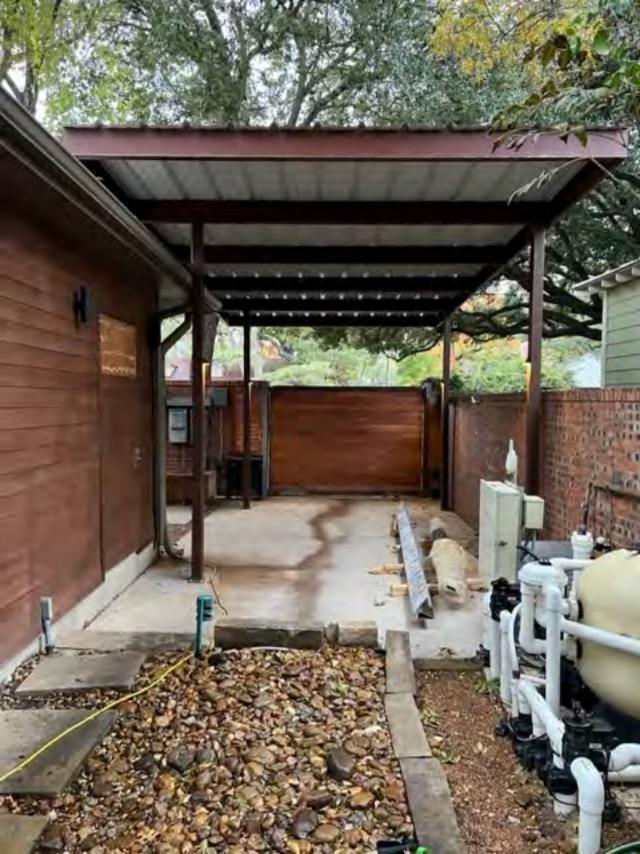
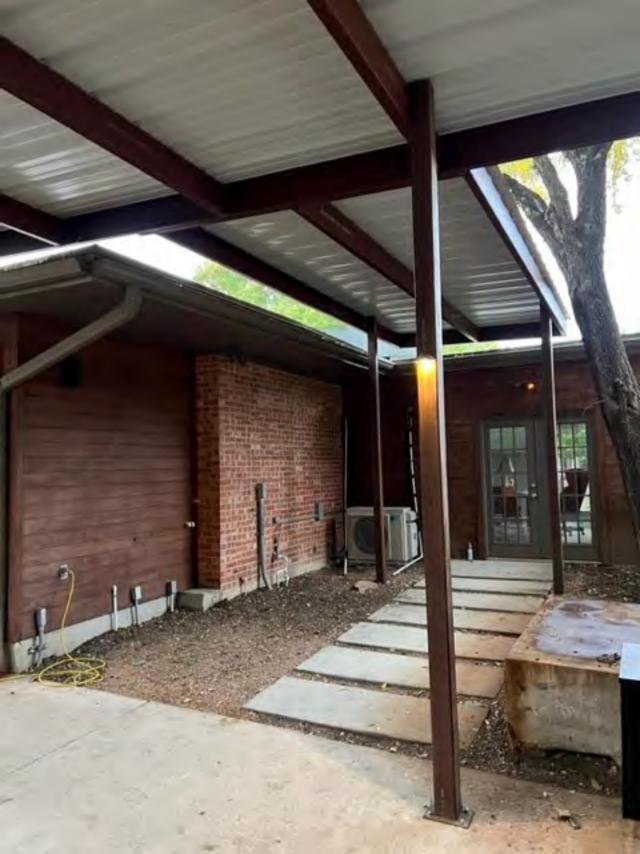
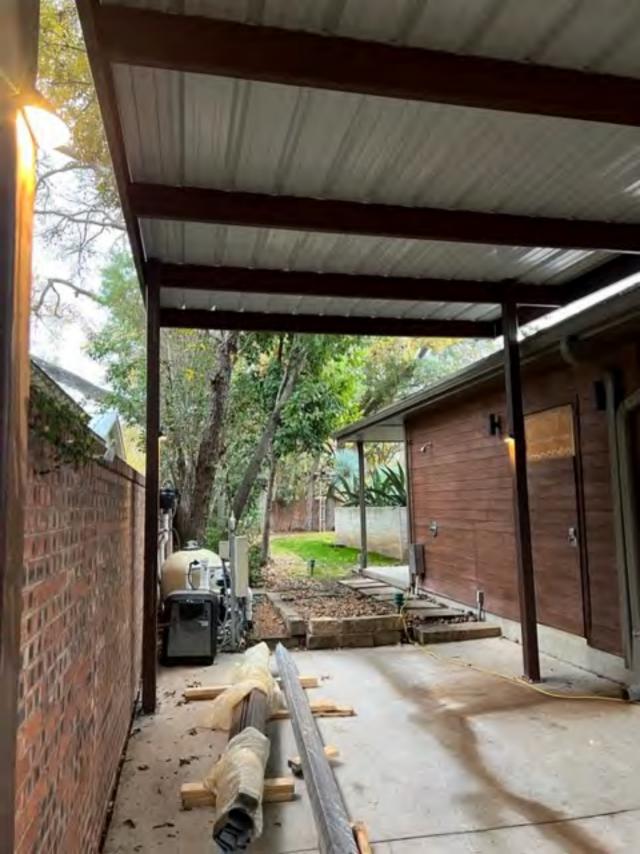
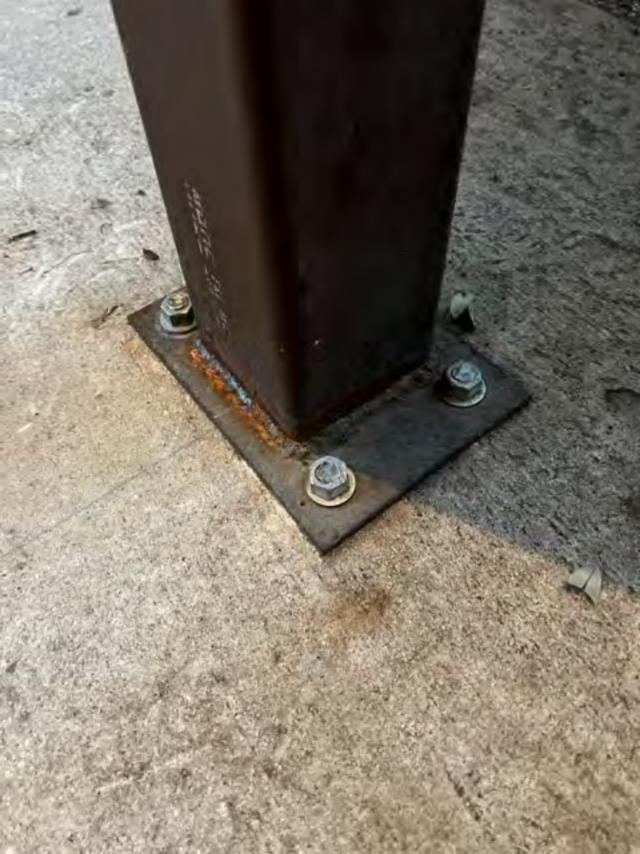
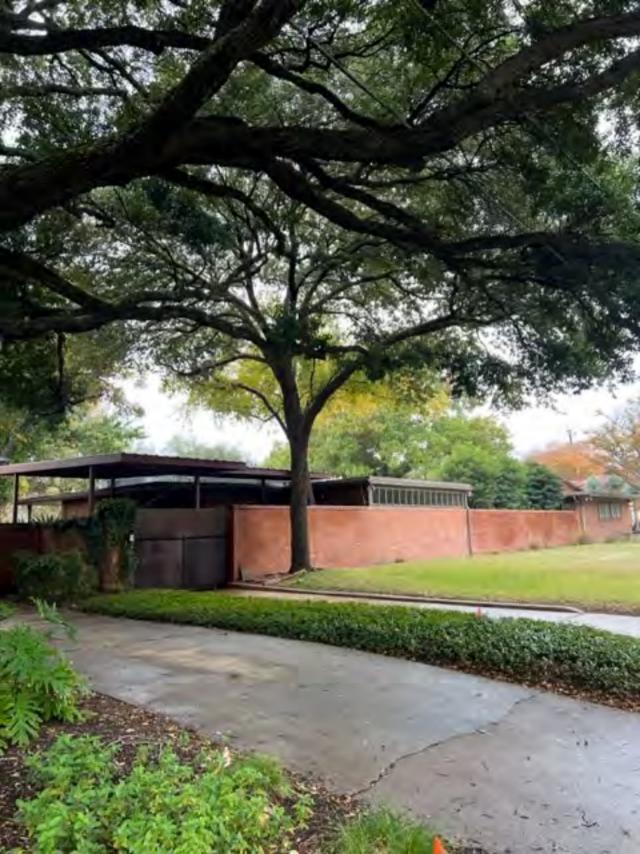
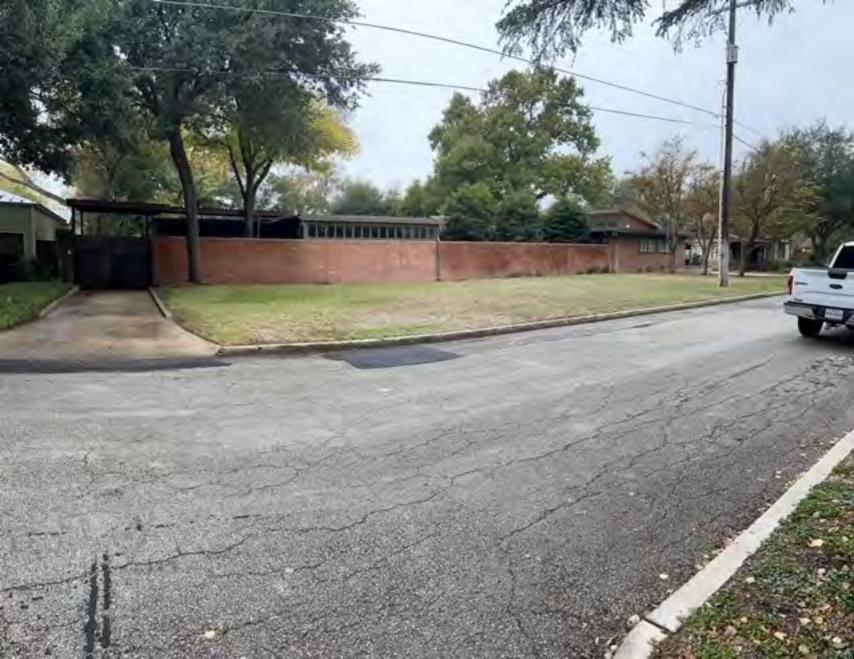
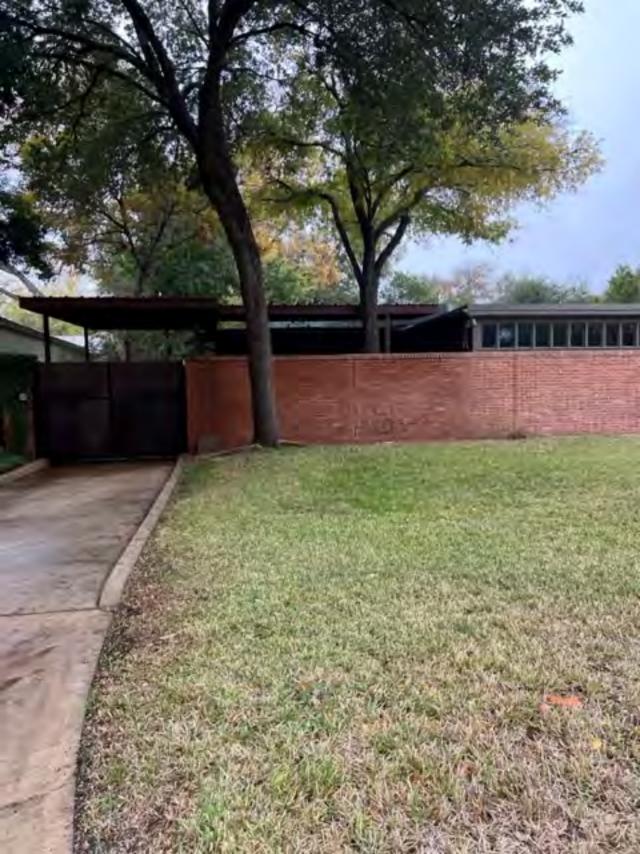
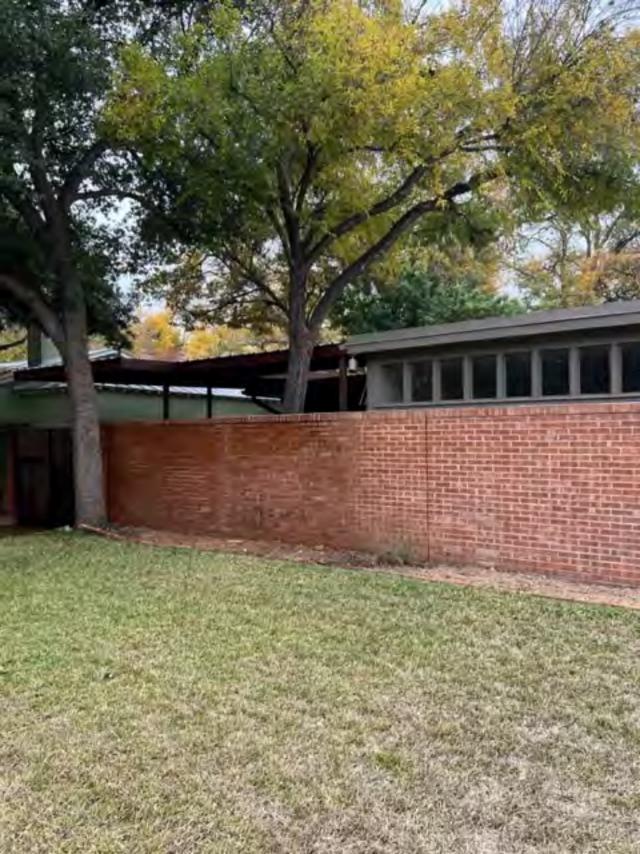
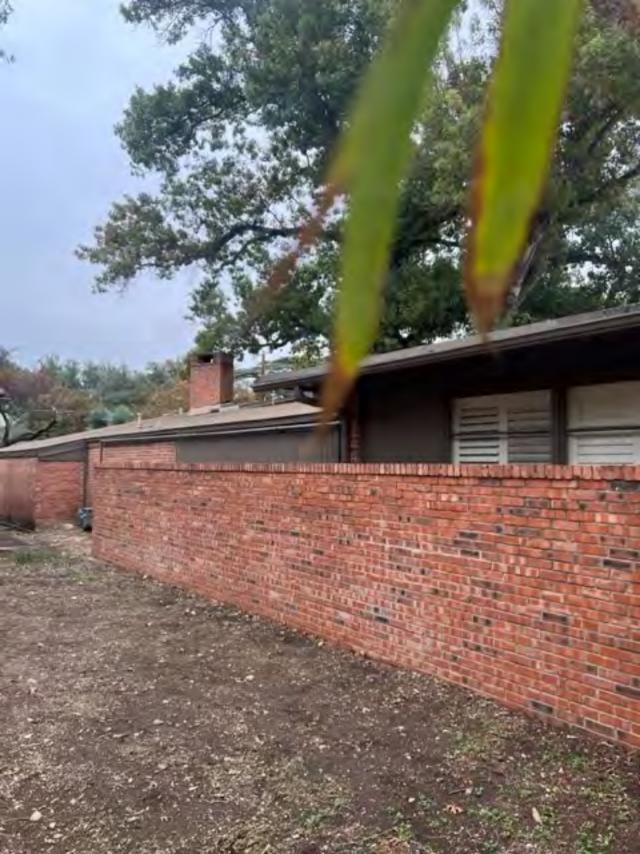
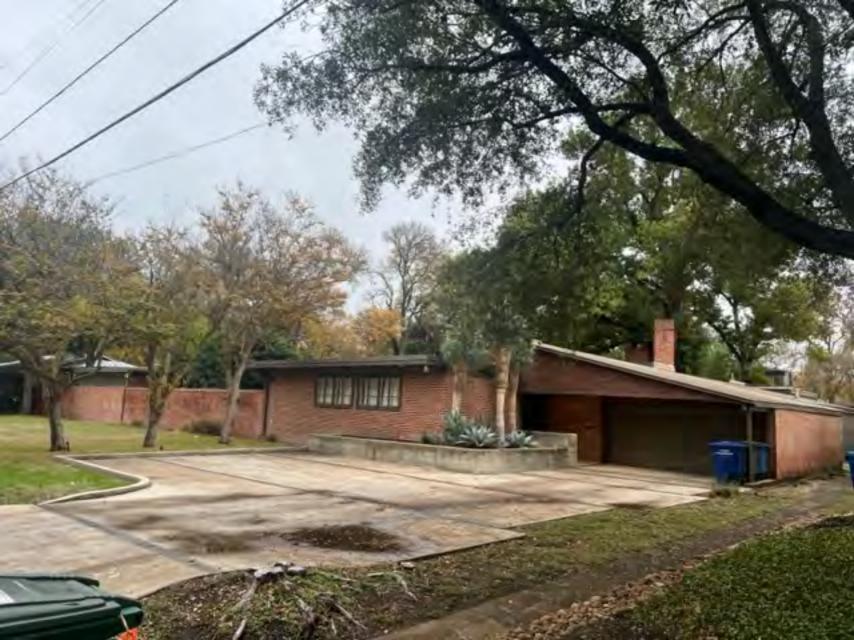
- d. CARPORT (MASSING AND FORM): The applicant installed a detached metal-framed carport with a flat R-panel metal roof on the east side of the property. Though it is detached, the carport is taller than the primary flat roof form and overlaps the east edge of the roof. Historic Design Guidelines for Additions 5.A.i states that new garages and outbuildings should be designed to be visually subordinate to the principal historic structure in terms of their height, massing, and form. Staff finds the carport does not conform to guidelines.

- i. That the applicant proposes a carport with a roof form subordinate to that of the primary structure, specifically one that is shorter than the primary roof.
- ii. That the applicant meets all setback standards as required by city zoning requirements, and obtains a variance from the Board of Adjustment if applicable.

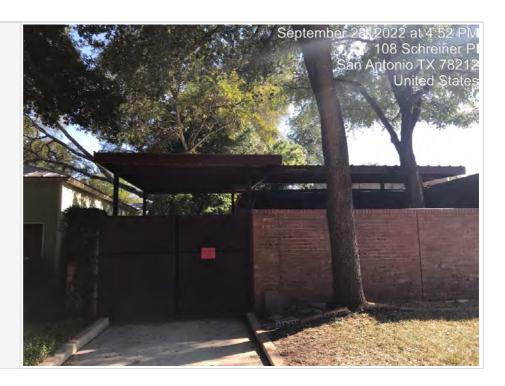
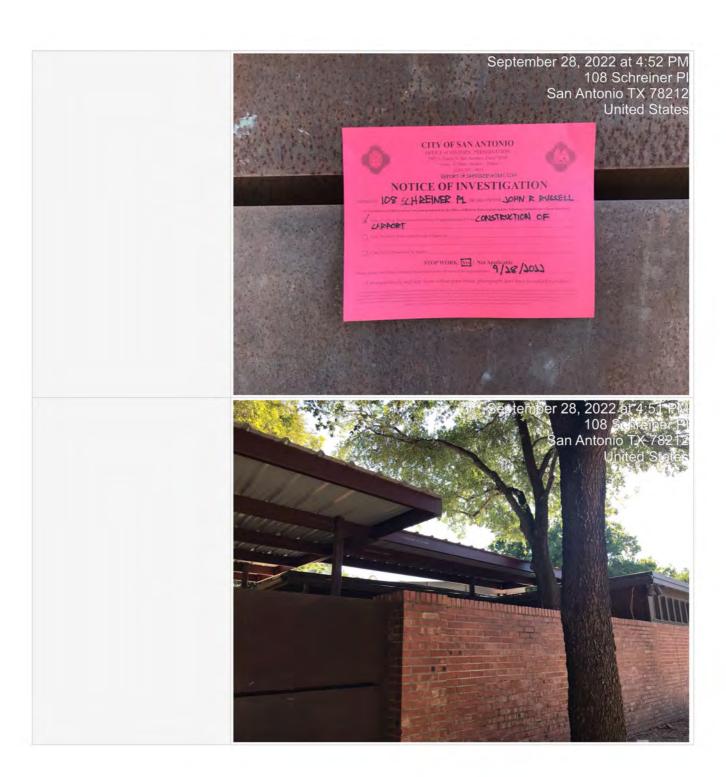
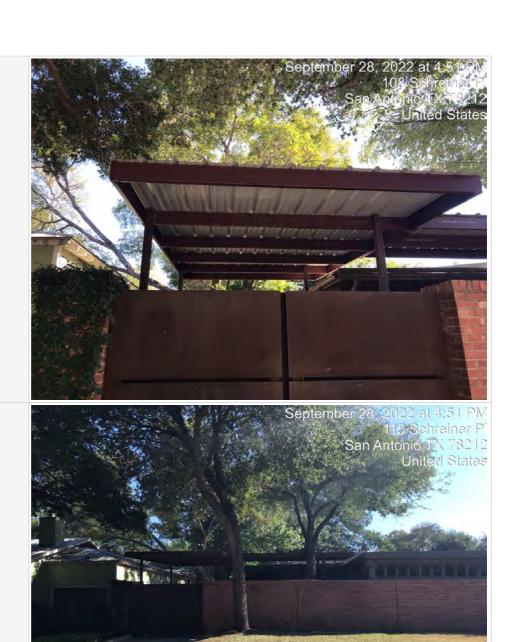
Photographs

Date         09/28/2022           Time         04:52 PM (-5 GMT)	
<b>Time</b> 04:52 PM (-5 GMT)	
Context citizen report	
Present Staff Edward Hall	
Present Individuals None	
Types of Work Observed New Construction	
Amount of Work Completed 75%	
Description of work Construction of a carport structure.	
Description of interaction OHP left a Stop Work Order on site.

Violation Type	No Certificate of Appropriateness (Code 35-451a)
OHP Action	Posted "Notice of Investigation", Posted additional "Stop Work Notice"
Will post-work application fee apply?	To be determined
