HISTORIC AND DESIGN REVIEW COMMISSION

HDRC CASE NO: 2023-106
ADDRESS: 501 E LOCUST
LEGAL DESCRIPTION: NCB 1736 BLK 10 LOT 1
ZONING: MF-33, H
CITY COUNCIL DIST.: 1
HIST. DIST. NAME: Tobin Hill Historic District
APPLICANT: Matthew Carson/Pella South Texas
OWNER: WOHLRABE SHANE & IRENE
TYPE OF WORK: Window replacement
APPLICATION RECEIVED: March 01, 2023
60-DAY REVIEW: Not applicable due to City Council Emergency Orders
CASE MANAGER: Jessica Anderson

The applicant requests a Certificate of Appropriateness for approval to replace 18 one-over-one wood windows with aluminum-clad wood windows.

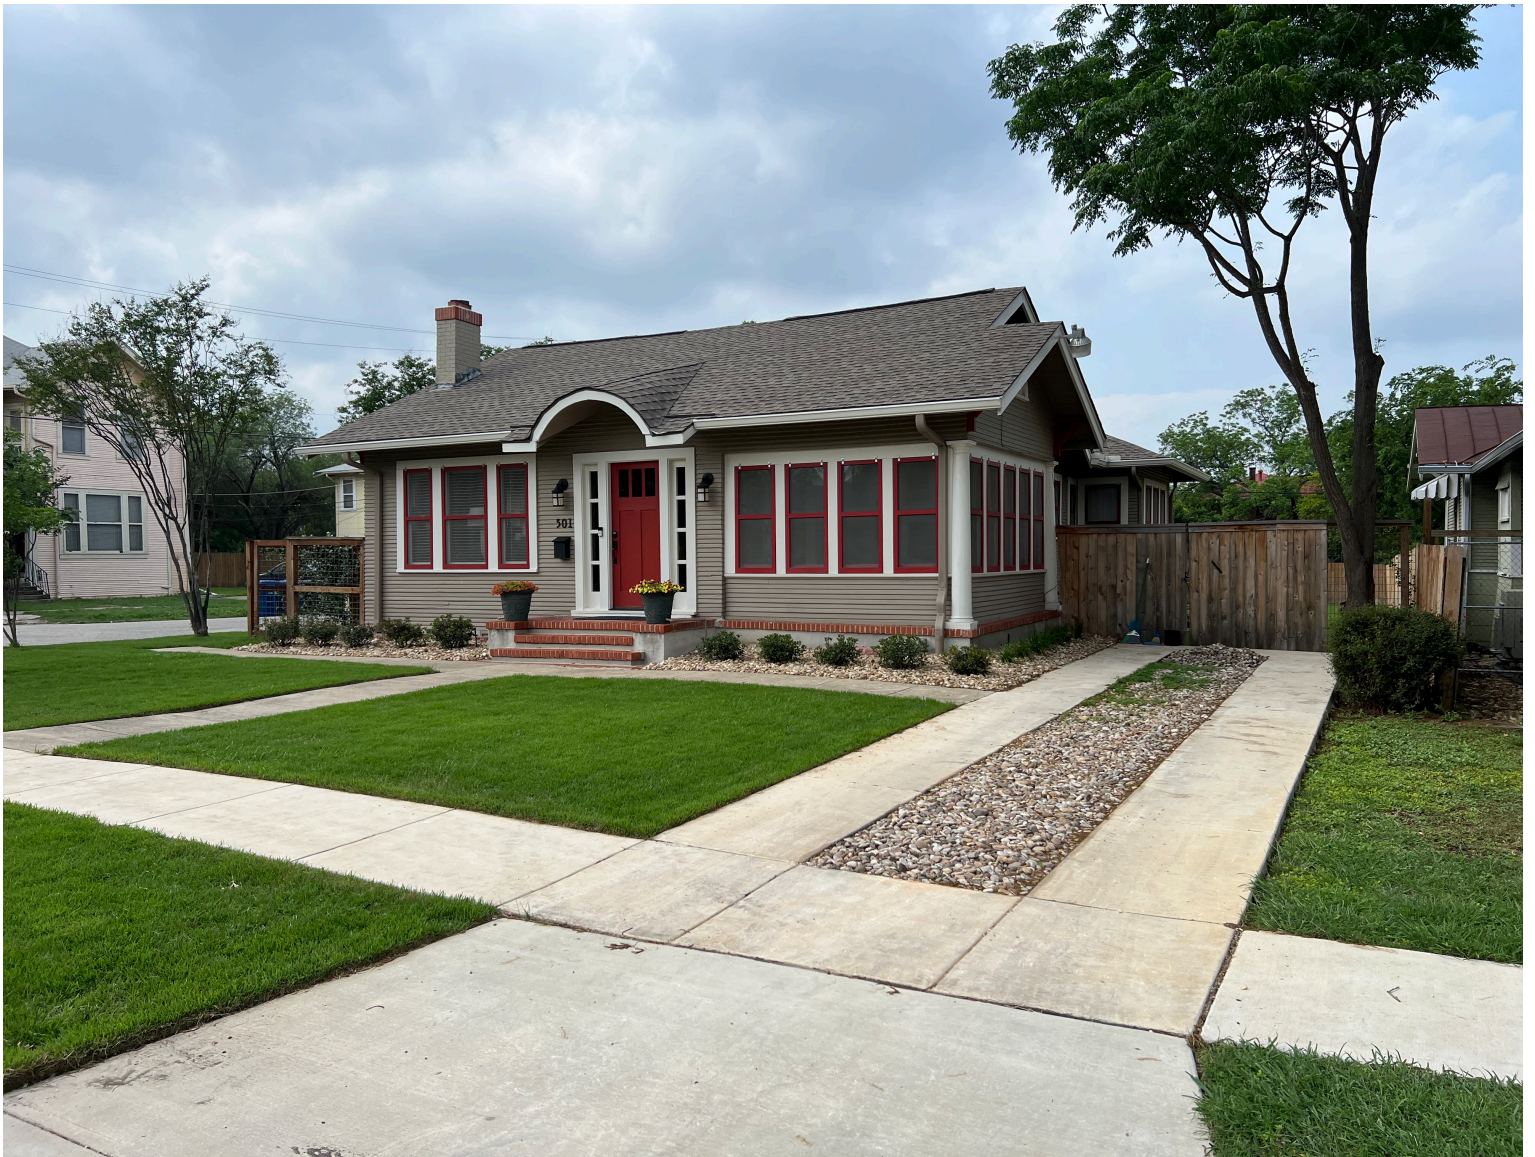
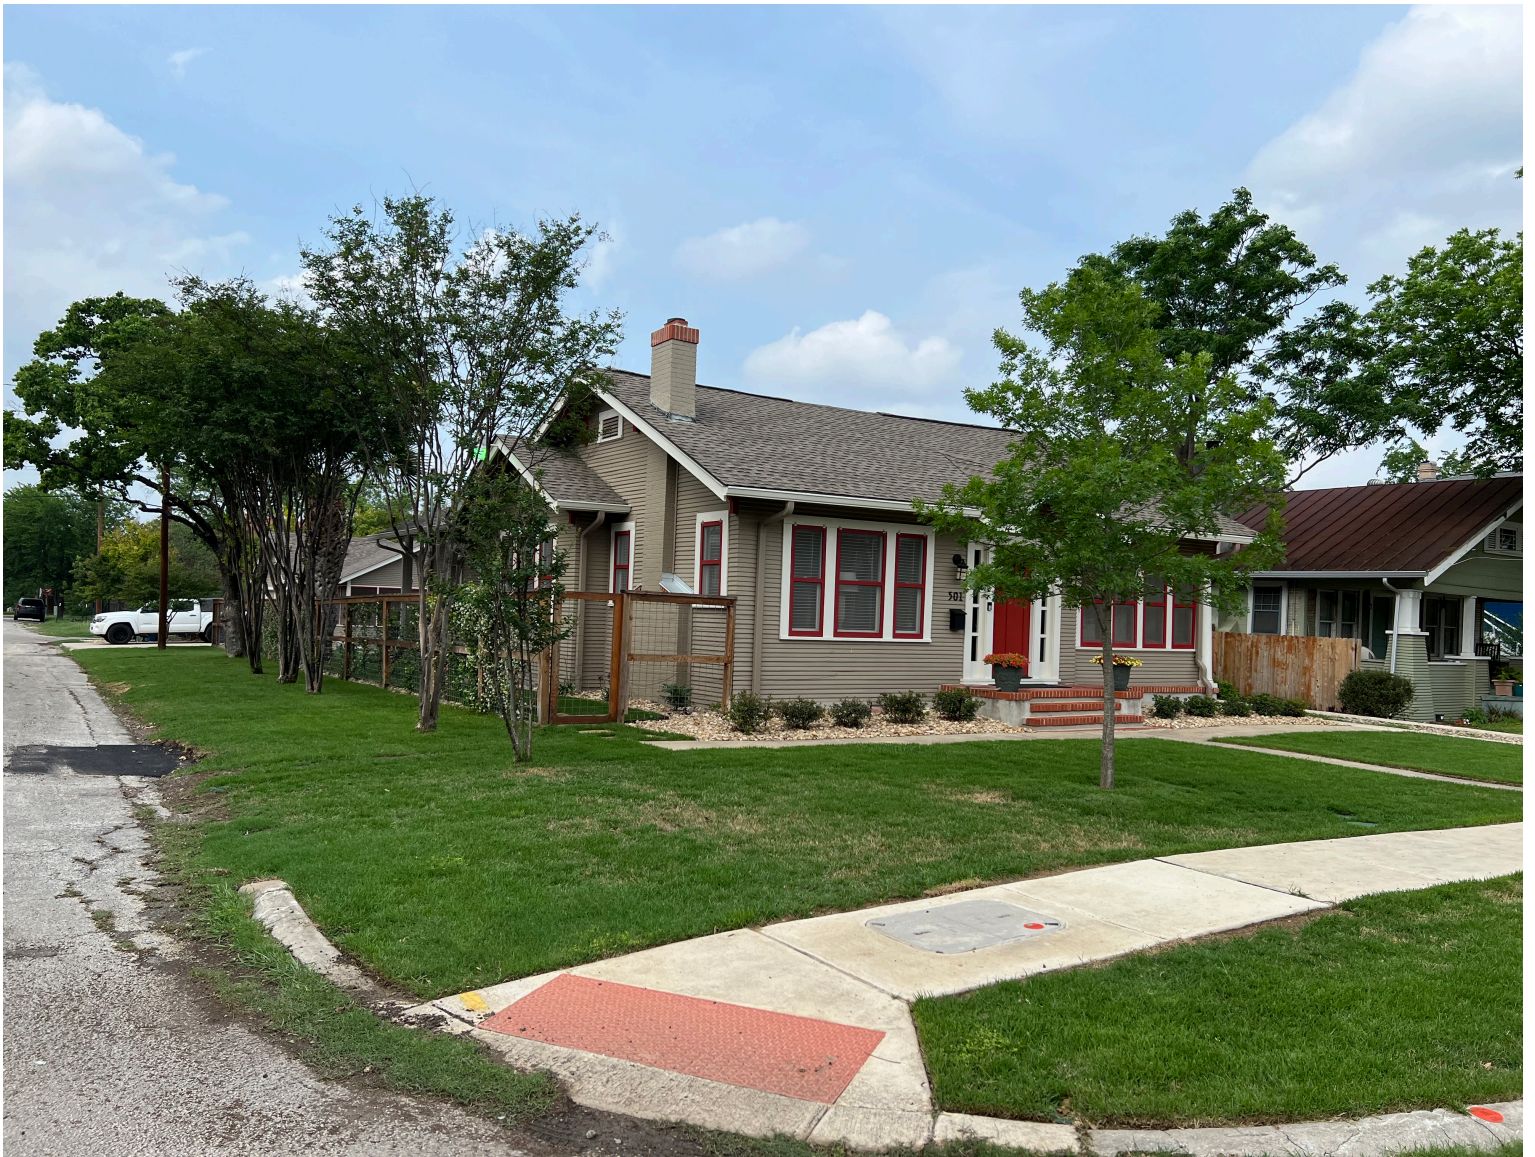
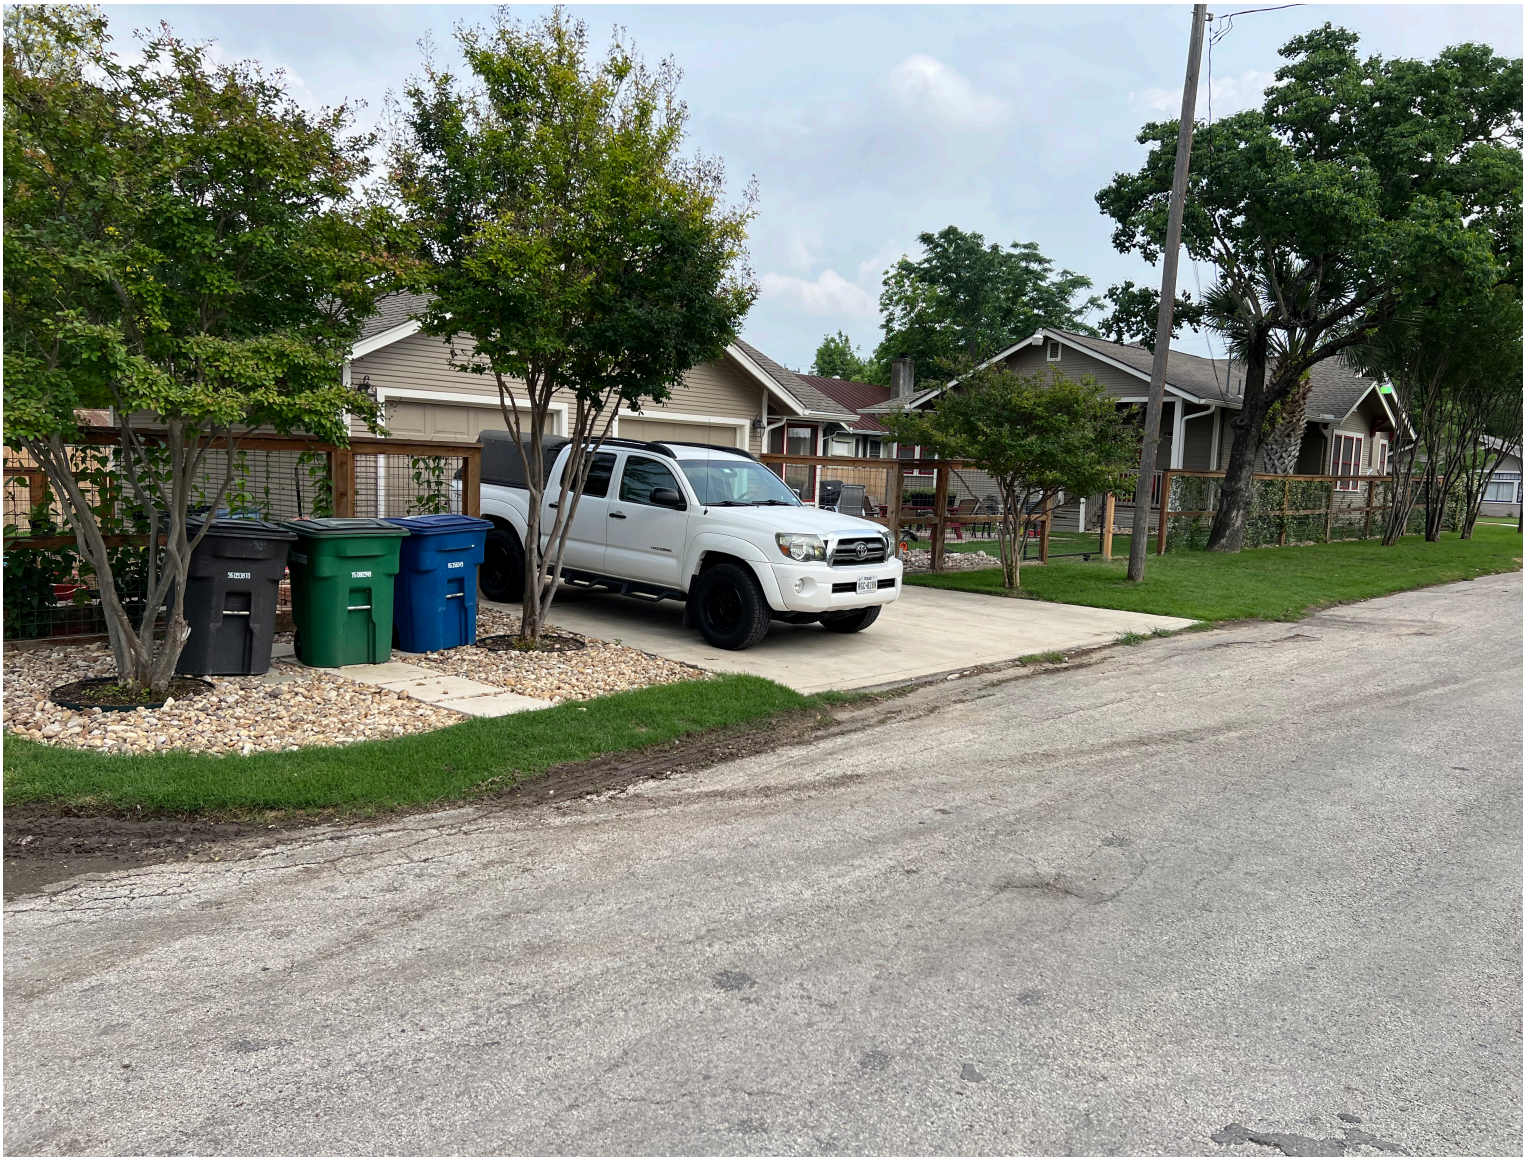
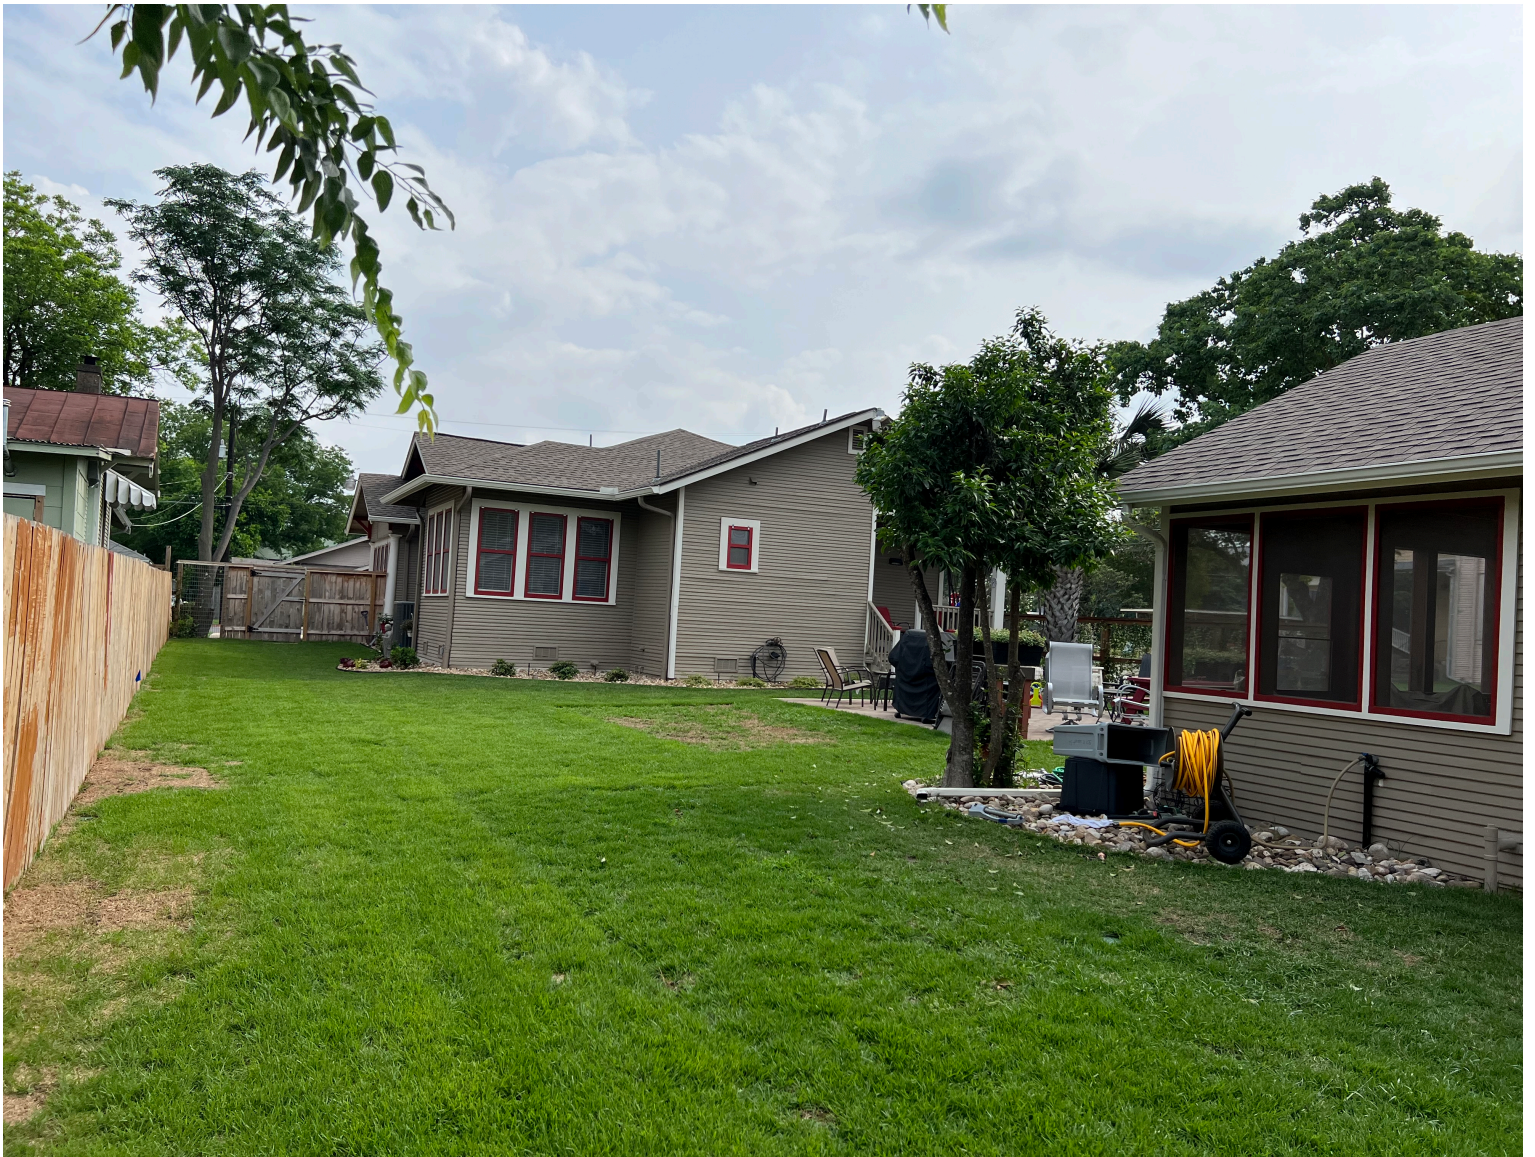
Staff site visit
23 March 2023 9 AM

- b. **WINDOW REPLACEMENT: EXISTING CONDITION:** Staff conducted a site visit on March 24, 2023, to assess the condition of the existing windows and found that all 18 wood windows proposed for replacement are in repairable condition. Most require minimal repair and intervention such as scraping and repainting or replacing damaged sash cords.

Wood windows requested for replacement; all appear in reparable condition.

Staff does not recommend approval based on findings c through f. Staff recommends that all existing wood windows are retained and repaired.

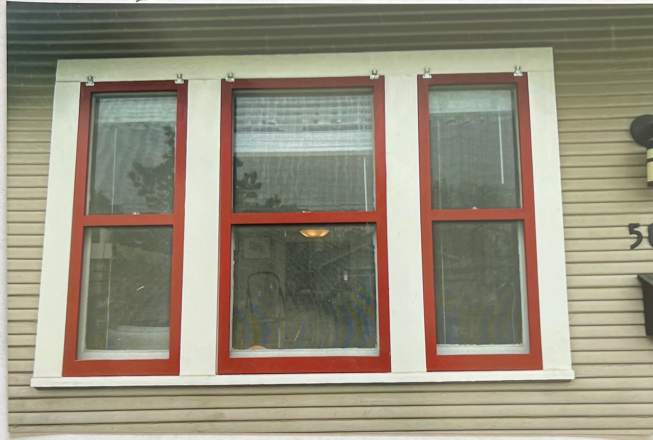
(Exterior)

1-3 will
be replaced

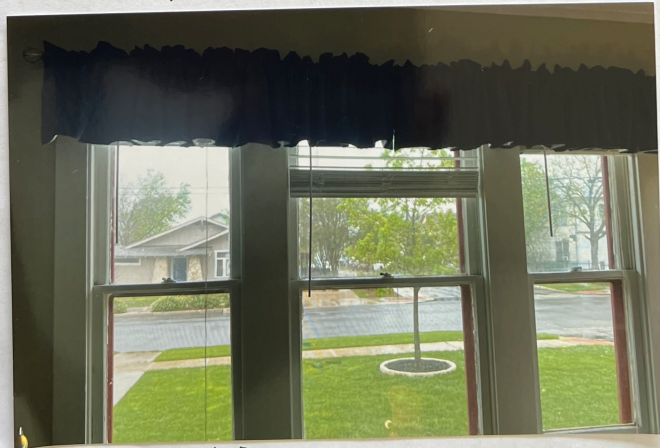
(Interior)

Replacing 1-3

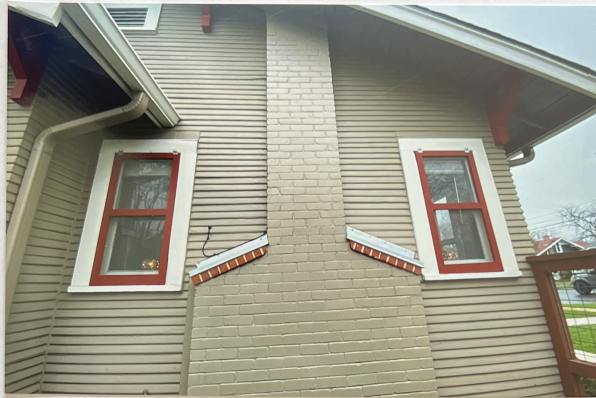
(Exterior)

4-5 will be replaced

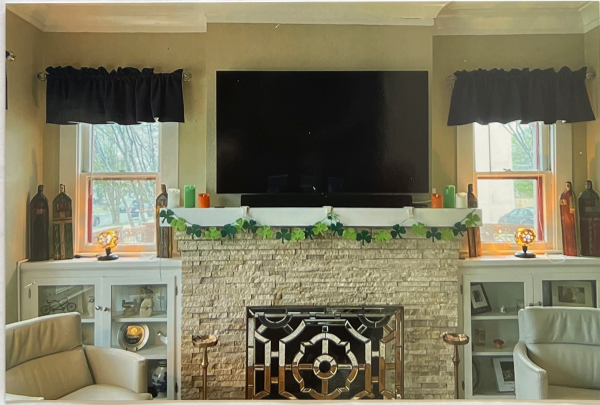
(Interior)

Replacing 4-5

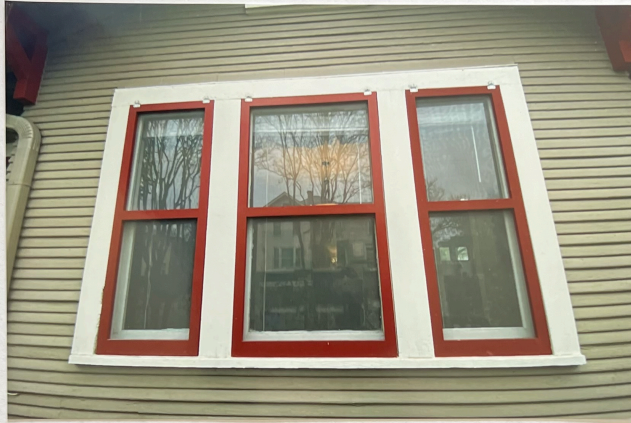
(Exterior)

6-8 will
be replaced

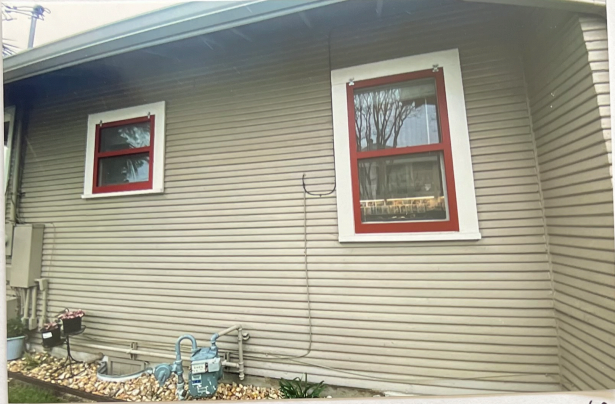
(Exterior)

#9 ~~will~~ will be
replace

#10 will ~~not~~
be replaced

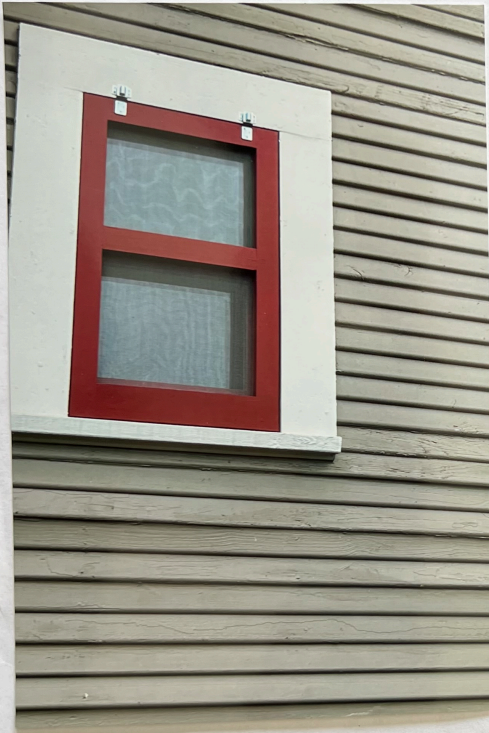
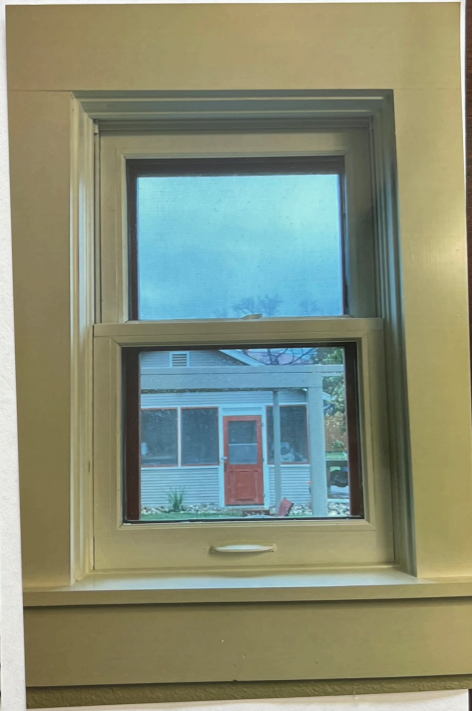
Window #11 will not be replaced

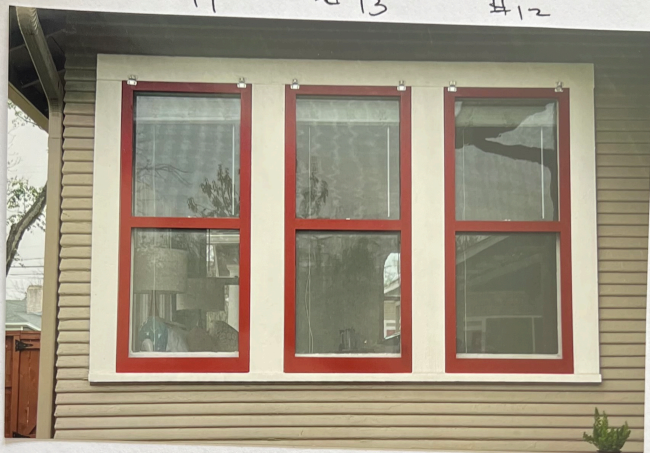
12-14 will
be replaced

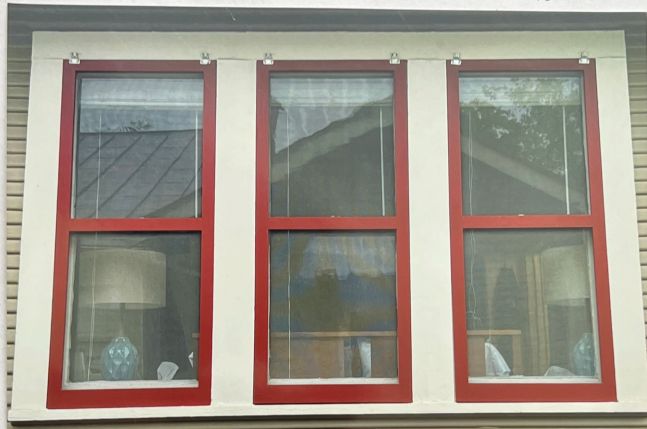
#15-17
will be
replaced

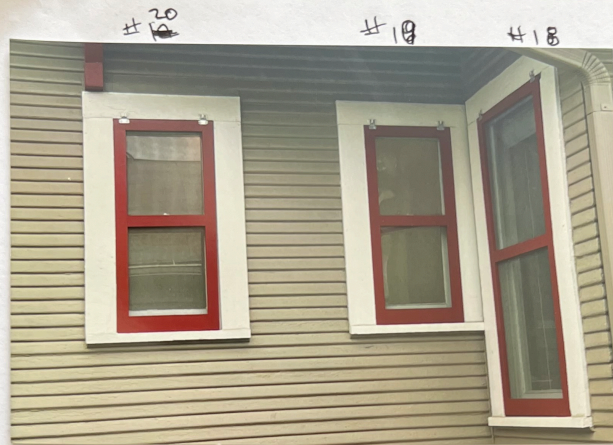
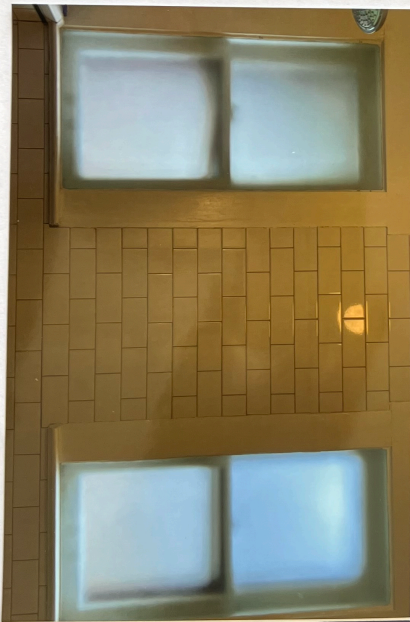
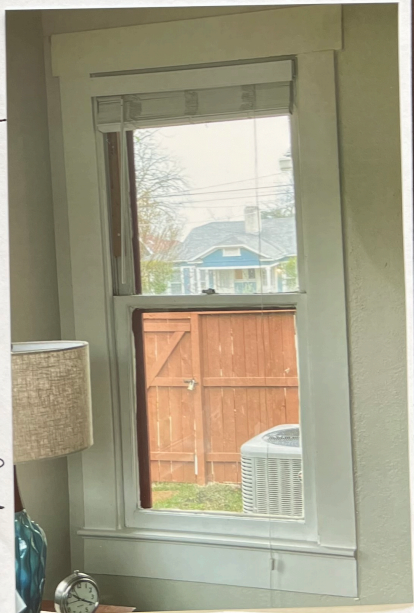
SE Exhaust (3)

#18 will be replaced

#19-20 will not be replaced

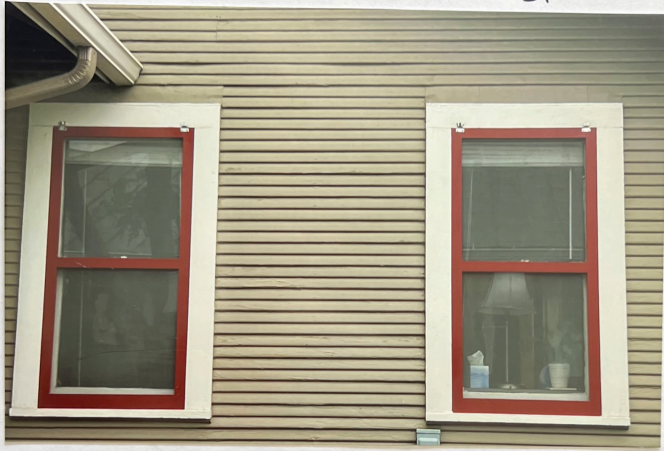
21-22 will
be replaced

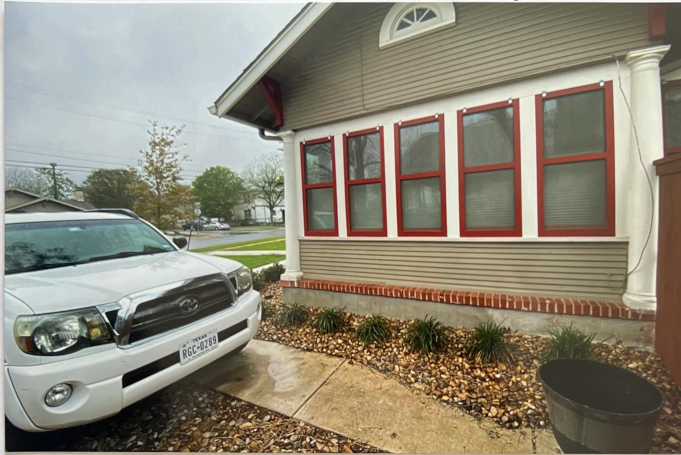
23-27
Will Not
be Replaced

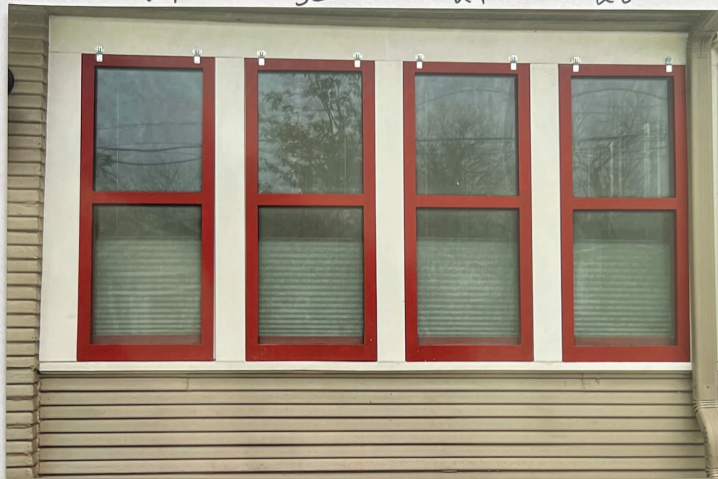
28-31 will
NOT be
replaced
