HISTORIC AND DESIGN REVIEW COMMISSION

May 03, 2023

HDRC CASE NO: 2023-159
ADDRESS: 1402 FULTON AVE
LEGAL DESCRIPTION: NCB 2752 BLK 58 LOT 12
ZONING: R-4, H
CITY COUNCIL DIST.: 1
DISTRICT: Fulton Historic District
APPLICANT: Maria Luisa Cesar & Esnire Abigail Gomez
OWNER: Maria Luisa Cesar & Esnire Abigail Gomez
TYPE OF WORK: Courtyard wall modification & Historic Tax Certification
APPLICATION RECEIVED: April 25, 2023
60-DAY REVIEW: Not applicable due to City Council Emergency Orders
CASE MANAGER: Rachel Rettaliata

Application Materials: Office of Historic Preservation – Complete Plans for Restoration and Rehabilitation for 1402 Fulton Avenue, San Antonio, Texas, 78210

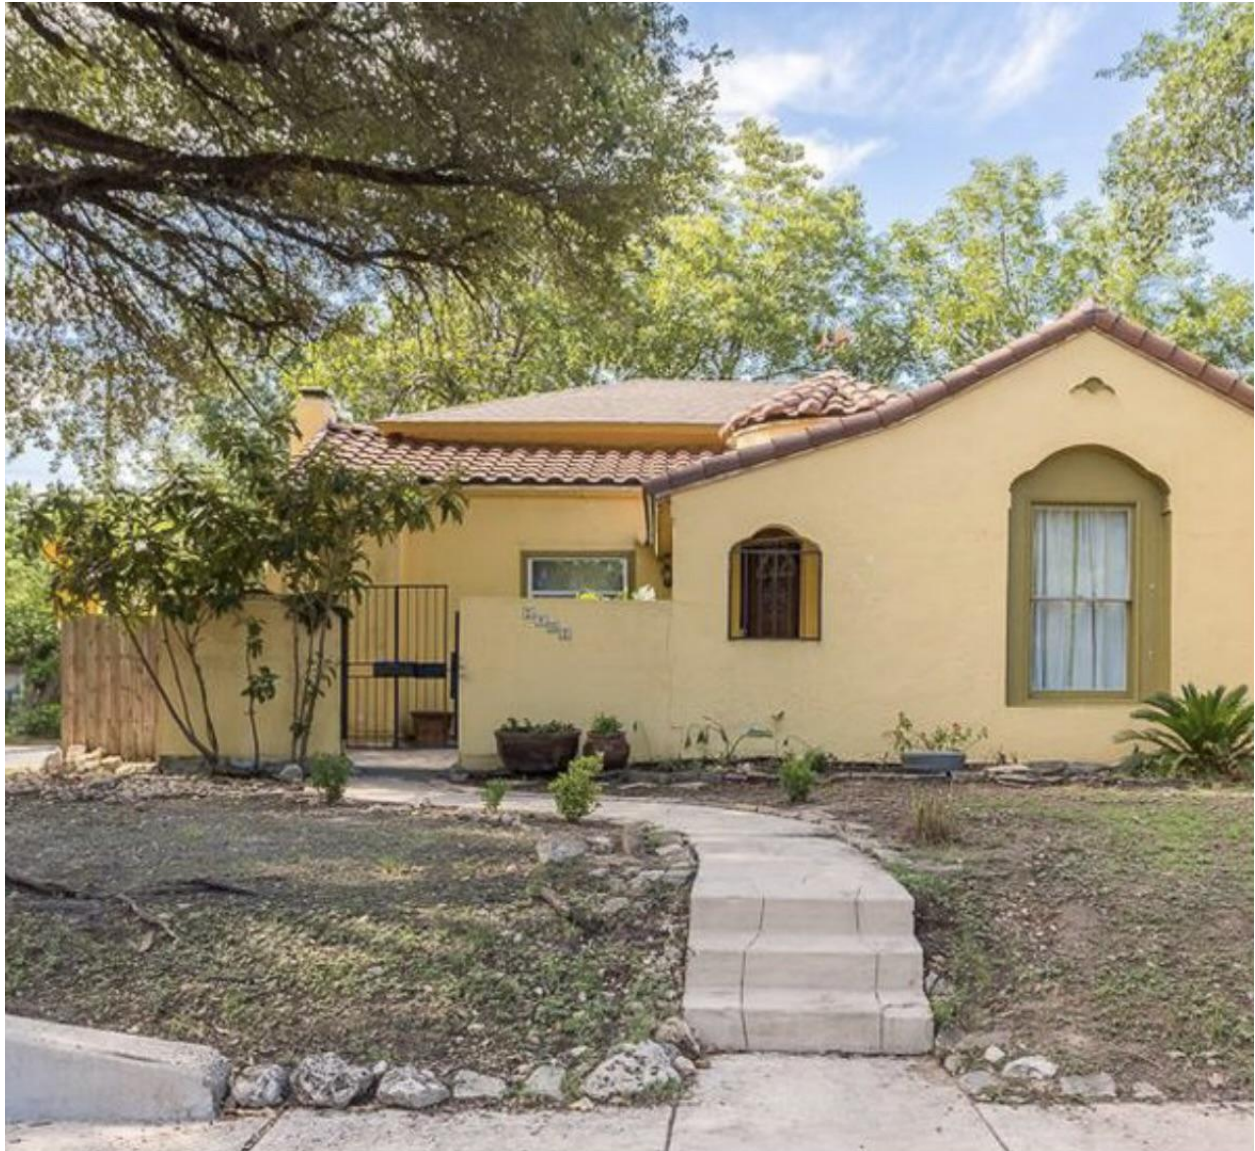
****Important Note:** Although the house purchase listing included the above photo, the house did not have the front gate nor the wall to the right when we bid on and purchased the home.**

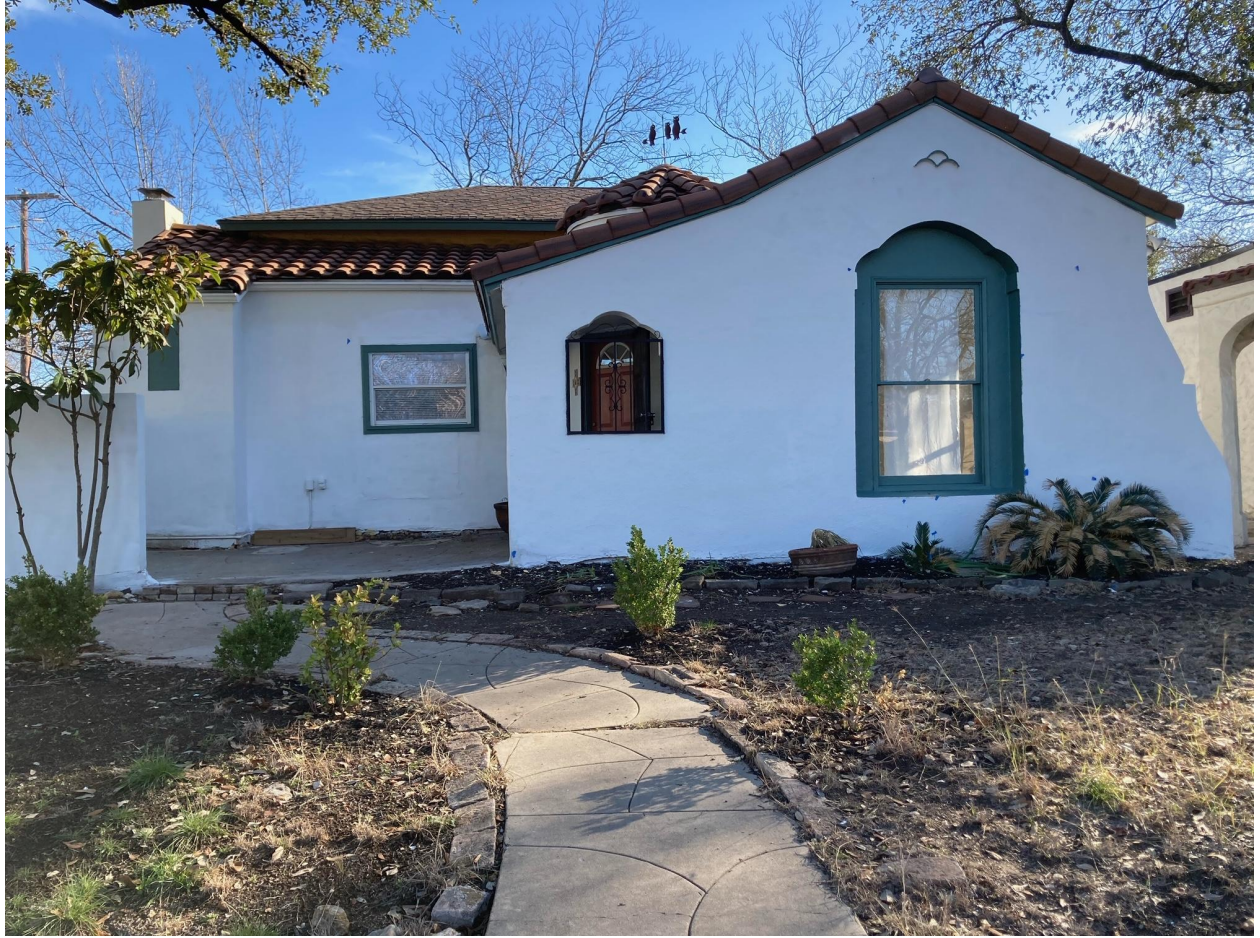
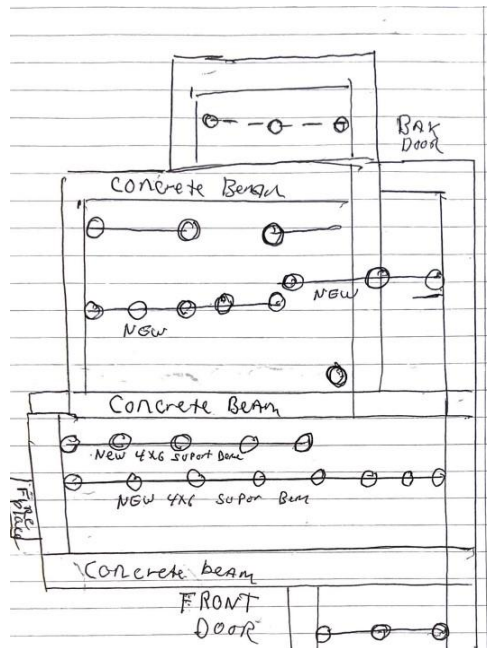
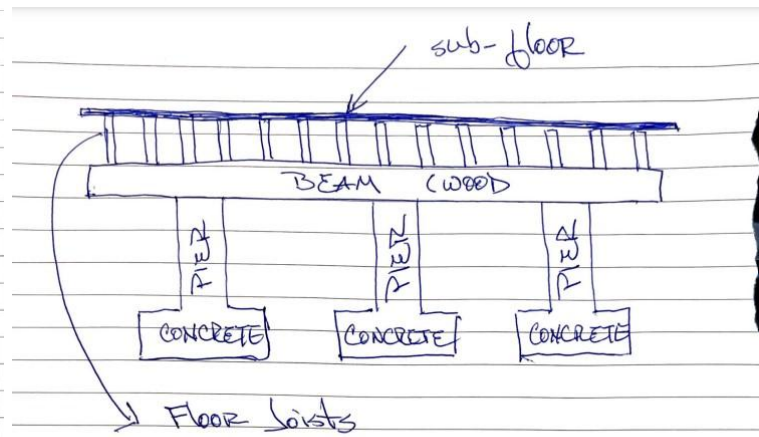
Our contractors removed close to three dozen rotting and termite-bitten pieces of wood logs that were being used to prop up the house! Based on the direction of the structural engineer, our contractors worked to remove the wood pilings, insert new 4X 6 support beams, and pour new concrete floor joists below the subfloor, floor joists. **Cost (labor and materials):**

Work Plan and Solution: Work with a structural engineer to develop a plan to repair foundation by removing rotten wood logs being used to prop up the house, construct support beams, and pour 35 concrete piers underneath sub-flooring. We received a signed engineer report and a 3-year warranty.

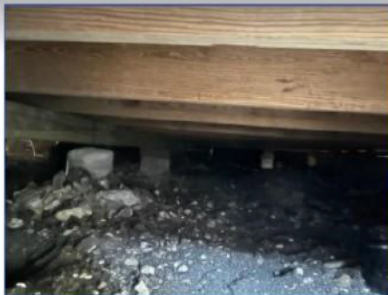
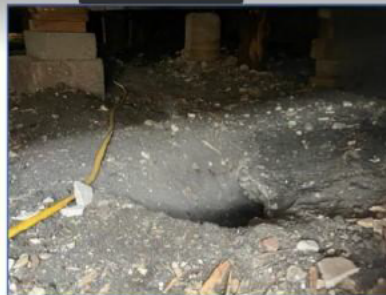
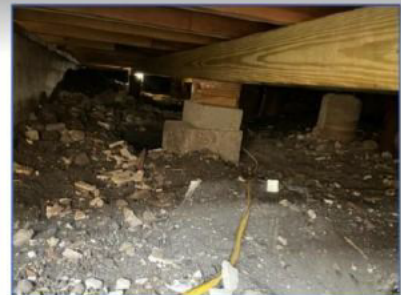
- Elevations were taken on November 4, 2022, and showed higher elevations at the front of the dining and living rooms. Lower elevations were measured at the kitchen interior corner. The elevation change from highest to lowest is 2-1/8 inches (0.18 feet).

- The scope of the foundation repair did not require construction documents. Details and specifications were provided as needed to aid in the construction. New beams and concrete foundation posts were installed.

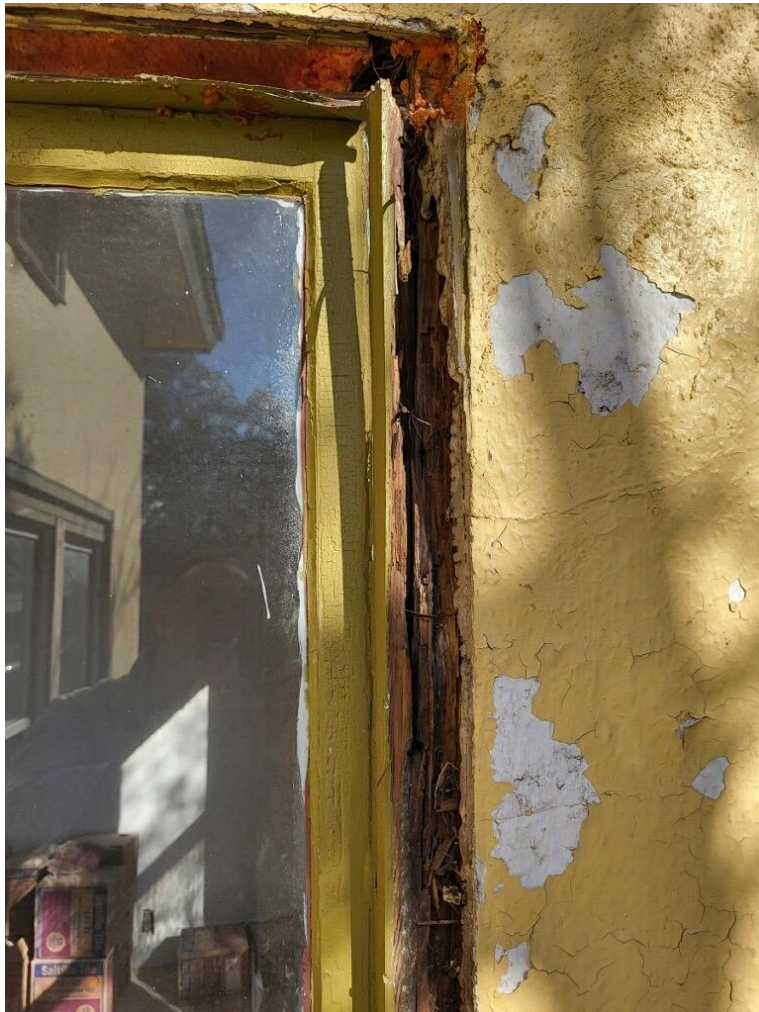
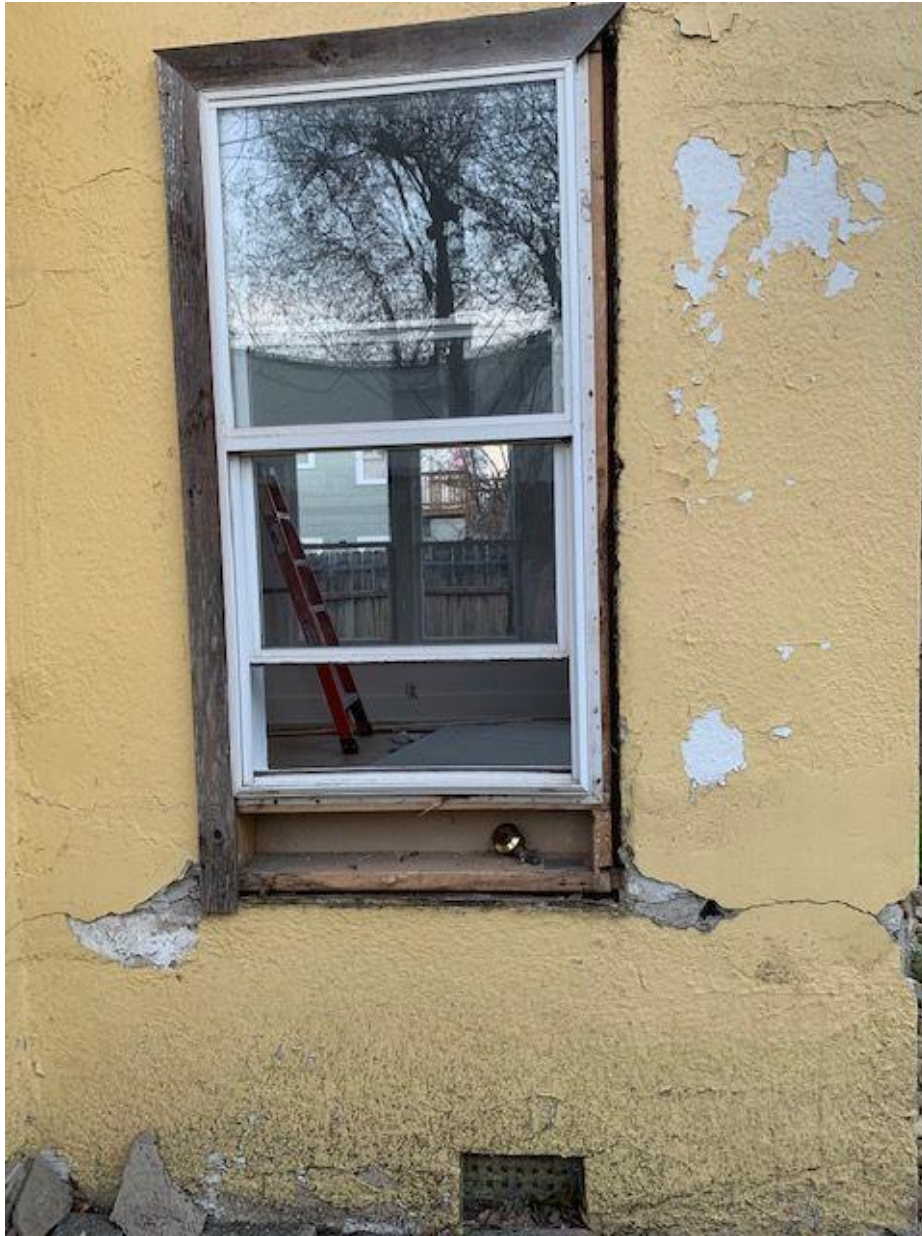
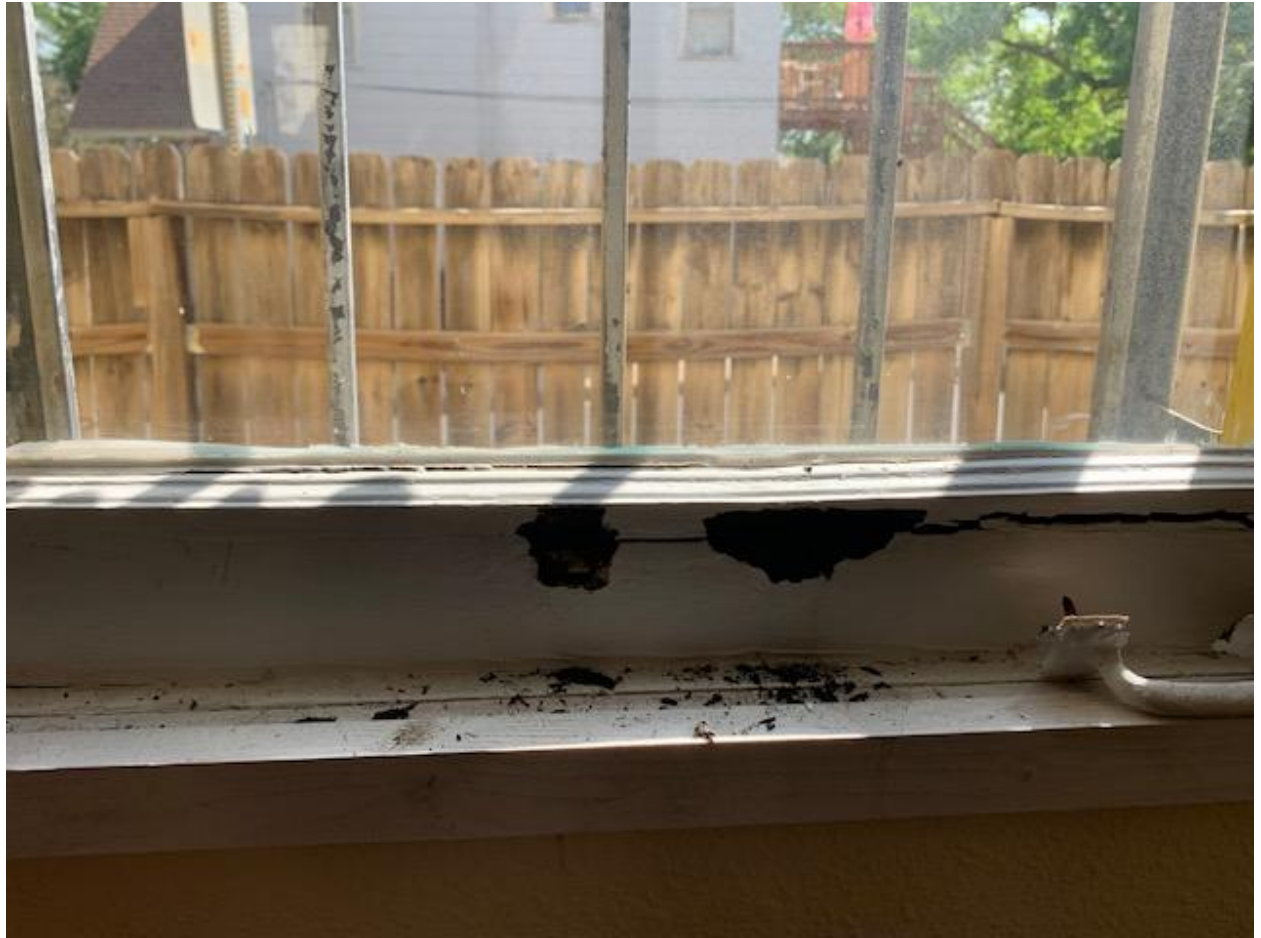
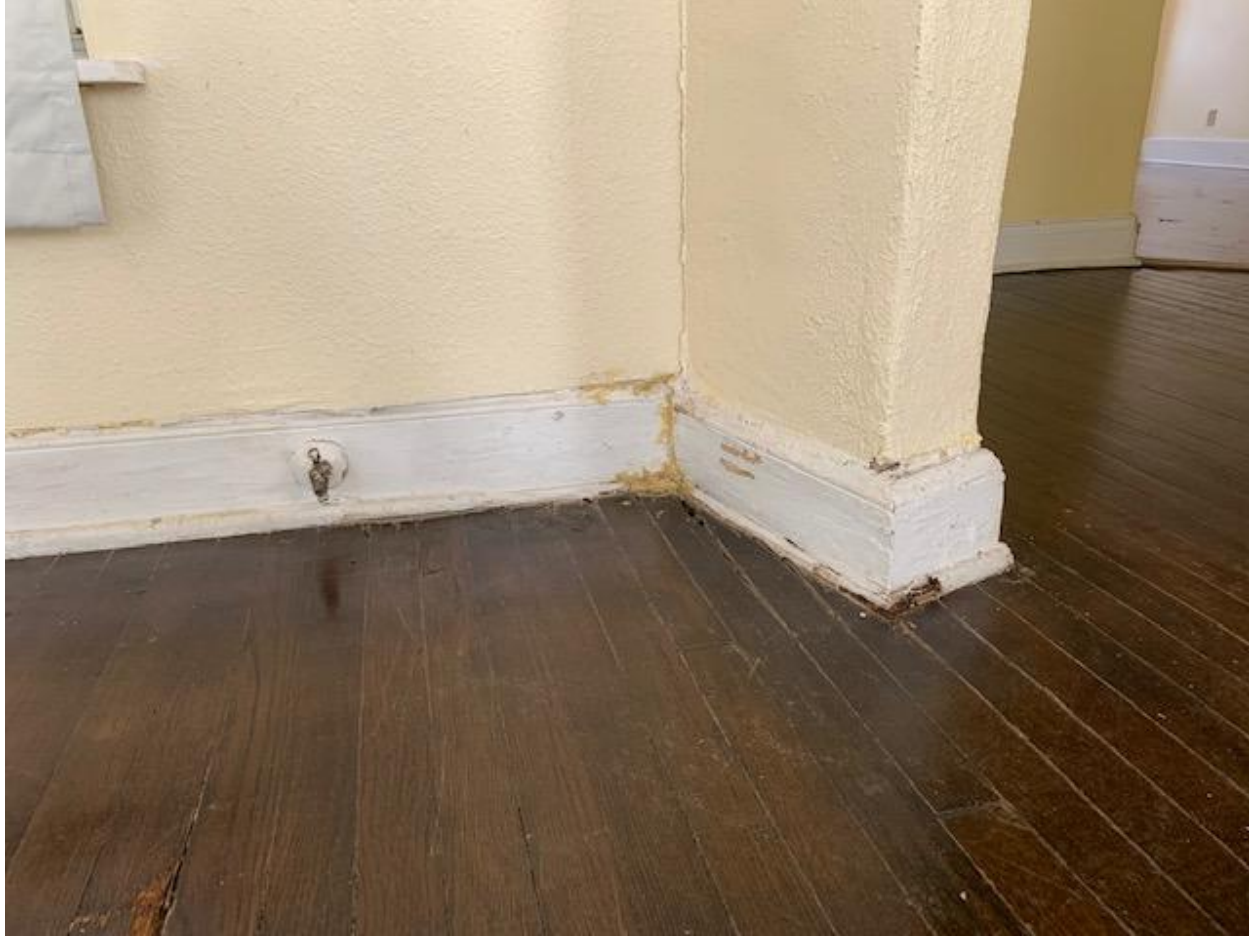
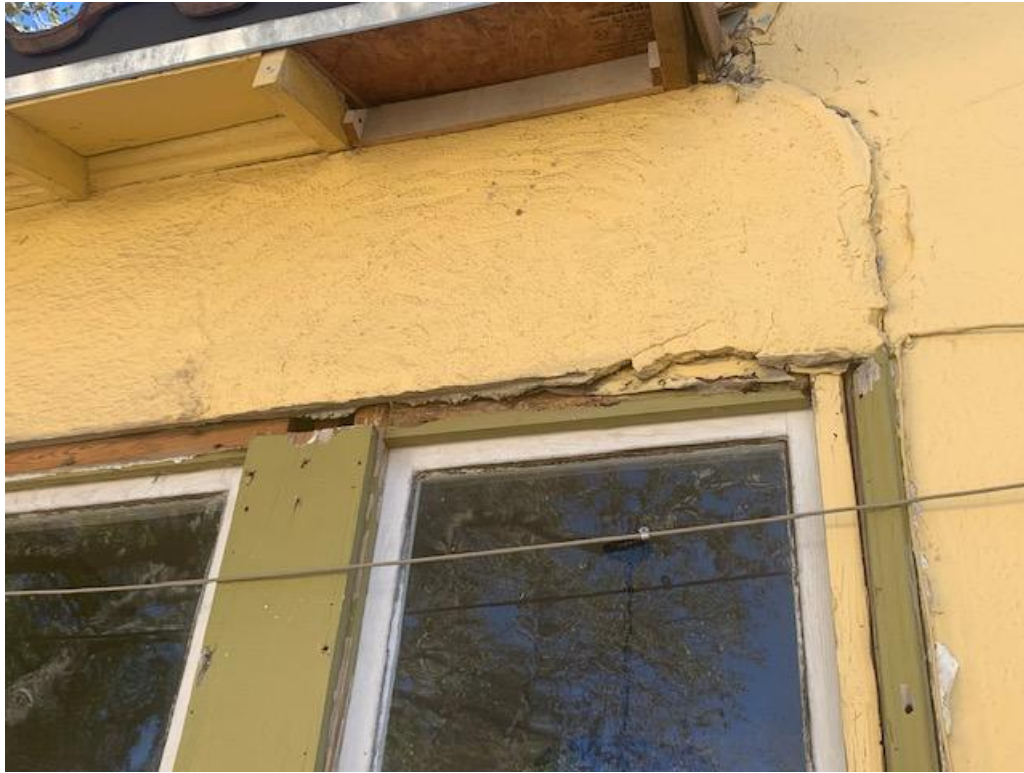
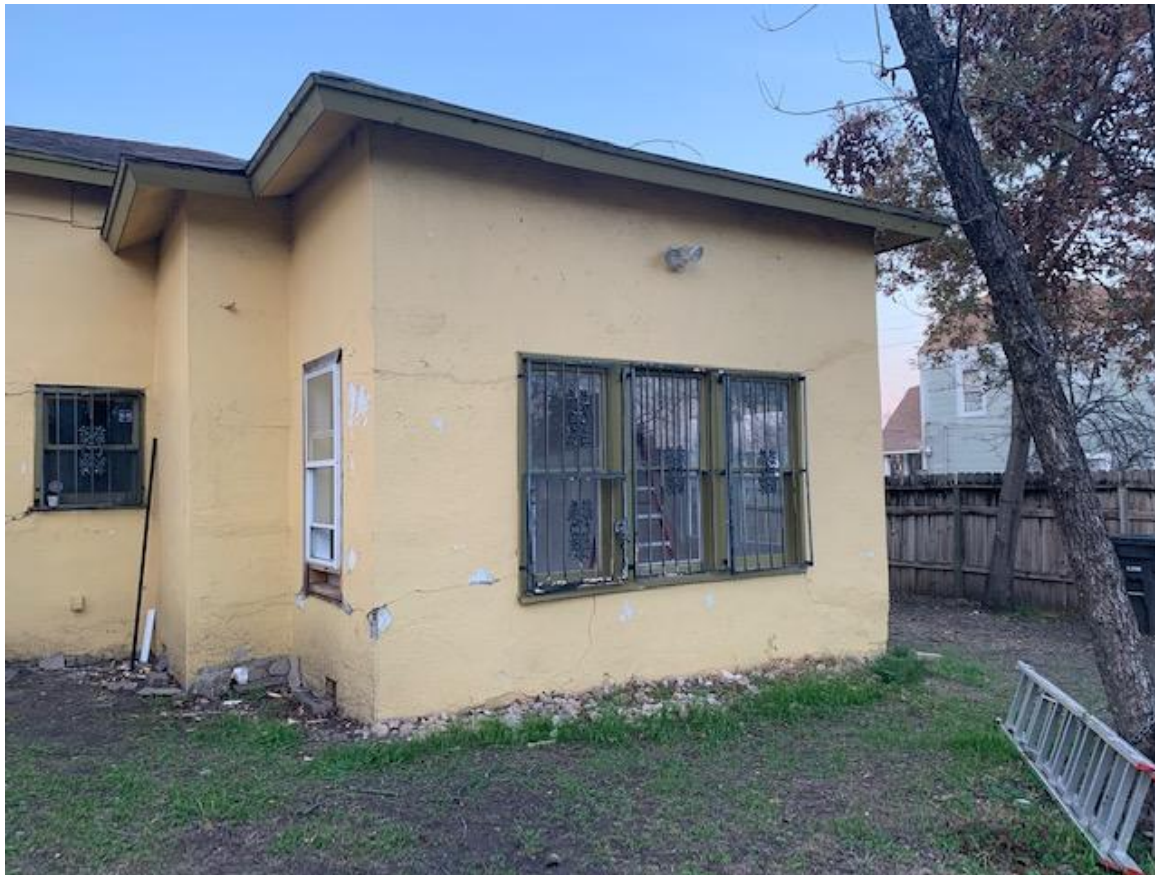
Before and After Photos:

Issue: Exterior and interior cracks, wood rot on exterior windows and exterior paint chipping

Work Plan and Solution: The home had significant fractures on exterior walls that gave us structural concerns as the stucco had detached itself from the wood beams that made up the house frame. We also realized that significant wood rot across the window trim was keeping the house from being insulated from the elements and properly weatherized. Working with our contractor and his team, we sketched out a plan to repair and restore the exterior stucco, remove areas of wood rot along the window trim and replace with new wood and add sealant to ensure we were “drying” the home and protecting it from the elements. We also decided to repair all interior cracks that existed when we purchased the home and those that formed as the house settled after the foundation work. Our contractor and his team repaired shoddy interior

trim work, and added wood trim to the house where previous patchwork had failed to produce standard, up-to-code work. These repairs added structural security and insulation to the home while also restoring it. Our contracting team also took this opportunity to replace the door leading to the exterior of the house. They also repaired rotting wood trim on the interior of the house and repaired windows in each room, ensuring that at least one window in each room was functional for egress, per code and safety standards. To complete the work, we worked with our contractor to ensure that the paint we selected was approved by the Office of Historic Preservation, a task he completed on our behalf. Lastly, our contractor and his team repaired areas of the interior trim and baseboard that were damaged.

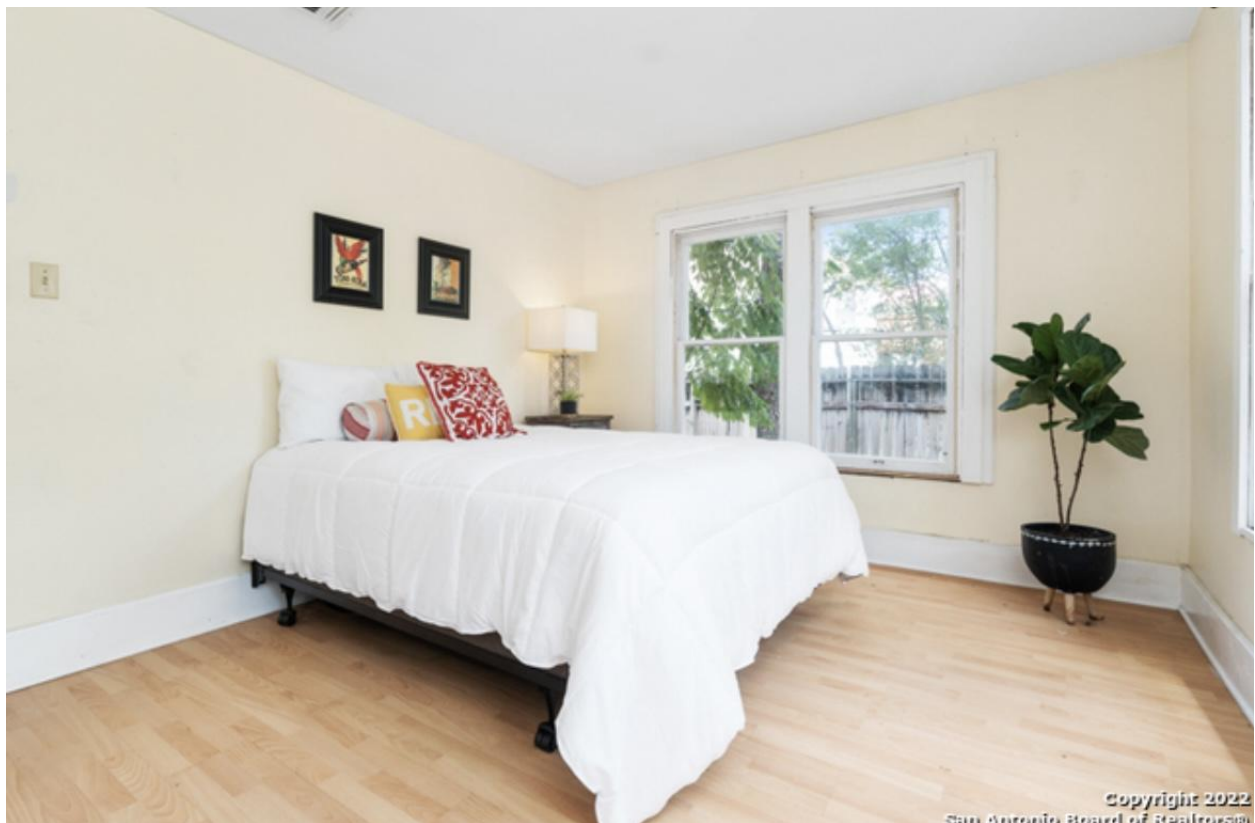
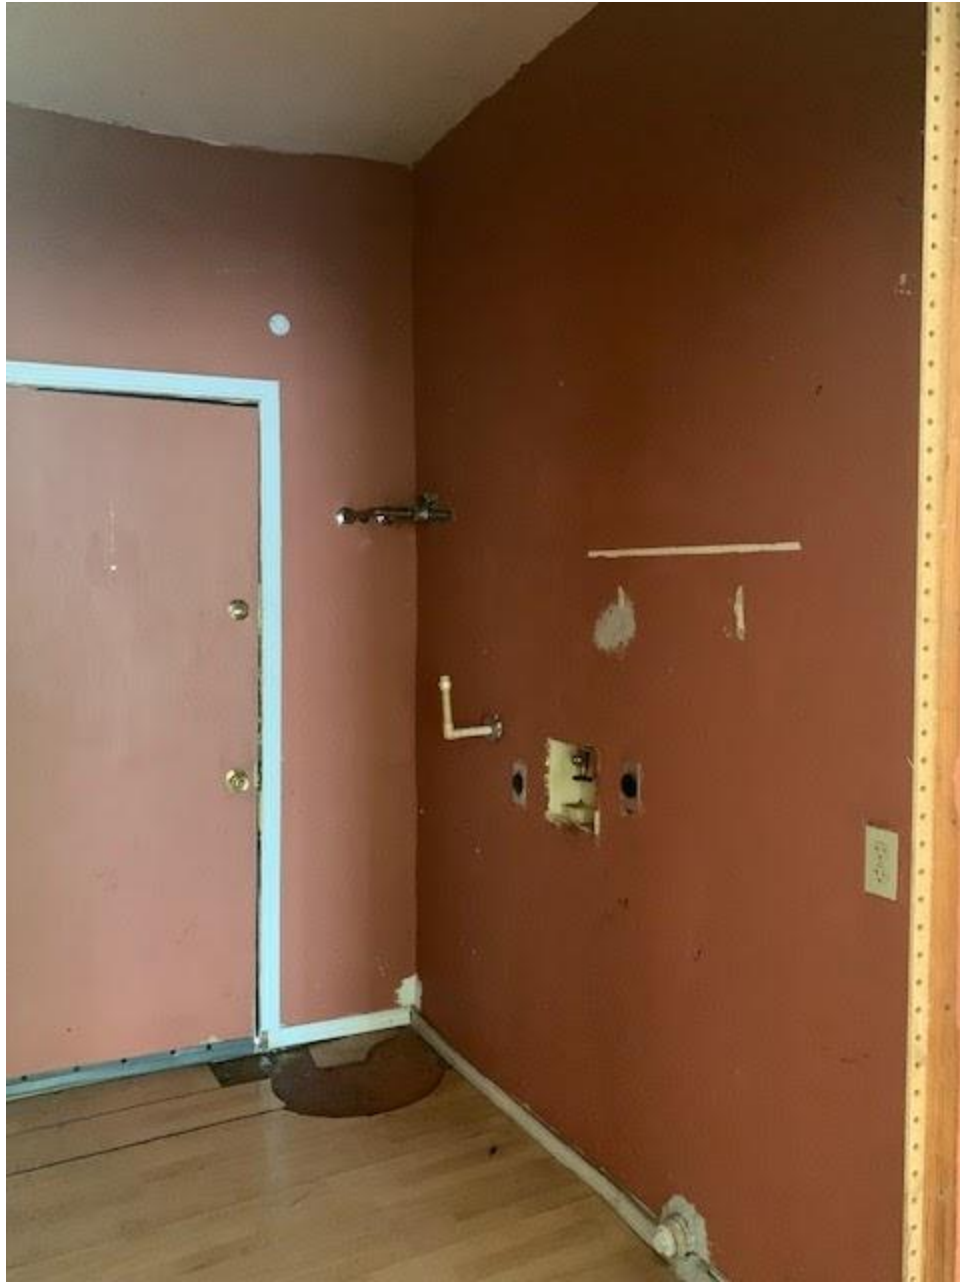
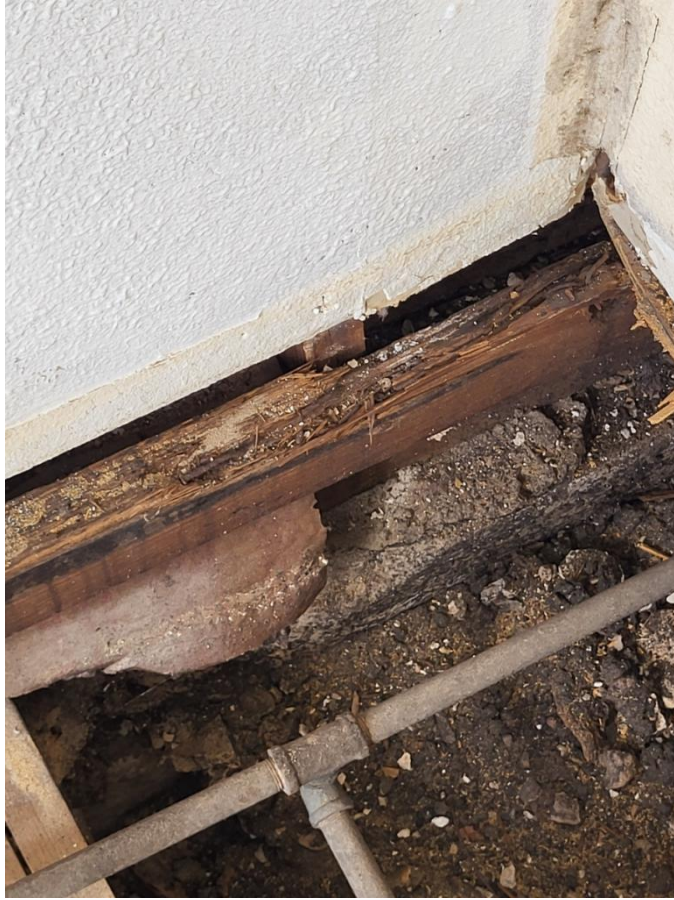
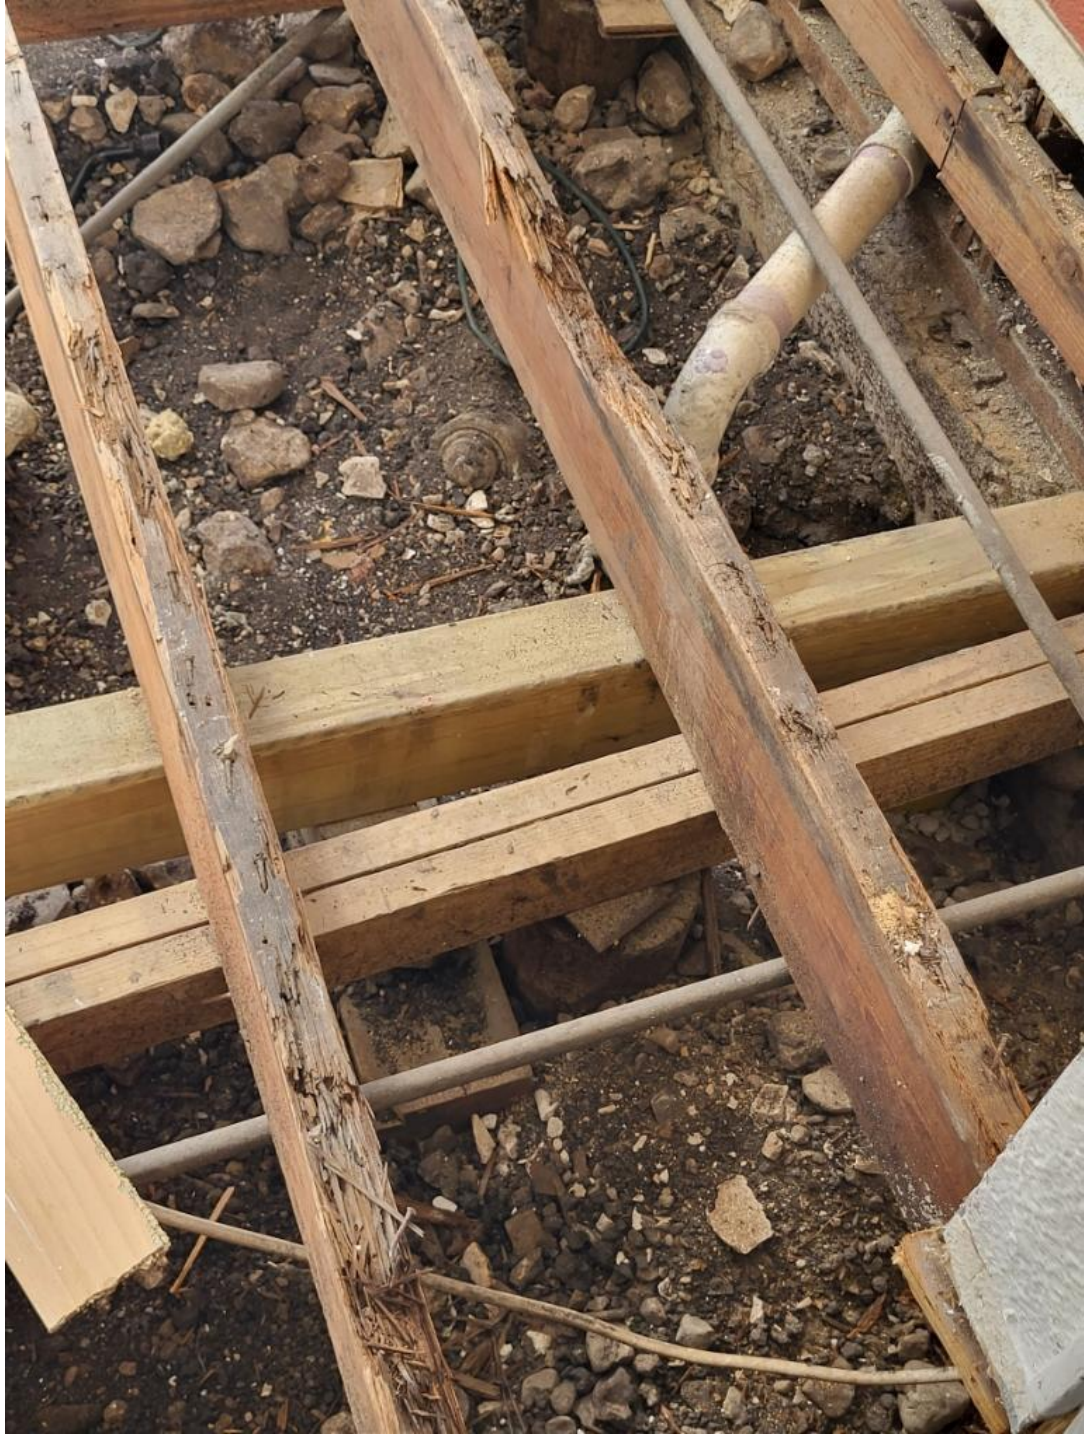
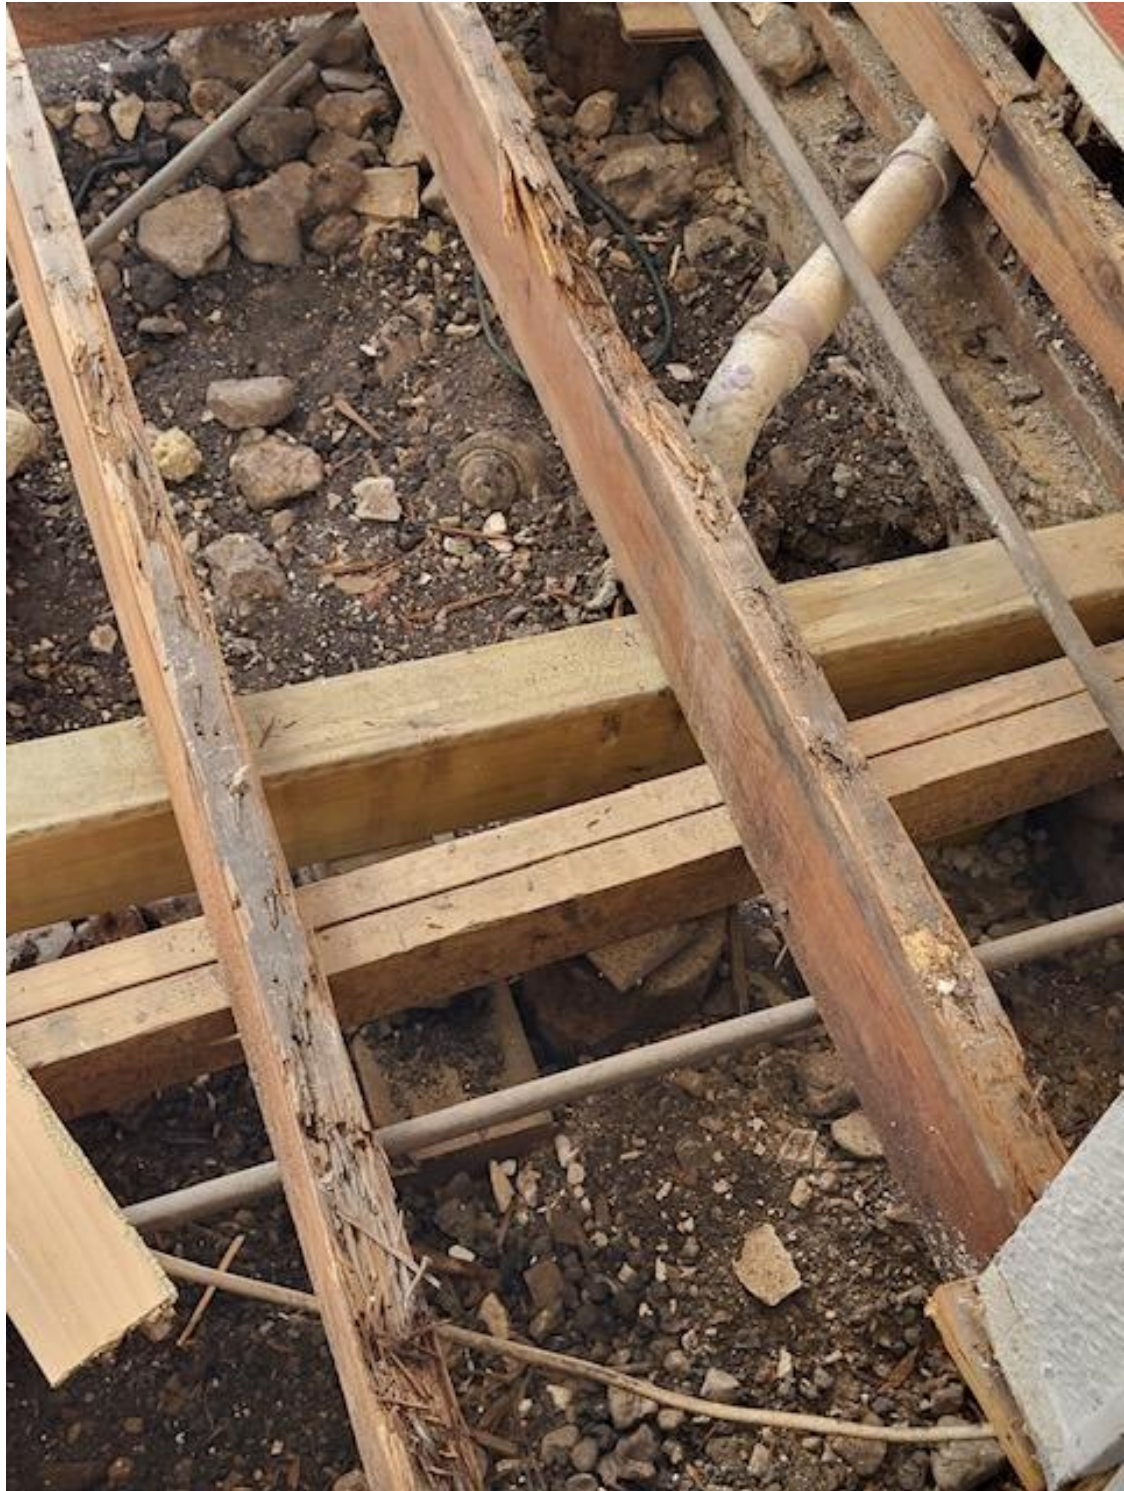
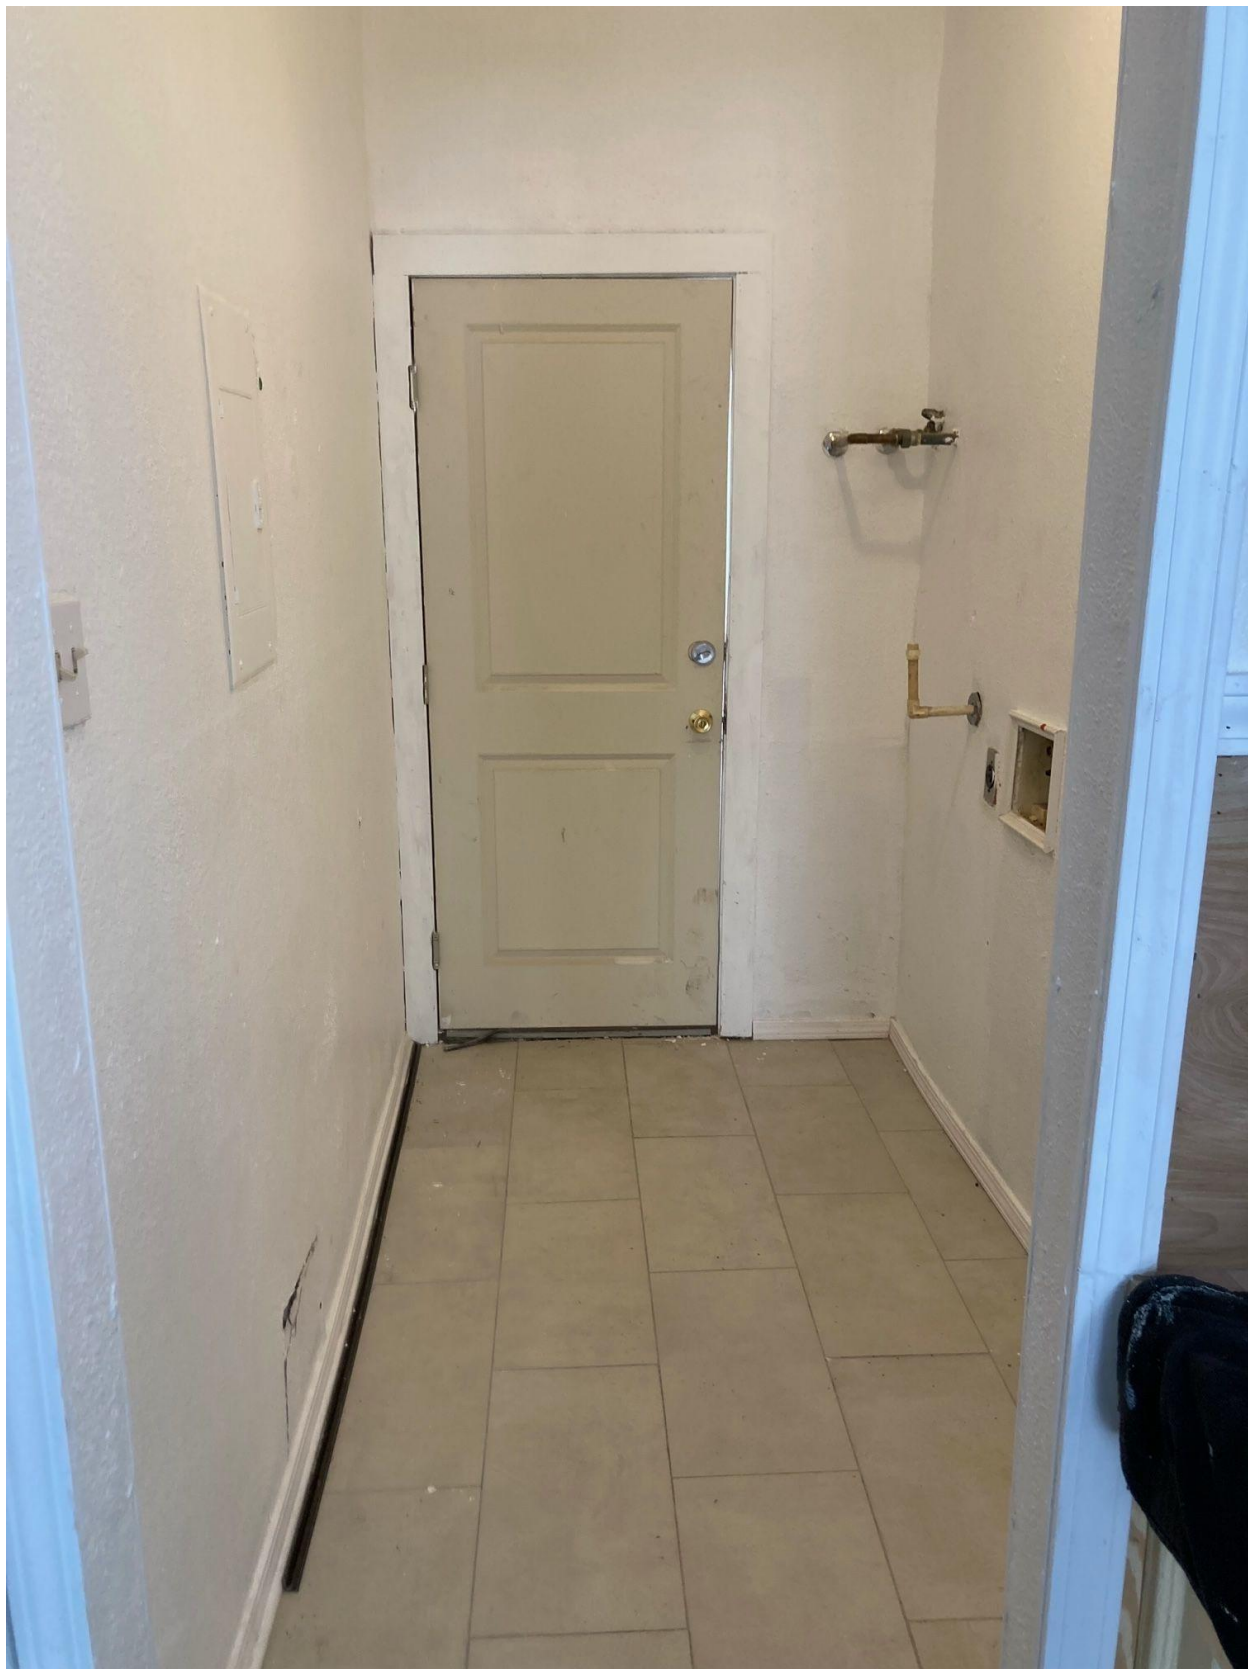
Before and After Photos:

Issue: Damaged laminate flooring in hallway, bedroom and laundry room

Work Plan and Solution: When we purchased the home, there was cheap laminate faux wood flooring leading from the hallway to the two bedrooms, with moderate damage in some places and significant damage in other places. What's more, when we removed the flooring in the laundry room, where stepping over the floor would give in certain places, we found significant wood rot.

Working with our contractor, we decided to remove the laminate flooring, replace rotten floor joists where necessary and repair those pieces that could be salvaged, and then replace the laminate flooring with tile that matched the style of the house.

More Information: After doing research, we found that saltillo tile was popular among the style of home and settled on replacing the laminate floor in the bedroom and hallway. We also replaced the flooring of the bathroom, which was done poorly and lacked grout in certain areas. To replace the laminate in the laundry room, we chose a different style but adhered to tile flooring. **Cost (Labor and materials):** [REDACTED]
