HISTORIC AND DESIGN REVIEW COMMISSION

May 03, 2023

HDRC CASE NO: 2023-159
ADDRESS: 1402 FULTON AVE
LEGAL DESCRIPTION: NCB 2752 BLK 58 LOT 12
ZONING: R-4, H
CITY COUNCIL DIST.: 1
DISTRICT: Fulton Historic District
APPLICANT: Maria Luisa Cesar & Esnire Abigail Gomez
OWNER: Maria Luisa Cesar & Esnire Abigail Gomez
TYPE OF WORK: Courtyard wall modification & Historic Tax Certification
APPLICATION RECEIVED: April 25, 2023
60-DAY REVIEW: Not applicable due to City Council Emergency Orders
CASE MANAGER: Rachel Rettaliata

Application Materials: Office of Historic Preservation – Complete Plans for Restoration and Rehabilitation for 1402 Fulton Avenue, San Antonio, Texas, 78210

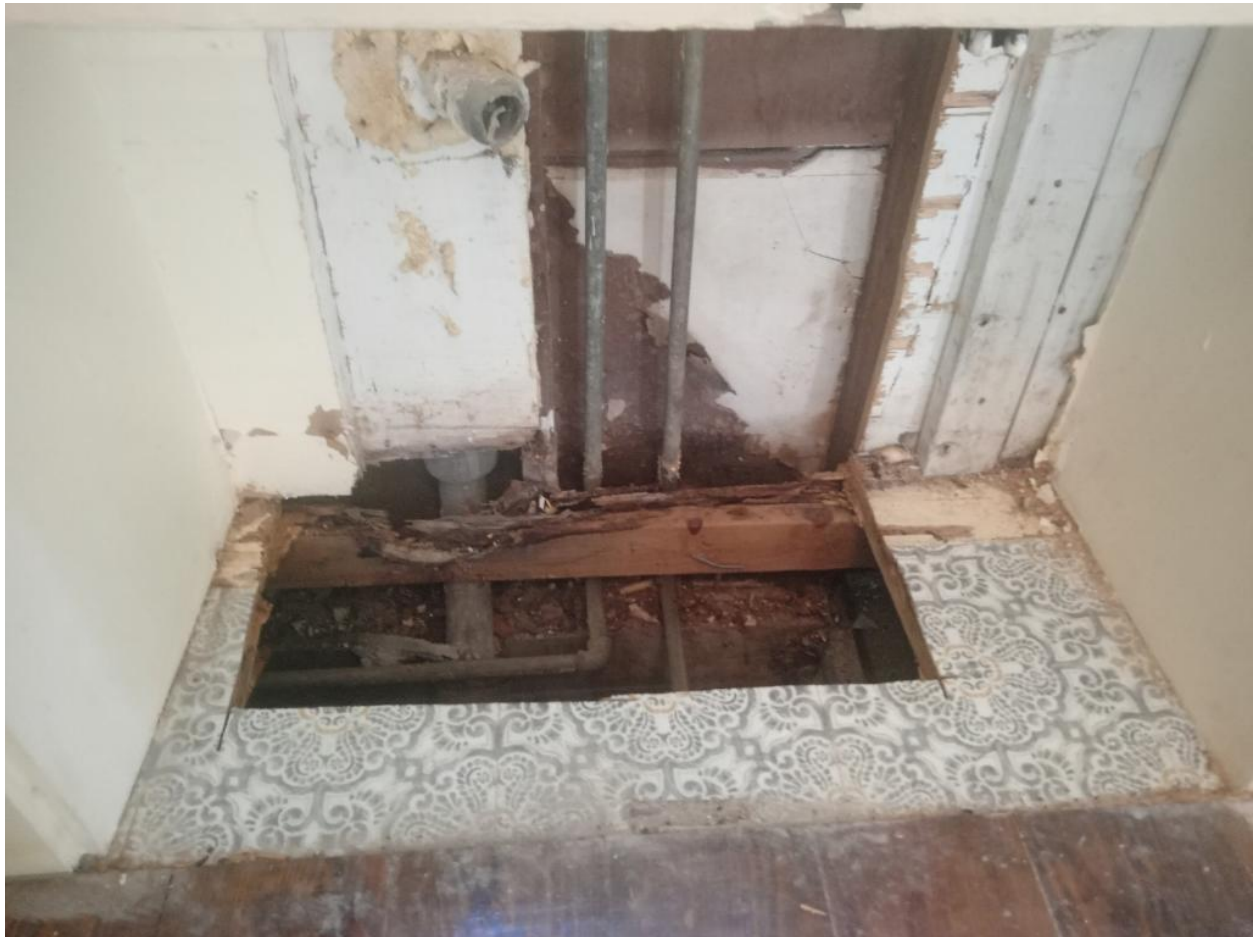
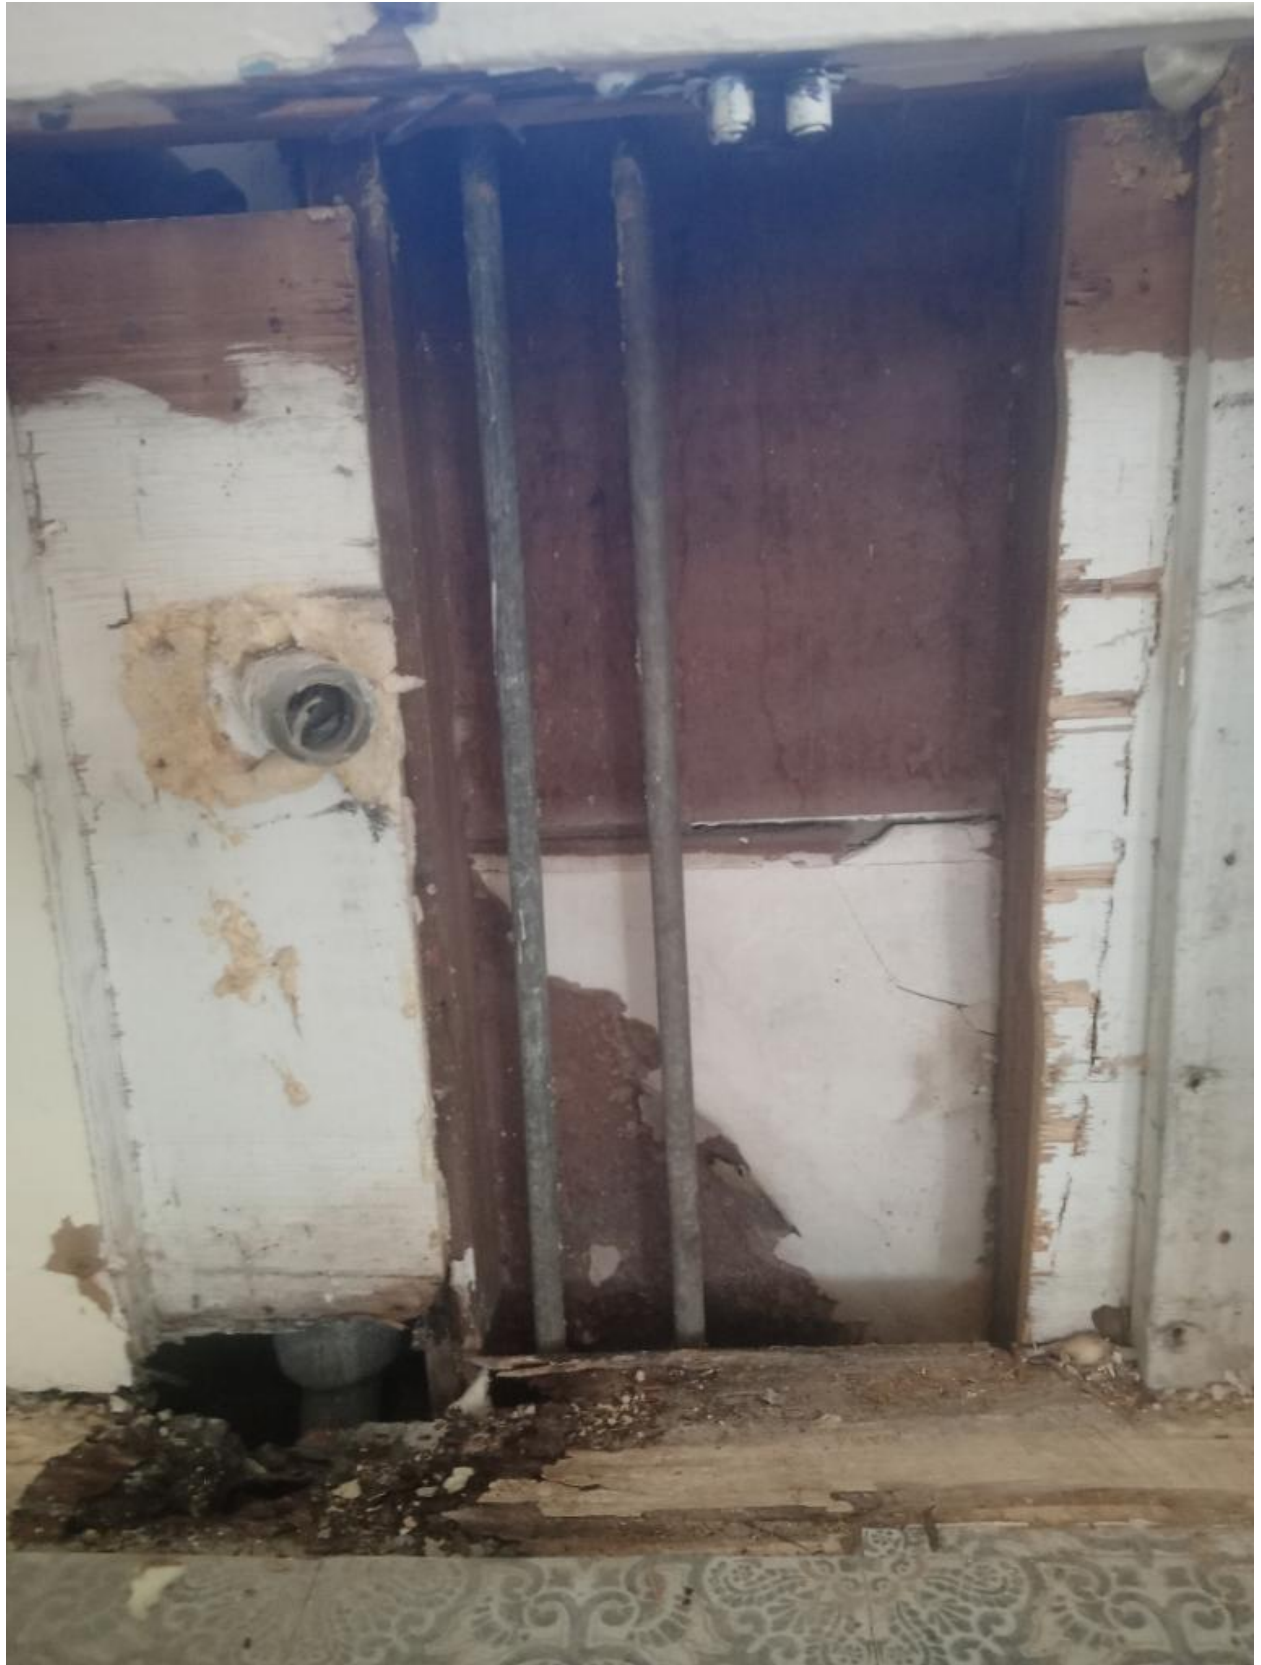
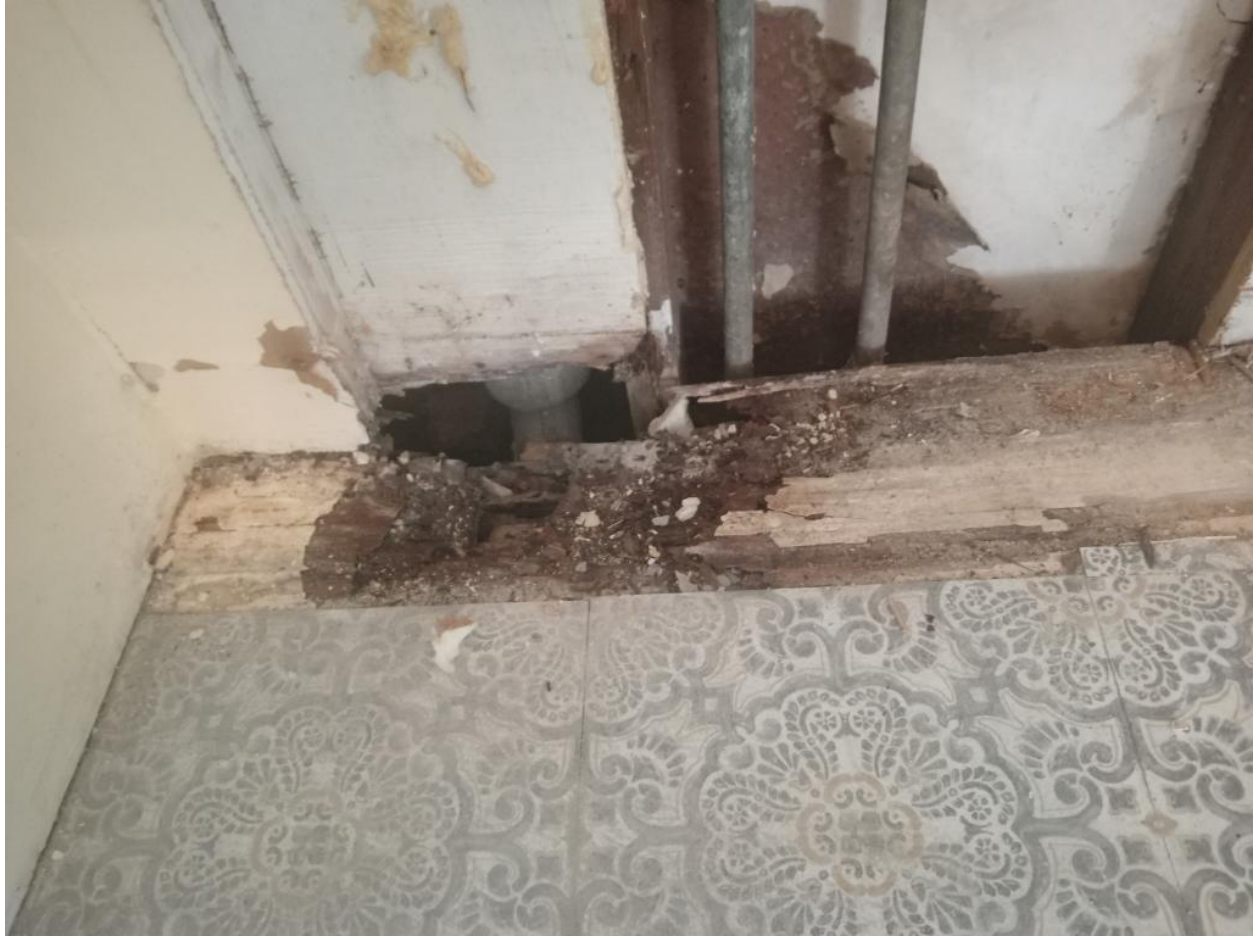
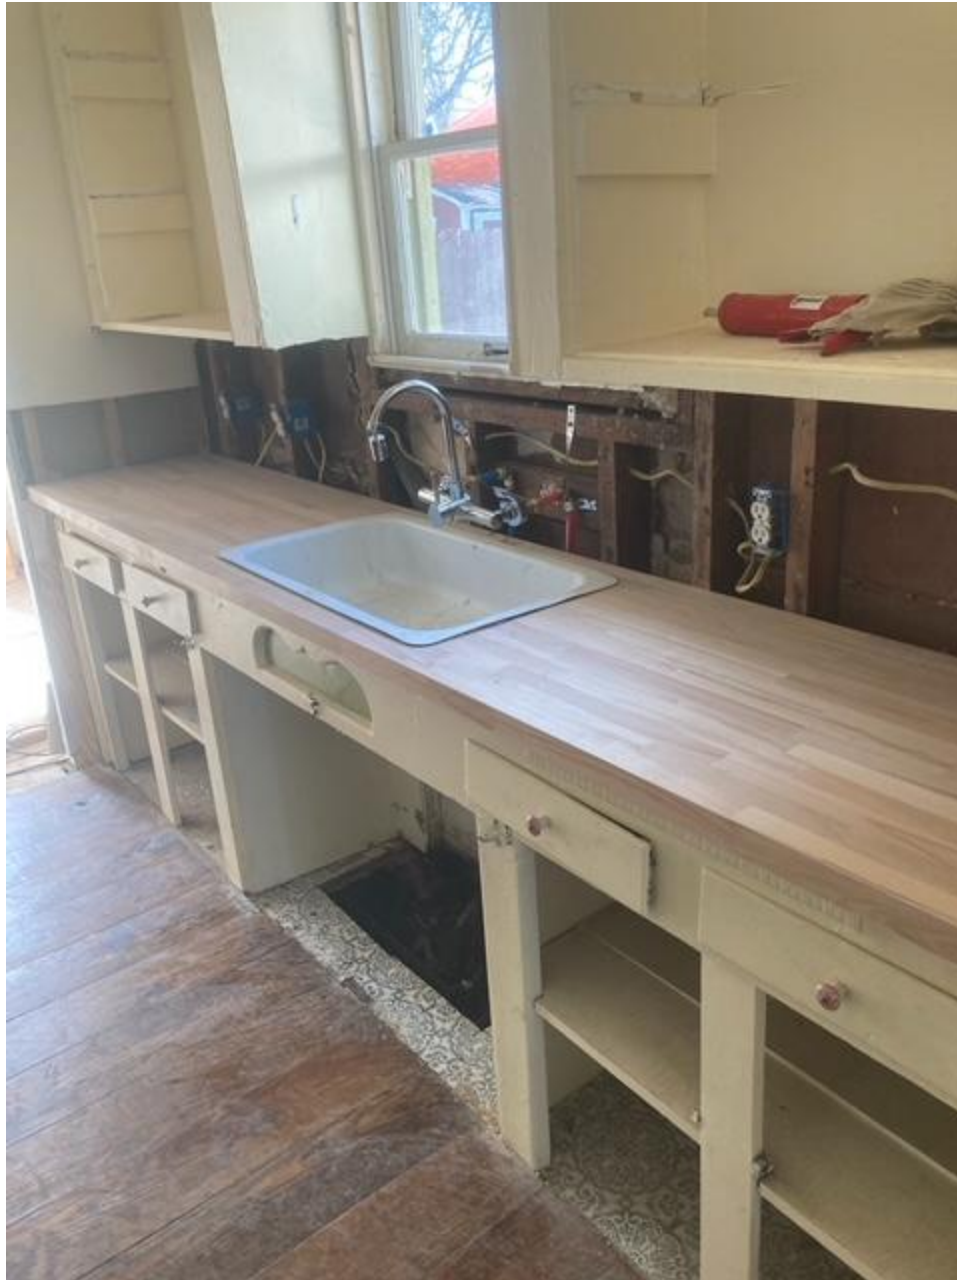
Before and After Photos:

Issue: Galvanized pipes susceptible to leaks

Work Plan and Solution: In the initial inspection report we were made aware of leaks in the kitchen. Our faucet and underneath the sink. We were later informed that there was rotten wood present underneath the sink. We consulted with our contractor and their plumber. We decided it was best to replace all the rotten wood. He also recommended that we change out all galvanized pipes in the kitchen and laundry room with PEX. During the freeze that took place during December 2022, we had an outside pipe burst that has also been replaced with PEX pipe.

More Information: Future plans include replacing all galvanized pipes with PEX pipe, which would total [REDACTED] In the short term, we replaced all kitchen and laundry galvanized pipes.
