# HISTORIC AND DESIGN REVIEW COMMISSION

**HDRC CASE NO:** 2023-081  
**ADDRESS:** 8623 OLD CORPUS CHRISTI RD  
**LEGAL DESCRIPTION:** NCB 10923 BLK 4 LOT N 58.17 FT OF 3A  
**ZONING:** R-6, H  
**CITY COUNCIL DIST.:** 3  
**DISTRICT:** Mission Historic District  
**APPLICANT:** ARMANDO H MARTINEZ/A D A INC.  
**OWNER:** ARCELIA SANDOVAL/SANDOVAL ARCELIA  
**TYPE OF WORK:** Review of demolition with replacement plans  
**APPLICATION RECEIVED:** February 28, 2023  
**60-DAY REVIEW:** Not applicable due to City Council Emergency Orders  
**CASE MANAGER:** Rachel Rettaliata

The applicant is requesting a Certificate of Appropriateness for approval to demolish the primary structure.

Re: Existing Structure Conditions  
8623 Old Corpus Christi Hwy.

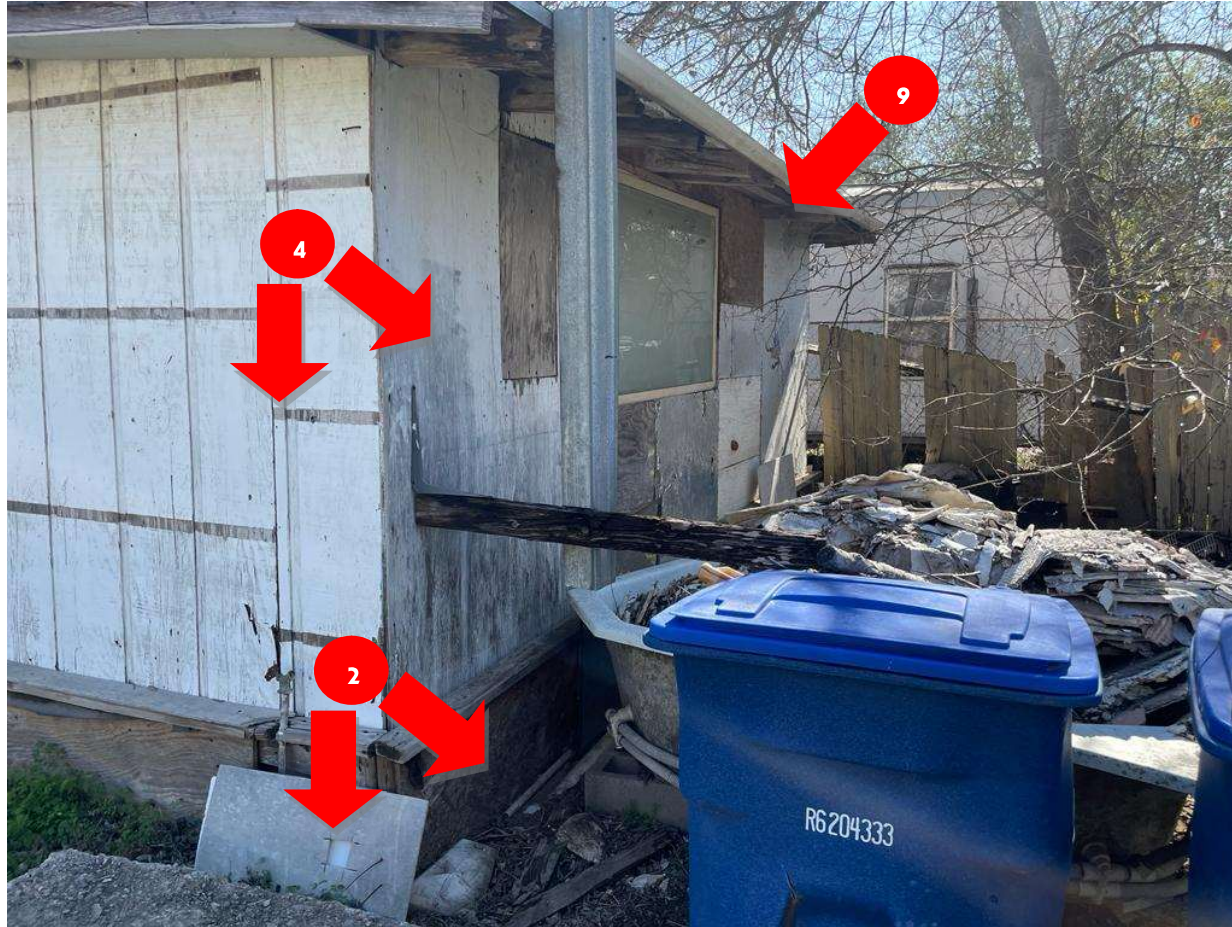
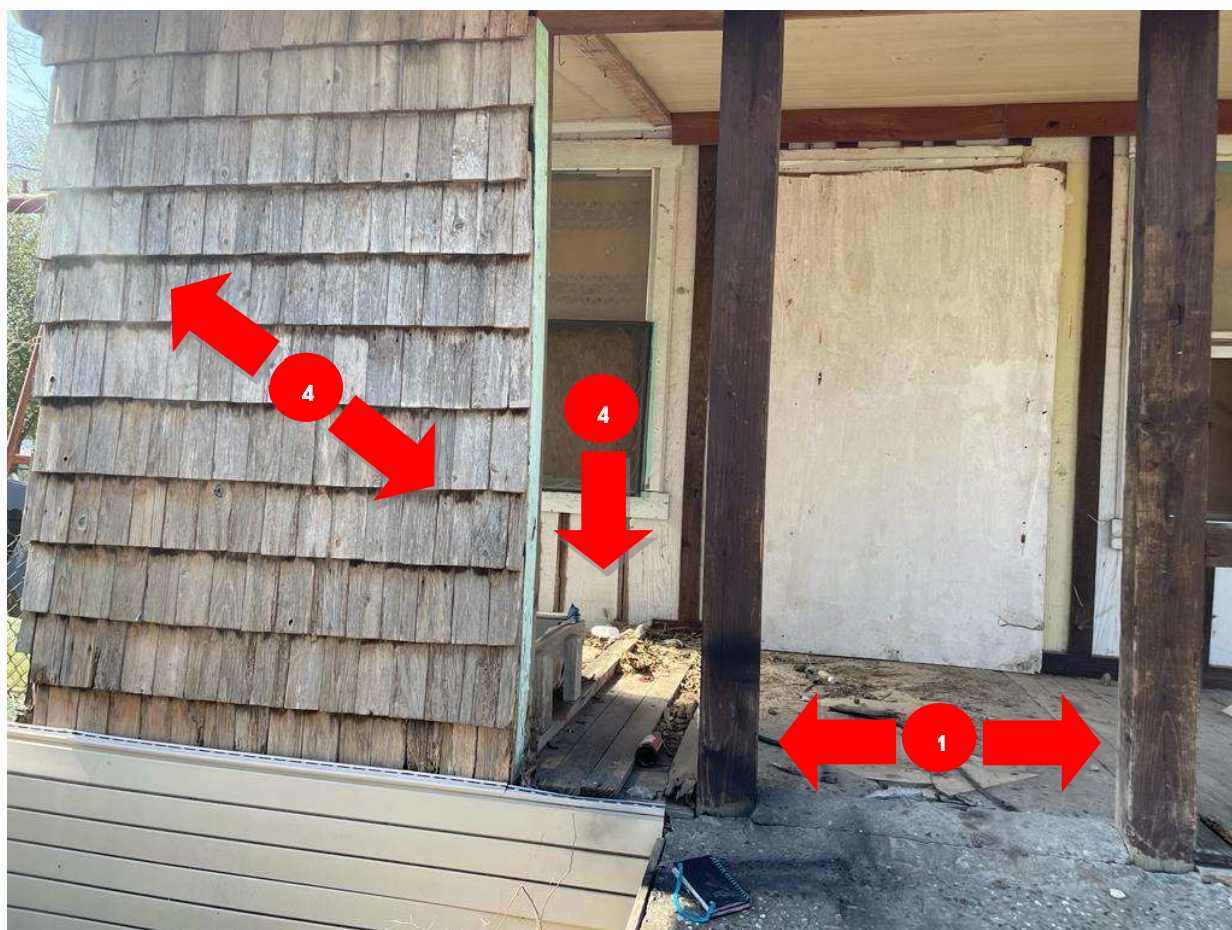
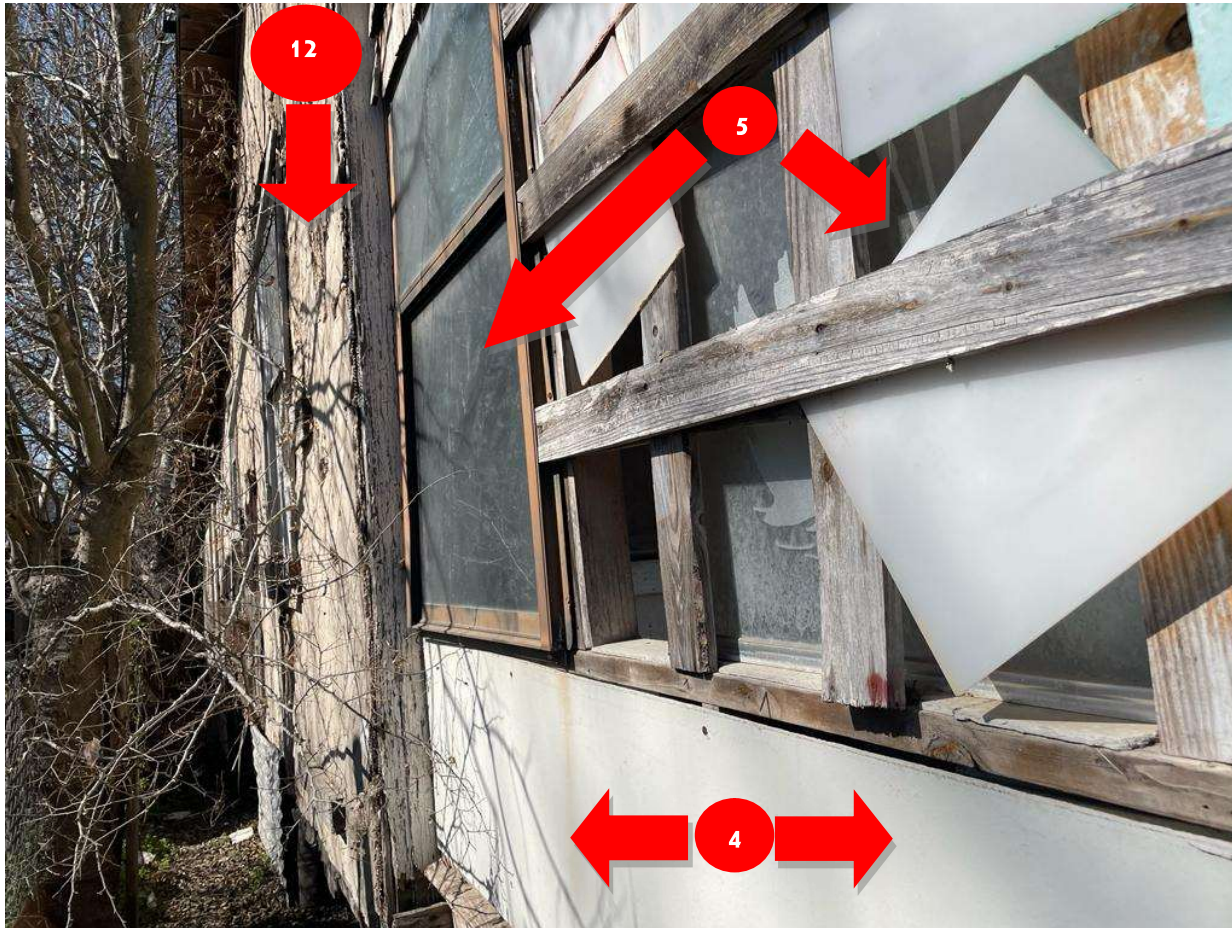
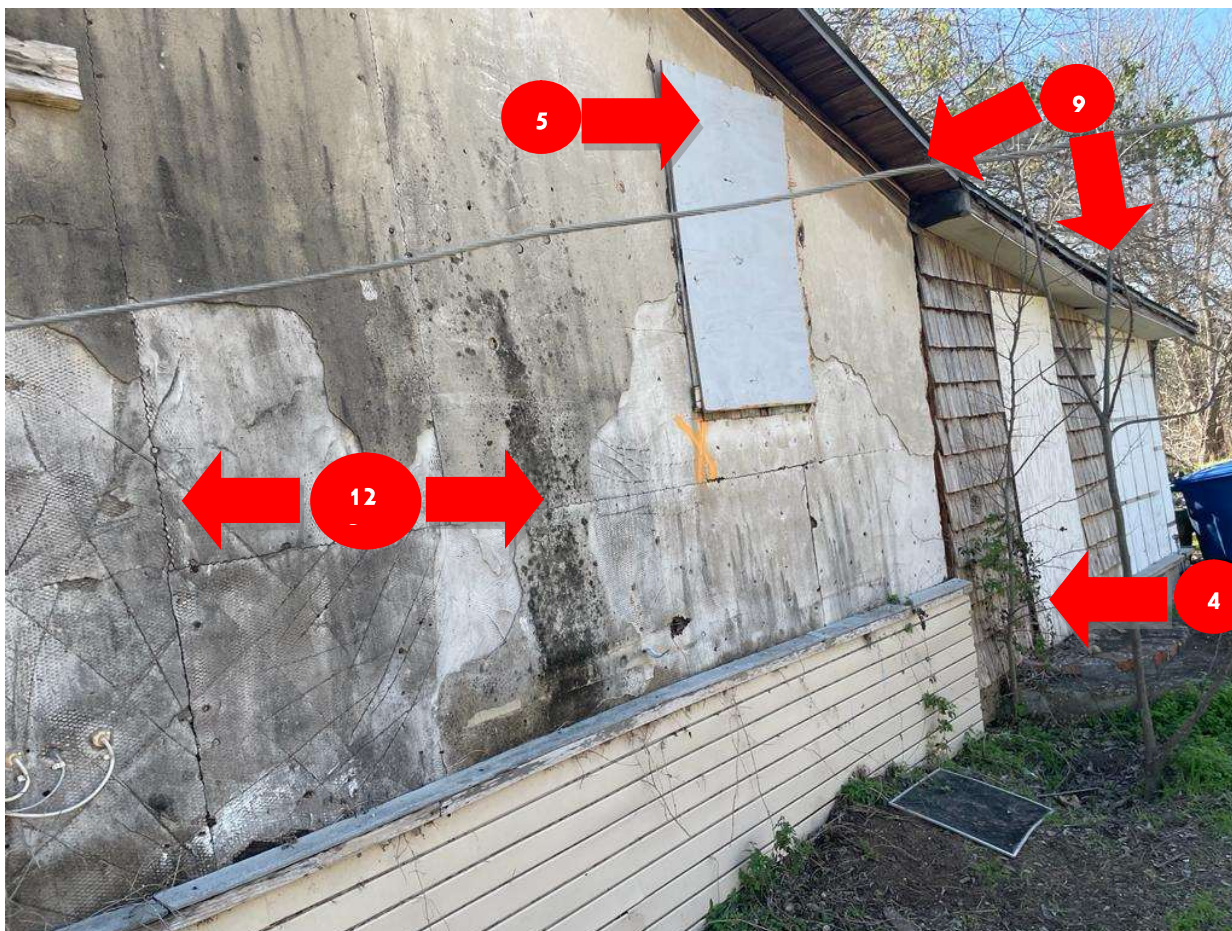
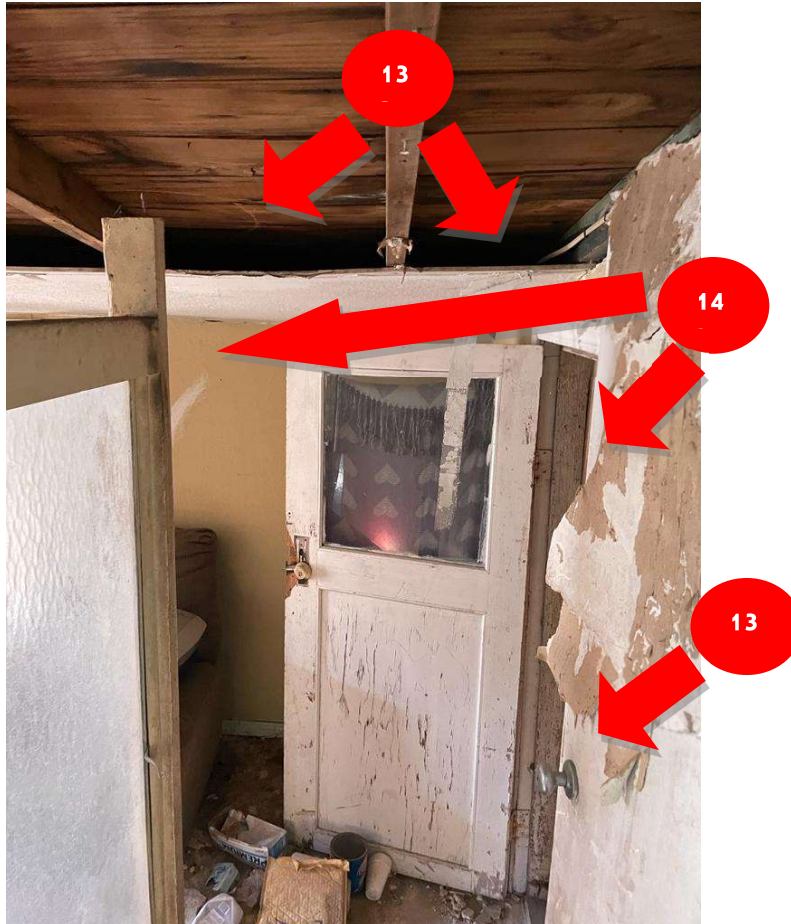
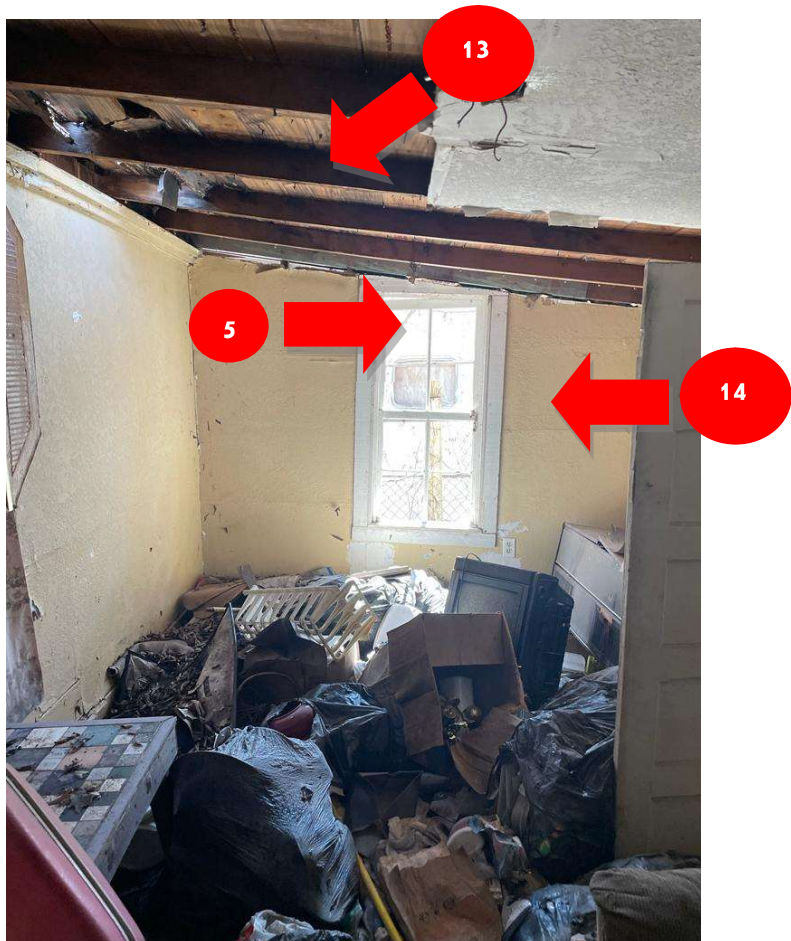
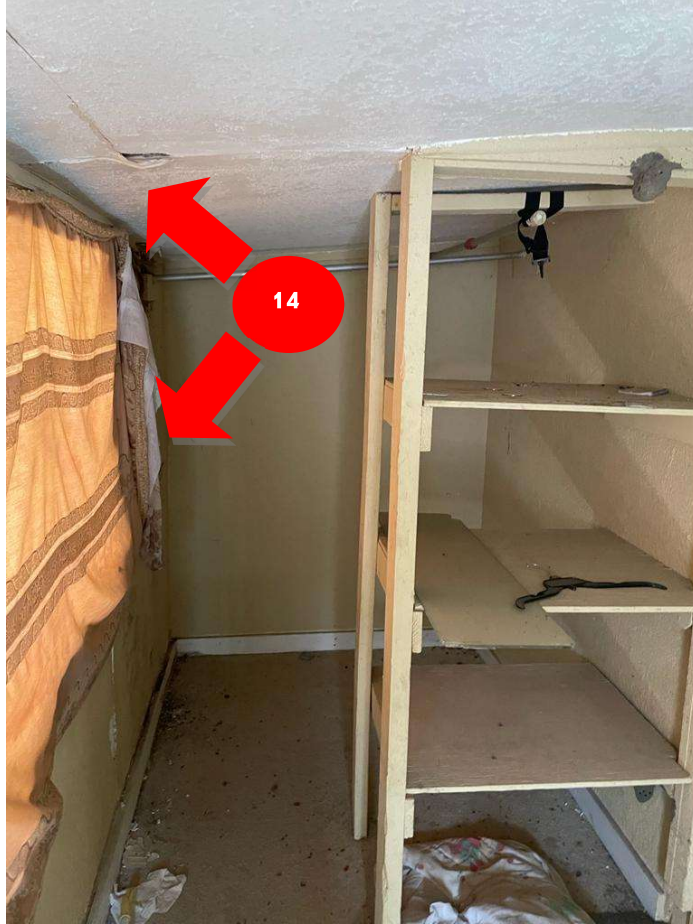
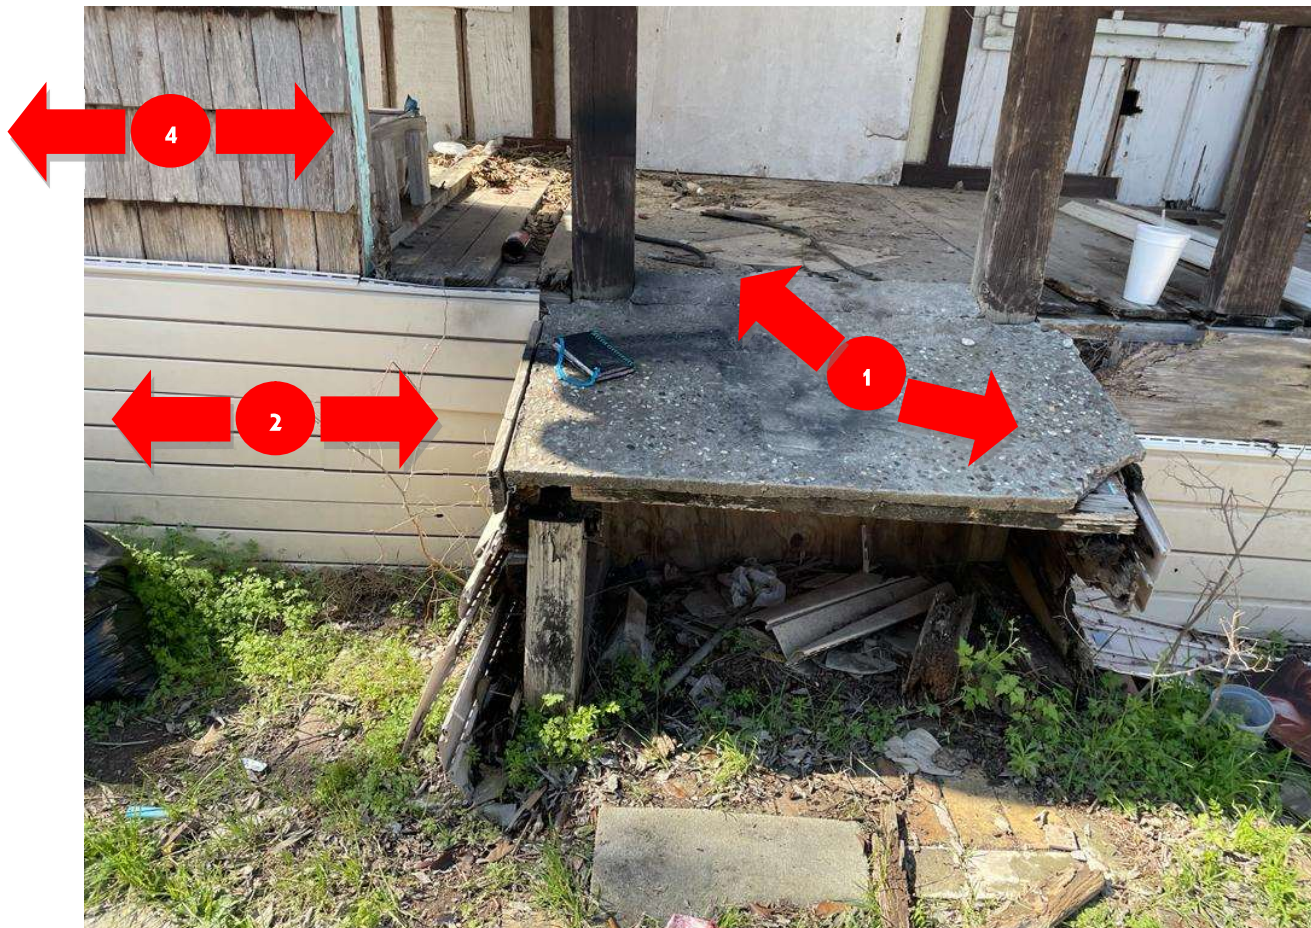
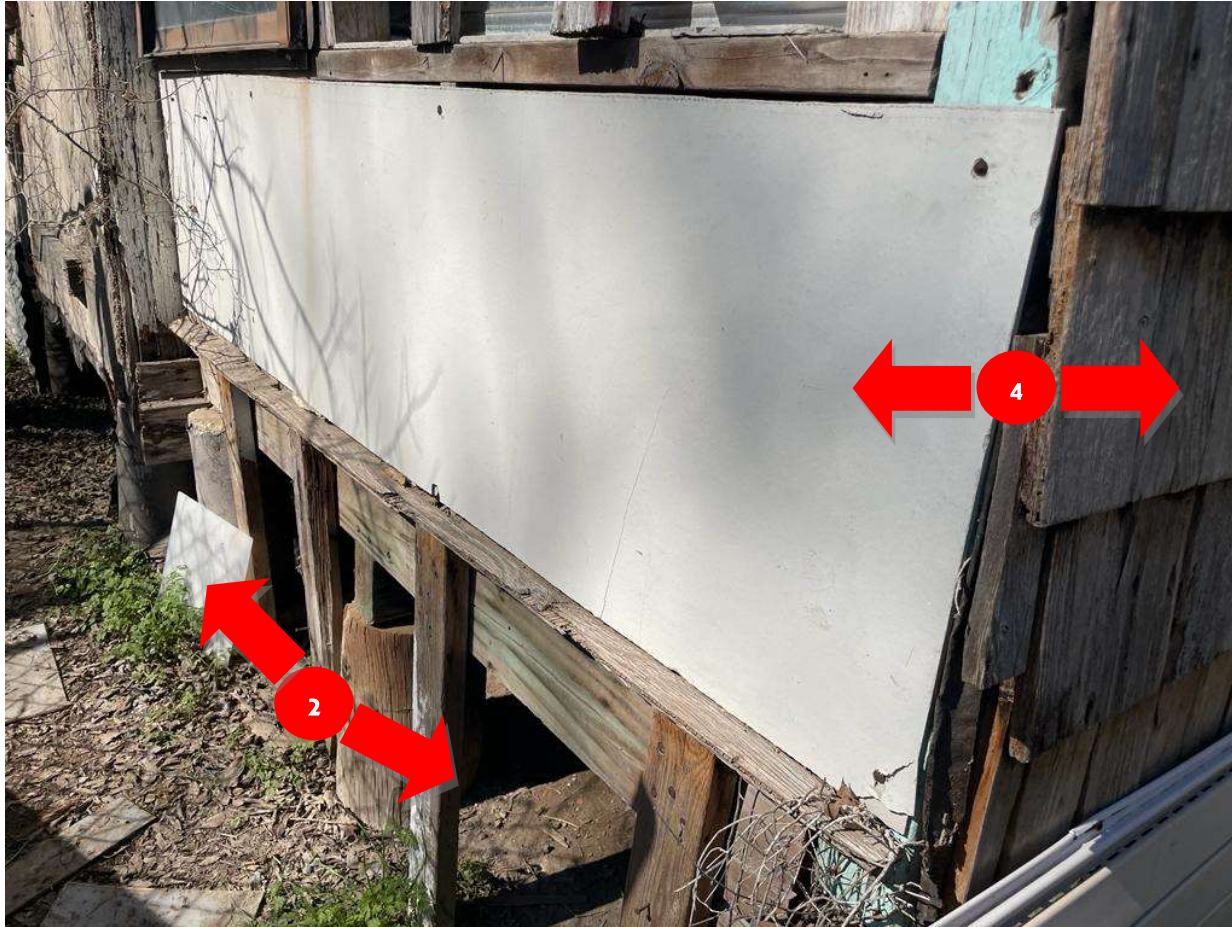
1. Existing wood deck needs to be replaced with foundation post replaced in new IBC code applicable.
2. Skirting below existing finish floor needs to be replaced.
3. Front elevation railings required to be replaced to meet code.
4. Existing siding requires to be replaced and be replaced by one pattern siding. existing siding needs to be removed.
5. Existing windows need to be removed and replaced with required windows meeting the code.
6. Existing structure has several types of roofs and requires new roof.
7. Observation of foundation footings requires replacement with new engineered design.
8. Structure requires new main framing that will meet the current code requirements.
9. Exterior fascia needs to be replaced and installed properly.

10. Existing structure does not have proper wall waterproofing barrier with base flashings. Existing porch needs new sub floor replacement.
11. Existing stucco requires replacement and to be replaced with selected siding.

12. Interior walls need to be properly spaced and plumed according to current code.
13. All existing sheet rock needs replacement with proper tape, float and texture painted.

14. Existing bathroom fixtures need replacement along with faucets and drains.
15. Existing plumbing vents and main drains do not meet current code.
16. Existing main sewer lines need to be replaced and in compliance with current plumbing code.

Note: The above observations of visual inspections, justifies the recommendation of existing residential structure to be removed and demolish. Replacement of a suitable residential structure is present for review and approval.

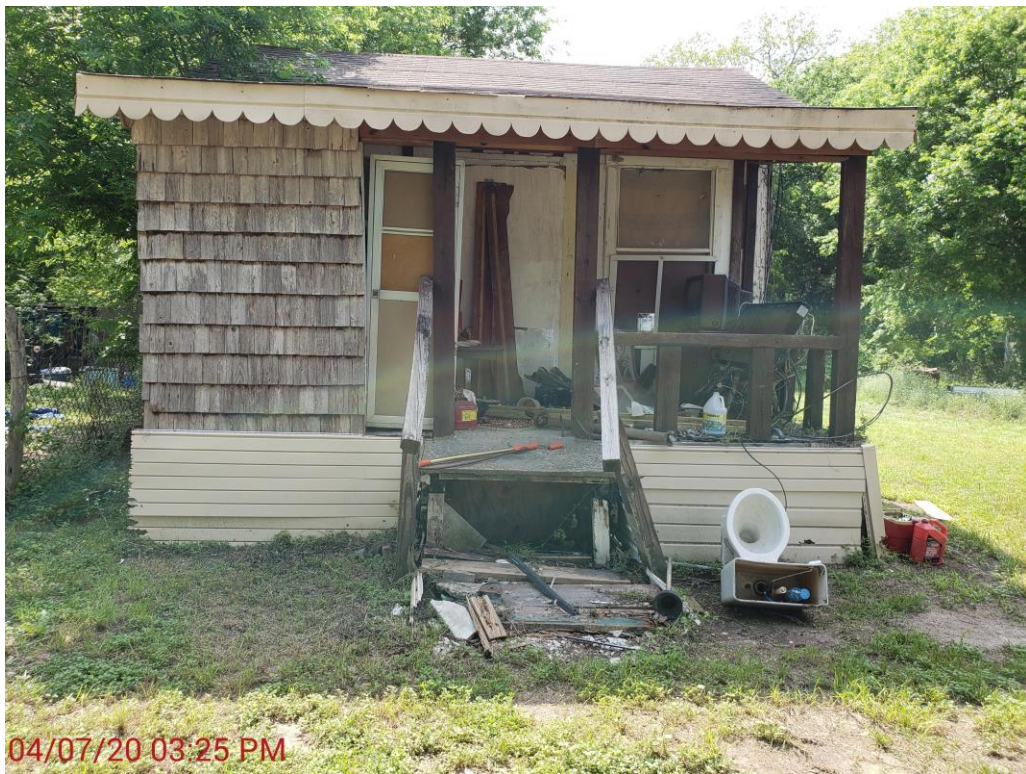
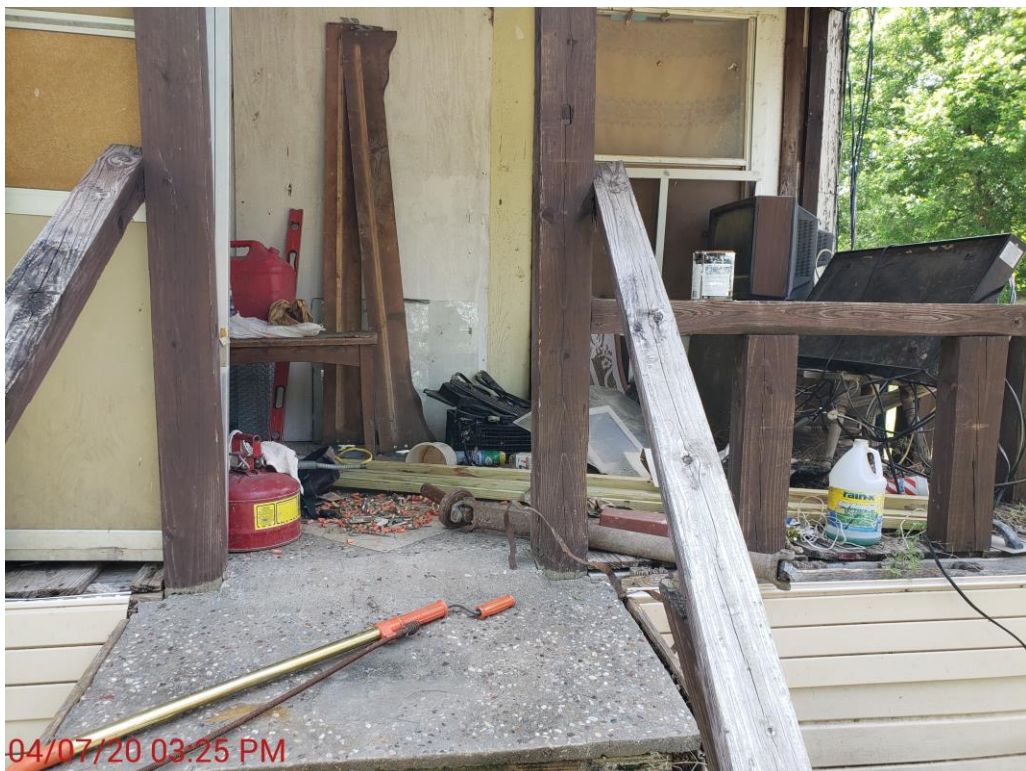
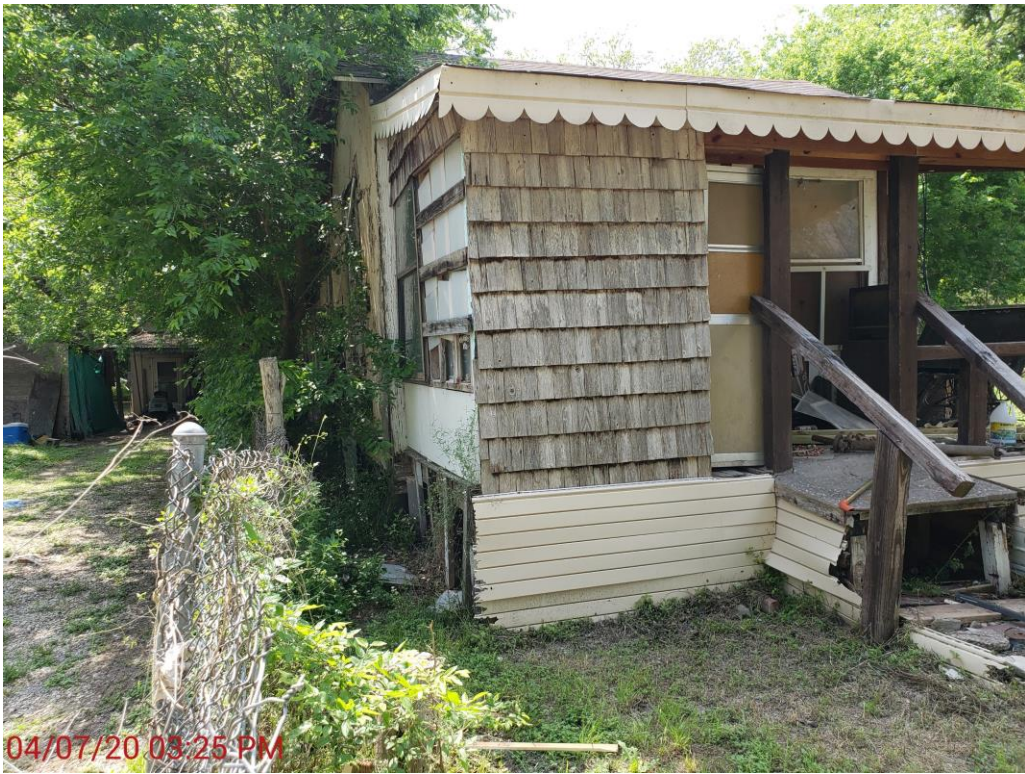
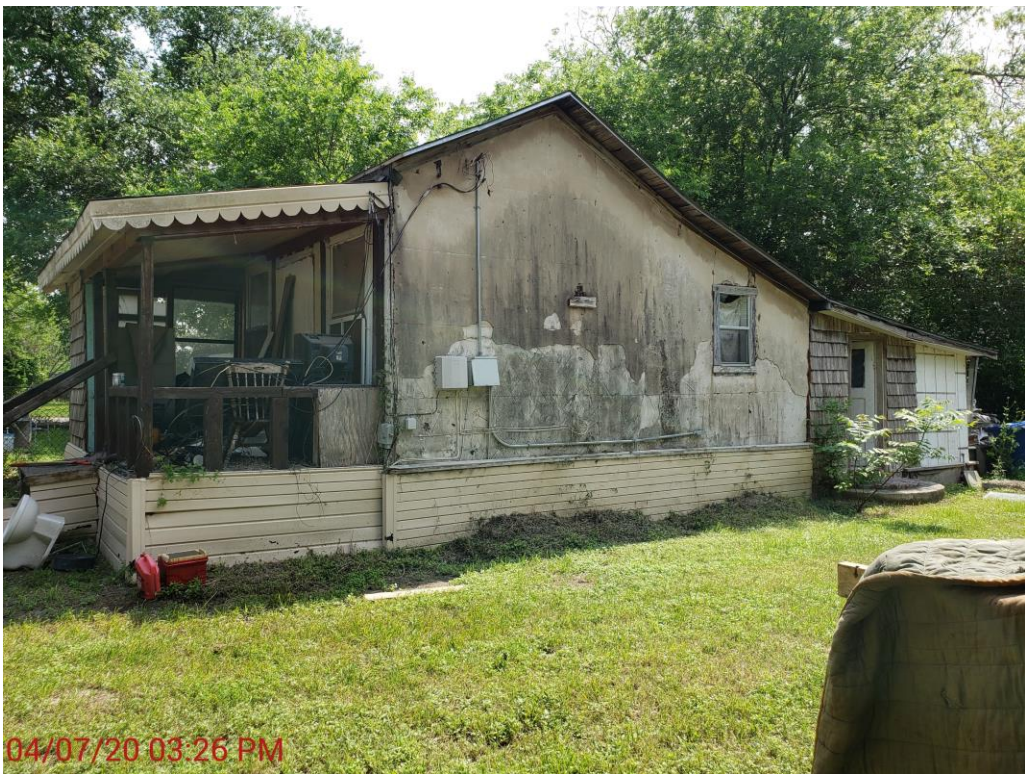
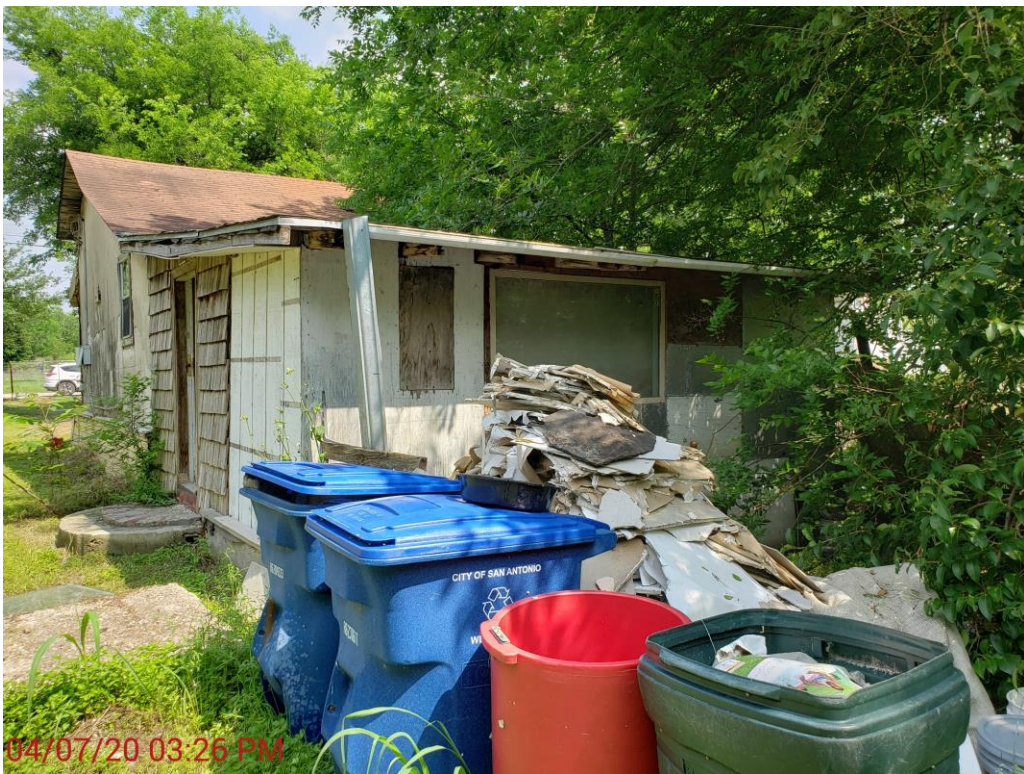
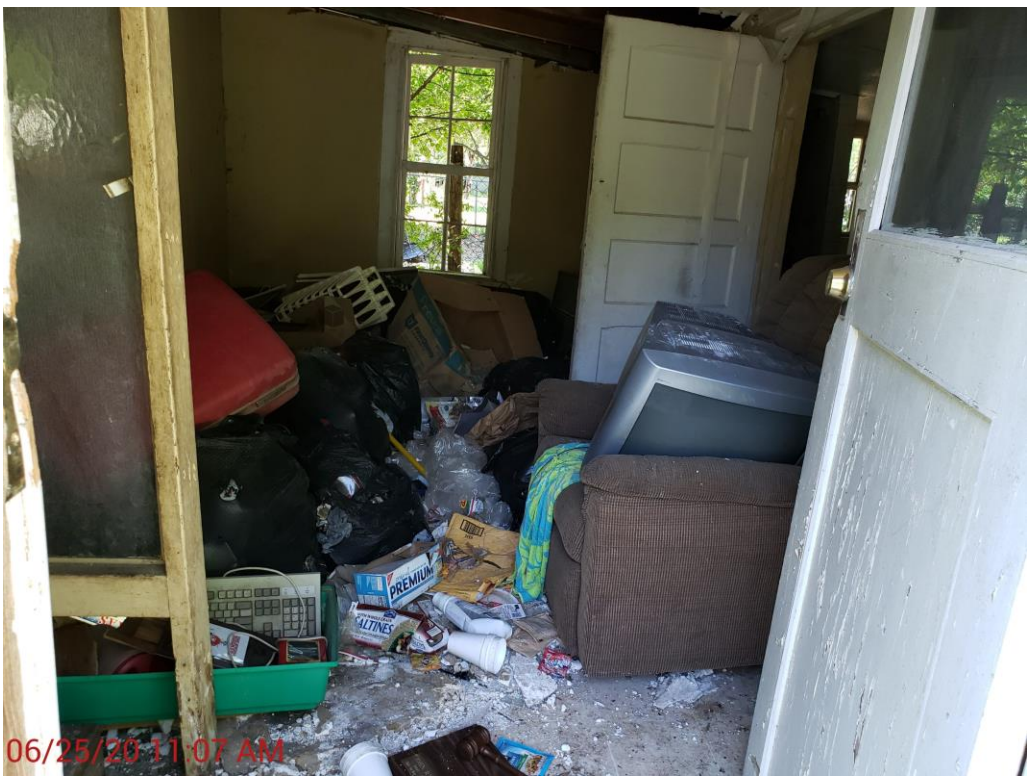
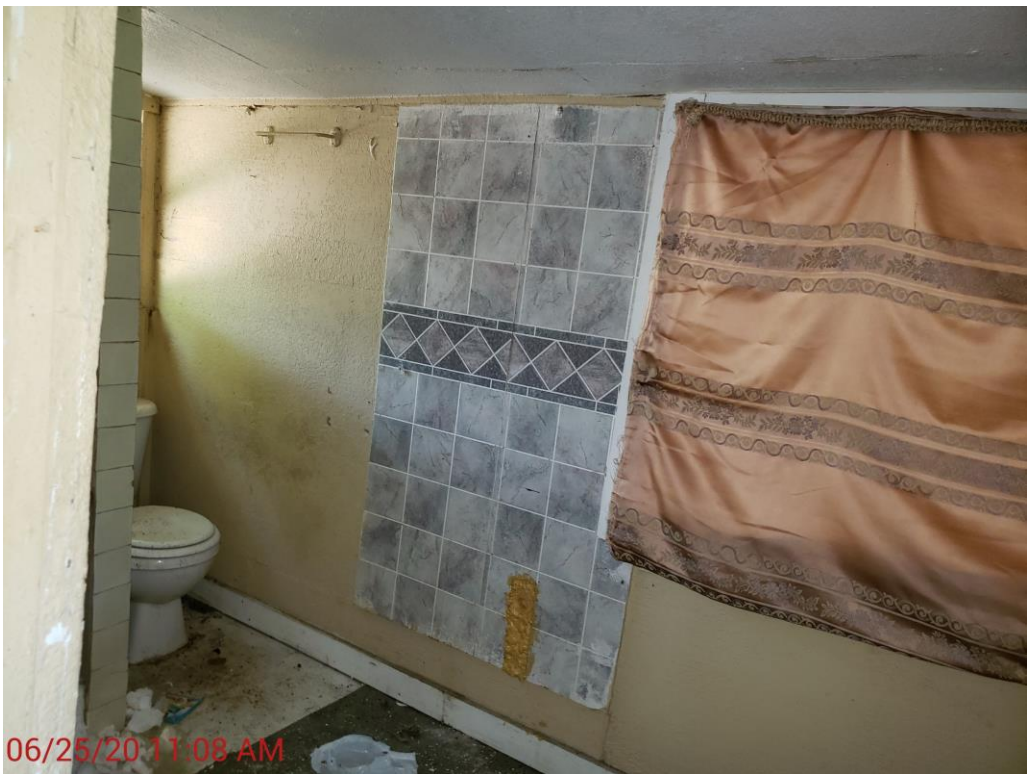
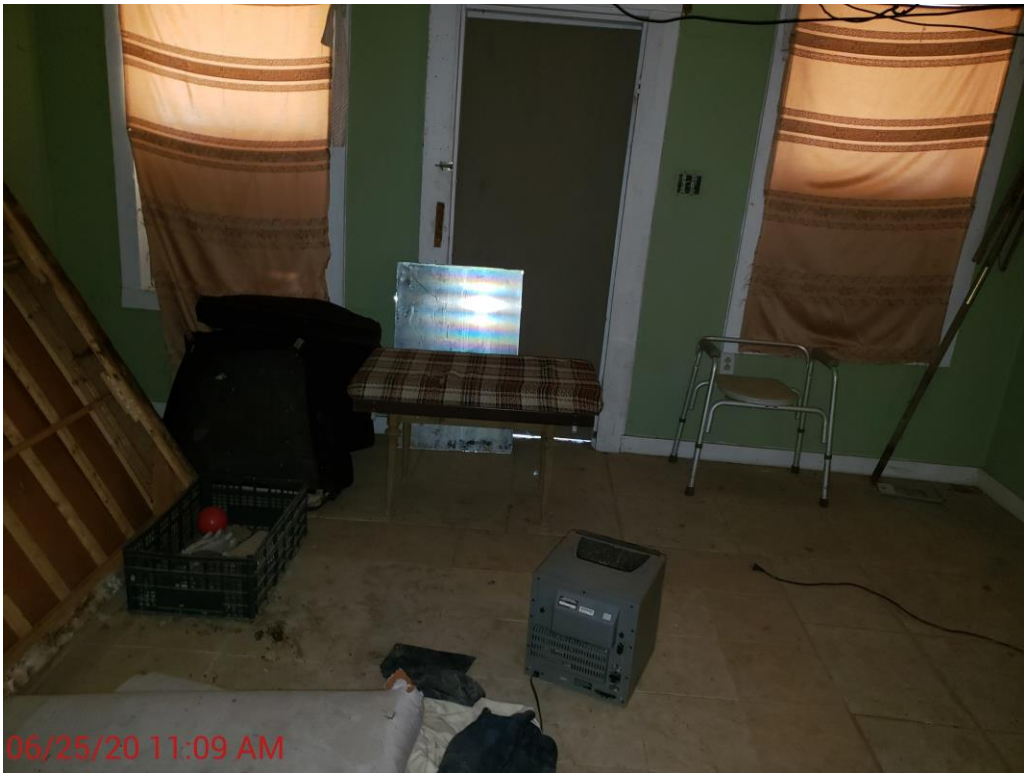
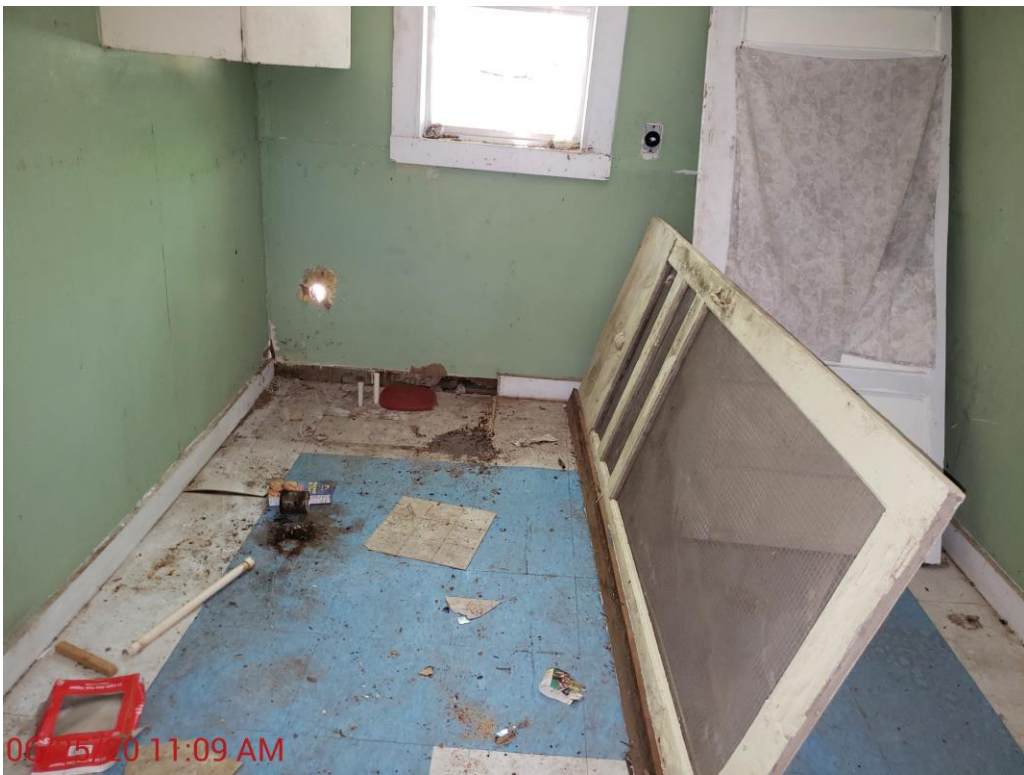
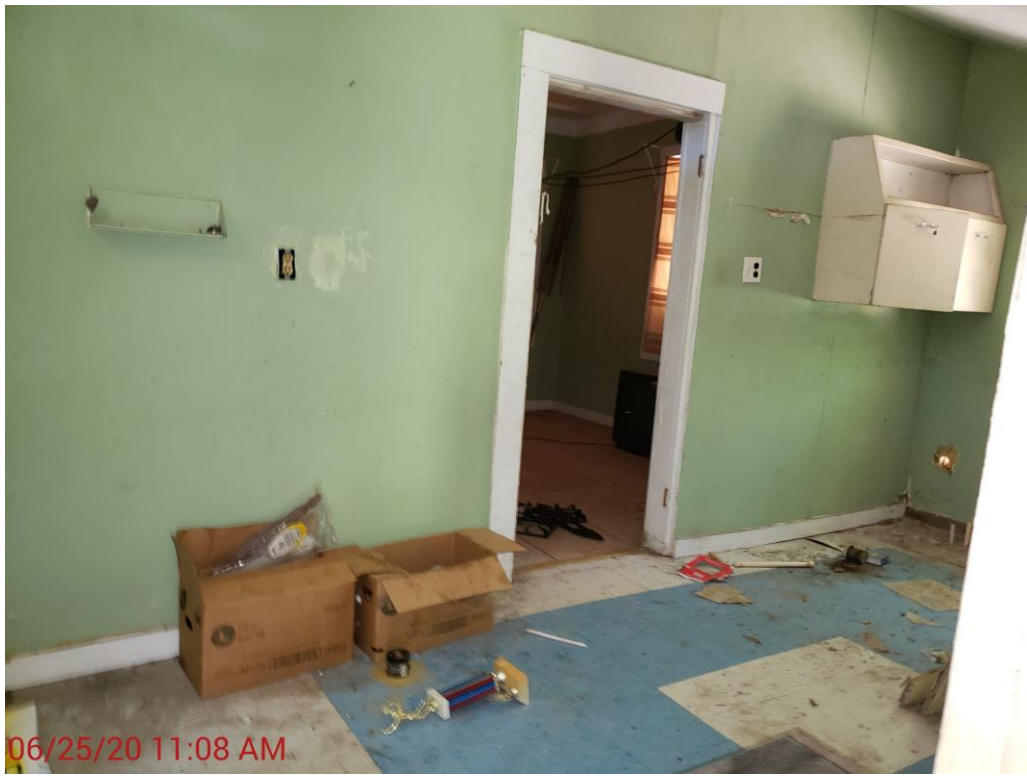
Action: 23428654

| <input checked="" type="checkbox"/> Roof holes/collapsed | <input type="checkbox"/> Missing flashing | <input checked="" type="checkbox"/> Roof Sheathing rotted/damaged |
| <input type="checkbox"/> Ridge-board missing/damaged | <input checked="" type="checkbox"/> Roof covering missing/damaged | <input checked="" type="checkbox"/> Overhang deteriorated/rotted |
| <input checked="" type="checkbox"/> Rafters rotted/damaged | <input type="checkbox"/> Missing purlins/brace/collar ties | <input type="checkbox"/> Roof trusses rotted/damaged |

| <input checked="" type="checkbox"/> Siding damaged/deteriorated | <input type="checkbox"/> Ceiling severely deflected | <input type="checkbox"/> Floor has holes |
| <input checked="" type="checkbox"/> Windows damaged/broken | <input checked="" type="checkbox"/> Sheetrock damaged/missing | <input type="checkbox"/> Floor joists rotten/damaged |

| <input checked="" type="checkbox"/> Front/rear porch damaged | <input checked="" type="checkbox"/> Front/rear steps rotted/damaged/detaching | <input type="checkbox"/> Missing/damaged handrails |
