HISTORIC AND DESIGN REVIEW COMMISSION

October 06, 2021

HDRC CASE NO: 2021-475
ADDRESS: 901 MASON ST
LEGAL DESCRIPTION: NCB 1267 BLK 3 LOT S 137.0 OF 9 & 10 & N 50.0 OF E 24.0 FT OF 9 ARB 9C, 10A, & 9B
ZONING: O-2, H
CITY COUNCIL DIST.: 2
DISTRICT: Government Hill Historic District
LANDMARK: Individual Landmark
APPLICANT: robert miranda/finesse construction llc
OWNER: logan fullmer/901 MASON LLC
TYPE OF WORK: Installation of a standing seam metal roof with a ridge cap
APPLICATION RECEIVED: September 03, 2021
60-DAY REVIEW: Not applicable due to City Council Emergency Orders
CASE MANAGER: Edward Hall
REQUEST:

The applicant is requesting a Certificate of Appropriateness for approval to install a standing seam metal roof with a ridge cap on the historic structure at 901 Mason, located within the Dignowity Hill Historic District.

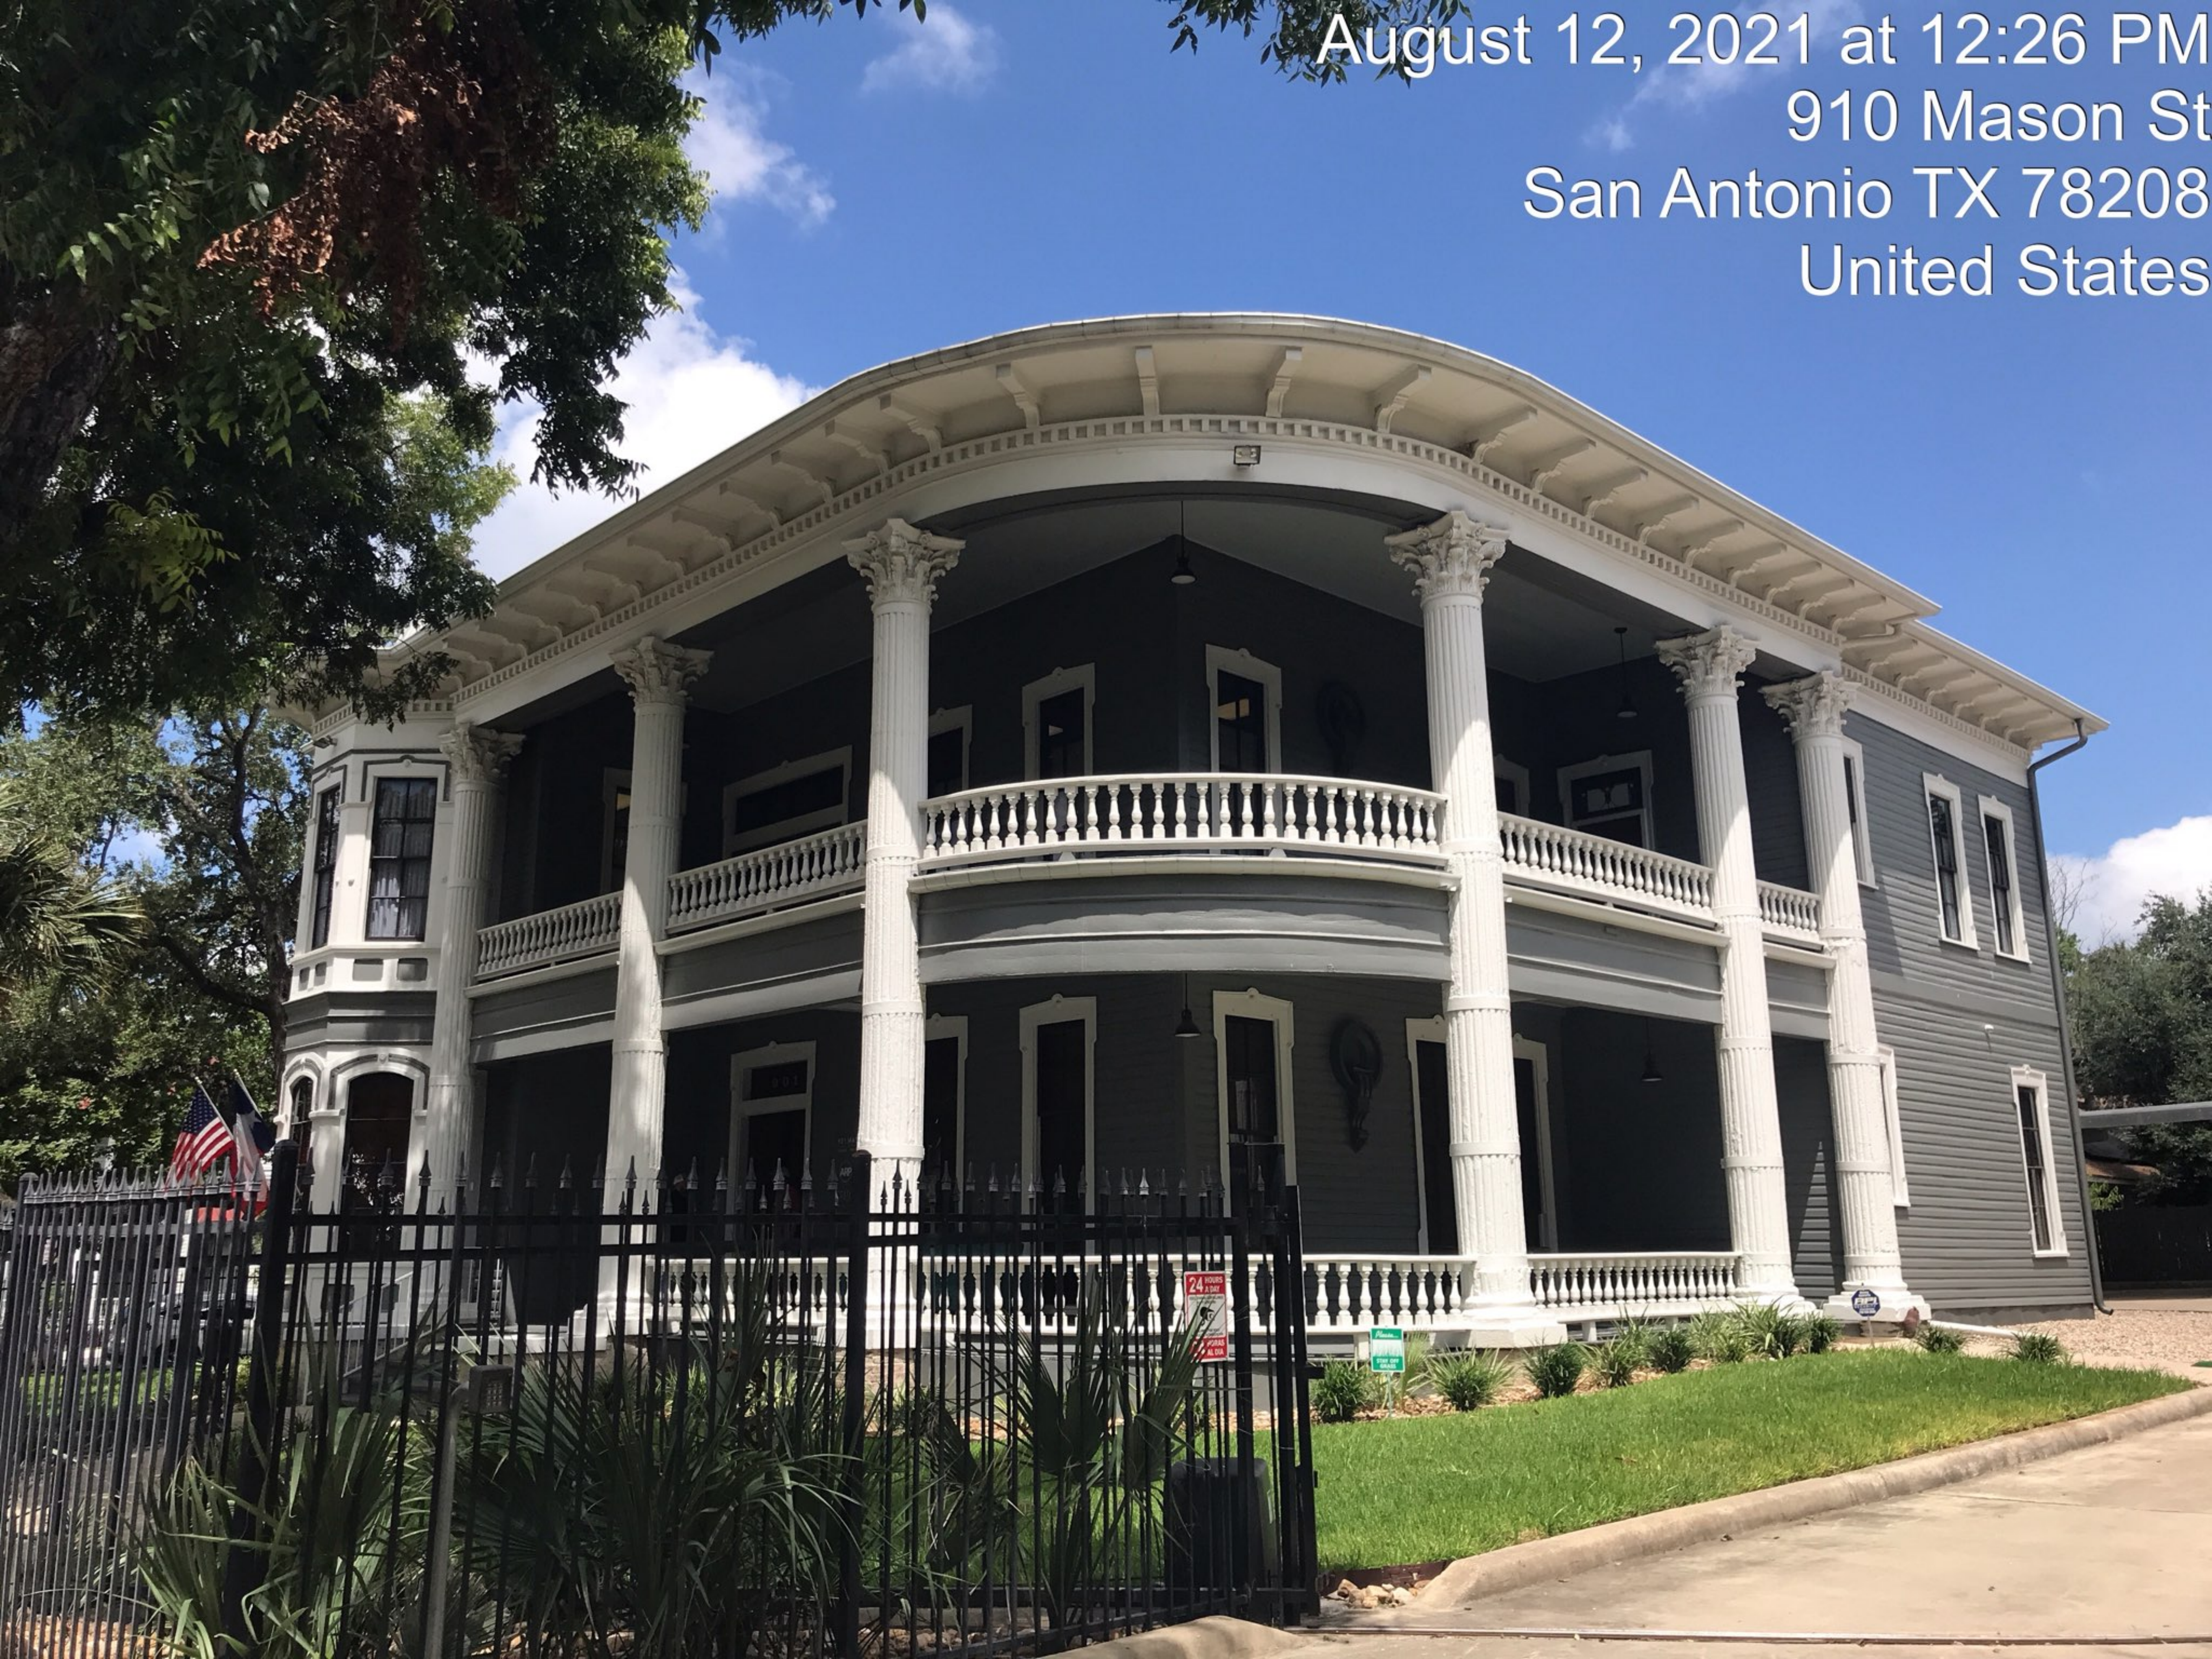
August 12, 2021 at 12:26 PM
910 Mason St
San Antonio TX 78208
United States

- b. VIOLATION – Office of Historic Preservation staff performed a site visit on August 12, 2021, to inspect the roof work that had been done to date. At that time, OHP staff found a ridge cap installed. No roofing inspection was performed to inspect materials prior to installation.

Staff recommends that a standing seam metal roof that is consistent with the Guidelines regarding ridge detail (crimped/munched ridge seam or a crimped ridge sleeve) be installed in place of the installed ridge cap.

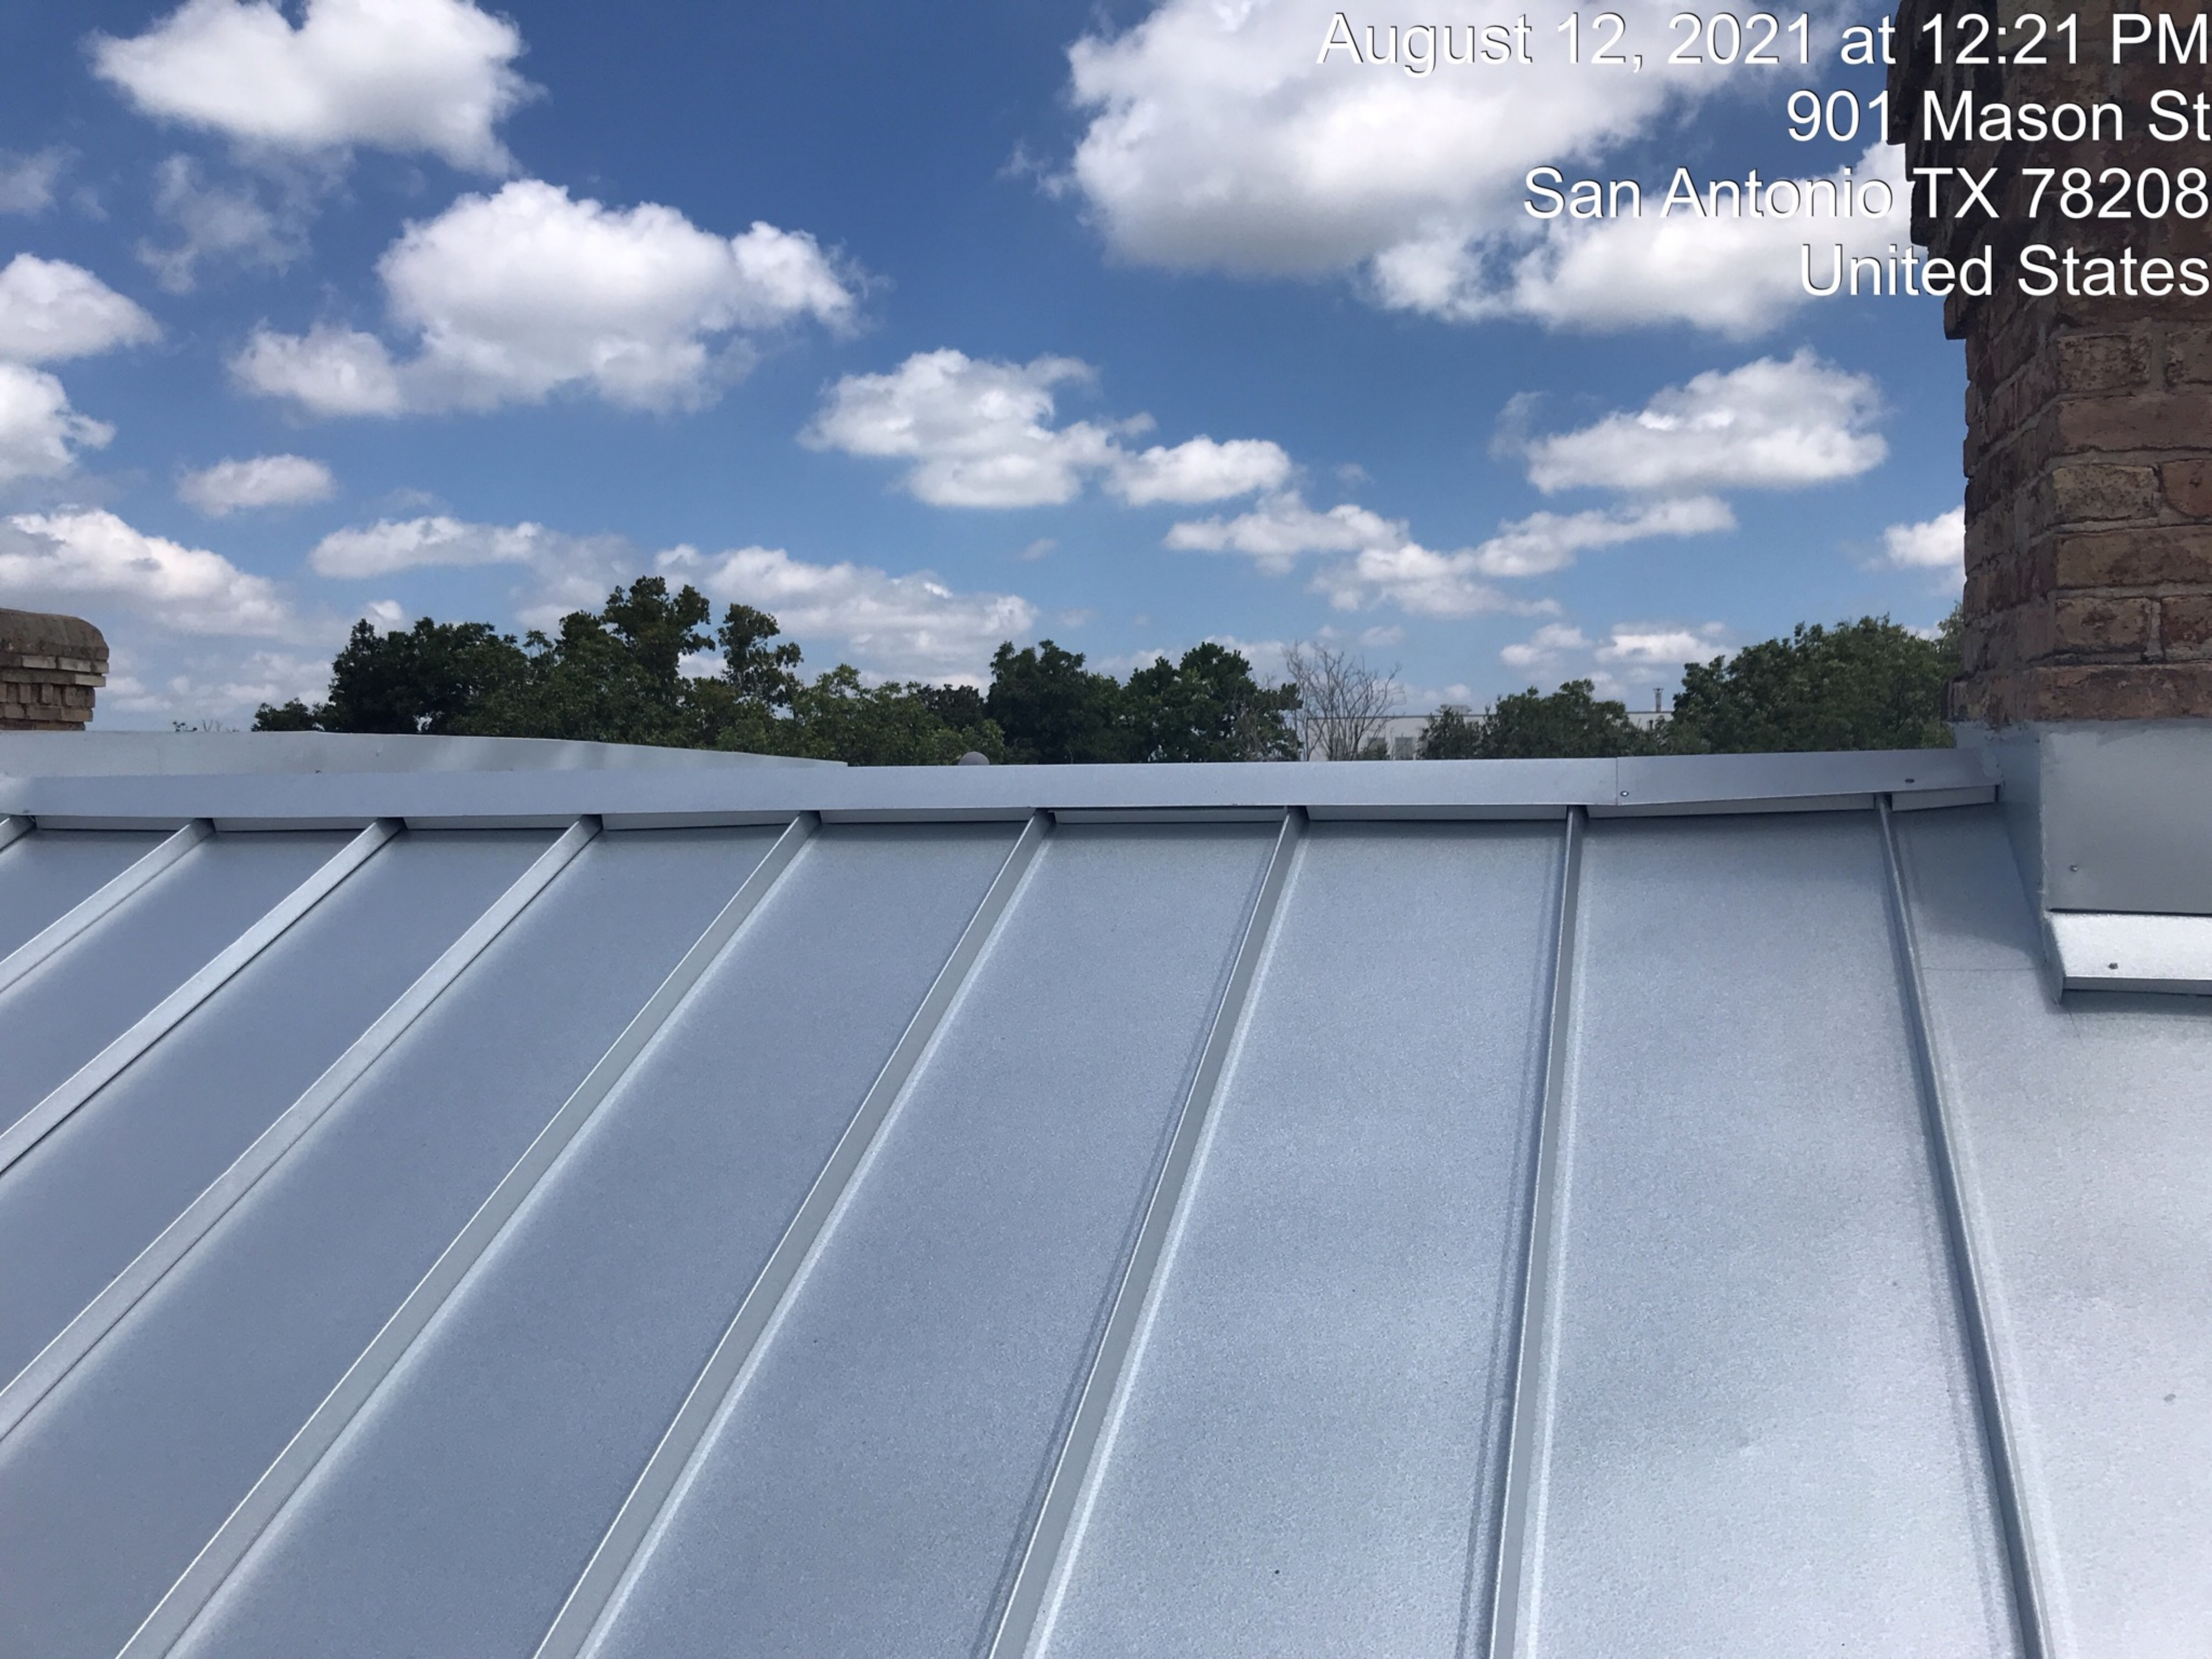
August 12, 2021 at 12:21 PM
901 Mason St
San Antonio TX 78208
United States

- c. ROOF REPLACEMENT – Per the Guidelines for Exterior Maintenance and Alterations 3.B.vi., metal roofs should be installed where historically found or architecturally appropriate. Additionally, the Guidelines note that new metal roofs should adhere the specifications outlined in the Guidelines; panels should be smooth and feature 18 to 21 inches in width, seams should be 1 to 2 inches tall, ridge seams should featured a crimped ridge seam, and panels should feature a standard galvalume finish. Staff finds the ridge caps to be inconsistent with the Guidelines.
