# HISTORIC AND DESIGN REVIEW COMMISSION

October 06, 2021

**HDRC CASE NO:** 2021-453  
**ADDRESS:** 302 FURR DR  
**LEGAL DESCRIPTION:** NCB 6695 BLK 4 LOT 28  
**ZONING:** R-6, H  
**CITY COUNCIL DIST.:** 7  
**DISTRICT:** Monticello Park Historic District  
**APPLICANT:** Arash Pazouki /PEBBLE DAWN PROPERTIES LLC  
**OWNER:** PEBBLE DAWN PROPERTIES LLC  
**TYPE OF WORK:** Window replacement  
**APPLICATION RECEIVED:** August 31, 2021  
**60-DAY REVIEW:** Not applicable due to City Council Emergency Orders  
**CASE MANAGER:** Rachel Rettaliata

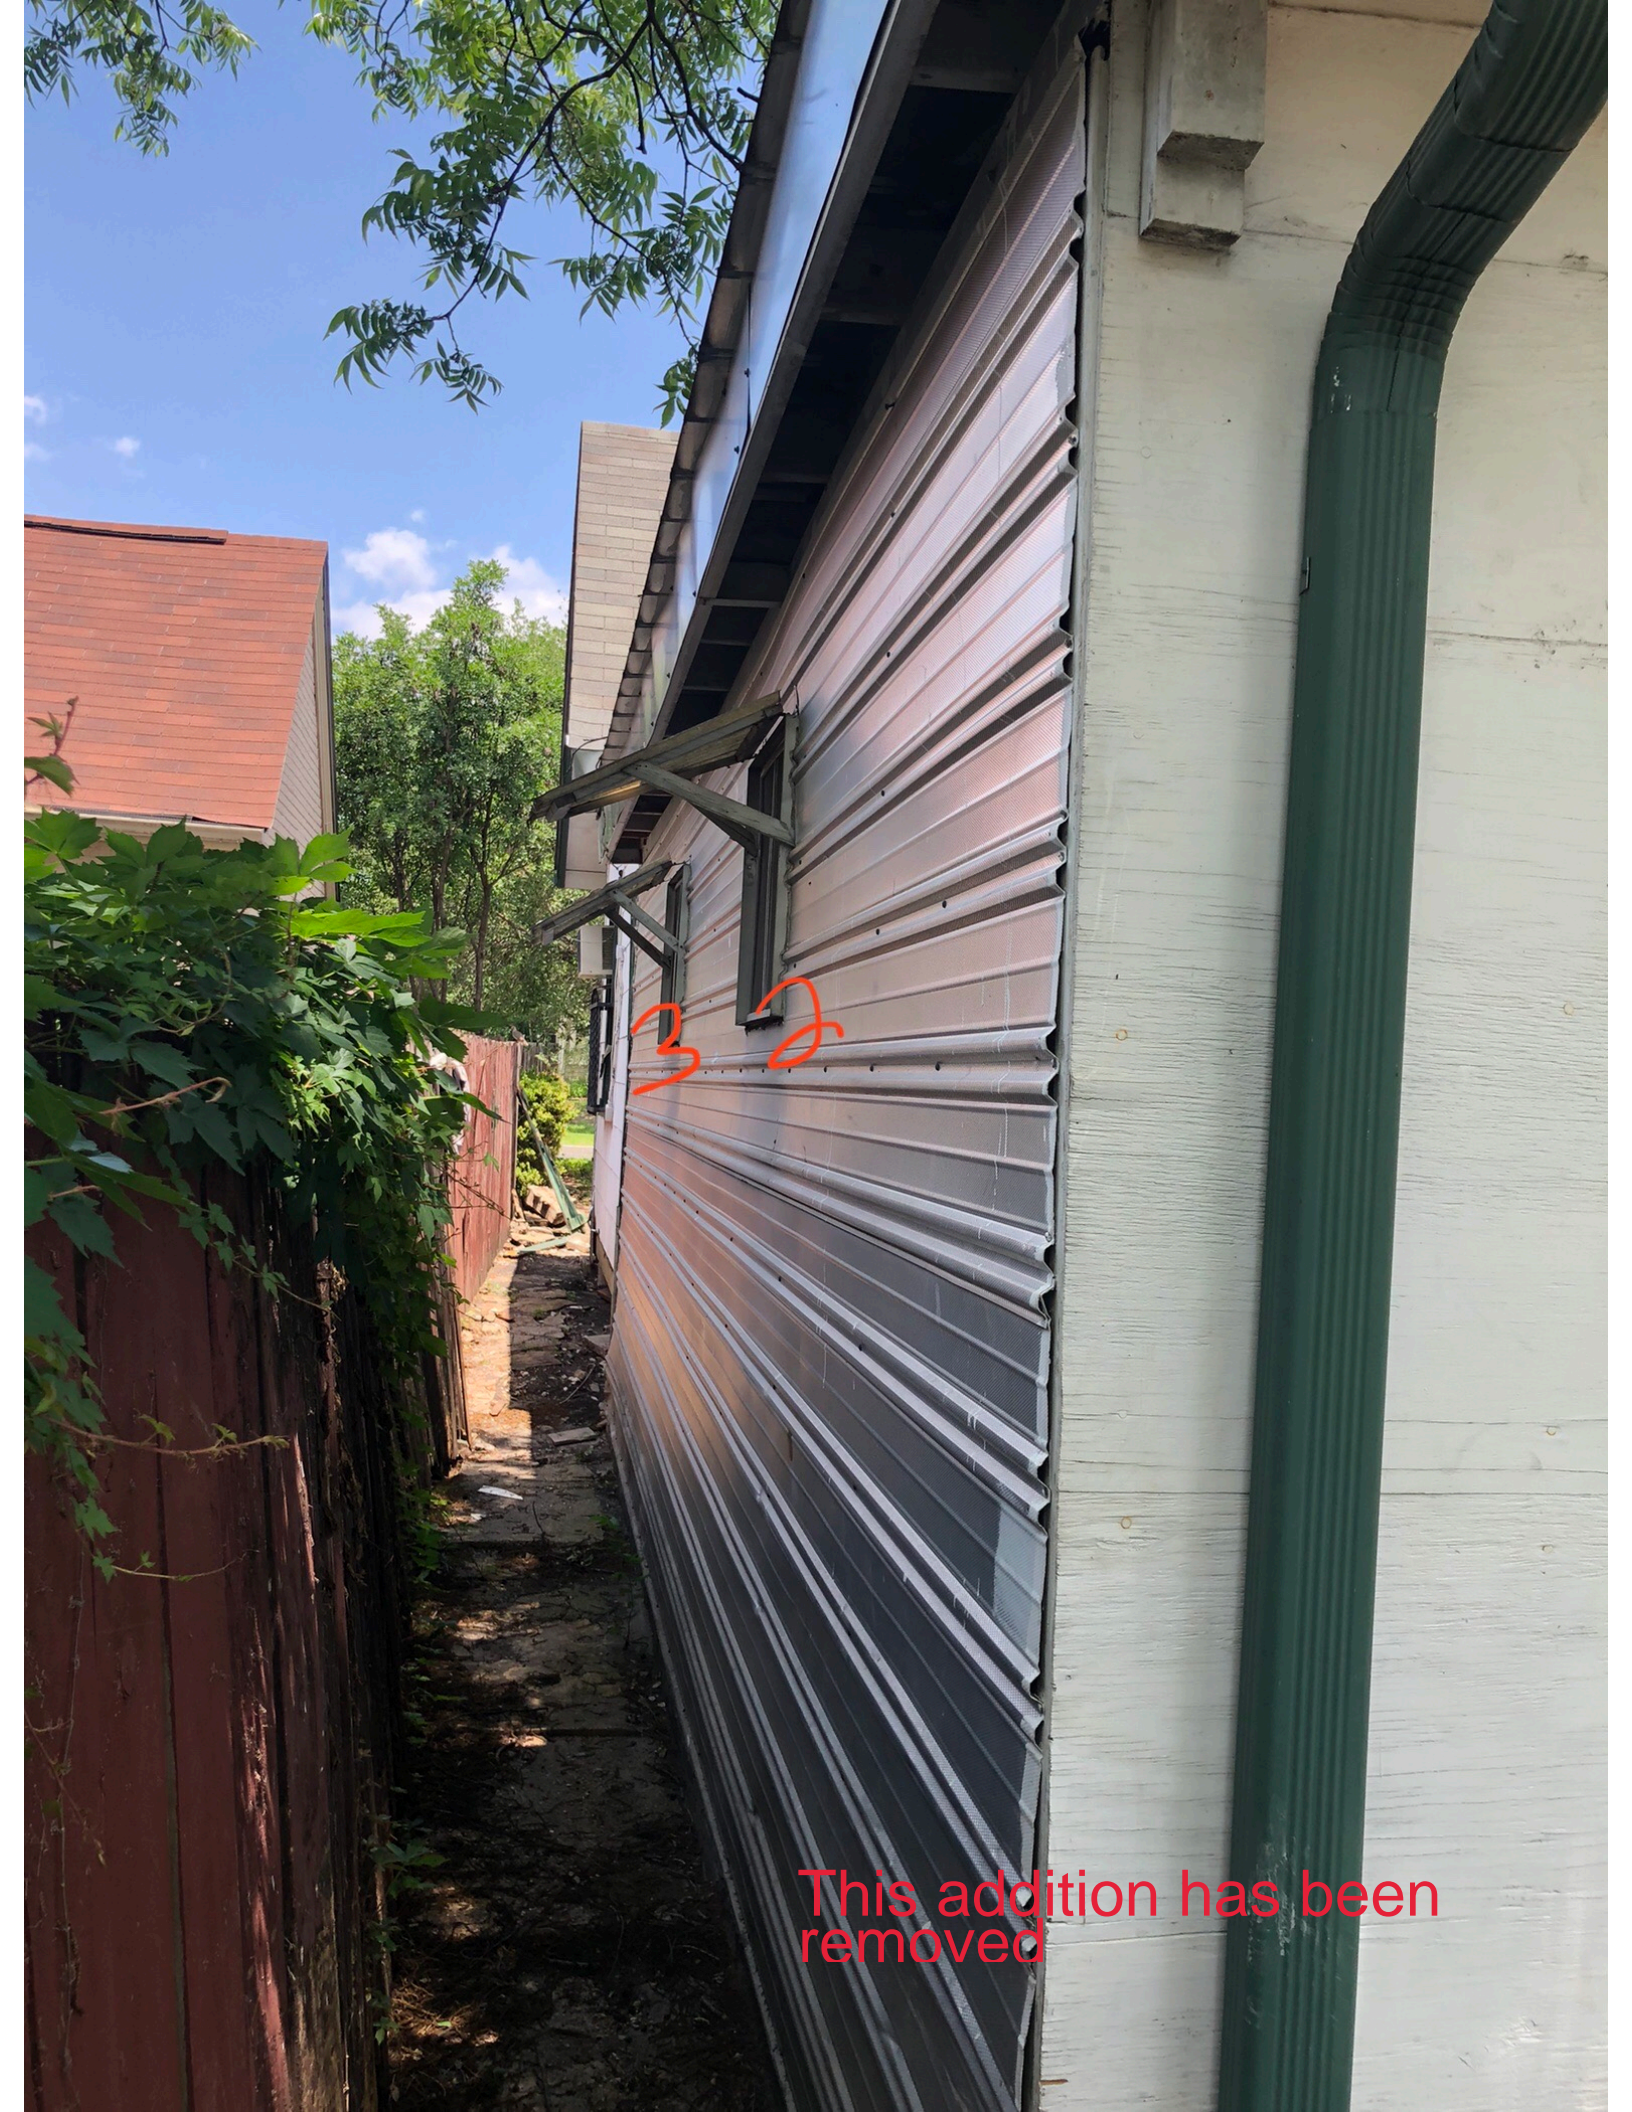
3

This addition has been removed

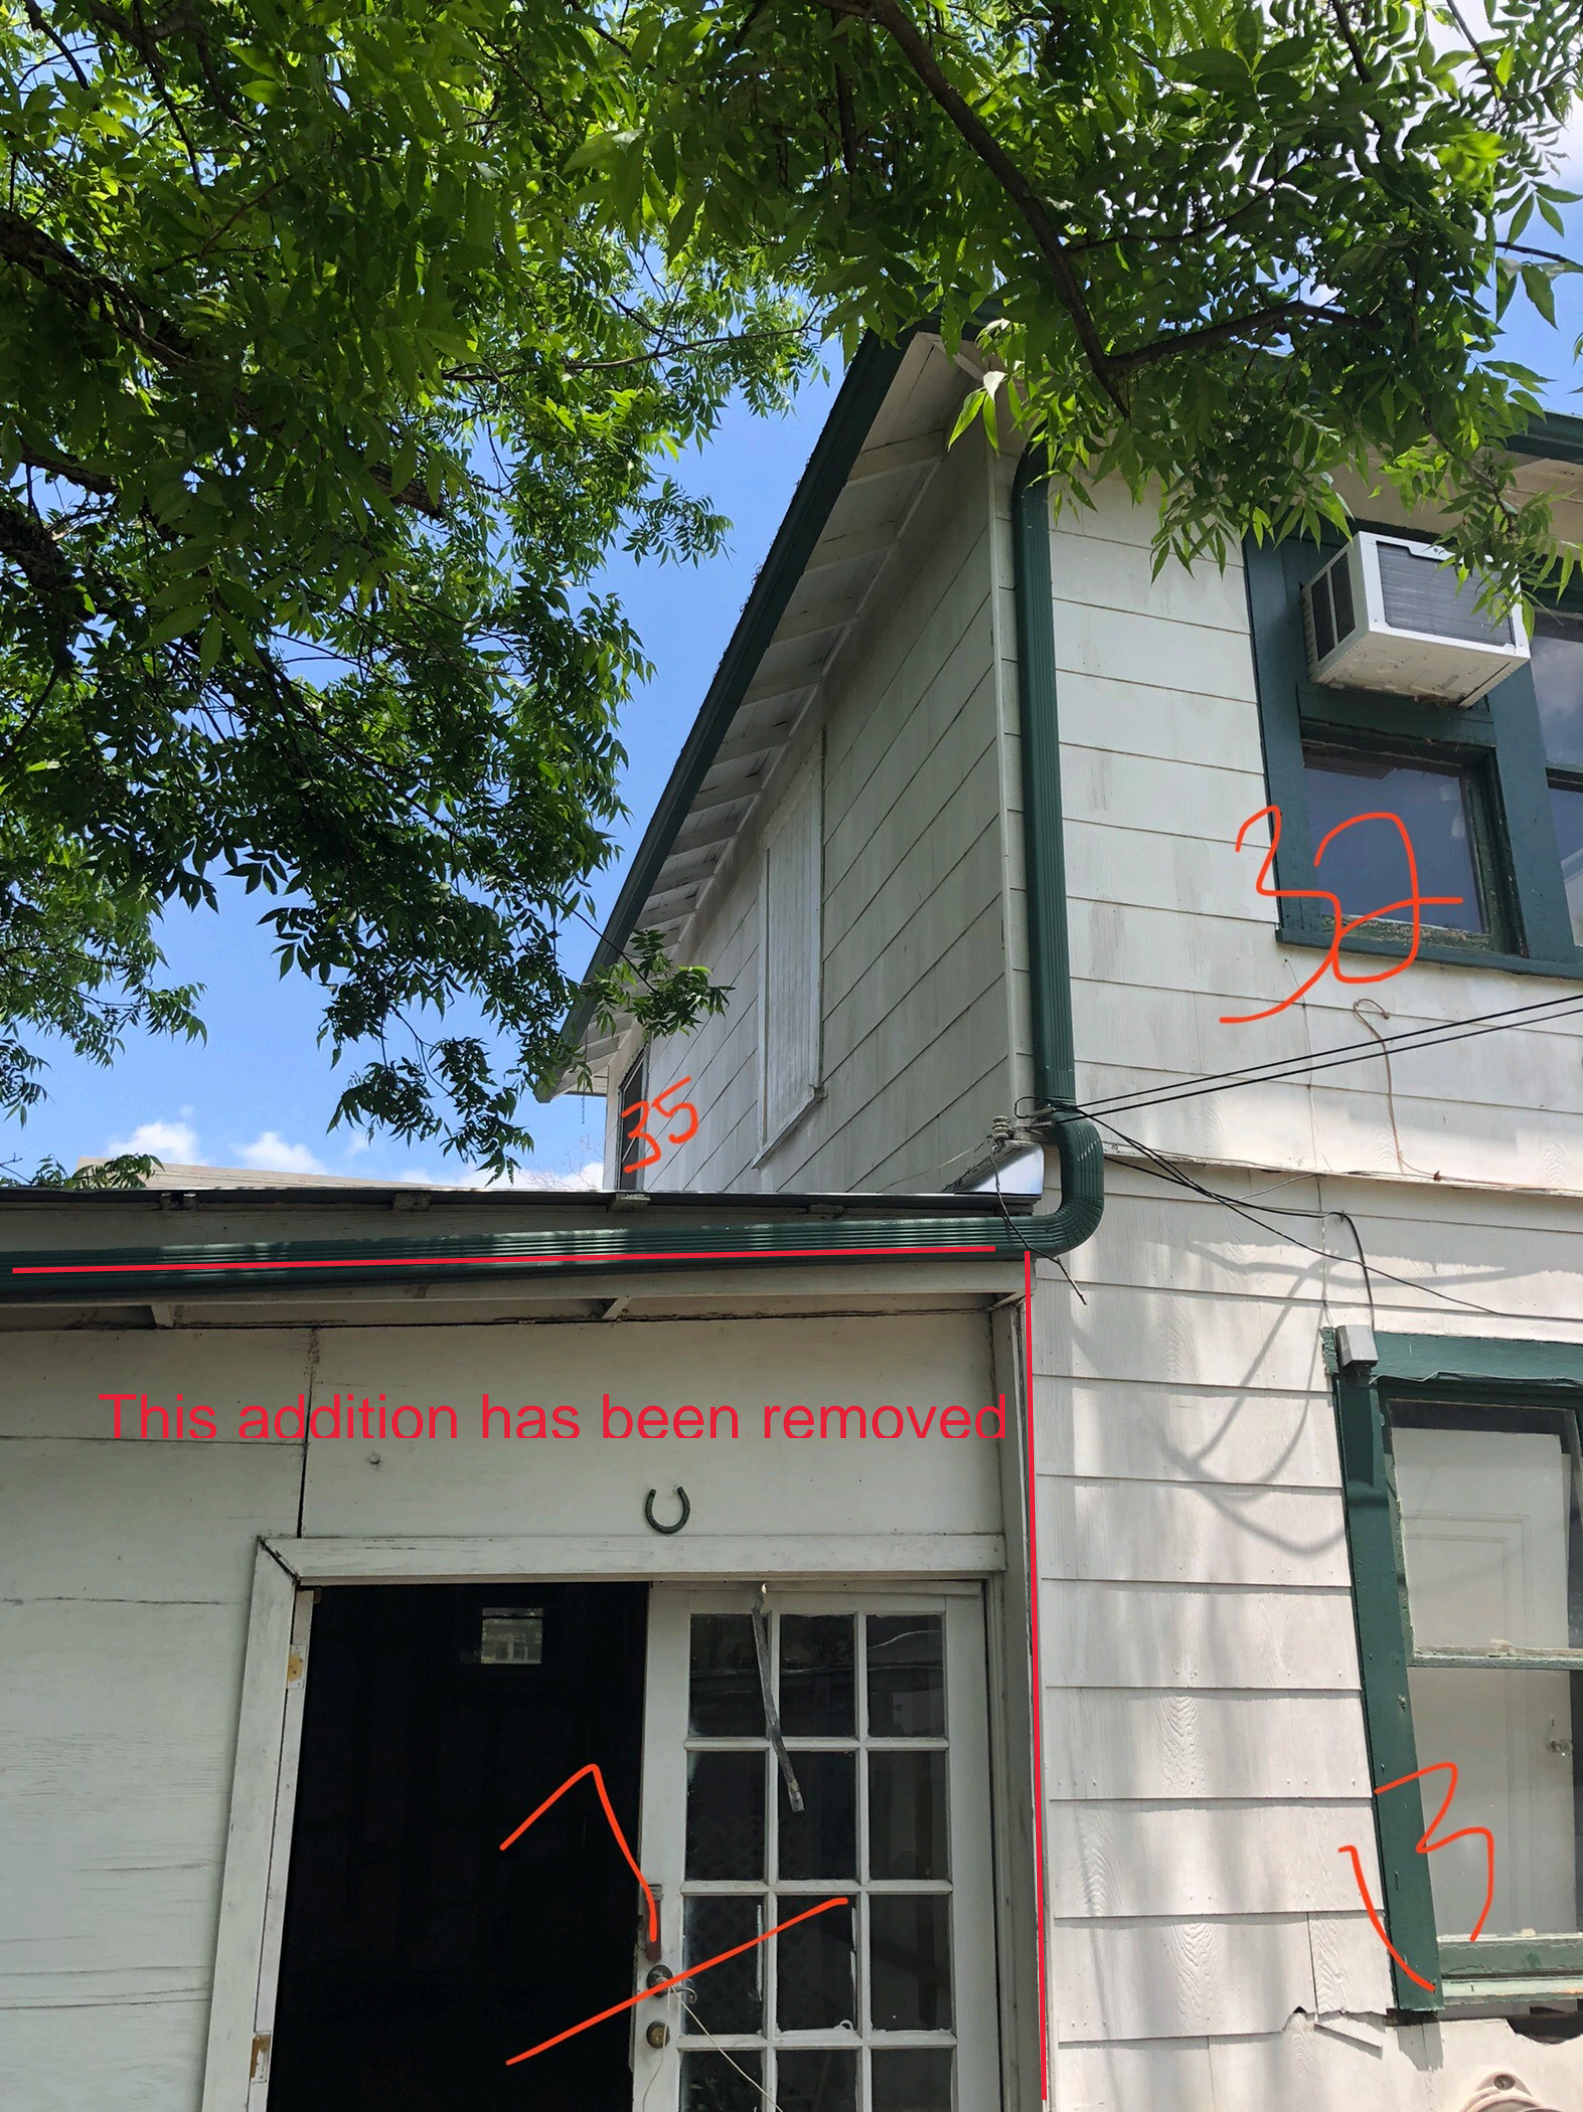
This addition has been removed
