HISTORIC AND DESIGN REVIEW COMMISSION

October 20, 2021

222 W WOODLAWN GARAGE PROJECT

RECONSTRUCTION AND SECOND STORY ADDITION

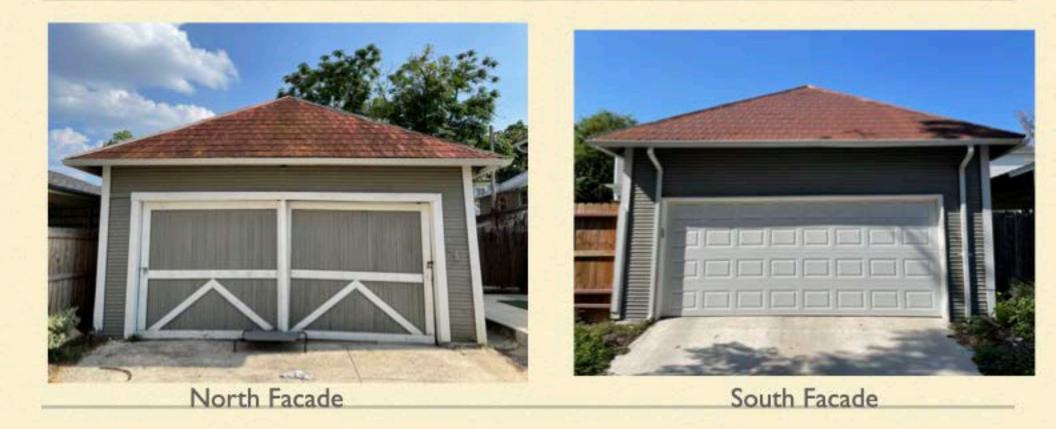
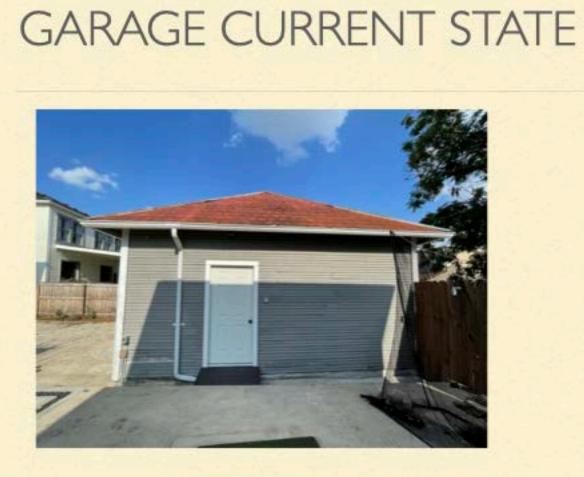
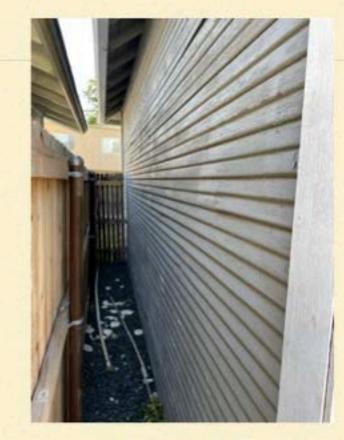
GARAGE CURRENT STATE

- On at least two bearing walls the top plate is not doubled. With the wall studs at 24" on center this condition will not properly support the weight of the roof and does not meet the current standards of the 2018 IRC.

- ? The concrete slab is poured on top of broken concrete and the sub base is in question.
- ? We were not able to determine the structural integrity of the foundation. Further investigation would be required involving digging and exposing the existing foundation.

- ? The building is leaning to the west.
- ? The roof structure does not have any collar ties.
- ? The roof structure does not have any purlins or purlin supports.

- ? There are no rat runs on the ceiling joists.
