# HISTORIC AND DESIGN REVIEW COMMISSION

**HDRC CASE NO:** 2025-045  
**ADDRESS:** 1020 BURNET ST  
**LEGAL DESCRIPTION:** NCB 1660 BLK H LOT N 50 FT OF 6  
**ZONING:** R-6, H  
**CITY COUNCIL DIST.:** 2  
**DISTRICT:** Dignowity Hill Historic District  
**APPLICANT:** Richard Gonzalez  
**OWNER:** Richard Gonzalez/NEXUS SERIES B LLC  
**TYPE OF WORK:** Demolition of rear accessory structure  
**APPLICATION RECEIVED:** February 19, 2025  
**60-DAY REVIEW:** April 20, 2025  
**CASE MANAGER:** Edward Hall  
**REQUEST:**

The applicant is requesting a Certificate of Appropriateness for approval to demolish the existing, rear accessory structure at 1020 Burnet. This property is located within the Dignowity Hill Historic District.

Subject: Structural Evaluation Report – NCB 1660 BLK H LOT N 50 FT OF 6

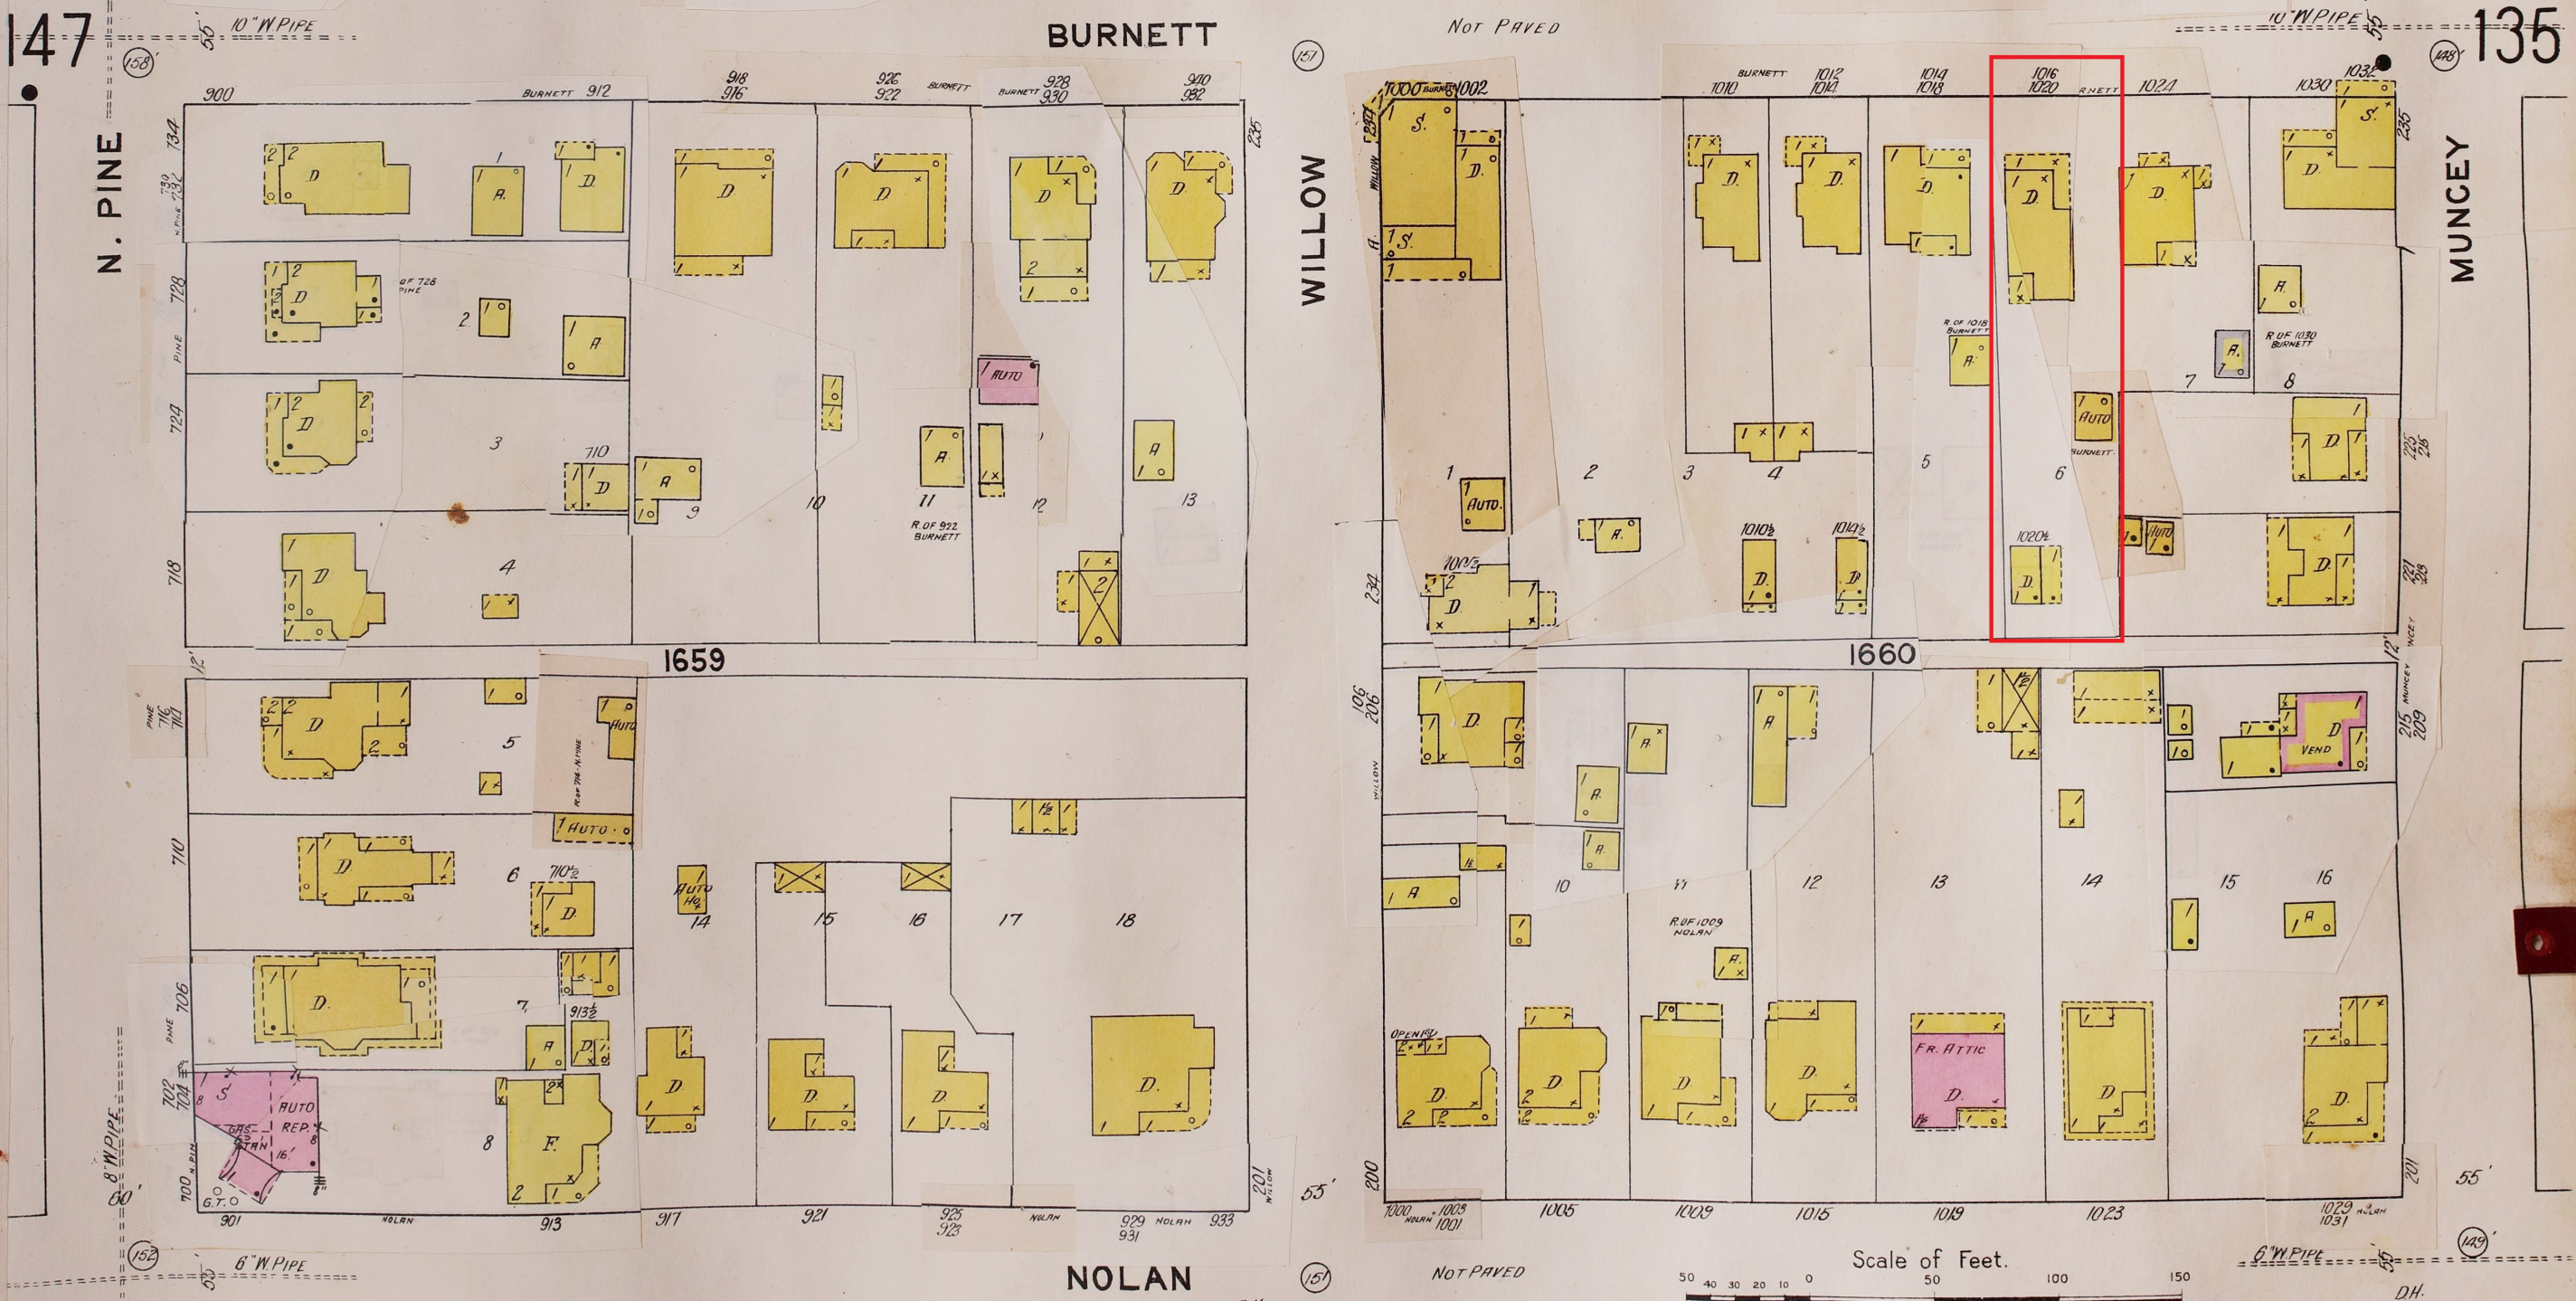
1951 SANBORN MAP

- b. CONTRIBUTING REAR ACCESSORY STRUCTURE DEMOLITION – The applicant has proposed to demolish one, existing rear accessory structure that is contributing to the site. The structure’s current footprint is found on the 1951 Sanborn Map. The oldest portion of the rear accessory structure is found on the 1931 Sanborn Map. The structure features construction details and materials that are contributing to both this property and the Dignowity Hill Historic District. OHP staff performed a site visit on March 27, 2025, and found the structure to be in disrepair with foundation and structural deficiencies.

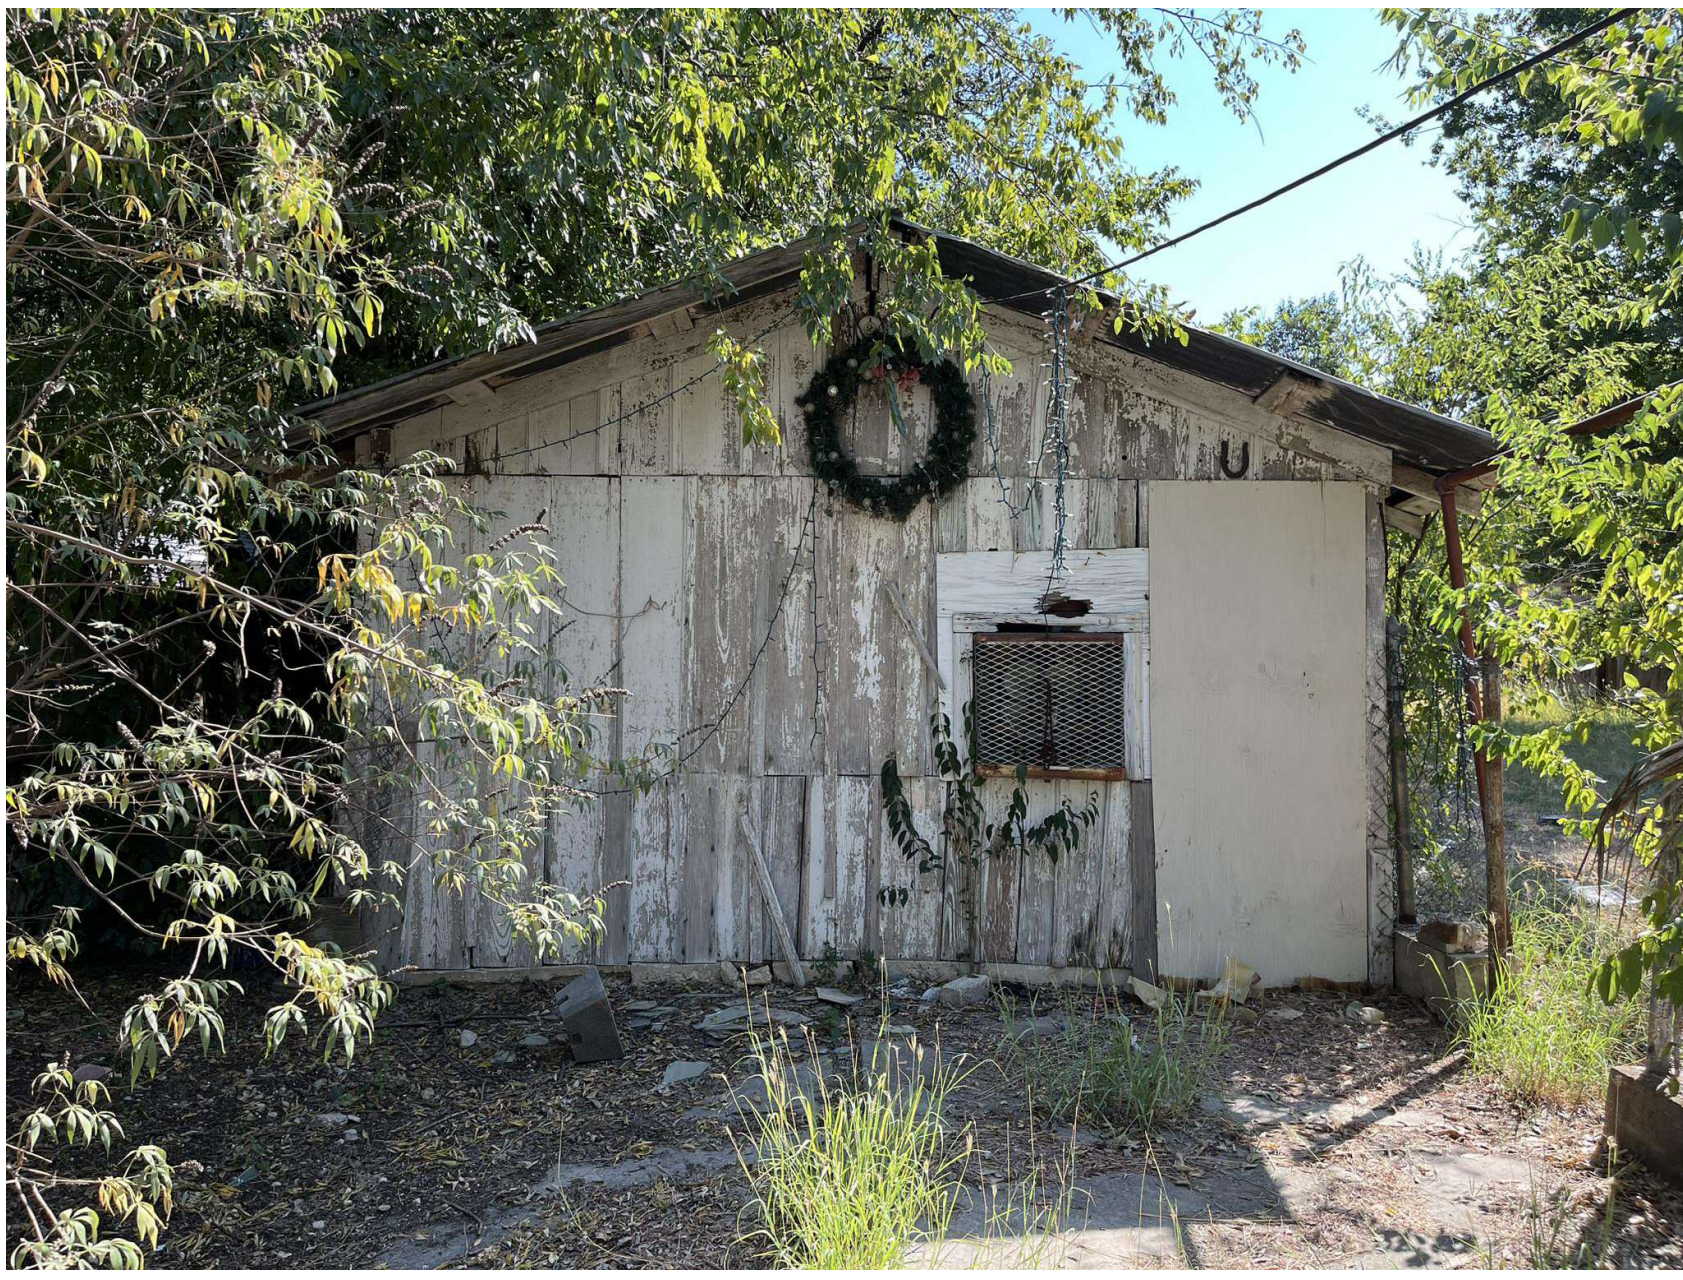
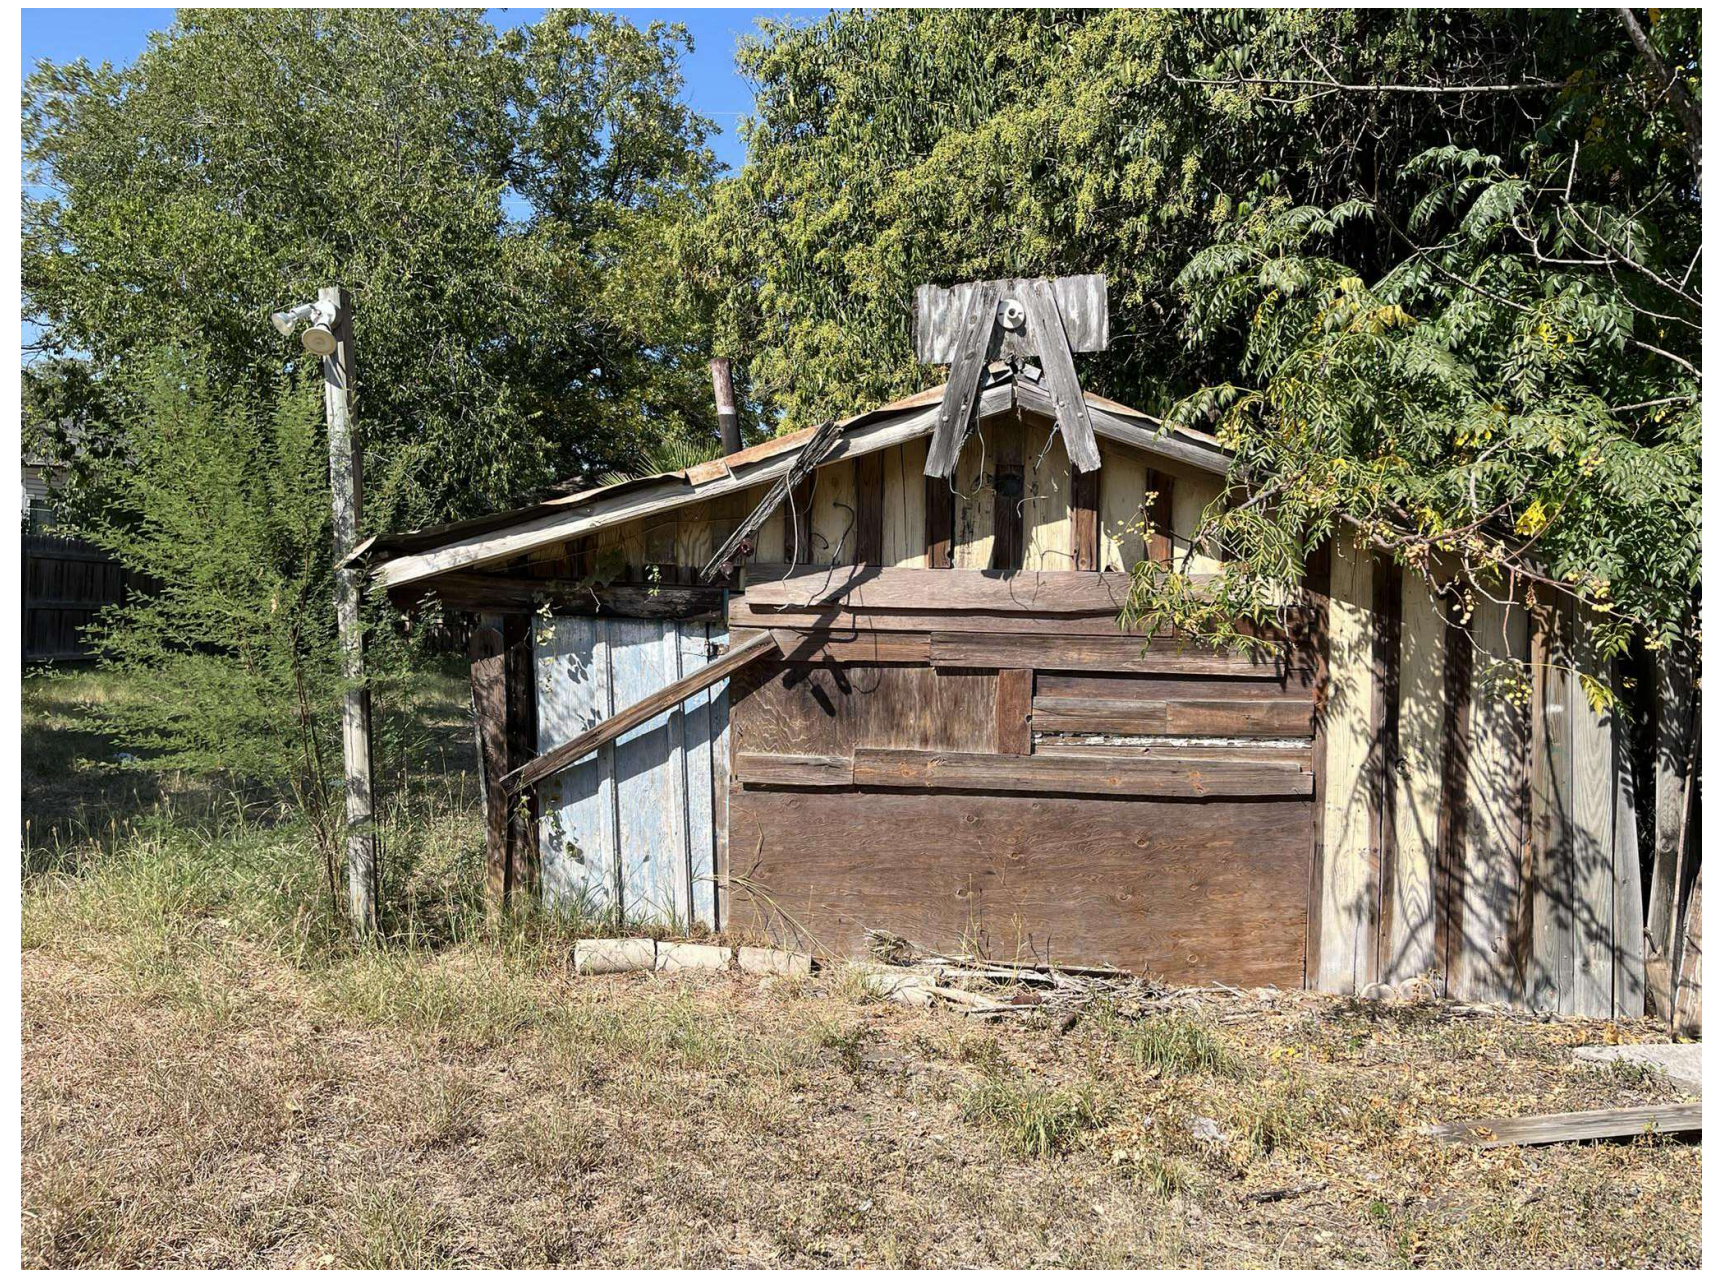
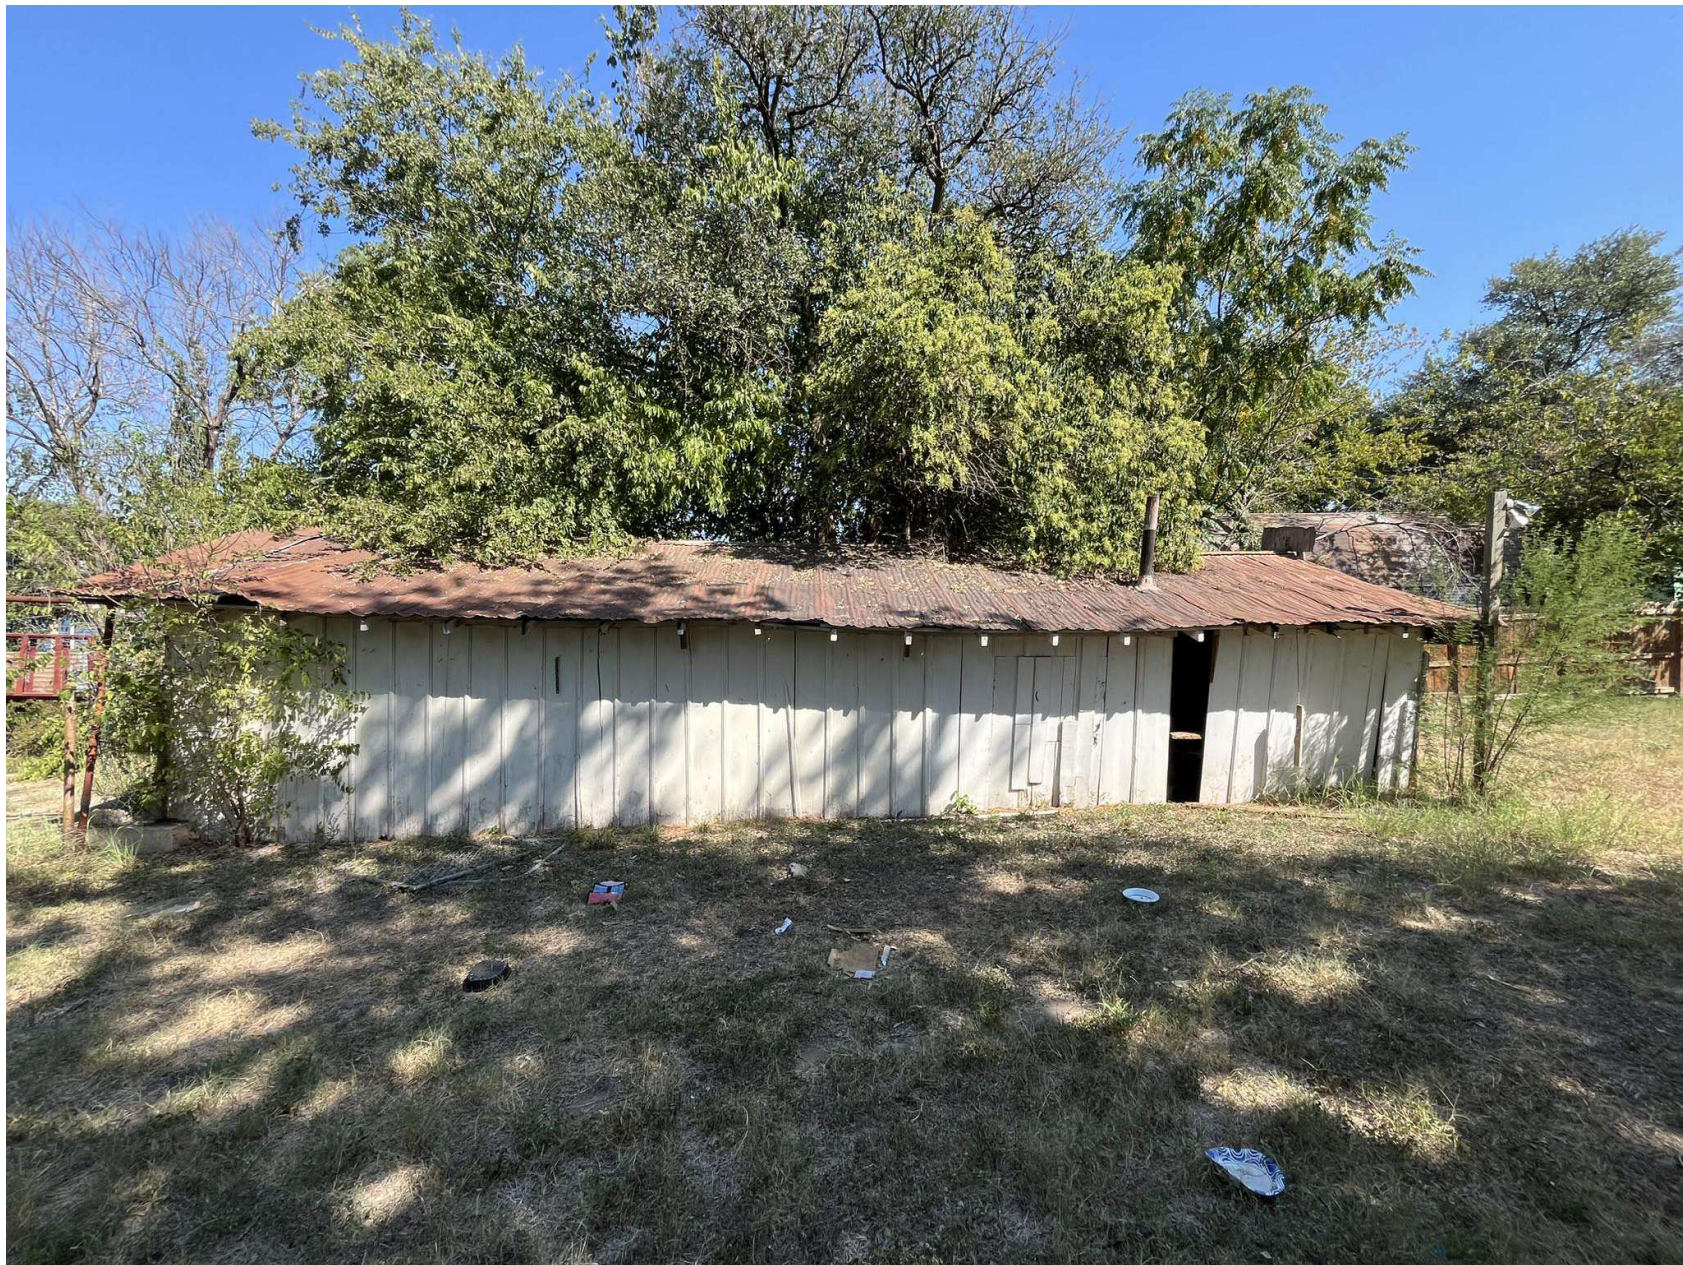
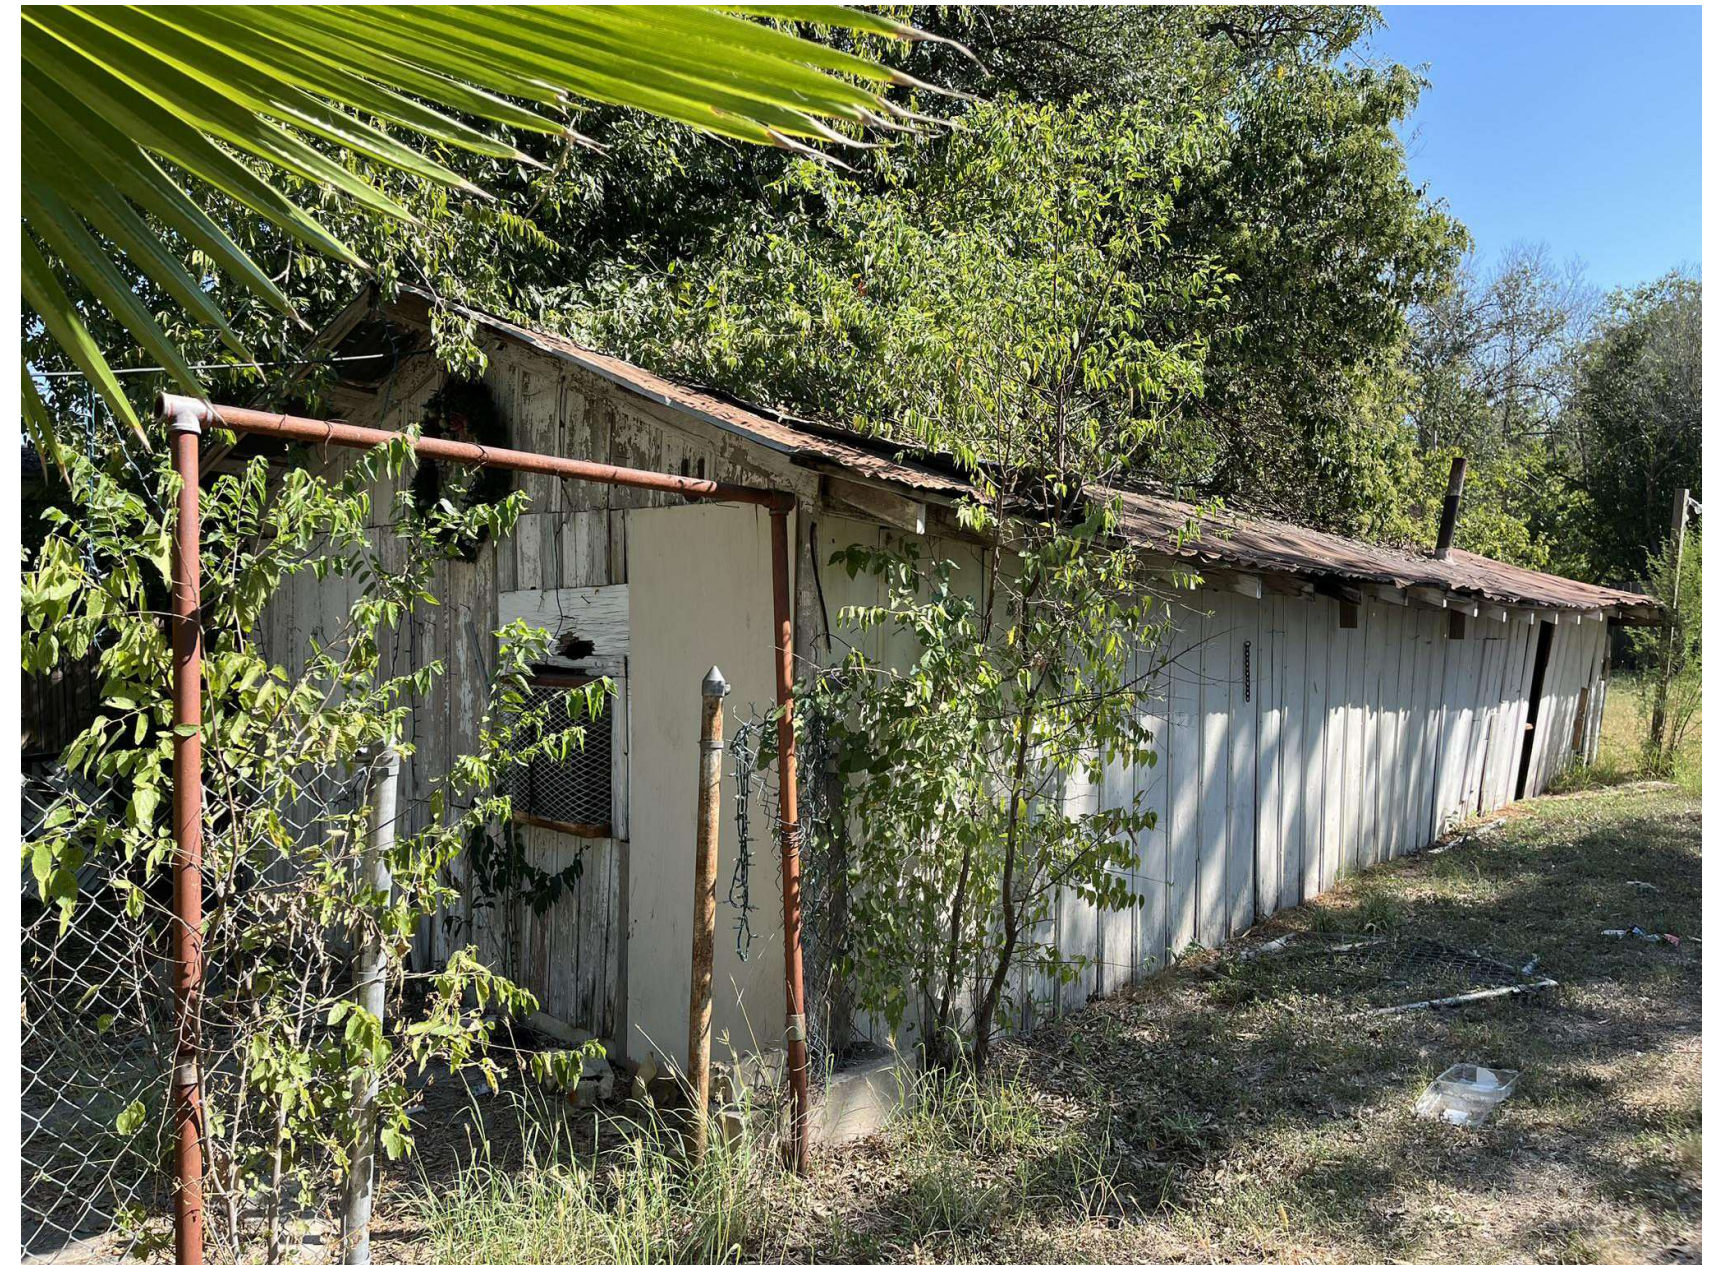
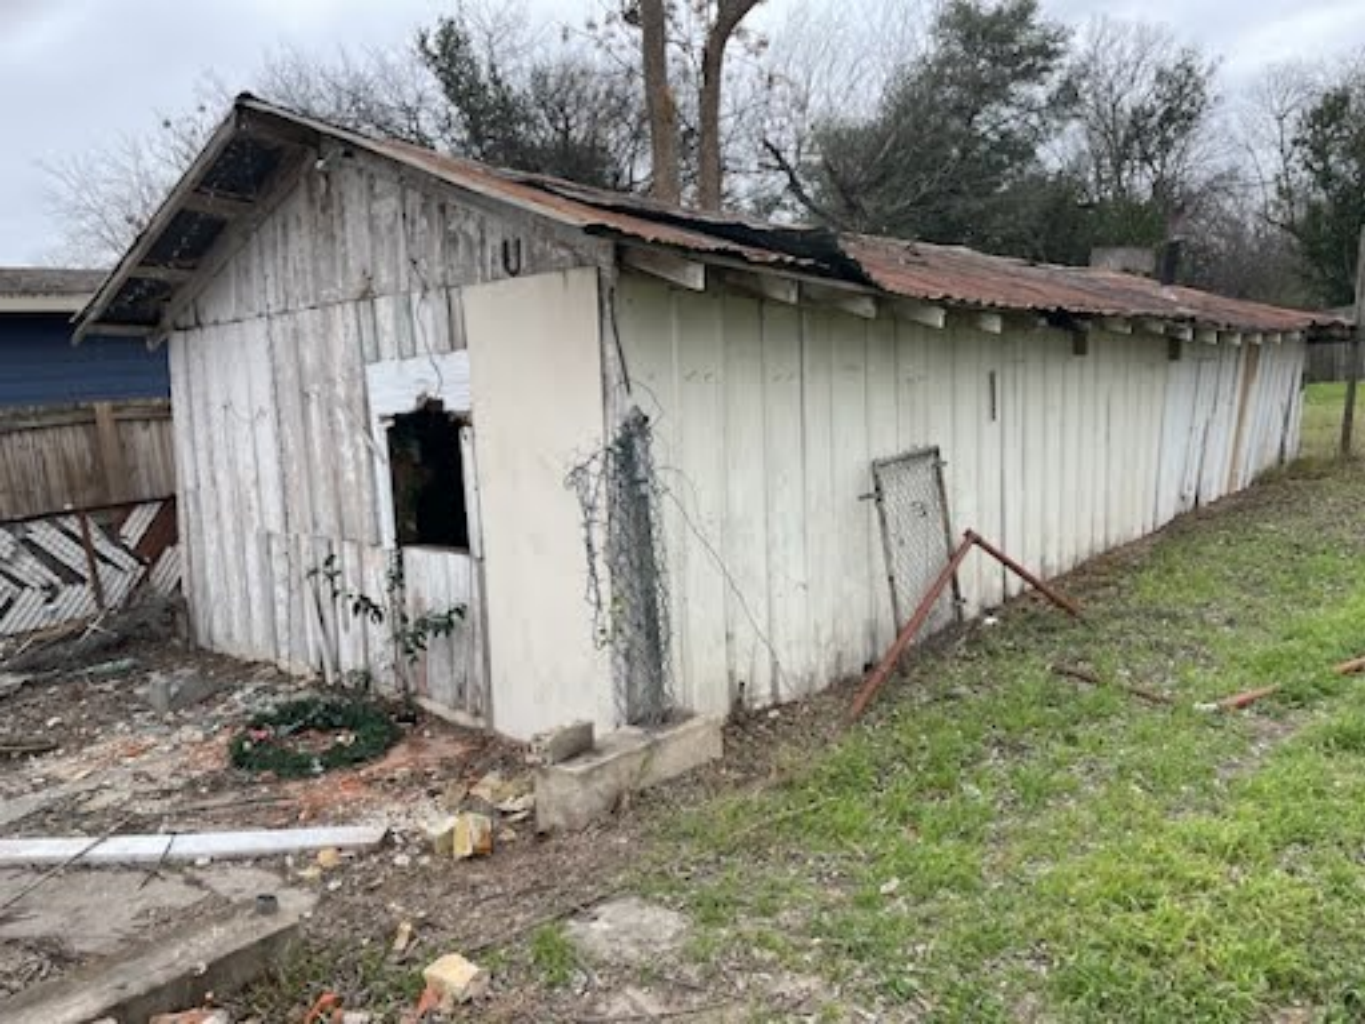
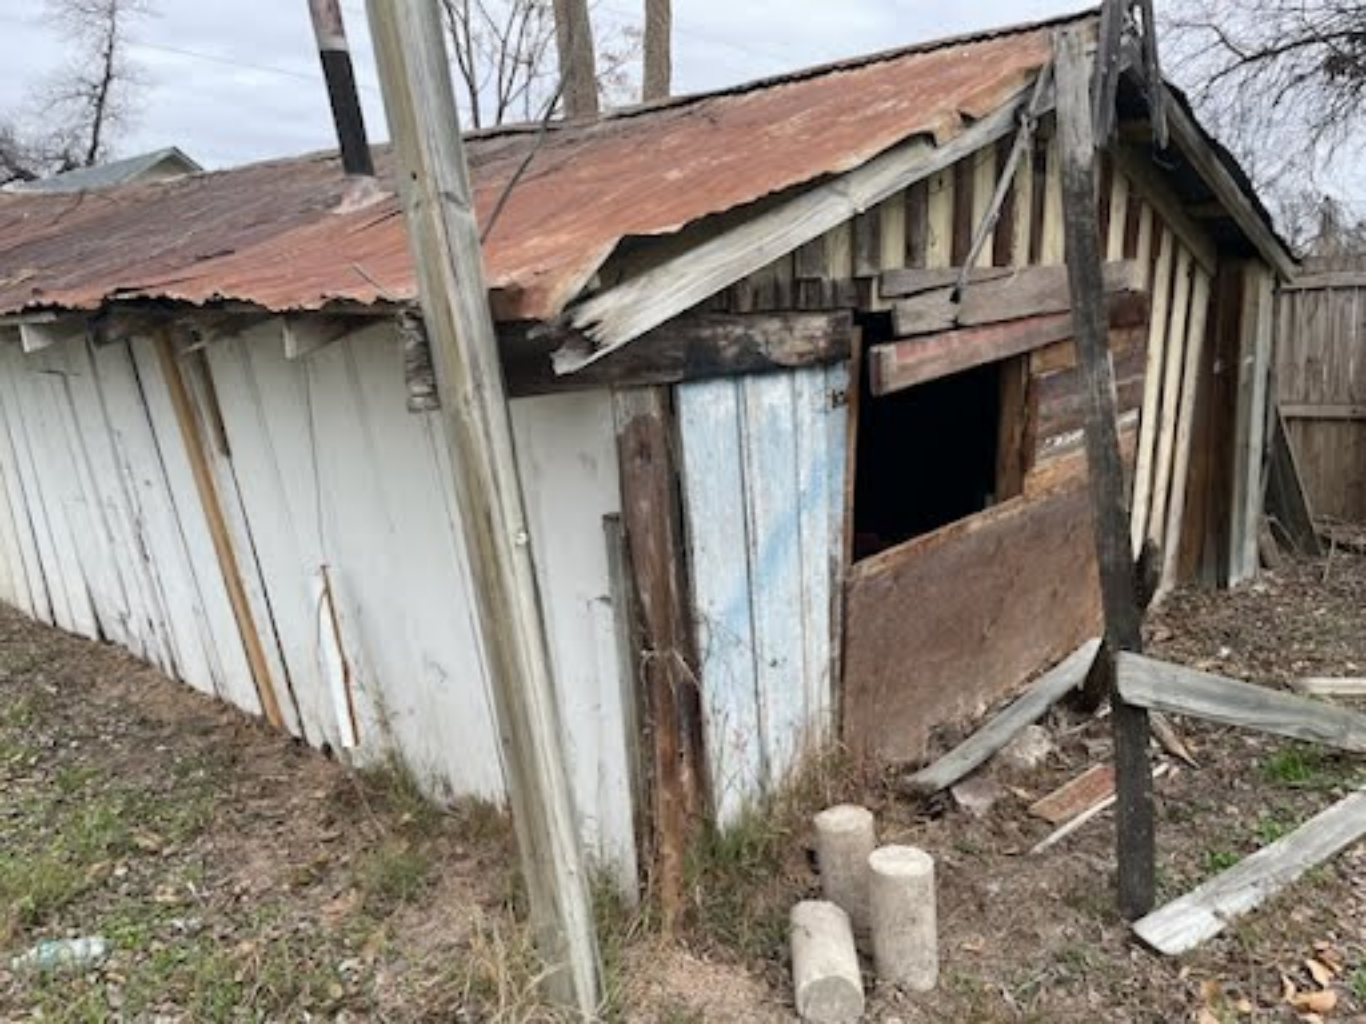
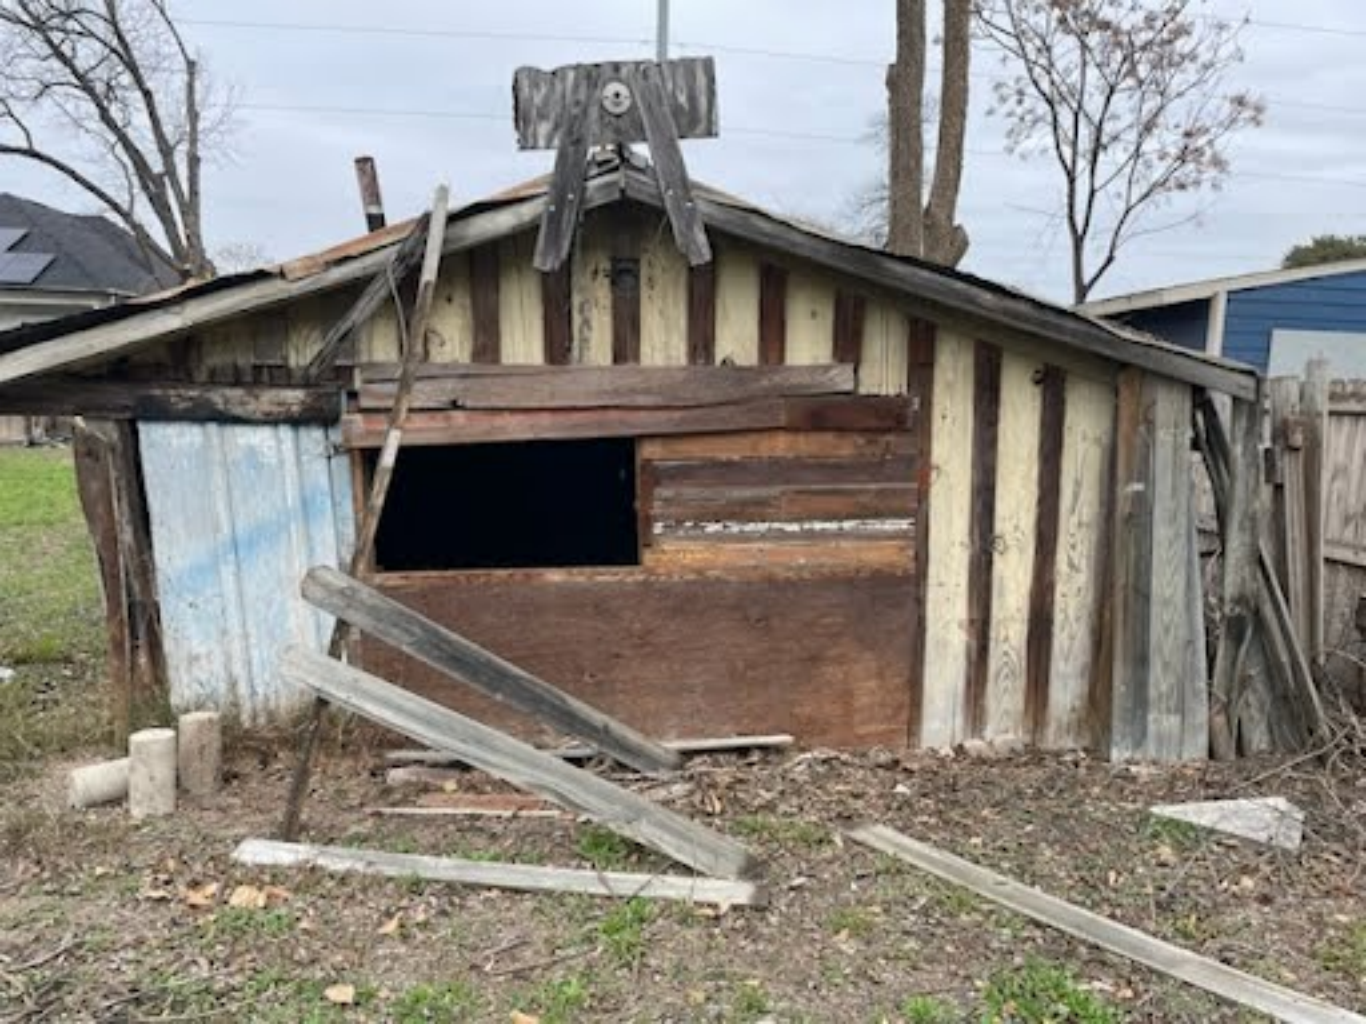
Upon inspection, it was determined that the structural integrity of the shed has significantly deteriorated beyond salvageable repair. The extent of damage observed, including material degradation and compromised load-bearing components, indicates that the structure is no longer viable for restoration or reinforcement. Due to its current condition, the shed does not meet the minimum safety and structural stability requirements outlined in the IRC and poses a potential hazard if left standing.

- **Severe deterioration** has rendered the structure unusable for commercial or residential purposes.
- **No potential revenue generation** due to its current condition, making leasing or selling infeasible.
- **Significant ongoing maintenance costs**, further reducing potential return.

Based on our professional experience, expertise, and adherence to Texas Engineering standards, it is our recommendation that the existing shed structure be fully demolished and replaced to ensure compliance with modern building codes and safety regulations.
