**HISTORIC AND DESIGN REVIEW
COMPLIANCE AND TECHNICAL ADVISORY BOARD
May 17, 2024**

HDRC CASE NO: 2024-180
ADDRESS: 504 N HACKBERRY ST
LEGAL DESCRIPTION: NCB 570 BLK 6 LOT N 56.05 FT OF 13-14
ZONING: C-2, H
CITY COUNCIL DIST.: 2
DISTRICT: Dignowity Hill Historic District
APPLICANT: Richard Gonzalez | CHAPAWU PROPERTIES LLC
OWNER: Richard Gonzalez | CHAPAWU PROPERTIES LLC
TYPE OF WORK: Fenestration modifications and window replacement
APPLICATION RECEIVED: May 3, 2024
60-DAY REVIEW: July 2, 2024

The applicant is requesting a Certificate of Appropriateness for approval to:

1. Replace wholesale the windows on the property.
2. Modify the existing fenestration pattern.

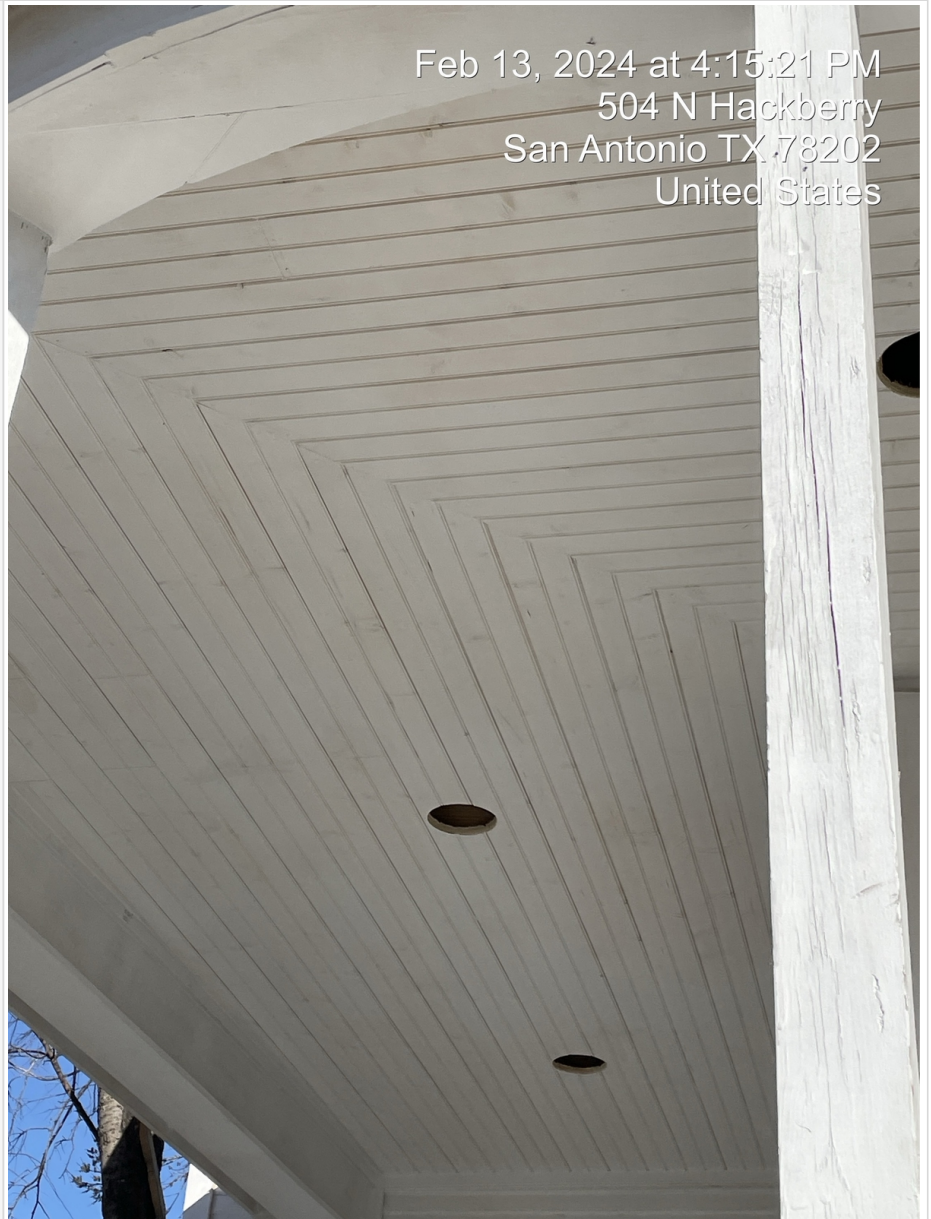
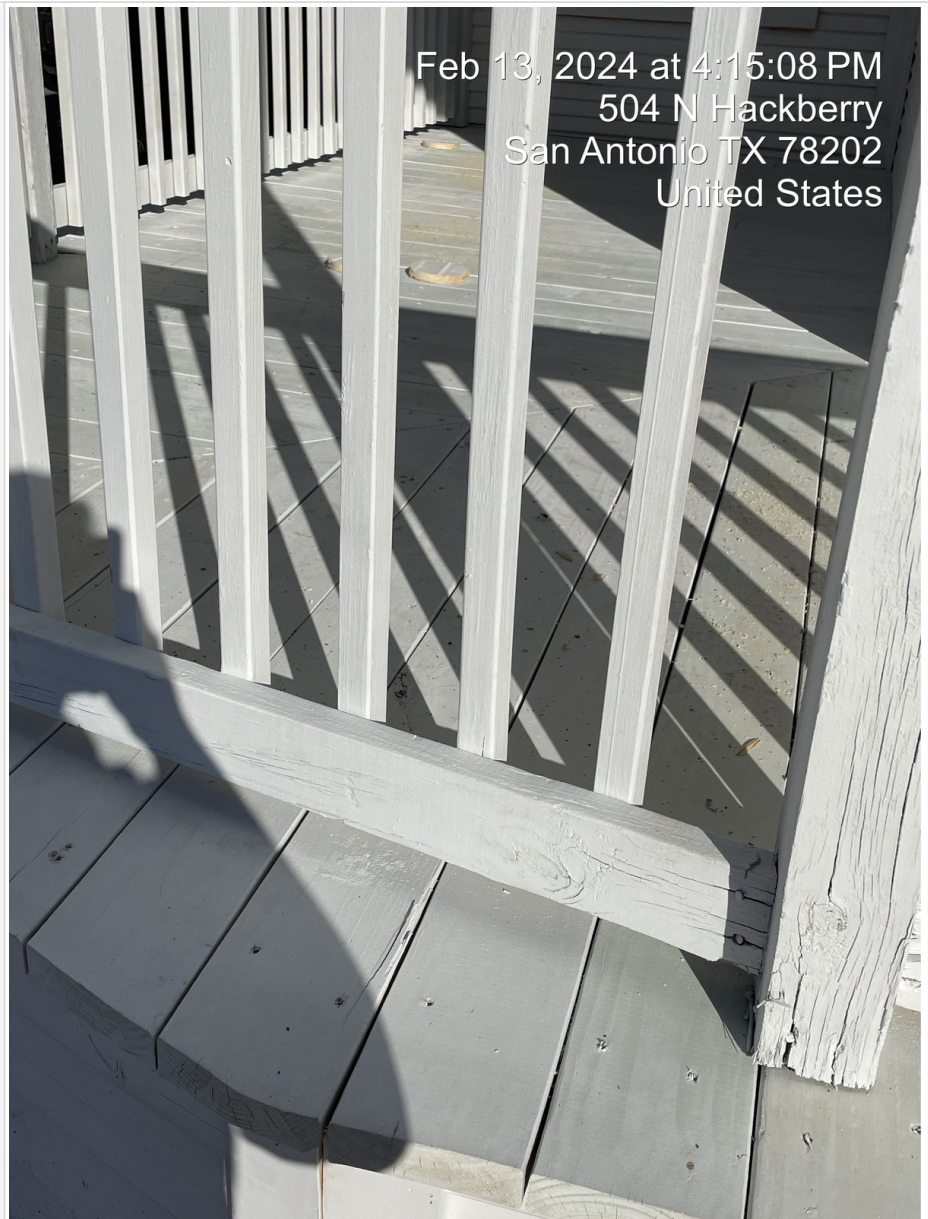
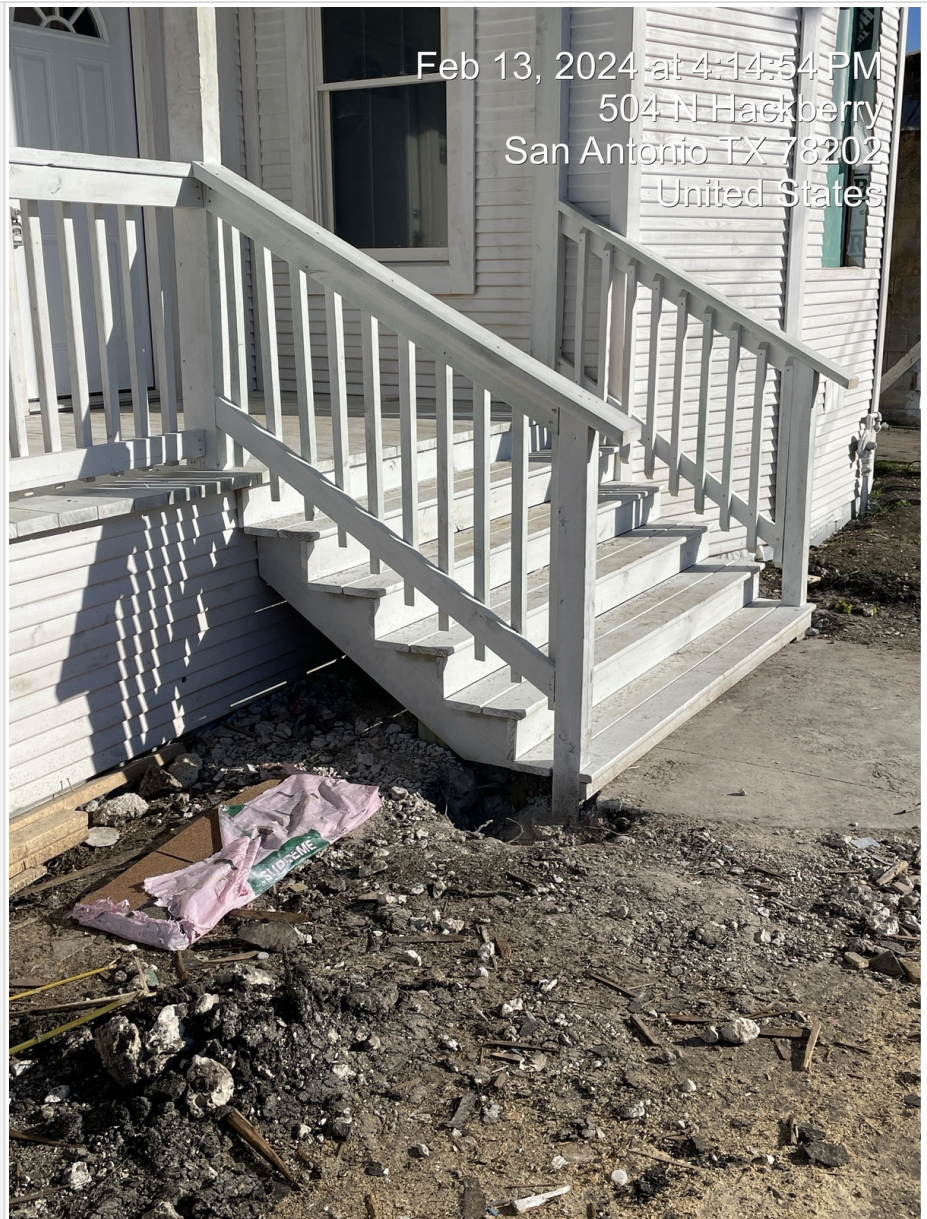
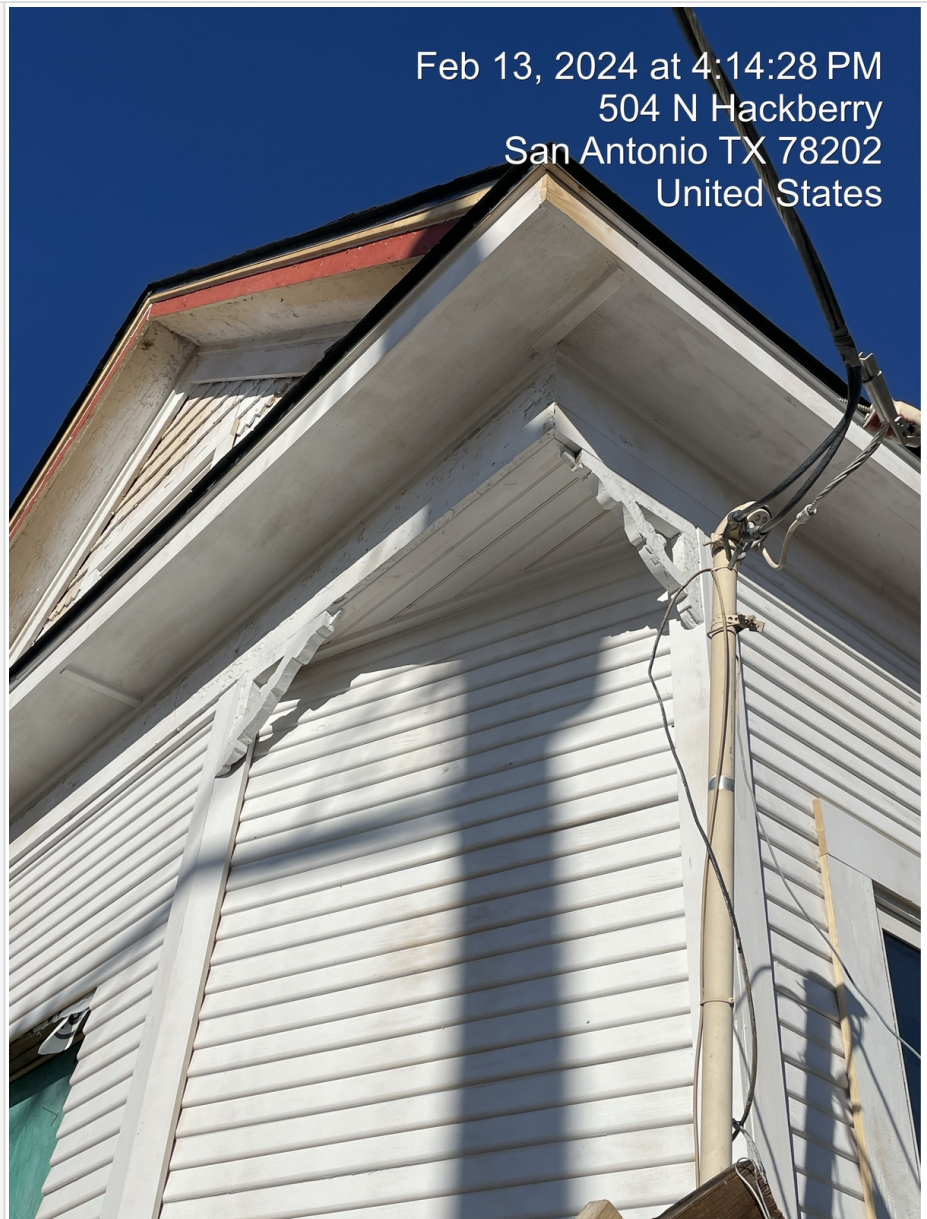
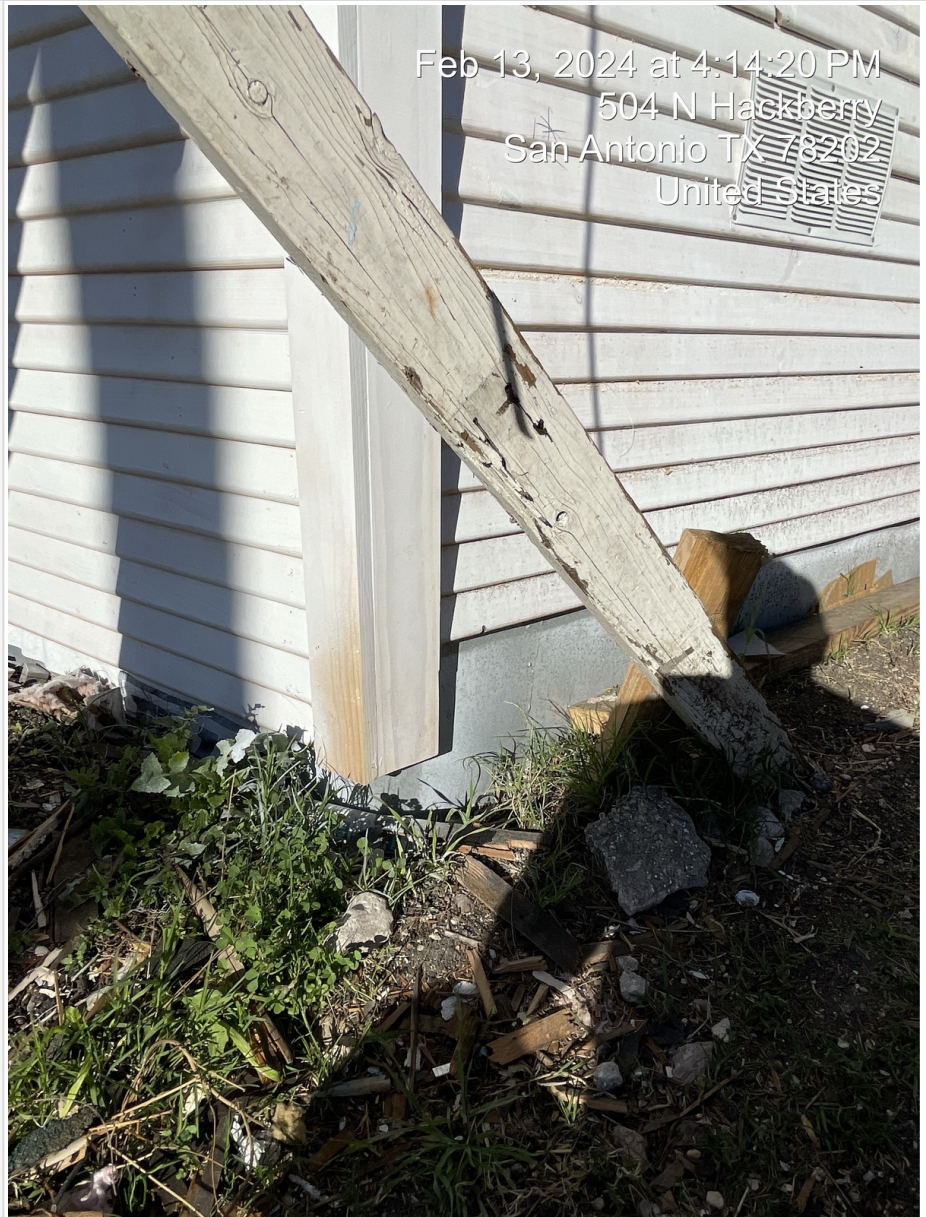
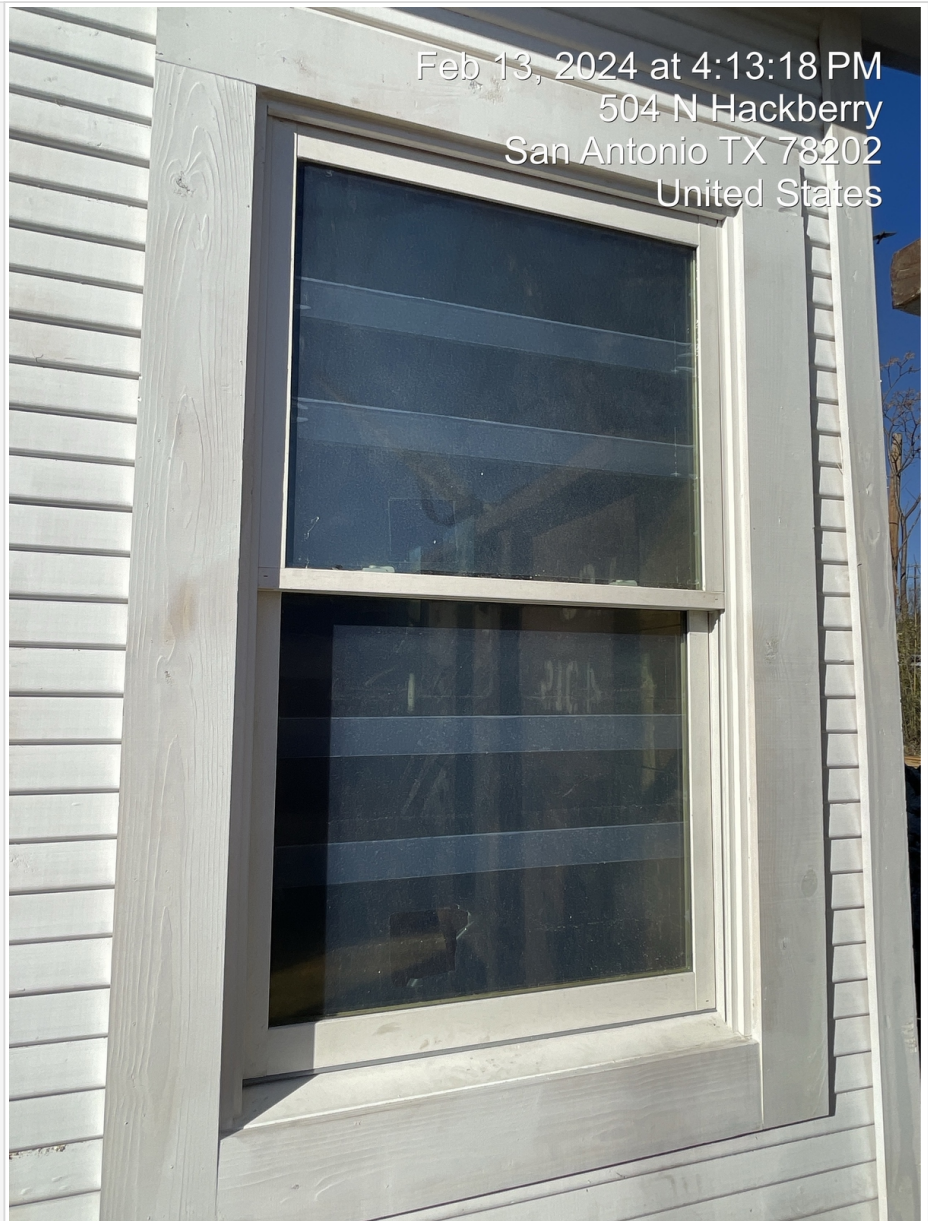
Photographs

- d. **SITE VISIT** – On February 13, 2024, staff conducted a site visit to take current photos of the structures condition. The photos taken show the modifications made as described in finding b.

Date	02/13/2024
Time	04:15 PM (-6 GMT)
Context	follow-up
Present Staff	Edward Hall, Bryan Morales
Present Individuals	None
Types of Work Observed	Exterior Maintenance and Alterations
Amount of Work Completed	75%
Description of work	Fenestration modifications, window replacement, wholesale siding replacement.
