HISTORIC AND DESIGN REVIEW COMMISSION

HDRC CASE NO: 2024-326
ADDRESS: 517 WICKES
LEGAL DESCRIPTION: NCB 2916 BLK 5 LOT 17
ZONING: RM-4, H
CITY COUNCIL DIST.: 1
DISTRICT: King William Historic District
APPLICANT: FLORES STEPHANIES & JOE MARK
OWNER: FLORES STEPHANIES & JOE MARK
TYPE OF WORK: Demolition of a landmark (rear accessory)
APPLICATION RECEIVED: September 02, 2024
60-DAY REVIEW: November 01, 2024
CASE MANAGER: Rachel Rettaliata

The applicant is requesting a Certificate of Appropriateness for approval to demolish the rear accessory structure and conceptual review of a replacement structure.

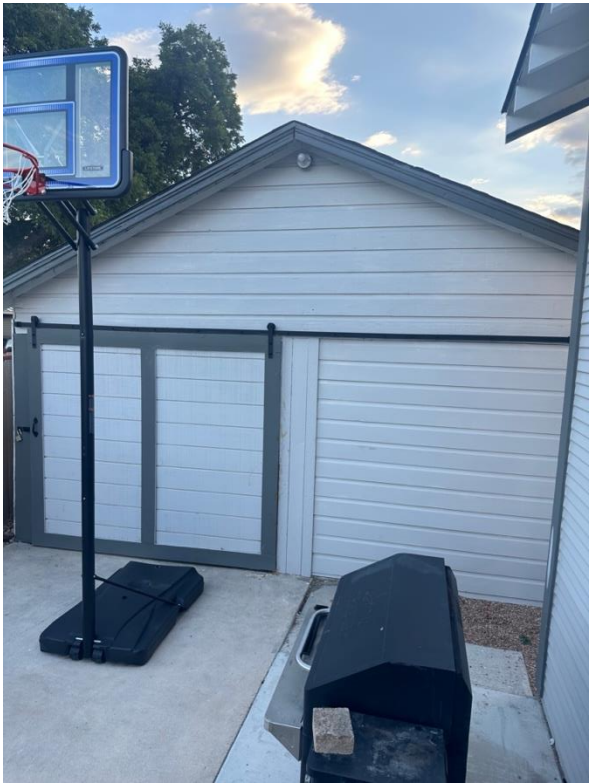
Front of garage with new temp door and replacement of some wood boards

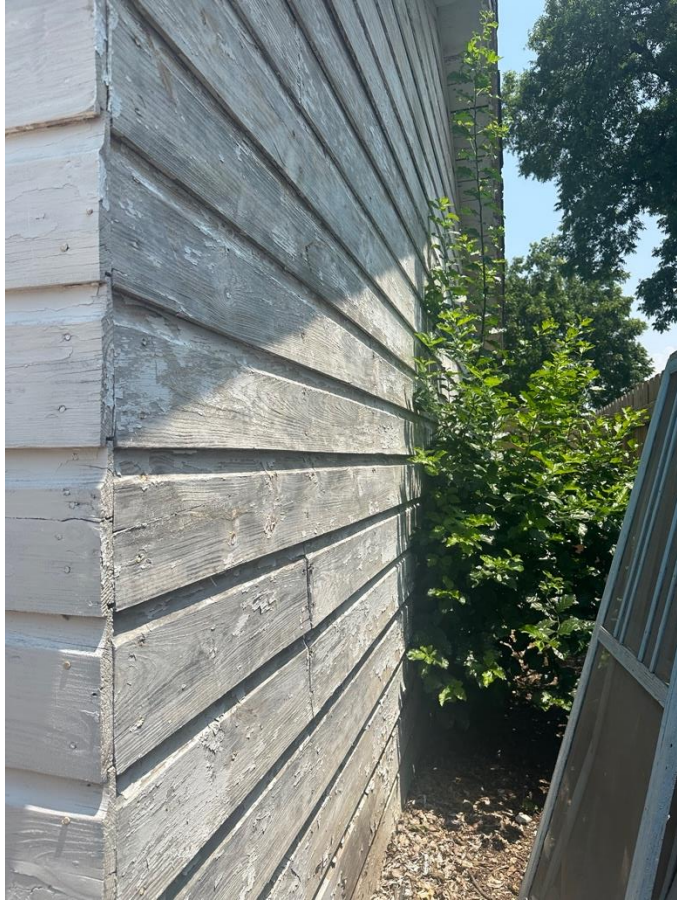
Rear of Garage.

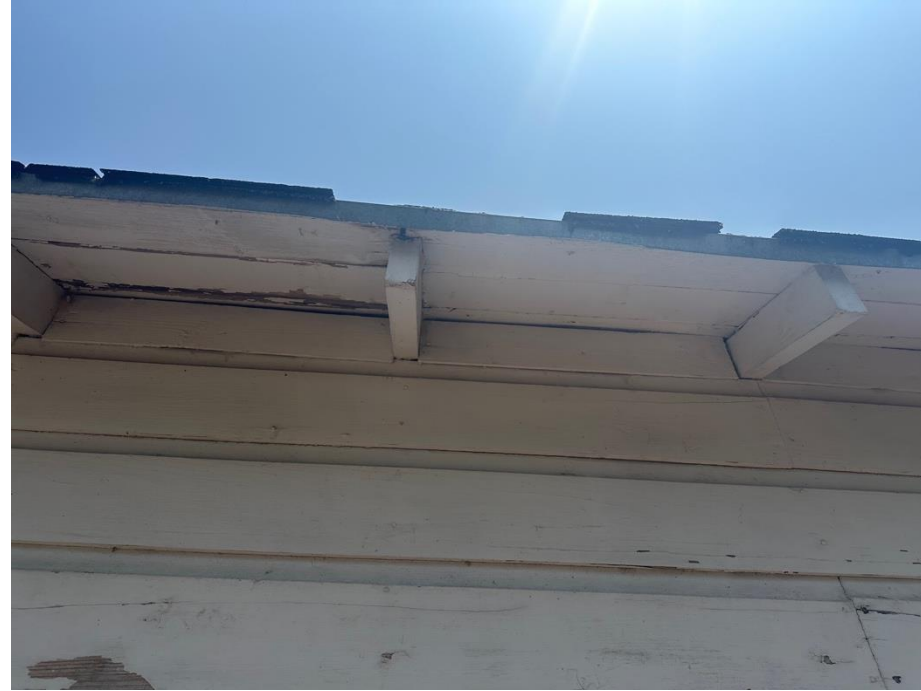
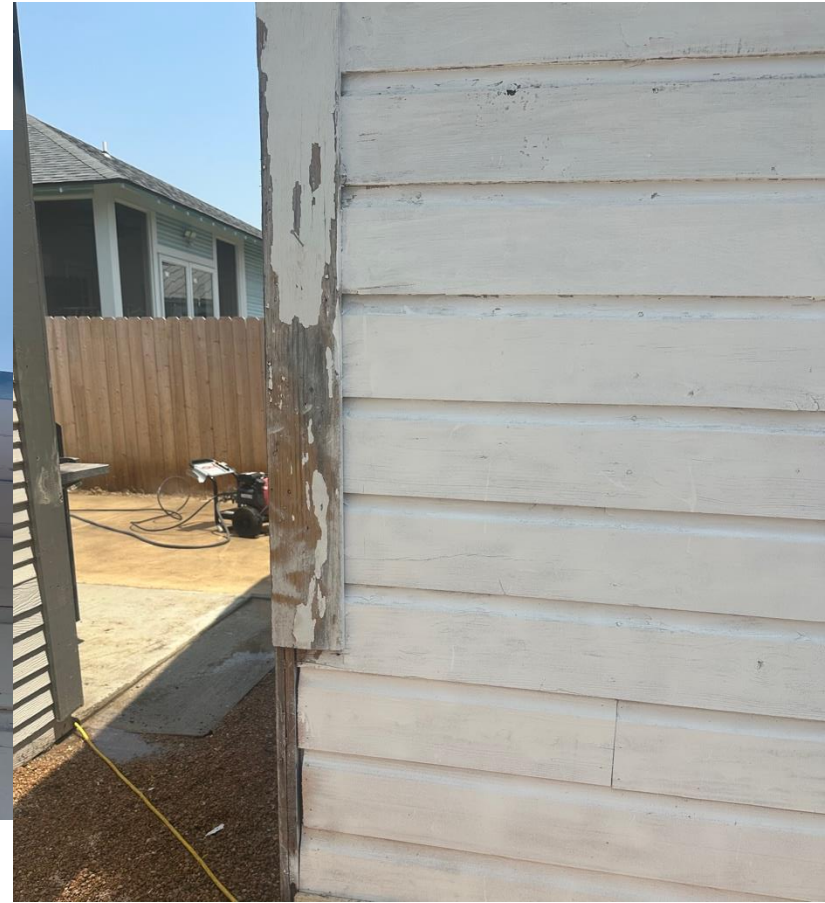
Sofit is damaged

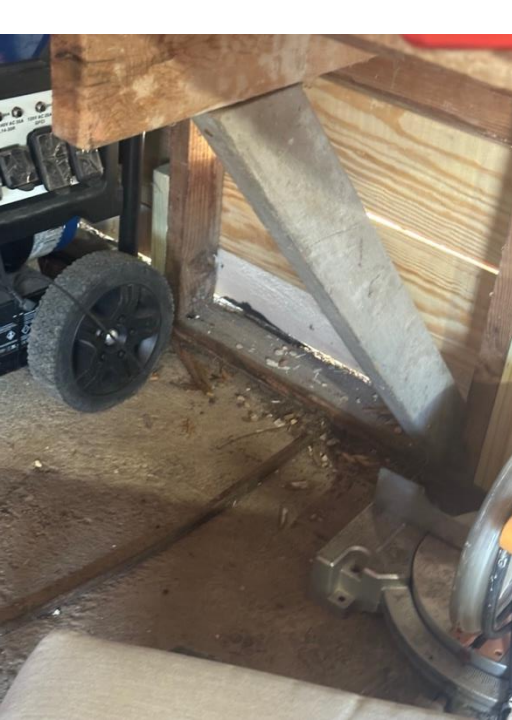
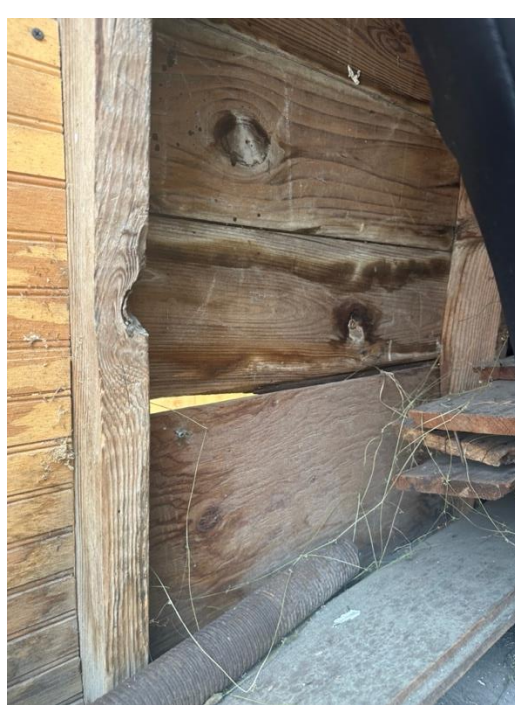
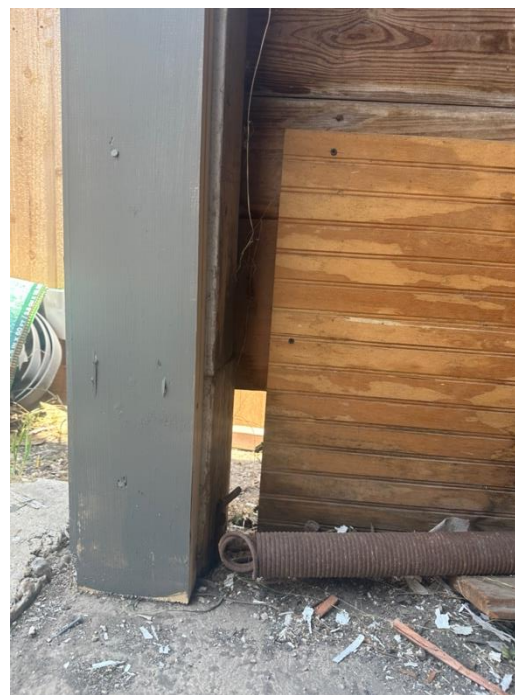
Damaged Wood

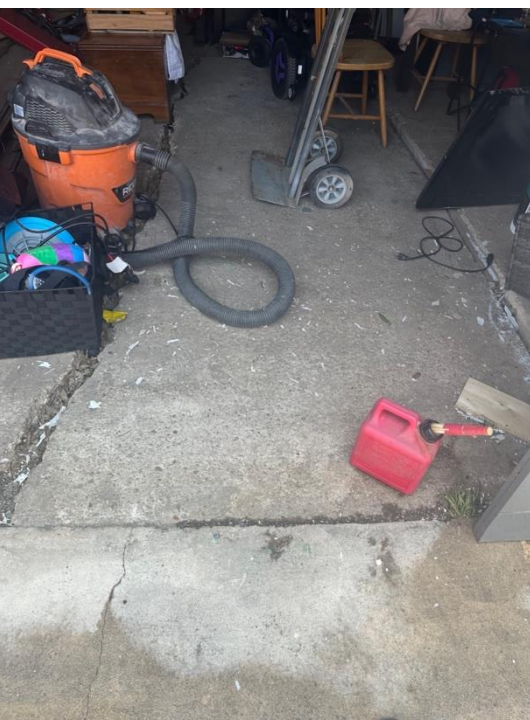
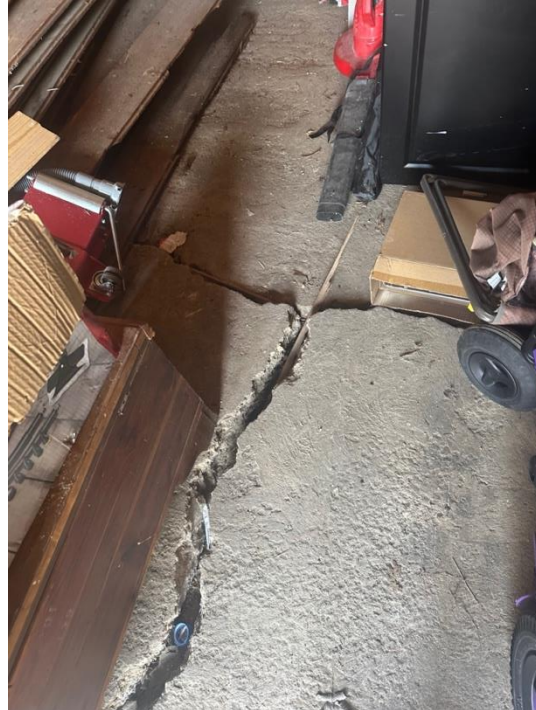
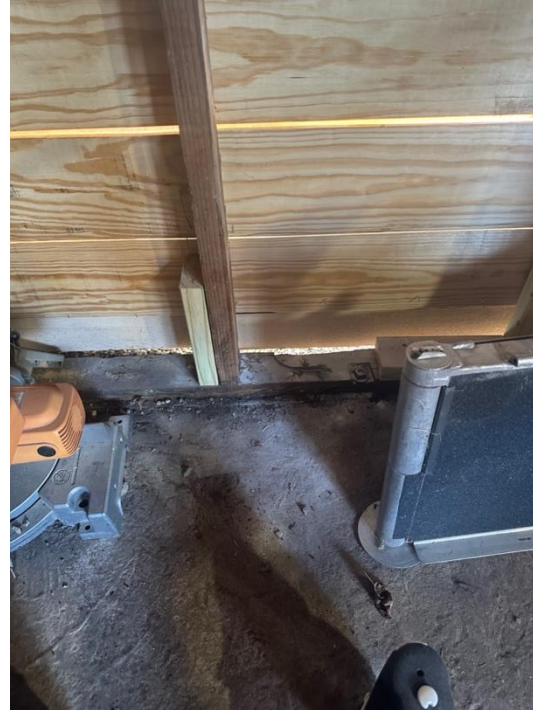
Cracked foundation

There are deep and wide cracks all over the foundation

The foundation of the existing garage is a concrete slab. From the time it was constructed and based on general observation, the slab appears to be a simple 4-inch concrete structure. It is in a state of significant deterioration, with multiple failures and noticeable settlement at each crack line. Repairing this existing structure is not feasible.

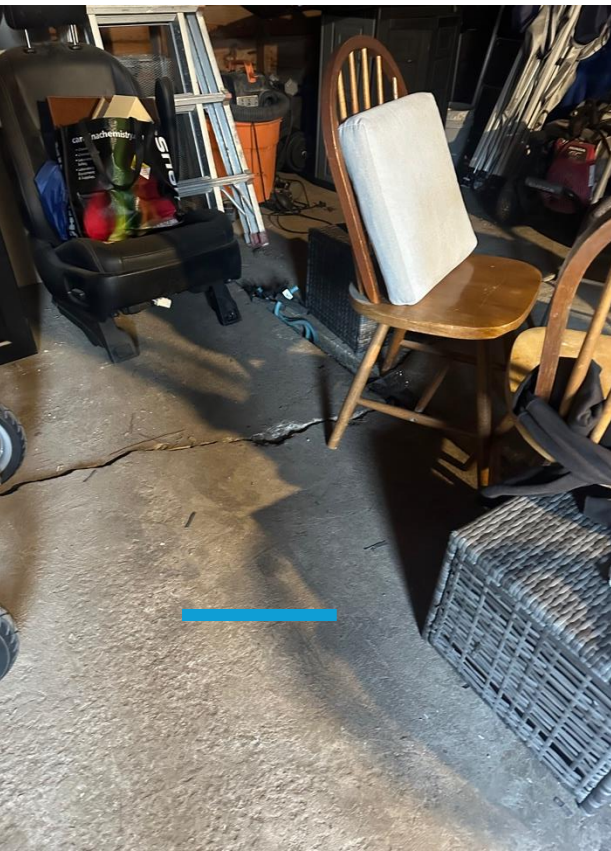
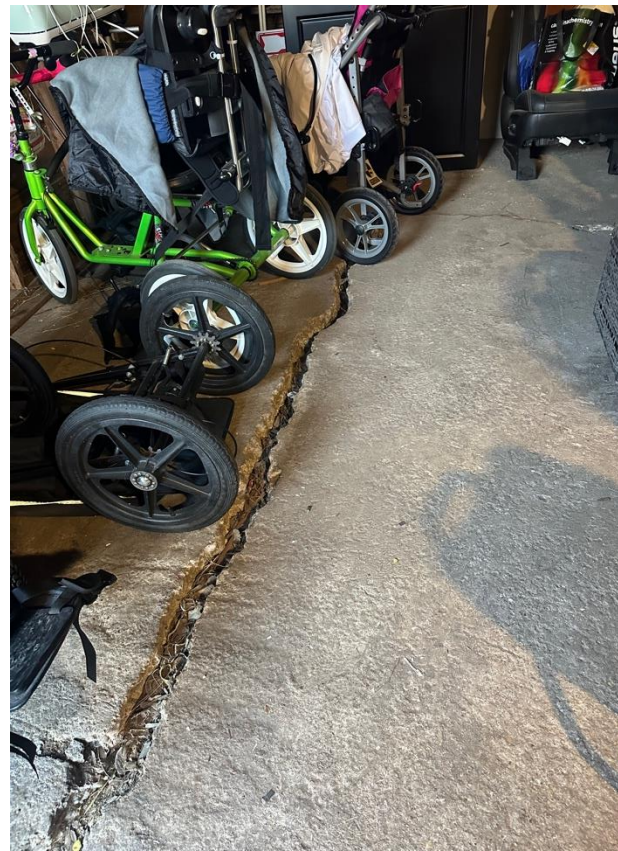
Interior of wood with rot and mold

The interior frame is also deteriorating, partly due to time and exposure to the elements, but mainly because of movement related to the failure of the concrete slab. As long as the current foundation continues to settle and shift, the structure above will remain prone to movement, cracking, and failure of any sheathing or openings that are repaired or created.

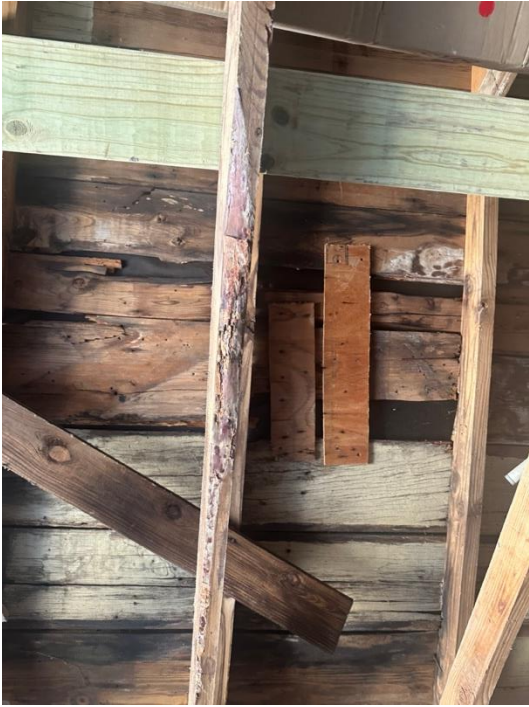
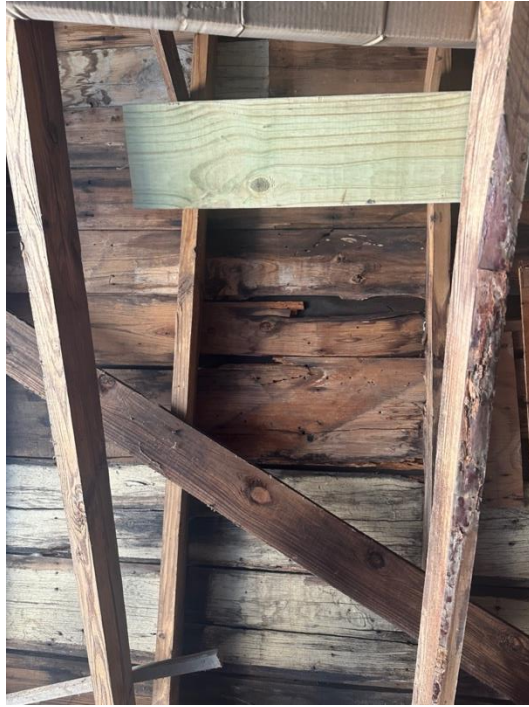
Interior of wood replaced to meet insurance requirement

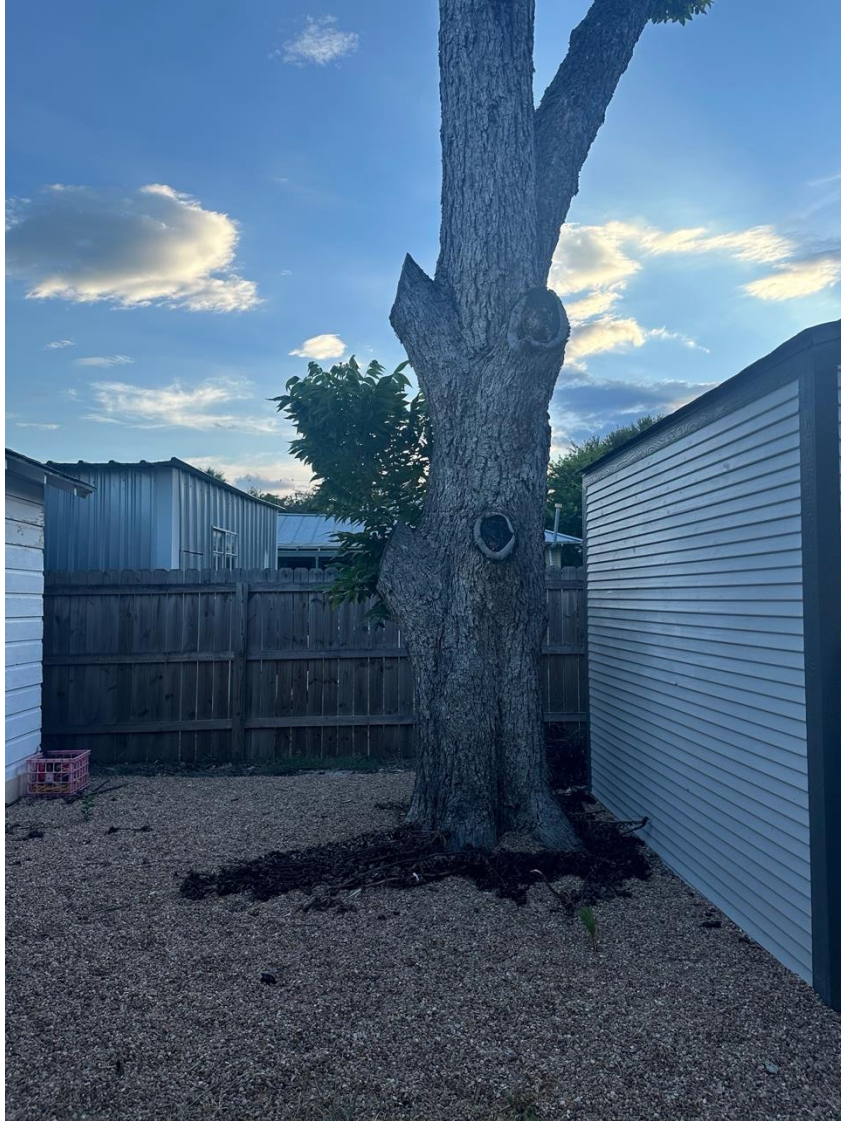
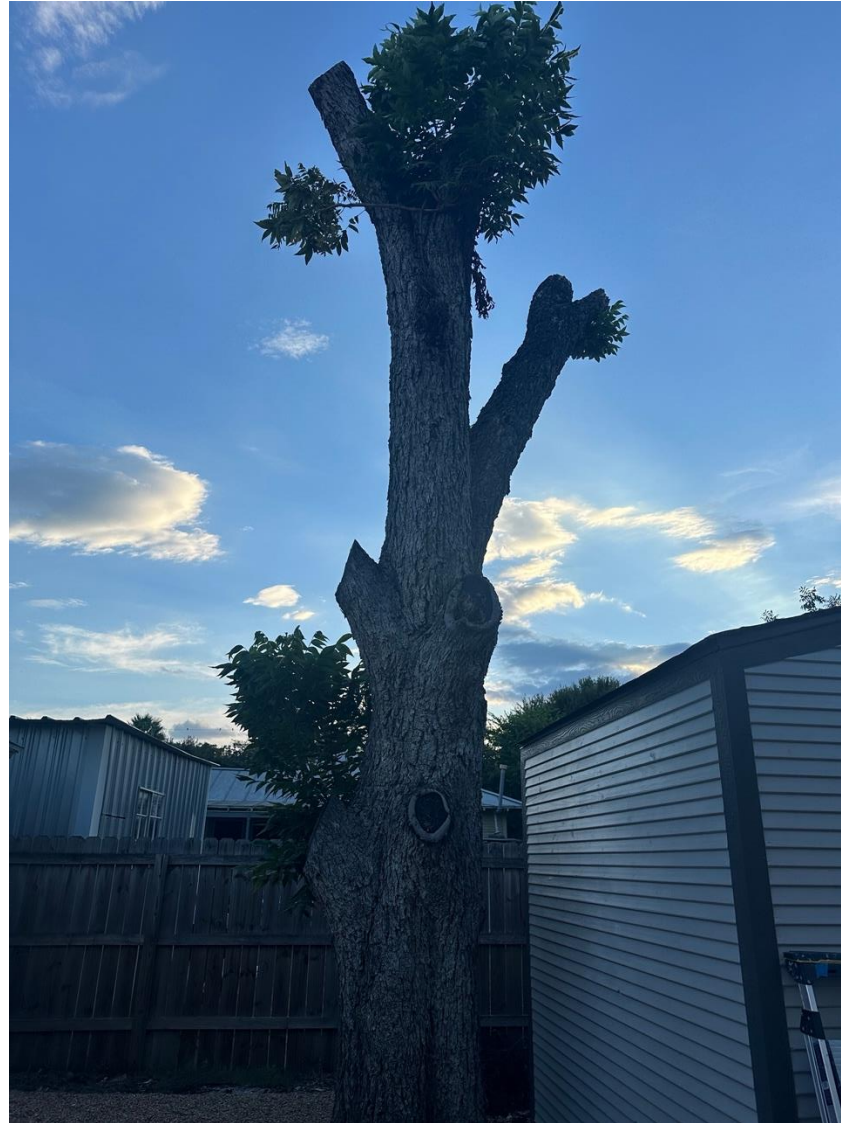
We would also like to remove the tree entirely

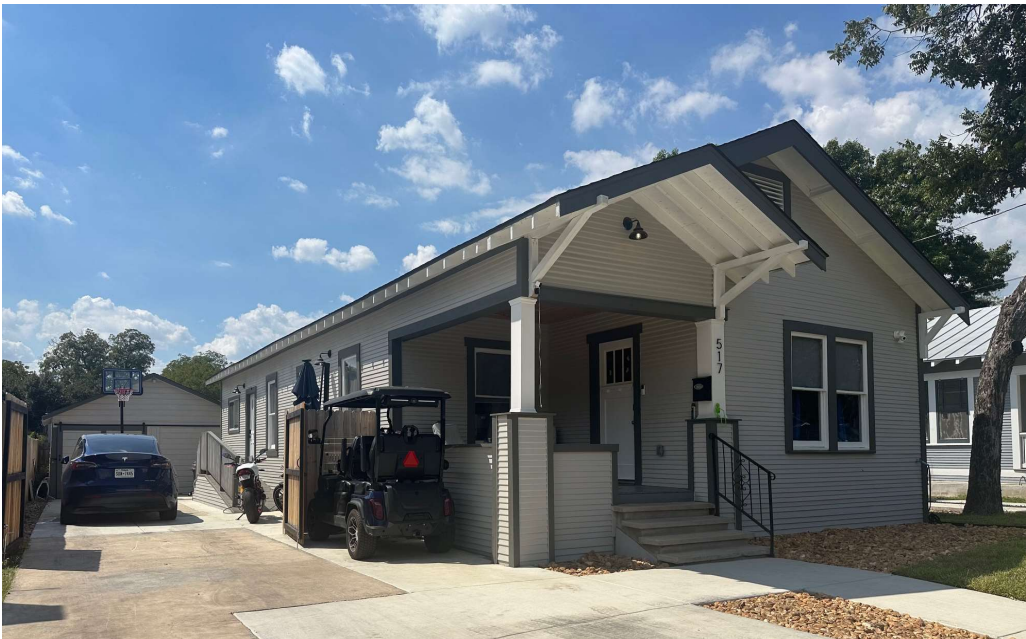
Proposed front view from Wickes St. Set back from view is a two-story garage with an additional living space above. Second-floor space provides living space to accommodate the needs of the family

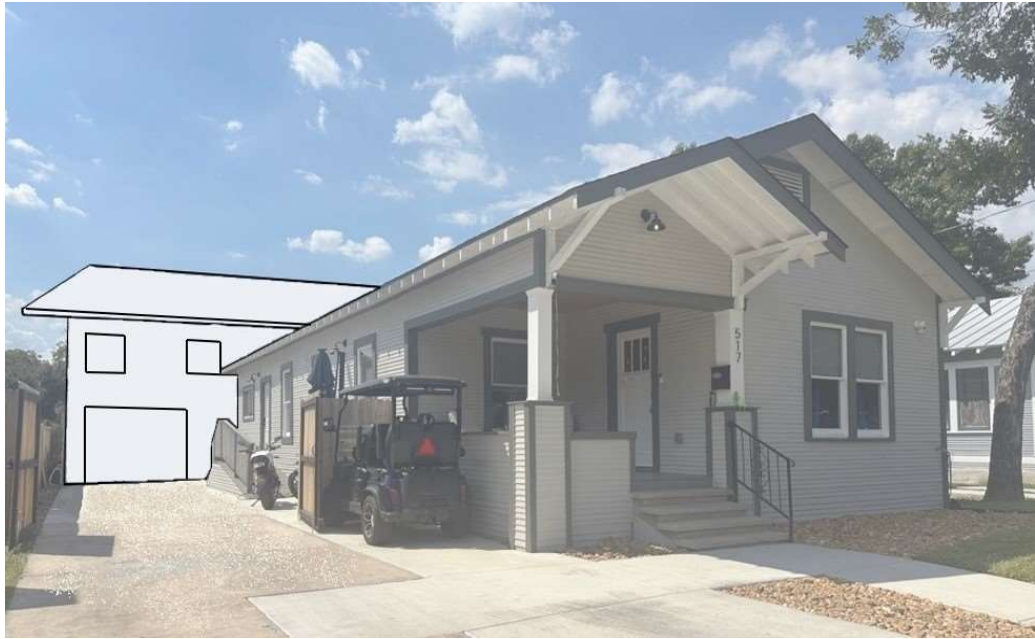
Proposed front view from Wickes St. Set back from view is a two-story garage with an additional living space above. Second-floor space provides living space to accommodate the needs of the family
