**HISTORIC AND DESIGN REVIEW
COMPLIANCE AND TECHNICAL ADVISORY BOARD
June 21, 2024**

HDRC CASE NO: 2024-203
ADDRESS: 922/924 E CROCKETT ST
LEGAL DESCRIPTION: NCB 583 BLK 8 LOT 3 & E 3.71 FT OF 4
ZONING: RM-4, H
CITY COUNCIL DIST.: 2
DISTRICT: Dignowity Hill Historic District
APPLICANT: Jose Rodriguez
OWNER: Jose Rodriguez
TYPE OF WORK: Carport installation, landscape modifications, and wholesale window replacement
APPLICATION RECEIVED: May 14, 2024
60-DAY REVIEW: July 13, 2024

The applicant is requesting a Certificate of Appropriateness for approval to:

1. Replace all of the existing windows on the property.
2. Construct a 20x20 foot metal framed carport.
3. Modify the existing landscape to include gravel mulch, concrete pavers, and minimal planting.

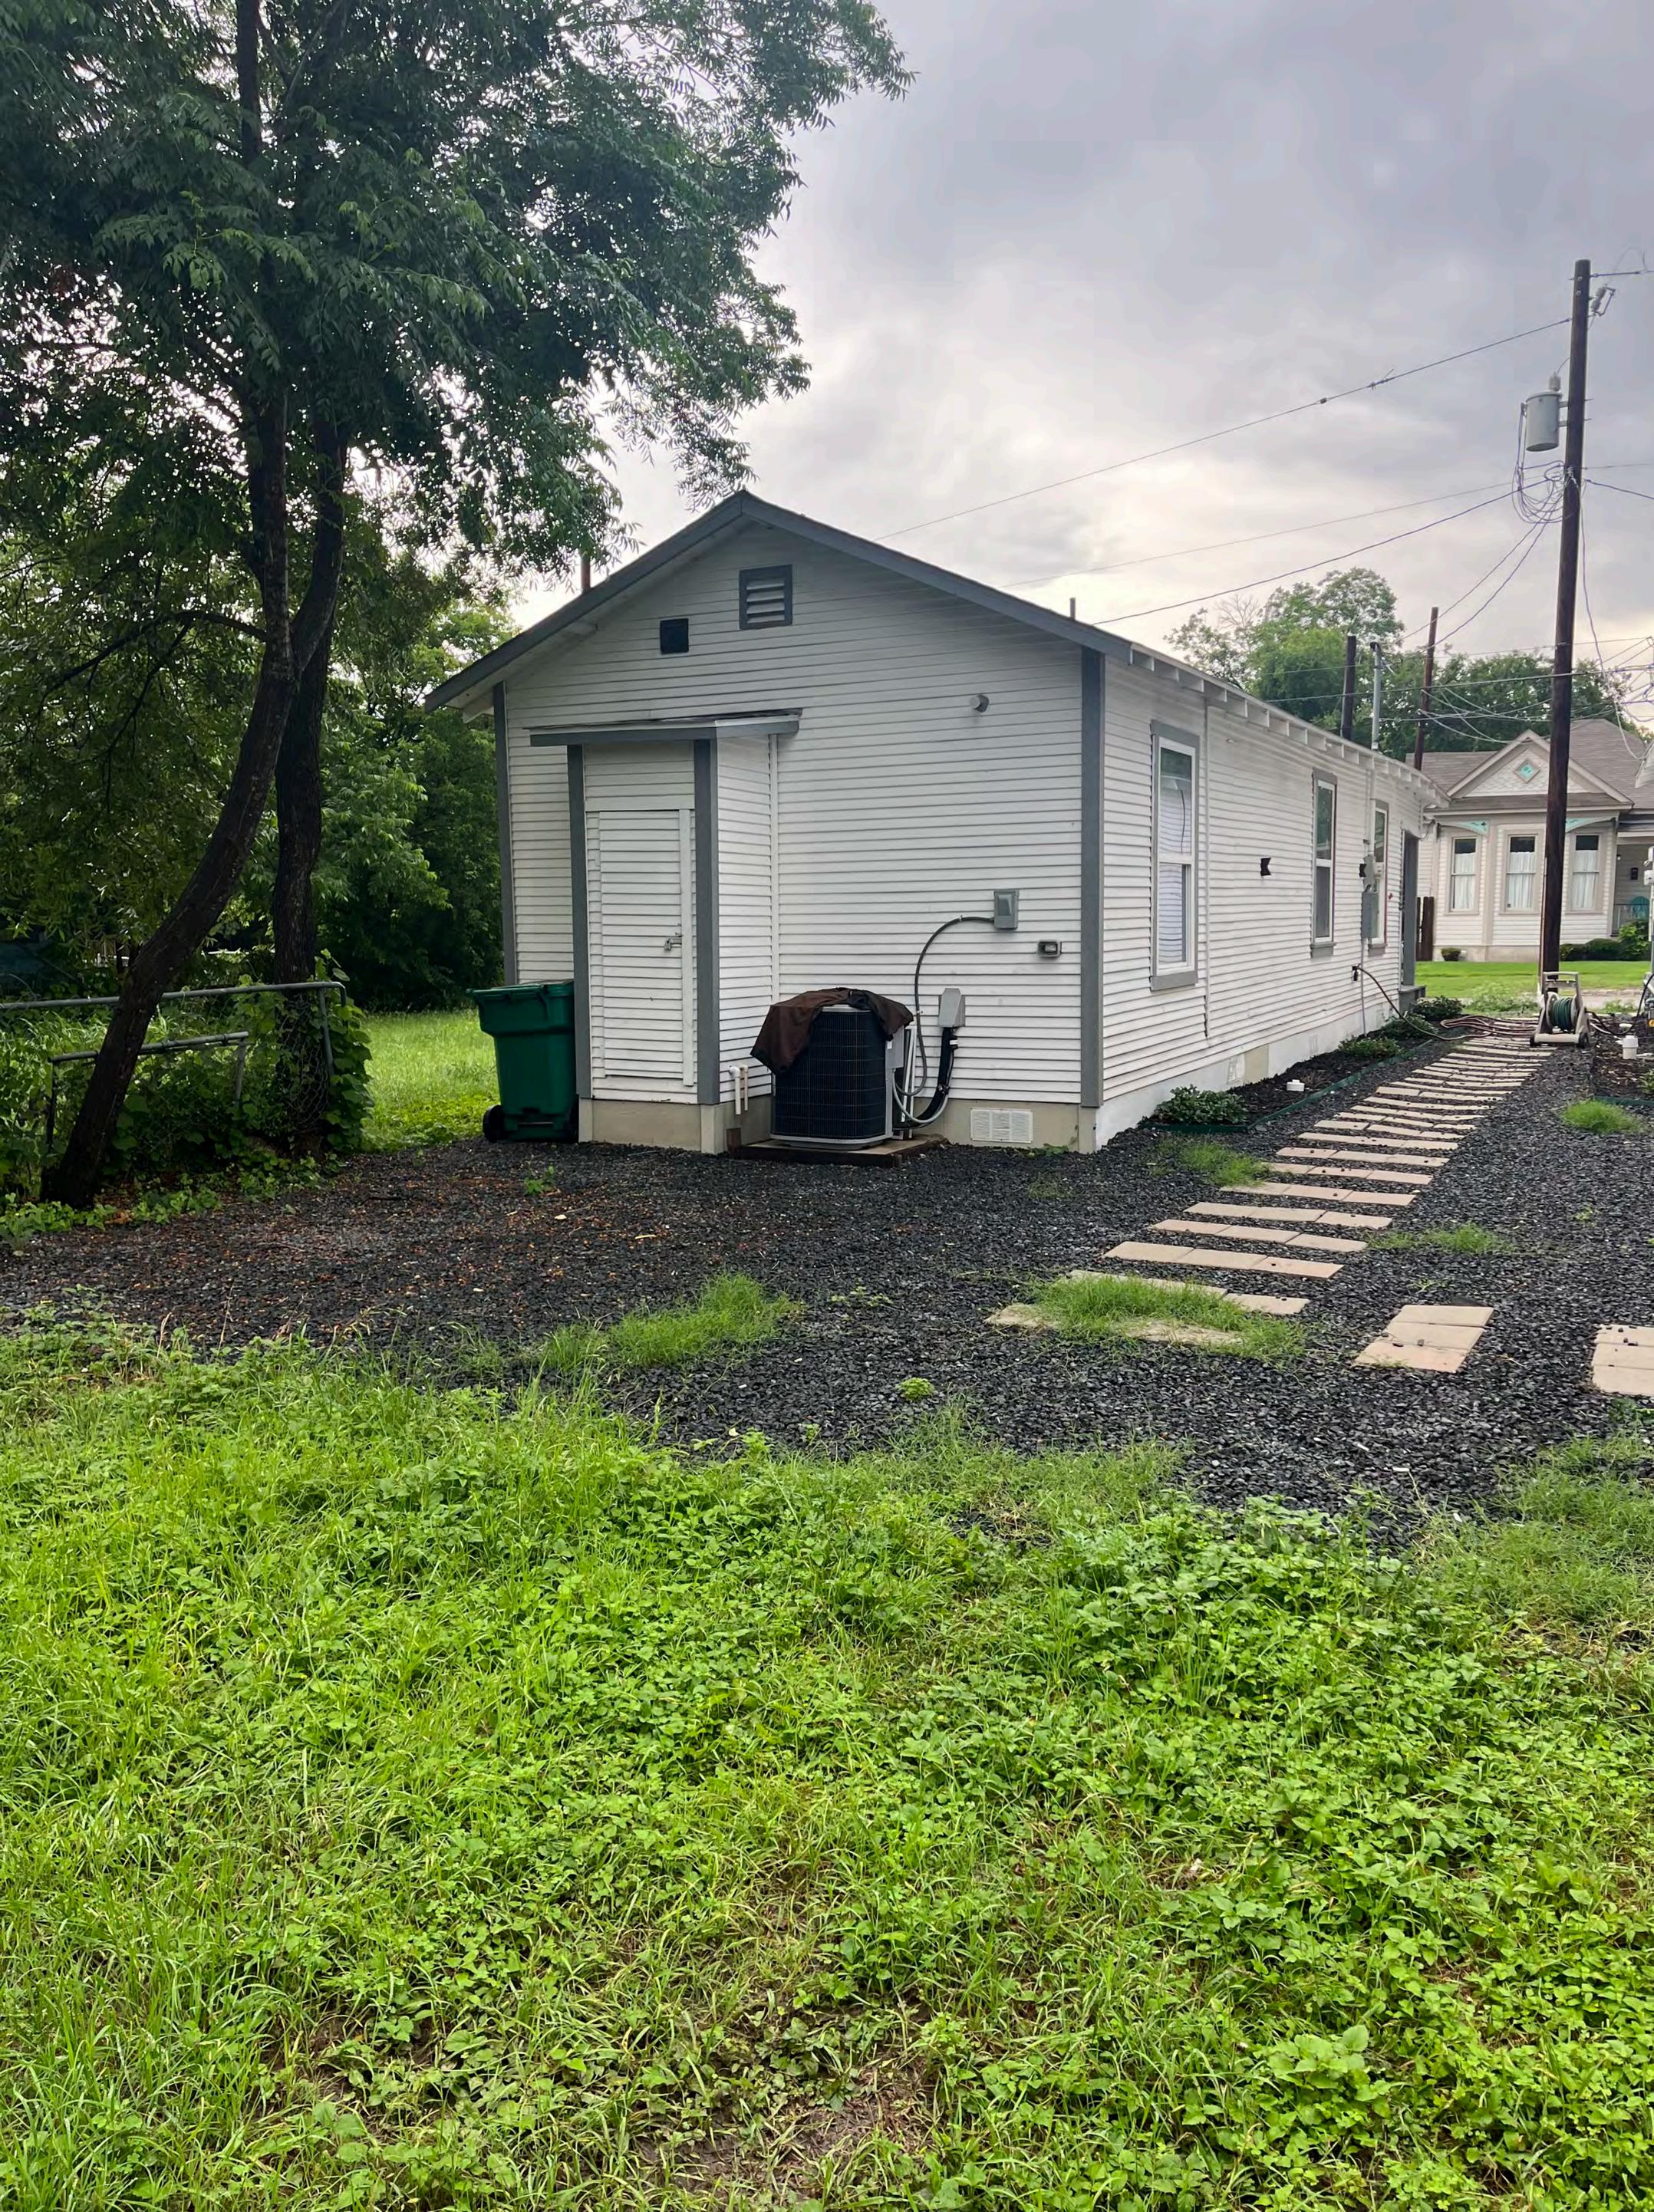
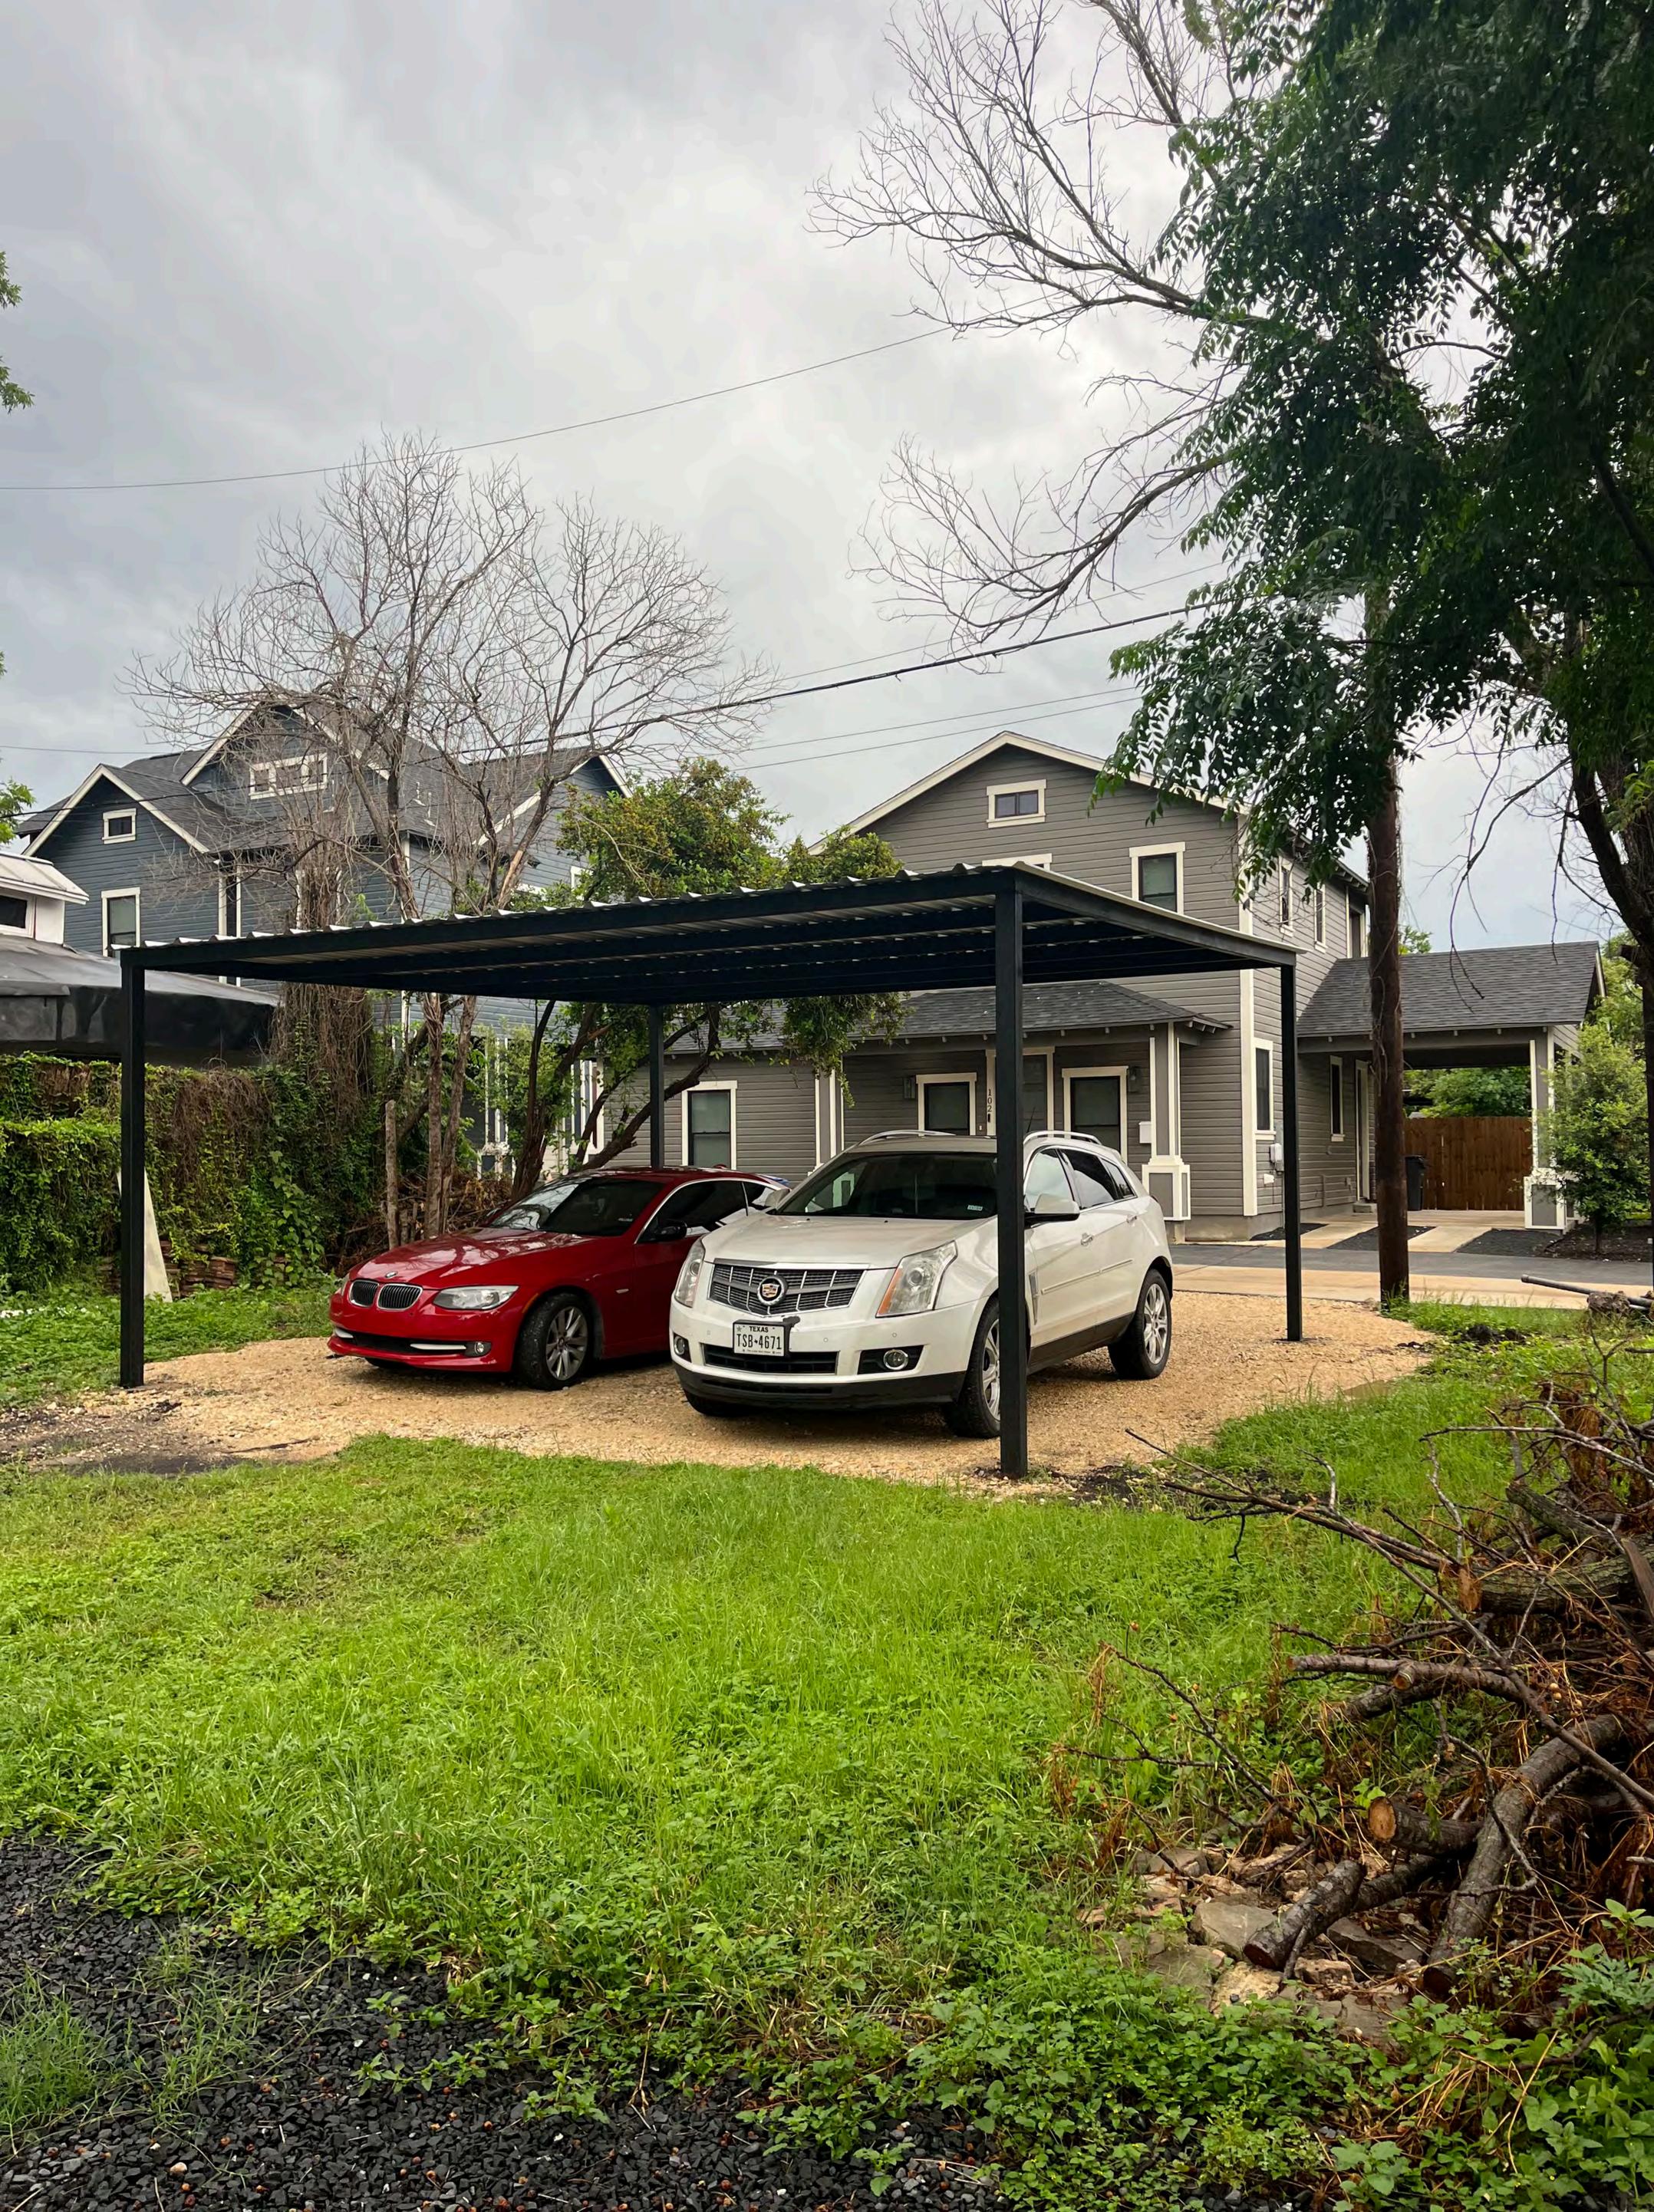
CARPORT MATERIAL (20 X 20)

4x4 14 GA SQ TUBING (STEEL) / POST /

Staff recommends approval of item 2, based on findings a through j, with the following stipulation:

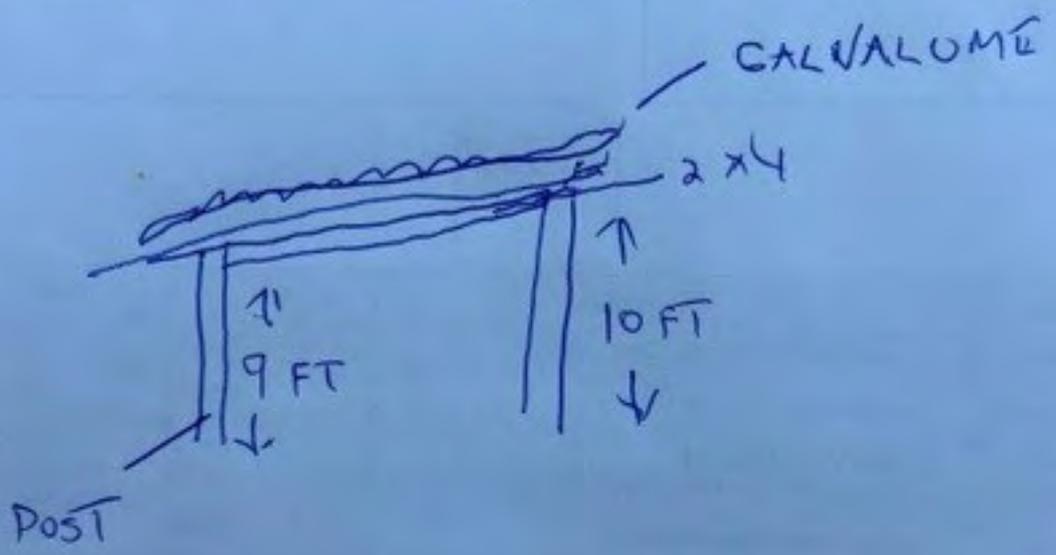
2x4x20 14 GA (STEEL)

GALVALUME R-PANEL (STEEL) / ROOF /
14 GA

- i. CARPORT (MASSING AND FORM) – The applicant is requesting to install a detached metal-framed carport with a R-panel metal roof and steel members on the south side of the property. The proposed carport features a shed roof and is 20’Lx20’W and measures between 9’ and 10’ feet in height. The Historic Design Guidelines for New Construction

- 5.A.i states that new garages and outbuildings should be designed to be visually subordinate to the principal historic structure in terms of their height, massing, and form. Staff finds the carport does not conform to guidelines.

- j. **CARPORT (MATERIALS)** – The applicant is requesting to install a detached metal-framed carport with a R-panel metal roof and steel members on the south side of the property. The Historic Design Guidelines for New Construction 5.A.iii states additions should relate to the period of construction of the principal building on the lot through the use of complementary materials and simplified architectural details. The structures on the lot features wood siding and a composition shingle roof. The use of metal posts and a R-panel metal roof are not consistent with the architectural style of the home and does not conform to guidelines.

- i. That the applicant construct a detached carport featuring wood members and a composition shingle roof.

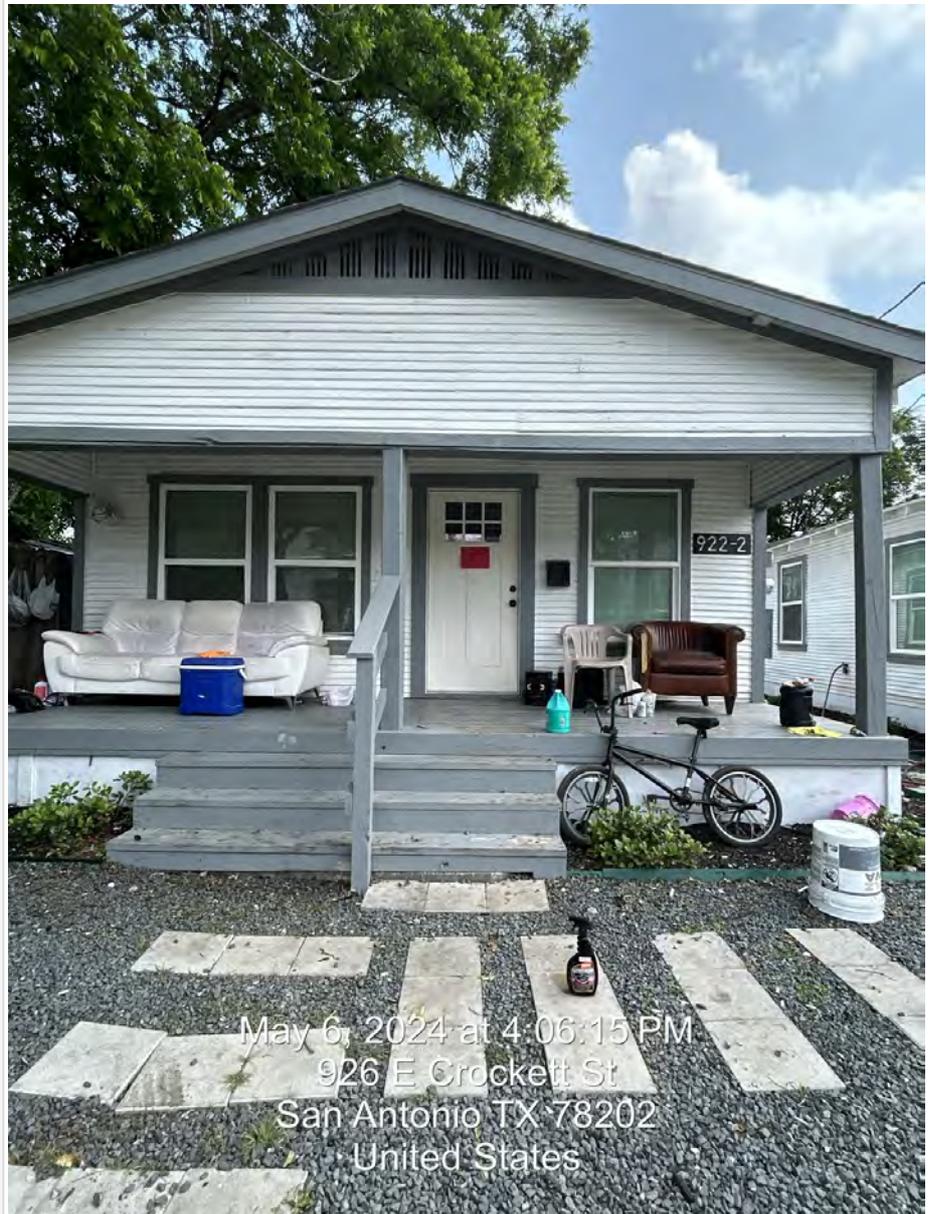
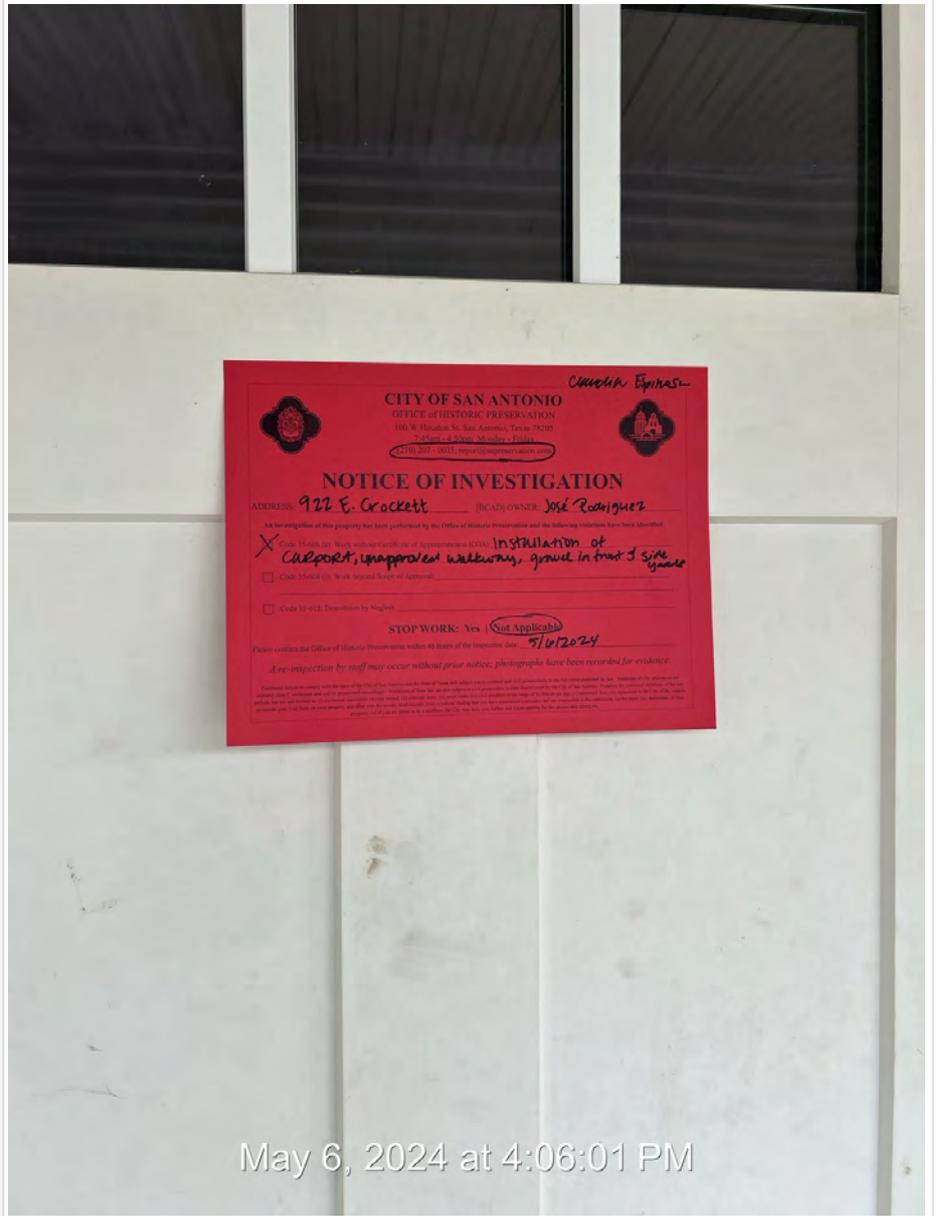
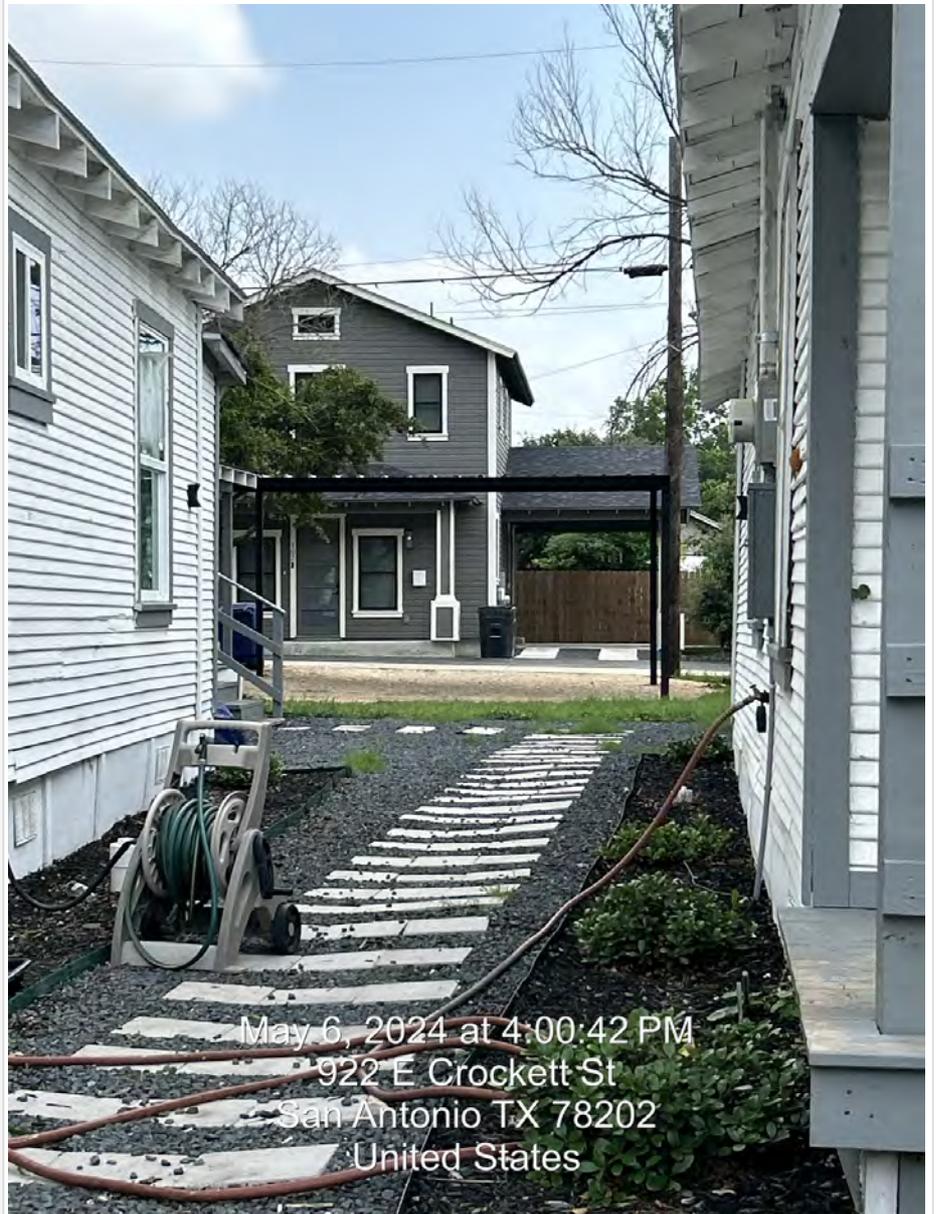
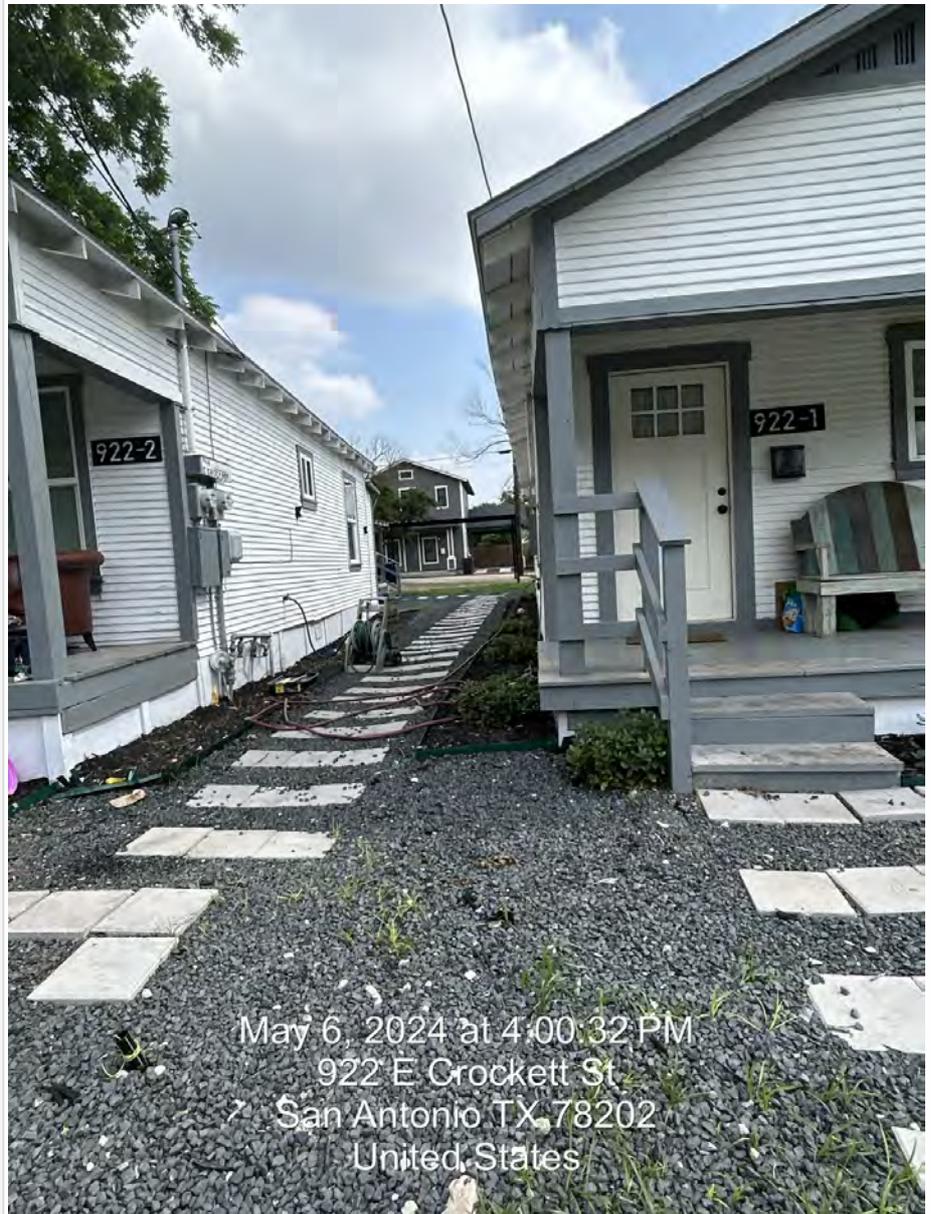
Photographs

- c. SITE VISIT – Staff issued a Stop Work Order onsite for landscape modifications and carport construction without a COA on May 6, 2024. Staff observed and took photos of the violations onsite.

Date	05/06/2024
Time	04:08 PM (-5 GMT)
Context	citizen report, drive-by
Present Staff	Claudia Espinosa
Present Individuals	None
Types of Work Observed	New Construction, Site Elements
Amount of Work Completed	Completed
Description of work	Removal of front yard landscaping and installing of dark colored rocks, unapproved walkway, installation of carport with metal posts and standing seam metal roof
Description of interaction	Staff received a report today of a carport being installed over the weekend and 922 E Crockett. While conducting the site visit staff noticed the following unapproved scopes of work: 1) Removal of front and side yard landscaping and installation of dark colored rocks. 2) Installation of a walkway using pavers. 3) Installation of a carport with metal posts and a r-panel standing seam metal roof with striations. No one was on site to speak with. Notice of Investigation was posted in the door with contact information.

Staff recommends approval of item 3, based on findings a through k, with the following stipulations:

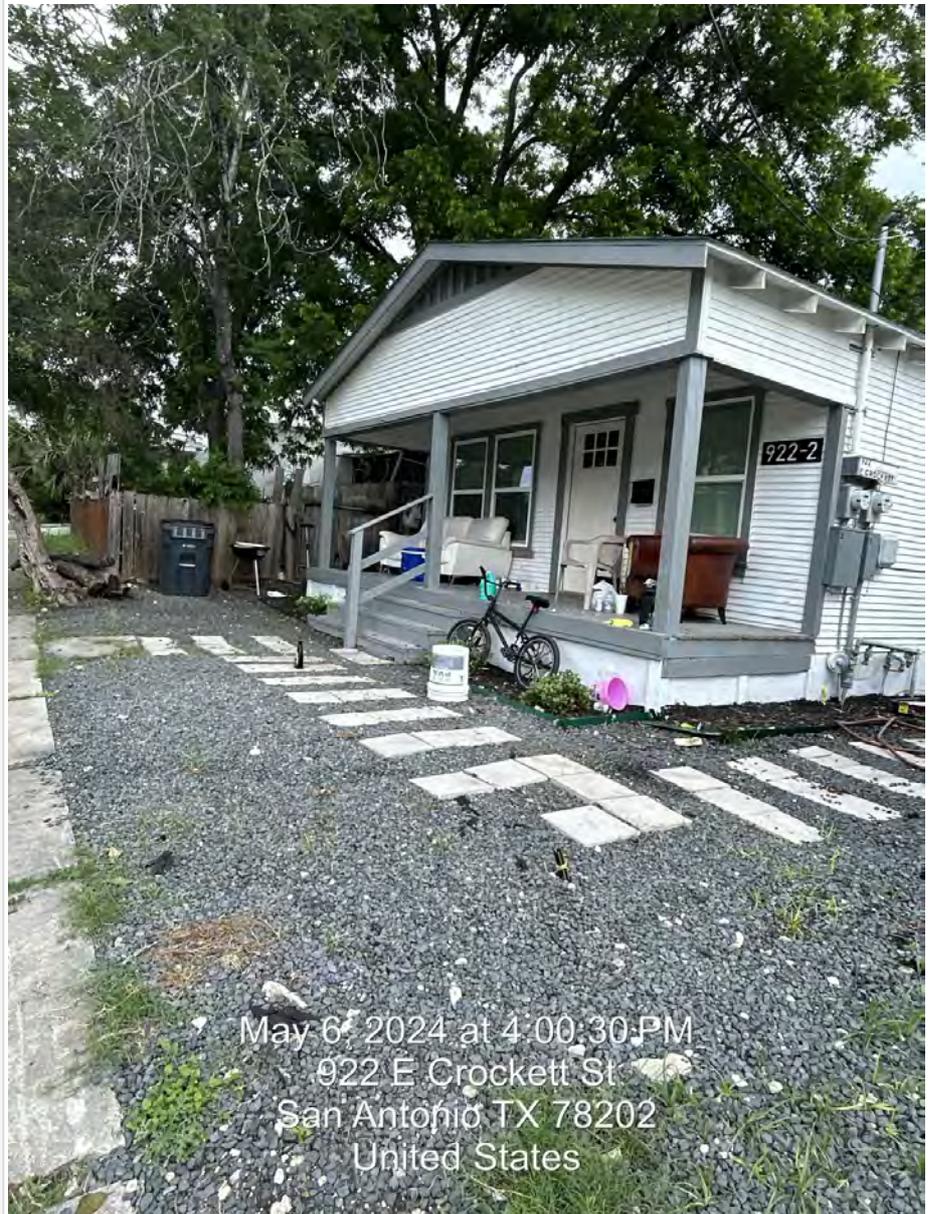
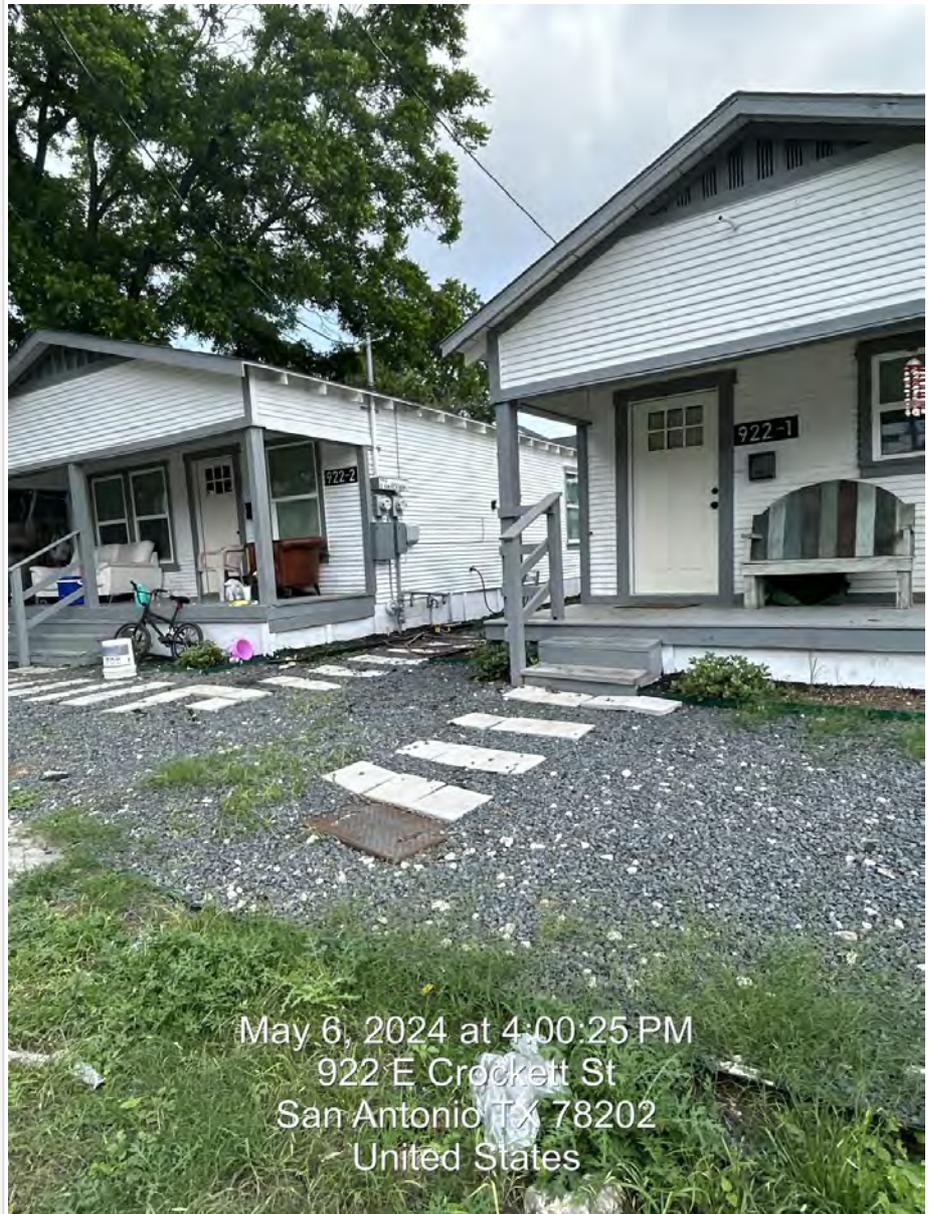
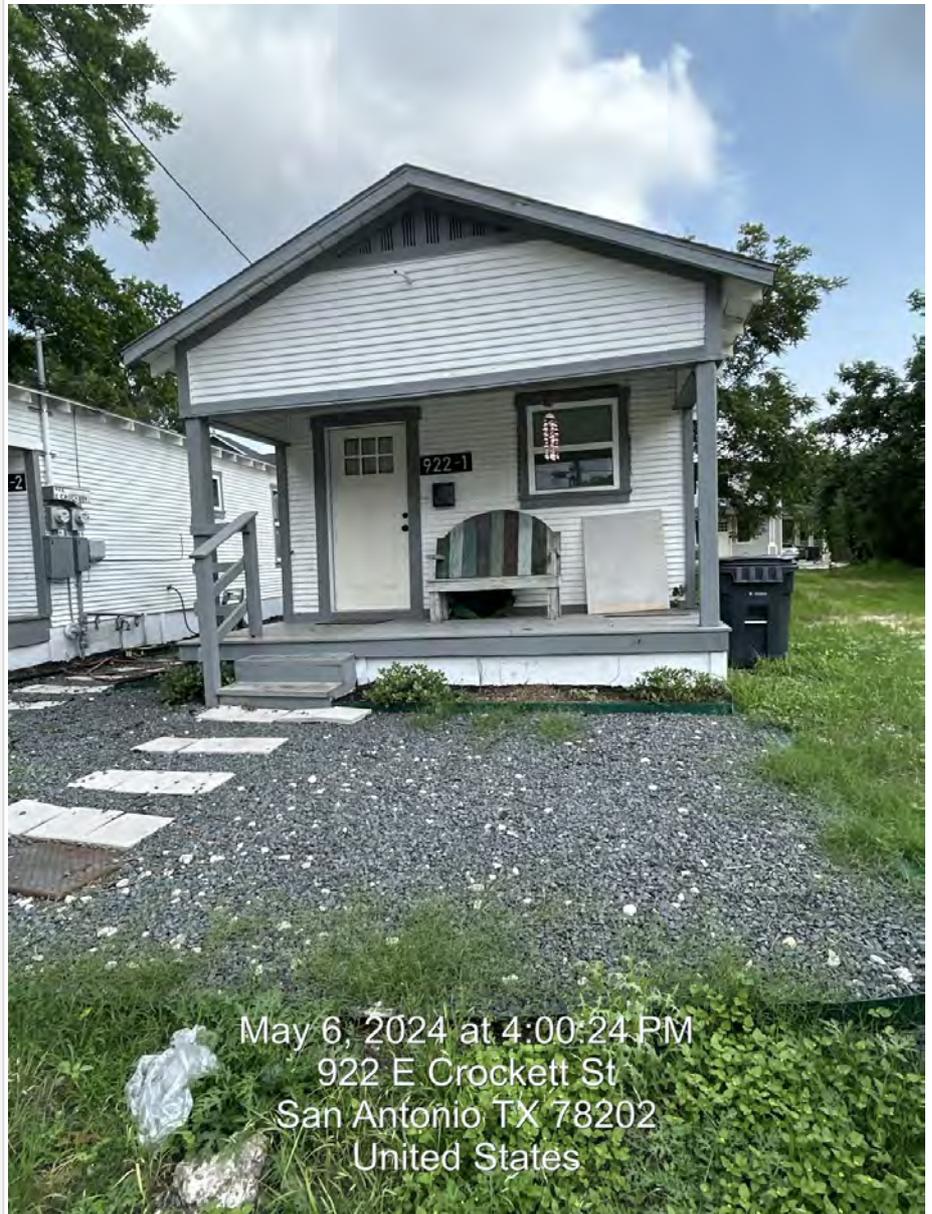
May 6, 2024 at 4:00:30 PM
922 E Crockett St
San Antonio TX 78202
United States

May 6, 2024 at 4:00:25 PM
922 E Crockett St
San Antonio TX 78202
United States

May 6, 2024 at 4:00:24 PM
922 E Crockett St
San Antonio TX 78202
United States

- k. **LANDSCAPE MODIFICATIONS** – The applicant is requesting approval to replace the existing natural turf and install grey rocks and concrete pavers. The Historic Design Guidelines for Site Elements 3.A.ii. states to limit the removal of lawn areas to mulched planting beds or pervious hardscapes in locations where they would historically be found, such as along fences, walkways, or drives. Historic lawns should never be reduced by more than 50%. Site Elements 3.B.ii. states new pervious hardscapes should be limited to areas that are not highly visible, and should not be used as wholesale replacement for plantings. If used, small plantings should be incorporated into the design. Site Elements 3.B.iii. states to not use rock mulch or gravel as a wholesale replacement for lawn area. The Xeriscaping & Responsible Landscaping policy document states to not incorporate black, non-native, or artificially colored rocks. Staff finds the proposed landscape modifications do not conform to guidelines.

- i. That the applicant use landscaping rocks that do not exceed 2” in size and are a natural color.
- ii. That the applicant incorporate natural plantings within the landscape that retain a minimum of 50% planting area.
- iii. That the applicant submit to staff an updated landscape site plan to feature a continuous concrete walkway at the front of the property.
