**HISTORIC AND DESIGN REVIEW
COMPLIANCE AND TECHNICAL ADVISORY BOARD
June 21, 2024**

HDRC CASE NO: 2024-203
ADDRESS: 922/924 E CROCKETT ST
LEGAL DESCRIPTION: NCB 583 BLK 8 LOT 3 & E 3.71 FT OF 4
ZONING: RM-4, H
CITY COUNCIL DIST.: 2
DISTRICT: Dignowity Hill Historic District
APPLICANT: Jose Rodriguez
OWNER: Jose Rodriguez
TYPE OF WORK: Carport installation, landscape modifications, and wholesale window replacement
APPLICATION RECEIVED: May 14, 2024
60-DAY REVIEW: July 13, 2024

The applicant is requesting a Certificate of Appropriateness for approval to:

1. Replace all of the existing windows on the property.
2. Construct a 20x20 foot metal framed carport.
3. Modify the existing landscape to include gravel mulch, concrete pavers, and minimal planting.

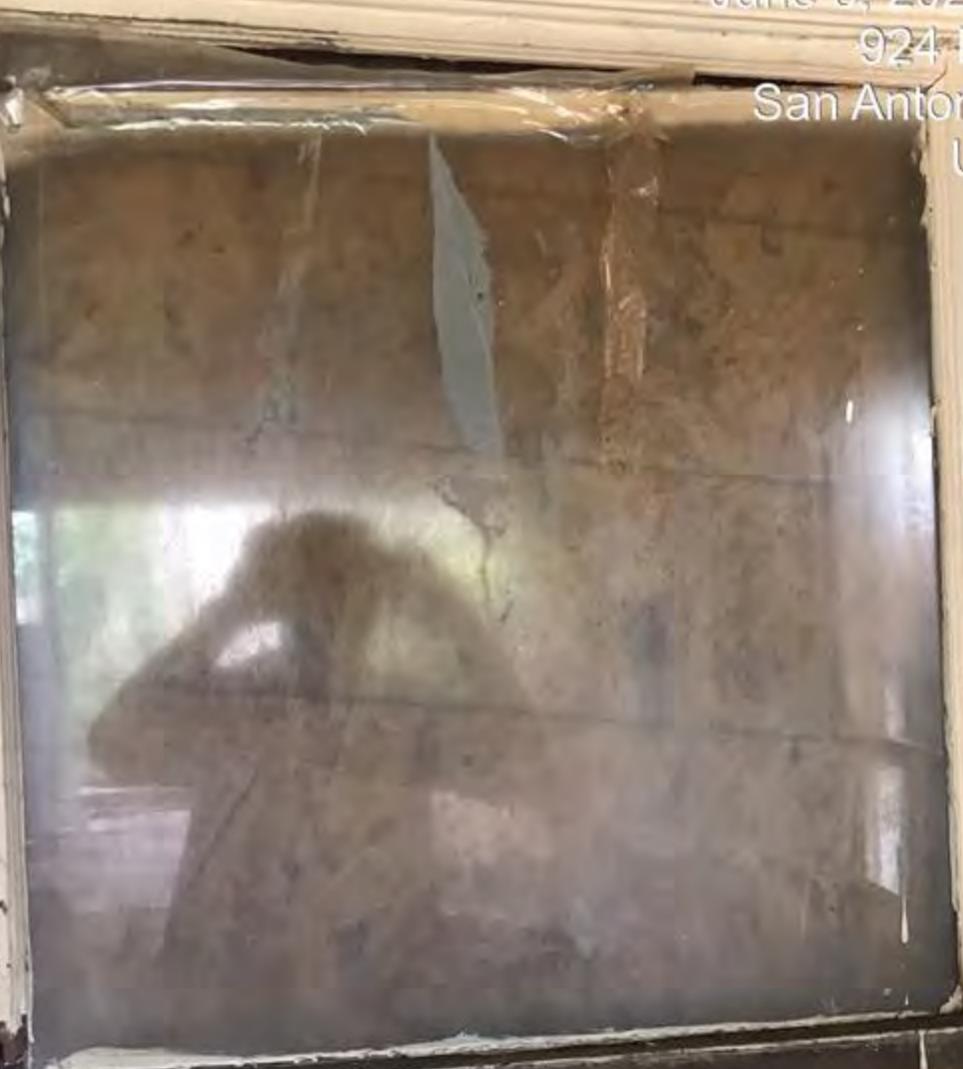
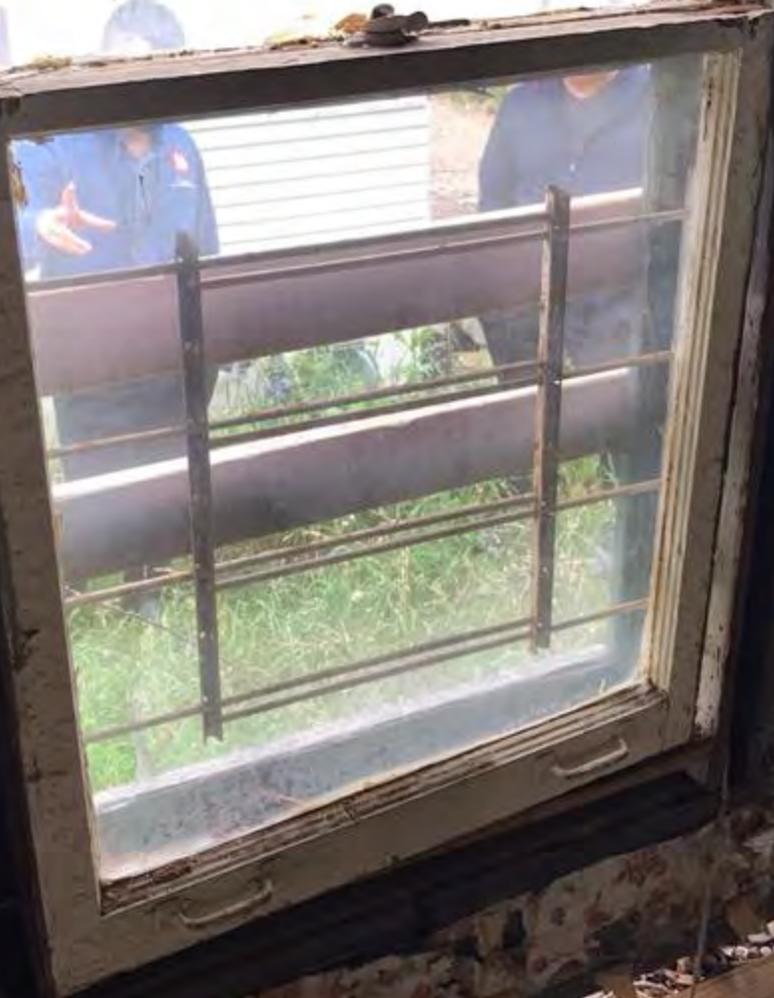
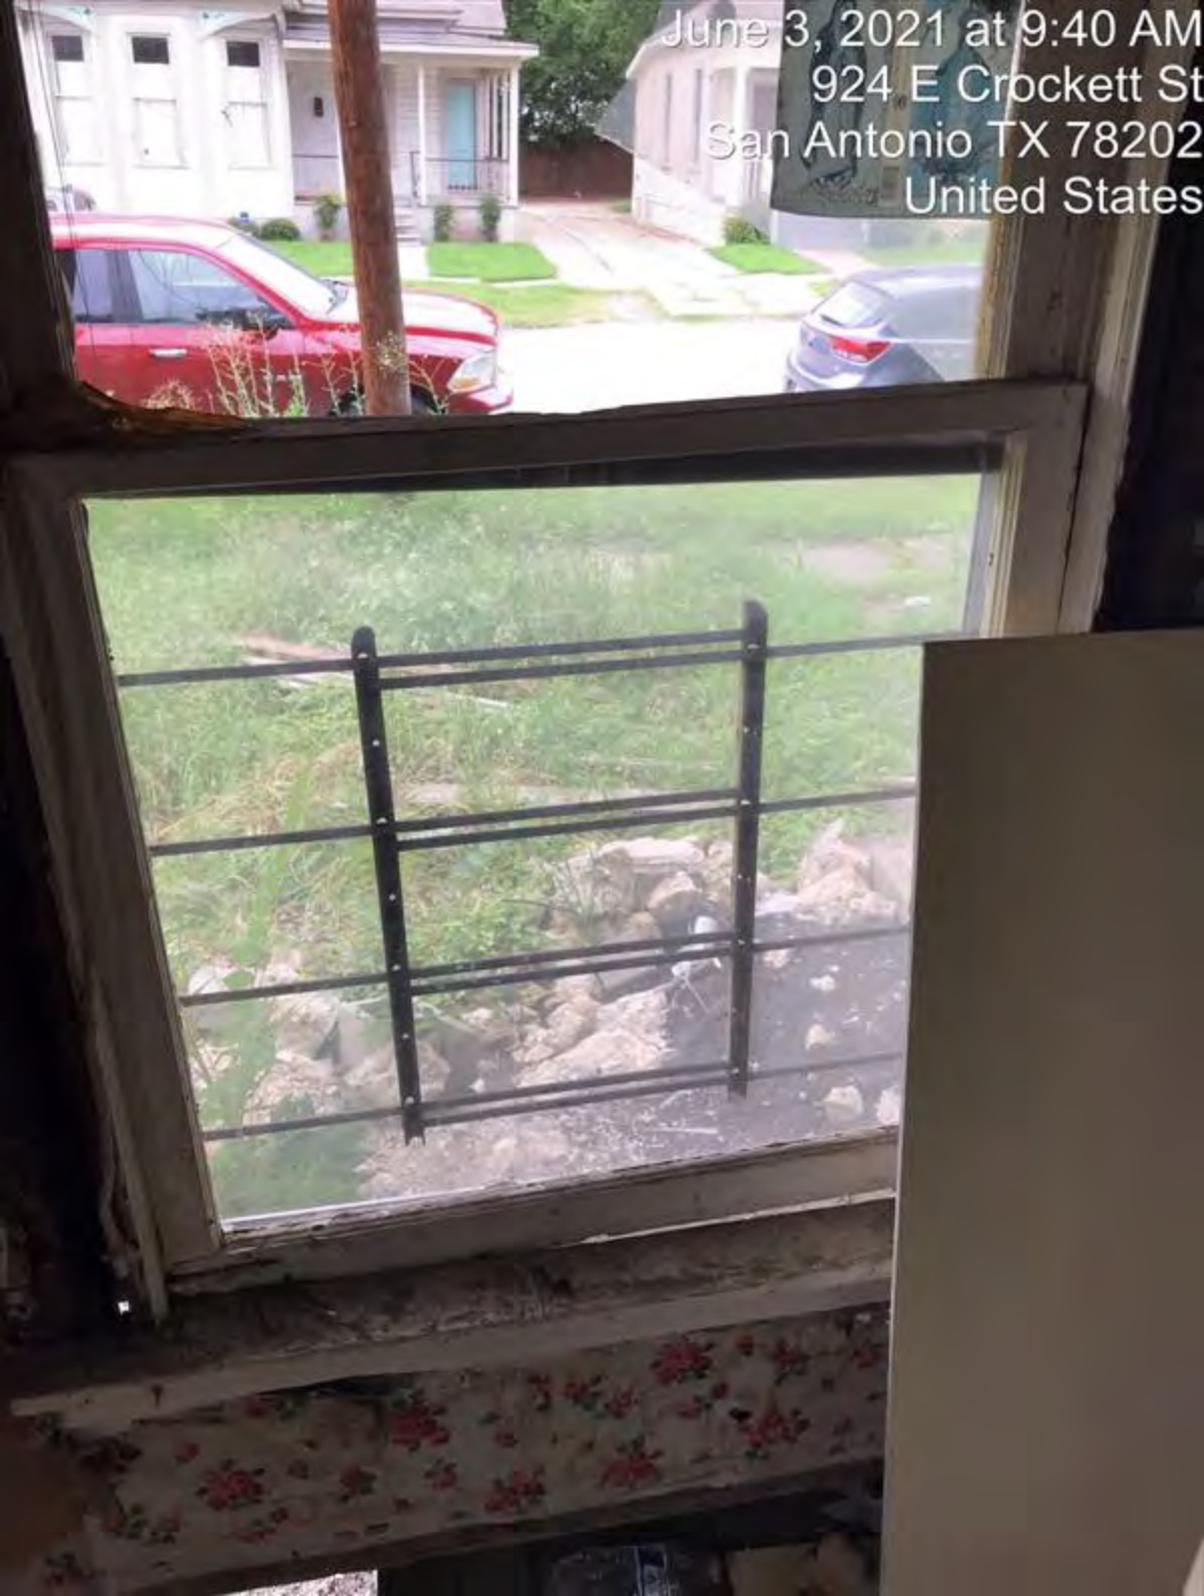
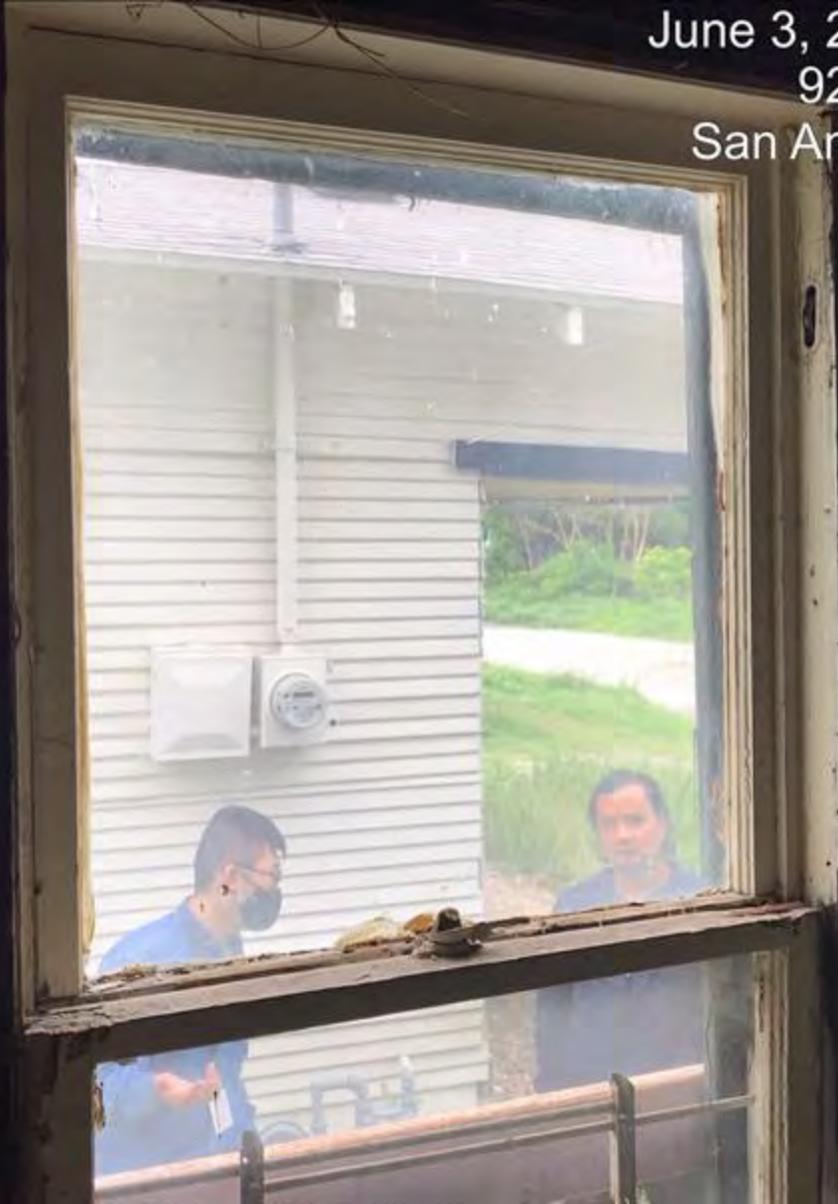
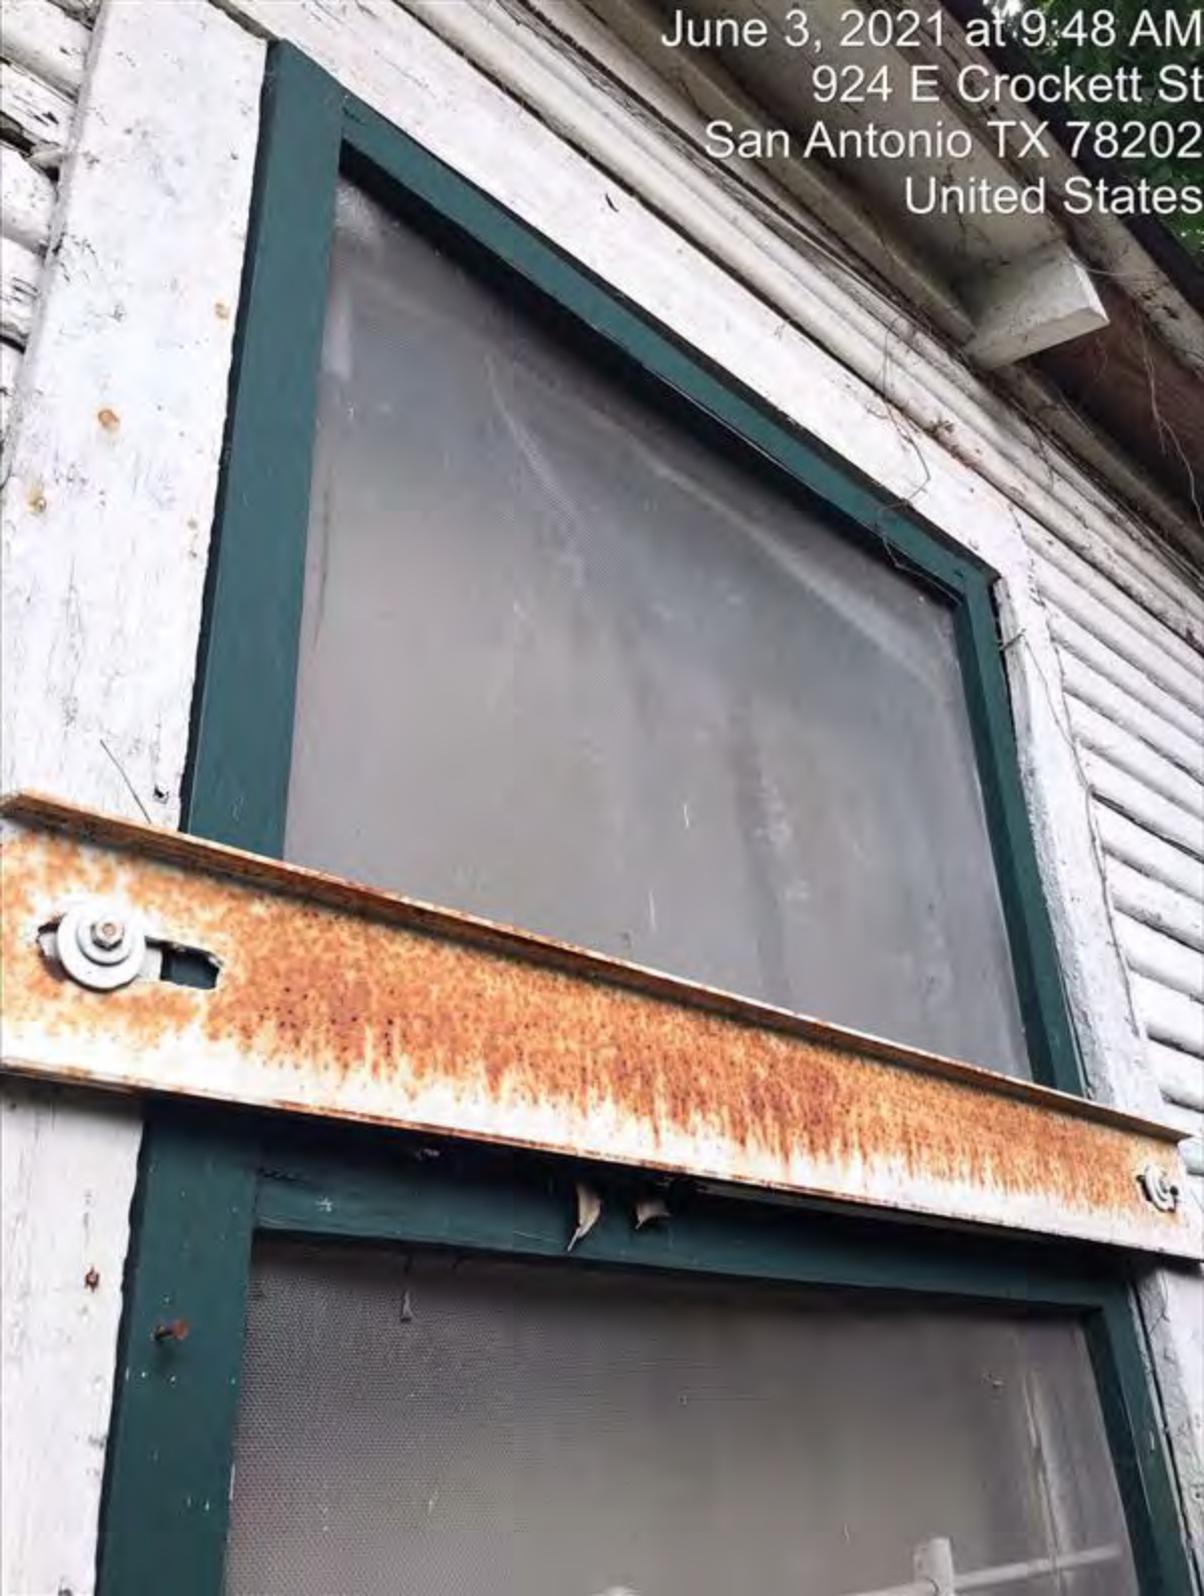
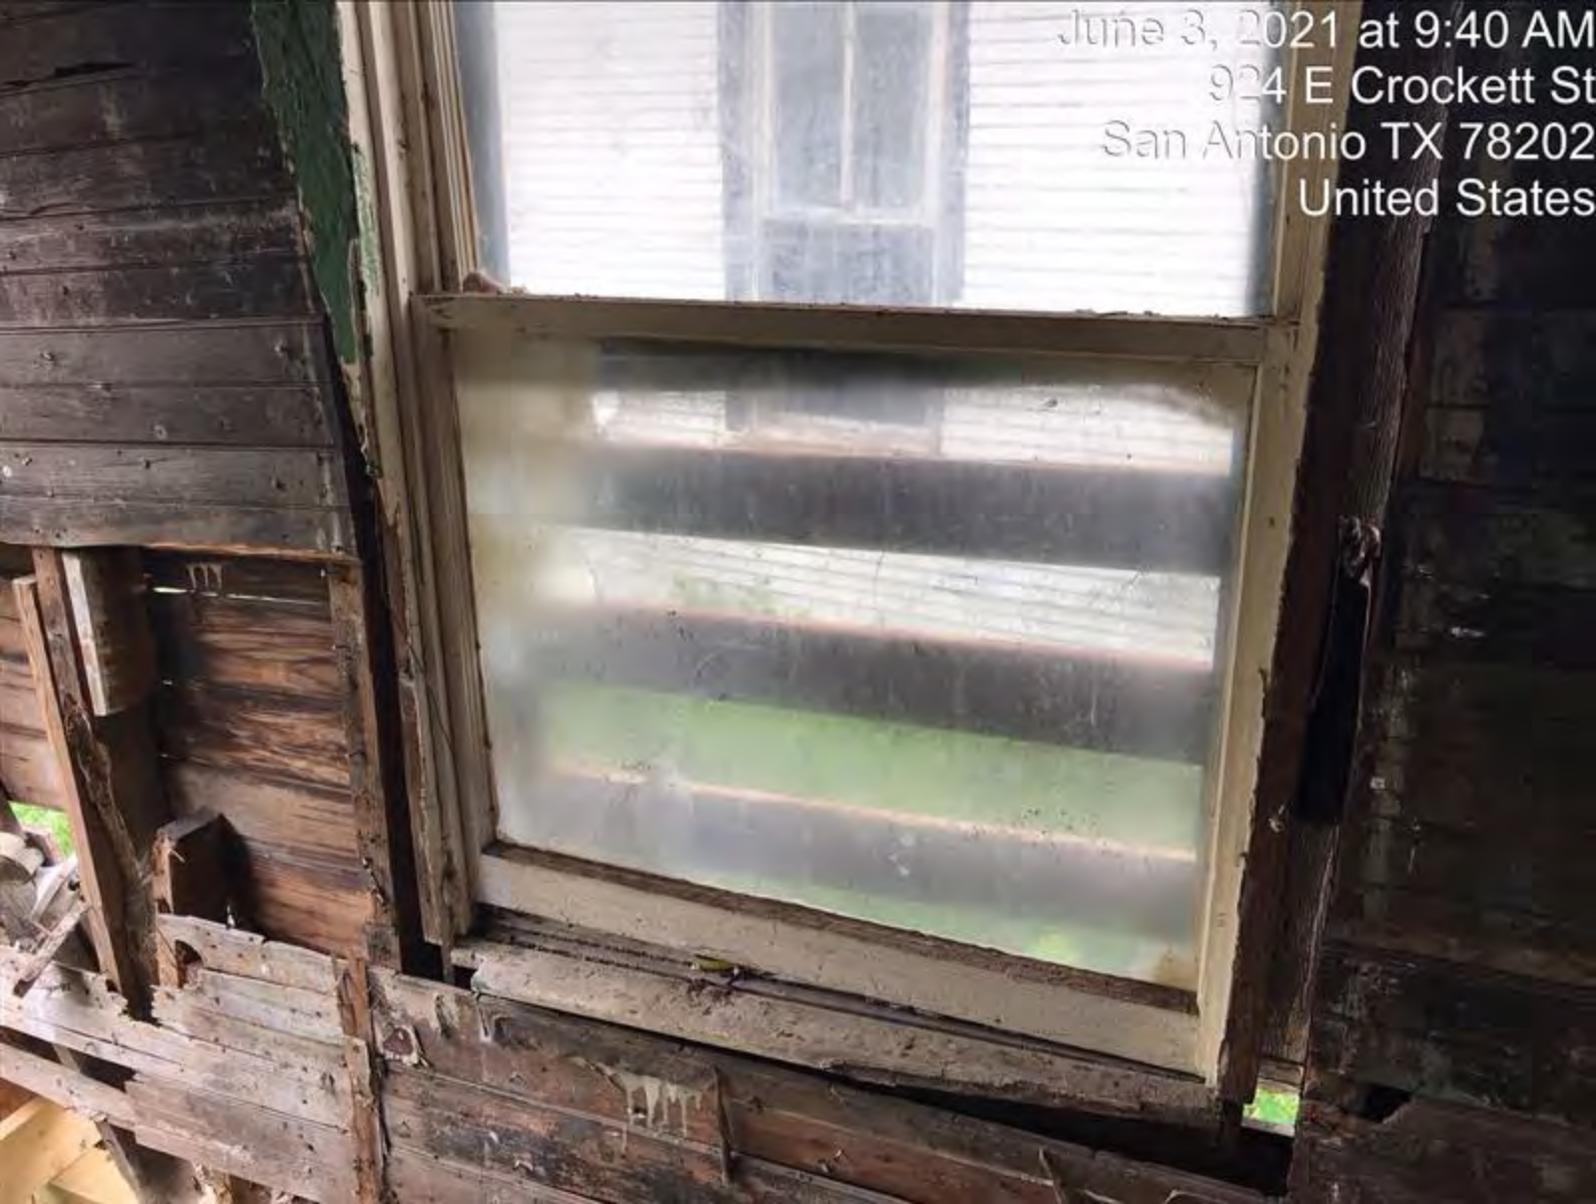
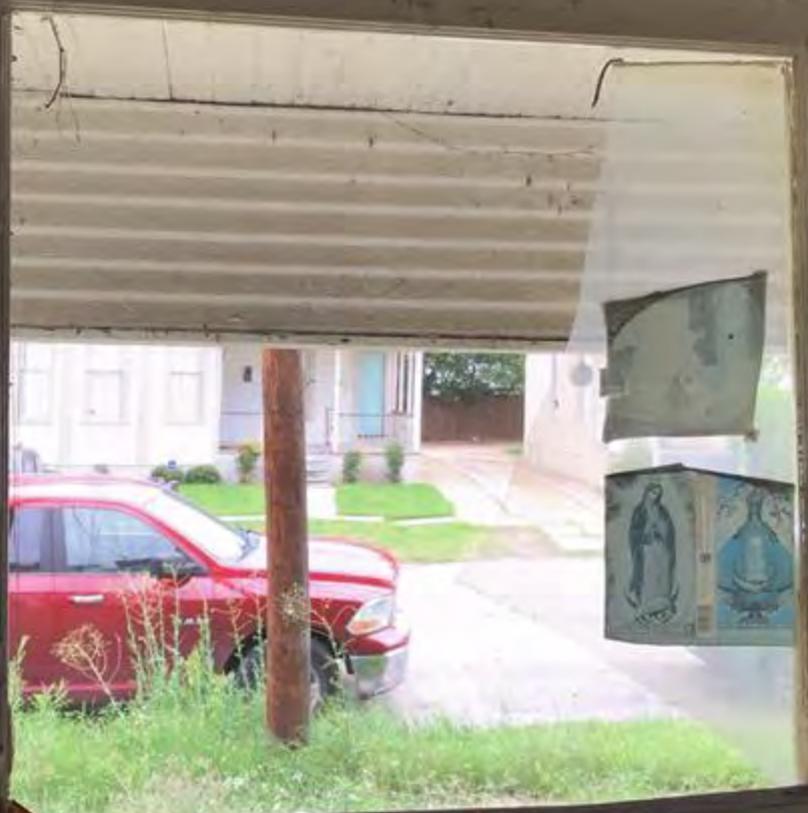
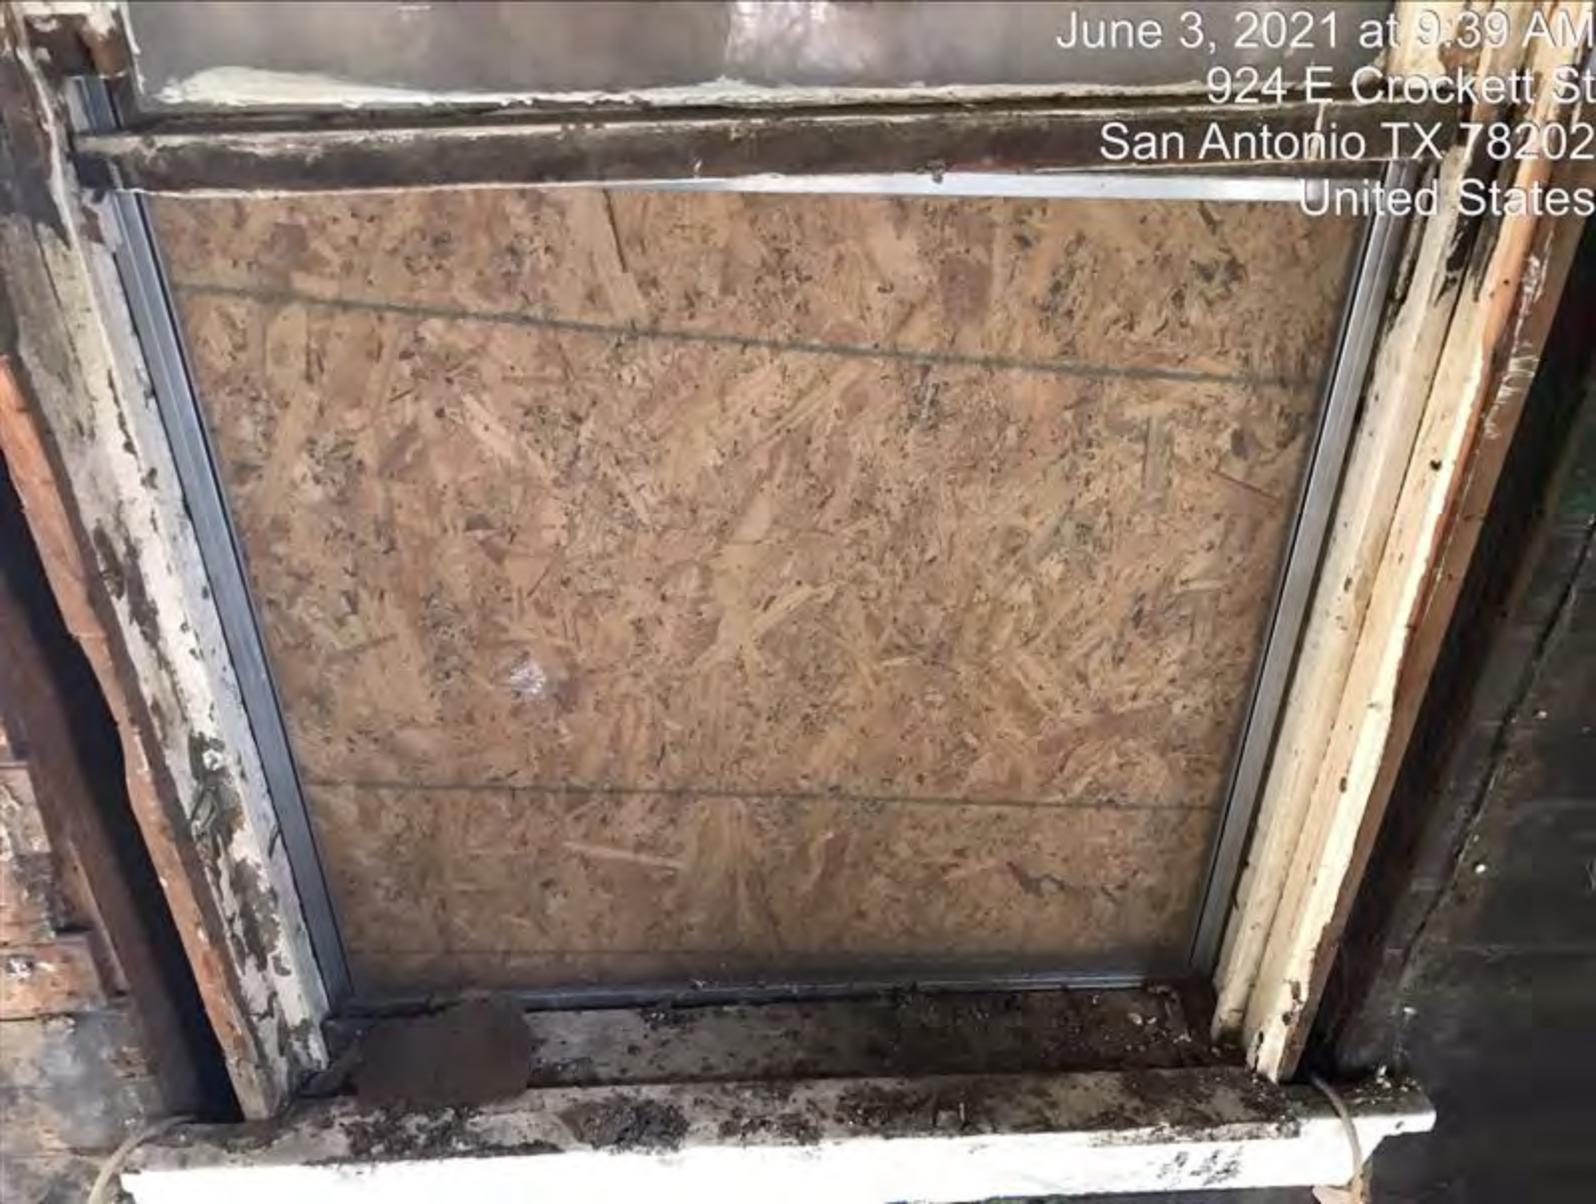
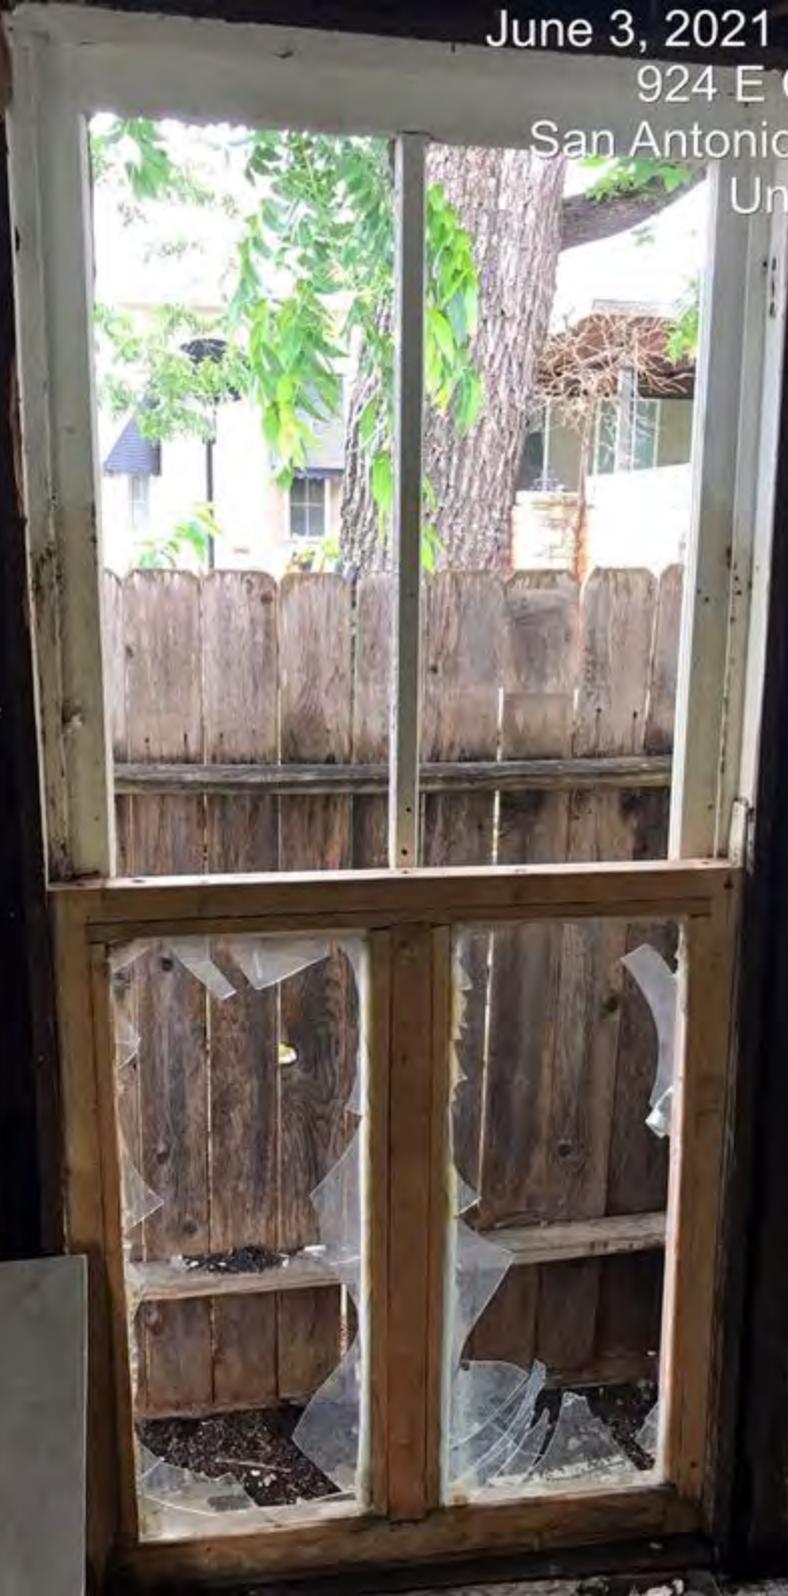
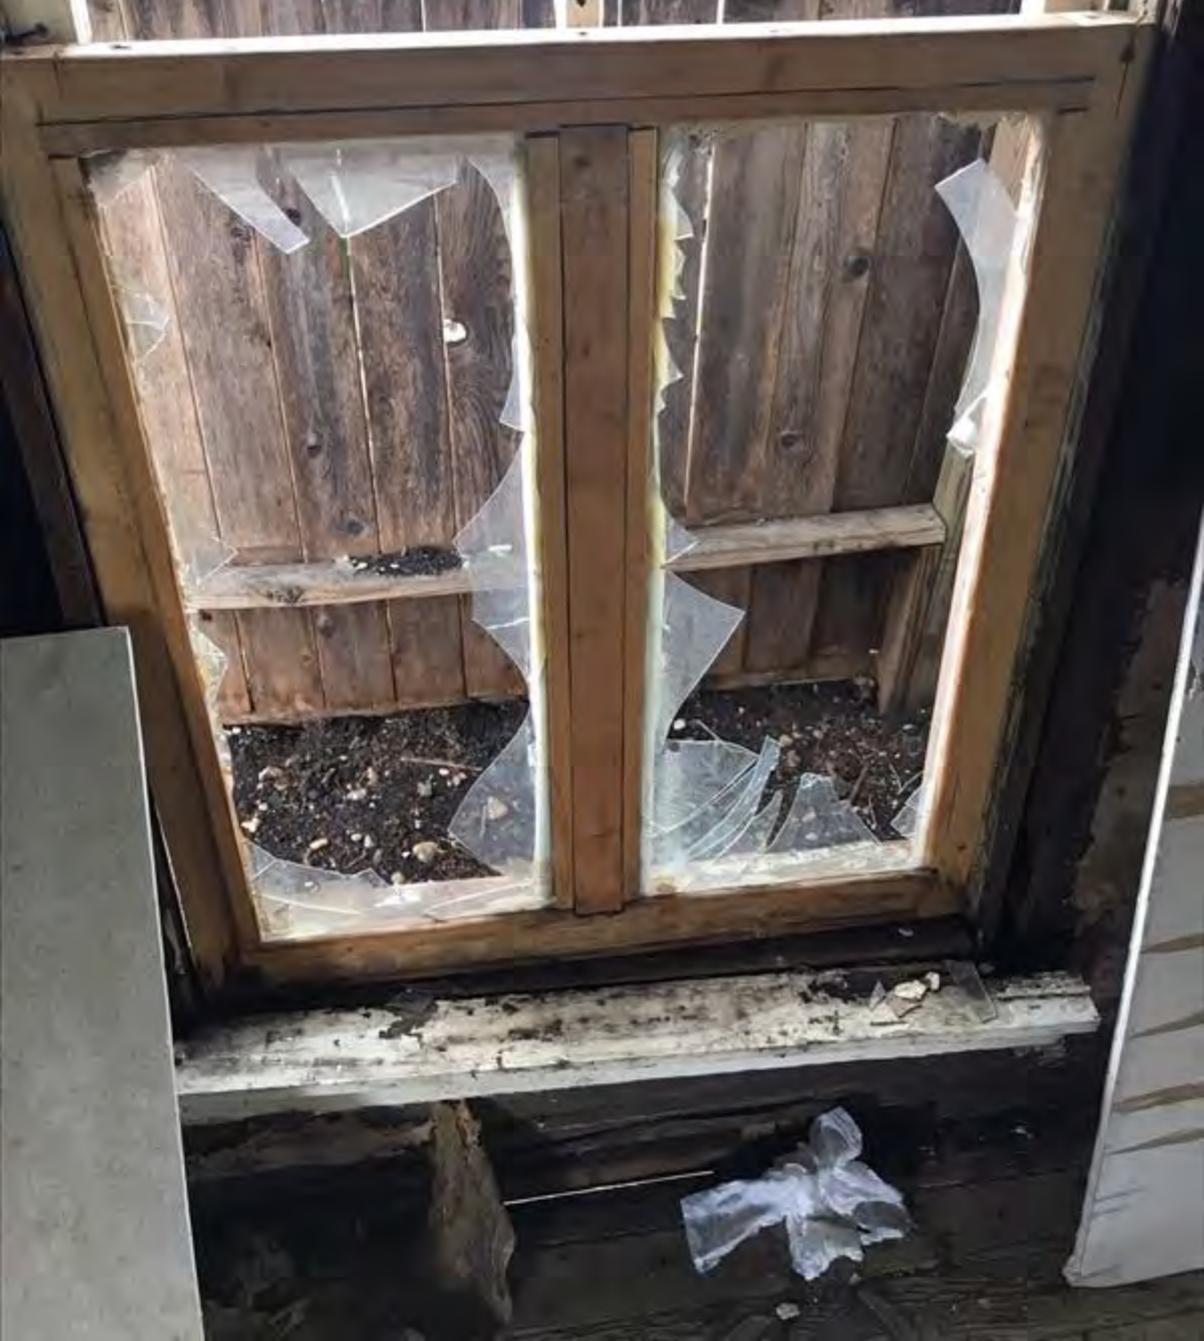
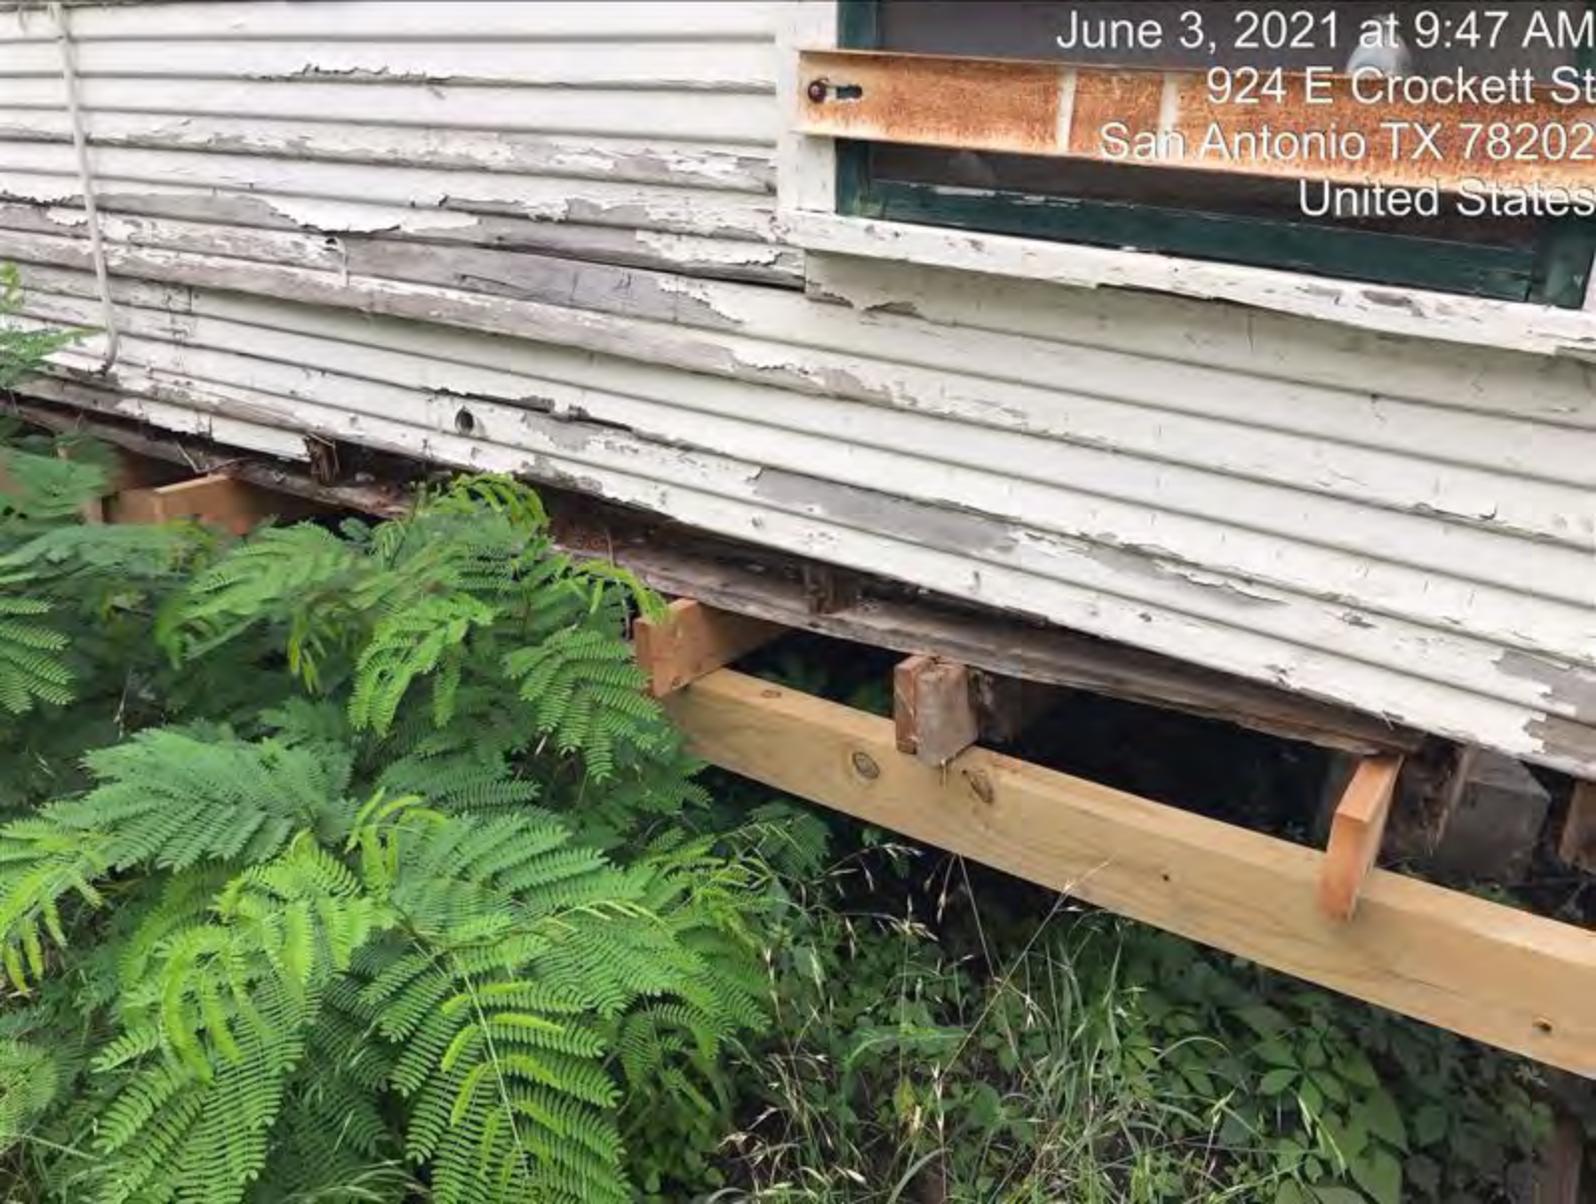
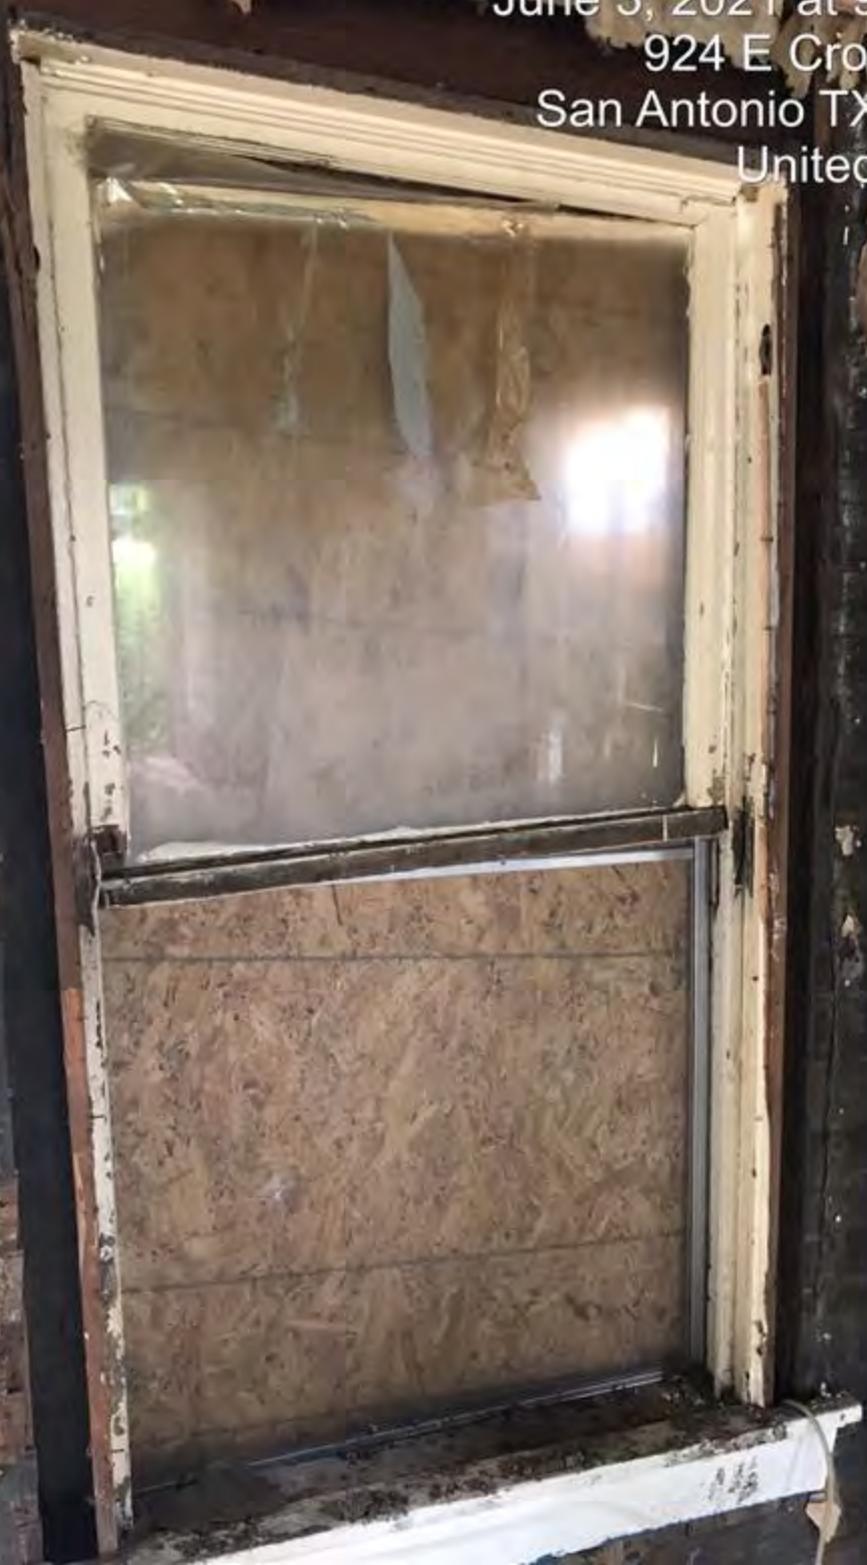
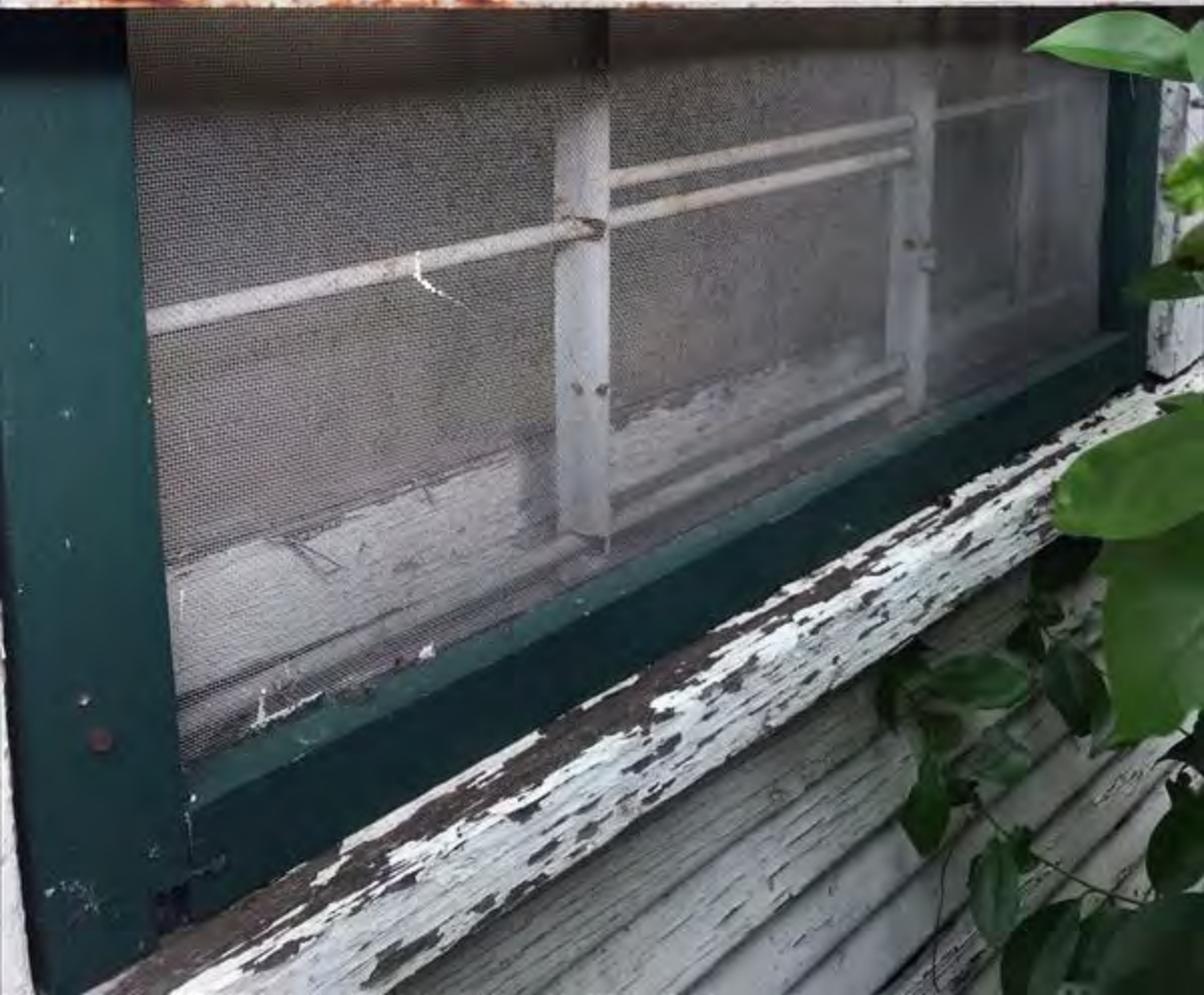
Photos from 2021

- e. WINDOW REPLACEMENT: EXISTING CONDITION – The applicant is requesting approval to replace all existing windows on the property. Staff did not have the opportunity to inspect the existing windows prior to their removal. Based on earlier photographs, most windows previously on the property were one-over-one wood windows. Staff has included the window photos on file from 2021.

Staff does not recommend approval of item 1, based on findings a through g. Staff recommends the applicant replace the existing windows on the property with windows that conform to Guidelines, namely one-over-one wood windows
