# HISTORIC AND DESIGN REVIEW COMMISSION

**HDRC CASE NO:** 2025-080  
**ADDRESS:** 125 SWEET  
**LEGAL DESCRIPTION:** NCB 2559 BLK B LOT 17 E 10 FT OF 16  
**ZONING:** RM-4, H  
**CITY COUNCIL DIST.:** 1  
**DISTRICT:** Nathan Historic District  
**APPLICANT:** Chris Coker/Blue Line Housing  
**OWNER:** Chris Coker/LOPEZ GREGORIA  
**TYPE OF WORK:** Demolition of a rear accessory structure  
**APPLICATION RECEIVED:** March 25, 2025  
**60-DAY REVIEW:** May 24, 2025  
**CASE MANAGER:** Edward Hall

Project: 125 Sweet (Storage building at rear)  
San Antonio, TX 78204  
Observation Letter  
Legal Description: NCB: 2559 BLK: B, LOT 17 E 10 Ft of 16

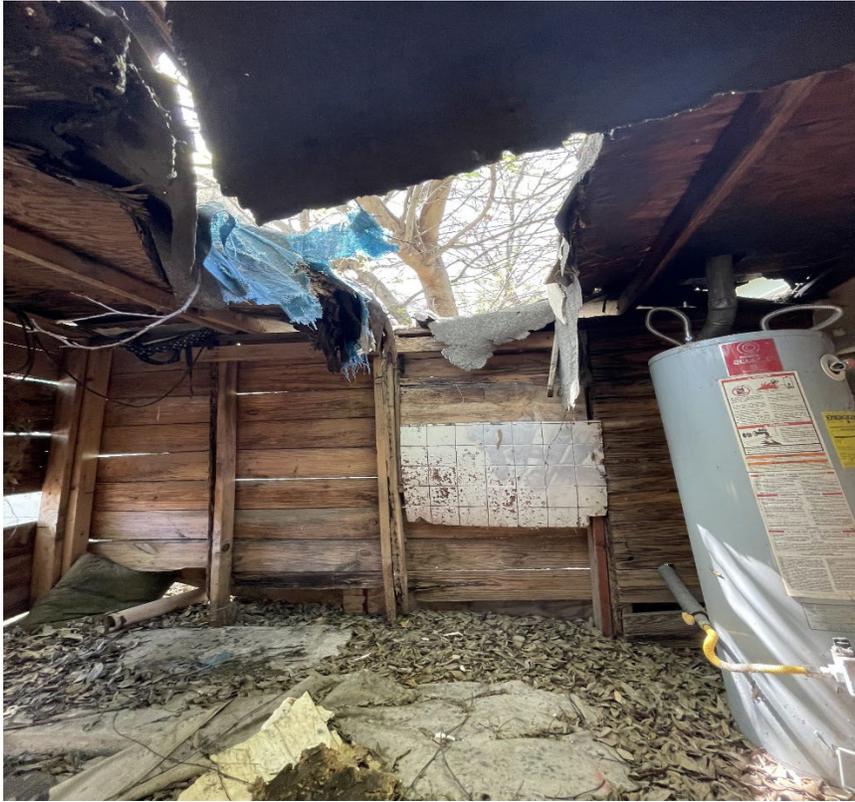
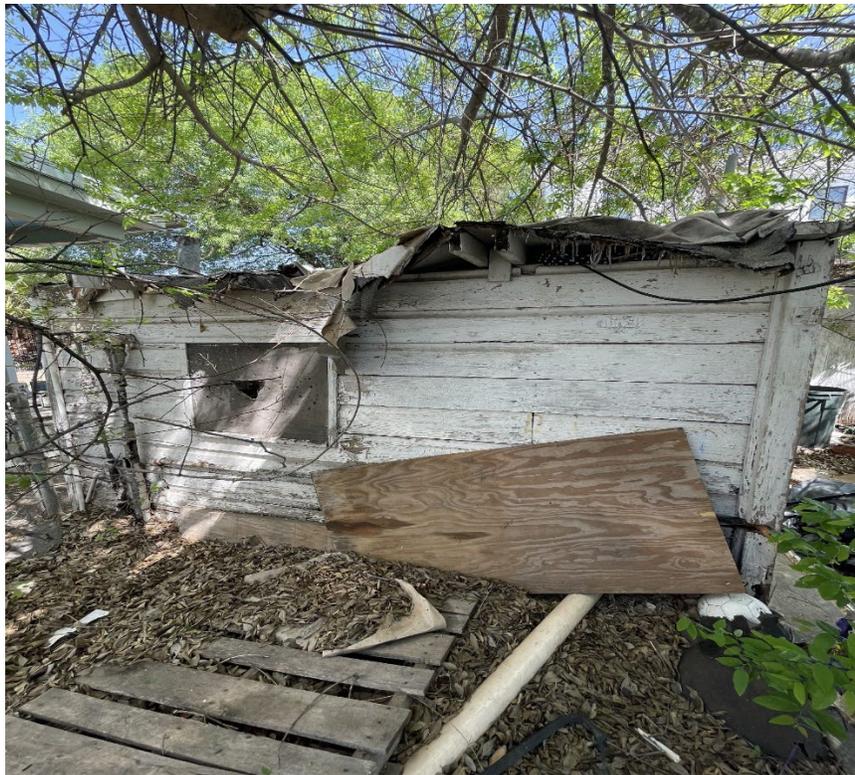
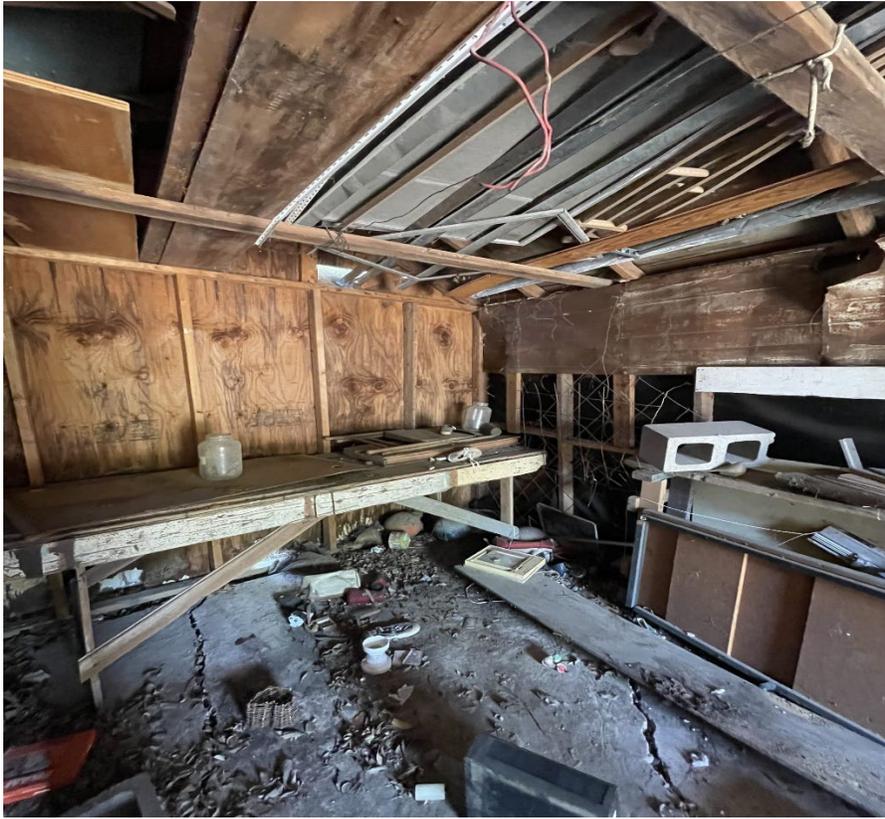
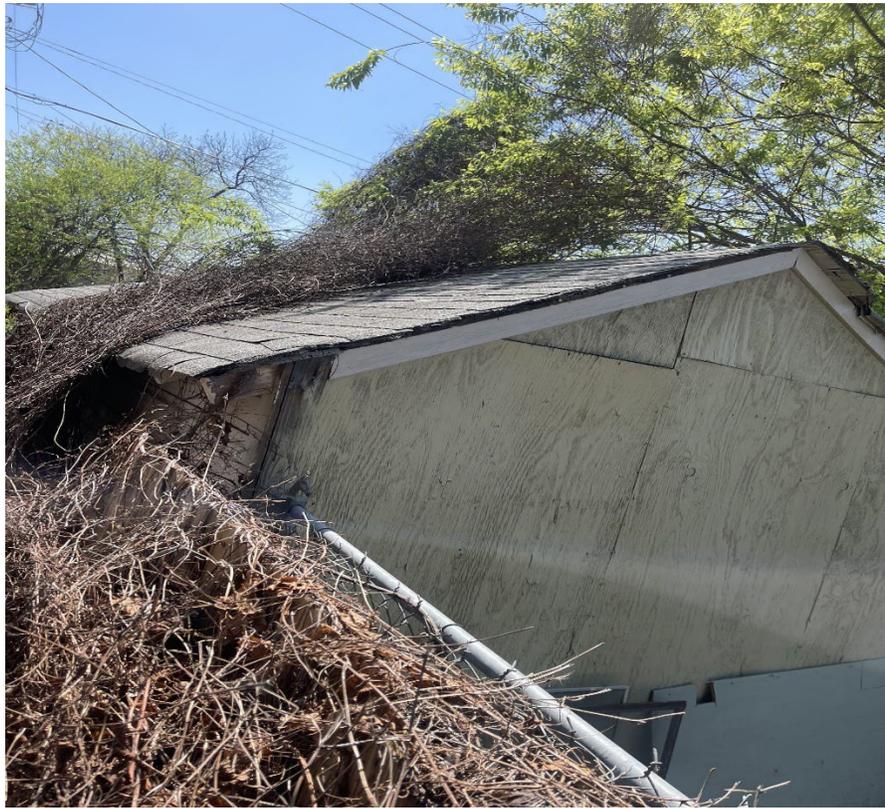
PICTURES

Our relative observations indicate that the foundation has failed, multiple fractures were observed.

The frame is out of plum with damaged wood and roof, also missing members,

Based on my experience, knowledge, information and belief, the stated constructions that we observed is damaged beyond design intent and in need of replacement.

Surface water should drain away from foundation walls. Drainage can be improved with grading and shall fall a minimum of 6 inches within the first 10 feet.

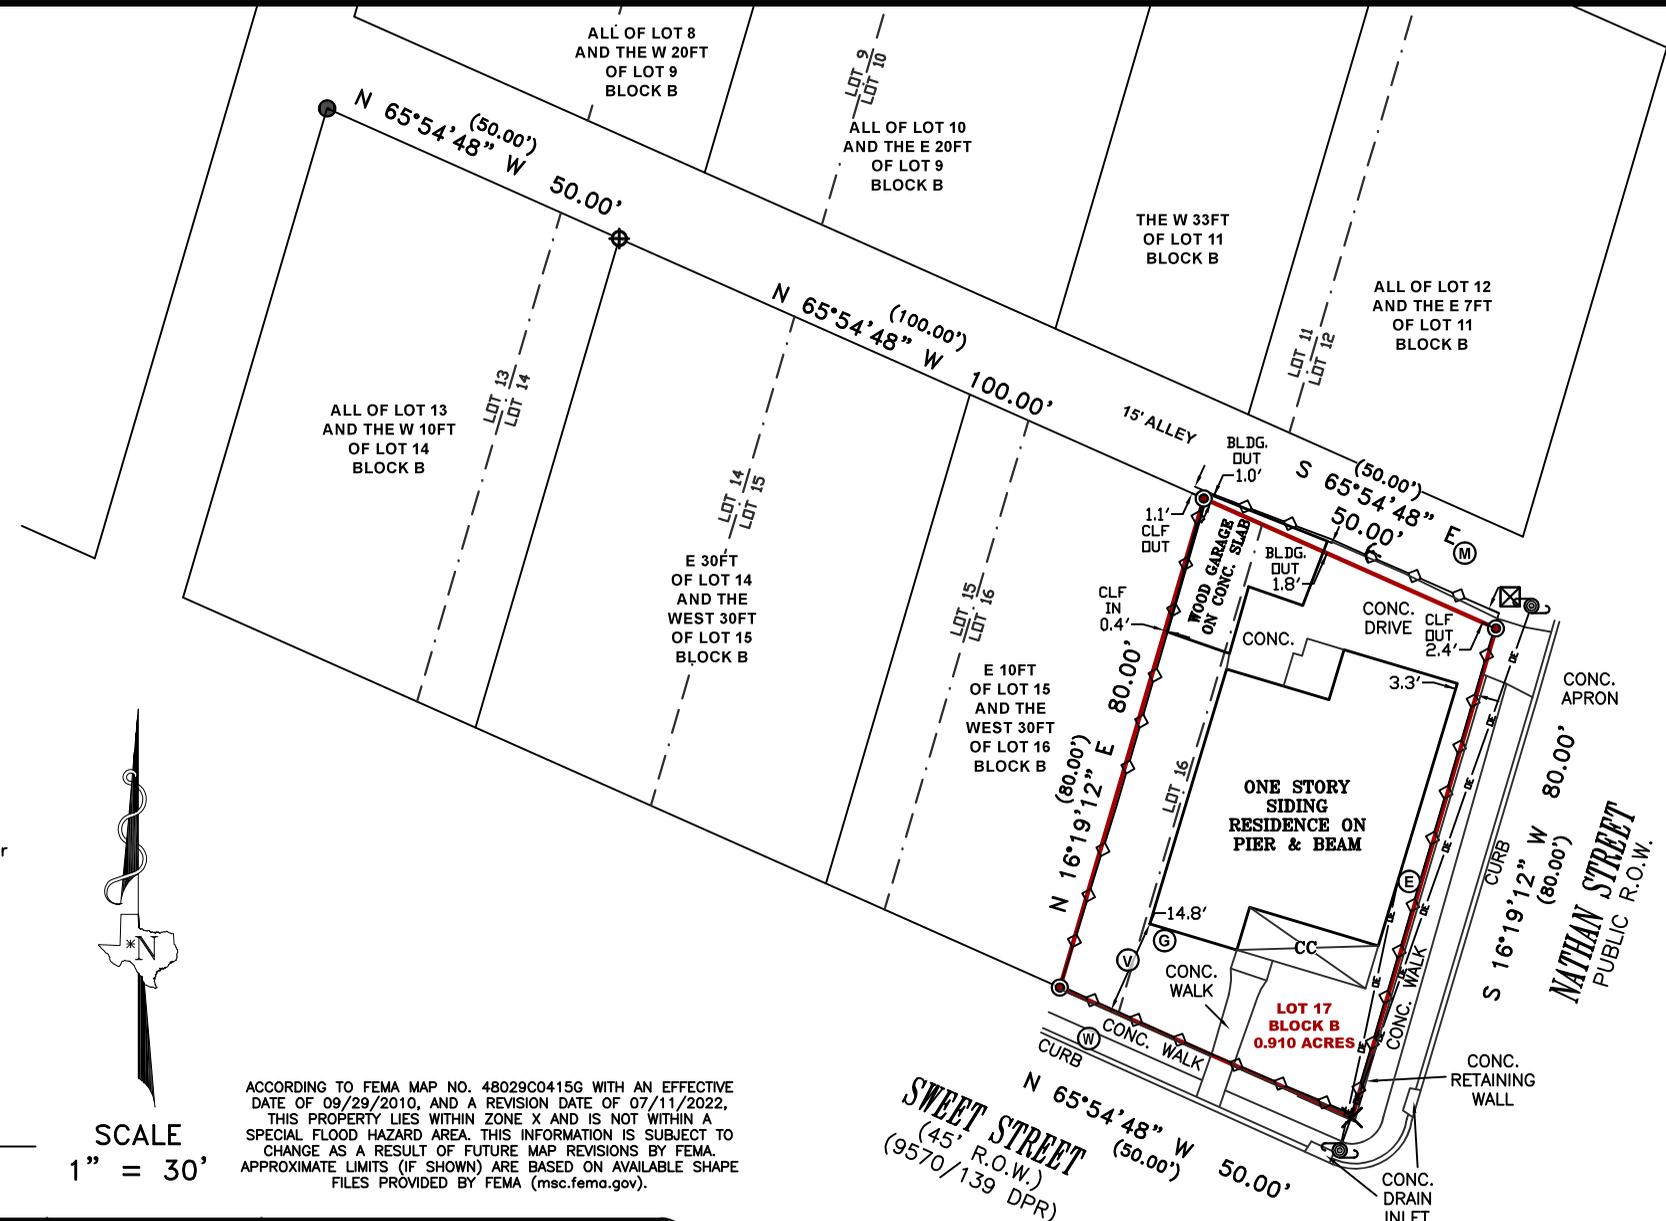
**LAND TITLE SURVEY**

THE EAST 10 FEET OF LOT SIXTEEN (16) AND ALL OF LOT SEVENTEEN (17), BLOCK "B", NEW CITY BLOCK TWO THOUSAND FIVE HUNDRED FIFTY-NINE (2559), IN THE CITY OF SAN ANTONIO, BEXAR COUNTY, TEXAS
