**HISTORIC AND DESIGN REVIEW
COMPLIANCE AND TECHNICAL ADVISORY BOARD**

HDRC CASE NO: 2024-152
ADDRESS: 250 QUENTIN DR
LEGAL DESCRIPTION: NCB 6708 BLK 18 LOT 21
ZONING: R-6, H
CITY COUNCIL DIST.: 7
DISTRICT: Monticello Park Historic District
APPLICANT: Maziyar Entezami/ENTEZAMI MAZIYAR
OWNER: Maziyar Entezami/ENTEZAMI MAZIYAR
TYPE OF WORK: Roof modifications, construction of a side garage addition, window replacement
APPLICATION RECEIVED: March 29, 2024
60-DAY REVIEW: May 28, 2024
CASE MANAGER: Edward Hall

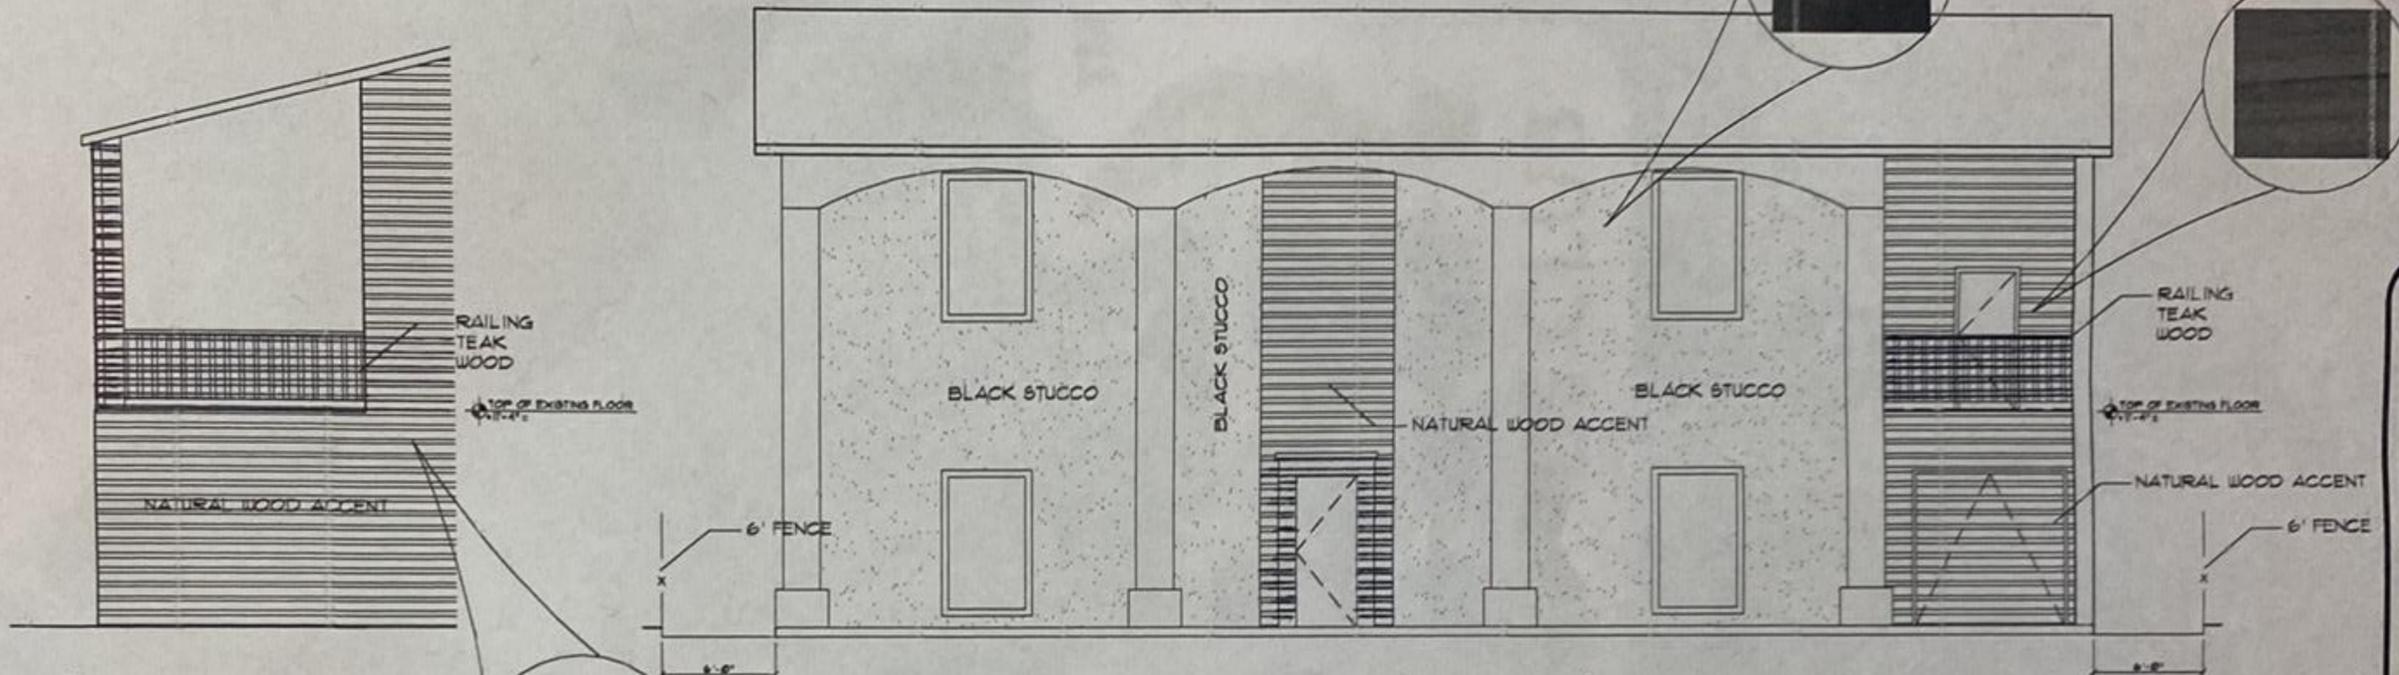
EXISTING/PROSED ELEVATION
SCALE: 1/4" = 1'-0"

- d. ROOF RECONSTRUCTION – The applicant has proposed to reconstruct the fire damaged roof structure to feature a modified roof pitch and an increased ridge height over an existing side addition. The applicant has not proposed to reconstruct the previously existing chimney. The previously constructed roof featured modifications from the original profile and a modified ridge height. Generally, staff finds the construction of one, centered ridge line to be appropriate; however, staff finds that the side addition should maintain a subordinate ridge height, as was previously constructed. The Guidelines for Additions notes that the roofs of additions should feature subordinate ridge heights.

- e. FAÇADE MODIFICATIONS (Main Structure) – The applicant has proposed to cover the existing, non-original stone façade with black stucco and to add wood siding to feature a natural wood finish. The Guidelines for Exterior Maintenance and Alterations 1.B.ii. notes that modern materials should not be introduced and that materials that match the original in size, scale, and character should be installed. Generally, staff finds the application of stucco and natural wood finish siding to be inconsistent with the Guidelines and historic examples found on this block. Similarly styled and constructed houses feature brick or painted wood siding. Staff finds that the existing façade materials should be maintained and matched or that an architecturally and historically appropriate material be proposed for review and approval.

- f. FAÇADE MODIFICATIONS (Side Garage) – The applicant has proposed to modify the façade of the existing, side addition by installed a front facing garage door and installing wood siding. The 1941 Sanborn Map notes a garage in the location of the current side addition, where the applicant has proposed to install a garage. Staff finds the proposed request to be appropriate; however, staff finds that the proposed door should feature wood construction or be profiles to appear consistent with those found historically within the Monticello Park Historic District. Staff finds that the façade materials should match the existing on site or that an architecturally and historically appropriate material be proposed for review and approval. Additionally, staff finds that additional
