**HISTORIC AND DESIGN REVIEW COMMISSION  
COMPLIANCE AND TECHNICAL ADVISORY BOARD**

**HDRC CASE NO:** 2025-029  
**ADDRESS:** 320 CLUB DR  
**LEGAL DESCRIPTION:** NCB 6703 BLK 13 LOT 31 & W 37.5 FT OF 32  
**ZONING:** R-6, H  
**CITY COUNCIL DIST.:** 7  
**DISTRICT:** Monticello Park Historic District  
**APPLICANT:** Robert Kesl  
**OWNER:** Robert Kesl/KESL ROBERT  
**TYPE OF WORK:** Screen door replacement  
**APPLICATION RECEIVED:** January 22, 2025  
**60-DAY REVIEW:** March 23, 2025  
**CASE MANAGER:** Rachel Rettaliata

The applicant is requesting a Certificate of Appropriateness to replace the existing wooden screen door with a full-lite metal storm door.

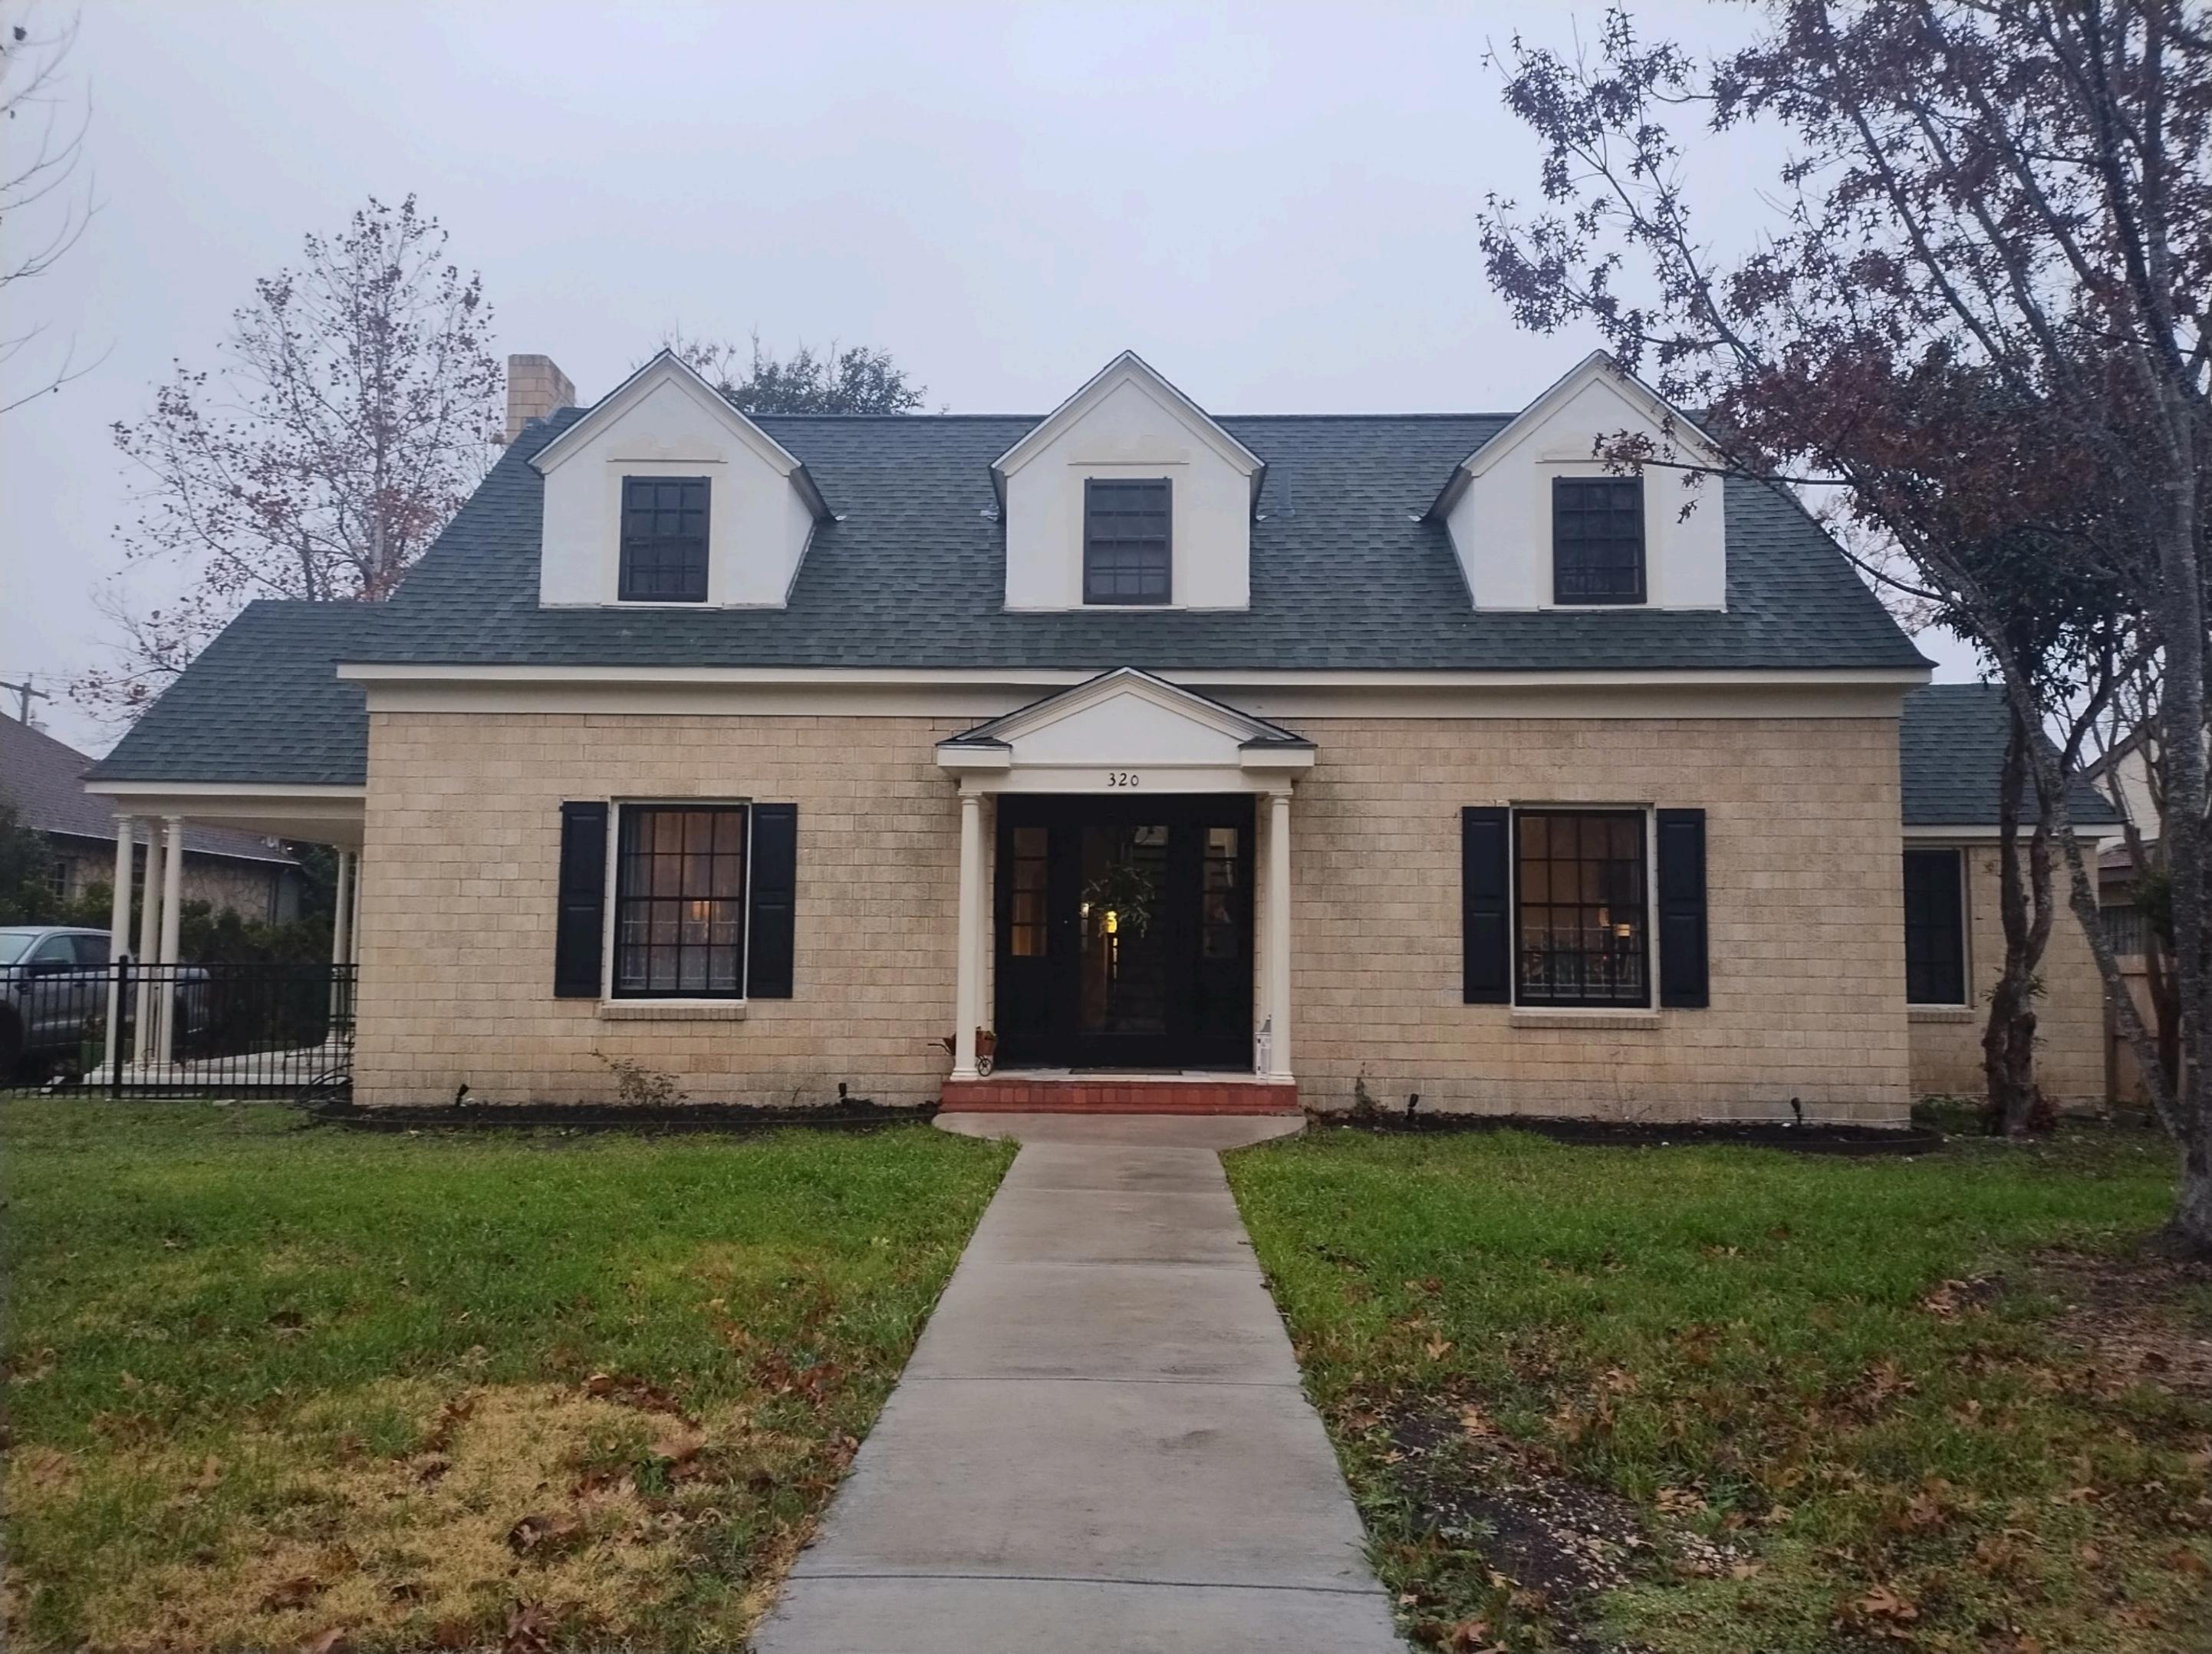
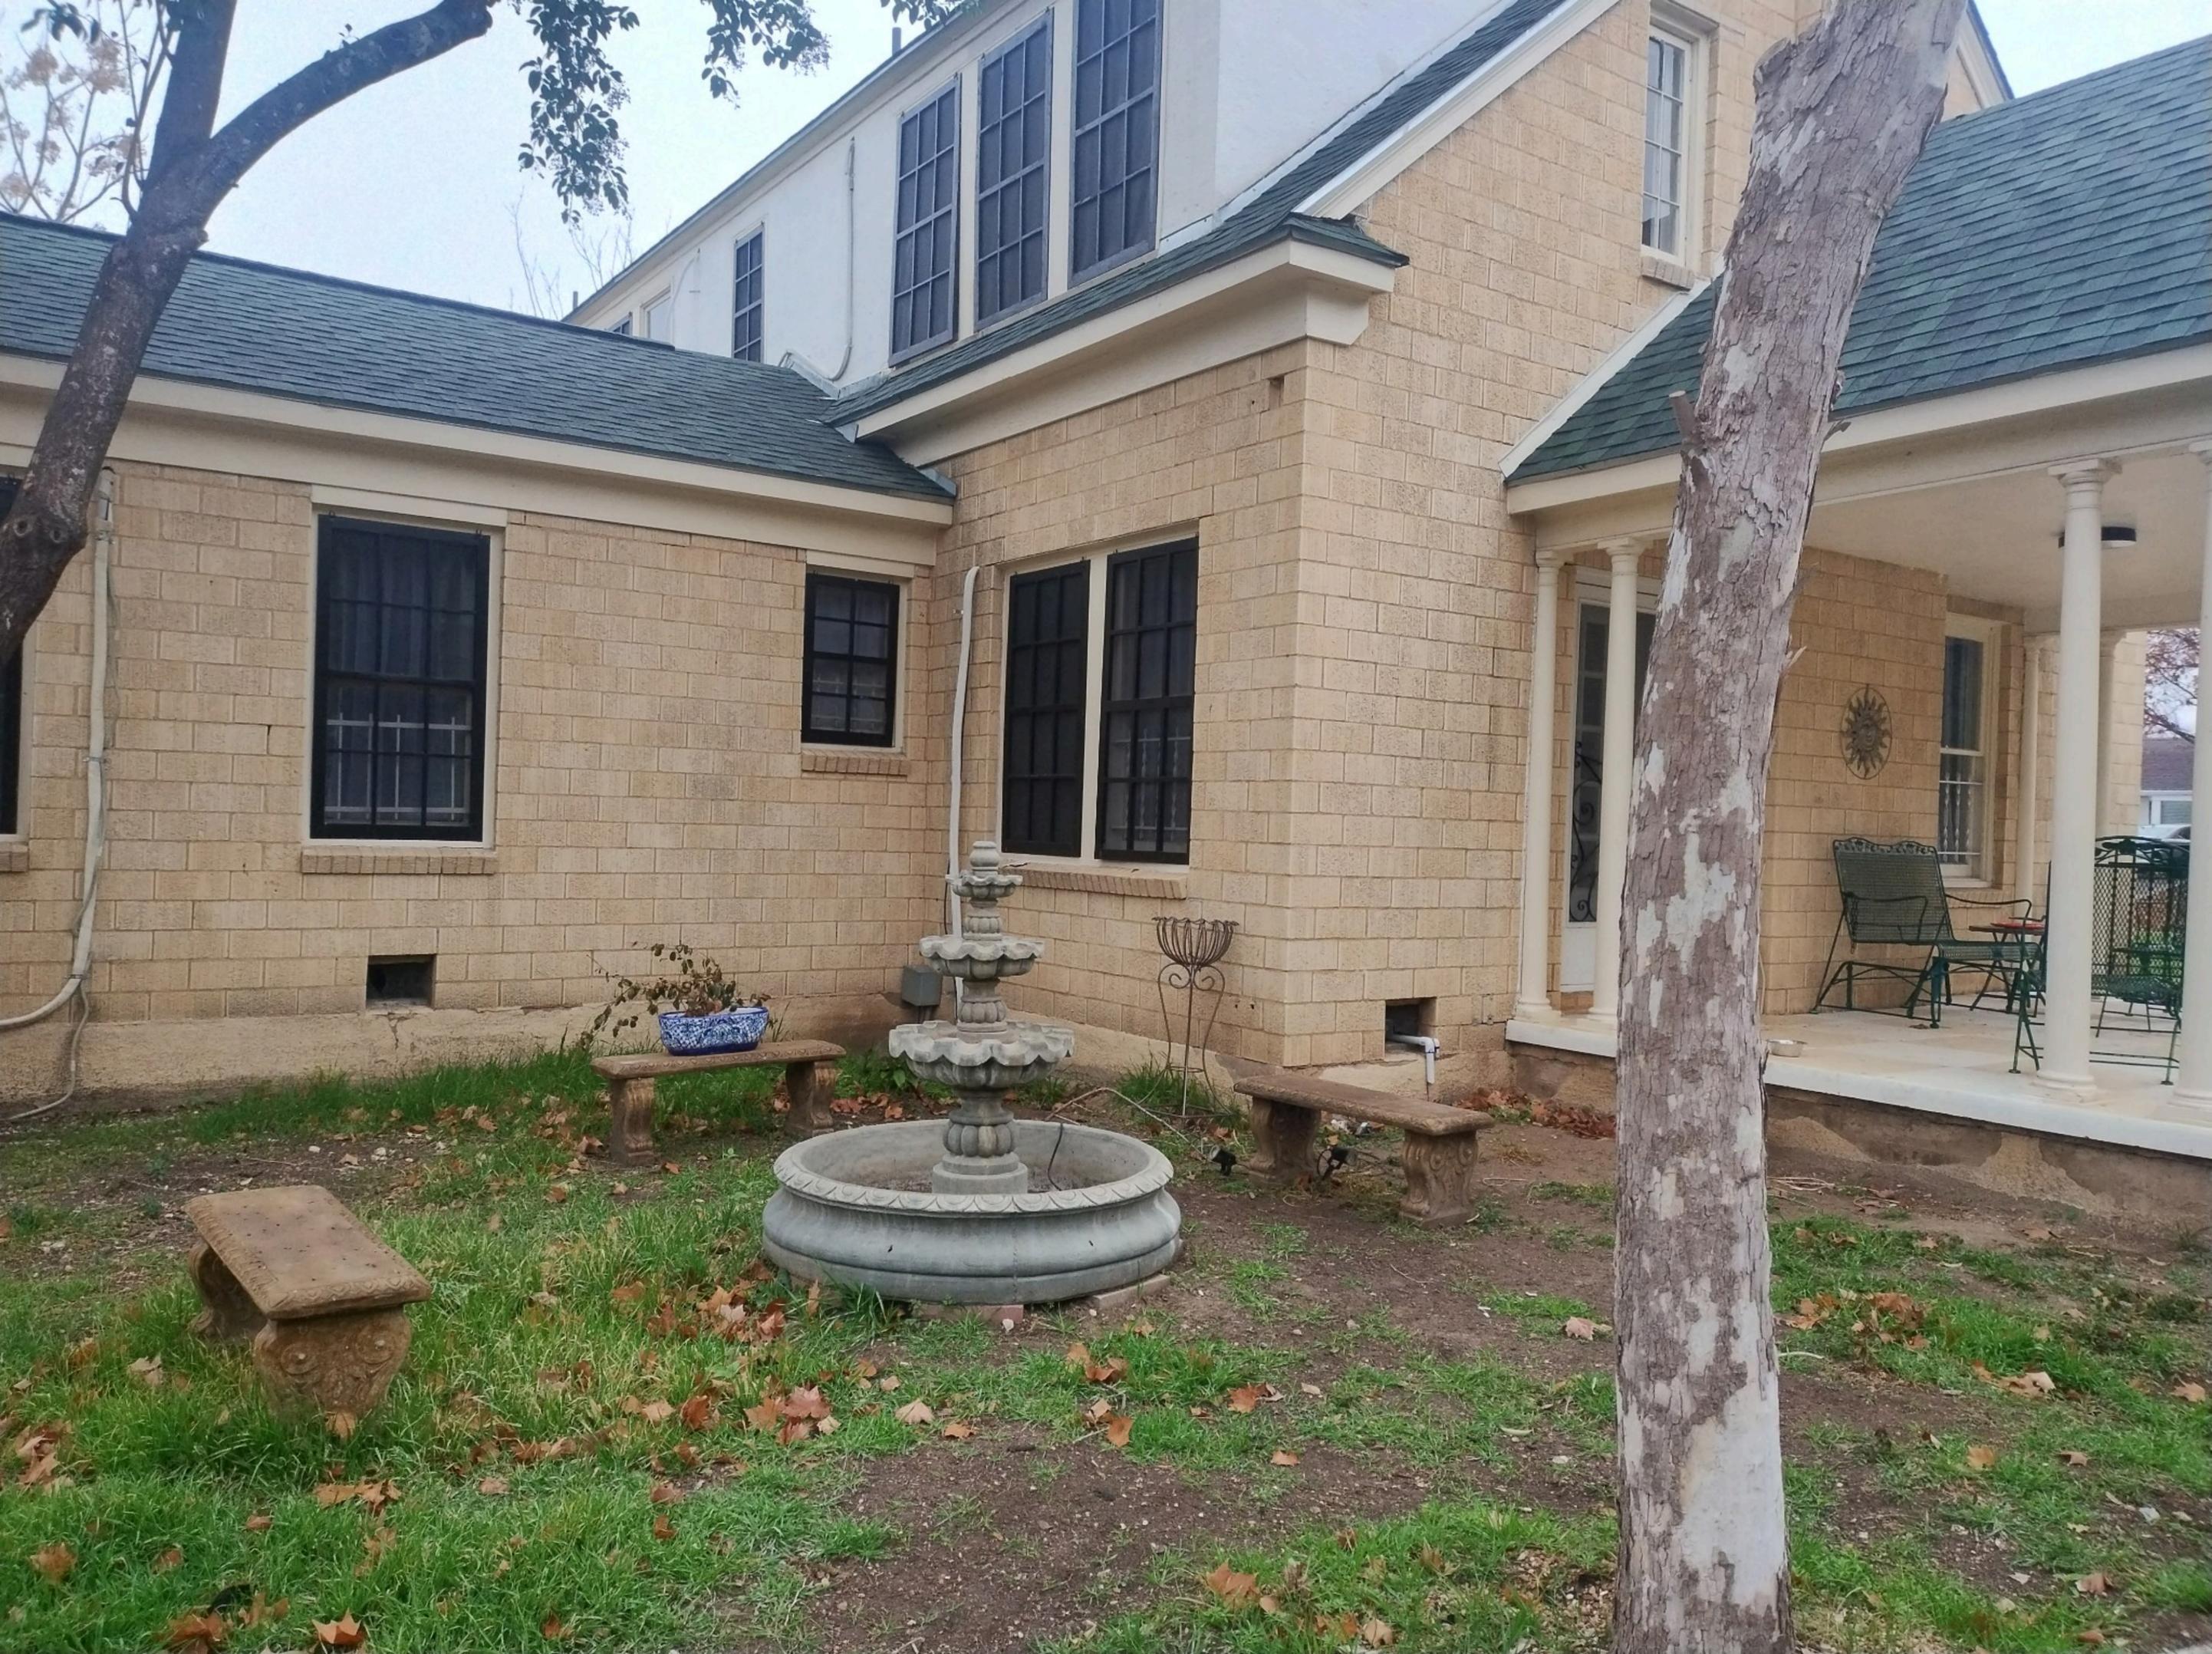
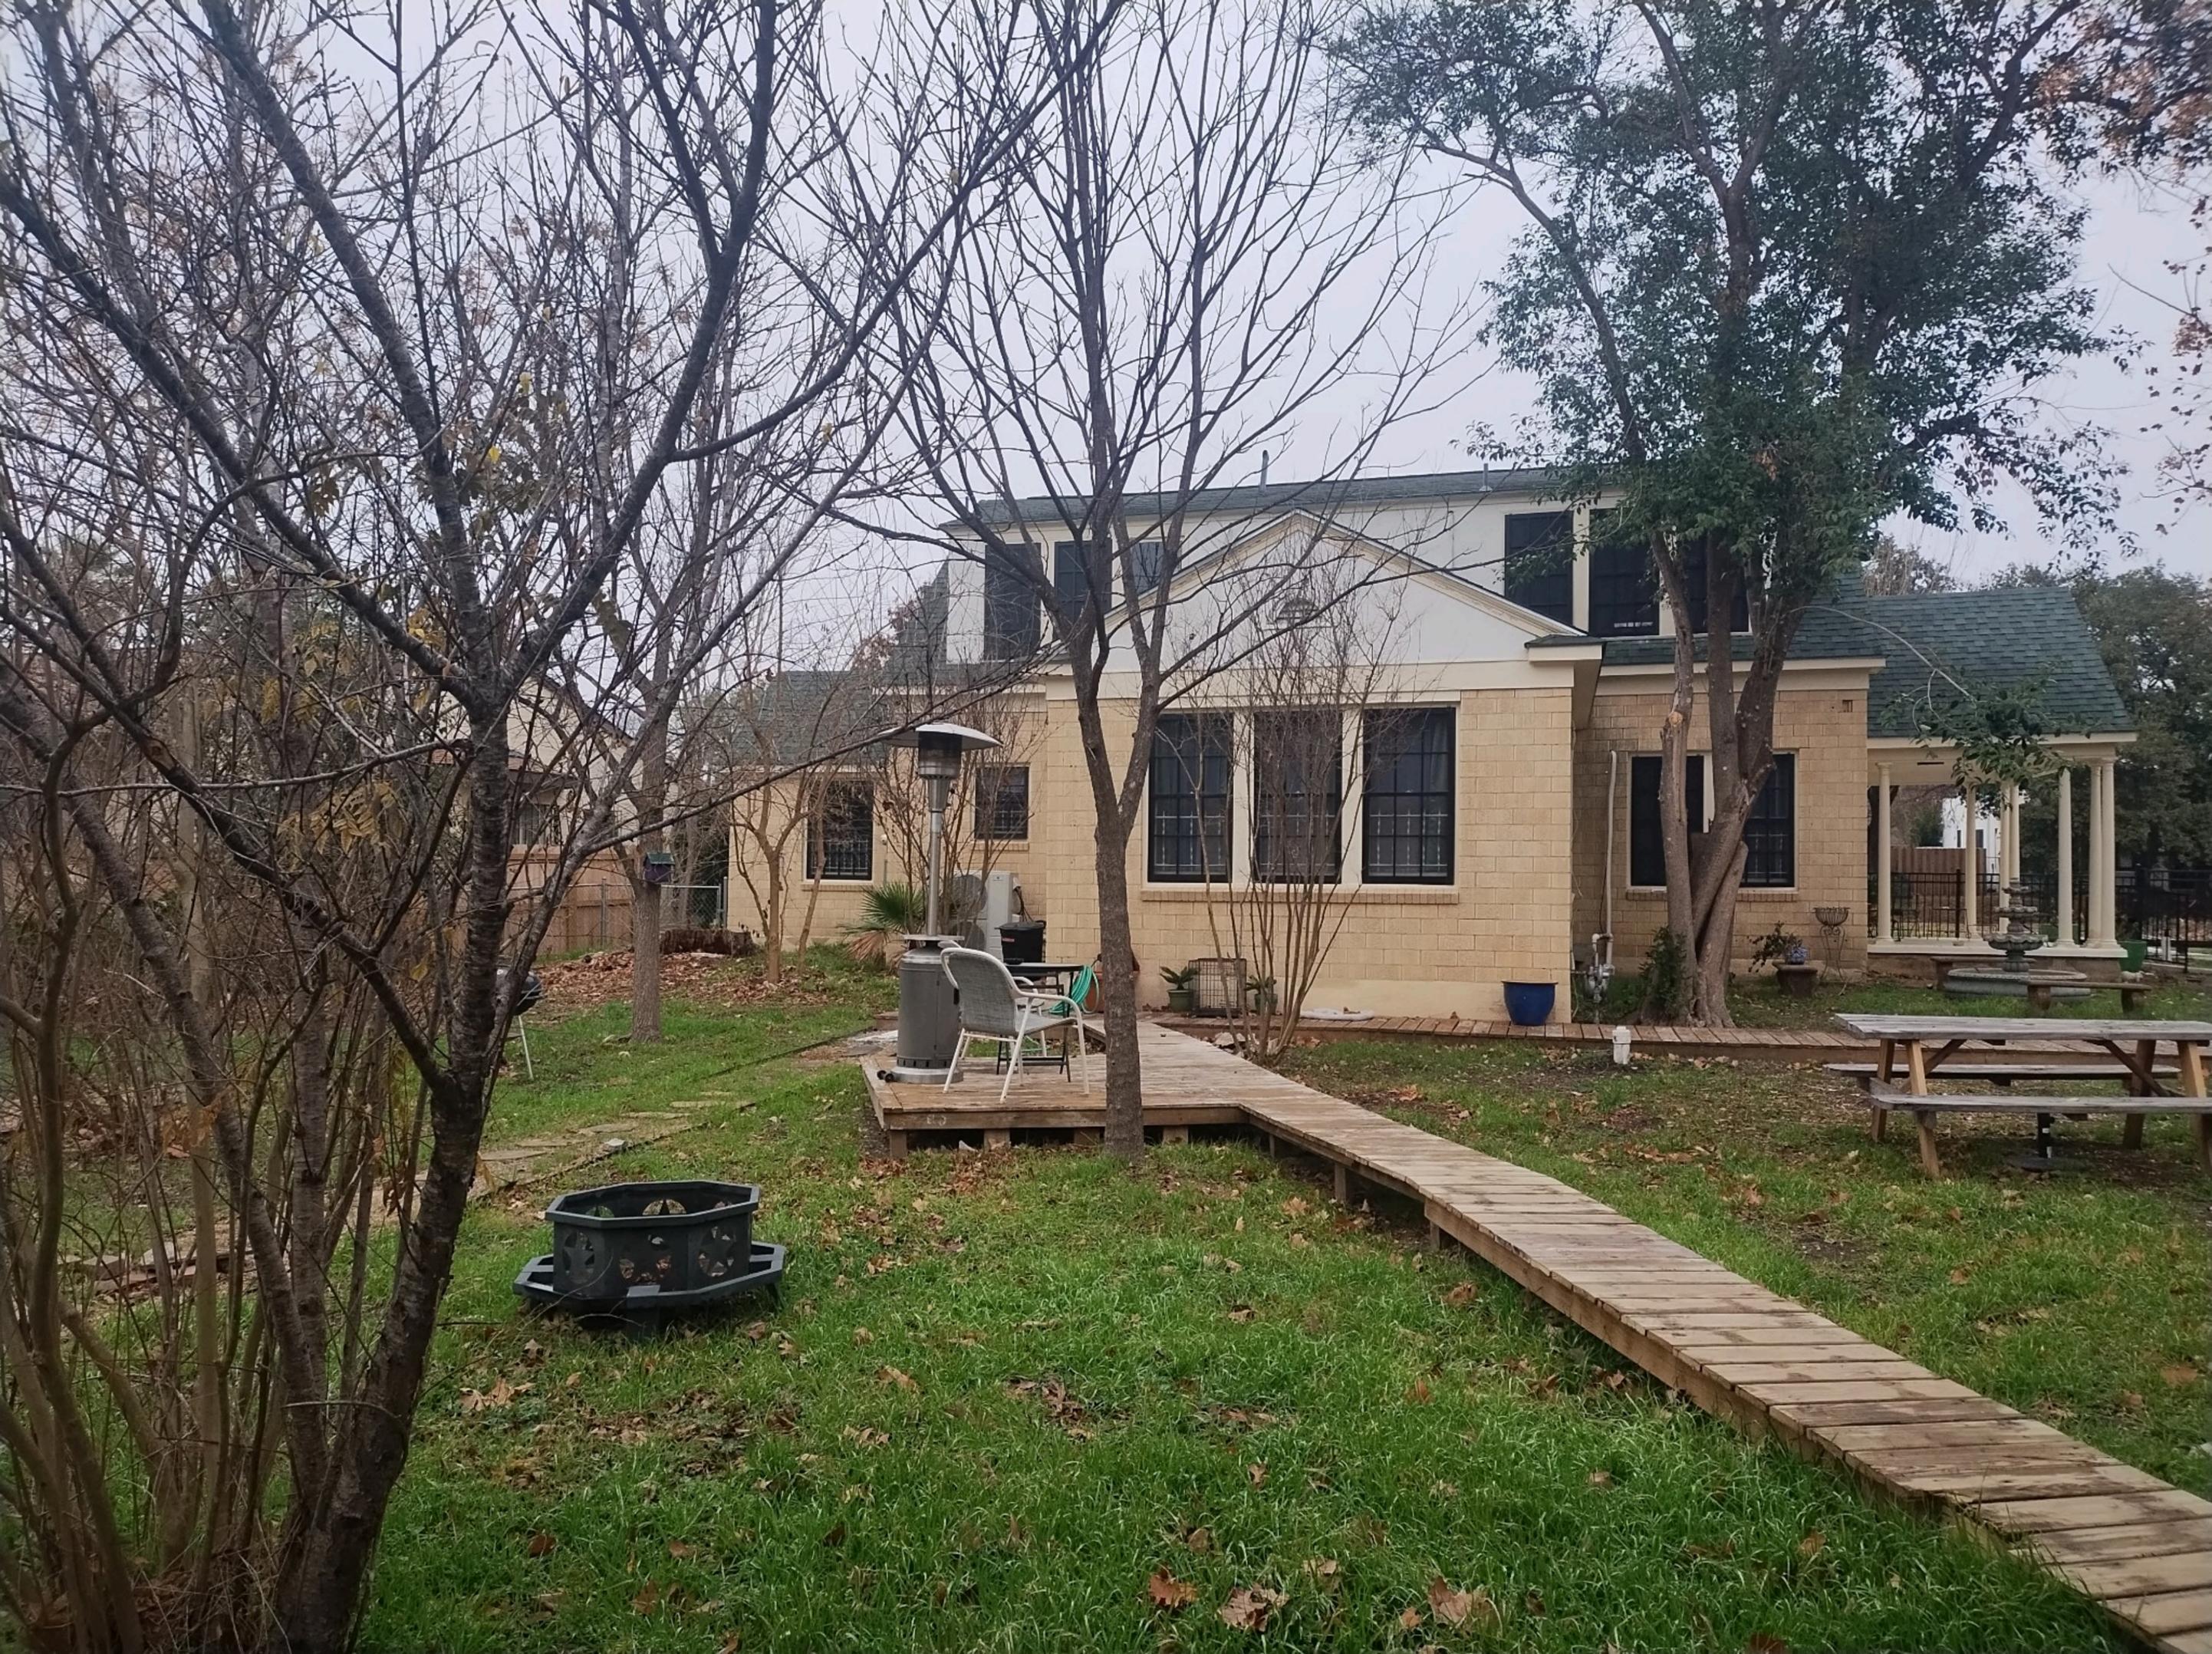
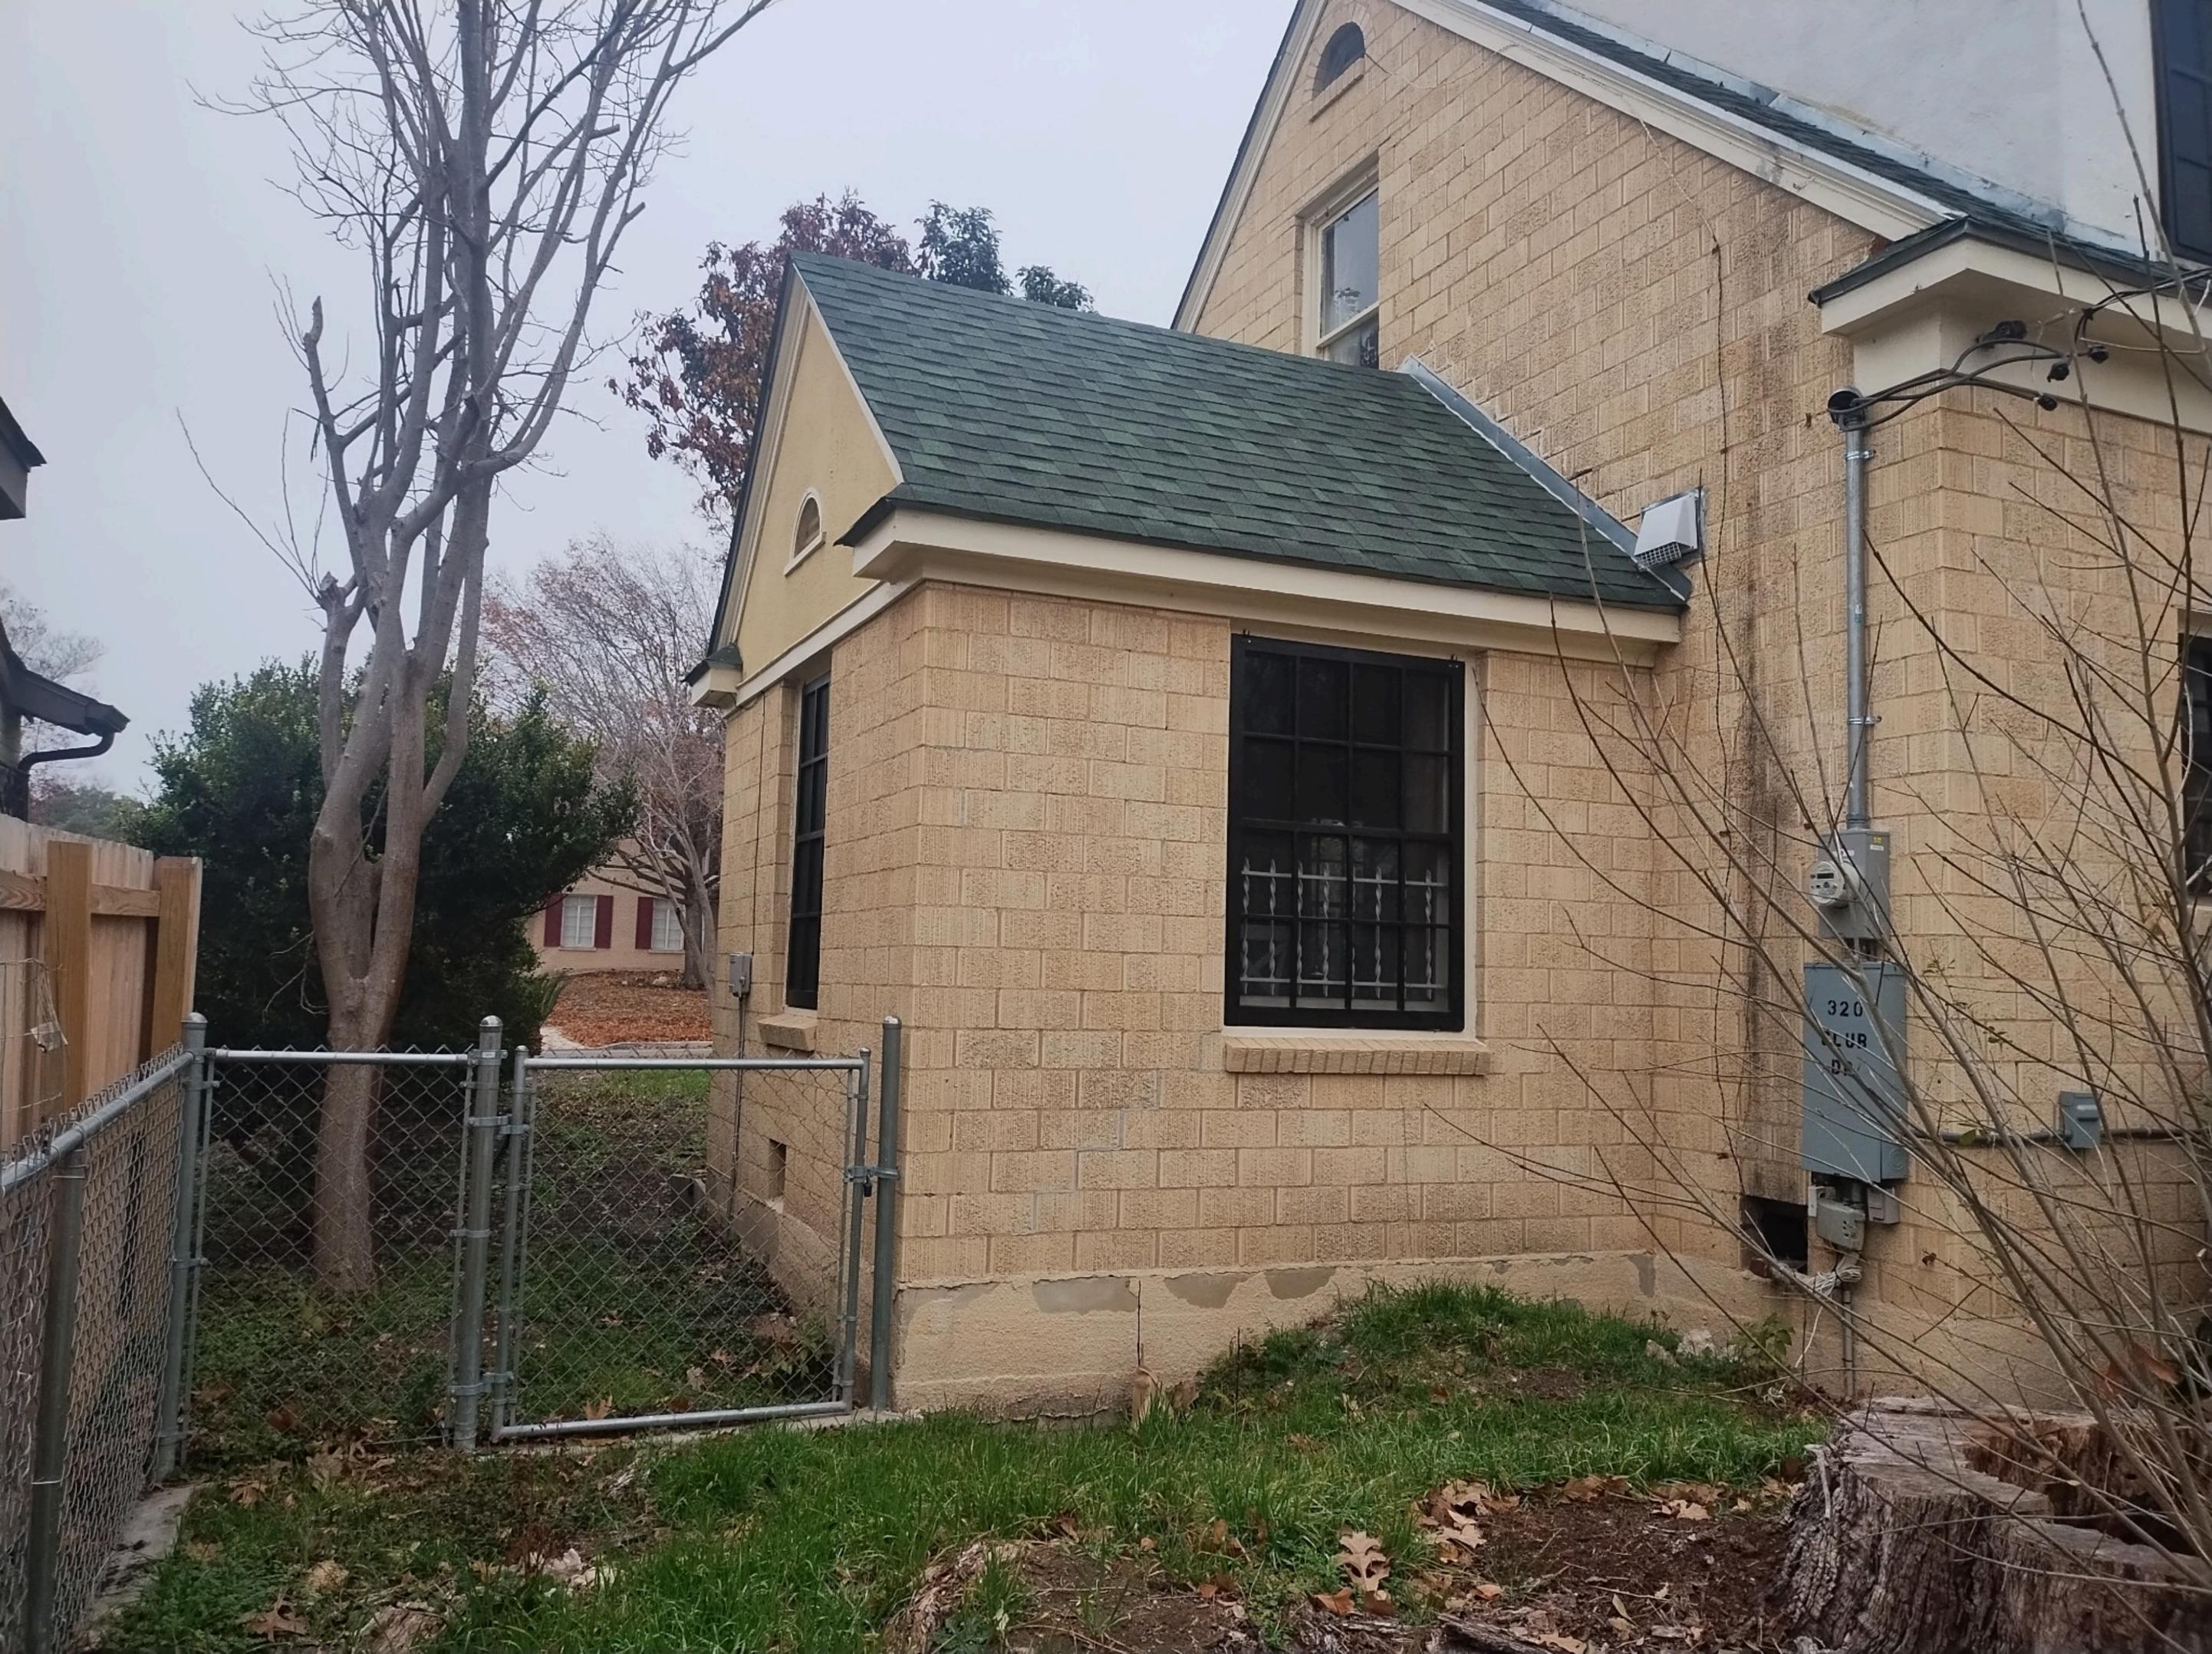
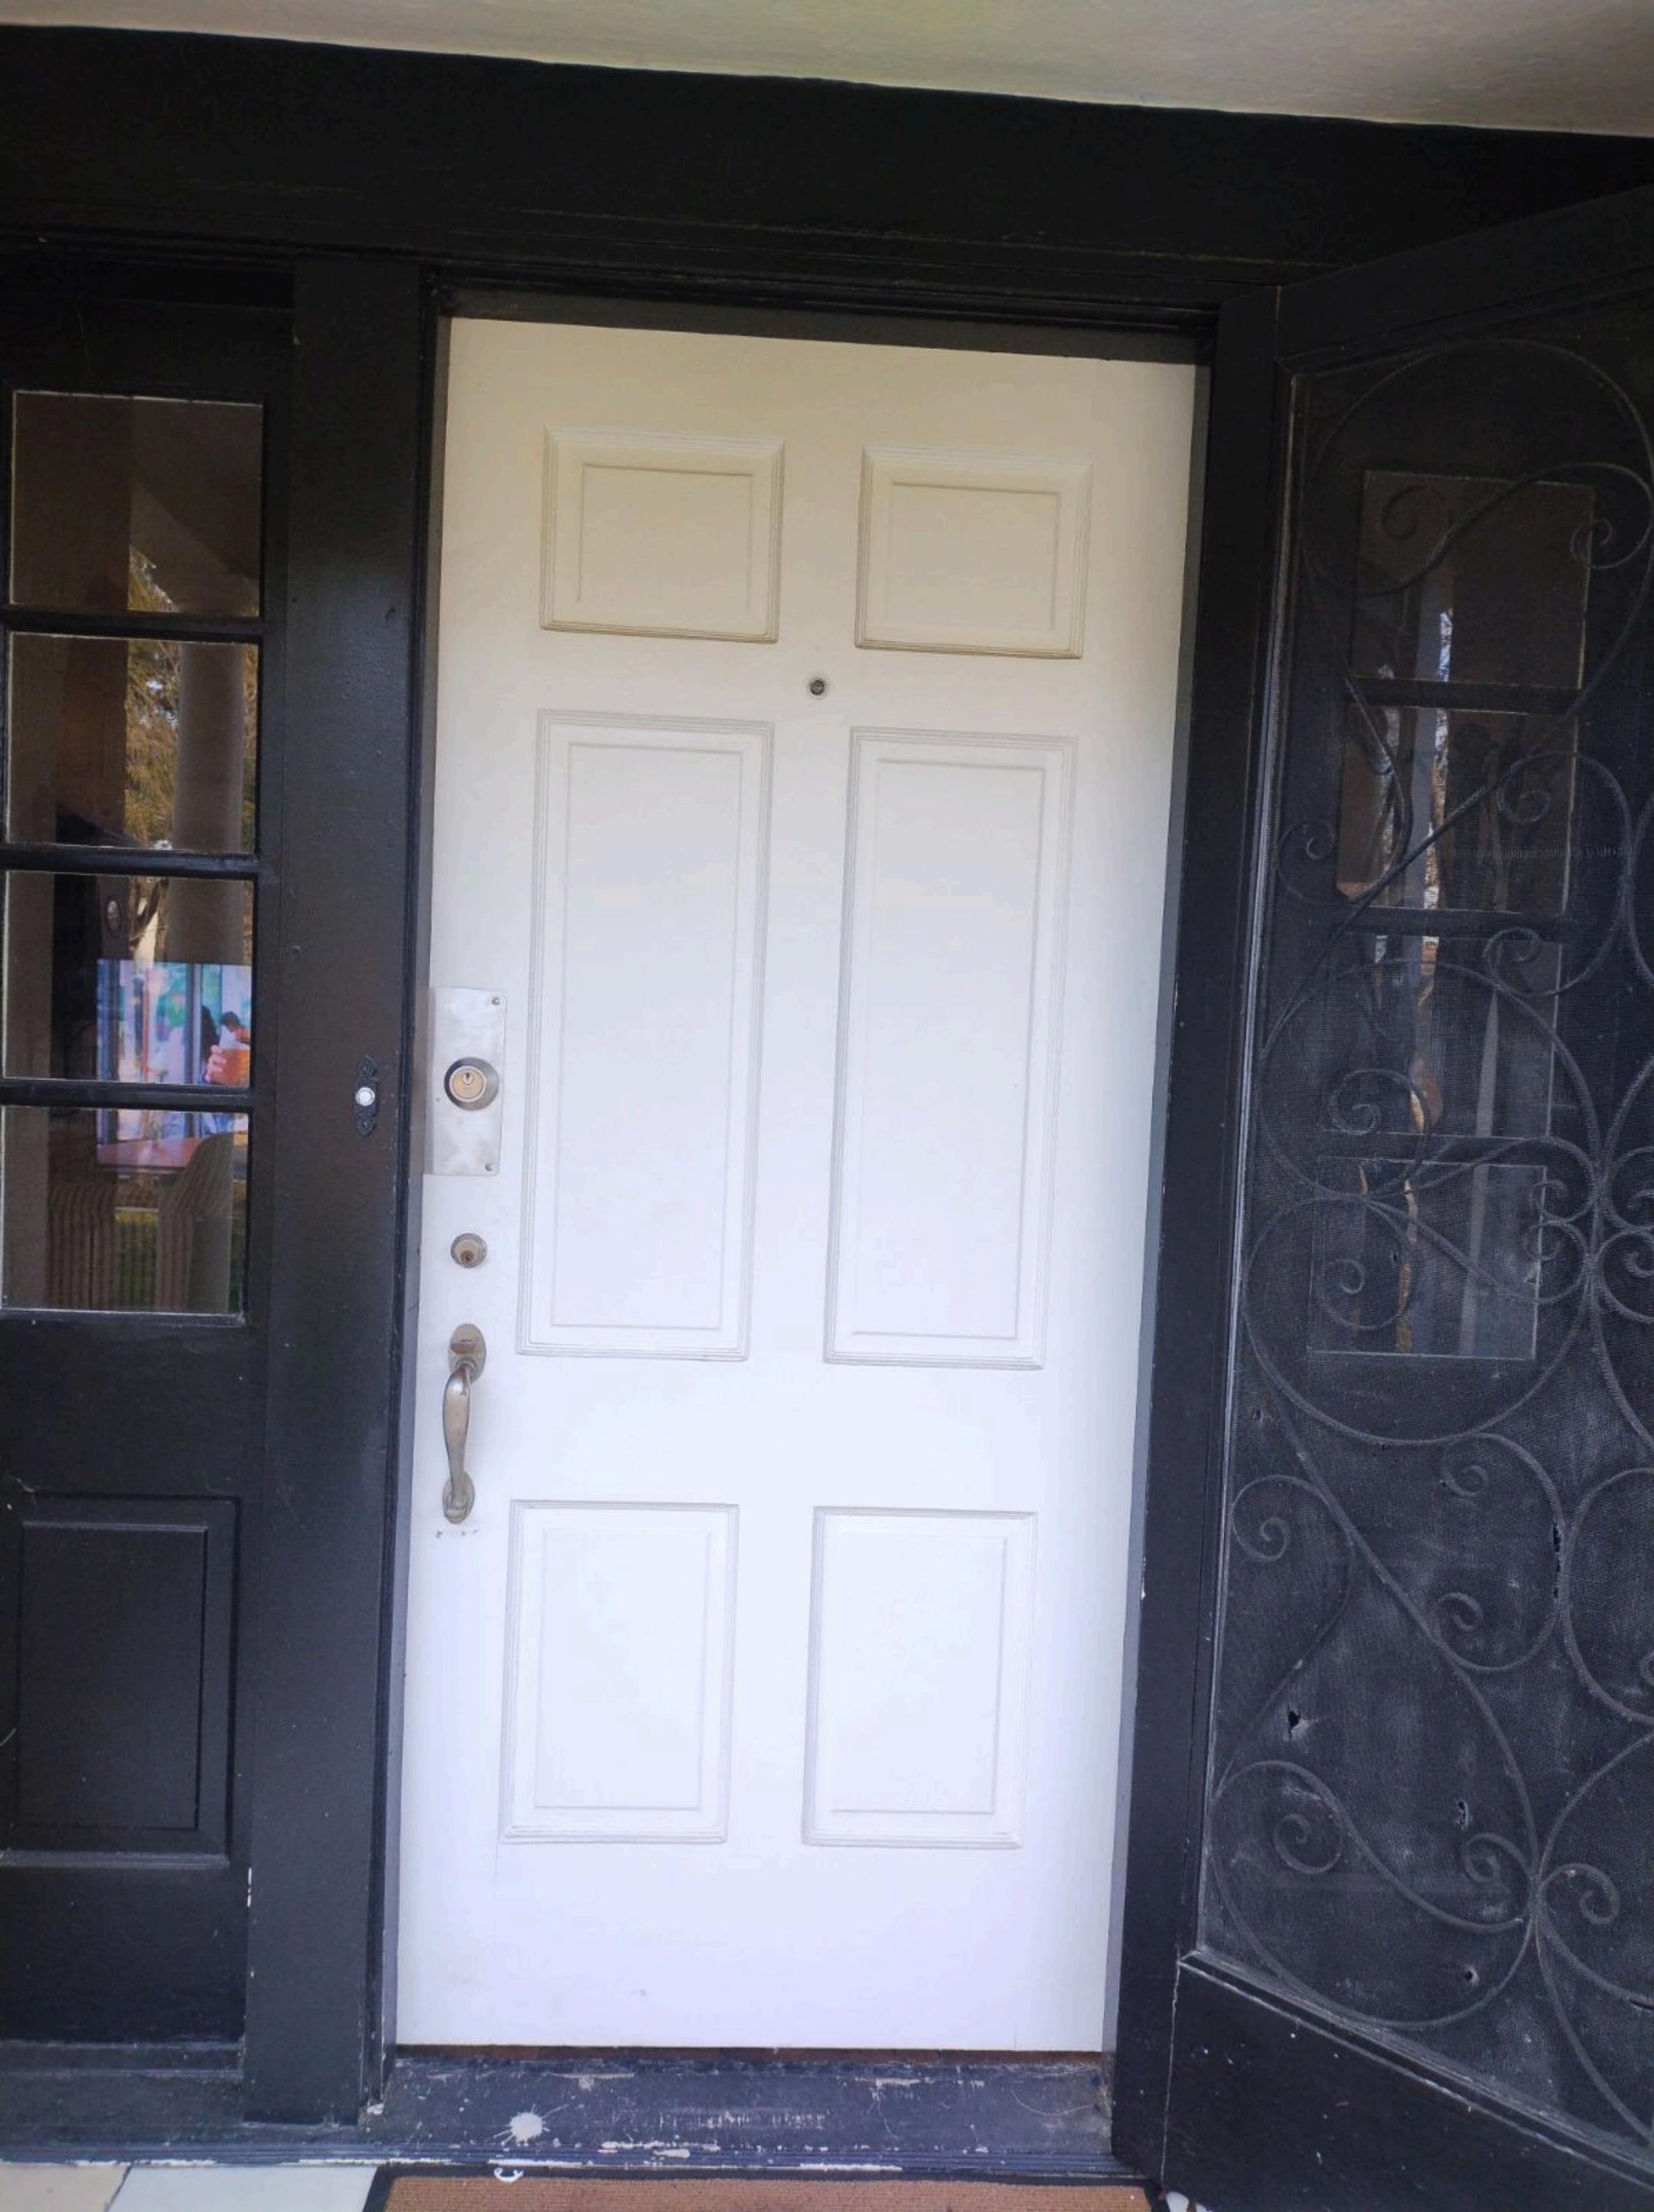
320  
CLUB  
DE

- b. **SCREEN DOOR REPLACEMENT** – The applicant has proposed to replace the existing wooden screen door with a mesh screen and decorative metal grille with a full-lite metal storm door. Guideline 6.B.i for Exterior Maintenance and Alterations states that historic doors should be preserved, and doors, hardware, fanlight, sidelights, pilasters, and entablatures should only be replaced in-kind when possible and when deteriorated beyond repair. When in-kind replacement is not feasible, ensure features match the size, material, and profile of the historic element. Staff finds that the applied metal grille is likely not original to the screen door. The installation of a metal storm door is not consistent with the Guidelines. Staff finds that the replacement of the existing wood screen door with a fully wood, full-lite storm door that features the existing hardware would be appropriate.

- i. That the applicant installs a fully wood, full-lite storm door to match the existing door in material, design, and appearance, and installs the existing hardware (handle and hinges) on the new storm door based on finding b. The applicant is required to submit final material specifications for the selected door product to staff for review and approval prior to the issuance of a Certificate of Appropriateness.
