# HISTORIC AND DESIGN REVIEW COMMISSION COMPLIANCE AND TECHNICAL ADVISORY BOARD

**HDRC CASE NO:** 2025-132  
**ADDRESS:** 112 W HOLLYWOOD AVE  
**LEGAL DESCRIPTION:** NCB 6388 8 77, 78, W 7.5 FT OF 76 & E 12.5 FT OF 79  
**ZONING:** R-5, H  
**CITY COUNCIL DIST.:** 1  
**DISTRICT:** Monte Vista Historic District  
**APPLICANT:** Victoria Gough  
**OWNER:** Gwen Stroud/STROUD GWENDOLYN ANNIE & GARY BRUCE  
**TYPE OF WORK:** Terracing work at the existing front yard berm  
**APPLICATION RECEIVED:** May 15, 2025  
**60-DAY REVIEW:** July 14, 2025  
**CASE MANAGER:** Edward Hall

## REQUEST:

The applicant is requesting a Certificate of Appropriateness for approval to perform terracing work at the existing front yard berm. The proposed terracing work will begin at the property line at the right of way and extend to the south towards the top of the existing berm.

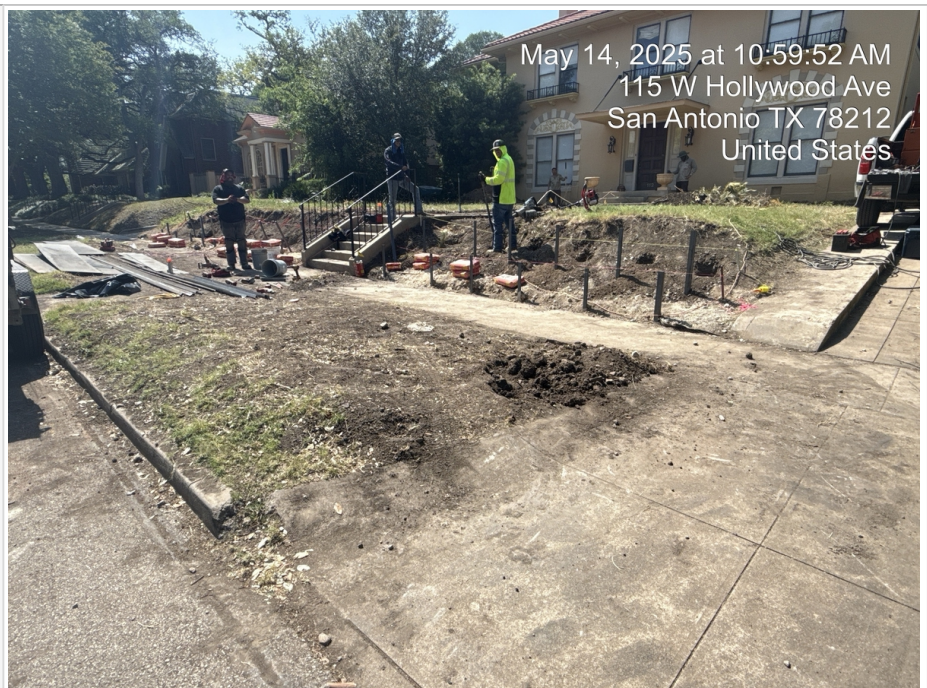
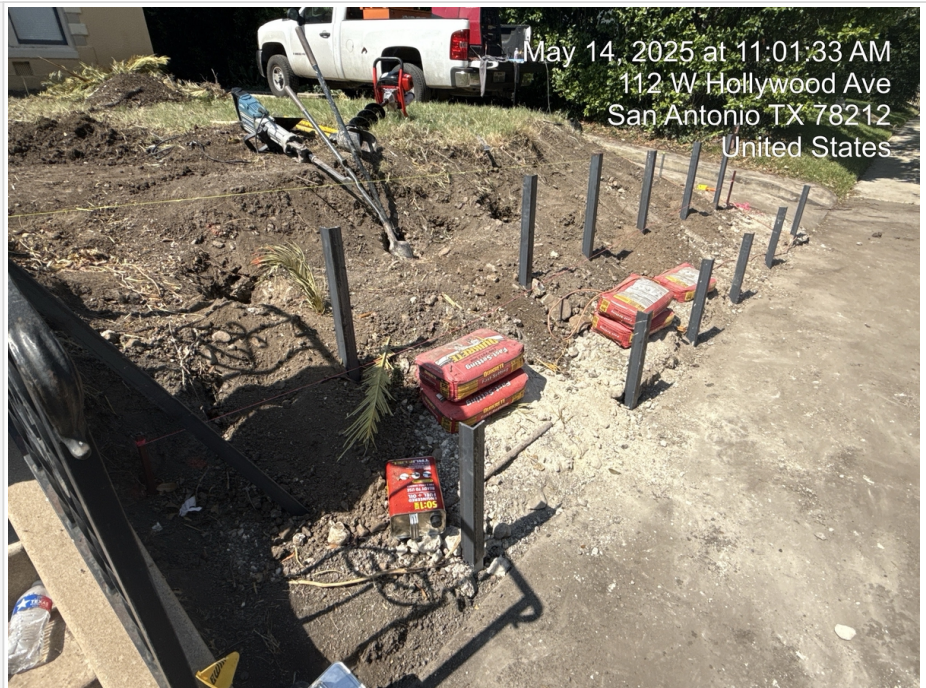
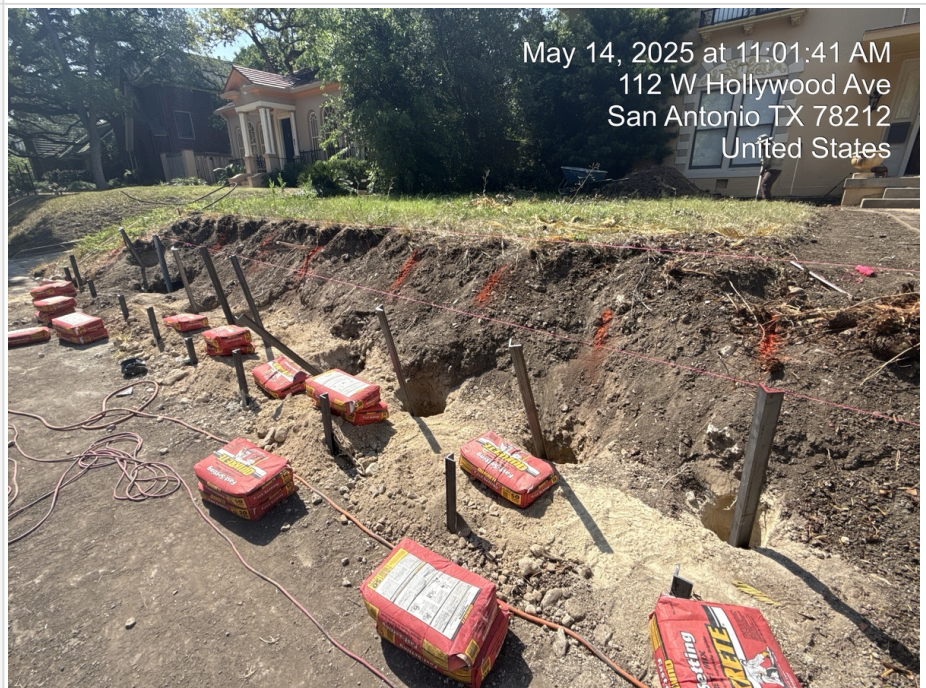
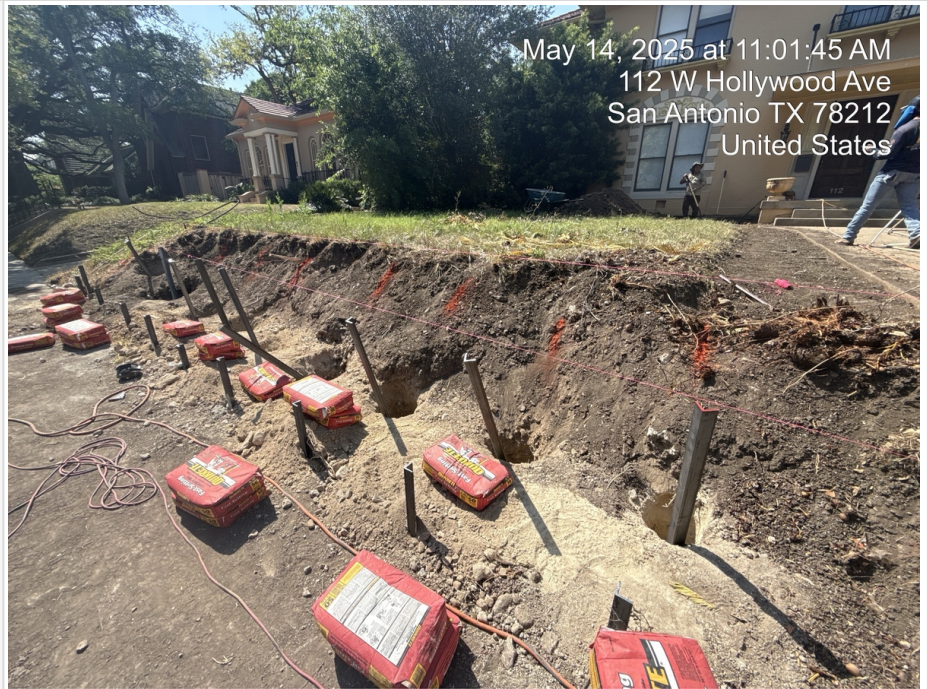
#### Photographs

- b. VIOLATION – Office of Historic Preservation staff issued a stop work order on May 14, 2025, for the removal of the existing front yard berm, site, and landscaping work without a Certificate of Appropriateness. Work stopped at that time and a Certificate of Appropriateness Application was submitted on May 15, 2025.

Date	05/14/2025
Time	11:10 AM (-5 GMT)
Context	citizen report
Present Staff	Edward Hall
Present Individuals	Contractor(s)
Contractor/Realtor Companies	Lush
Types of Work Observed	Other [see descriptions]
Amount of Work Completed	25%
Description of work	Site work in preparation for the construction of a retaining wall, grading.
Description of interaction	OHP staff spoke with the contractors on site and issued a Stop Work Order.

Violation Type	No Certificate of Appropriateness (Code 35-451a)
OHP Action	Spoke with contractor(s), Posted additional "Stop Work Notice"
Will post-work application fee apply?	To be determined

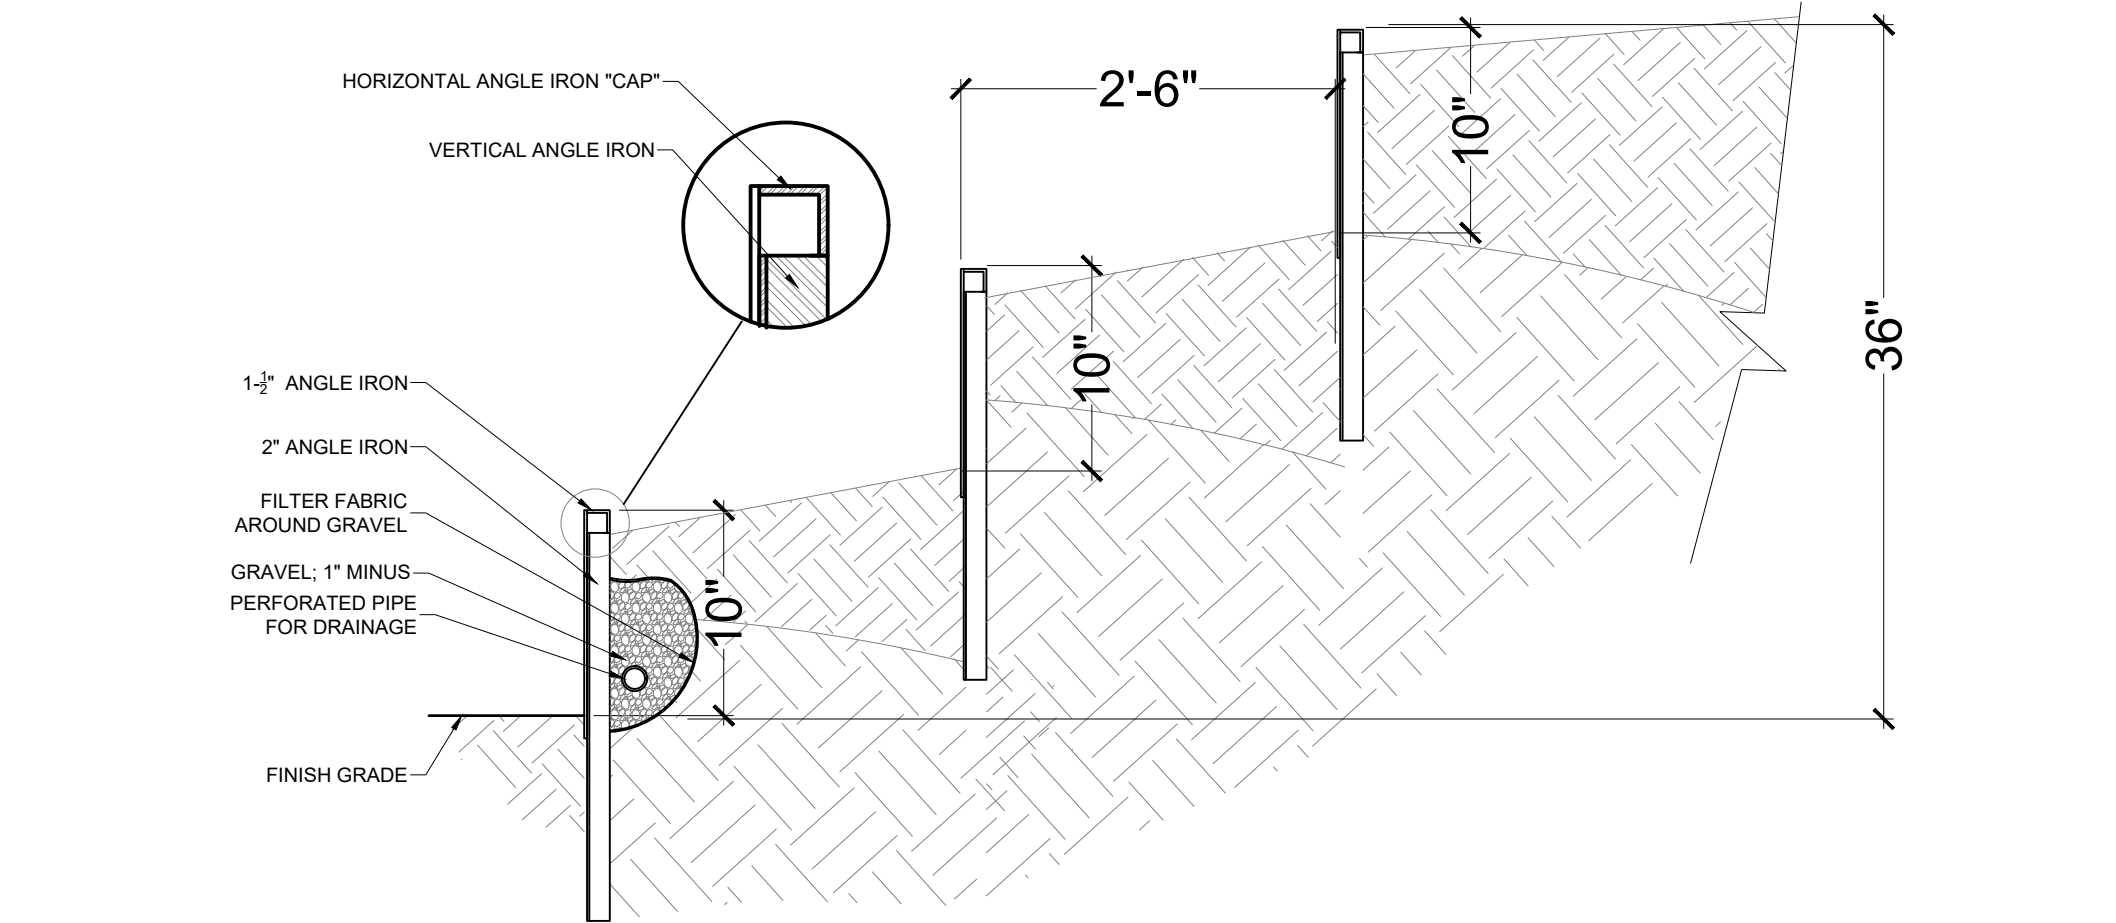
00 TERRACED PLANTINGS

top of the existing berm. The proposed terracing work will feature angle iron installed in three, ten-inch sections, 2' – 6" apart. At each terraced level the applicant has proposed to install native plants and landscaping materials.
