**HISTORIC AND DESIGN REVIEW COMMISSION
COMPLIANCE AND TECHNICAL ADVISORY BOARD**

HDRC CASE NO:	2024-201
ADDRESS:	516 E COURTLAND PLACE
LEGAL DESCRIPTION:	NCB 2964 BLK 3 LOT 17
ZONING:	R-6, H
CITY COUNCIL DIST.:	1
DISTRICT:	Tobin Hill Historic District
APPLICANT:	Mariel Nelson/NELSON MARIEL DIANE & SCHMIDT LOGAN MARCOS
OWNER:	NELSON MARIEL DIANE & SCHMIDT LOGAN MARCOS
TYPE OF WORK:	Front door replacement
APPLICATION RECEIVED:	May 17, 2024
60-DAY REVIEW:	July 16, 2024
CASE MANAGER:	Claudia Espinosa

516 E Courtland Door Replacement

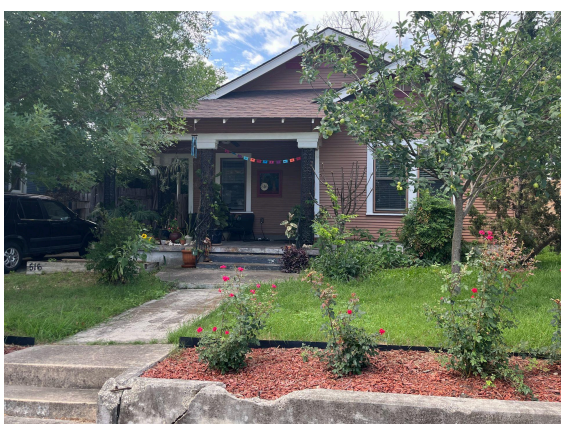
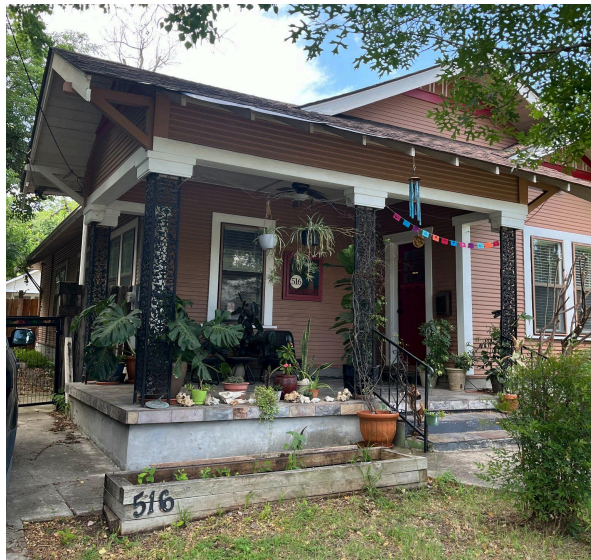
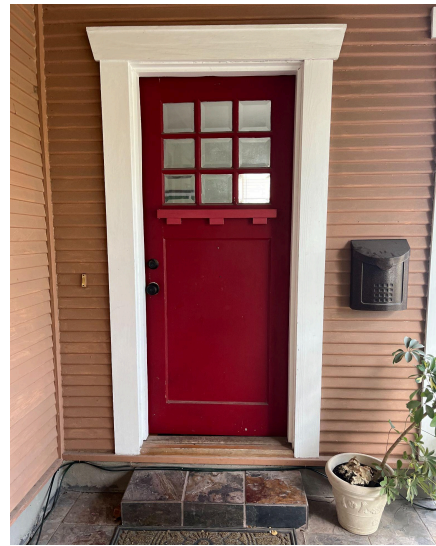
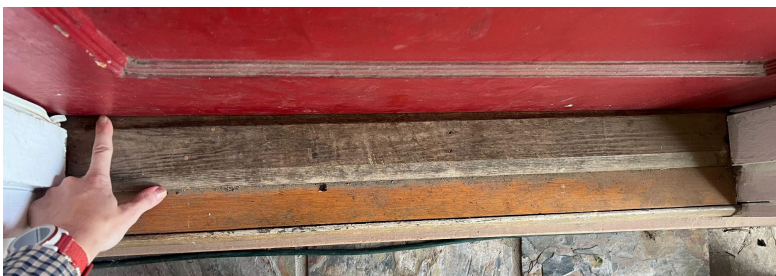
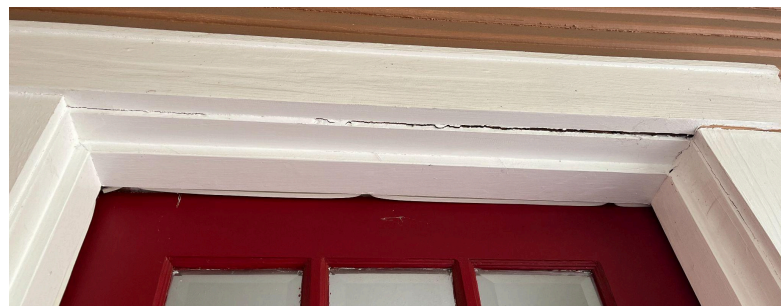
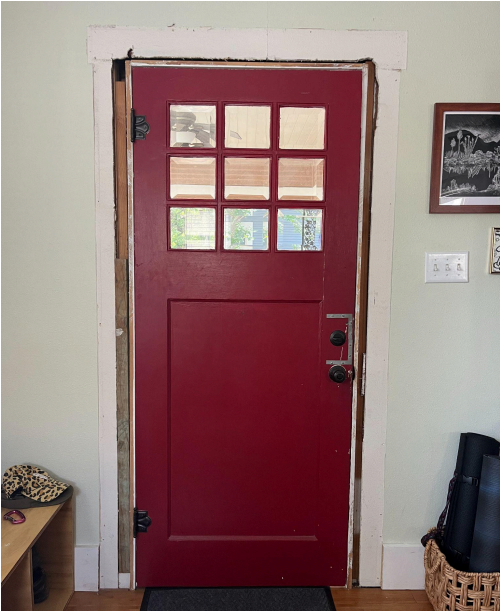
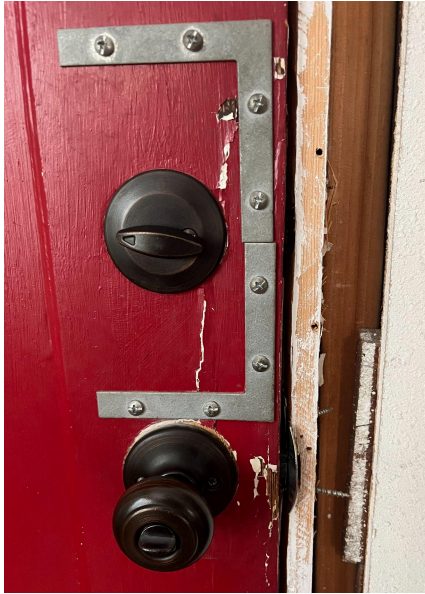
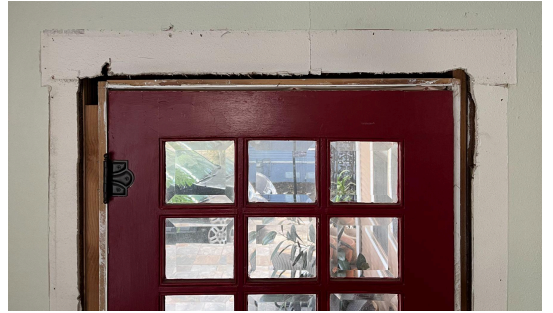
Front

Current door is solid wood in a wood jamb. We guess that it is not original because the framing and drywall can accommodate a 36" wide door and the current door slab is 34." Jamb is $\frac{3}{4}$ " too wide for the wall thickness and the interior trim is Selex branded white pine boards. This contrasts with the stained wood window casings throughout the house; not sure on wood type, it looks dense and is possibly restored original trim.

Door has some issues. 1) Wood is cracked around the hardware from being kicked in according to the house inspector when we bought it. 2) Glass panels have moved from their original positions and are no longer centered. 3) Door slab is pretty warped which in practice means we can't close it without the deadbolt and the edges are not flush with the jamb. The CPS energy inspector said the first thing we should do to decrease our energy use is to replace the door. You can feel air coming in around the slab when you stand next to the door and can actually see onto the porch between the weather stripping and the door slab.

Because the door is not original, is warped and cracked, and the door and jamb are the wrong size for the rough opening, we think replacement is reasonable and warranted.
