# HISTORIC AND DESIGN REVIEW COMMISSION

**HDRC CASE NO:** 2022-198  
**ADDRESS:** 801 MATAGORDA  
**LEGAL DESCRIPTION:** NCB 712 BLK 9 LOT N 63.56 FT OF 8  
**ZONING:** RM-4, H  
**CITY COUNCIL DIST.:** 1  
**DISTRICT:** Lavaca Historic District  
**APPLICANT:** James Caraway/Third Day Storm Restoration  
**OWNER:** GARCIA DORA E LIVING TRUST  
**TYPE OF WORK:** Installation of a standing seam metal roof with a ridge cap  
**APPLICATION RECEIVED:** March 29, 2022  
**60-DAY REVIEW:** Not applicant due to City Council Emergency Orders  
**CASE MANAGER:** Edward Hall

The applicant is requesting a Certificate of Appropriateness for approval to install a standing seam metal roof with a ridge cap on the historic structure at 801 Matagorda.

## Investigation Report

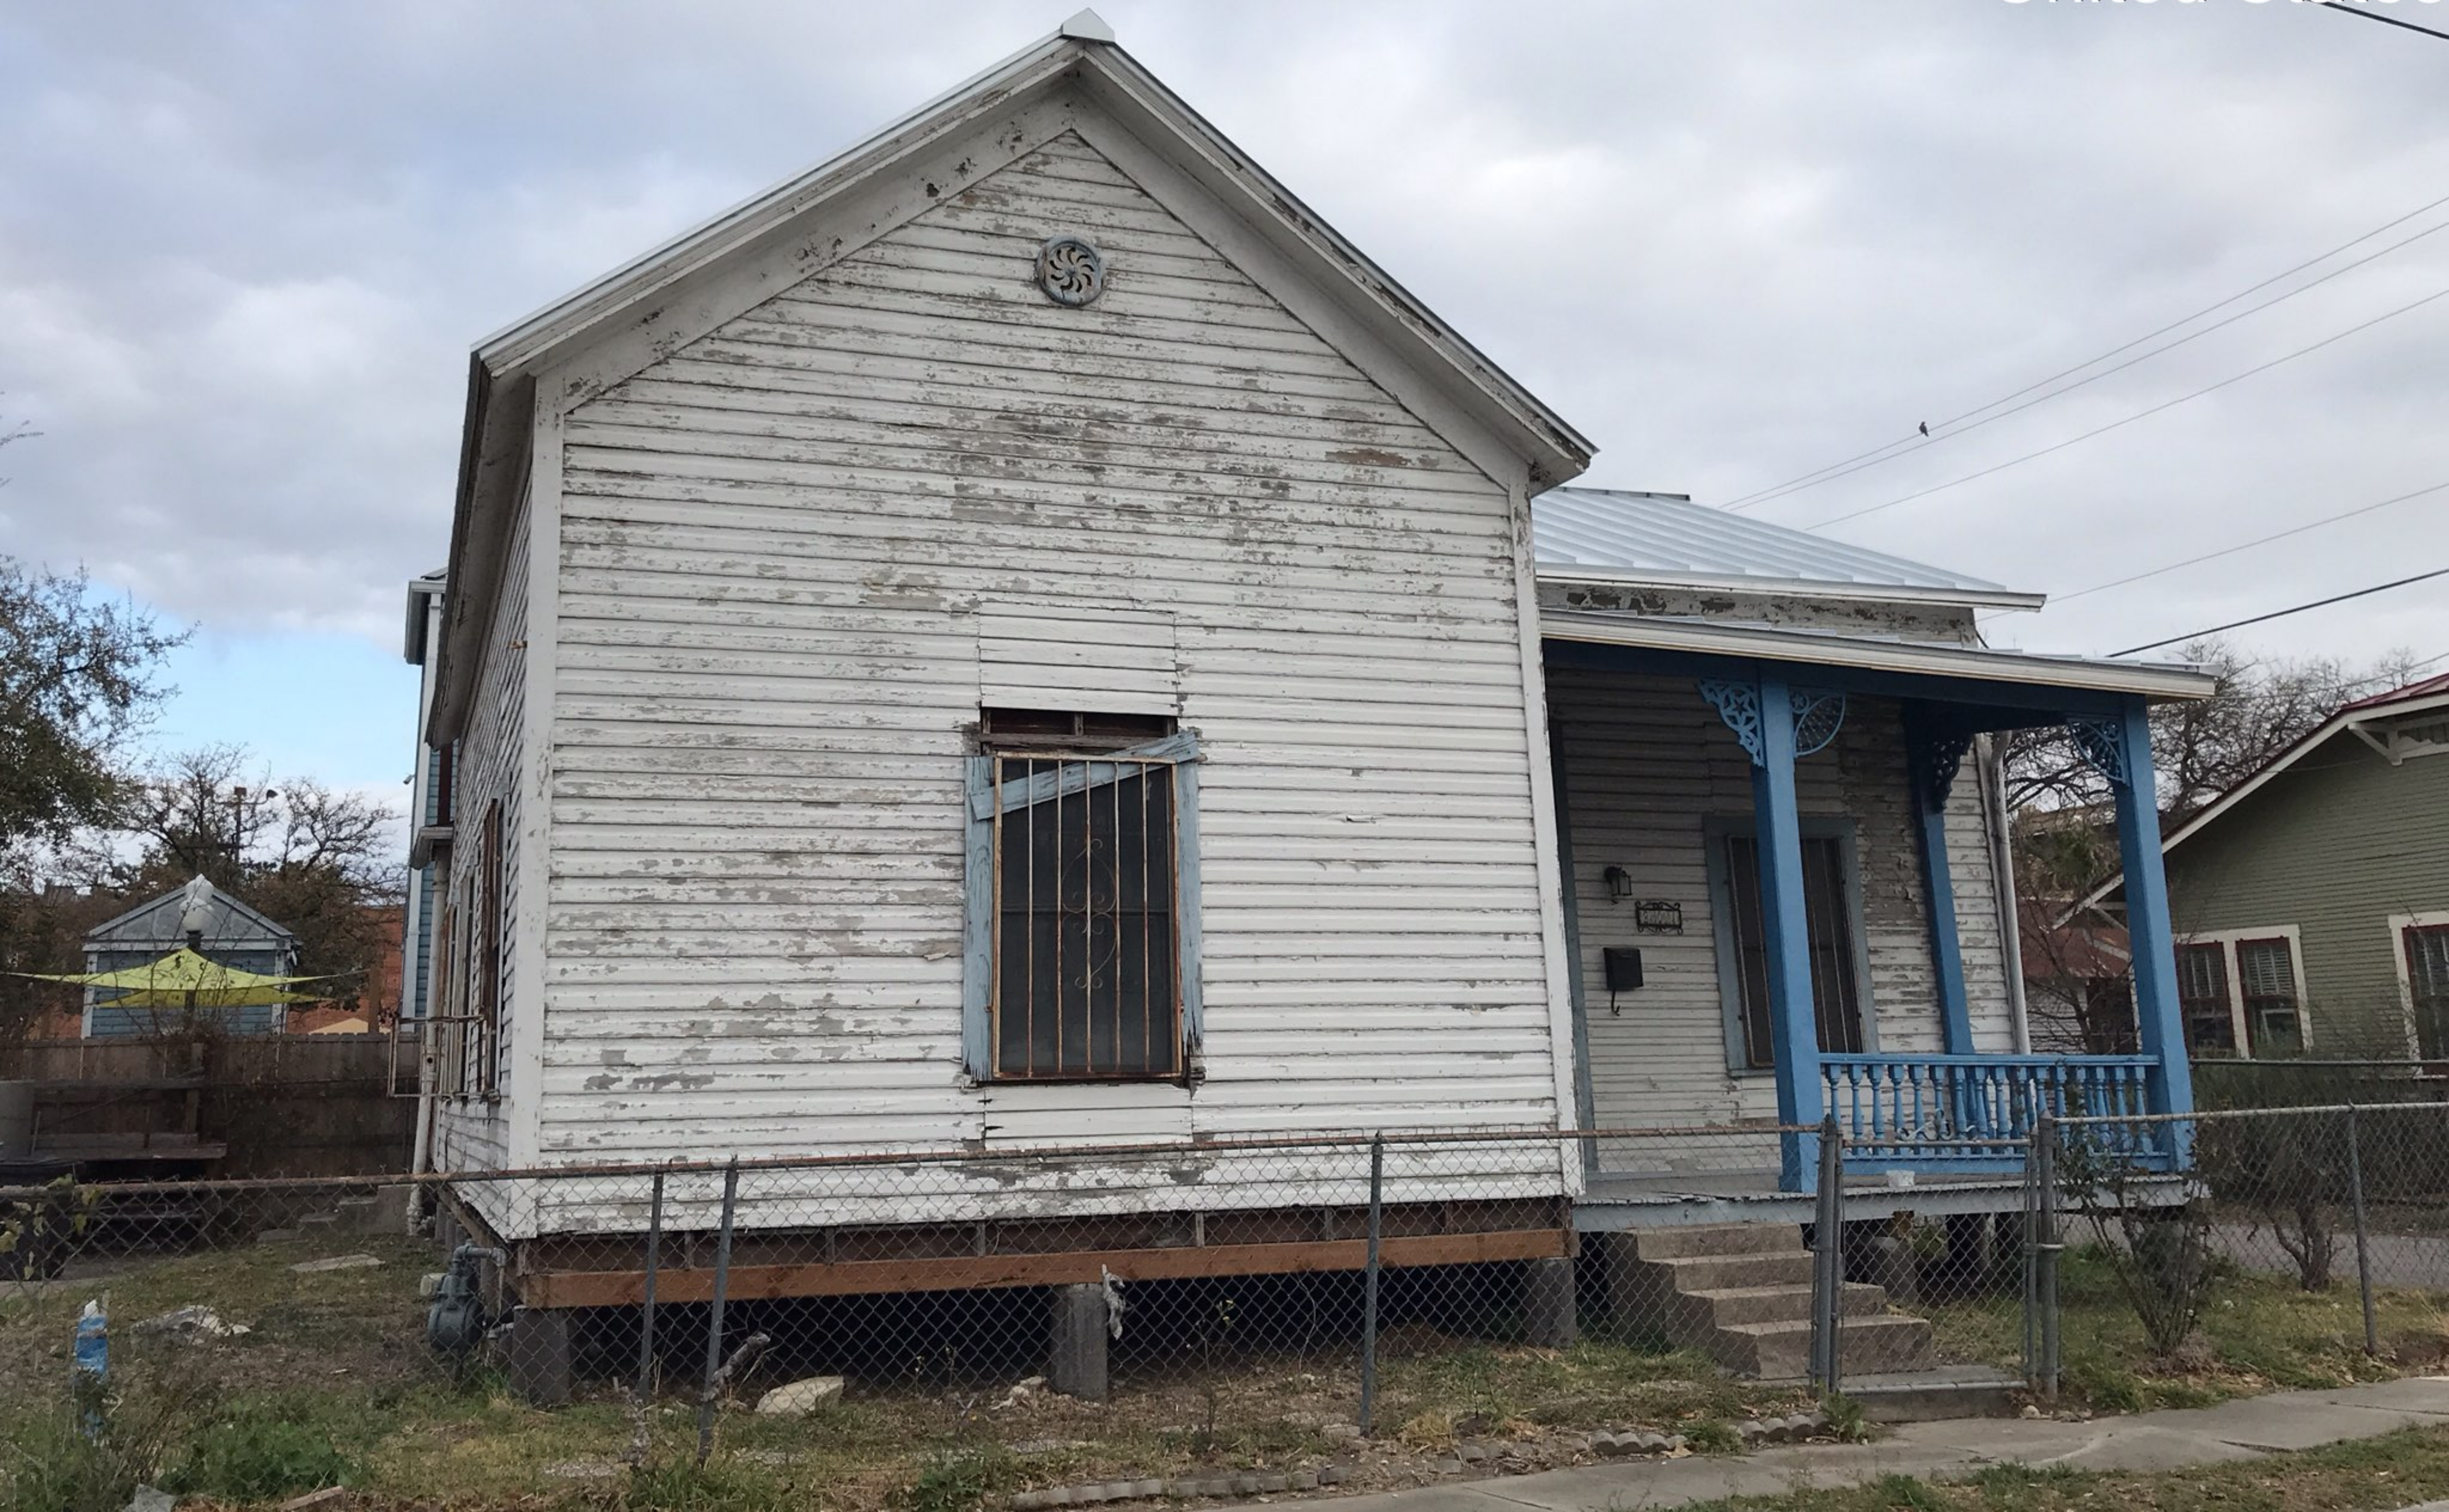
March 17, 2022 at 9:21 AM  
801 Matagorda St  
San Antonio TX 78210  
United States

- b. VIOLATION – Office of Historic Preservation staff performed a site visit on March 17, 2022, and observed a standing seam metal roof with a ridge cap being installed without a Certificate of Appropriateness. OHP staff issued a stop work order at that time. At a follow up site visit on March 18, 2022, it was found that the stop work order was ignored and the roofing work completed. No permit was issued by Development Services Department for roof replacement.

Date	03/17/2022
Time	09:00 AM (-5 GMT)
Context	drive-by
Present Staff	Edward Hall
Present Individuals	None
Contractor/Realtor Companies	James Caraway, Third Day Storm Restoration
Types of Work Observed	Exterior Maintenance and Alterations
Amount of Work Completed	Completed
Description of work	A stop work order was issued on site by Edward Hall and Rachel Rettaliata in March 3/15/2022. The stop work order was issued to James Caraway. As of 3/17/2022, the roofing job has been completed, ignoring the stop work order.

- i. That the proposed standing seam metal roof feature smooth panels that are 18 to 21 inches in width, seams that are 1 to 2 inches in height, a crimped ridge seam and a standard galvalume finish. Panels should not feature corrugation or striations.
