# HISTORIC AND DESIGN REVIEW COMMISSION

**HDRC CASE NO:** 2022-389  
**ADDRESS:** 509 DELAWARE  
**LEGAL DESCRIPTION:** NCB 656 BLK W 1-2 OF 11 LOT E 149.61 FT OF 5 & 6  
**ZONING:** IDZ-3, H  
**CITY COUNCIL DIST.:** 2  
**LANDMARK:** Achtzehn House  
**APPLICANT:** Thomas Glendenning/BRIGHT LAKES REAL ESTATE LLC  
**OWNER:** Thomas Glendenning/BRIGHT LAKES REAL ESTATE LLC  
**TYPE OF WORK:** Demolition of a landmark, approval of a site plan  
**APPLICATION RECEIVED:** July 19, 2022  
**60-DAY REVIEW:** Not applicable due to City Council Emergency Orders  
**CASE MANAGER:** Edward Hall

The applicant is requesting a Certificate of Appropriateness for approval to demolish the historic landmark at 509 Delaware, commonly known as the Achtzehn House.

Re: Burned Out Historic Building at 509 Delaware Street

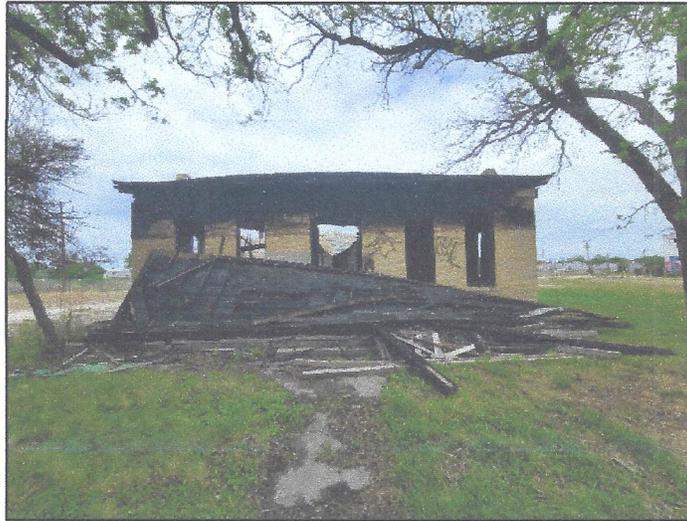
Commercial Building located at 509 Delaware Street, San Antonio, Texas.

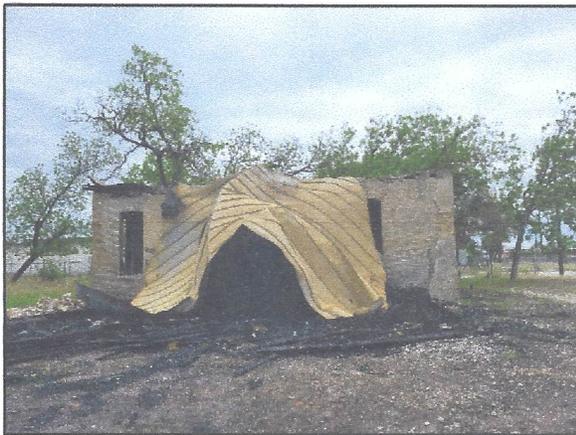
View of north side of building.

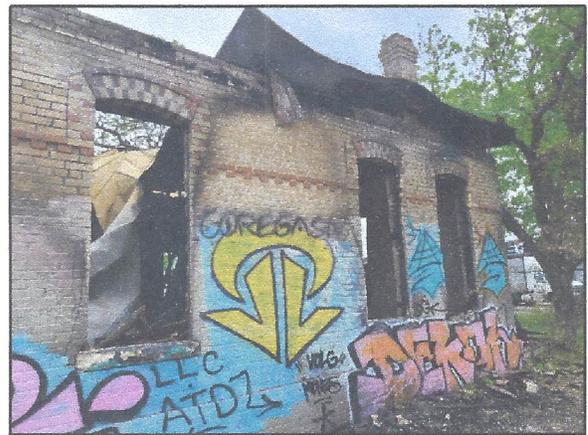
View of west side of building.

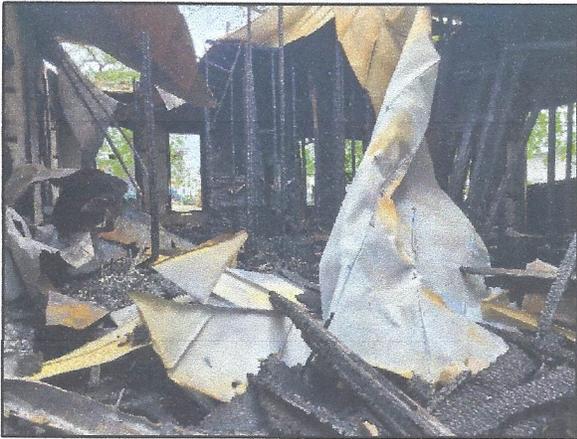
Photo taken through window on west side of building. Burned debris inside building. Wood, metal, and brick debris - Not suspect ACM.

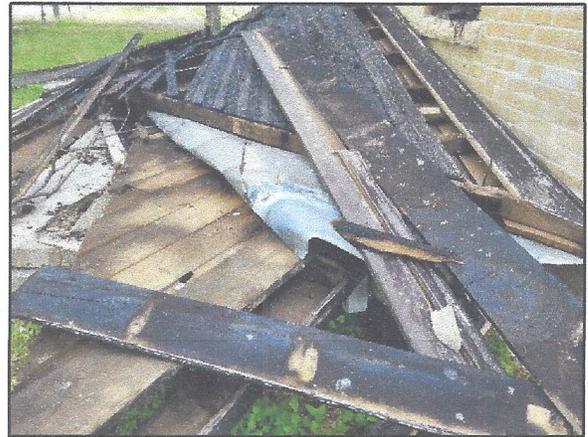
South side of building where metal and wooden debris from roof has fallen. Not suspect ACM.

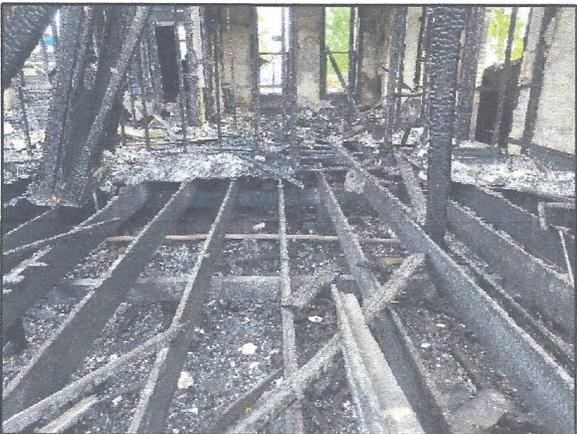
View inside the building showing where the subflooring has burned and fallen into crawlspace. Piping in crawlspace has no insulation. Not suspect ACM.

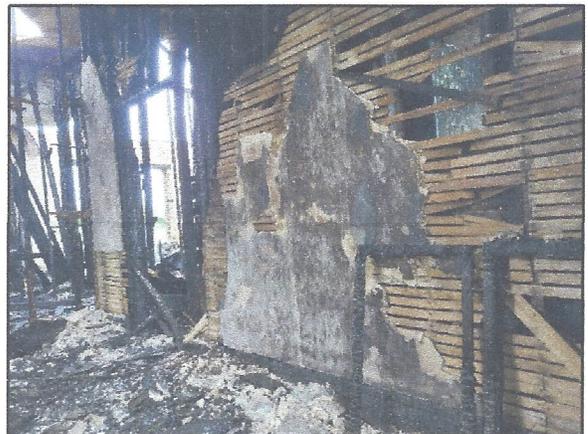
View of rock lath remnants on wall. Photo taken through window on east side of building. The cellar is located below this area. Not suspect ACM.

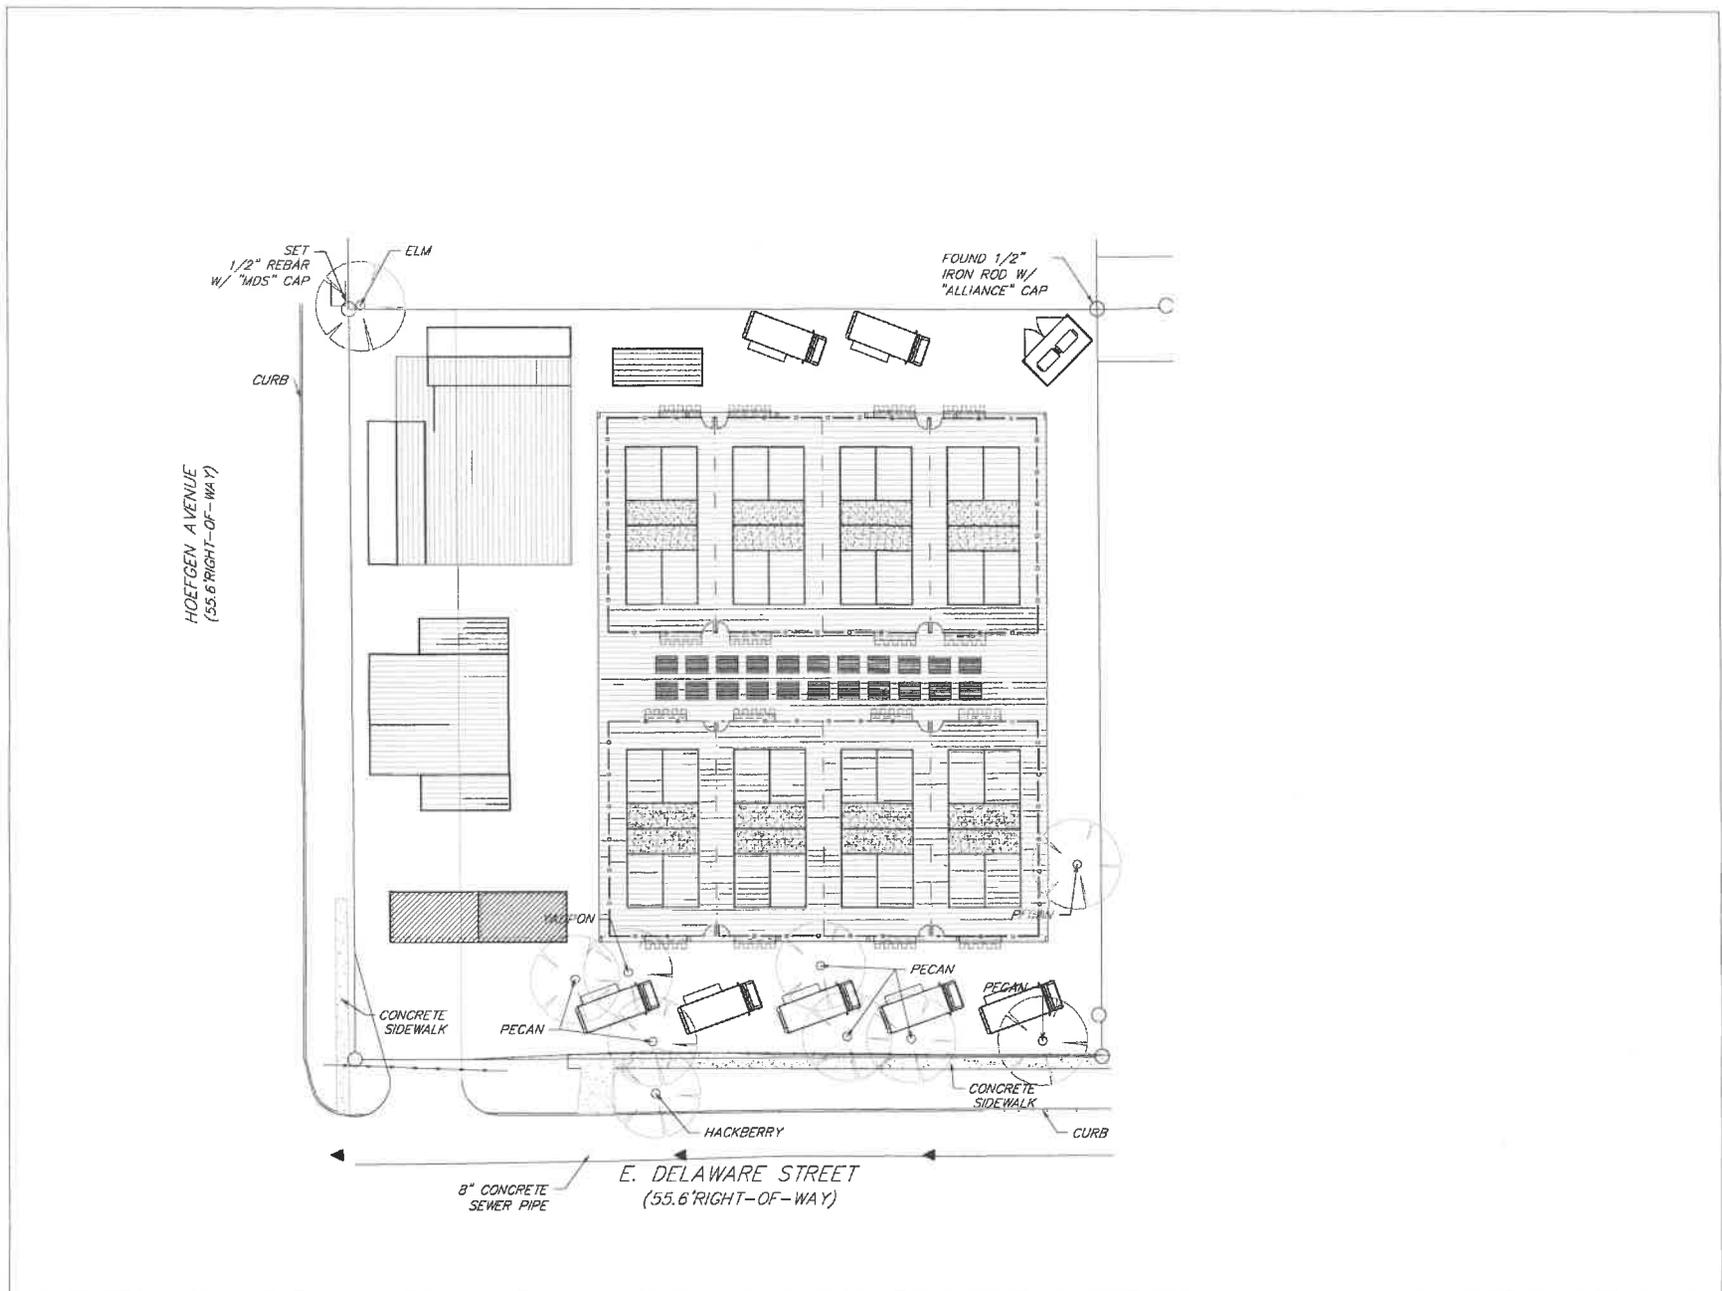
**1** PROPOSED SITE PLAN "A"  
 1/8" = 1'-0"

- h. REPLACEMENT PLANS – The applicant has proposed to install a food truck park and has provided a site plan noting the construction of buildings, dumpster locations and outdoor seating. Generally, staff finds a commercial structure on site would be appropriate; however, staff finds that additional information should be provided, such as information regarding site paving, on-site parking and building setbacks from the right of way.
