# HISTORIC AND DESIGN REVIEW COMMISSION

October 05, 2022

**HDRC CASE NO:** 2022-468  
**ADDRESS:** 131 E MULBERRY AVE  
**LEGAL DESCRIPTION:** NCB 1701 BLK 4 LOT 21  
**ZONING:** R-4, H  
**CITY COUNCIL DIST.:** 1  
**DISTRICT:** Monte Vista Historic District  
**APPLICANT:** Jason Stone  
**OWNER:** Jason Stone  
**TYPE OF WORK:** Retaining wall installation and landscaping  
**APPLICATION RECEIVED:** August 29, 2022  
**60-DAY REVIEW:** Not applicable due to City Council Emergency Orders  
**CASE MANAGER:** Claudia Espinosa

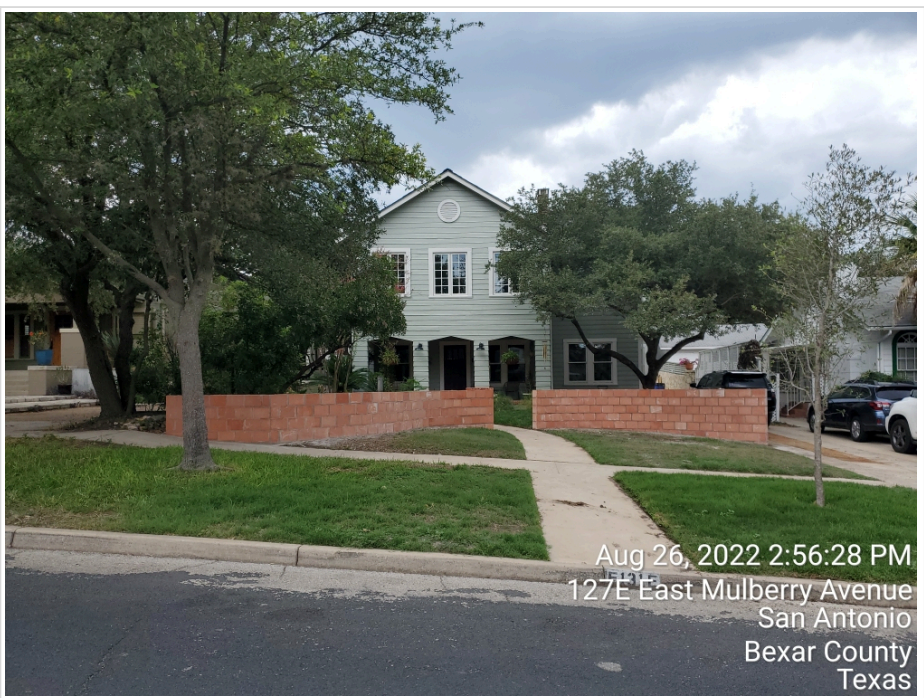
Date	08/26/2022
Time	03:01 PM (-5 GMT)
Context	citizen report
Present Staff	Jessica Anderson
Present Individuals	None
Types of Work Observed	Site Elements
Amount of Work Completed	75%
Description of work	4' front-yard masonry wall
Description of interaction	<p>No one on site. Left SWO on window next to front door. There is a pile of masonry and a wheelbarrow near the front porch, and it appears they're about to cap the wall in tile.</p> <p>Note that more timestamped photos are available; report app wouldn't allow me to upload more. Will be available in property file.</p>

08/26/2022 03:09 PM
<p>Additional photos were taken on another device.</p>	Yes

- 1. Staff does not recommend approval of item #1, the construction of a front yard masonry wall based on finding d. A traditional landscape border using compatible materials such as small limestone blocks would be more appropriate.
- 2. Staff recommends approval of item #2, the front yard landscaping based on finding e.
