HISTORIC AND DESIGN REVIEW COMMISSION
February 15, 2023

HDRC CASE NO: 2023-036
ADDRESS: 453 CLUB DRIVE
LEGAL DESCRIPTION: NCB 7014 BLK LOT 13 AND W 5FT OF 12
ZONING: RM-4, H
CITY COUNCIL DIST.: 7
DISTRICT: Monticello Park Historic District
APPLICANT: Linda L Smith | Smith, Linda Lou Trust
OWNER: Linda L Smith | Smith, Linda Lou Trust
TYPE OF WORK: Screen Door Installation
APPLICATION RECEIVED: January 30, 2023
60-DAY REVIEW: Not applicable due to City Council Emergency Orders
CASE MANAGER: Bryan Morales

The applicant requests approval to install a metal security door with perforated metal screen in front of the existing front door.

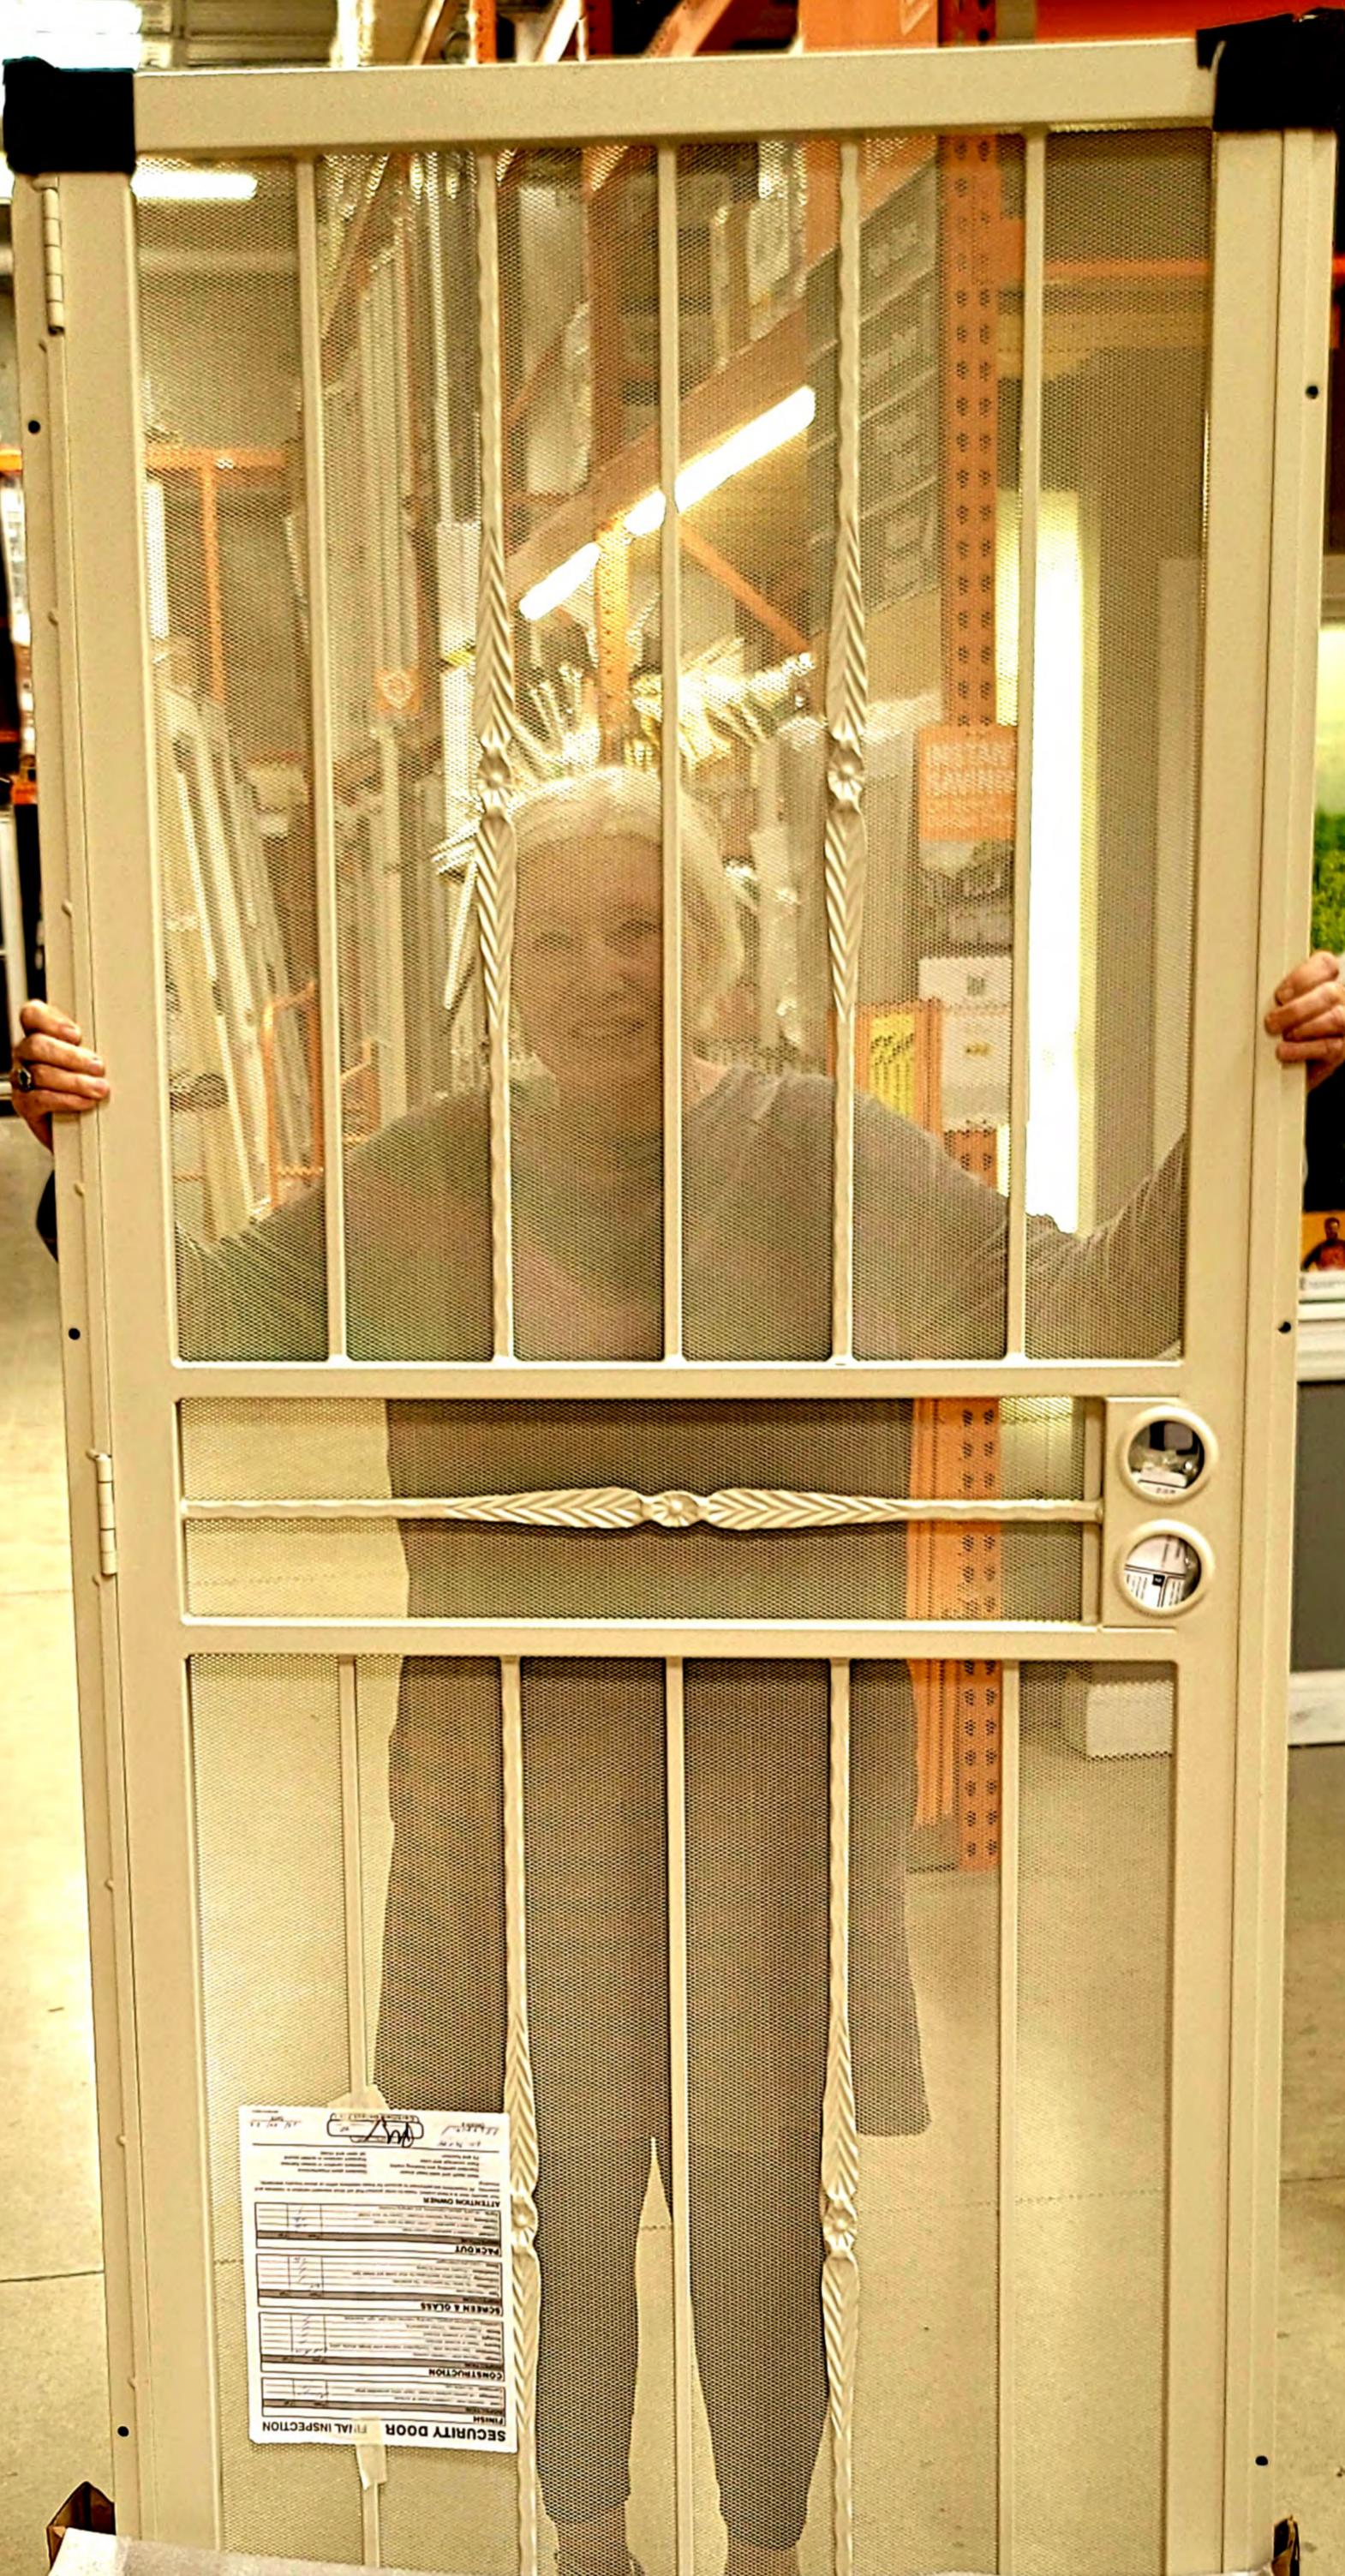
SECURITY DOOR FINAL INSPECTION

FINISH	
CONSTRUCTION	
SCREWS & GLASS	
PACKOUT	
ATTENTION OWNER

- b. **SCREEN DOOR:** The applicant requests approval to install a 36"x84" metal screen door with decorative metal elements and a metal mesh screen. Historic Design Guidelines for Exterior Maintenance and Alterations 6.A.ii says to preserve historic doors including hardware, fanlights, sidelights, pilasters, and entablatures. Guideline 6.B.i states that new doors should match the size, material, and profile of the historic element, and 6.B.viii states that the installation of security bars be only installed in the interior as to not distract from the historic elements of the property. Staff finds the proposed metal screen door does not conform to guidelines. A predominately transparent screen door with a tradition design would be more appropriate.
