HISTORIC AND DESIGN REVIEW COMMISSION

HDRC CASE NO: 2023-136
ADDRESS: 526 DONALDSON AVE
LEGAL DESCRIPTION: NCB 6821 BLK LOT W 25 FT OF 6 & E 25 FT OF 7
ZONING: R-6, H
CITY COUNCIL DIST.: 7
DISTRICT: Monticello Park Historic District
APPLICANT: Raul Sampayo/Maid in America Cleaning Service
OWNER: CITY OF SAN ANTONIO
TYPE OF WORK: Front yard landscaping and hardscaping
APPLICATION RECEIVED: March 30, 2023
60-DAY REVIEW: Not applicable due to City Council Emergency Orders
CASE MANAGER: Claudia Espinosa

REQUEST:

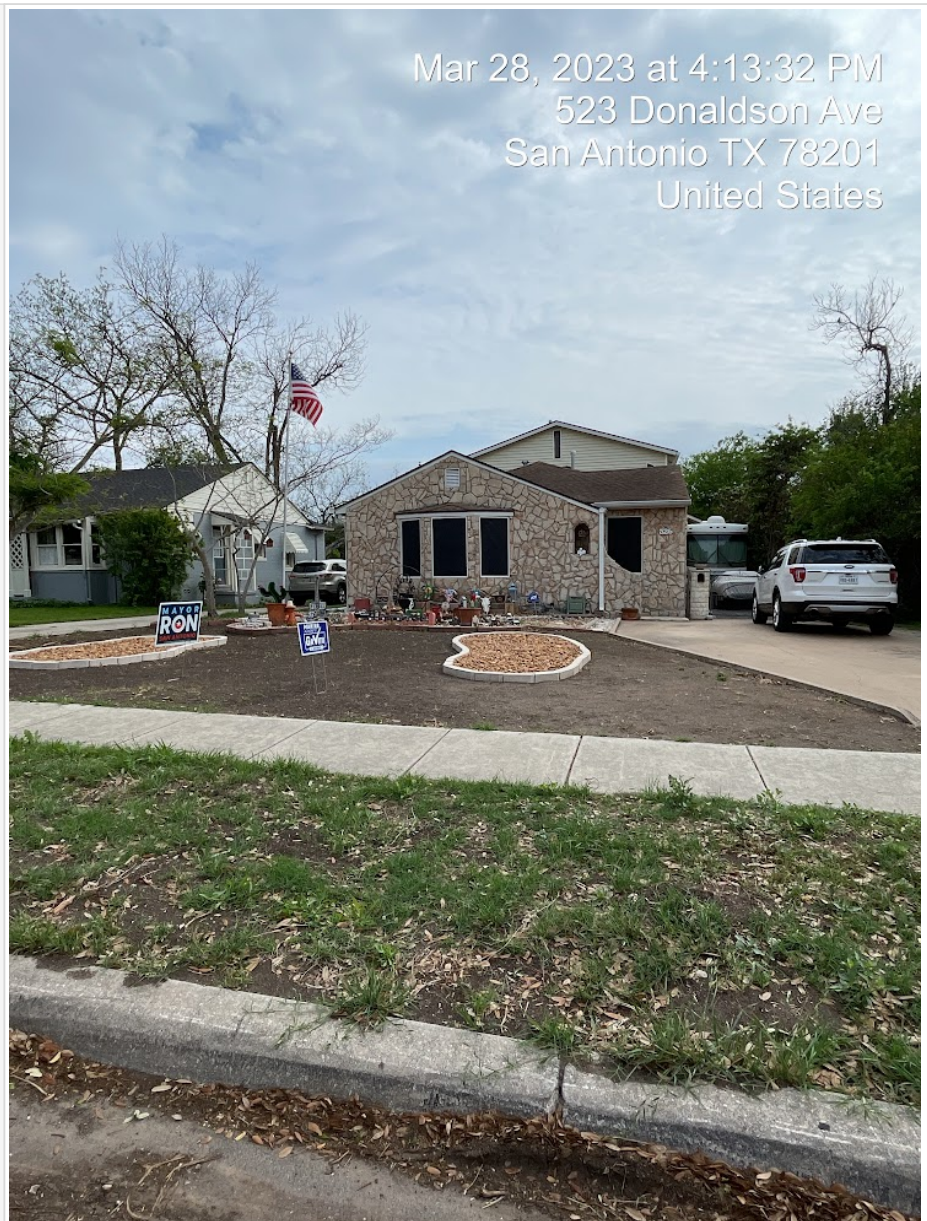
03/29/2023 09:42 AM

- b. CASE HISTORY – On March 28, 2023, staff received a report of the removal of the front yard landscaping. Staff conducted a site visit and noticed the front yard had been cleared of grass and two jellybean-shaped rock beds had been installed and filled with river rock. Staff spoke with the homeowners and issued a Notice of Investigation.

Date	03/28/2023
Time	04:13 PM (-5 GMT)
Context	citizen report, follow-up
Present Staff	Claudia Espinosa, Bryan Morales
Present Individuals	Homeowner
Types of Work Observed	Site Elements
Amount of Work Completed	Completed
Description of work	Removal of front yard landscaping and replacement with two round stone beds with rocks inside the stone beds.
Description of interaction	Bryan Morales spoke with the homeowners to explain the report and the process of submitting a COA for the site work. The homeowner received the Stop Work Order and stated they will be working with staff to bring the front yard into compliance.

Violation Type	No Certificate of Appropriateness (Code 35-451a)
OHP Action	Spoke with property owner, Posted "Notice of Investigation"
Will post-work application fee apply?	No
