HISTORIC AND DESIGN REVIEW COMMISSION

HDRC CASE NO: 2023-218
ADDRESS: 719 E CARSON
LEGAL DESCRIPTION: NCB 1261 BLK 29 LOT 19, 20 & S 9.8 FT OF 18
ZONING: R-6, H
CITY COUNCIL DIST.: 2
DISTRICT: Government Hill Historic District
APPLICANT: Eugene Walker Jr./EVENT HOLDINGS LLC
OWNER: Eugene Walker Jr./EVENT HOLDINGS LLC
TYPE OF WORK: Addition (turret)
APPLICATION RECEIVED: May 18, 2023
60-DAY REVIEW: July 17, 2023
CASE MANAGER: Jessica Anderson

The applicant requests a Certificate of Appropriateness for approval to add a turret at the southeast corner of the house.

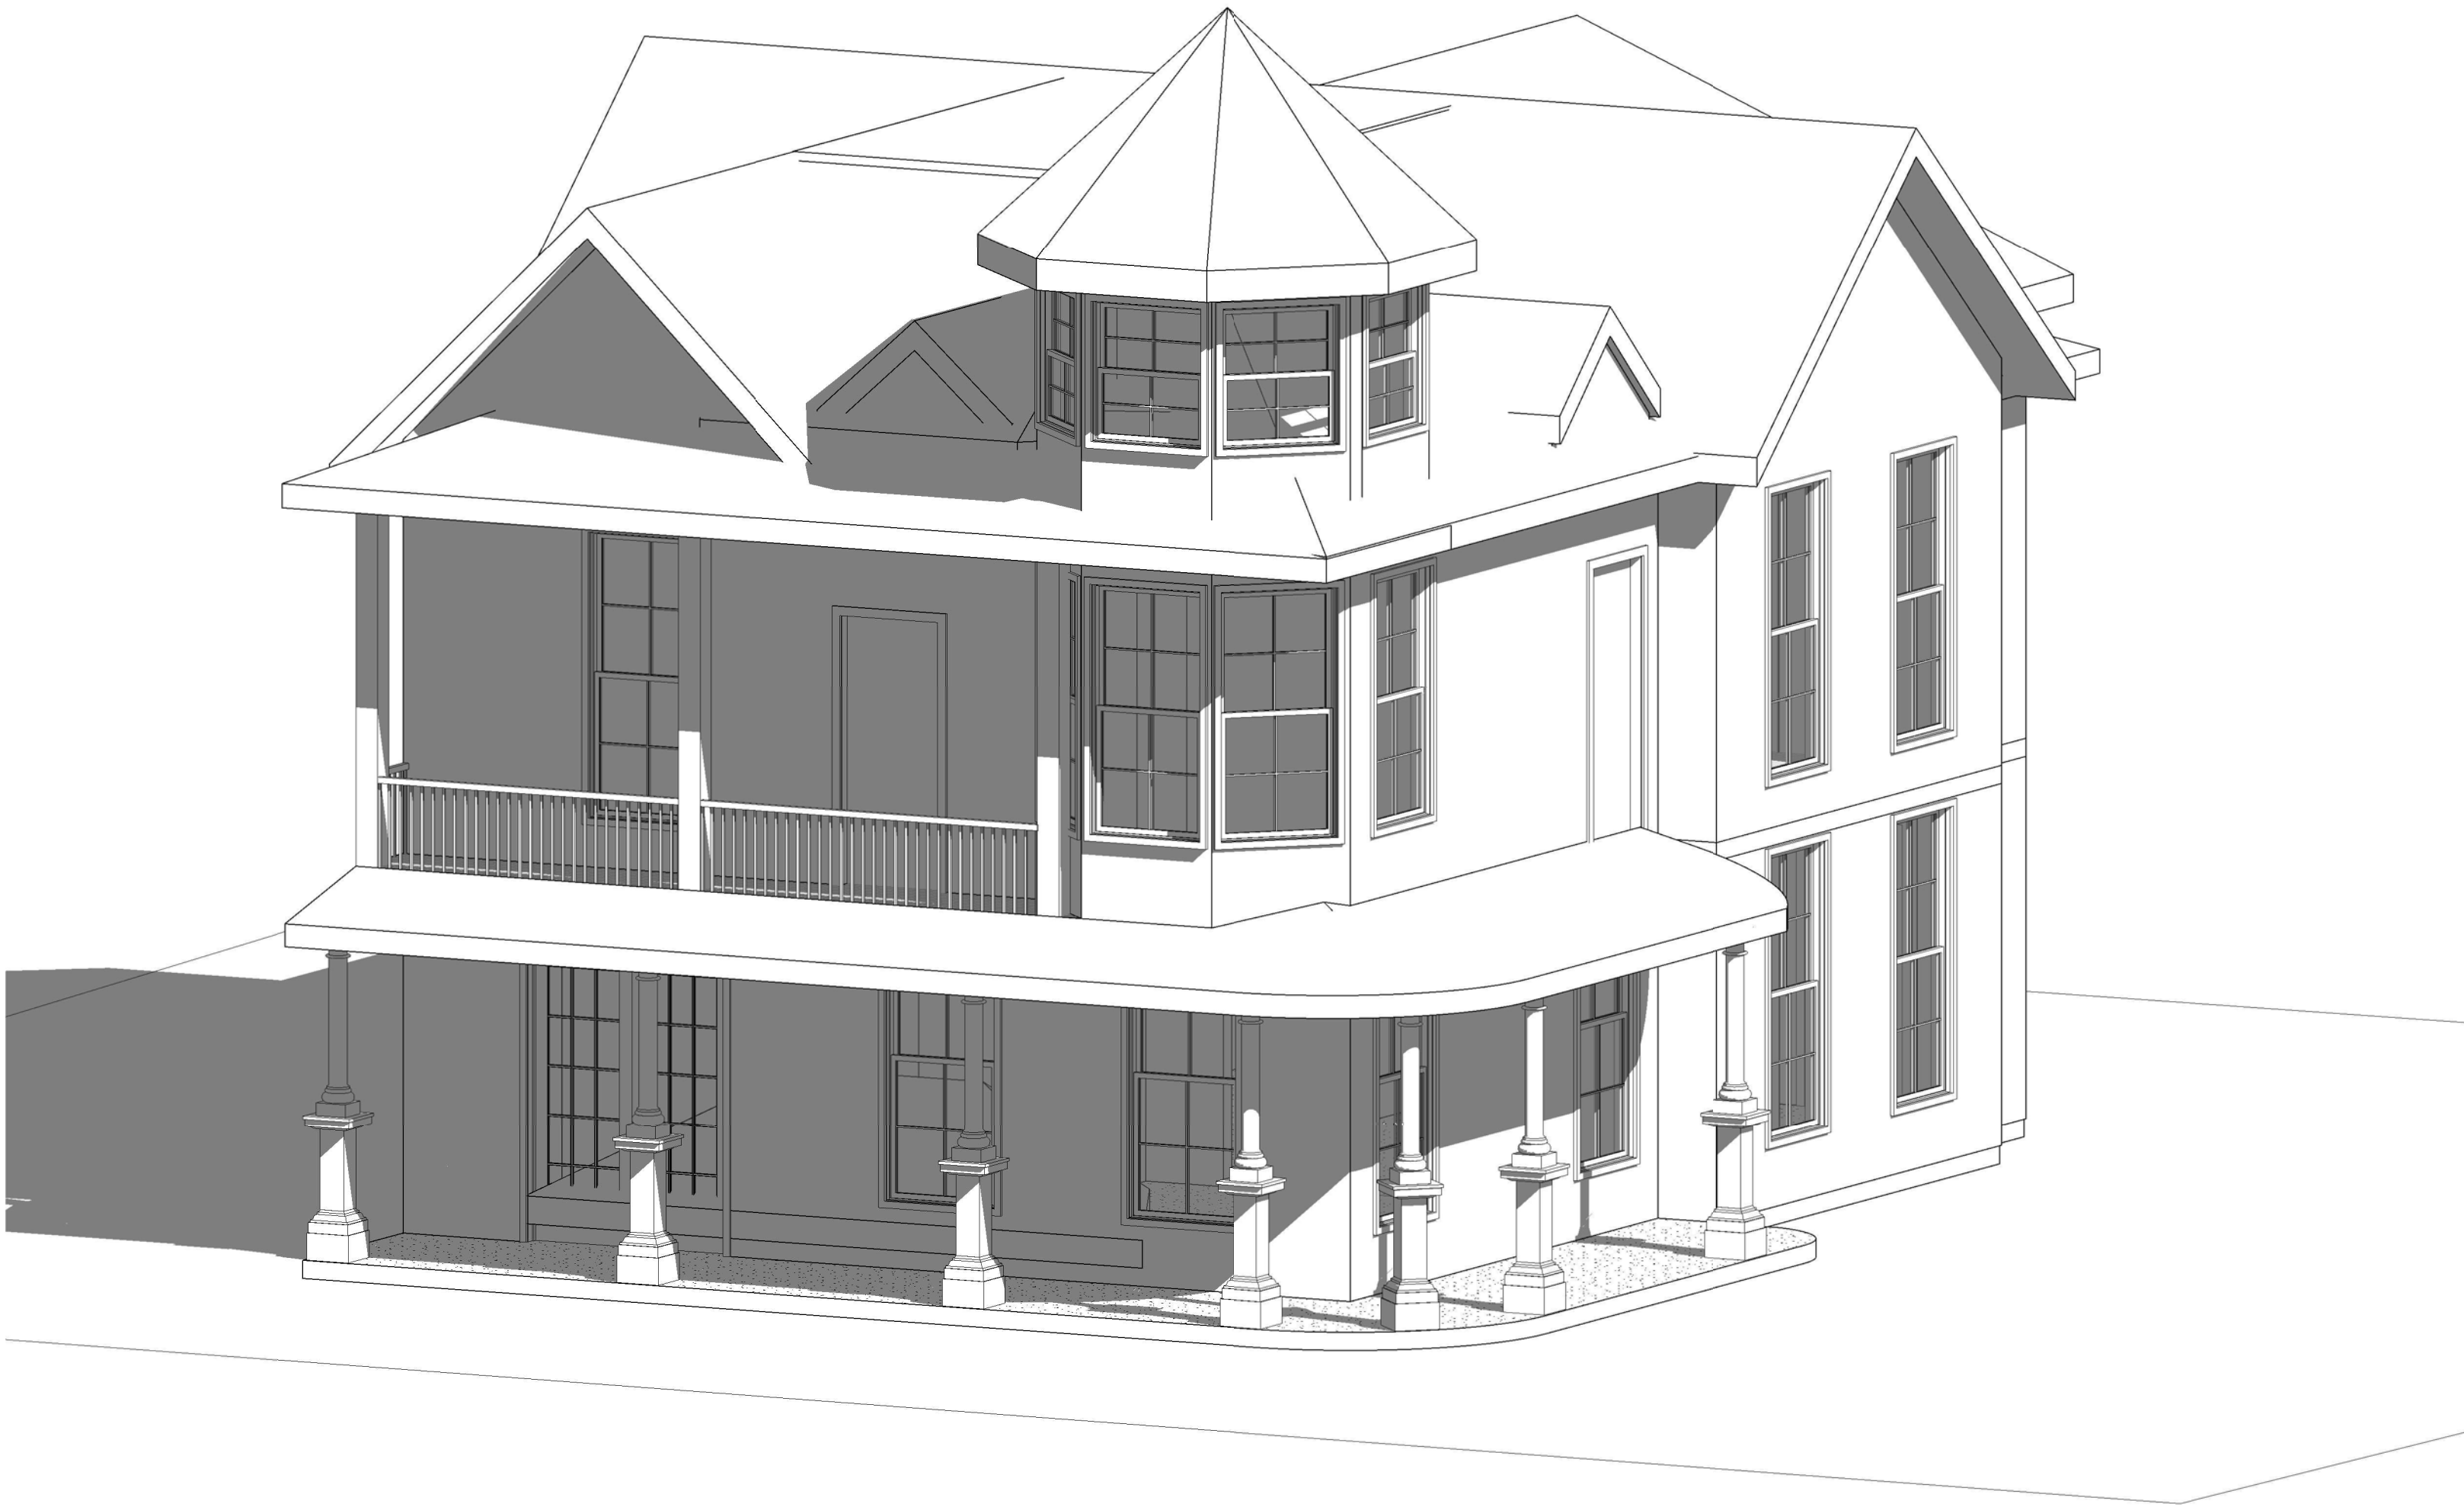
② {3D}

Project Name:
Queen Anne House Remodelation

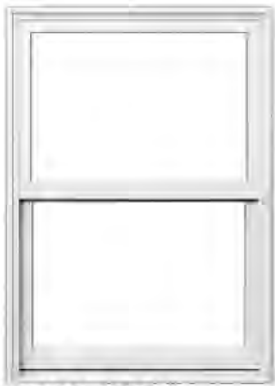
Siteline® Clad-Wood Windows: Double-Hung Pocket | Reliable and Energy Efficient Doors and Windows | JELD-WEN Windows & Doors

Pocket Replacement Window

- i. That the windows proposed for the addition match the second-story windows directly below the addition in width.
- ii. That the proposed windows feature meeting rails that are no taller than 1.25" and stiles no wider than 2.25".
- iii. That the turret roof be clad in the same material as the primary roof form.

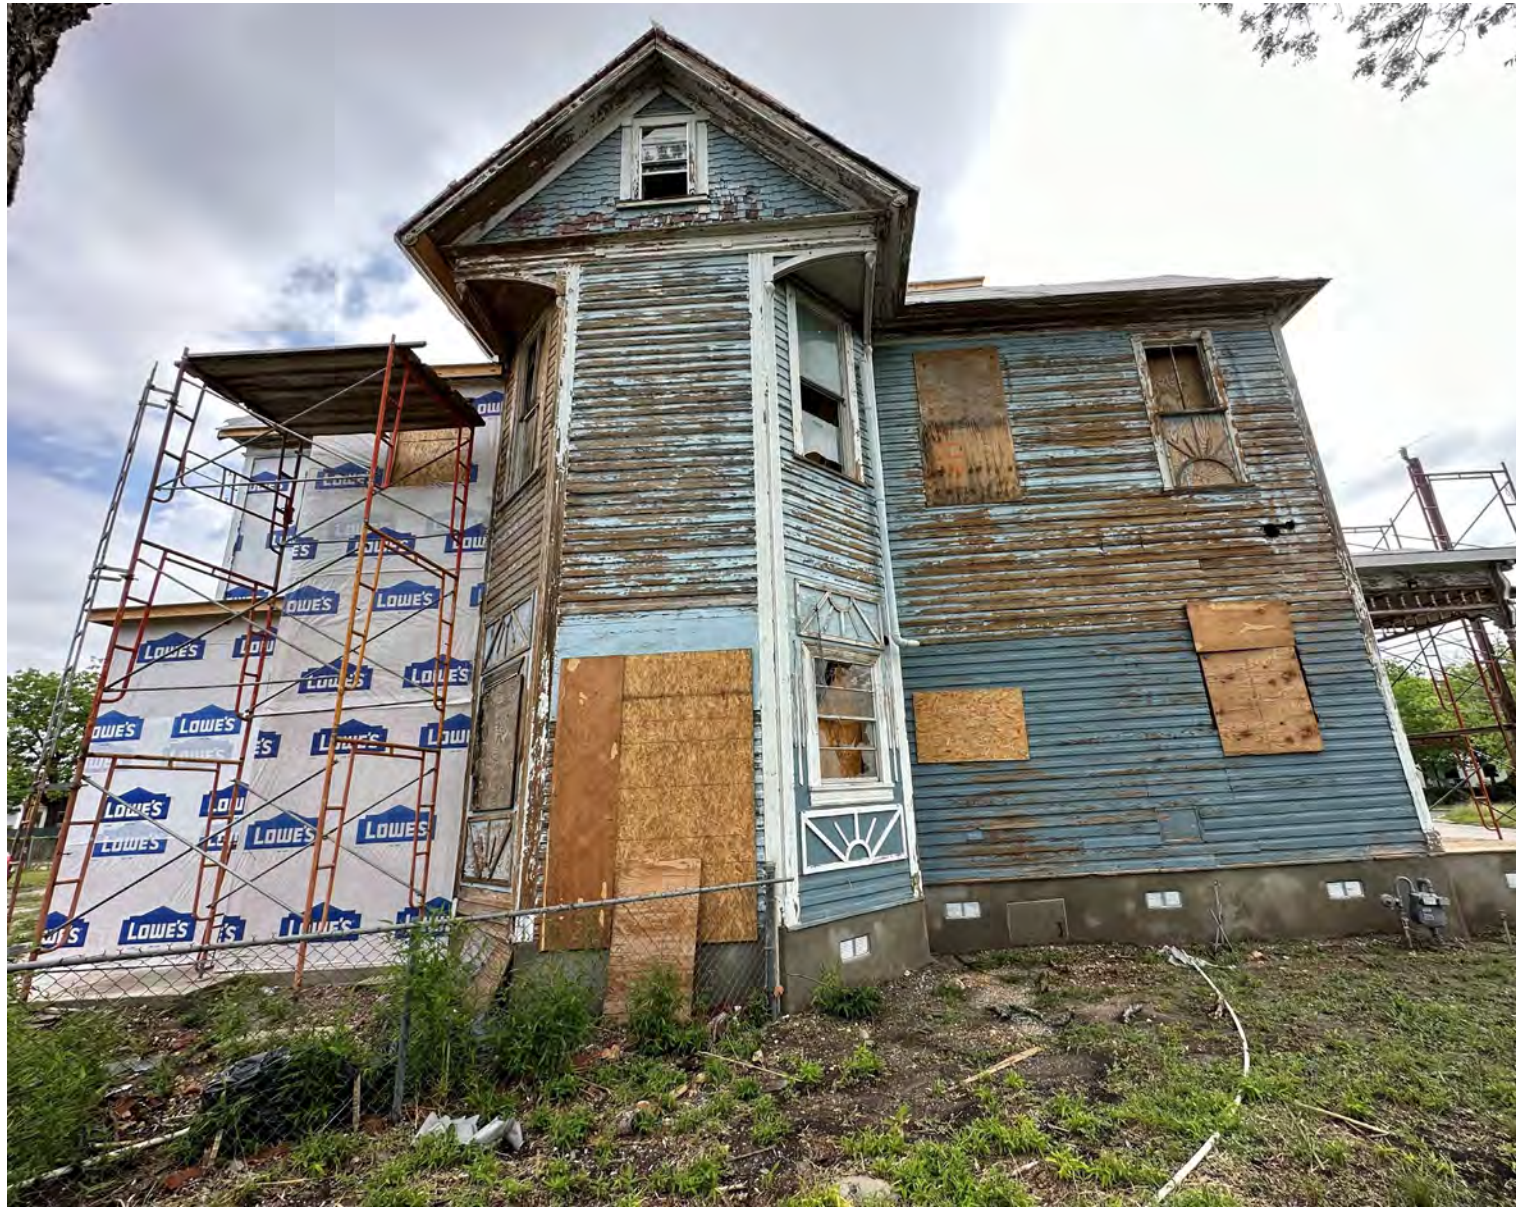
SIDE ELEVATION

A polygonal front corner tower with a conical roof, called “Turret” is a distinctive Queen Anne feature on many buildings of this style. This house had an evidence of a cutout in the attic that would suggest that historically there was a structural element standing up but was later removed. The proposal of a Turret in the front elevation of the house makes this a distinctive Queen Anne Style House. We are preserving the existing windows and adding 4 windows to the Turret proposed in this design.

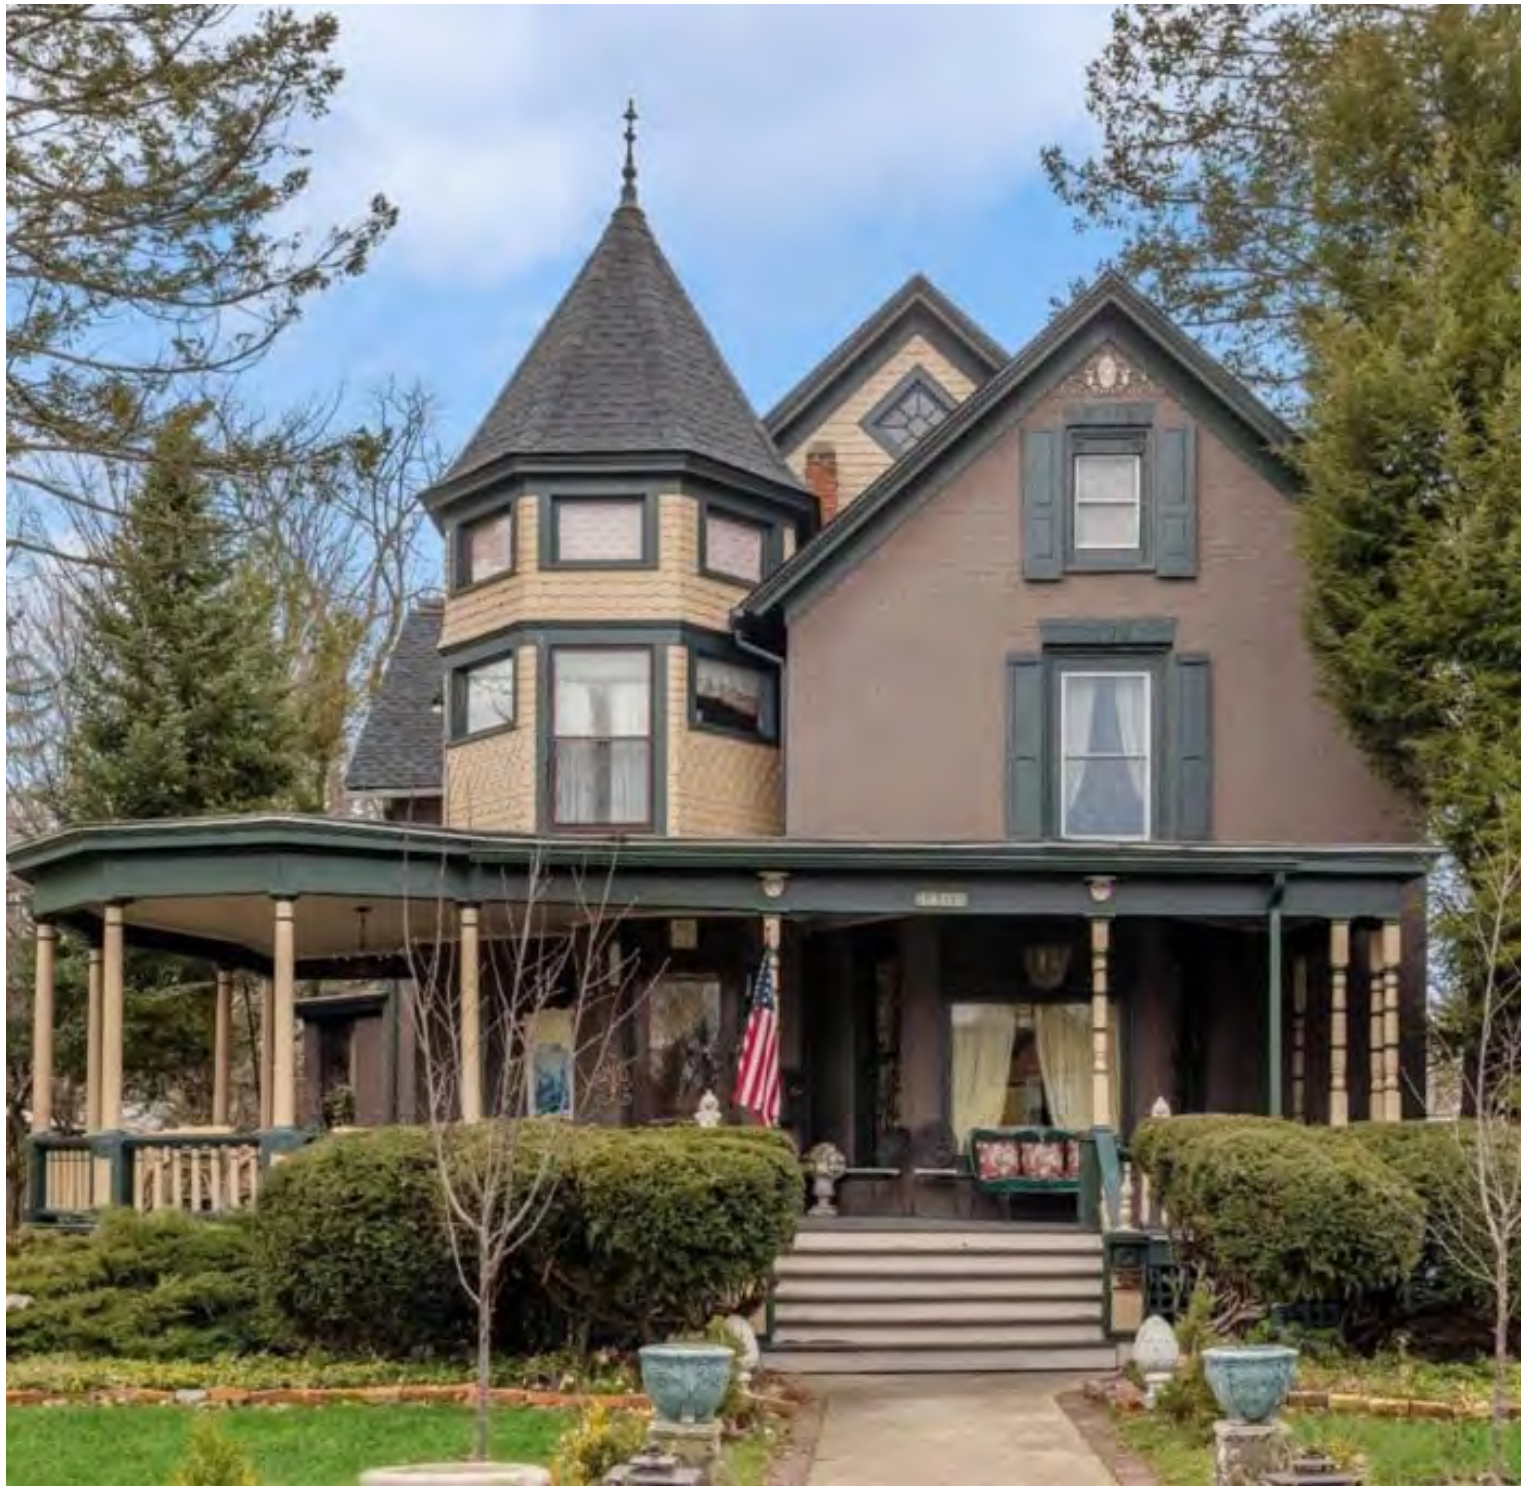
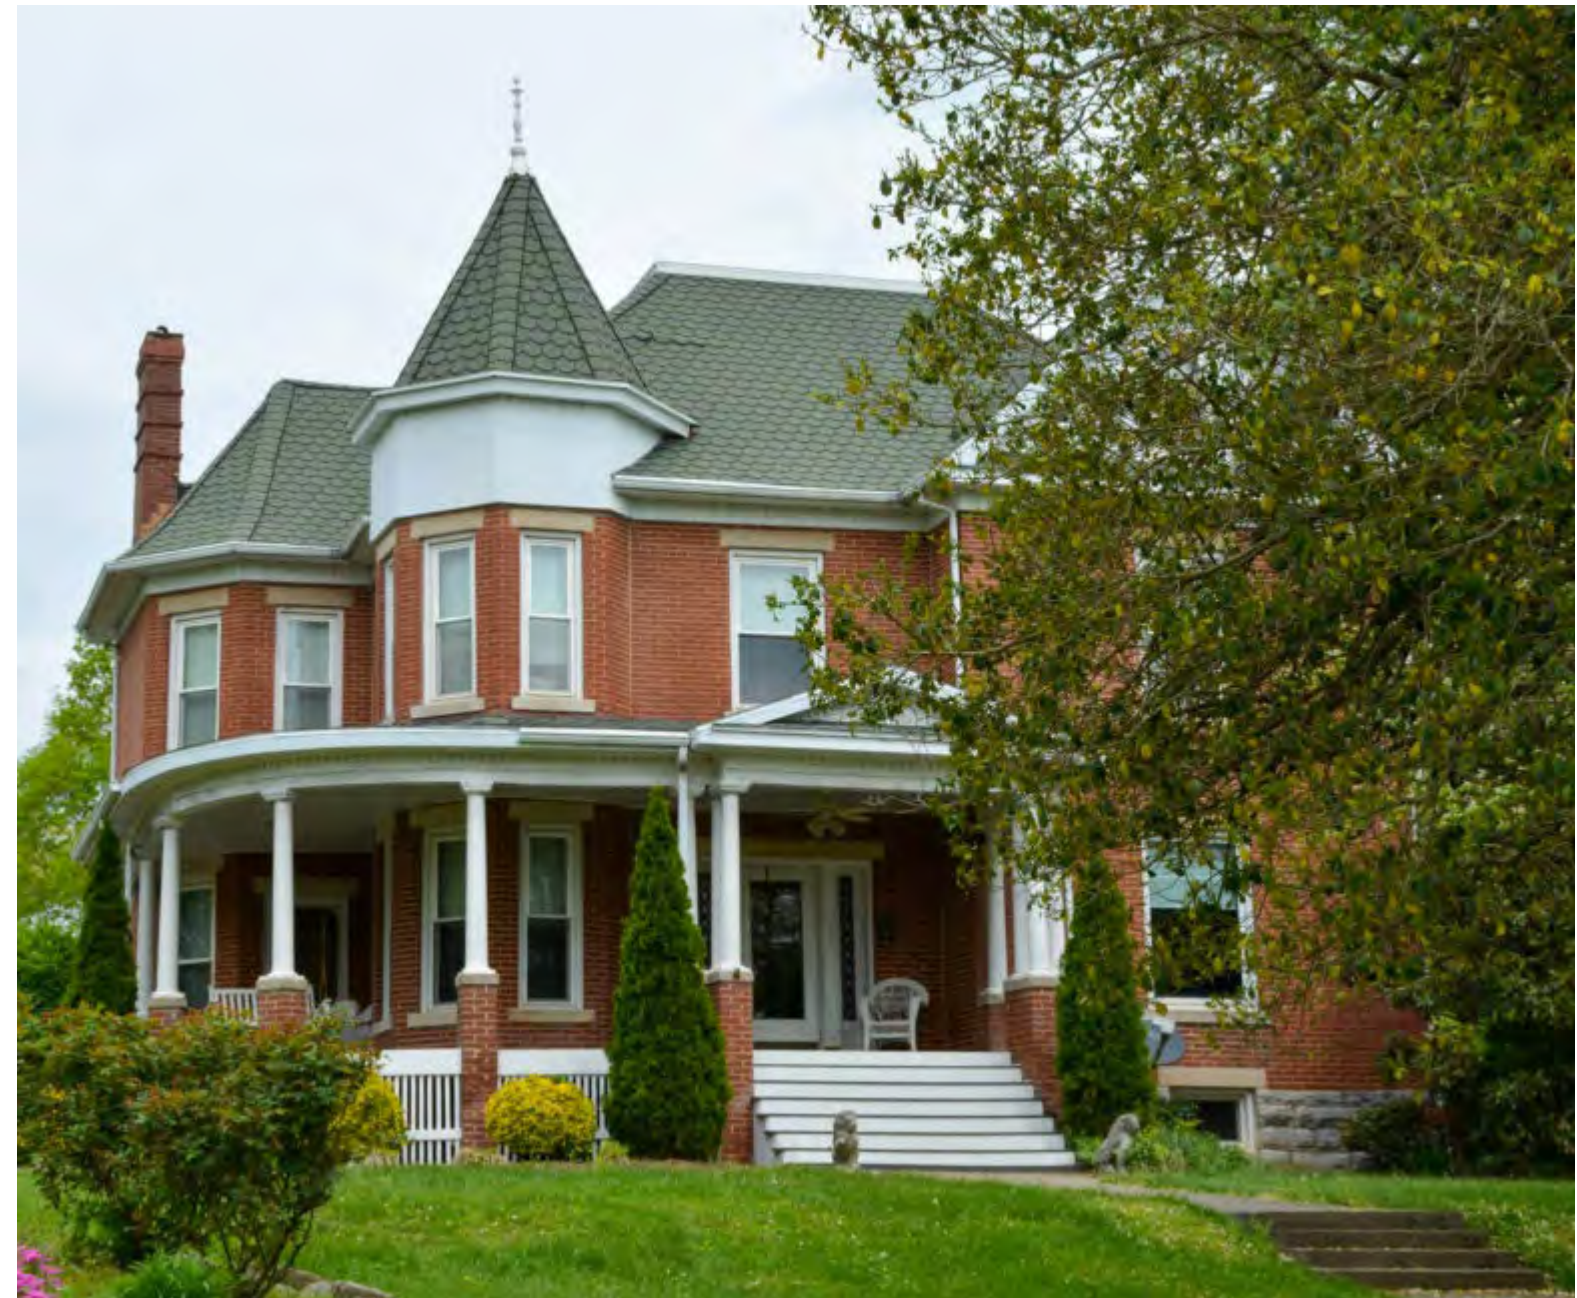
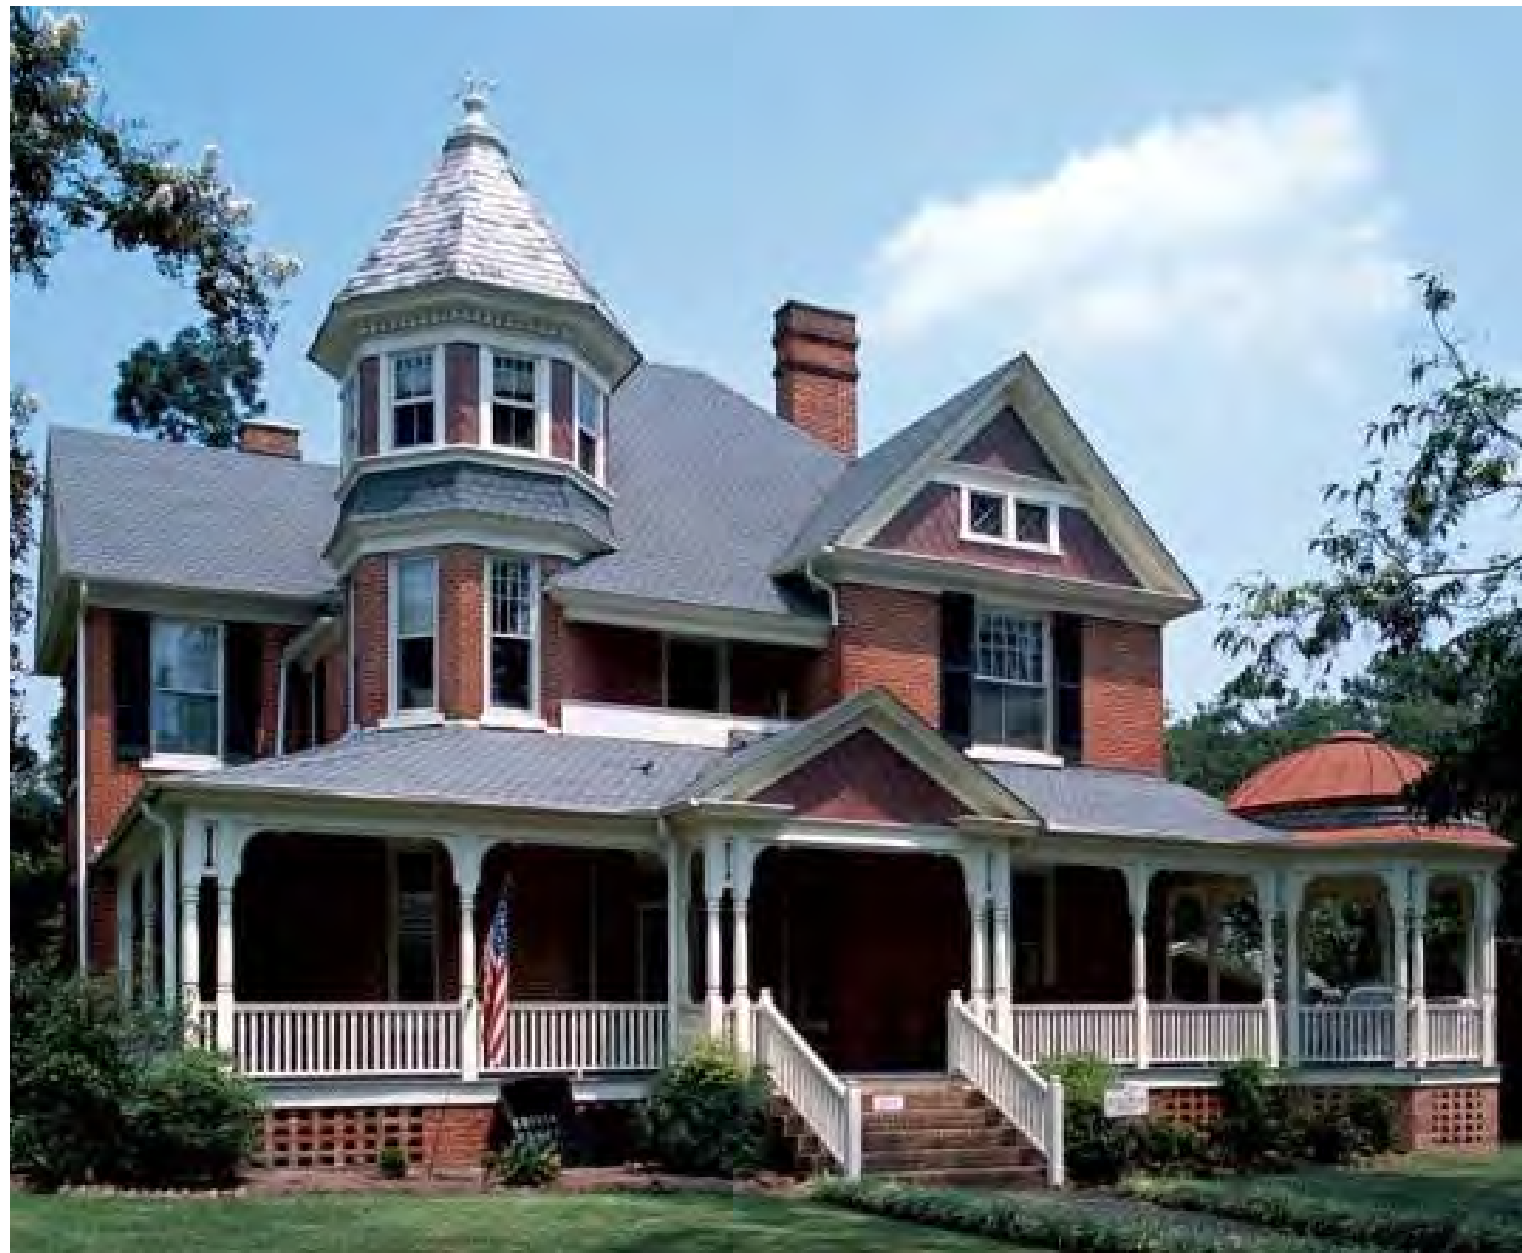
KEY ELEMENTS OF QUEEN ANNE STYLE HOUSE

- ASSYMETRICAL FAÇADE
- OVERHANGING EAVES
- ROUND, SQUARE OR POLYGONAL TOWERS
- PEDIMENTED PORCHES
- SECOND STORY PORCH/ BALCONIES
- PROJECTING BAY WINDOWS
