CITY OF SAN ANTONIO  
DEVELOPMENT SERVICES DEPARTMENT

NCB See below Property Address: 3700 N. St. Mary's St.  
NCD A49 PART OF A-2, A-4, A-52, (208 AC)  
Per Section 35-481 of the Unified Development Code (UDC), the Zoning Board of Adjustment is empowered to consider appeals of a decision made by an administration official.

The application for a Certificate of Appropriateness in HDRC case number 2022-091  
should have been denied for the reasons set out on Attachment "A", and its exhibits.

**ATTACHMENT A**  
**Exhibits A-1 to A-18**

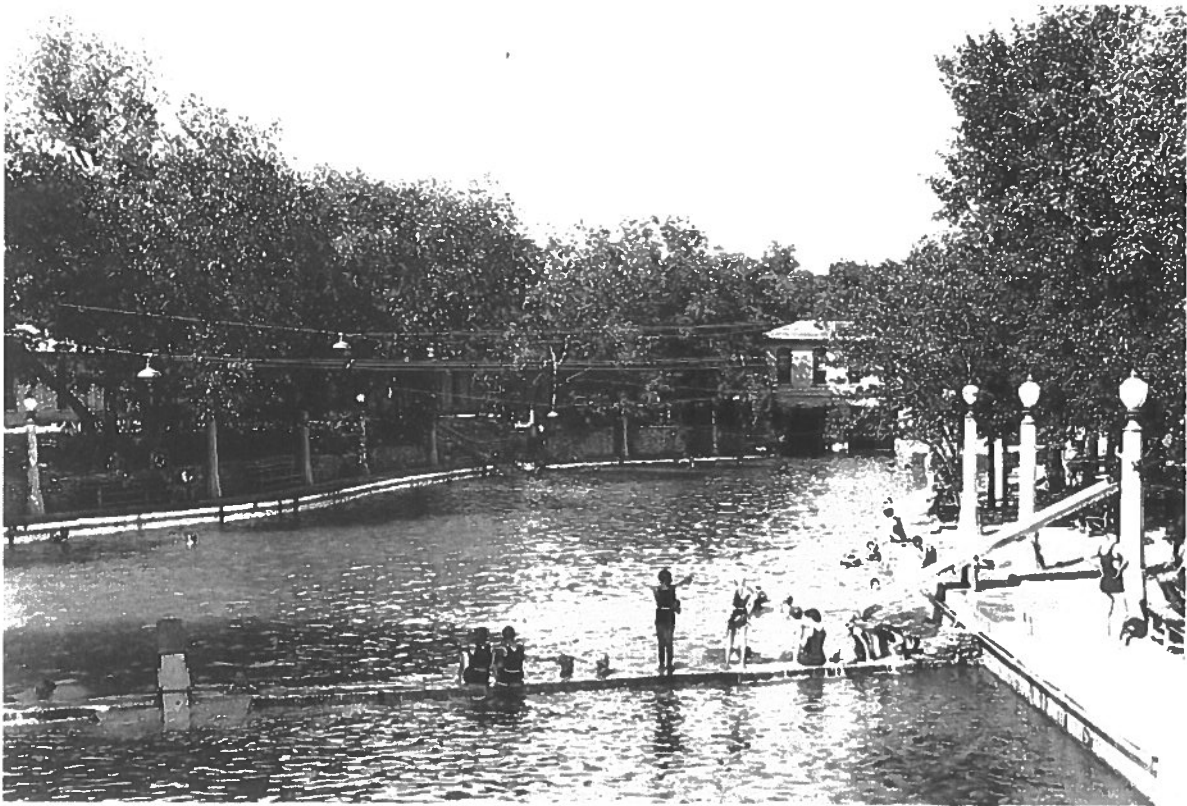
**1920’s Lambert Beach, showing live oaks and other trees on the banks. Compare to the concept drawing below. The historic integrity of the site is lost in the City’s design.**

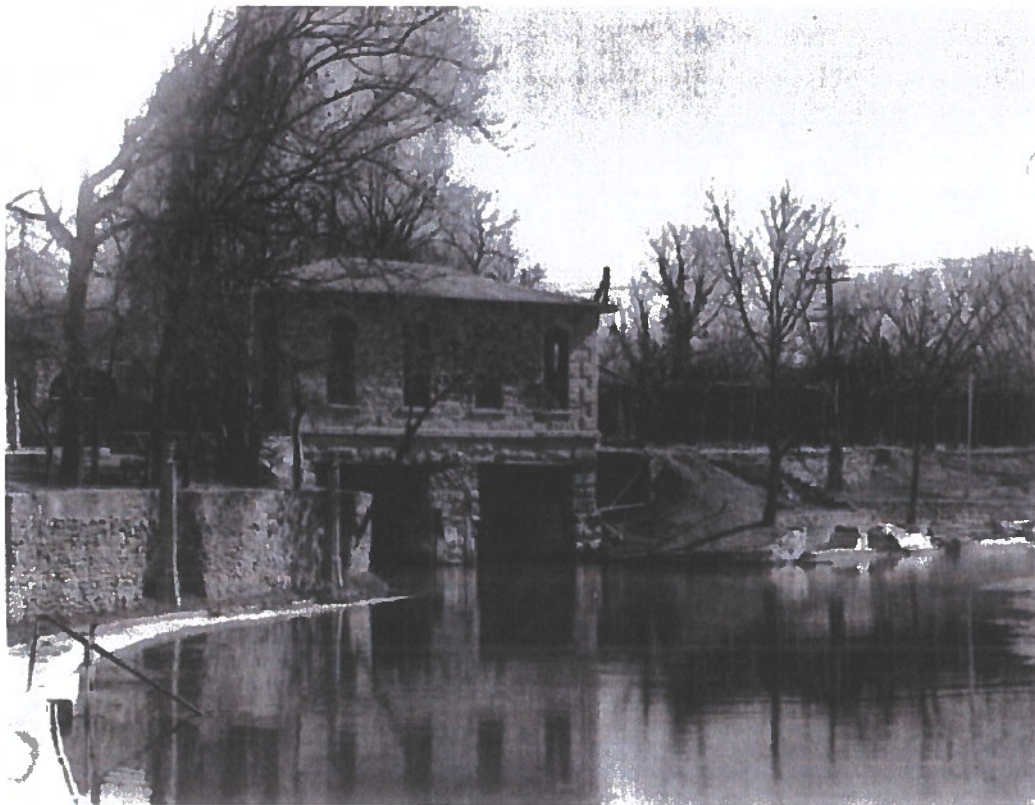
**1920's Lambert Beach. Note the tree growing through the wall at left, much as several live oaks do today. The proposed plan would not replace these trees, in violation of Secretary of Interior Standards.**

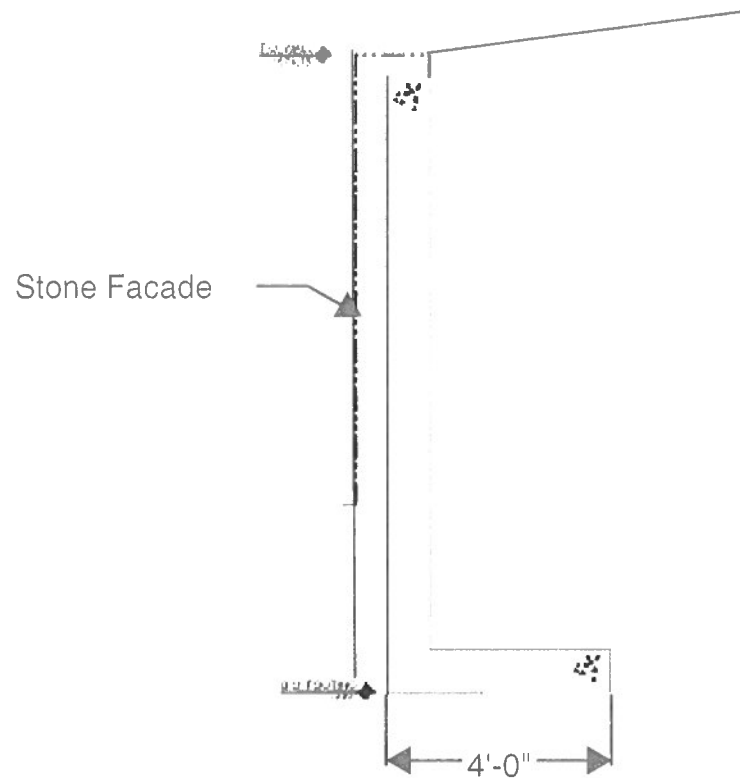
4. The City's construction plans revealed that it is proposing to build a shadow retaining wall and then rebuild or reconstruct the old walls to the new retaining wall. The proposed design uses a cantilever wall system. With this system, a 4-foot-long footer is built at the bottom of the retaining wall, extending into the riverbank. See Sketch on Next Page

5. This cantilever construction method would require removing all trees and earth approximately 5 feet into the riverbank away from the river and wall. This solution requires the destruction of trees near the walls.

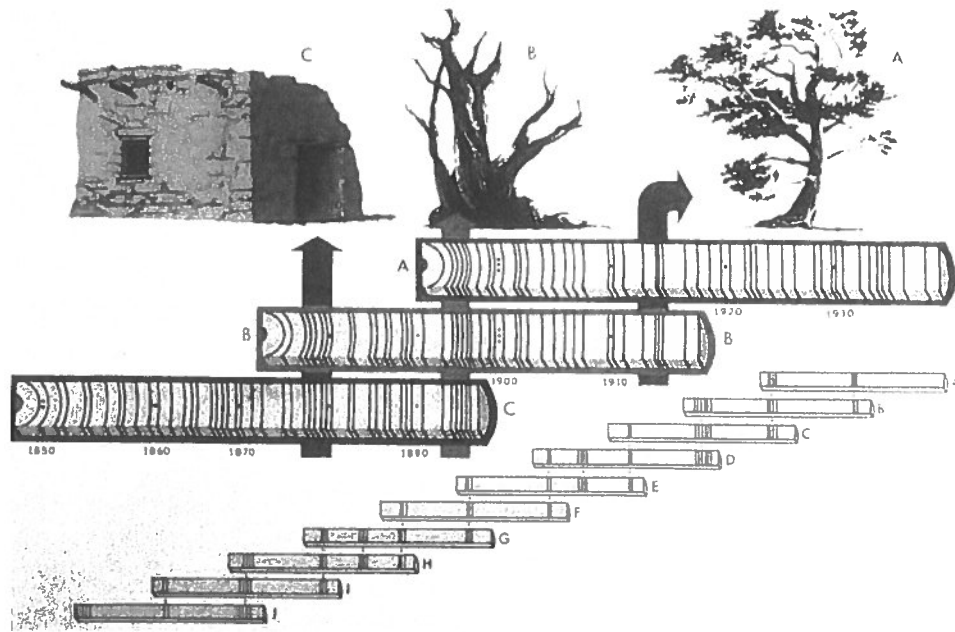
Figure 1. Patterns of tree ring-width variability are used to provide annual dates to historic structures by comparing them with living and dead trees. Courtesy of NOAA Paleoclimatology Program.

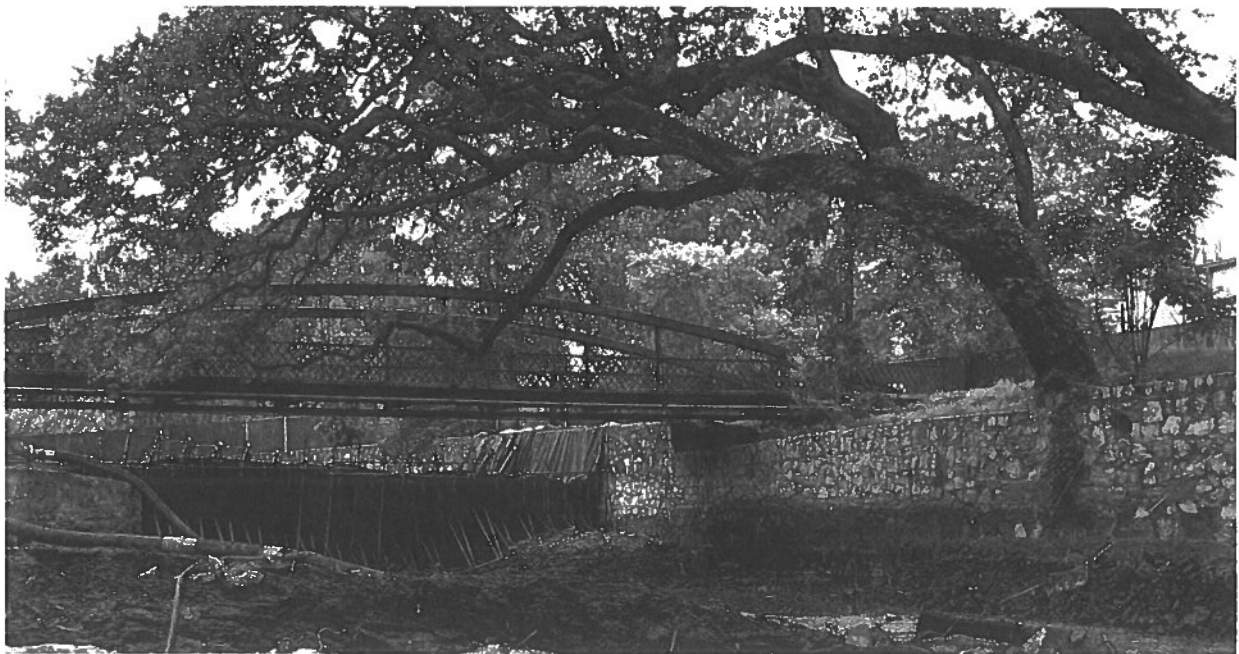
Figure 2. Photo of tree #95, a live oak (*Quercus virginiana/fusiformis*) successfully sampled at Brackenridge Park. Photo courtesy of City of San Antonio Parks and Recreation.

**RESPONSE:** With respect to the wall adjacent to trees 95 (a Heritage live oak) and 97 (a Significant live oak), the City has failed to consider or propose any alternatives to destruction. The City’s response is premised on its continuing assertion of a debunked premise that it cannot move or alter the walls in any way, no matter how slight, for any purpose, no matter how important to compliance with the law. The City’s continuous assertion in the face of multiple corrections by THC borders on the pretextual. Exhibits A-11, 15, 16.

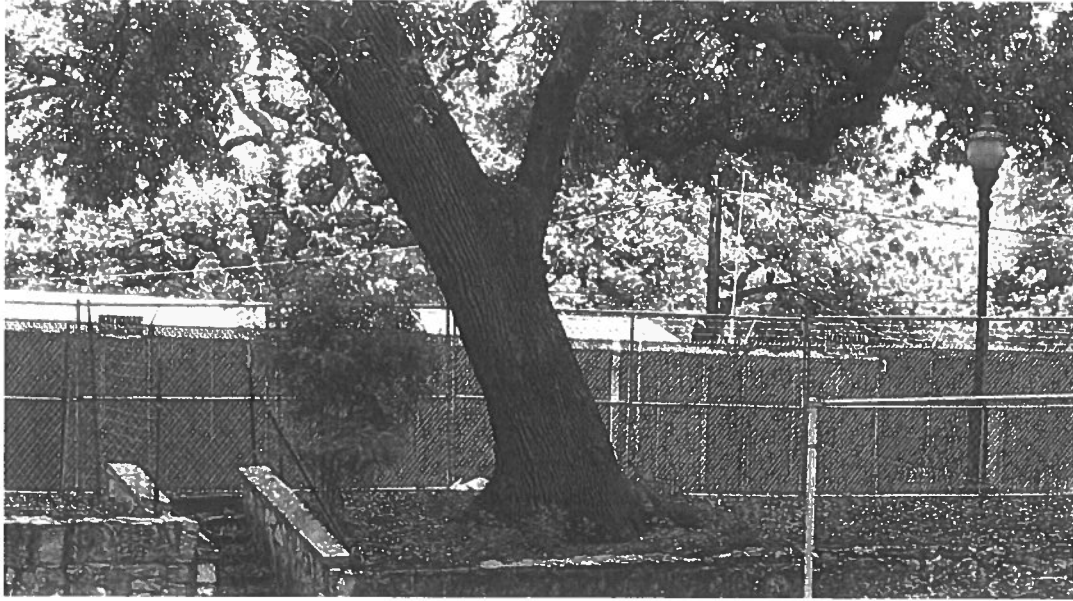
Figure 3. Photo of tree #100, a live oak (*Quercus virginiana/fusiformis*) successfully sampled at Brackenridge Park. Photo courtesy of City of San Antonio Parks and Recreation.

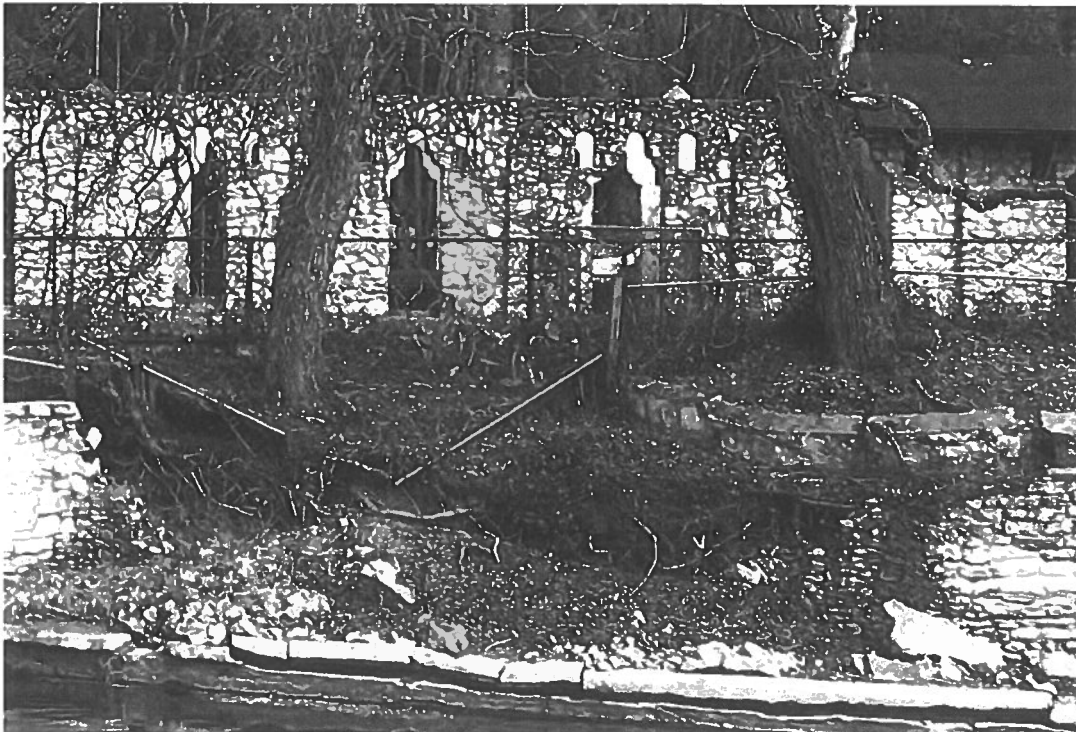
Figure 4. Photo of pecan (*Carya illinoensis*) trees #139 (left) and #140 (right). Tree #139 was successfully sampled. Tree #140 was hollow and not sampled. Photo courtesy of City of San Antonio Parks and Recreation.

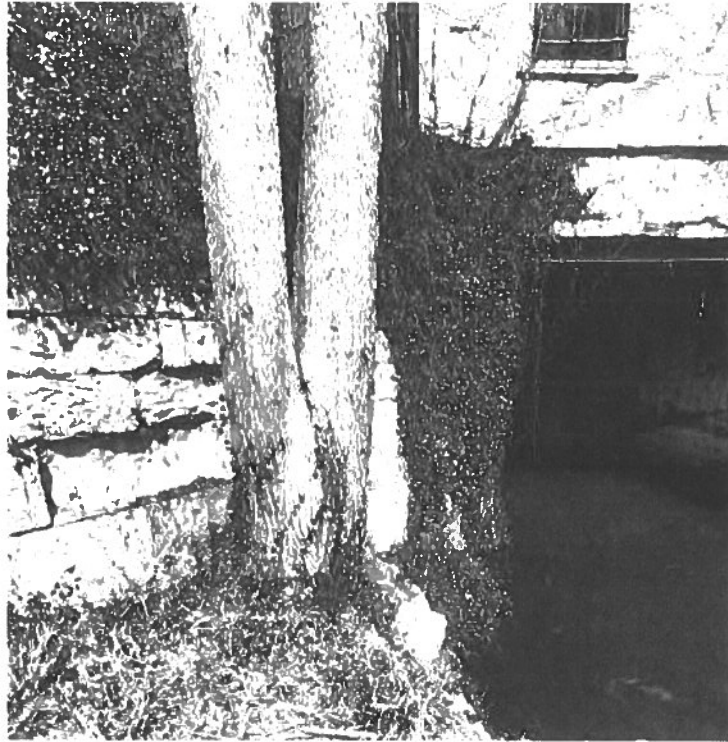
Figure 5. Photo of tree #141, a bald cypress (*Taxodium distichum*) successfully sampled at Brackenridge Park. Photo courtesy of City of San Antonio Parks and Recreation.

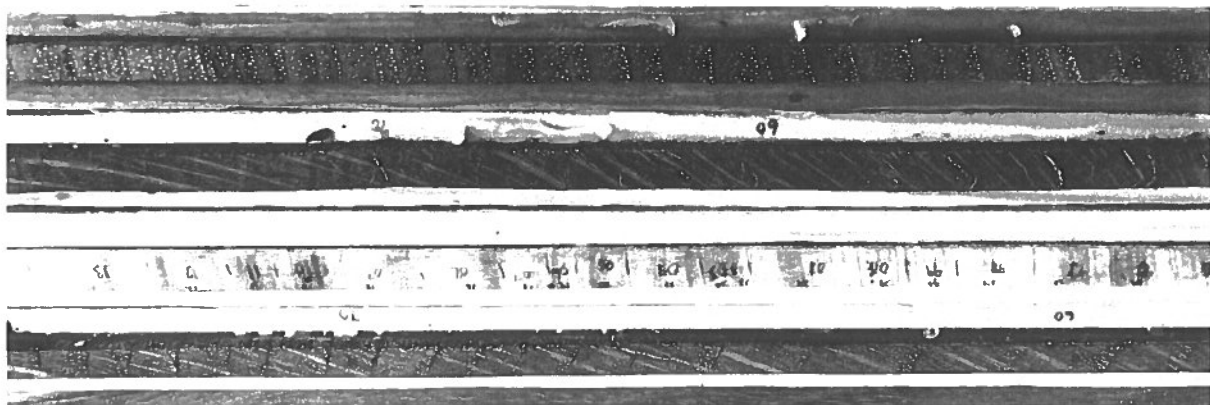
Figure 6. Photo of core four tree core samples. (Top to bottom: #139, #95, #141, #100)

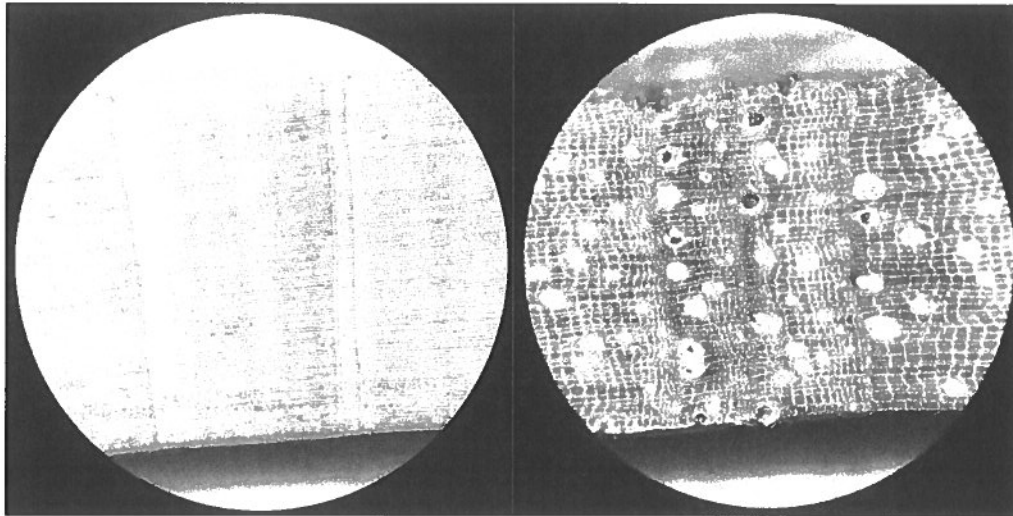
Figure 7. Photo of tree cores #141 (left) and #139 (right) under the microscope.

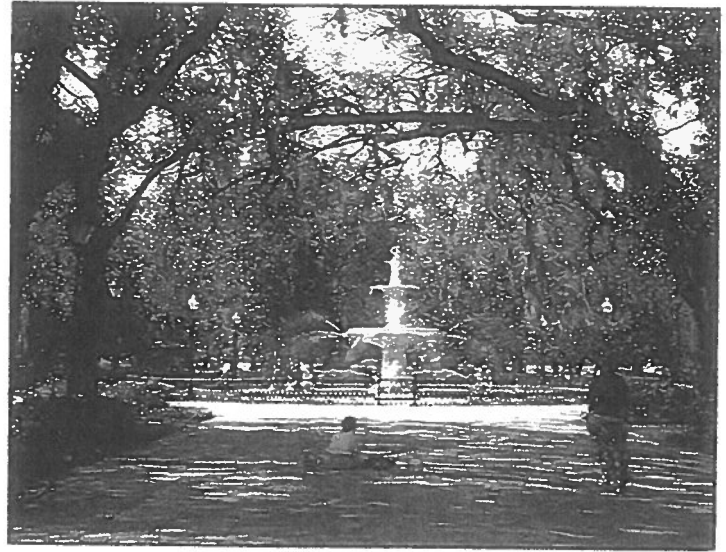
*This character-defining avenue of oaks in Forsyth Park, Savannah, Georgia, have been pruned to lighten their canopy, thus providing protection from severe storms. (author, 1996)*

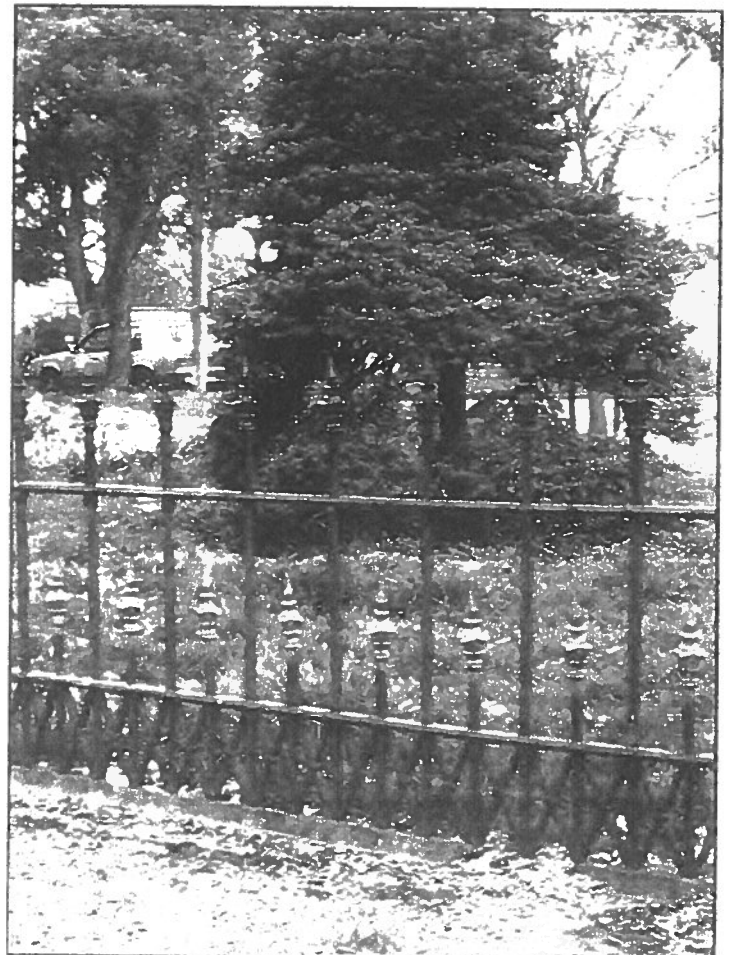
*Castings were made to replace a limited number of lost finials along the perimeter fence of Lafayette Square, St. Louis, Missouri. (author, 1994)*

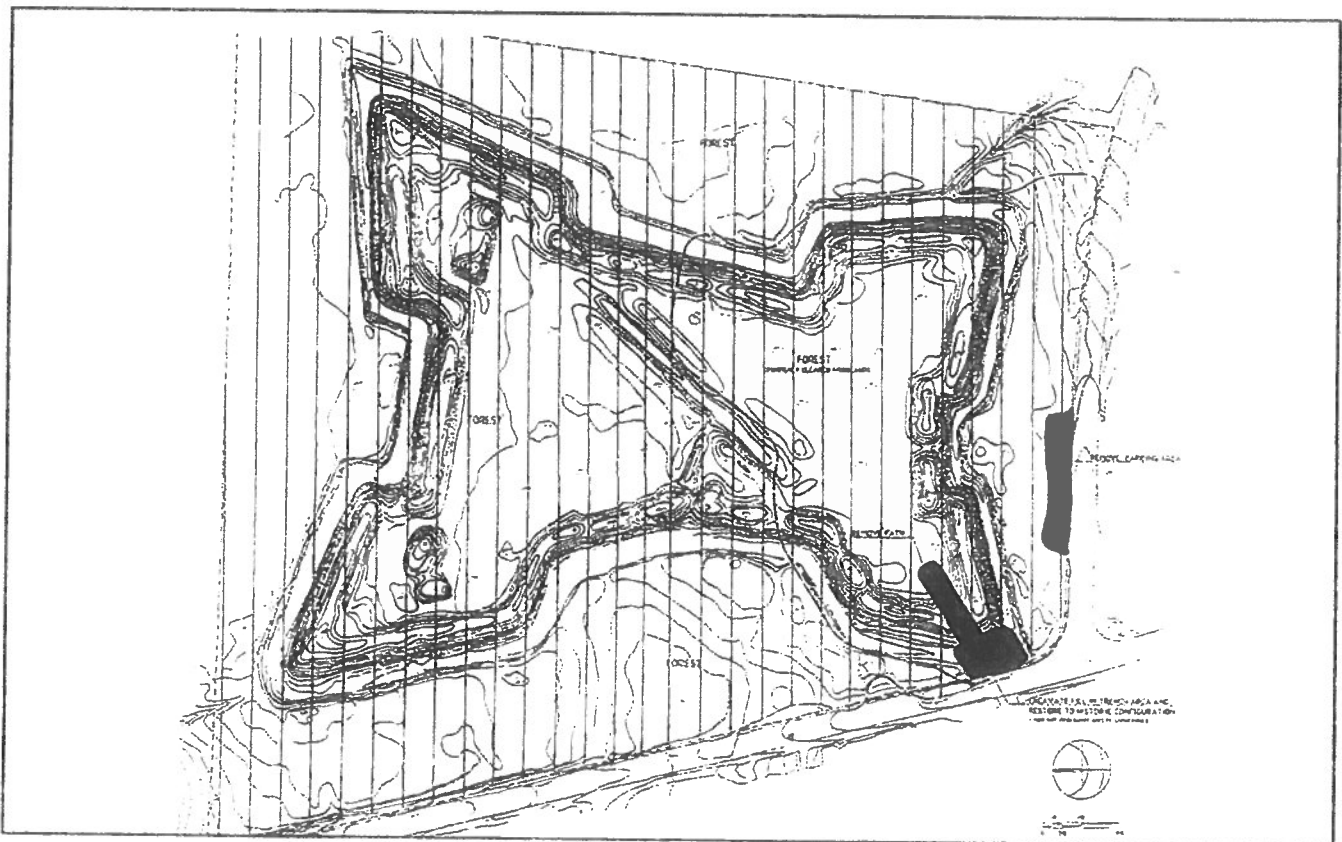
To stabilize the earthworks at Fort Fisher in Petersburg, North Carolina, access has now been restricted to the fragile fort. A parking lot and trench area have been removed [see black areas] and stormwater runoff from local roads have been redirected. (NPS, 1989)

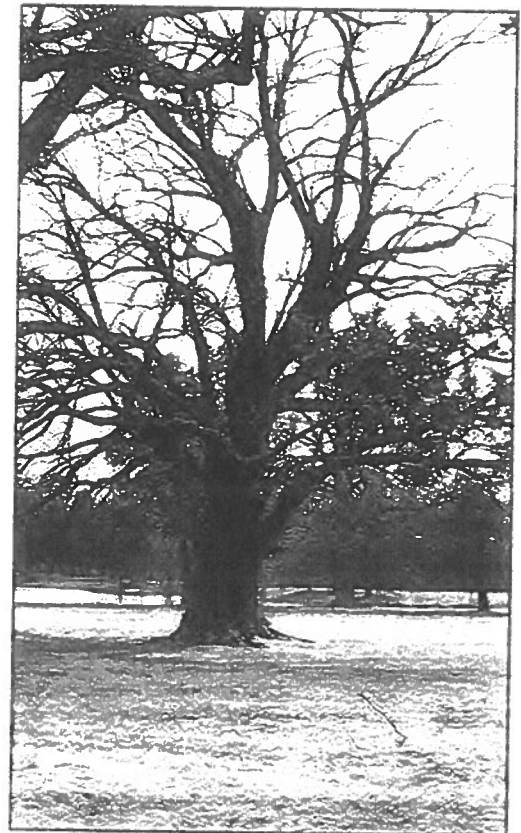
A large Osage orange (*Maclura pomifera*) at the Arkansas Post National Memorial needs to be cored to establish its age. (courtesy NPS)

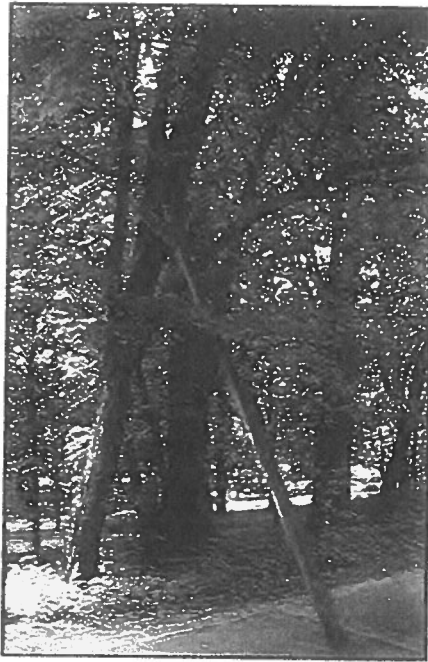
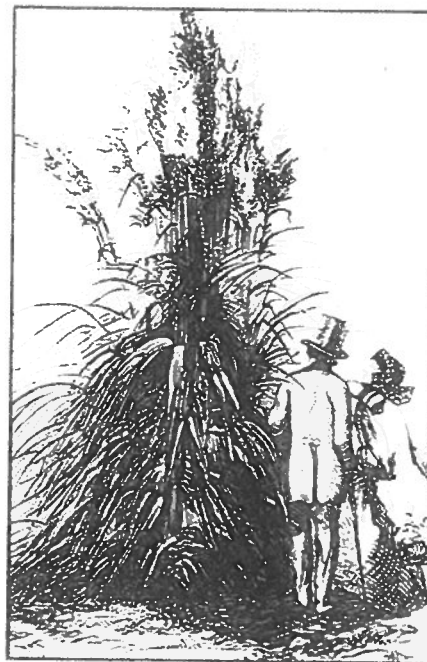
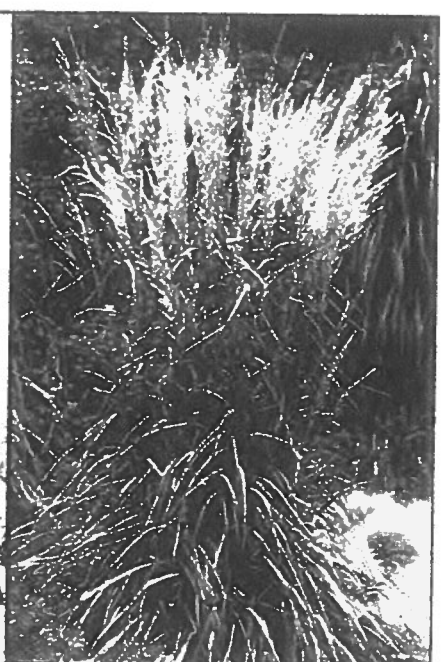
*Preservation principles in the Standards have parallels world wide. This tree in a public park in Warsaw, Poland, [top left] was protected and stabilized following a recent storm. (author, 1994) Pampas grass, as depicted in this 1858 engraving, [ top center] was often used as a bedding plant. Along the monumental core in Washington, D.C., some of the beds have been replaced in-kind [ top right] as a result of their easy availability in the nursery trade*

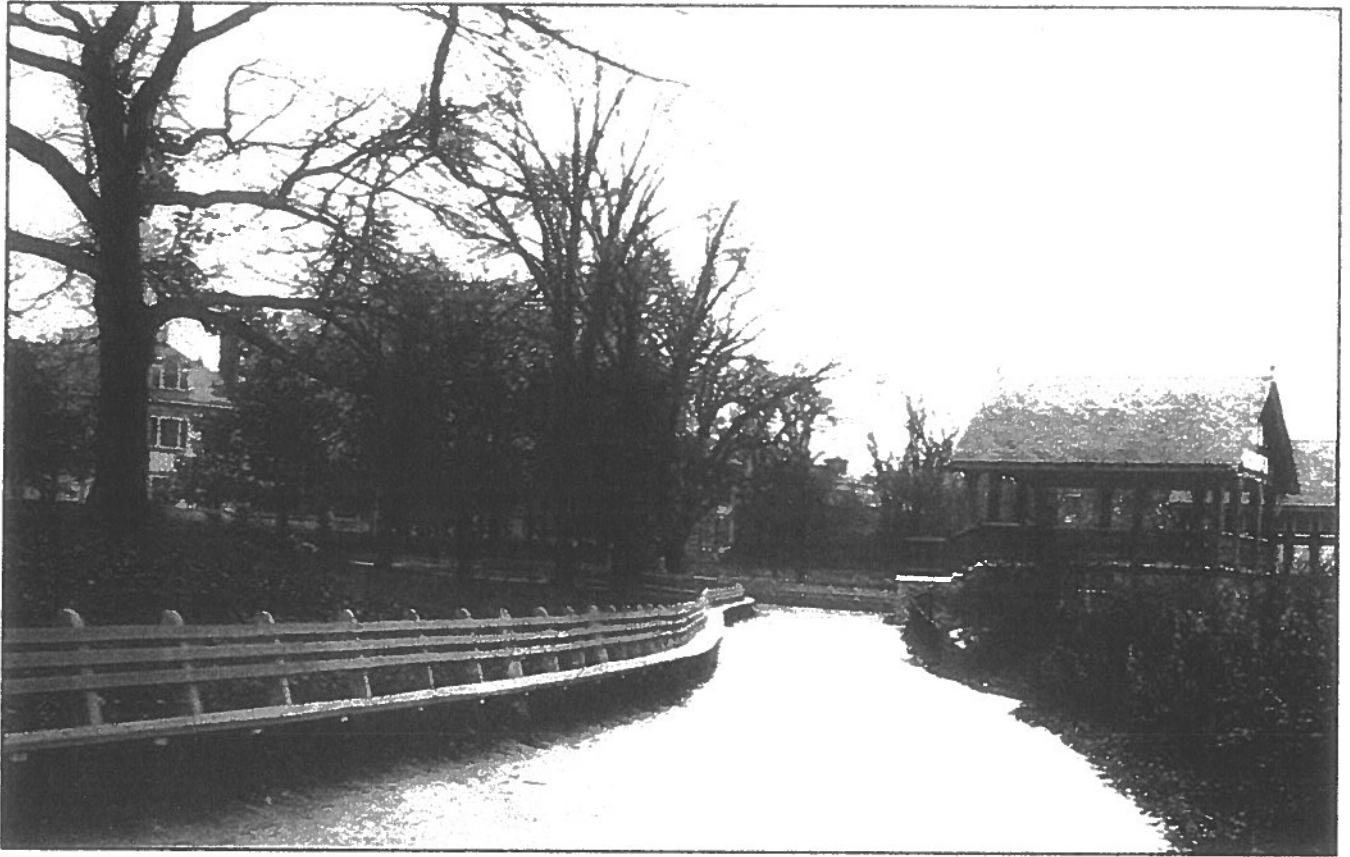
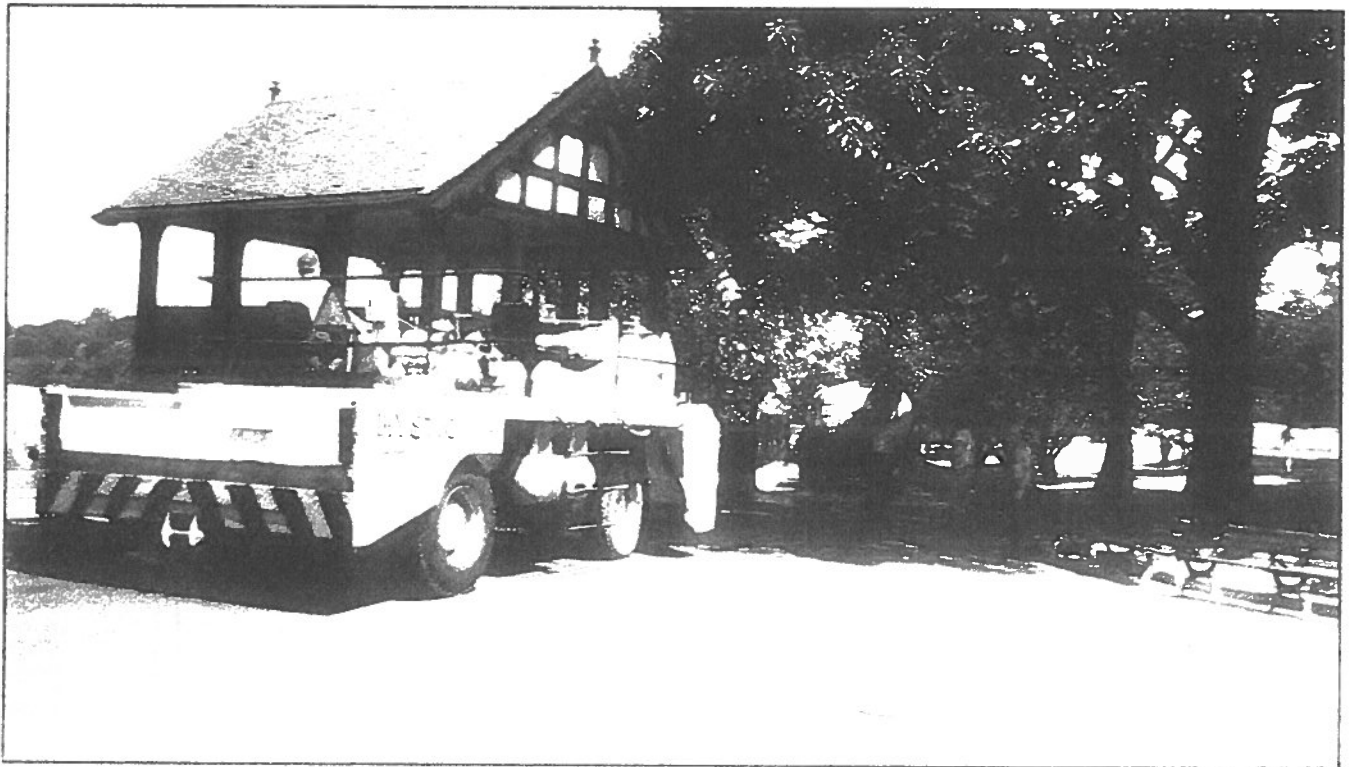
*As part of a preservation project, the walks around Boston's Jamaica Pond Park were repaired and resurfaced. A loose, crushed stone surface material (an embedded aggregate) was rolled into the asphalt surface, thus allowing for upgraded uses such as jogging, biking and snow removal, while retaining the historic character. (FLONHS and author, 1990)*
