HISTORIC AND DESIGN REVIEW COMMISSION

HDRC CASE NO: 2023-230
ADDRESS: 813 BURLESON ST
LEGAL DESCRIPTION: NCB 1301 BLK 2 LOT 17
ZONING: R-5, H
CITY COUNCIL DIST.: 2
DISTRICT: Dignowity Hill Historic District
APPLICANT: Kyle Braunlich
OWNER: Kyle Braunlich
TYPE OF WORK: Deconstruction of a rear accessory
APPLICATION RECEIVED: June 4, 2023
60-DAY REVIEW: August 3, 2023
CASE MANAGER: Bryan Morales

813 Burleson Garage Demolition
Kyle W. Braunlich – Property Owner

813 Burleson Garage Demolition – Statement of Work
Kyle W. Braunlich – Property Owner

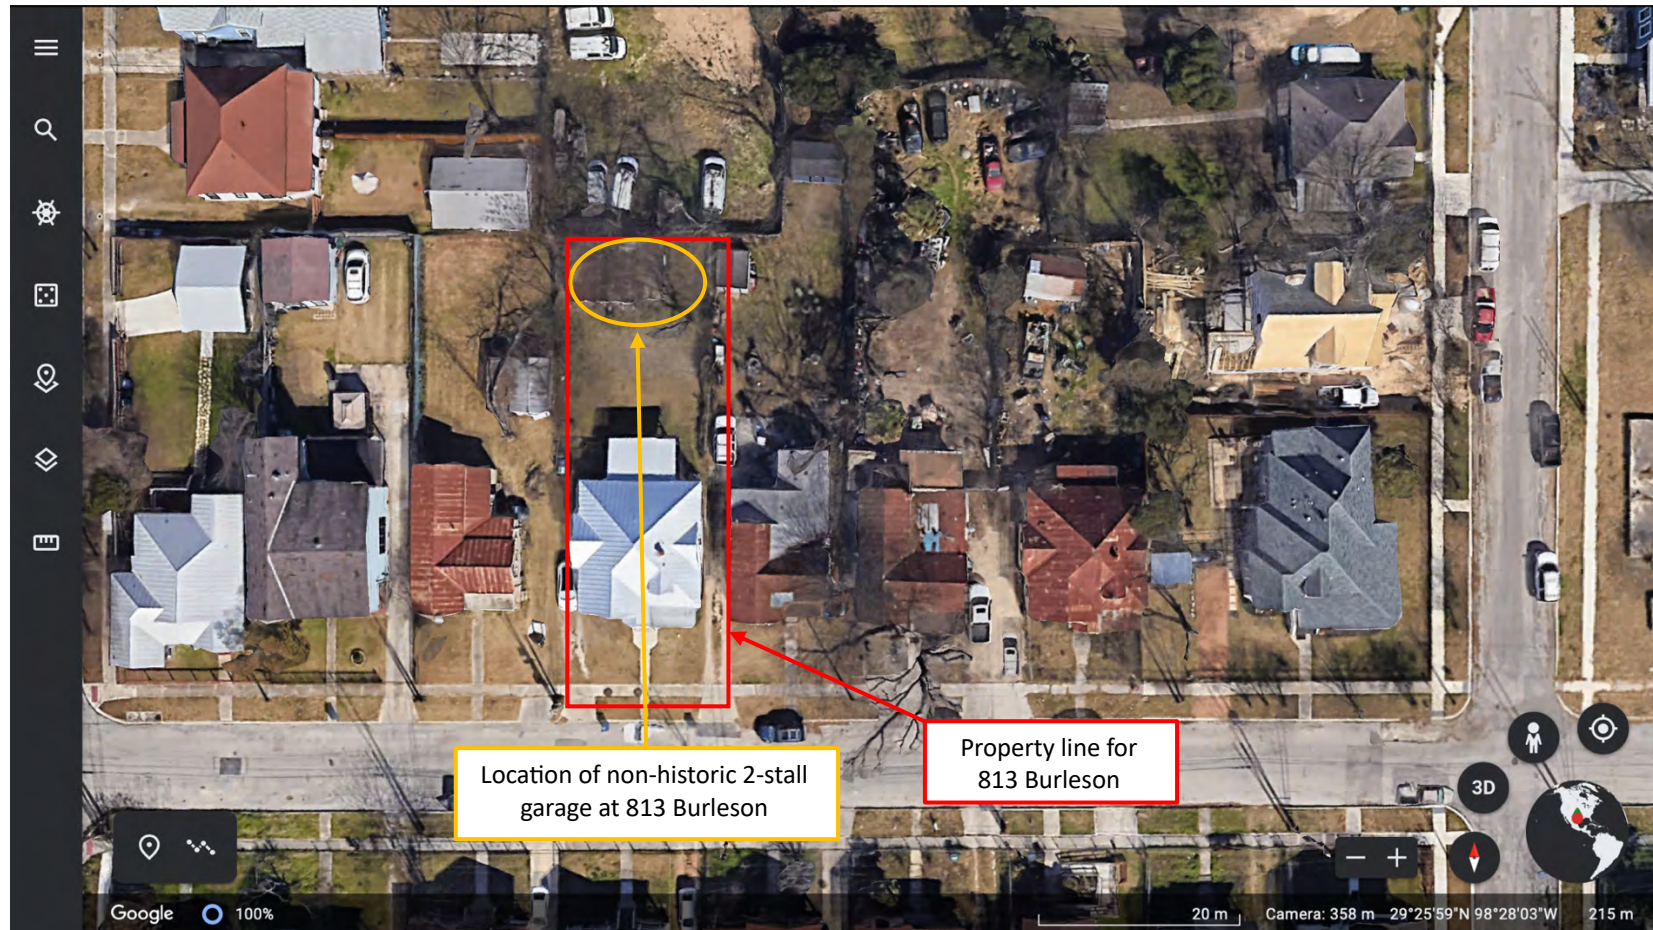
The image below was obtained from Google Maps® and depicts the property layout. Additional references were added for convenience.

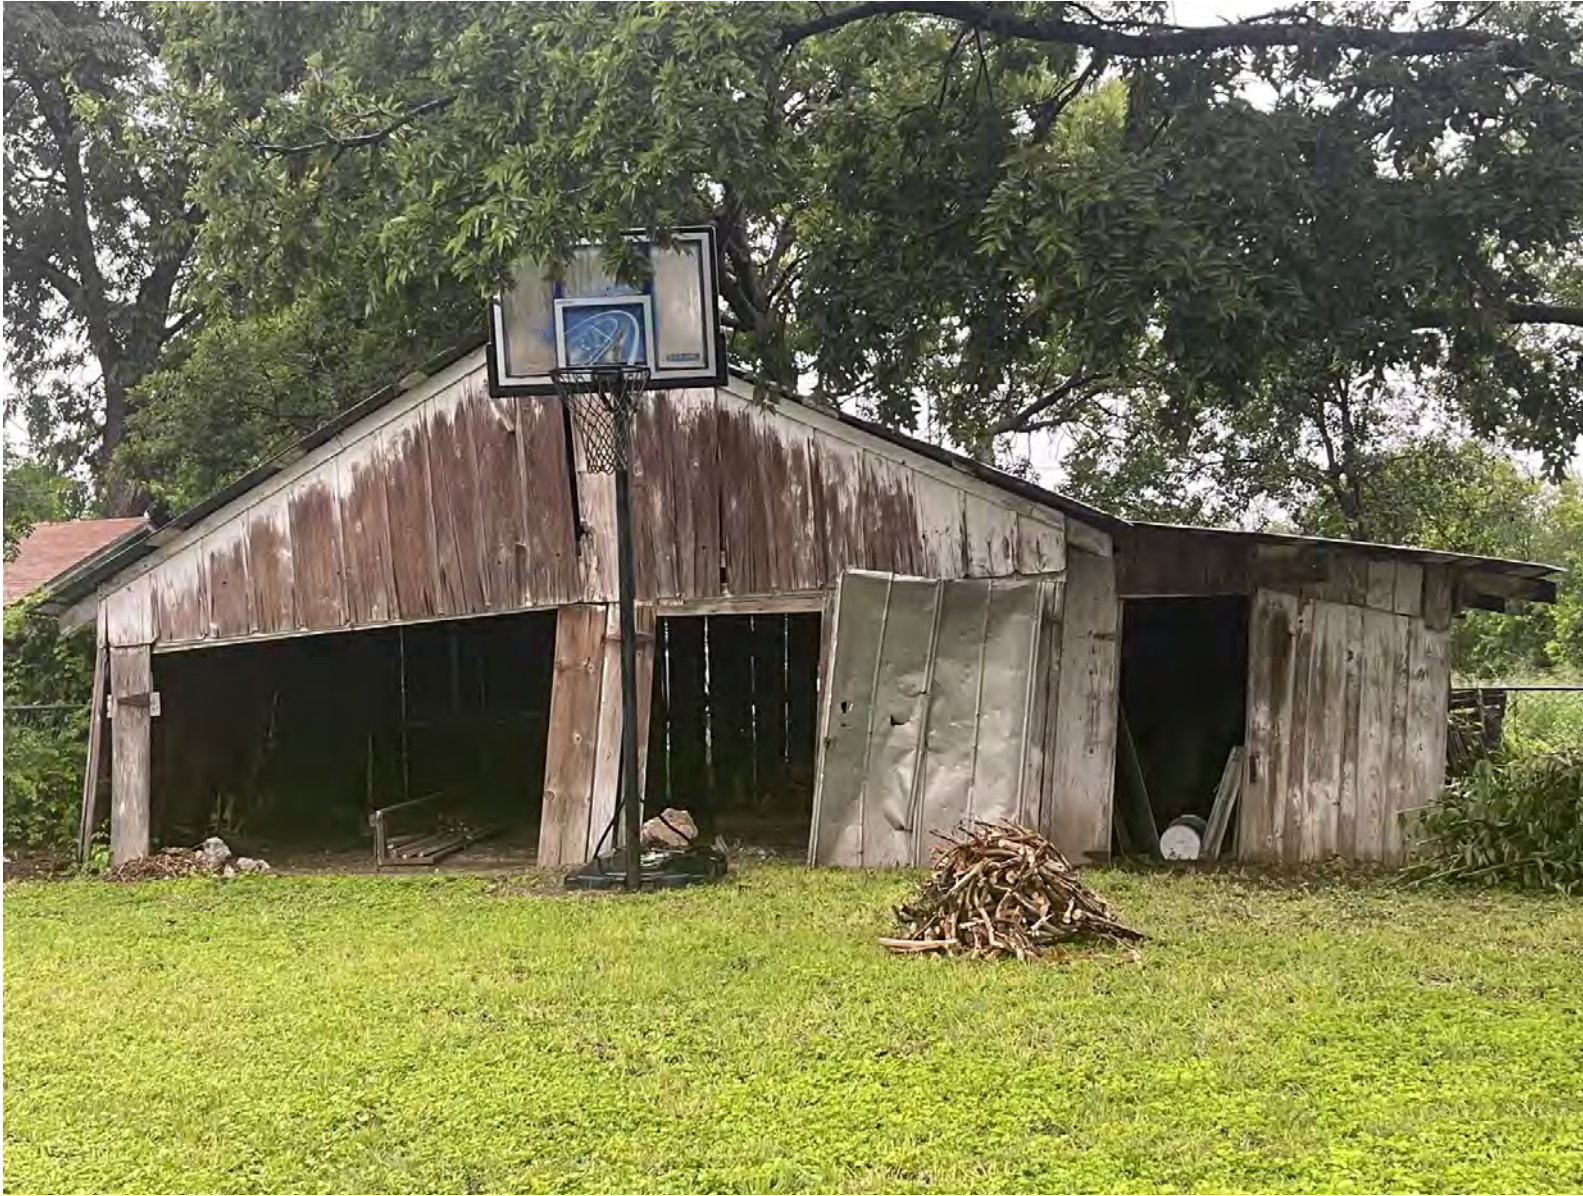
The picture below is of the **front** of the non-contributing/non-historic 2-stall garage.

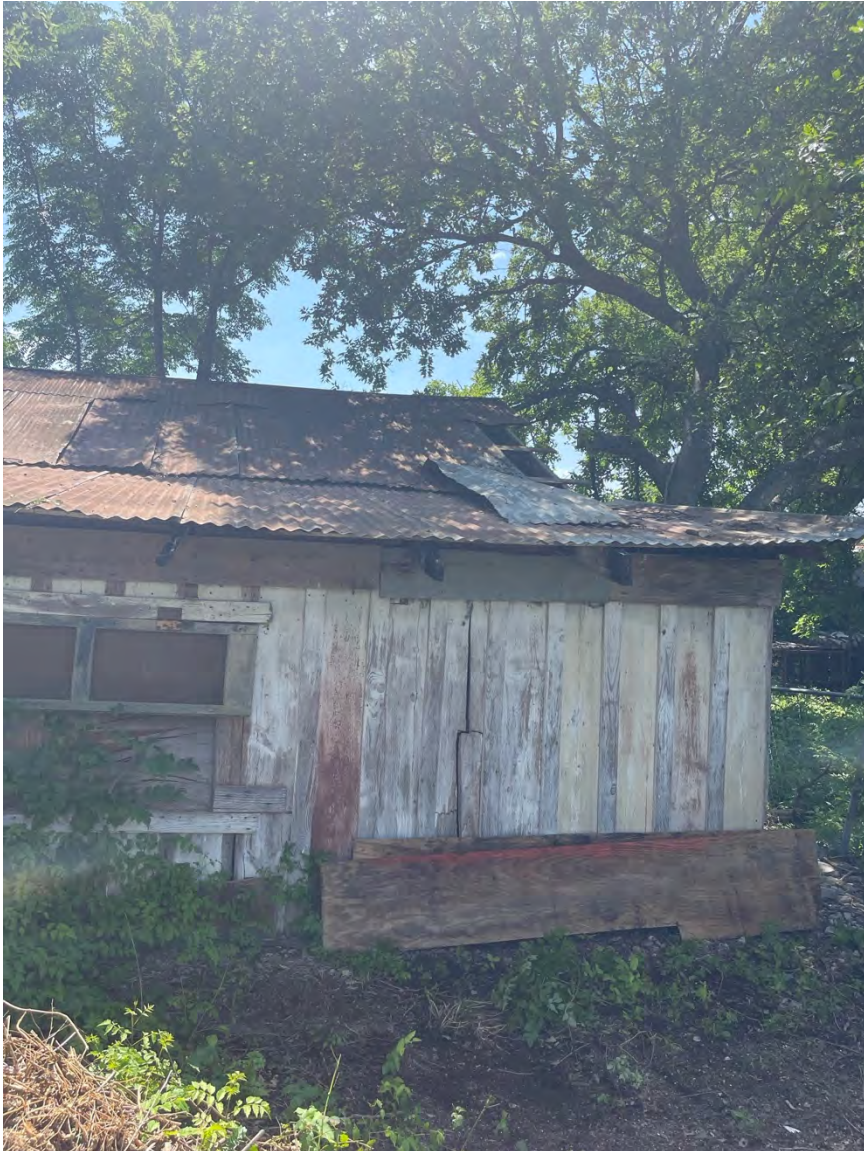
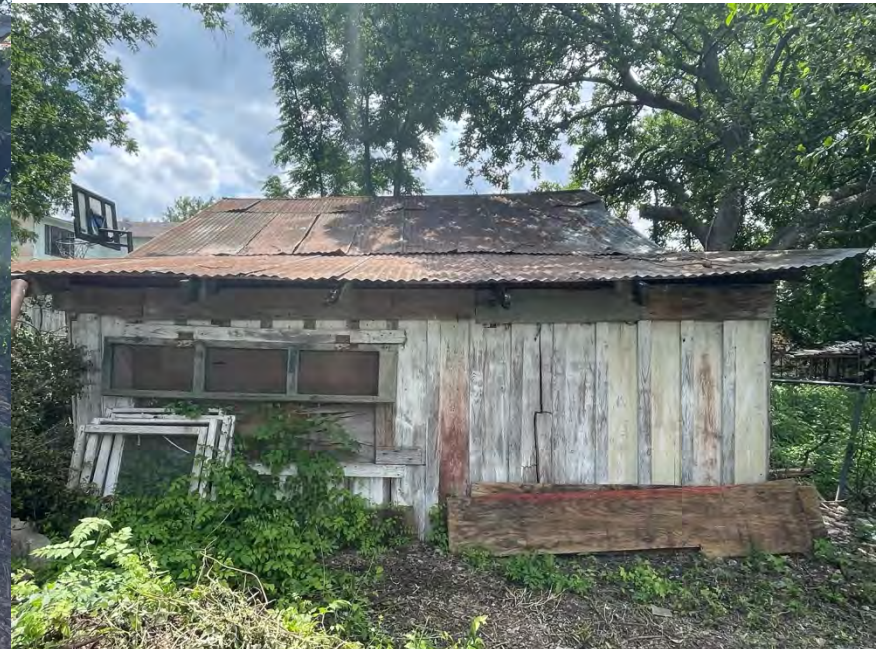
The two pictures below are of the **right side** of the non-contributing/non-historic 2-stall garage. Note, a piece of the metal roof was ripped off following the latest storm as shown in the left picture.

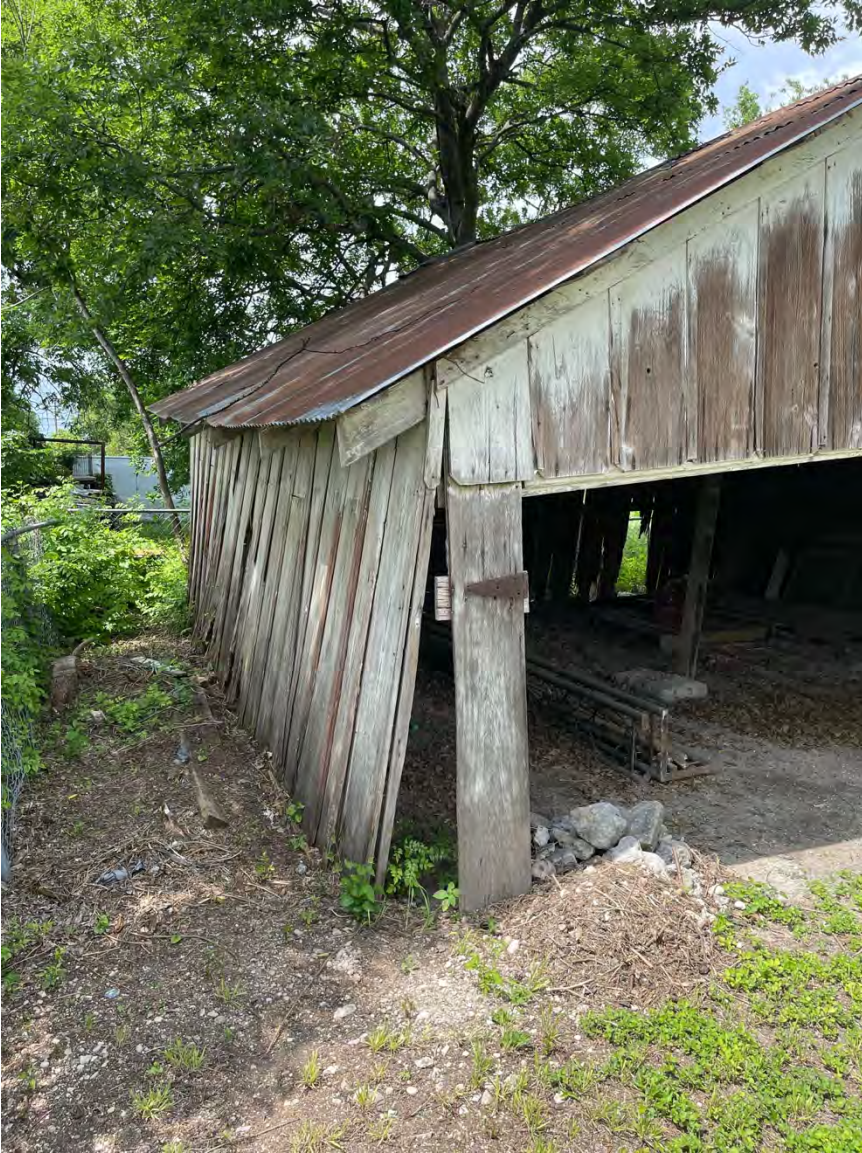
The picture below is of the left side of the non-contributing/non-historic 2-stall garage located at 813 Burleson.

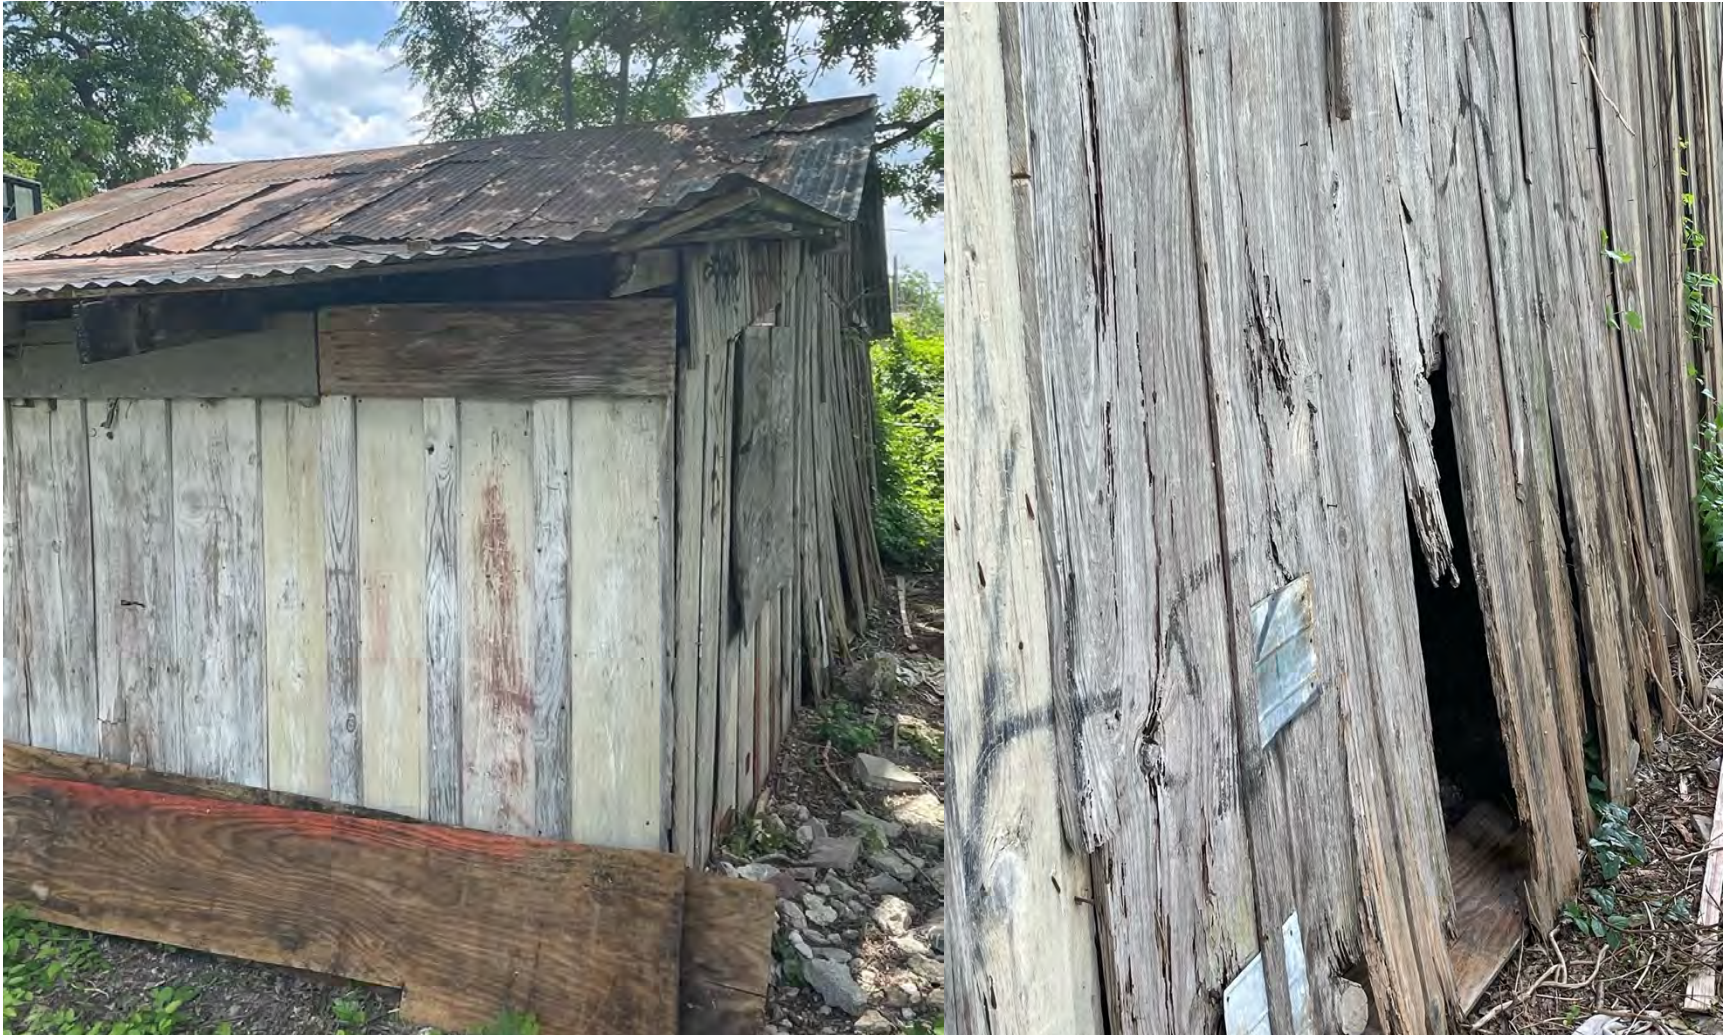
The two pictures below are of the rear of the non-contributing/non-historic 2-stall garage. Note, the picture on the right documents a significant amount of termite damage and rot on the rear of the garage.

Scope of Work: Demolish non-contributing/non-historic detached garage. Recycle metal roofing. Remove and dispose of garage wood siding and structure. Prepare and then seed ground with bermudagrass. Property owner to complete work.

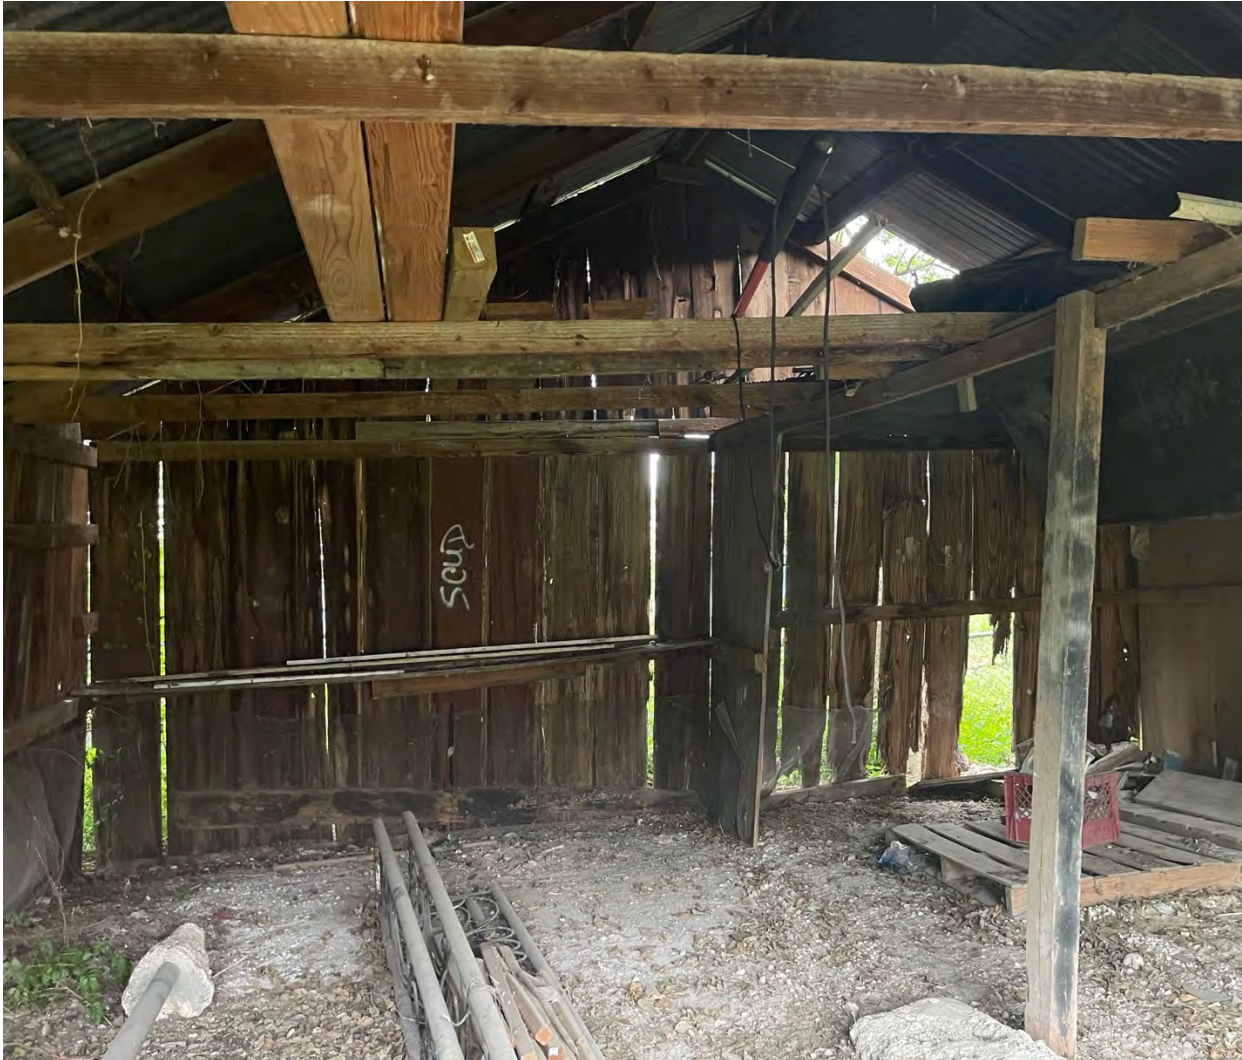
The pictures below is of the inside of the non-contributing/non-historic 2-stall garage. Note, the picture on the right documents a significant amount of termite damage and rot on the rear of the garage.
