# HISTORIC AND DESIGN REVIEW COMMISSION

**HDRC CASE NO:** 2023-279  
**ADDRESS:** 620 S PRESA ST  
**LEGAL DESCRIPTION:** NCB 923 BLK 1 LOT 1  
**ZONING:** C-2, H  
**CITY COUNCIL DIST.:** 1  
**DISTRICT:** Lavaca Historic District  
**APPLICANT:** Eluterio Tenorio/ETDesign Studio  
**OWNER:** Gordon Jones/620 S PRESA REALTY LTD  
**TYPE OF WORK:** Roof and parapet modifications  
**APPLICATION RECEIVED:** July 12, 2023  
**60-DAY REVIEW:** September 10, 2023  
**CASE MANAGER:** Rachel Rettaliata

The applicant is requesting a Certificate of Appropriateness for approval to raise the top plate of the roof, the parapet wall, and pilasters to accommodate new structural framing.

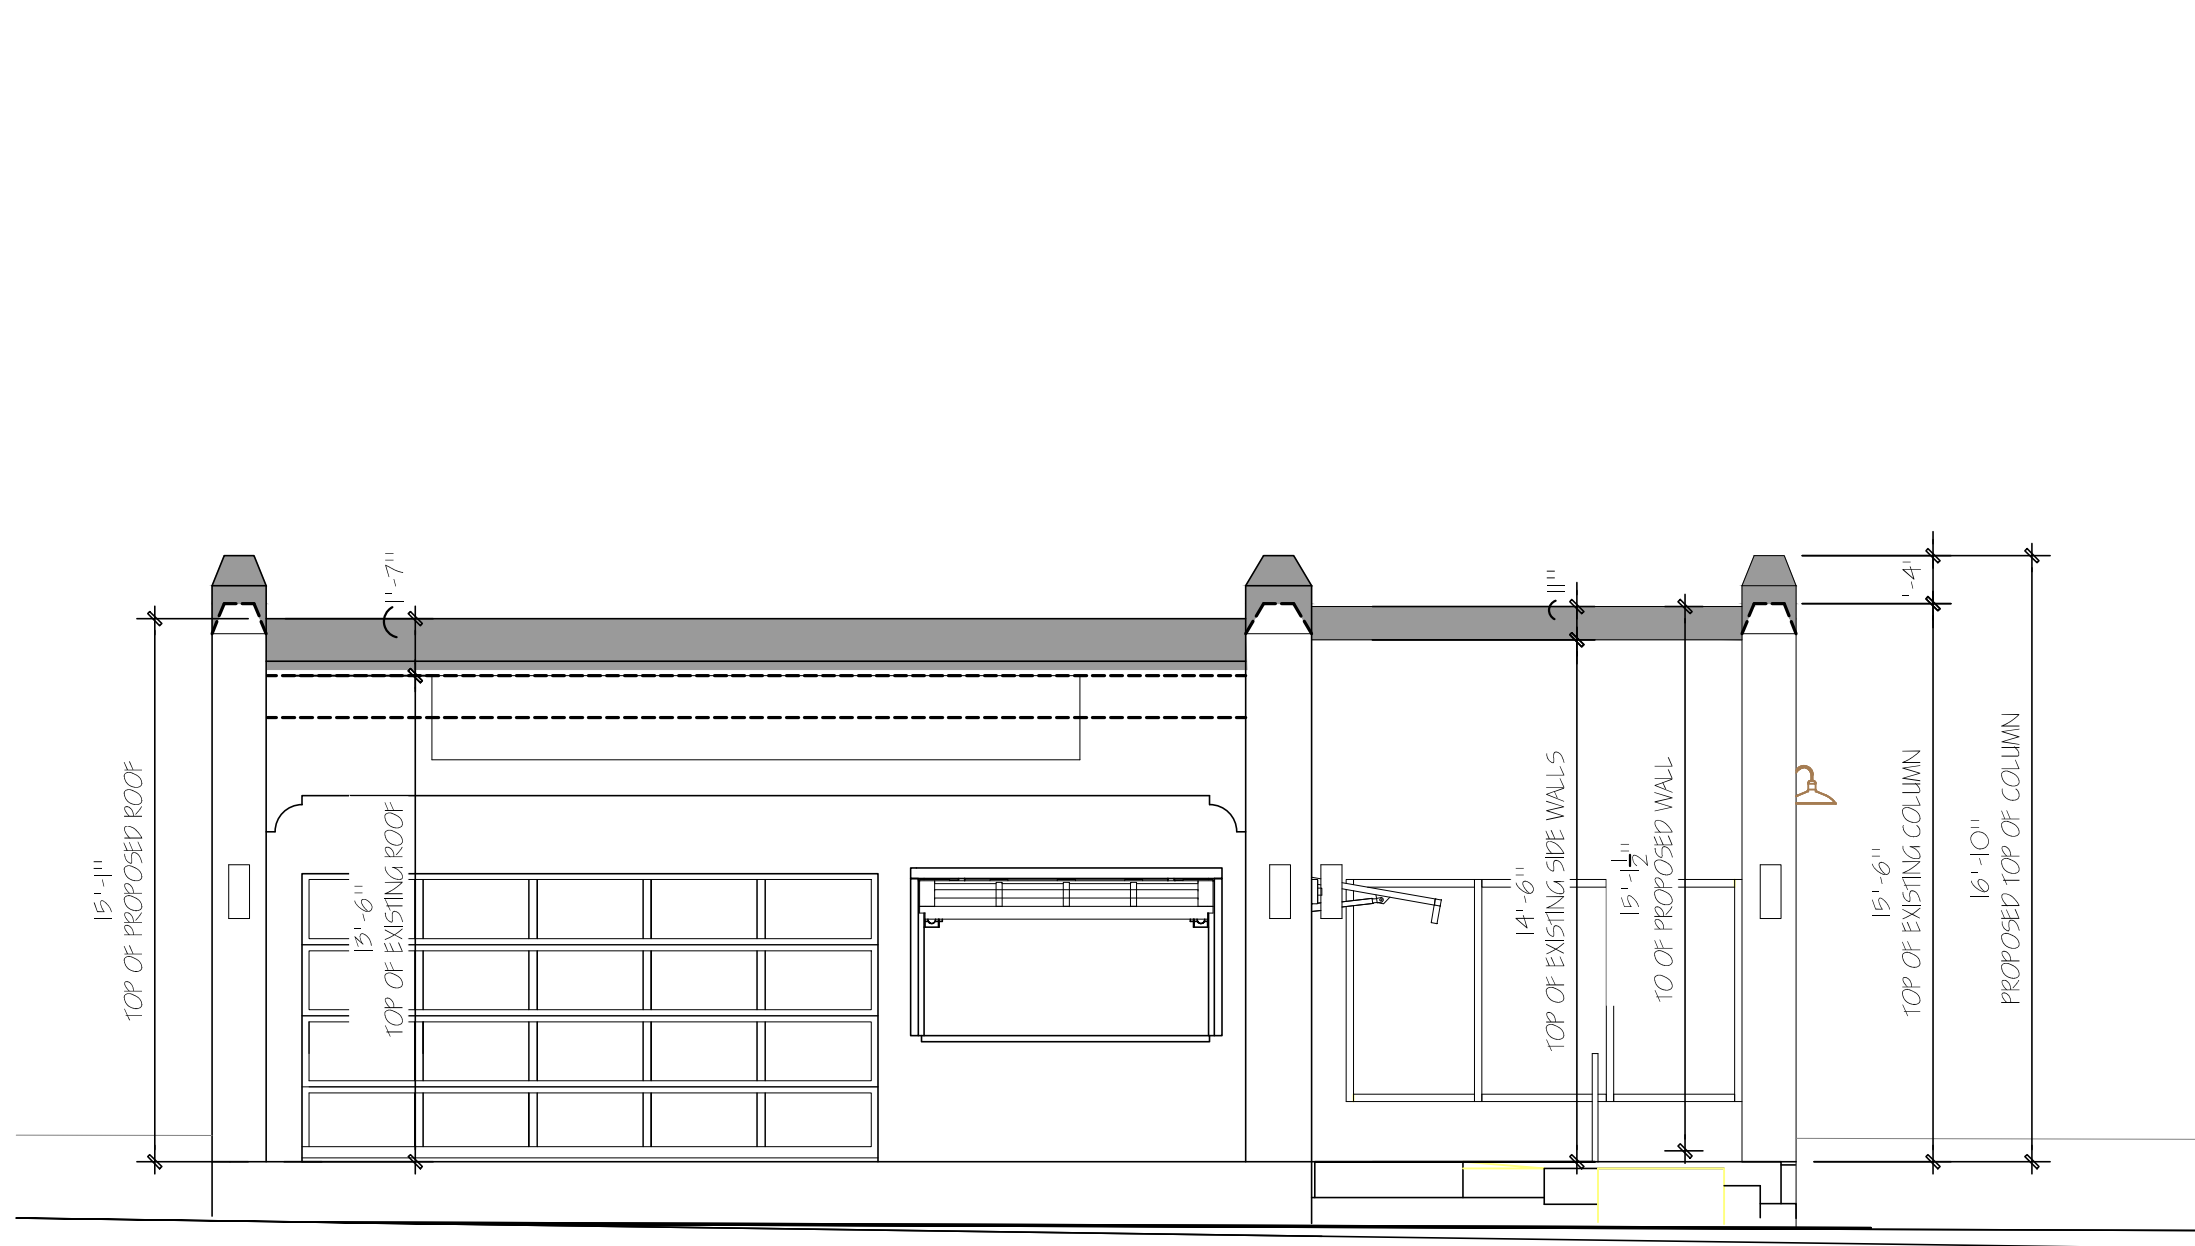
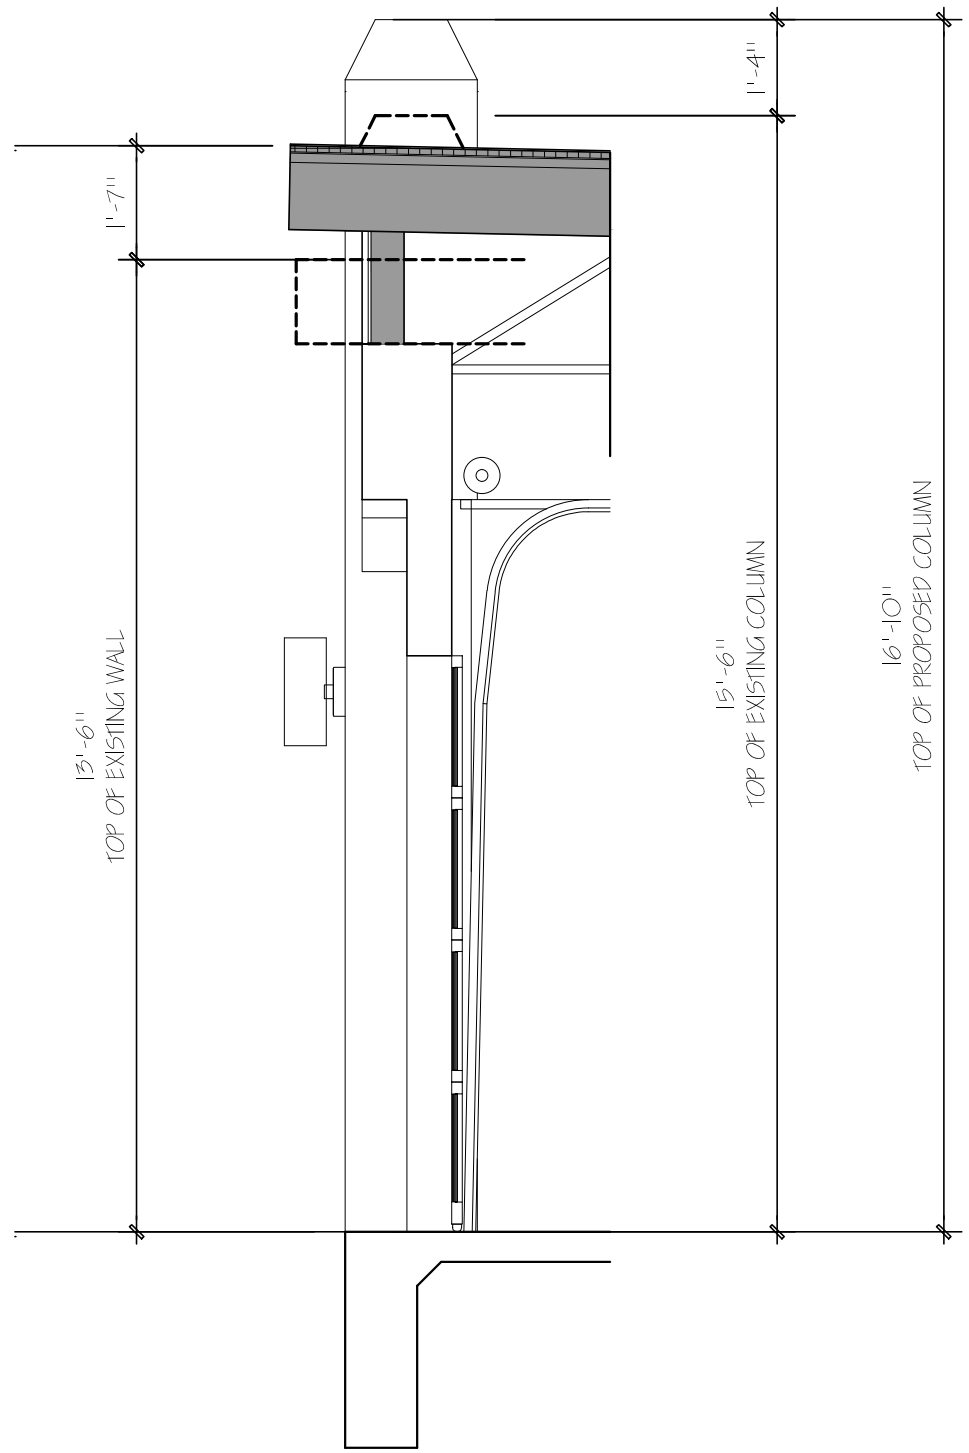
EXISTING  
ALUMINUM  
ADDITONS TO  
PARAPET

ADDED ALUMINUM COVER  
OVER PARAPET

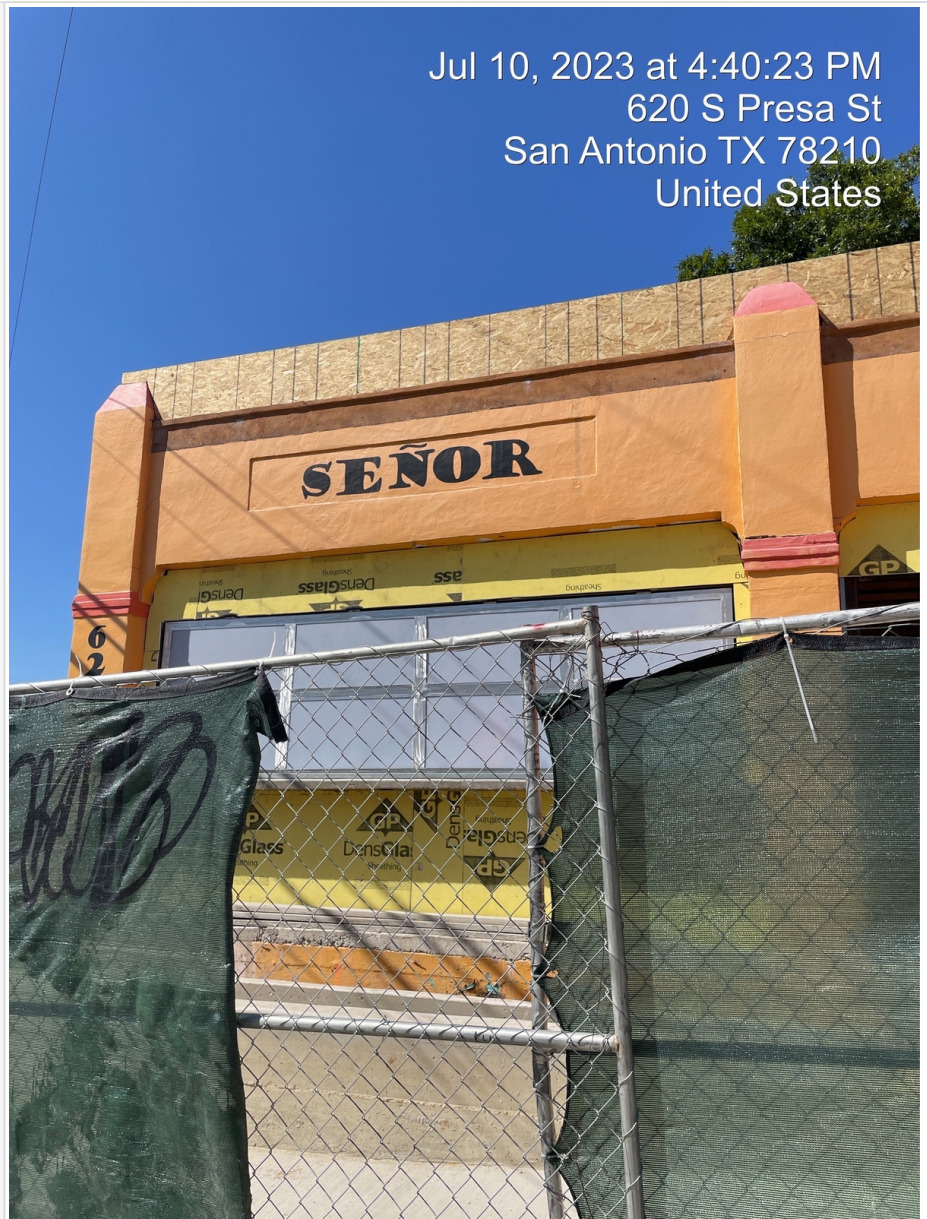
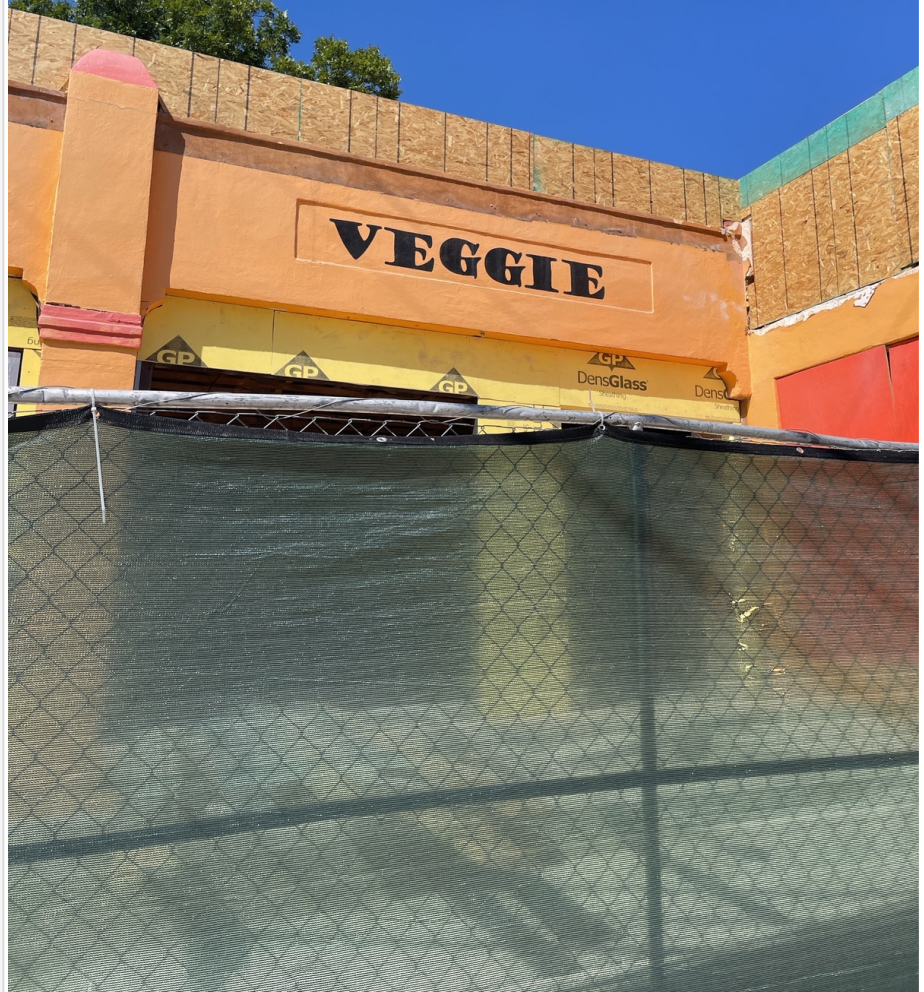
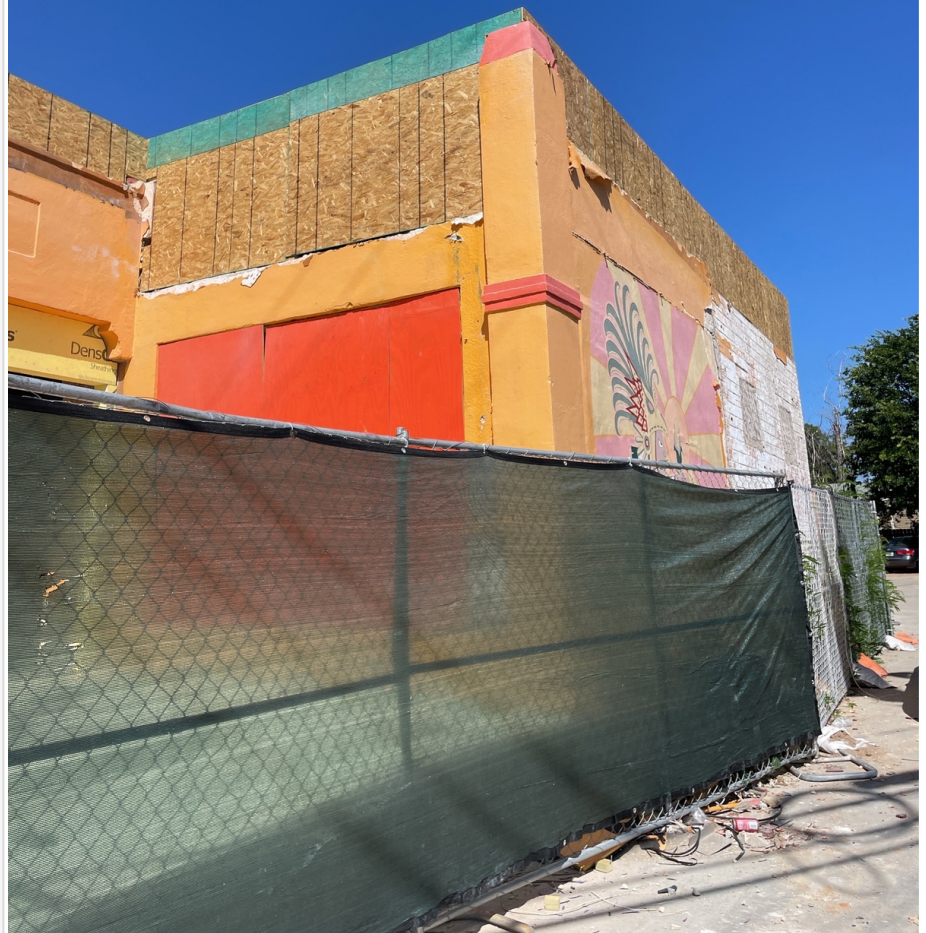
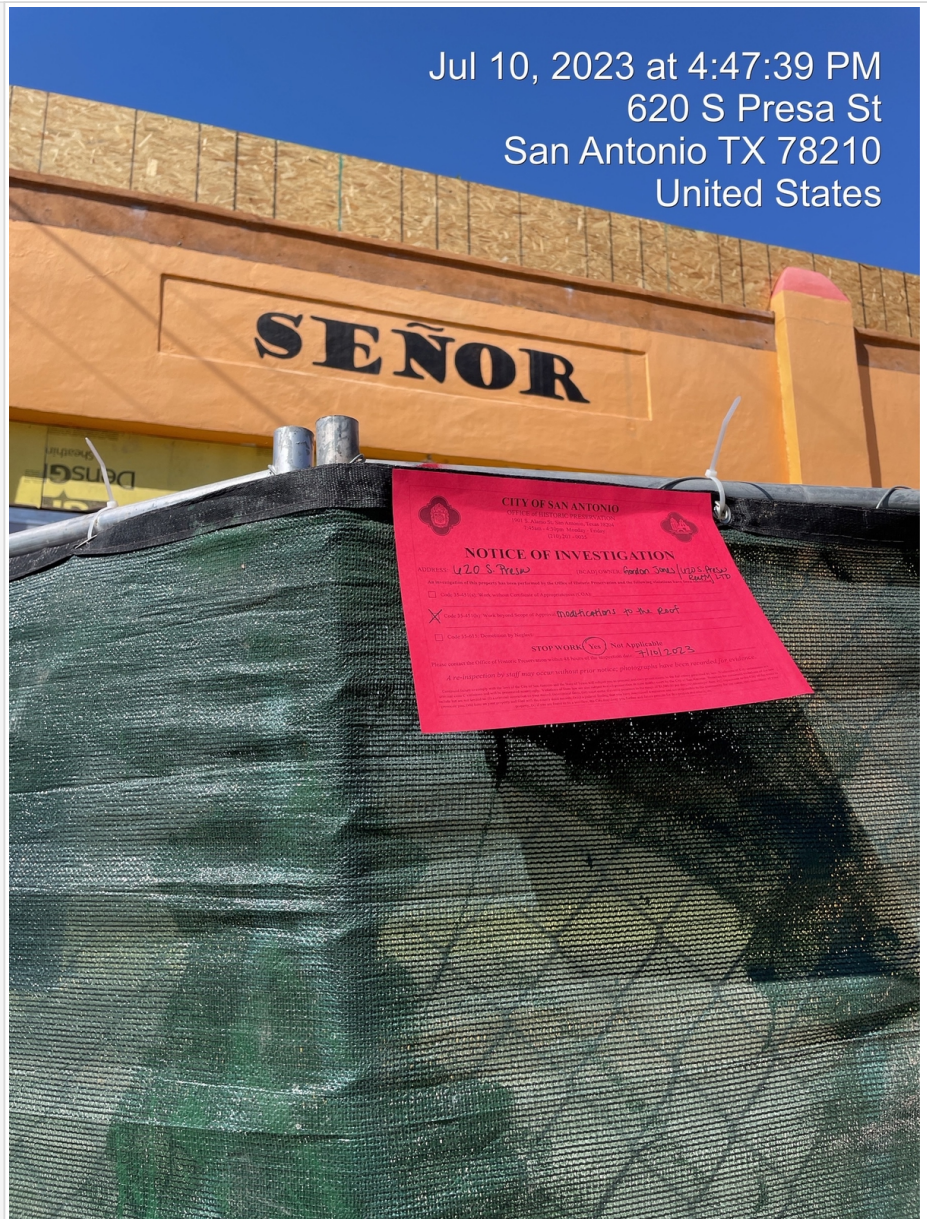
### Photographs

Date	07/10/2023
Time	04:40 PM (-5 GMT)
Context	citizen report, follow-up
Present Staff	Claudia Espinosa
Present Individuals	Contractor(s)
Types of Work Observed	Exterior Maintenance and Alterations
Amount of Work Completed	75%
Description of work	Modifications to the roof.
Description of interaction	Spoke with the contractors about the roof modifications, what they were approved for, and what the next steps are. The contractor called Pablo and explained the next steps. Pablo then requested to speak with staff. I spoke with Pablo and let him know about the modifications that were in the process of being made, that work needed to be stopped, what the next steps are. The SWO was then issued and placed on the construction fence since access to the building was denied.

Violation Type	Beyond scope of Certificate of Appropriateness (Code 35-451h)
OHP Action	Spoke with property owner, Spoke with contractor(s), Posted additional "Stop Work Notice"
Will post-work application fee apply?	To be determined
