HISTORIC AND DESIGN REVIEW COMMISSION

HDRC CASE NO: 2023-308
ADDRESS: 1115 WYOMING ST
LEGAL DESCRIPTION: NCB 611 BLK E 1-2 14 LOT 15
ZONING: RM-4, HL
CITY COUNCIL DIST.: 2
APPLICANT: Robert Alvarado/South Antonio Builders
OWNER: Kathryn Ruckman
TYPE OF WORK: Dormer addition
APPLICATION RECEIVED: July 28, 2023
60-DAY REVIEW: September 26, 2023
CASE MANAGER: Jessica Anderson

The applicant is requesting a Certificate of Appropriateness for approval to add a dormer to the roof on the primary elevation.

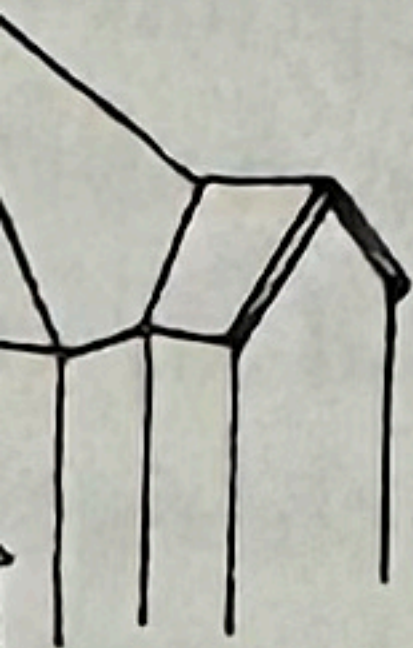
2. dominant front-facing gable may be replaced by large front-facing gabled dormer (more frequent after 1890 and in houses with towers)

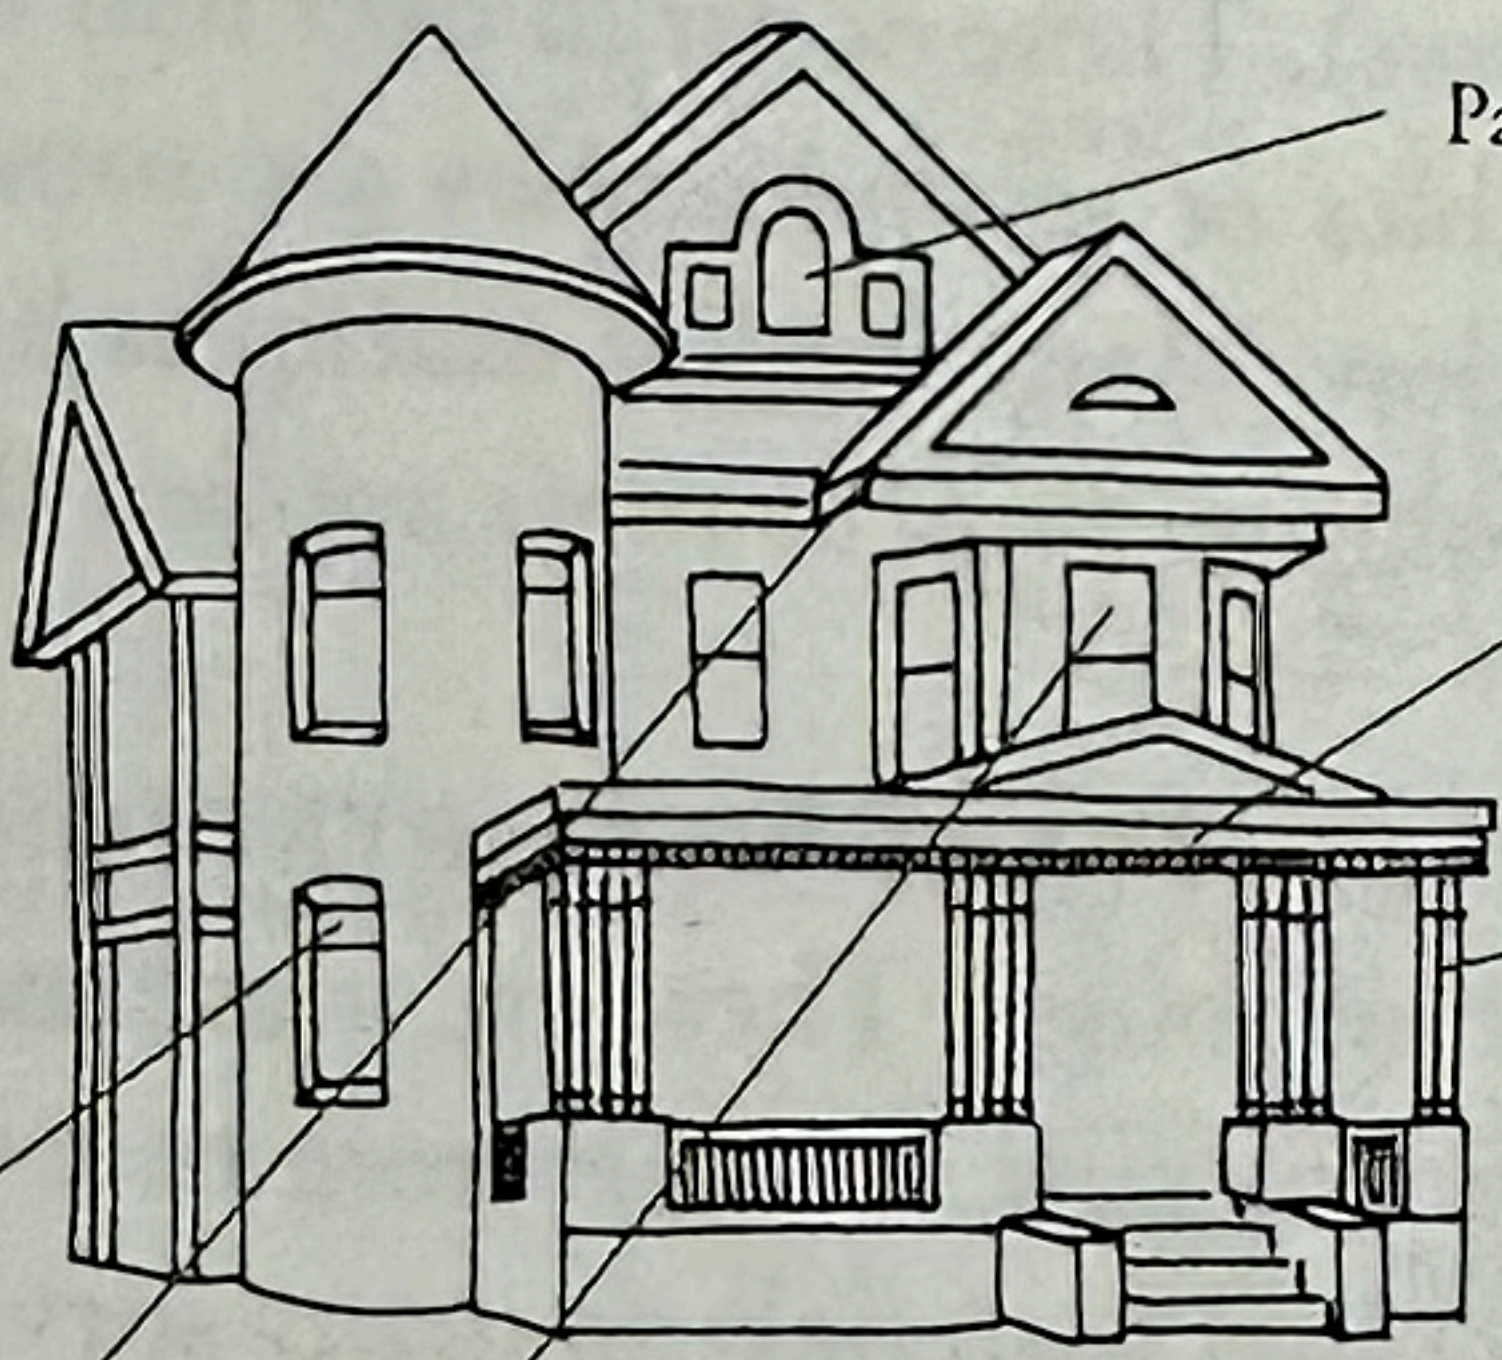
Palladian window

dentils

classic
columns may
be grouped
and/or
raised to
porch-rail
level
