HISTORIC AND DESIGN REVIEW COMMISSION

HDRC CASE NO: 2023-320
ADDRESS: 320 MADISON ST
LEGAL DESCRIPTION: NCB 744 BLK 3 LOT 16
ZONING: RM-4, H
CITY COUNCIL DIST.: 1
DISTRICT: King William Historic District
APPLICANT: Maggie Wilmoth
OWNER: Maggie Wilmoth
TYPE OF WORK: Roof replacement
APPLICATION RECEIVED: July 26, 2023
60-DAY REVIEW: September 25, 2023
CASE MANAGER: Rachel Rettaliata

The applicant is requesting a Certificate of Appropriateness for approval to replace the existing metal roof with a standing seam metal roof in charcoal grey.

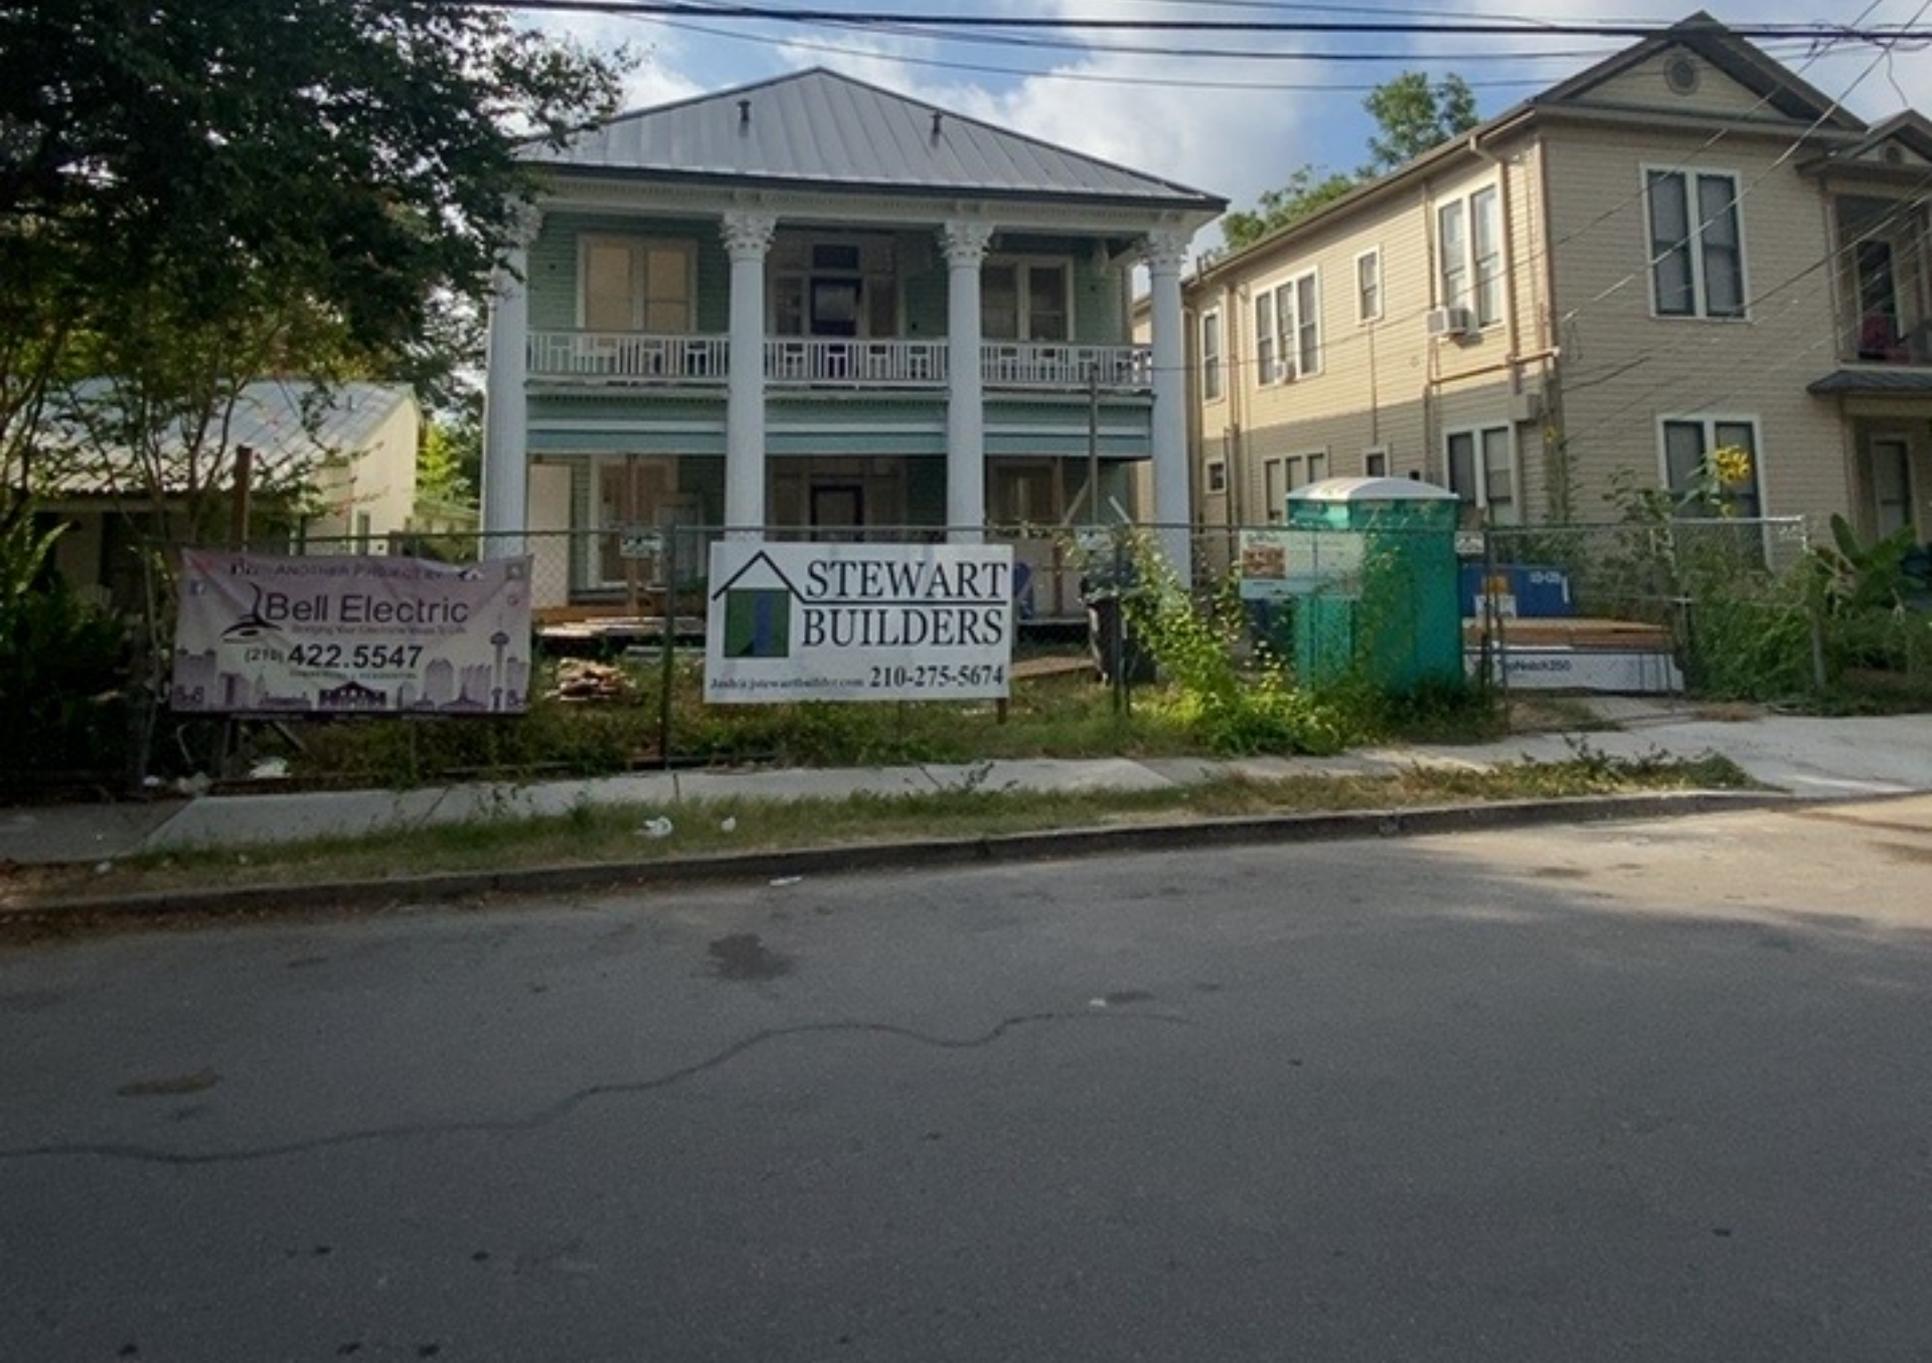
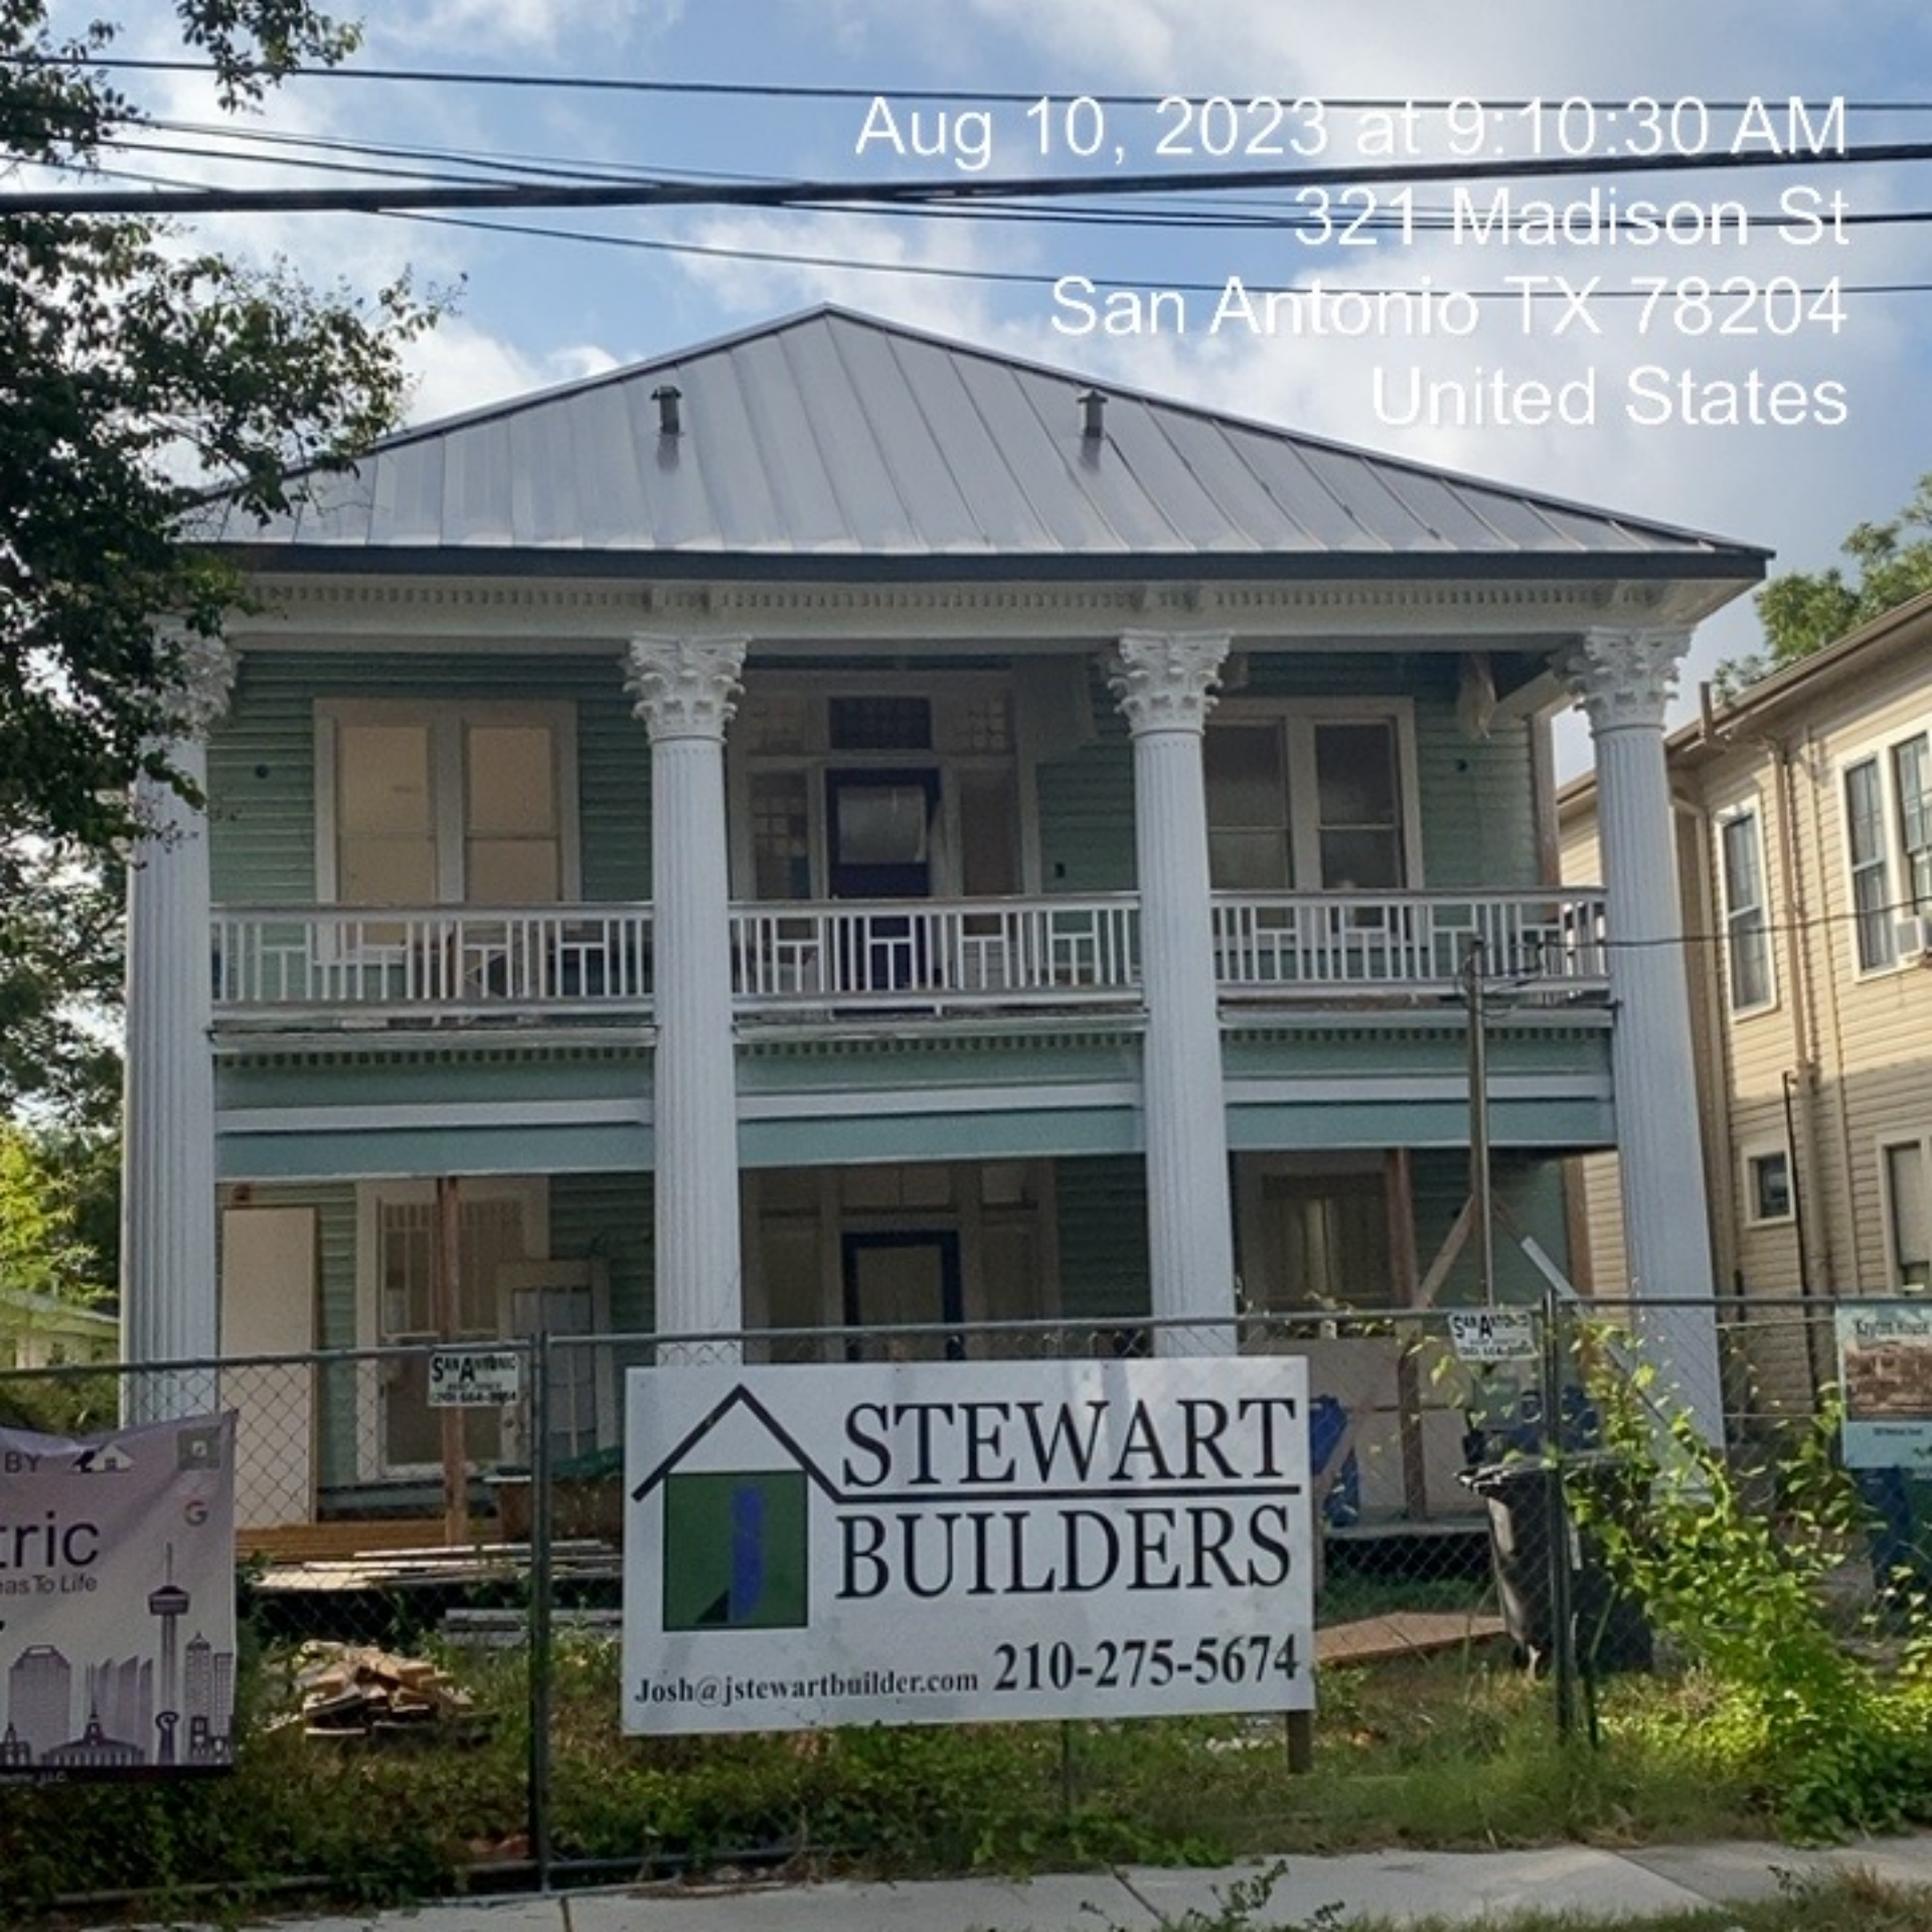
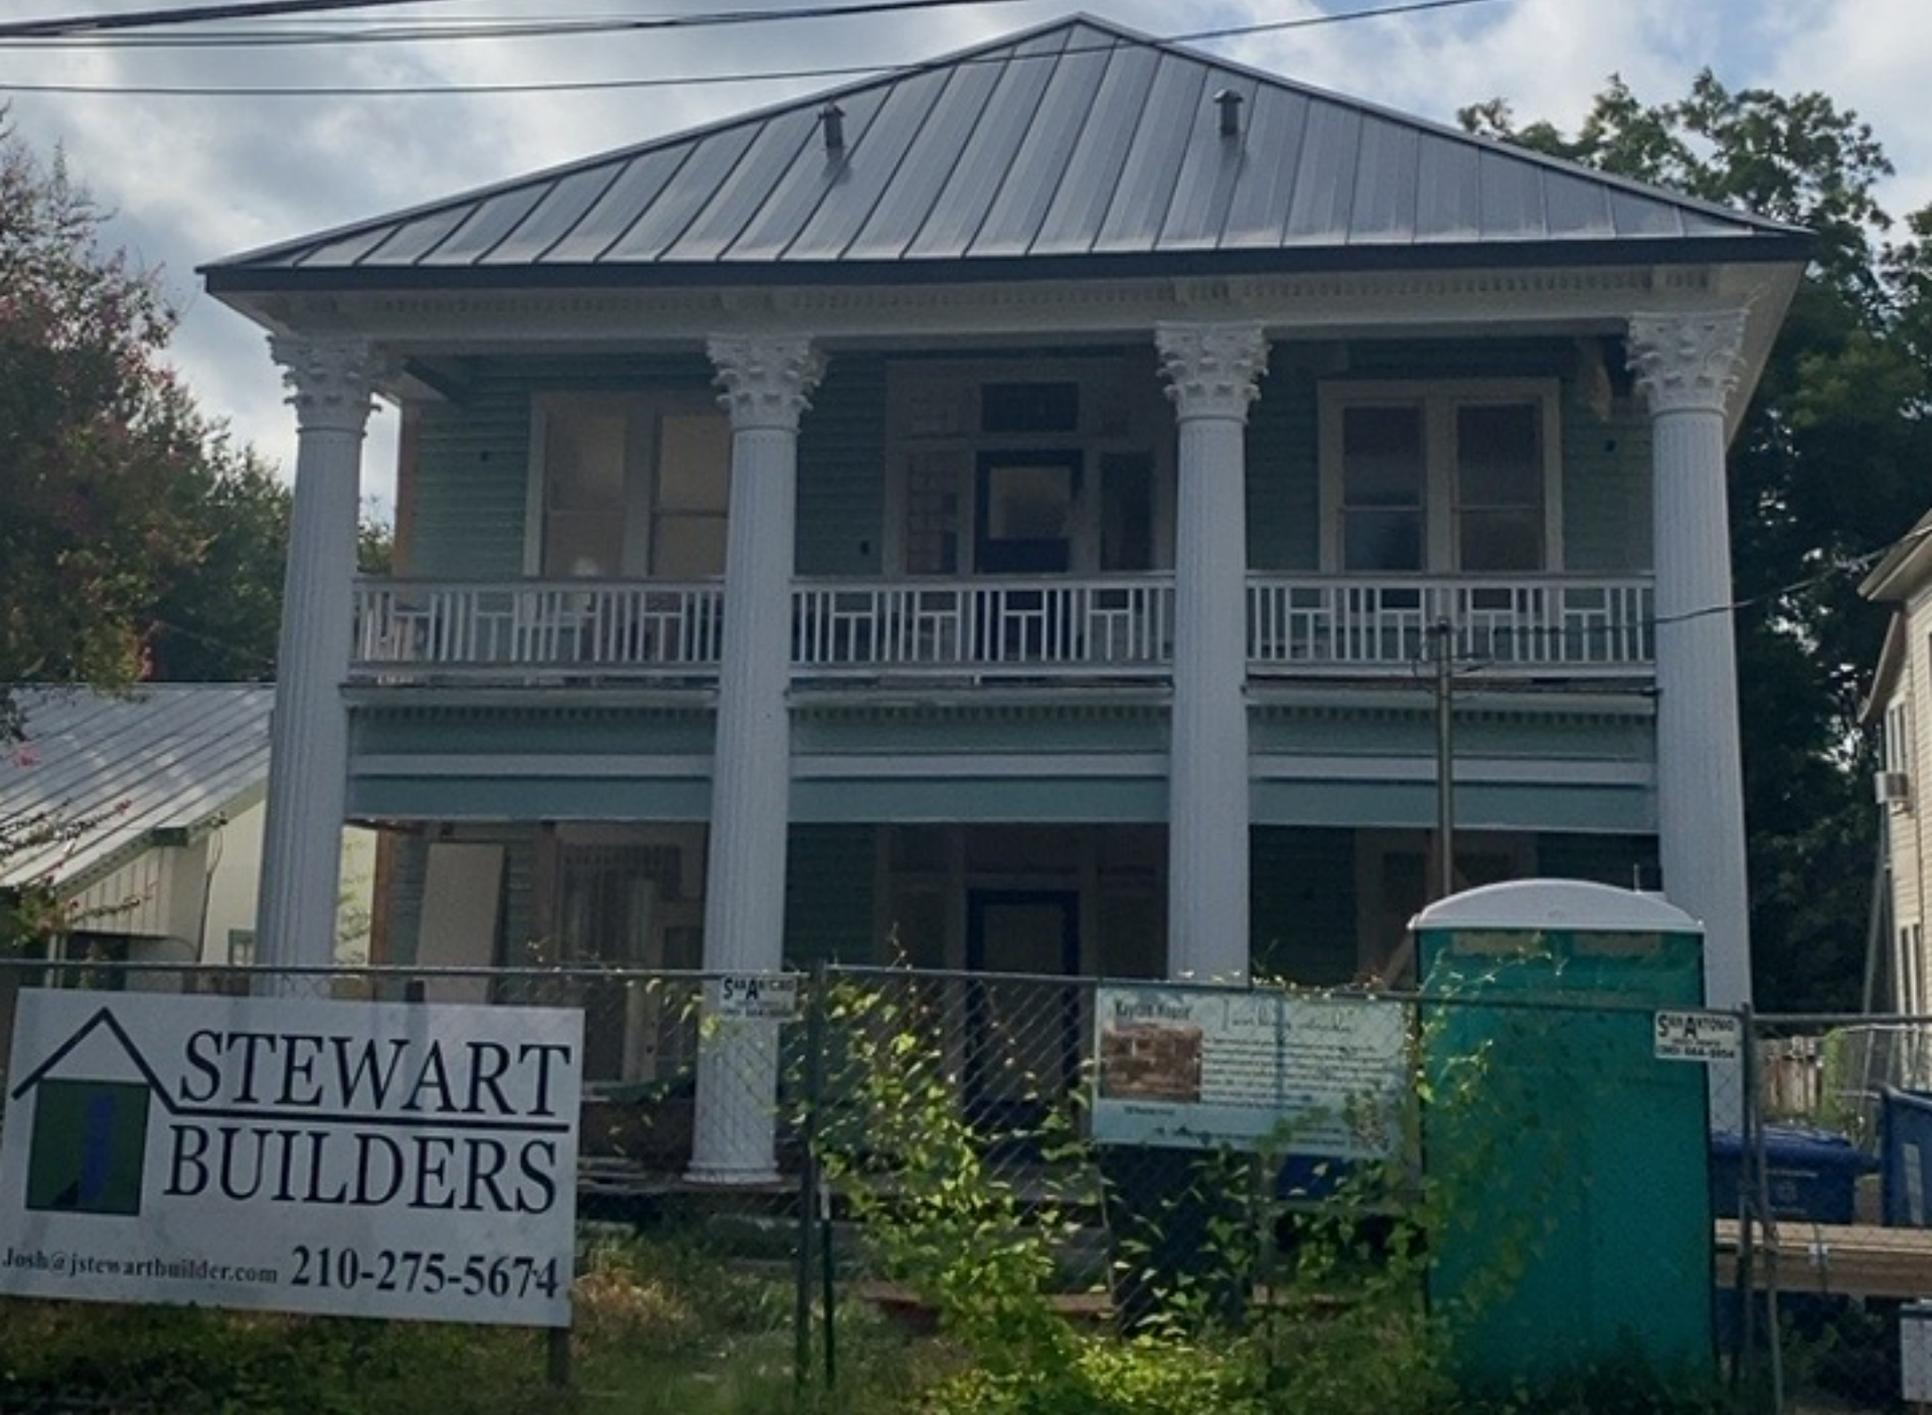
- c. ROOF REPLACEMENT – The applicant has proposed to replace the existing non-compliant standing seam metal roof featuring striations, a ridge cap, and front-facing vents with a compliant standing seam metal roof in a charcoal finish. The Historic Design Guidelines state that new metal roofs must match the existing historic metal roof color or use the standard galvalume; modern manufacturer’s colors are not permitted. Staff finds the request for a charcoal standing seam metal roof inconsistent with the Guidelines and the previous HDRC stipulation as approved in HDRC Case No. 2021-293. Per the Berridge Manufacturing Company color chart, the requested standing seam metal roof product is available in “Preweathered Galvalume,” as approved by the HDRC, and in a “Zinc Gray” finish that is similar in appearance to the “Preweathered Galvalume.” Staff finds that the proposed “Charcoal Grey” option is not consistent with the Guidelines or the previous HDRC approval. Staff finds a galvalume standing seam metal roof or a pre-weathered galvalume finish to be most appropriate and that the new standing seam metal roof should comply with the standard specifications.

- i. That the applicant installs a standing seam metal roof featuring panels that are 18 to 21 inches wide, seams that are 1 to 2 inches high, and a crimped ridge seam. Panels should be smooth without striation or corrugation. Ridges are to feature a double-munch or crimped ridge configuration; no vented ridge caps or end caps are allowed. All chimney, flue, and related existing roof details must be preserved. An on-site inspection must be scheduled with OHP staff prior to the start of work to verify that the roofing material matches the approved specifications.

- ii. That the applicant installs a standing seam metal roof in a standard galvalume finish or in a pre-weathered galvalume finish to match the previous HDRC approval per HDRC Case No. 2021-293 based on finding b.

- iii. That the applicant does not install front-facing roof vents where they did not exist historically based on finding b.

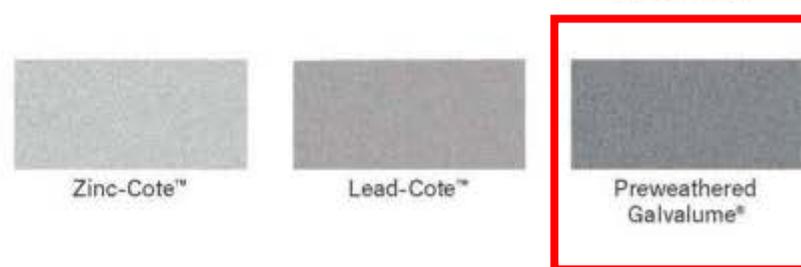
Acrylic-Coated Galvalume® is a coated sheet product that combines the corrosion resistance of Galvalume® steel sheet with a clear, organic resin applied to the top side and bottom side of Galvalume® substrate.

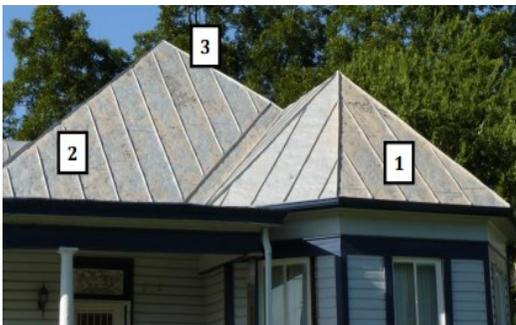
Historic standing-seam metal roof

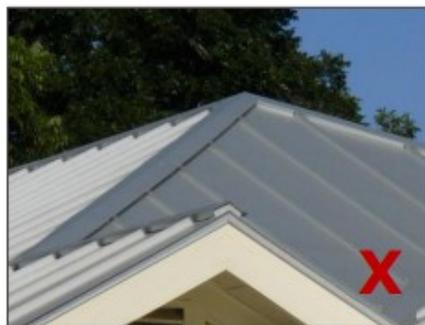
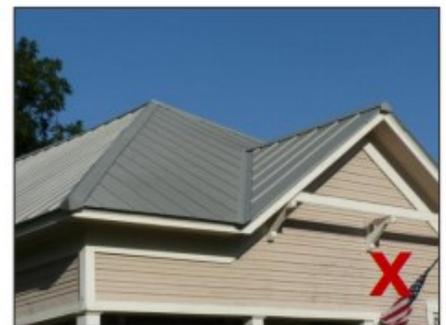
Do not use ridge caps with vents (left) or end caps (right).
