HISTORIC AND DESIGN REVIEW COMMISSION October 4, 2023

HDRC CASE NO: 2023-378

ADDRESS: 2228 W HUISACHE AVE

TYPE OF WORK: Siding replacement, front porch modifications, and front door modifications

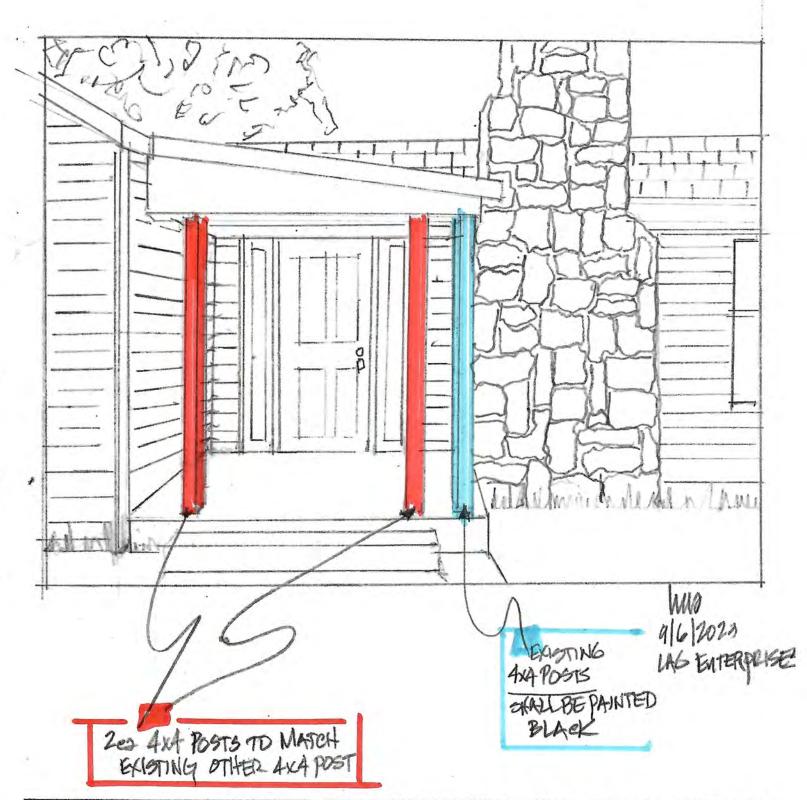
2228 W. HUISACHE AVE. NÖRTH VIEW - MAIN ENTRY

4X4 POSTS. PLACEMENT

- 1. Shall finish installing siding and use similar materials. Refer to picture "Siding Materials Sample". Refer to existing siding on East 1, 2, 3, West 1, 2, 3, and South View.
- 2. Refer to North 1 remove existing concrete veneer & install new siding to match existing siding On east, west and south walls. Refer to picture "Siding Materials Sample".
- 3. Finish fixing the existing wood deck. Refer to picture "Existing Wood Deck Repairs" and South view.
- 4. Pressure wash the entire house.
- 5. Existing posts shall remain and install 2 new 4x4 posts like existing post. Shall be painted black. Refer to picture North 4 and refer to sketch "4x4 Posts Location".
- 6. Finish painting, all trim, brick chimney, and posts shall be black.
- 7. The front door main entry shall be painted red.
