HISTORIC AND DESIGN REVIEW COMMISSION

HDRC CASE NO: 2021-511
ADDRESS: 134 E MULBERRY AVE
LEGAL DESCRIPTION: NCB 1702 BLK 6 LOT 9, W25 FT OF 10
ZONING: R-4
CITY COUNCIL DIST.: 1
DISTRICT: Monte Vista Historic District
APPLICANT: Robert Lee/LindLee, LLC
OWNER: Charlie & Linda Gonzalez/GONZALEZ LINDA LOPEZ & CHARLES
TYPE OF WORK: Exterior alterations
APPLICATION RECEIVED: September 24, 2021
60-DAY REVIEW: Not applicable due to City Council Emergency Orders
CASE MANAGER: Katie Totman
REQUEST:

The applicant is requesting a Certificate of Appropriateness for approval to remove one (1) existing rear window and One (1) door and install one set of French doors.

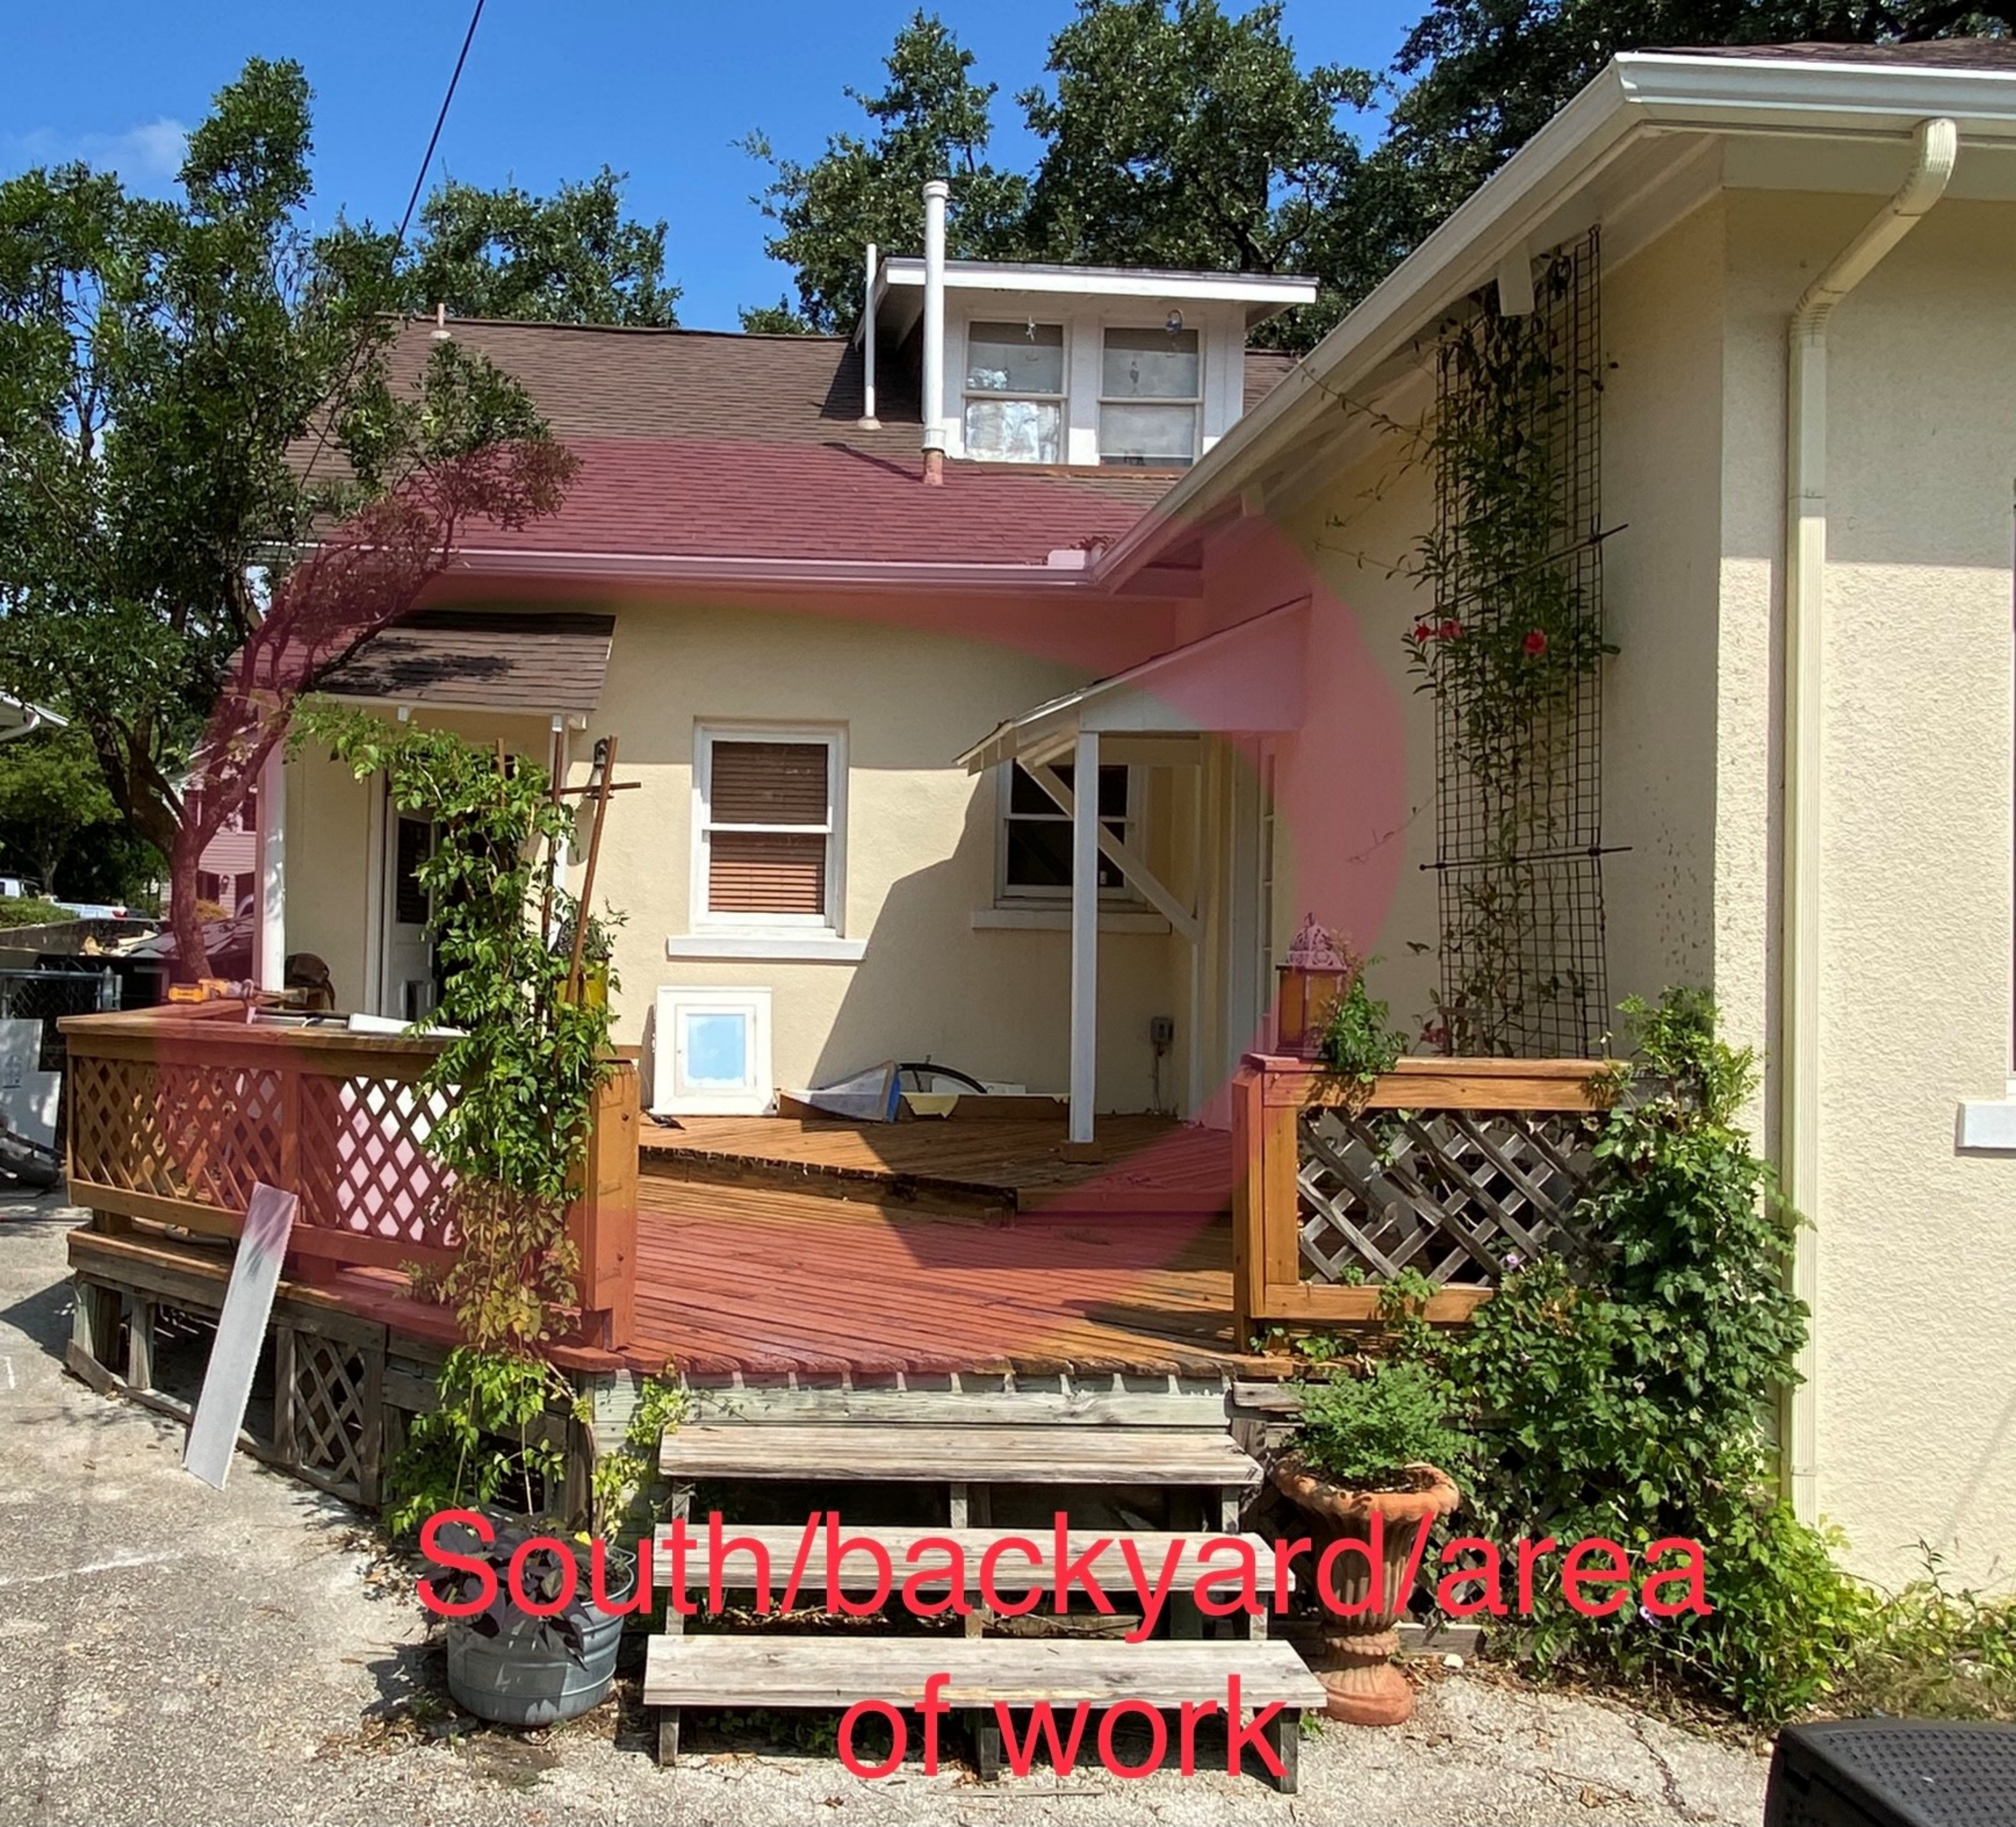
South/backyard/area
of work

- b. EXTERIOR ALTERATIONS – The applicant is requesting to replace an existing one over one wood window and pedestrian door on the rear of elevation of the primary structure with new wooden French doors. The existing window has a smaller proportion relative to the majority of the historic window openings on the primary and secondary facades of the home. The modifications will not be visible from the public right-of-way. According to the Historic Design Guidelines, new elements should not significantly alter or destroy historic building character. Opening modifications should be compatible and should be appropriate for the building style. The proposed doors echo the rhythm and proportions on the existing structure and will utilize a portion of the existing window frame opening. Staff finds the request acceptable with the stipulations listed in the recommendation.

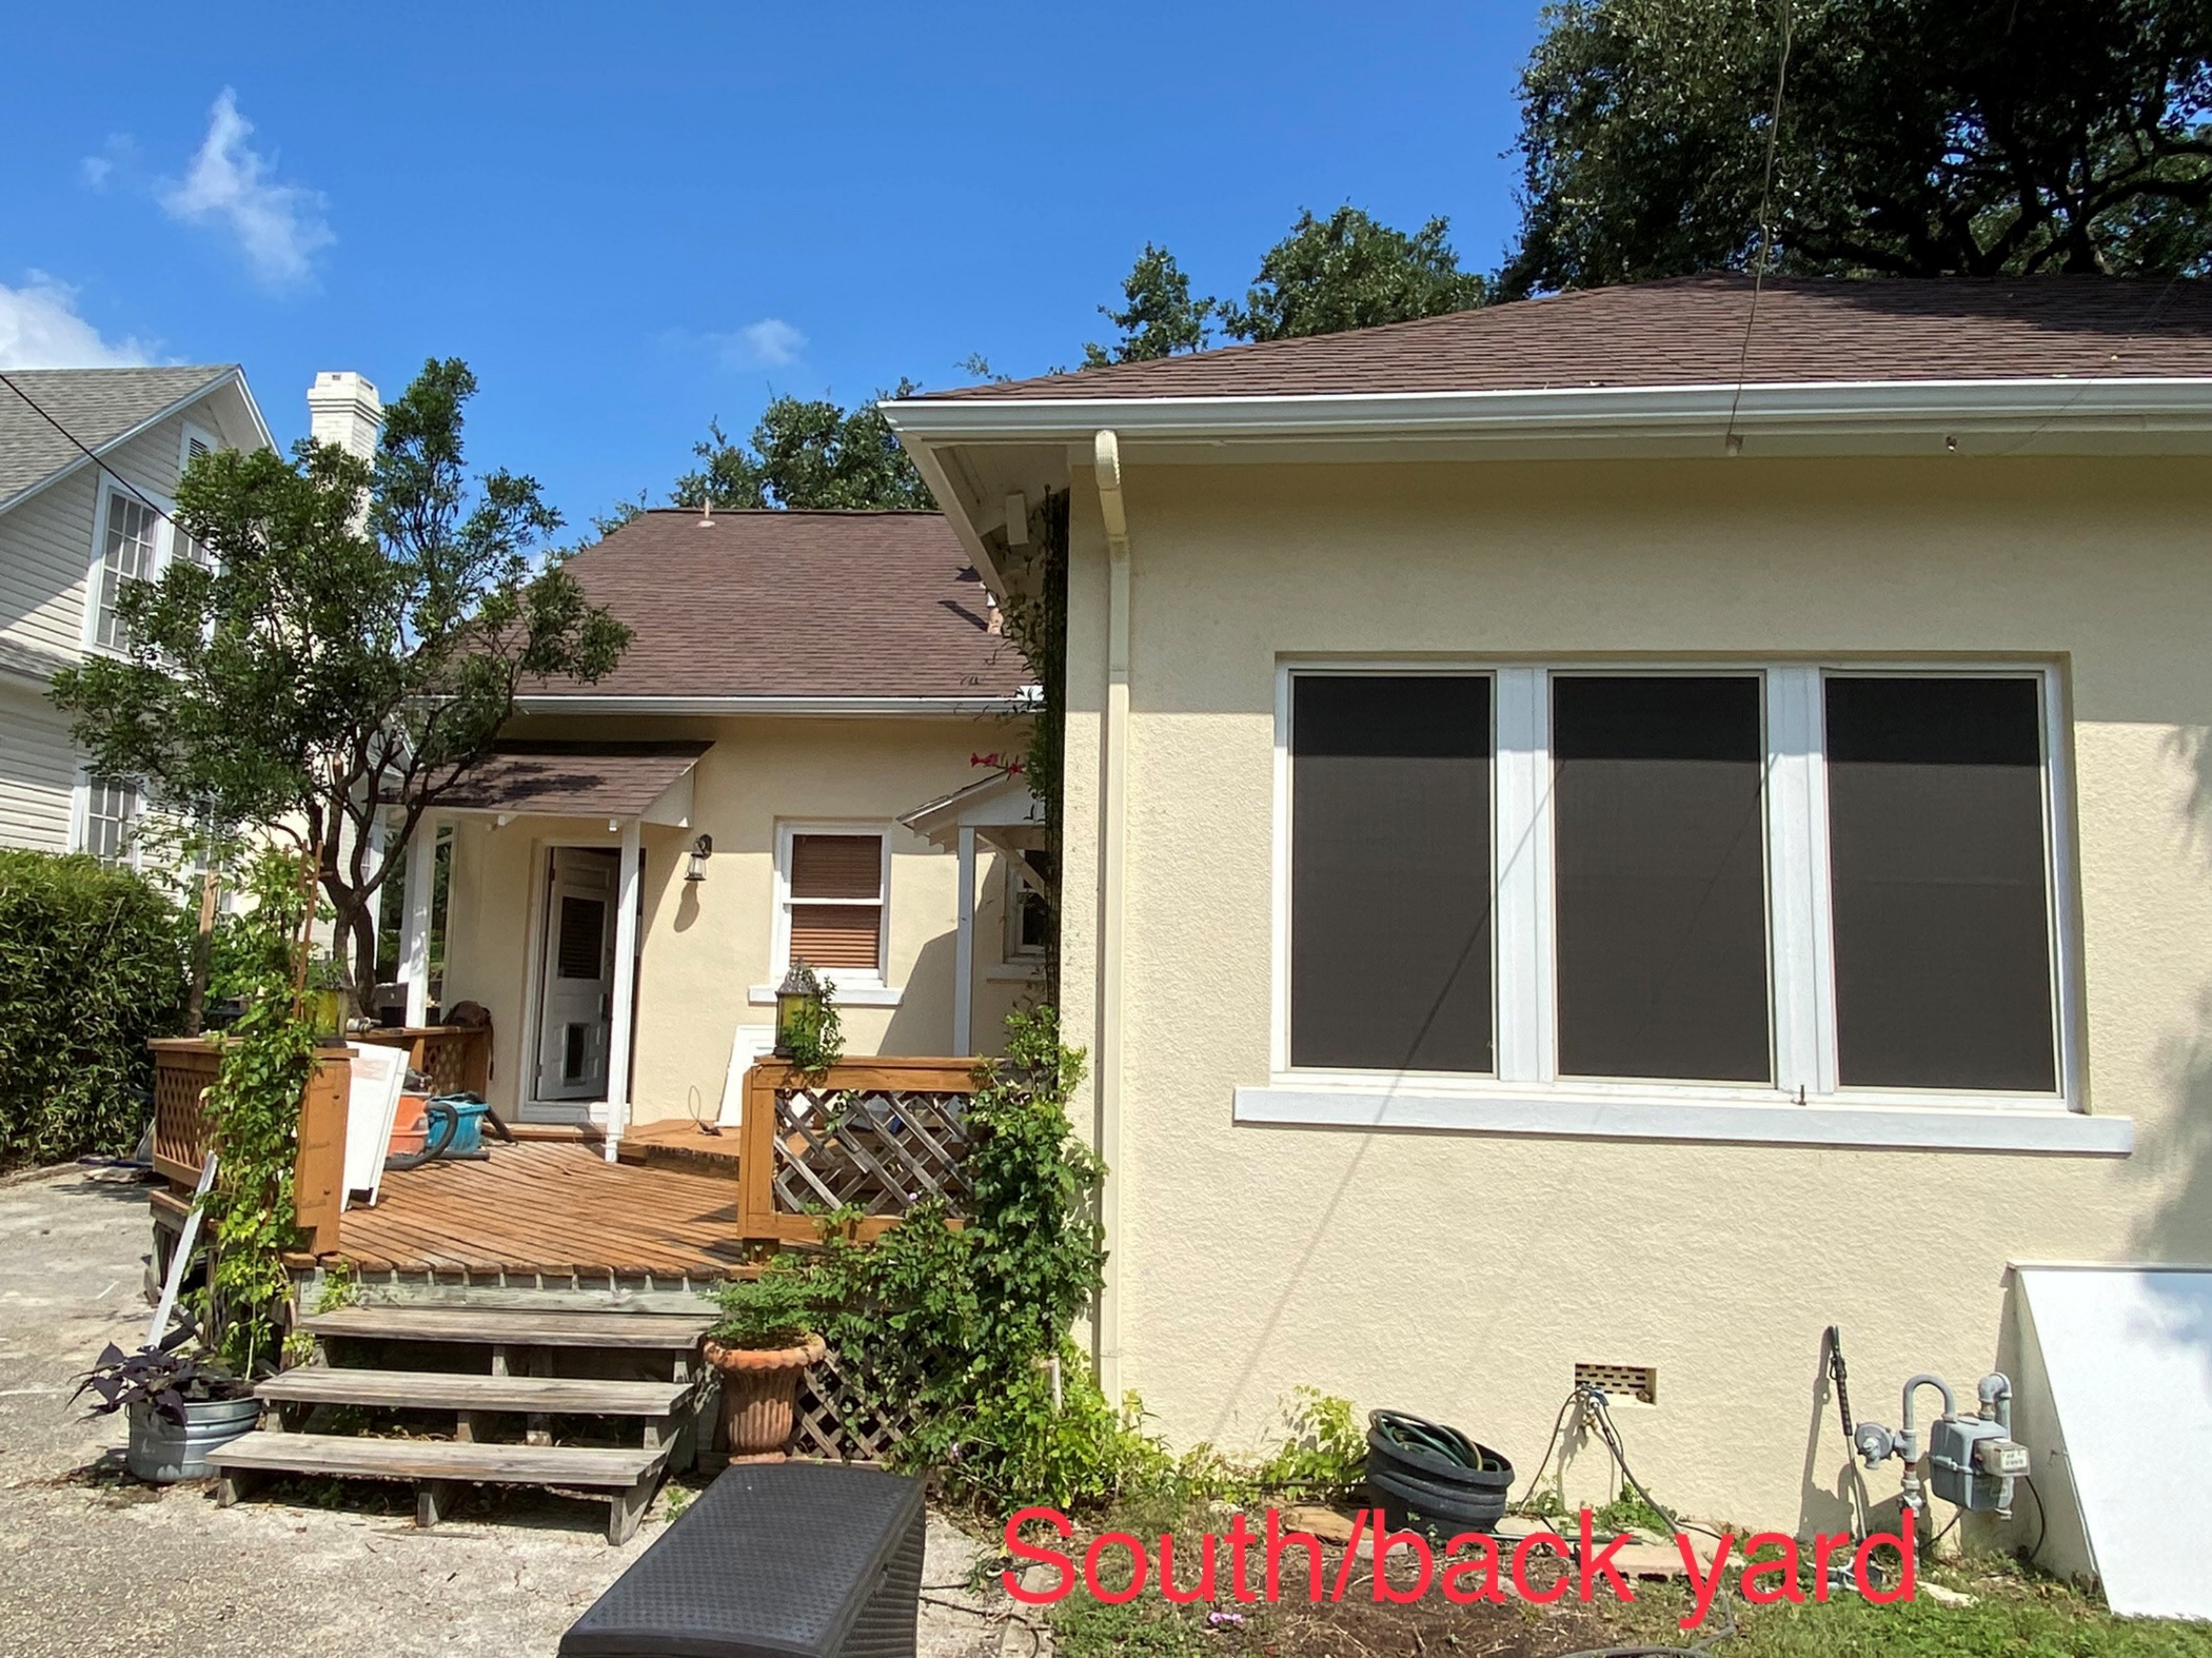
South/back yard

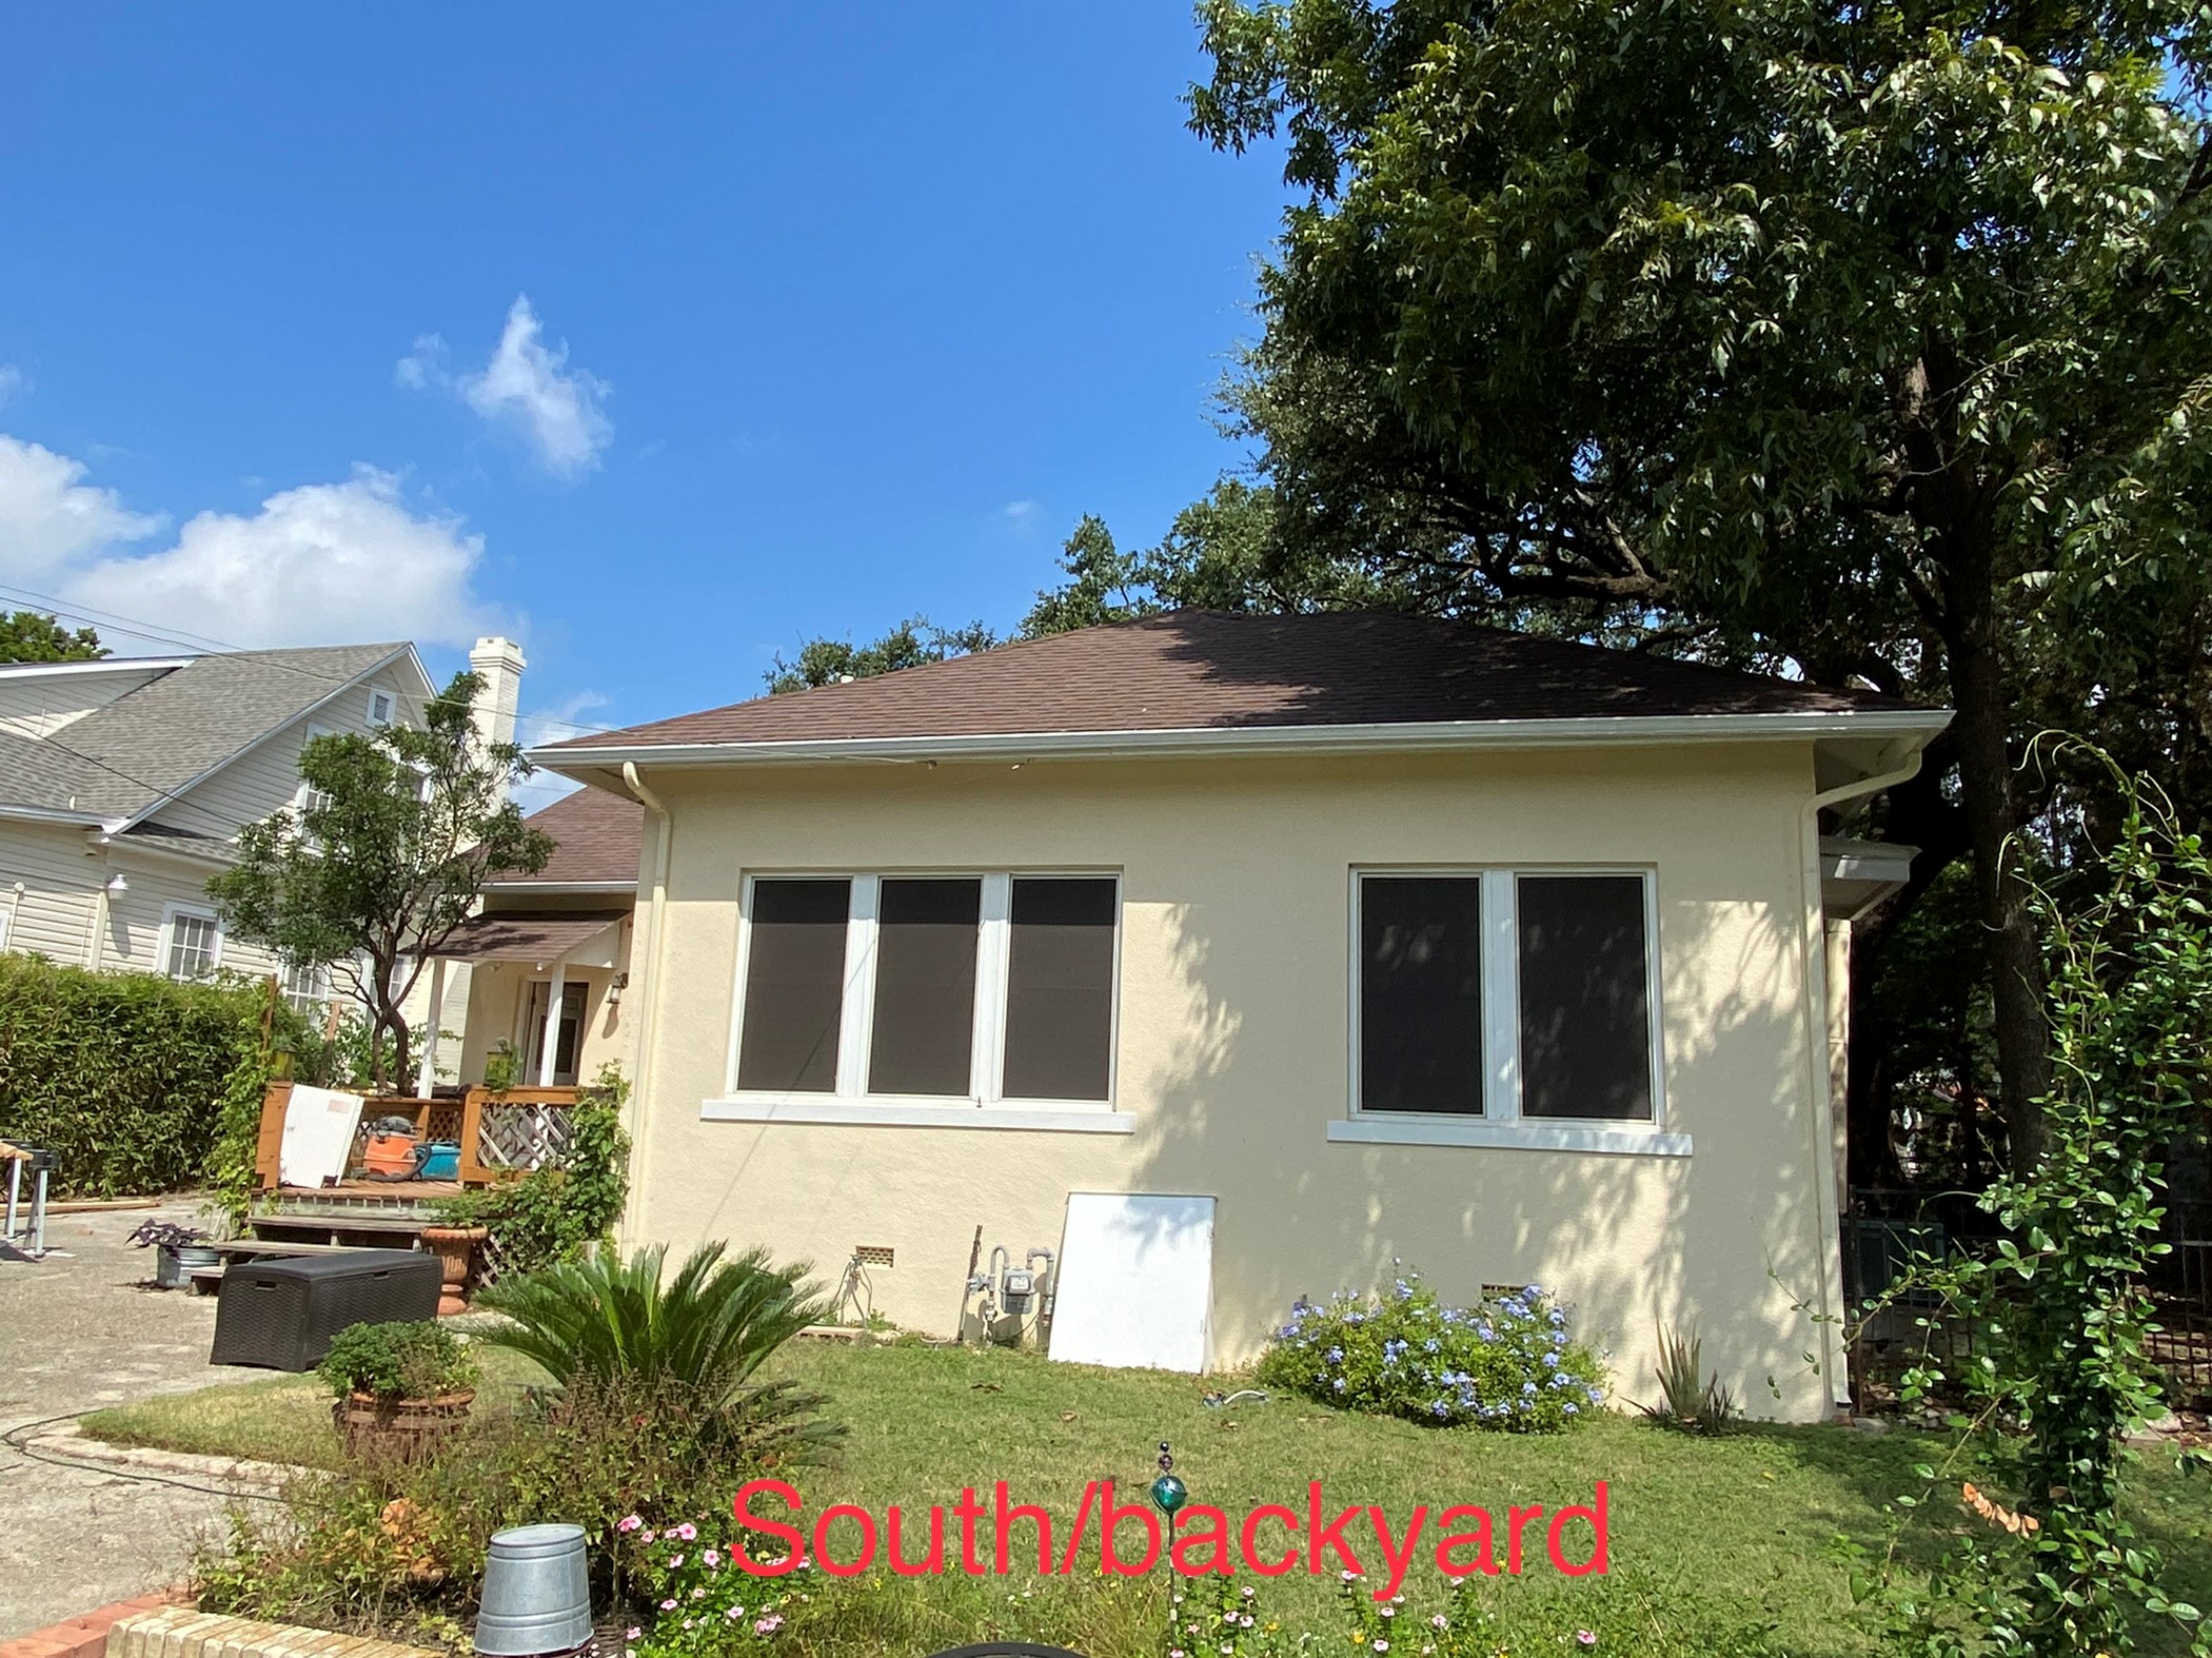
South/backyard
