HISTORIC AND DESIGN REVIEW COMMISSION

HDRC CASE NO: 2021-541
ADDRESS: 210 LAVACA ST
LEGAL DESCRIPTION: NCB 713 BLK 10 LOT 11
ZONING: RM-4
CITY COUNCIL DIST.: 1
DISTRICT: Lavaca Historic District
APPLICANT: Vicki Yuan/Lake Flato Architects
OWNER: HILL STACEY L
TYPE OF WORK: Carport trellis installation and fenestration modifications
APPLICATION RECEIVED: October 15, 2021
60-DAY REVIEW: Not applicable due to City Council Emergency Orders
CASE MANAGER: Katie Totman

210 Lavaca Street
Supporting Documentation for Certificate of Appropriateness Request
10.15.2021
Lake|Flato Architects, contact Vicki Yuan at vyuan@lakeflato.com

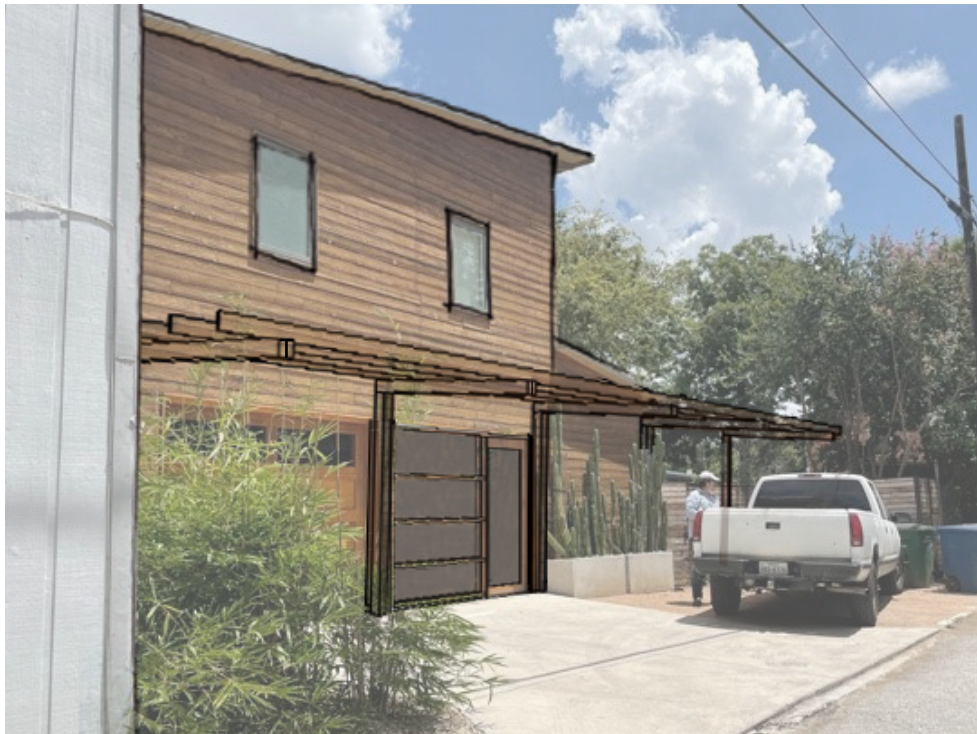
Proposed Carport Trellis + New Fenestration

Carport Trellis: Painted Steel Columns/Beams and Cedar Purlins

Fenestration: Custom Wood/Glass Door and Window: Stained Mahogany, Clear Insulating Glass

- b. TRELLIS INSTALLATION – The applicant is proposing to add a steel and wood trellis that will extend approximately 6-feet away from the edge of the building and cover the driveway. It will also feature a 3-foot setback from the property line. The existing conditions in the immediate vicinity of this area of Refugio Street is comprised of properties where rear yards back up to the street, with a few primary structures fronting Refugio Street. Staff finds that the trellis and its location is appropriate.

- c. EXTERIOR ALTERATIONS – The applicant is proposing to replace one (1) existing garage door with a wood and glass pedestrian entry door and one (1) window. According to the Guidelines for Exterior Maintenance and Alterations. 6. B. ii., new entrances should be compatible in size, scale, shape, proportion, material, and massing with historic entrances. The proposed pedestrian door appears to be generally consistent to the other doors on the structure. Staff finds this modification to be consistent with the Guidelines.
