CITY OF SAN ANTONIO  
DEVELOPMENT SERVICES DEPARTMENT

NCB 399 Property Address: 615 E. EVERGREEN ST.

Per Section 35-451 of the Unified Development Code (UDC), the Zoning Board of Adjustment is empowered to consider an appeal from an applicant for a Certificate of Appropriateness.

### WINDOWS: REPAIR, REPLACEMENT, AND NEW CONSTRUCTION

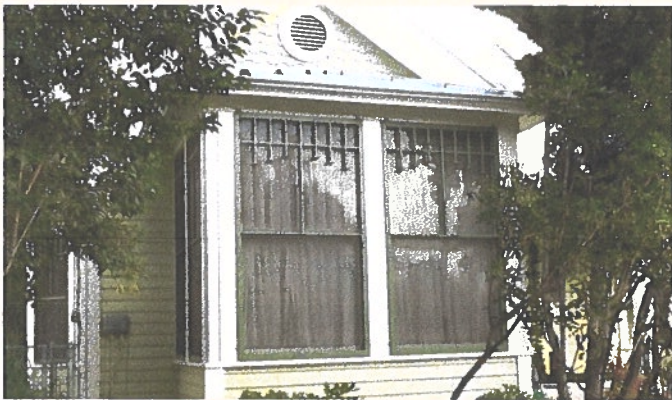
*These historic window screens are unique in design and contribute significantly to the character of the building.*

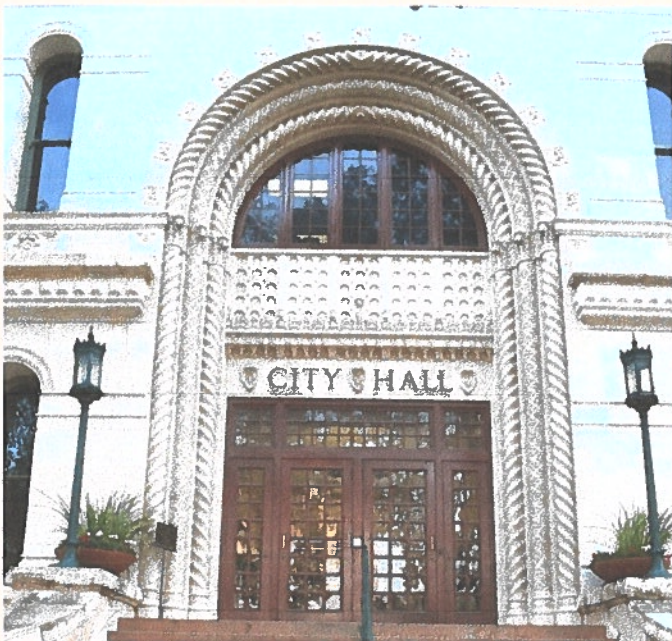
*The fanlight, detailing, and glazed area of this entrance help define the character of this public building.*

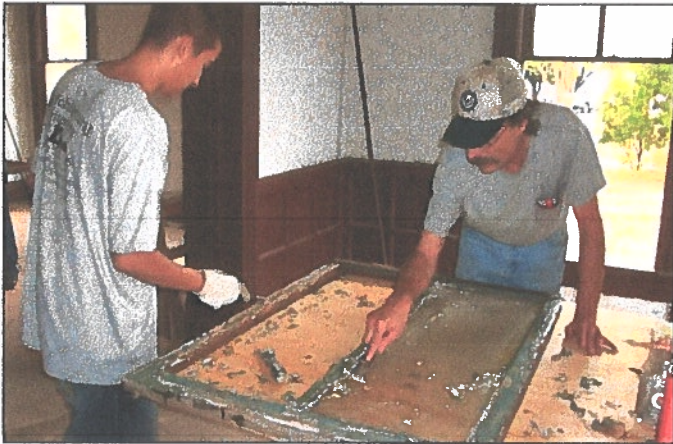
***Repair historic windows when possible rather than replacing them. (Photo: San Antonio Office of Historic Preservation)***

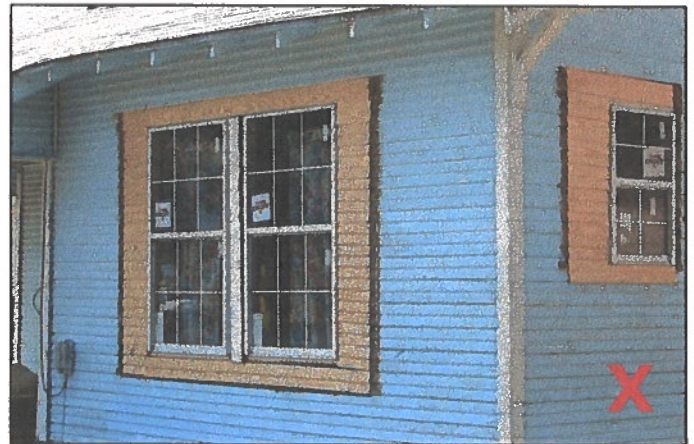
***Do not reduce historic window openings to fit stock window sizes or use faux divided lights when replacement is necessary. (Photo: Ron Bauml, San Antonio Conservation Society)***

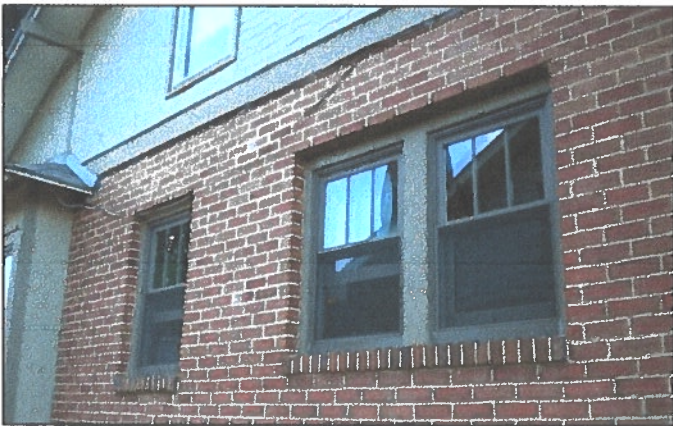
***Use the exterior muntin pattern, profile, and size appropriate for the historic building when replacement windows are necessary.***

- v. **Muntins**—Use the exterior muntin pattern, profile, and size appropriate for the historic building when replacement windows are necessary. Do not use internal muntins sandwiched between layers of glass.

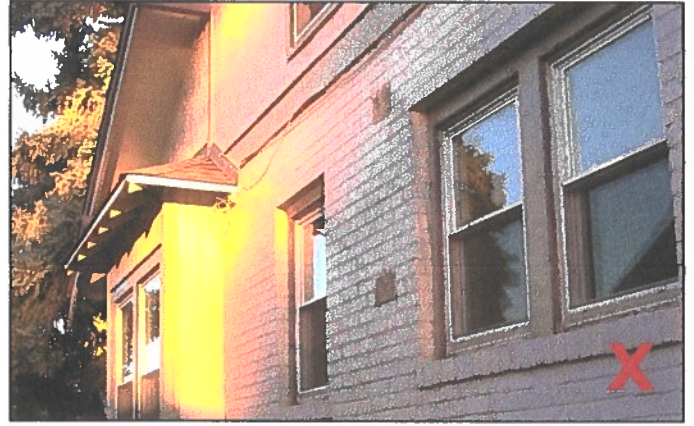
***Do not use replacement windows, such as these vinyl inserts, that do not match the historic character of the building's original windows.***

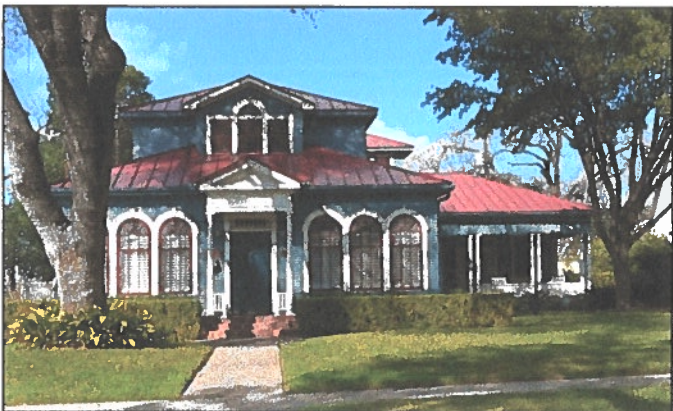
***Maintain the character and symmetry of the façade by maintaining the historic window and door openings.***

- i. **Openings**—Preserve existing window and door openings. Avoid enlarging or diminishing to fit stock sizes or air conditioning units. Avoid filling in historic door or window openings. Avoid creating new primary entrances or window openings on the primary façade or where visible from the public right-of-way.

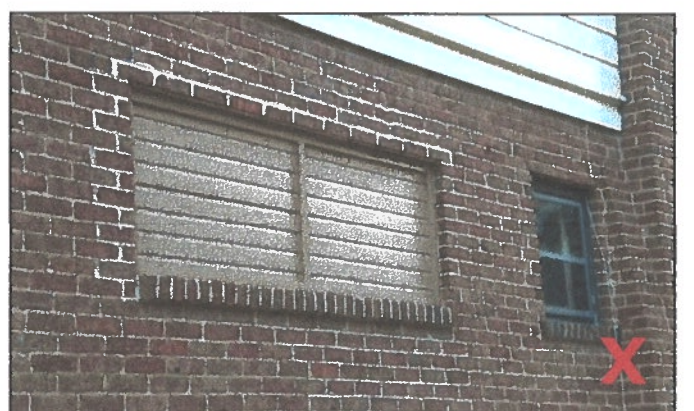
***Do not alter the character and symmetry of the façade by filling historic window openings.***

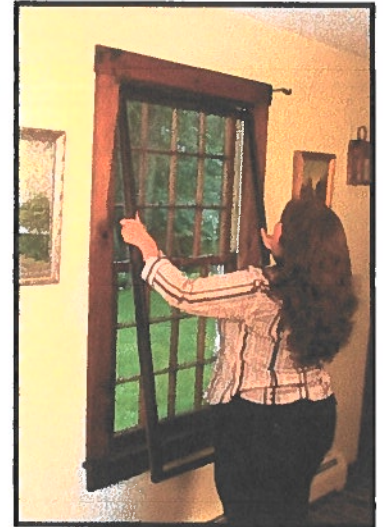
Storm windows can be used to provide an additional transparent barrier between the outside and inside of a historic home. Their installation creates an insulating air pocket which reduces heat transfer. Storm windows can be hung from the interior of a window and simply clipped or wedged into place (some even use magnets) for easy removal and cleaning. Some exterior storm windows may be appropriate provided that they have a thin frame and are used with either a decorative screen or in a manner that does not obscure any architectural details.

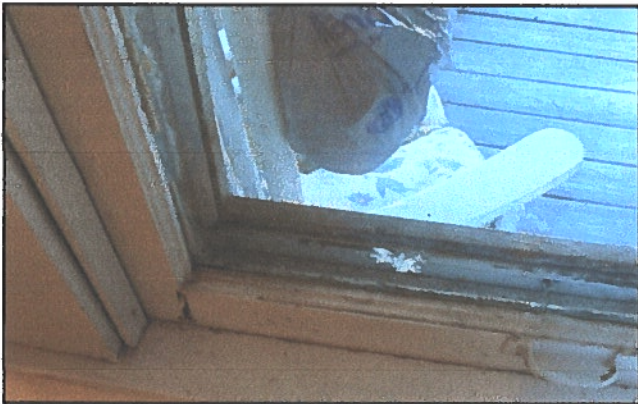
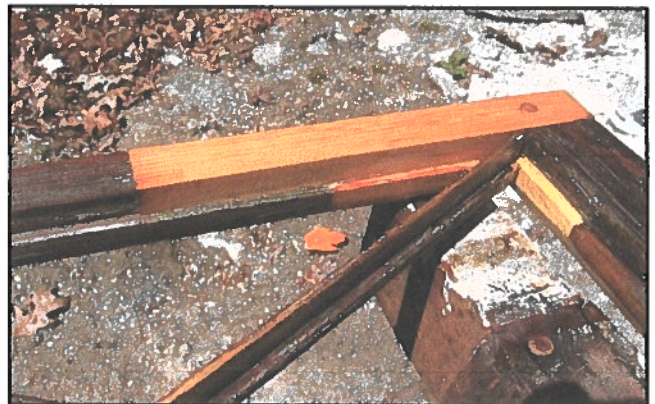
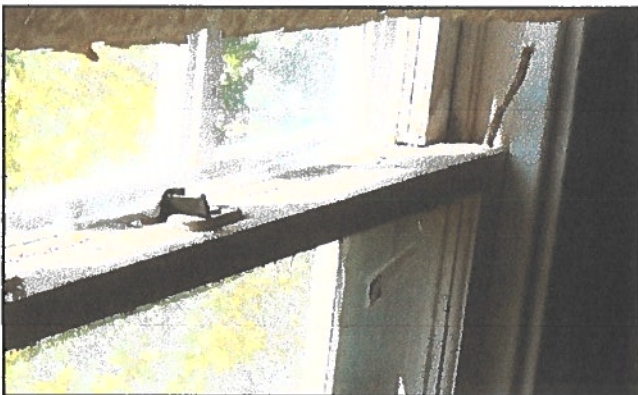
## Examples of Repairable Windows:

- Glass missing or broken;
- Meeting rails not aligning;
- Cords broken or hardware missing;
- Sill or frame rotted;
- Partially rotted rails and stiles which require patching.

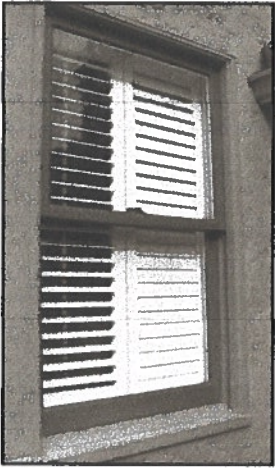
*6.B.iv. Install new windows to match the historic or existing windows in terms of size, type, configuration, material, form, appearance, and detail when original windows are deteriorated beyond repair.*

### Recommended stipulations for replacement:

Individual sashes should be replaced where possible. Should a full window unit require replacement, inserts should

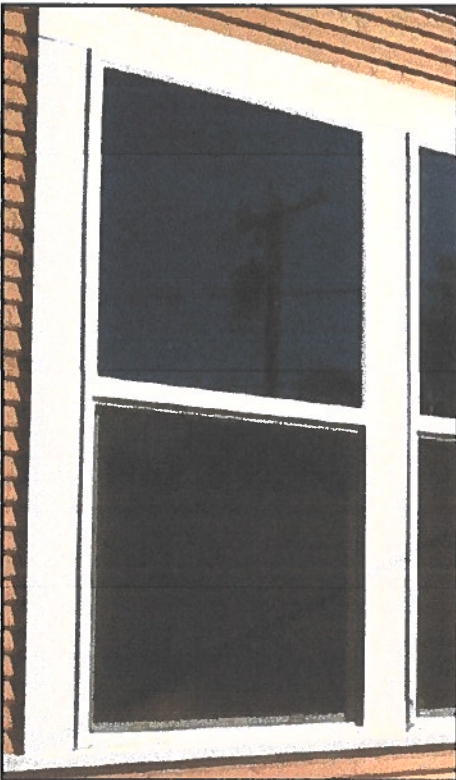
- Vinyl product changes the material
- Window is not recessed within frame
- Sash components do not feature traditional

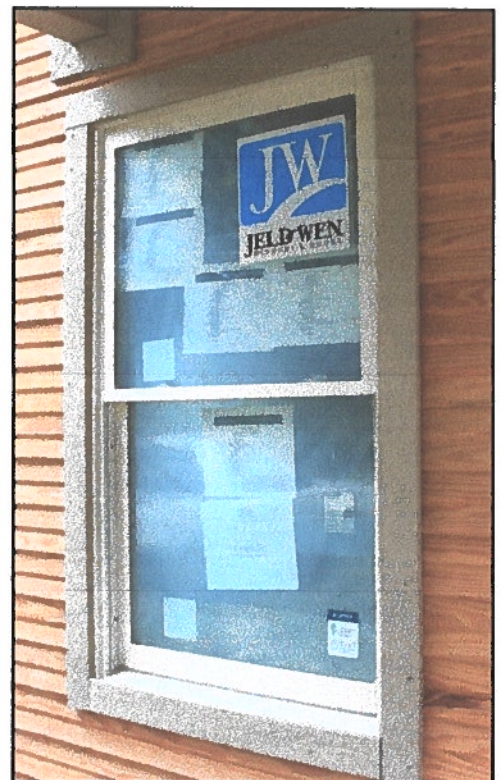
- Window trim and sill detail not consistent with original
